Standing Building Recording Survey & Archaeological Observation

Barn to south of
Green Farm
Preston-on-Wye
Herefordshire

NGR: SO 38427 41509
SMR No: 44552

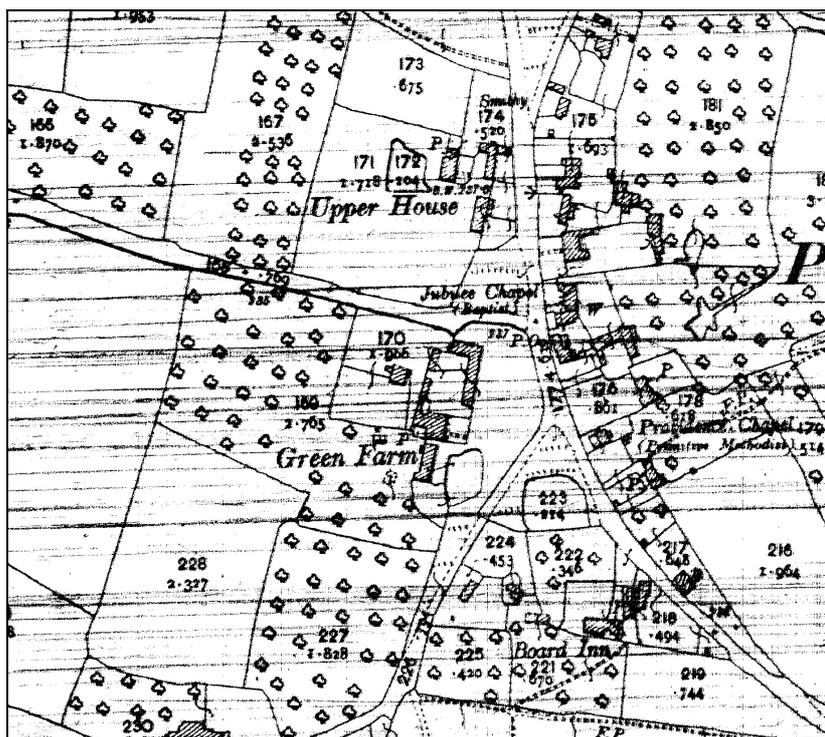
Comparison between the tithe map of 1844 and the OS 2nd edition map of 1904 indicates that a number of changes had been made to the ground plan of the barn during the intervening 60 years. Specifically, the 1844 map shows two wings projecting W at the N and S ends of the barn (**Fig. 2**). By 1904, however, the N wing had been demolished, leaving only the southern extension with its distinctive catslide roof, which still survives today (**Fig. 3**).

Fig. 3: Extract from OS 2nd edition 25 inch map of 1904 showing the barn SSW of Green Farm
 (Reproduced by courtesy of the Herefordshire Record Office)

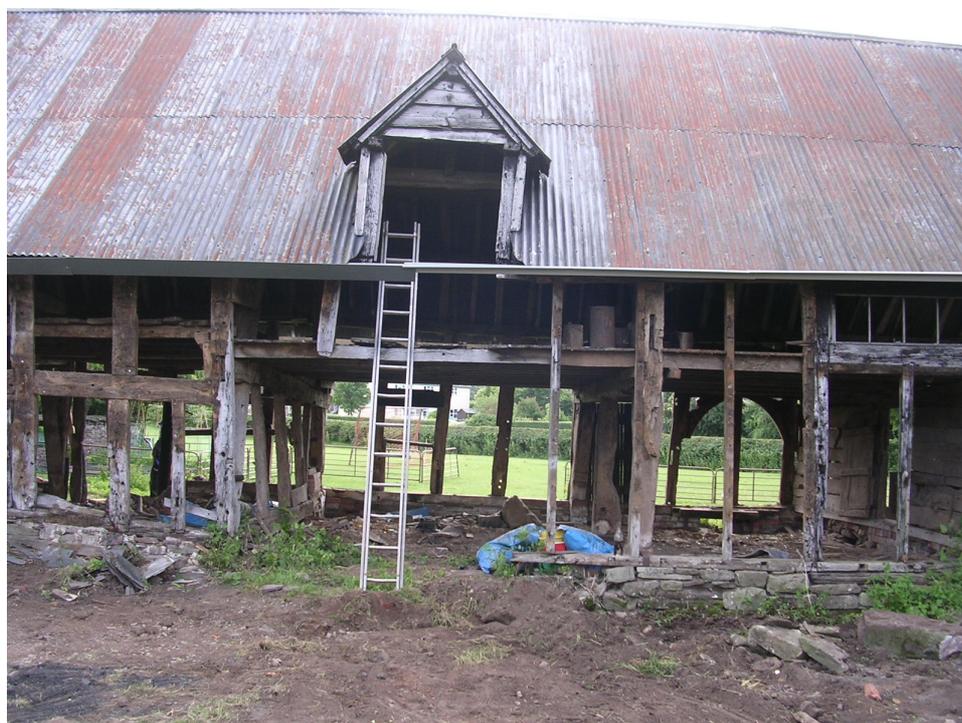
The principal, W-facing elevation comprised a wide central entrance for carts at ground floor level, measuring approximately 3m wide and 2m high, surmounted by a wooden lintel. Located 0.9m above the entrance was a gabled dormer set into the corrugated iron roof providing access to the upper storey of the barn, which previously served as a hayloft (**Plate 1**).

Plate 1: View E showing central two bays with entrance for carts in W-facing elevation of barn

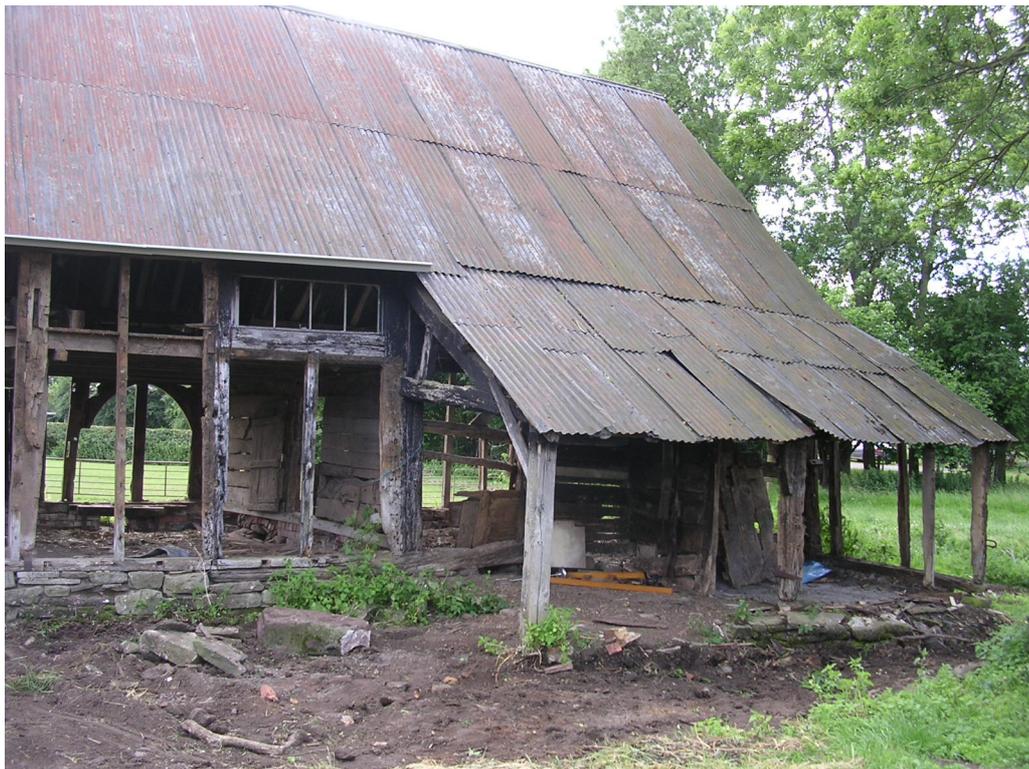
At the southernmost end of the W-facing elevation, a lean-to extension (formerly weatherboarded) measuring 5.26m (N-S) × 2.3m (E-W) had been added to the main structure of the barn with a distinctive catslide roof (**Plate 2**). The lean-to structure was presumably intended to function as a shelter for livestock; it is shown on the tithe map of 1844 together with a corresponding lean-to building at the N end of the W-facing elevation. However, by 1904 the lean-to structure at the N end of the barn had been removed.

Plate 2: View SE showing extension to S end of W-facing elevation with catslide roof, following removal of weatherboarding

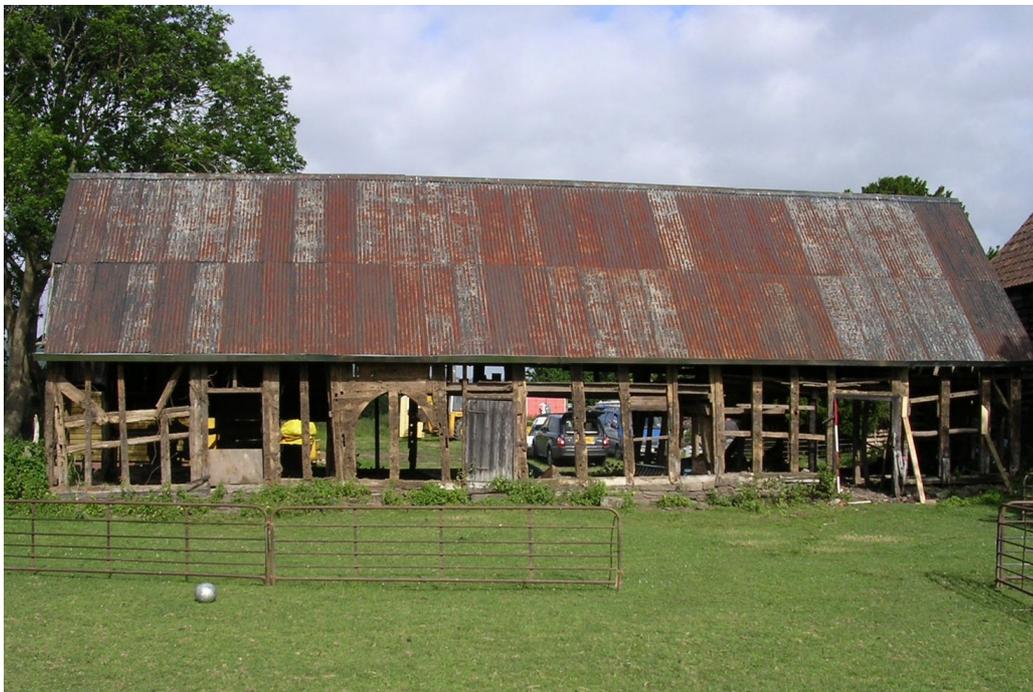
Plate 3: View W showing E-facing elevation of barn and internal timber-framing following removal of weatherboarding

The E-facing elevation of the barn was similarly clad with weatherboarding (prior to its removal) with three doorways of slightly varying sizes inserted at ground-floor level

(Plate 3). These doors appeared to be later insertions, not contemporary with the original construction of the building, and were presumably inserted when the structure was converted for use as stabling.

The smallest of the three doorways, giving access to the central bay of the barn, consisted of a plank-and-batten vertically hinged door surmounted by a wooden lintel. Two other plank-and-batten doors were inserted into the northernmost and southernmost bays of the E-facing elevation.

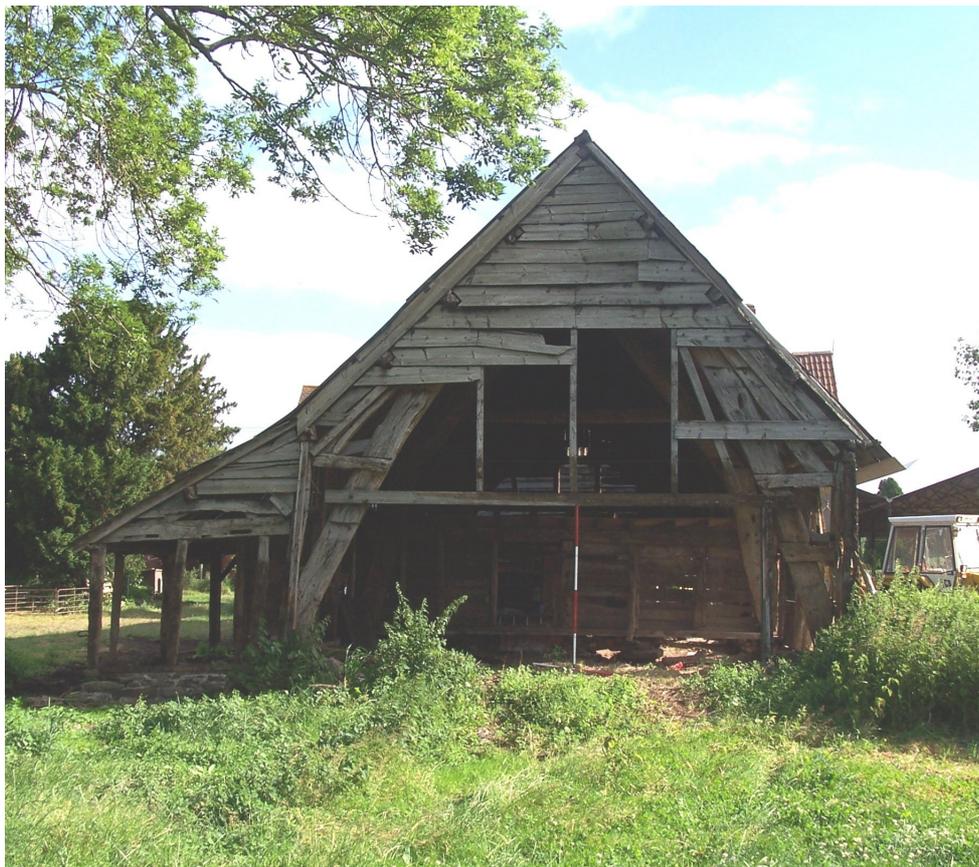
Plate 4: View N showing S-facing external elevation of barn following partial removal of weatherboarding

The S-facing gable elevation measured 6.4m × 7m, excluding the lean-to structure projecting to the W (**Plate 4**). Most of the weatherboarding had been removed prior to recording (excepting the apex of the gable), exposing the internal framing of the S gable with its tapering cruck blades.

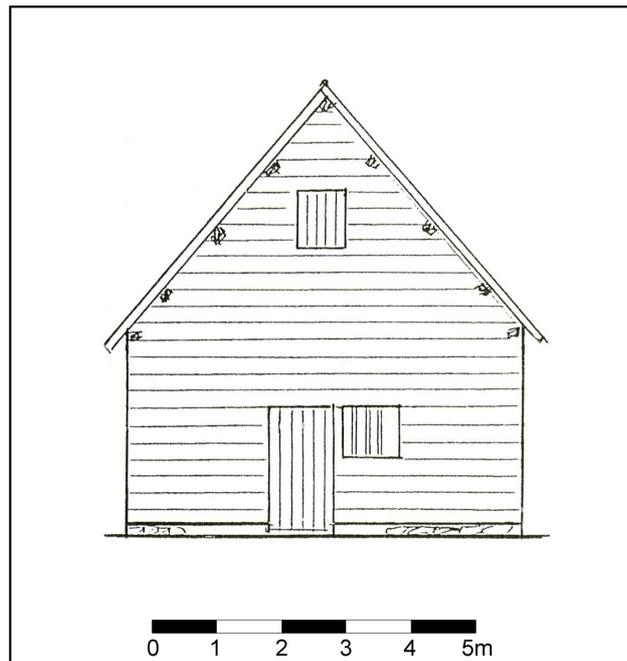
The N-facing gable elevation (**Fig. 4**) was formerly clad in weatherboarding and comprised a centrally placed rectangular entrance with a vertically hinged plank-and-batten door, immediately to the right of which was a small, four-light window with wooden mullions. Set into the apex of the gable above the central doorway was a small plank-and-batten hatch giving access to the hayloft at first-floor level.

Fig. 4: View N showing N external elevation of barn prior to removal of weatherboarding

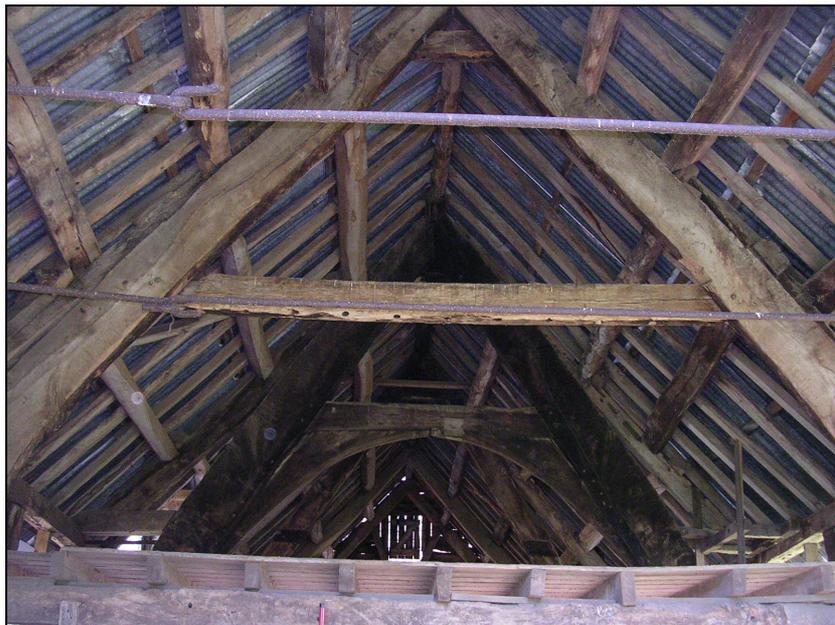
The removal of the weatherboard cladding at an early stage in the building works permitted a clear impression to be gained of the internal construction of the barn. Internally, the barn was divided into five bays, the roof framing (proceeding from N to S) consisting of a box-framed truss at the N gable end of the barn, followed by four regularly spaced full cruck trusses extending to the S gable end. Three tiers of trenched purlins and a ridge purlin extended along the entire length of the roof (**Plate 5**).

Plate 5: Internal view W showing roof framing comprising a series of cruck trusses with three tiers of trenched purlins and a ridge purlin

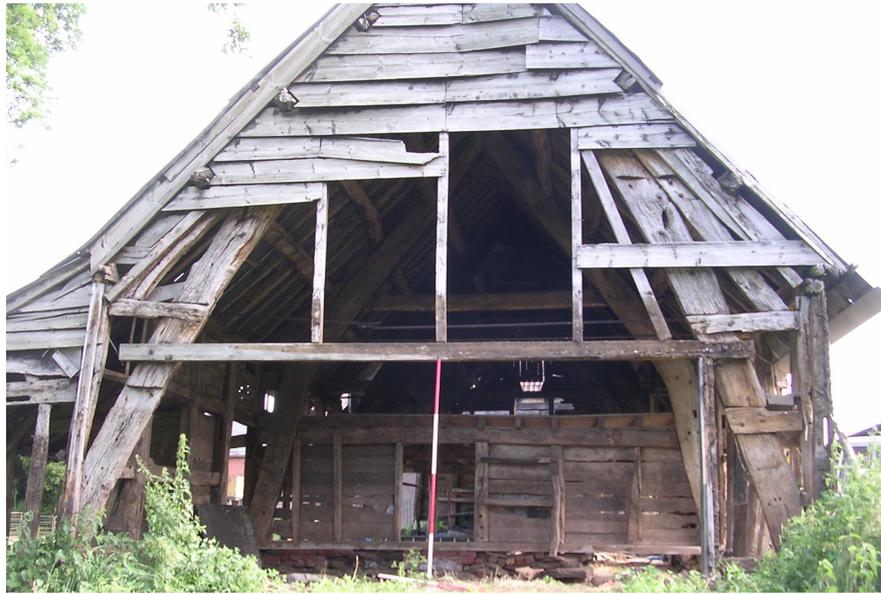
Plate 6: View looking N showing interior of southernmost bay of the barn and cruck framing

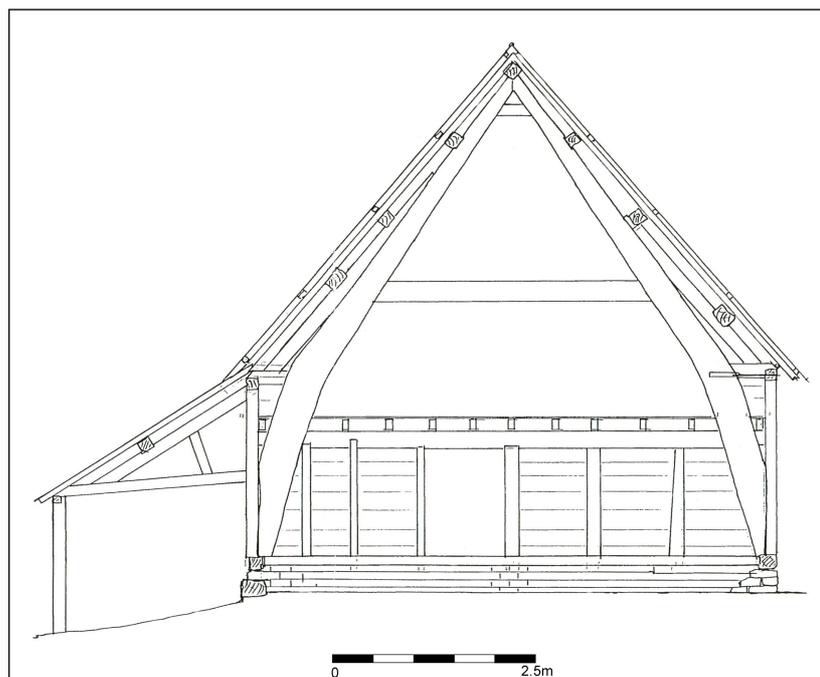
The open cruck truss at the S gable end of the barn comprised two smoothly curved, tapering cruck blades measuring approximately 0.15m thick and firmly linked to the wallposts by two sets of cruck spurs, one at wallplate level and the other some 0.3m below. However, the following truss to the N was differently constructed, consisting of two tapering cruck blades connected by a collar with a yoke at the apex of the truss and linked to the wallposts by a single set of spurs at wallplate level (**Plate 6; Fig. 5**). A low tie beam, 0.3m below the level of the wallplate, connected the cruck blades to the wallposts on either side, below which was a plank-and-batten partition wall with close studding, resting on a standard gauge red brick plinth three courses in height (**Plate 10**).

Fig. 5: View showing collared cruck truss and partition wall in southernmost bay of barn

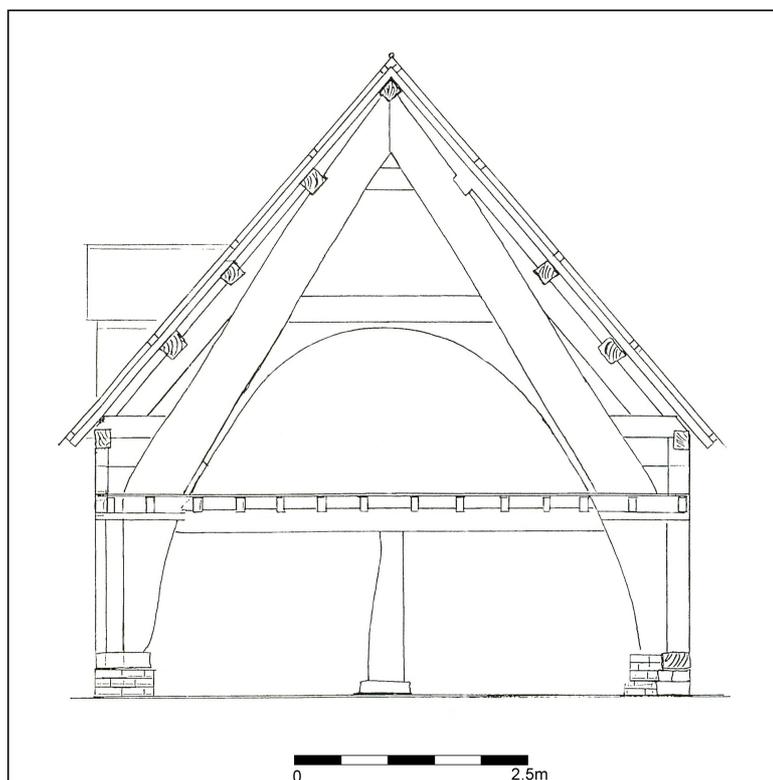
The following truss to the N, representing the central truss of the barn, was markedly different in construction from its predecessor, comprising two sharply elbowed cruck blades connected by a finely carved, arch-braced collar with a yoke at the apex of the truss. The thickness of the cruck blades was noticeably greater than those of the other cruck trusses, measuring 0.4m. The quality of the carpentry exhibited by this particular truss was in marked contrast to the roughly hewn character of the majority of the roof framing (**Plate 7; Fig. 6**).

Fig. 6: View looking N showing arch-braced cruck truss in central bay of barn

This truss was also noticeably smoke-blackened, compared to the other cruck trusses, implying the presence of a central hearth, and on this basis it has been convincingly suggested that this formed the central truss of a medieval open-hall house. However, no further structural evidence, in the form of a central hearth or louvre (a centrally placed opening in the roof to allow smoke to escape), was found to confirm this hypothesis. The cruck blades were joined to the wallposts by a single set of cruck spurs at wallplate level and were connected by a low tie-beam, which, in turn, was supported by a centrally placed, roughly hewn wooden post resting on a stone plinth.

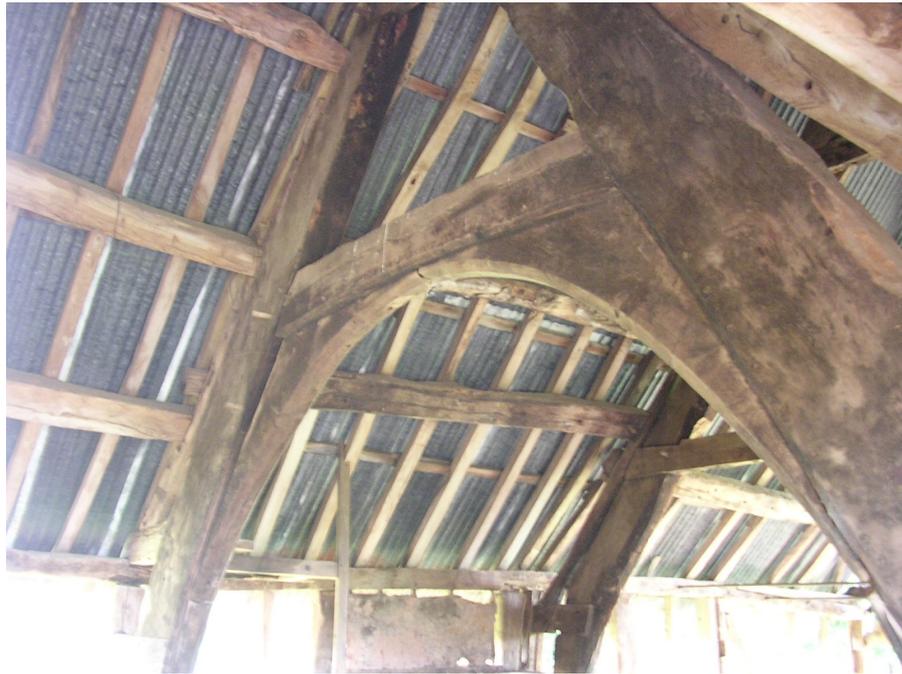
Plate 7: View SE showing smoke-blackened central truss of barn with arch-braced collar

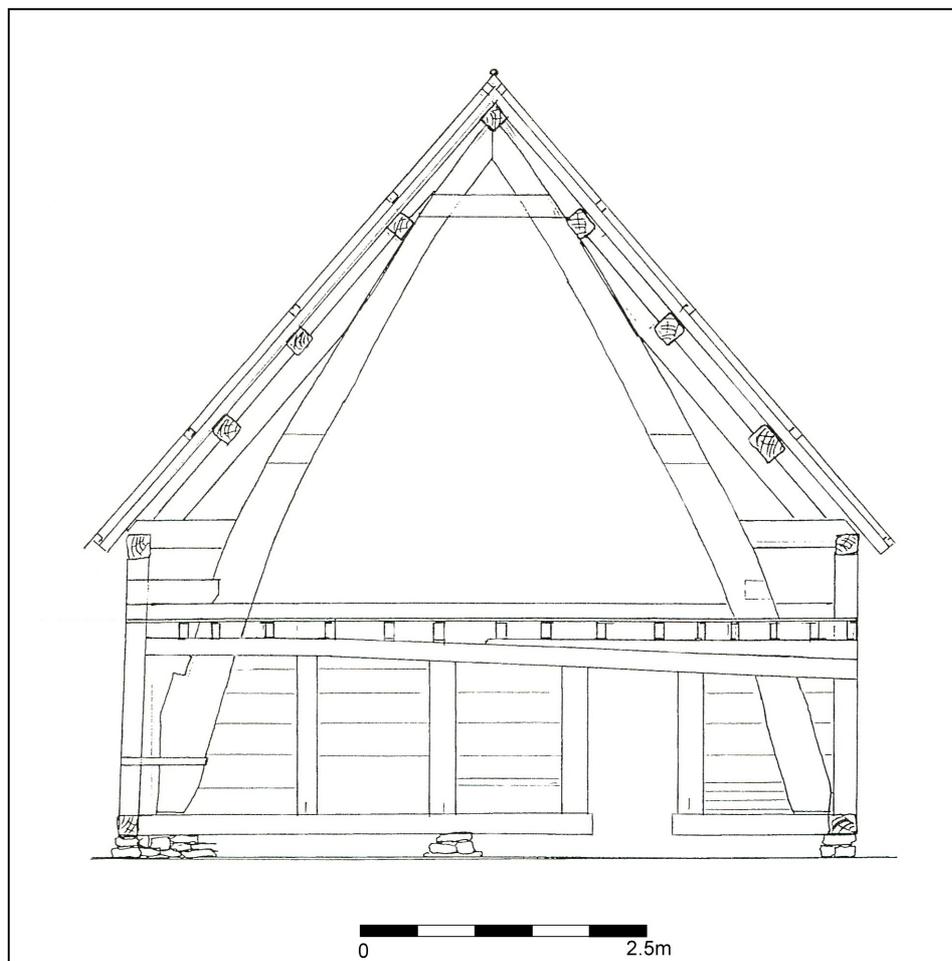
The next roof truss to the N exhibited significant evidence of alteration (**Fig. 7**). Although ostensibly an open cruck truss with a yoke at the apex of the truss, the evidence of slots inserted in the upper part of the cruck frame indicated that it was originally a collared cruck frame. The cruck blades were joined to the wallposts by two sets of cruck spurs at wallplate level and below. A close-studded plank-and-batten partition wall, resting on a stone foundation plinth repaired in brick, demarcated this bay from the northern two bays of the barn. The N gable truss was of typical box-frame construction, with a tiebeam at wallplate level and a collar above, both of which were connected to the principal rafters by angled braces.

Fig. 7: View N showing open cruck truss (originally collared) with wooden partition wall resting on stone plinth

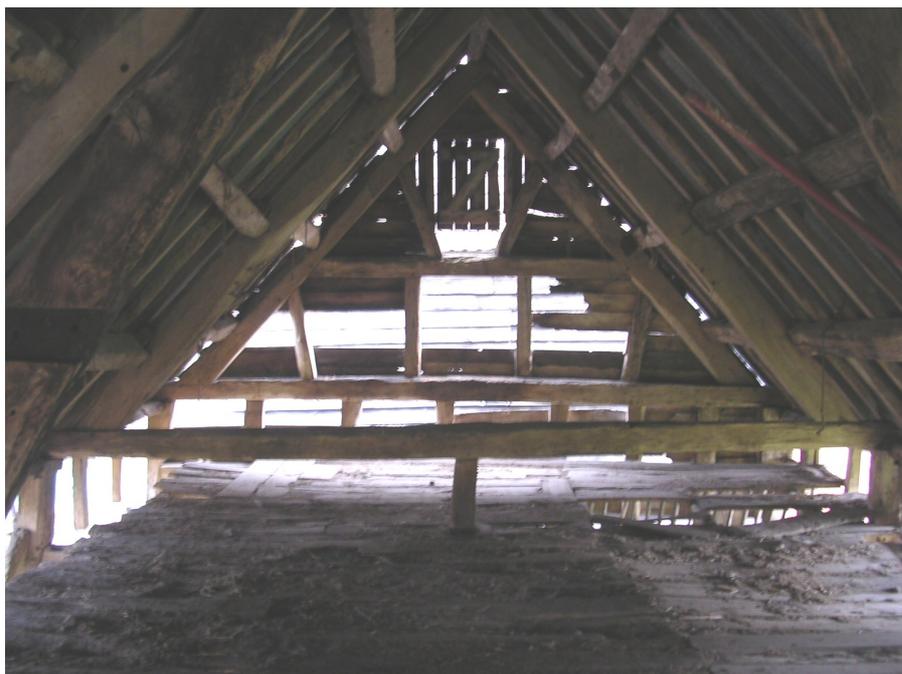
Plate 8: Internal view N showing roof framing of northernmost bay of barn

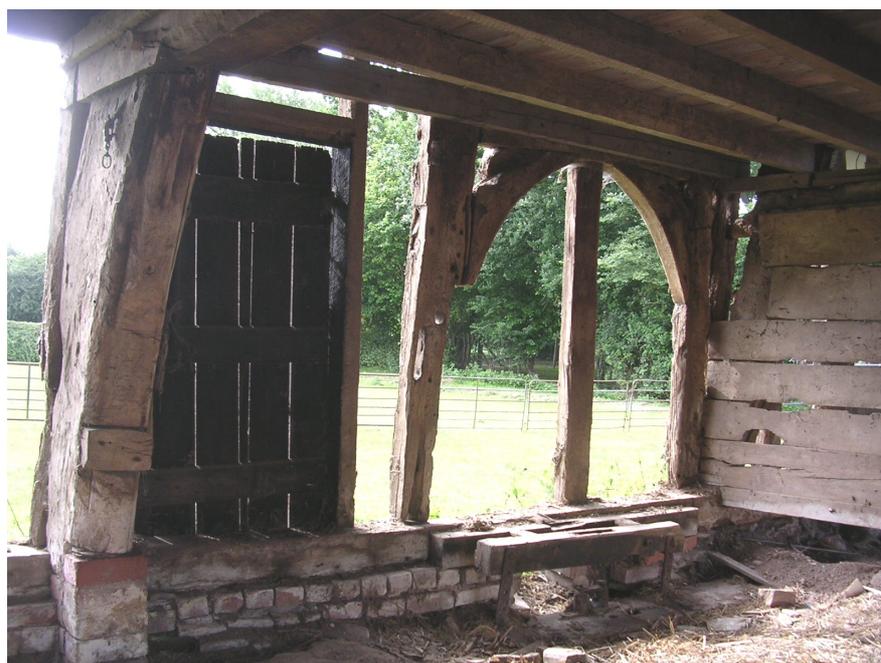
Plate 9: Internal view SE showing panels with curved braces to right of centre doorway in E-facing elevation

The wall framing of the barn exhibited evidence of significant alteration and rebuilding. The framing of the internal E-facing elevation was composed of a series of regularly spaced vertical studs extending from sill to wallplate level, interrupted by two tiers of rails. There was a noticeable difference between the carpentry of the studs (which were squared timbers) and the roughly hewn rails. Of particular interest were the two panels to the right of the centre doorway in the E-facing elevation, with a central stud flanked by two curved braces, which appeared to be reused timbers, connecting the studs on either side to the wallplate (**Plate 9**).

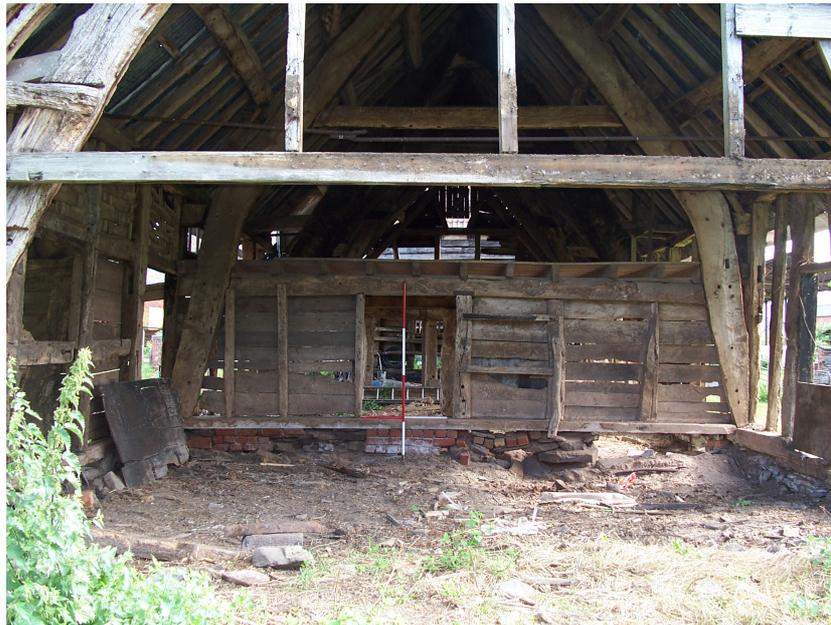
Plate 10: Internal view N showing interior of southernmost bay of barn with collared cruck truss and wooden partition standing upon a 19th century red brick plinth

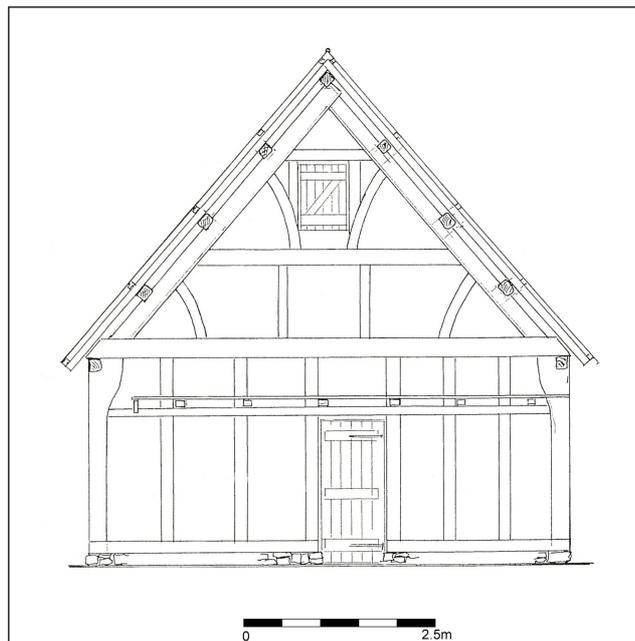
Fig. 8: Internal view showing N gable elevation, of box-framed construction

of a series of closely spaced studs resting on an irregularly coursed stone plinth partly rebuilt in brick and standing to two courses in height (**Fig. 8**).

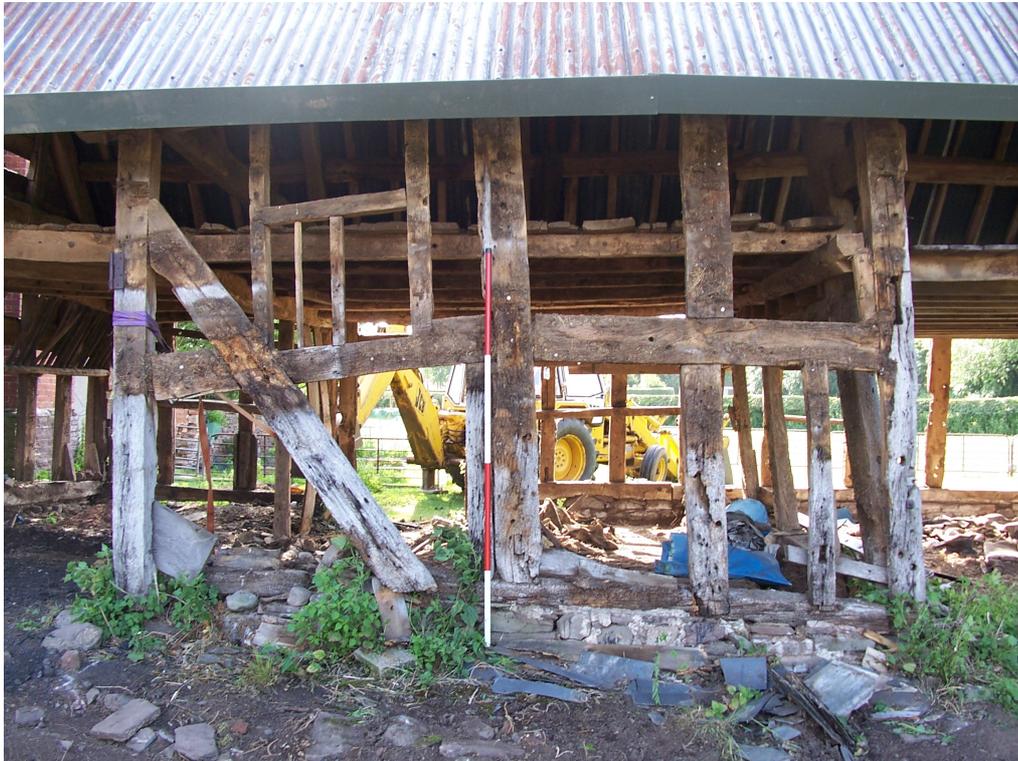
The framing of the W-facing internal elevation, which appeared to have been heavily truncated prior to recording, consisted of a series of regularly spaced vertical studs from sill to wallplate level, with a single tier of roughly hewn rails. Evidence of a mullioned window frame, concealed by the weatherboarding, was identified in the central bay of the elevation (**Plate 11**). Remnants of infilling comprising a series of split-oak pales woven around vertical oak staves were visible in the upper part of the framing in the southernmost bay of the elevation (**Plate 12**). The wall framing of the N gable consisted

Plate 11: View looking E showing wall framing of W-facing elevation with partial remains of window frame

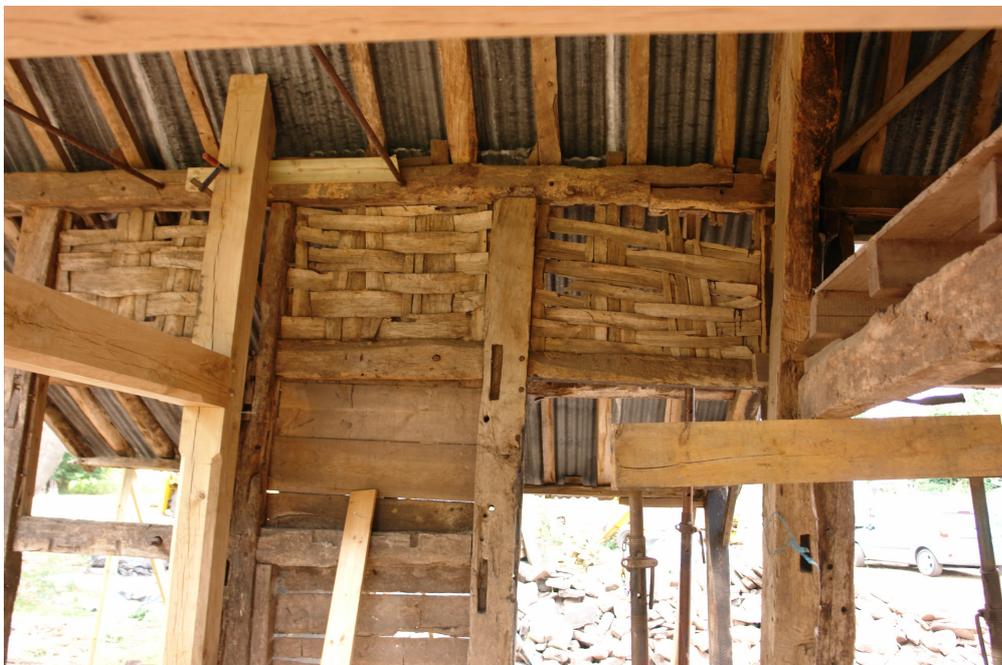
Plate 12: Internal view W showing infilling consisting of split-oak pales woven around vertical oak staves in upper framing of southernmost bay of barn

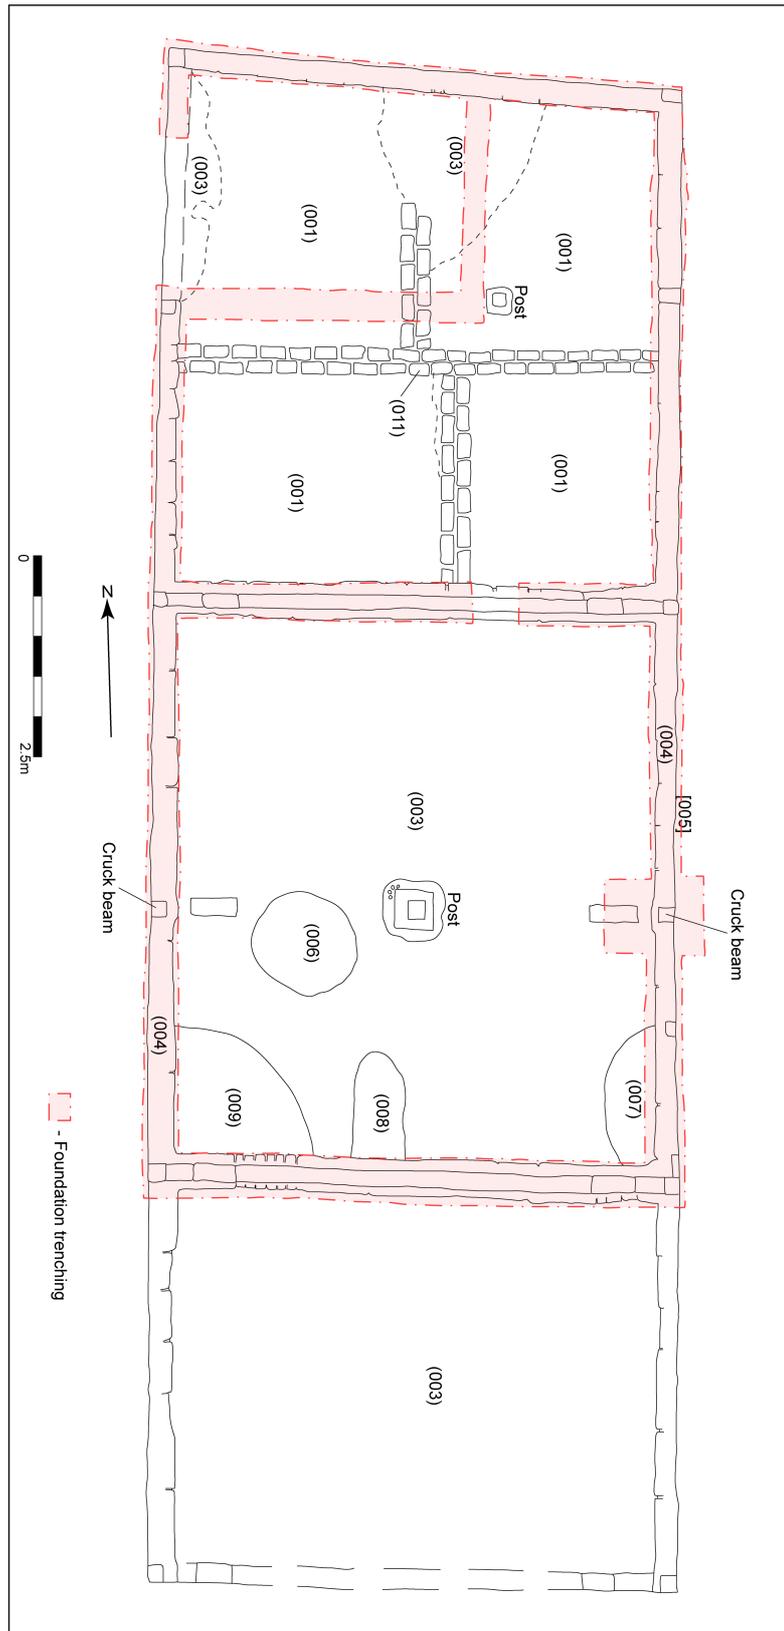
Fig. 9: Plan showing archaeological features revealed within interior of barn during observation of foundation trenching

A total of 11 contexts were identified during the archaeological observation of groundworks (**Fig. 9**), the uppermost of which was a cobbled surface (001) extending across the northernmost two bays of the barn measuring 6.4m (N-S) × 5.4m (E-W) × 0.2m, with frogged red brick channels (011), two courses in width and bonded with cement, extending E-W and N-S across the centre of the cobbled surface (**Plate 13**).

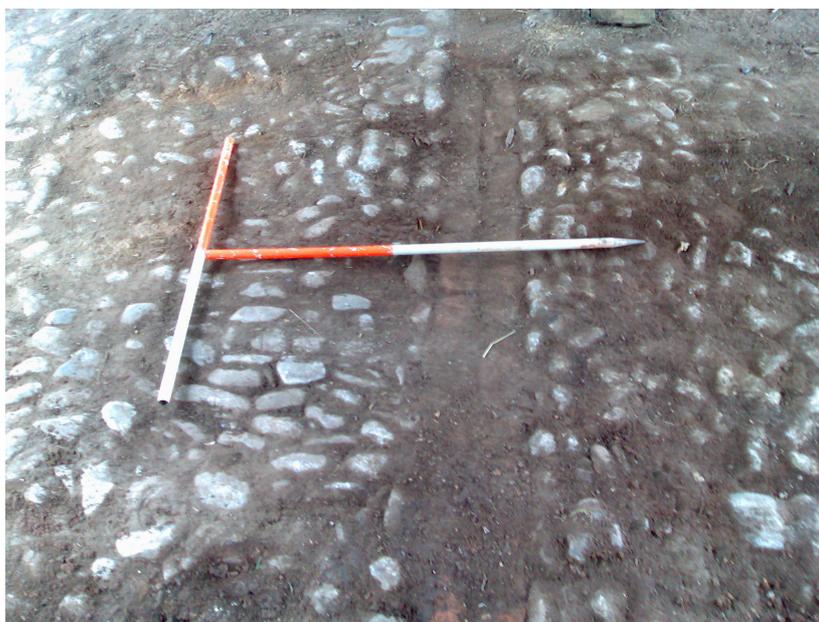
Plate 13: View looking N showing cobbled surface (001) with brick channels (011) at N end of barn

The cobbled surface appeared to be contemporary with the construction of the N extension in the 17th/early 18th century while the brick channels appeared to be a later insertion. The bricks bore the stamp of the Holmer Brickworks at Hereford, which is known to have been in operation from the 1830s onwards.

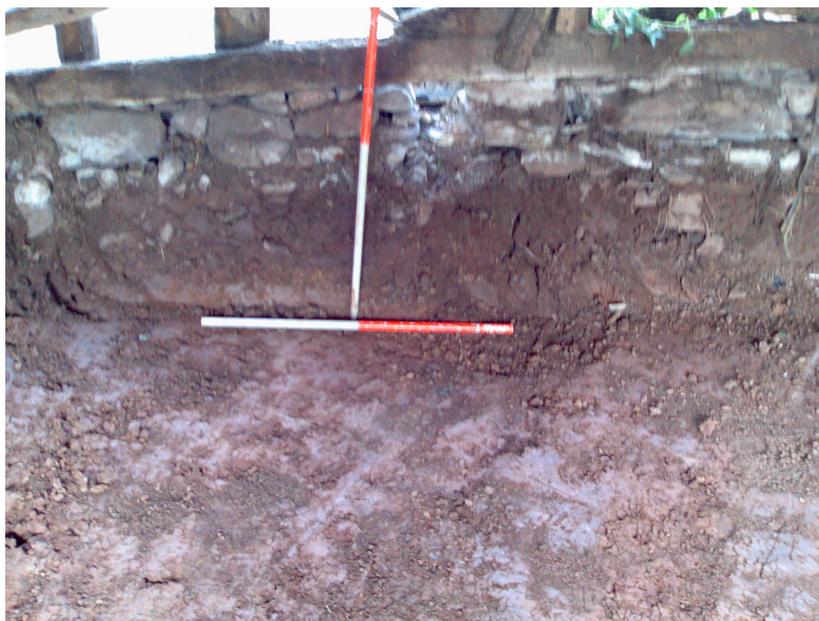
Revealed in section, cutting into (003), was [005], the foundation cut for the outer wall of the barn, measuring 0.35m wide and 0.3-0.4m deep, with a sharp break of slope at the top, vertical sides and a flat base (**Plate 14**). The outer wall itself (004), measuring 0.35m wide and 0.6m in high, was constructed of roughly worked, randomly coursed sandstone blocks with extensive repairs in frogged red brick bonded with a lime mortar. It was extremely difficult to determine which parts of the extant sandstone masonry related to the original construction of the barn or to subsequent rebuilding work that took place in the 17th/18th century.

Plate 14: Internal view looking W showing foundation plinth (004) cutting into subsoil deposit (003)

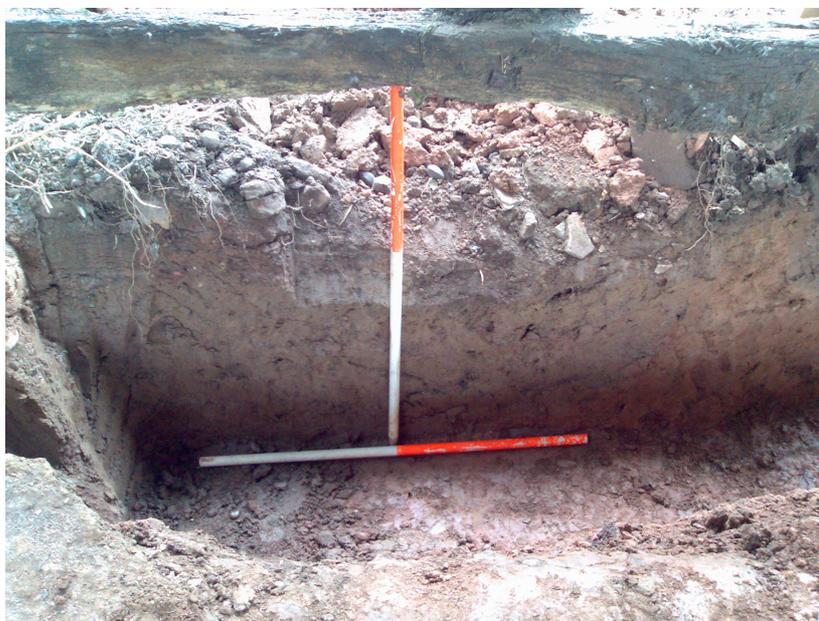
Identified in section in the extreme NE corner of the barn, cutting into (003) and underlying the foundation plinth (004), was [010], the cut for a pit of indeterminate function measuring 1.9m × 0.62m, with a gradual break of slope at the top, gently sloping sides and a concave base (**Plate 15**). [010] was filled by (002), a moderately compacted mid brown sandy clay with frequent charcoal flecking. No finds were recovered from this deposit.

Plate 15: View looking E showing pit feature [010] in NE corner of barn

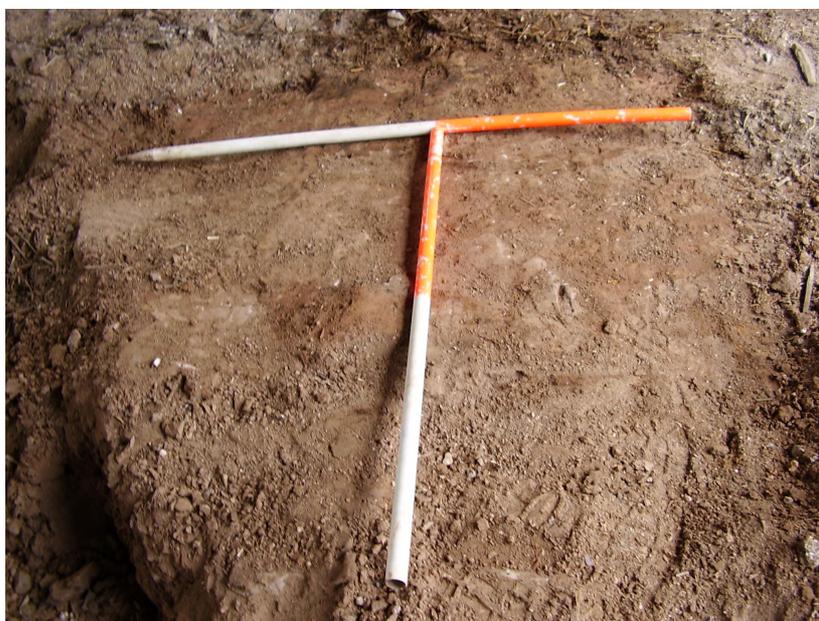
Plate 16: View S showing remains of rammed clay floor surface (009) in SW corner of barn

(009)	Weakly cemented mid brown silty clay, moderate subangular stones (2.5m x 0.1m). Overlies (003).
<i>INTERPRETATION:</i>	<i>Remains of rammed clay floor surface</i>
[010]	Cut measuring 1.9m x 0.62m, gradual break of slope at top, gently sloping sides, gradual break of slope at base. Filled by (002). Cuts (003). Underlies (004)
<i>INTERPRETATION:</i>	<i>Cut for pit of indeterminate function</i>
