ARCHAEOLOGICAL OBSERVATION

**No. 19 St Thomas Street
Winchester
Hampshire**

NGR SU 4798 2928

BORDER ARCHAEOLOGY

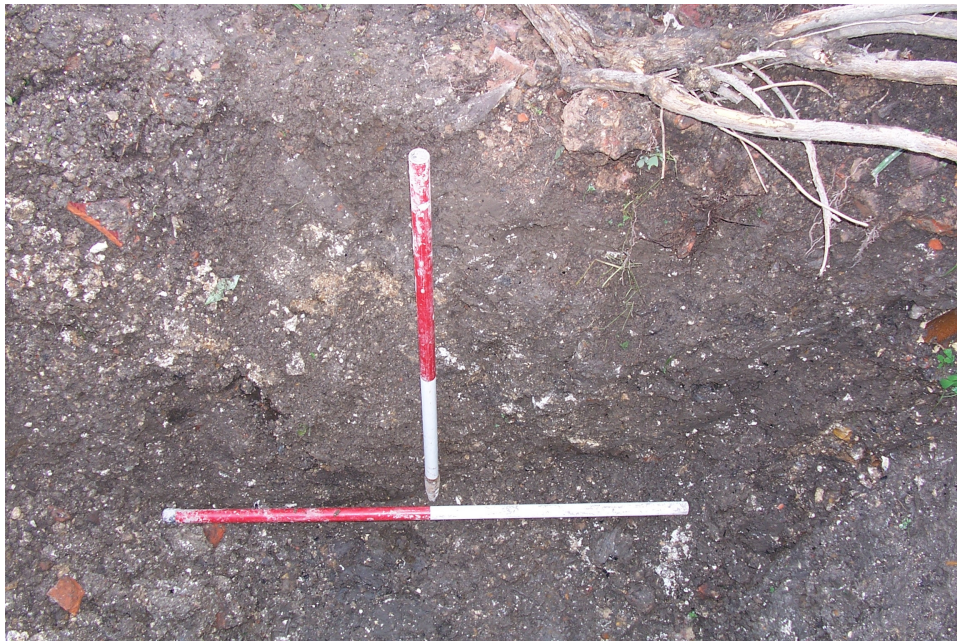
Plate 2: General view of Trench 1, looking NE

The initial phase of groundworks consisted of the excavation of a trench measuring 10m x 0.6m x 0.5m for the installation of a drainage pipe, which ran in a NW-SE direction from the SW corner of No. 19 to the S side of the proposed new extension. The majority of the trench consisted of a loose dark brown sandy silt with occasional post-medieval brick, charcoal and mortar flecks (107) extending site wide to a depth of 0.4m (**Plate 2; Fig. 4**). Underlying (107) was a thin loose to moderately compacted layer of chalk with small amounts of light brown silty sand within its make-up (114). Underlying (114) was a loose dark brown sandy silt with occasional post-medieval CBM (116), which ran to the base of the trench.

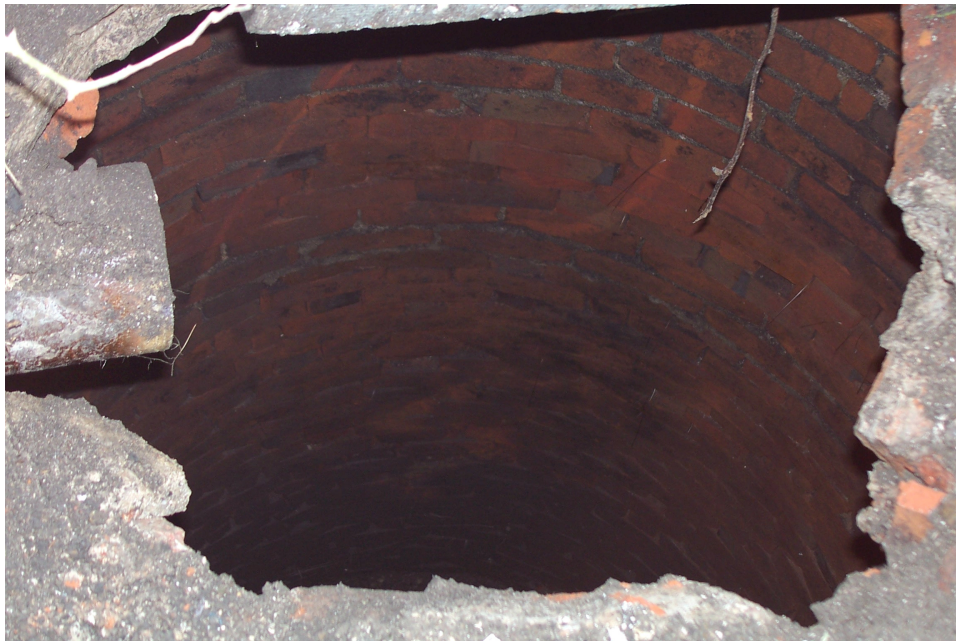
Approximately 3m from the SE end of the trench, was a brick-lined well (111), which had been incorporated as a soak-away for a later, modern drainage pipe, and what appeared to be a domed cap to the well had been mostly removed as part of this process. The well was constructed in irregular Flemish bond and bonded with a cement mortar. The well was more than 1.5m in diameter and over 3m deep, although it appeared to have partially silted up (**Plate 3**).

Plate 3: Post-medieval brick-lined well (111)

No obvious evidence of a construction cut relating to the well was identified, although this might have been due to the interpretative constraints imposed by the narrow

trenching, combined with the homogenous nature of the surrounding post-medieval soils. Unfortunately, the condition of the well was such that no drawn record could be made; however, no further damage occurred during the excavation of the trench and the well was later backfilled with material from the other trenches. The trench also cut through a brick foundation for the post-medieval extension to No. 19 (104).

The remainder of the features identified are of post-medieval date and relate to the mid-late 18th century house and later 19th century extensions. These include the brick-lined well identified in Trench 1 and the foundations of the S wall of the rectangular annexe extending to the W of the house, which is shown on the OS 1st edition 25-inch map of 1870.

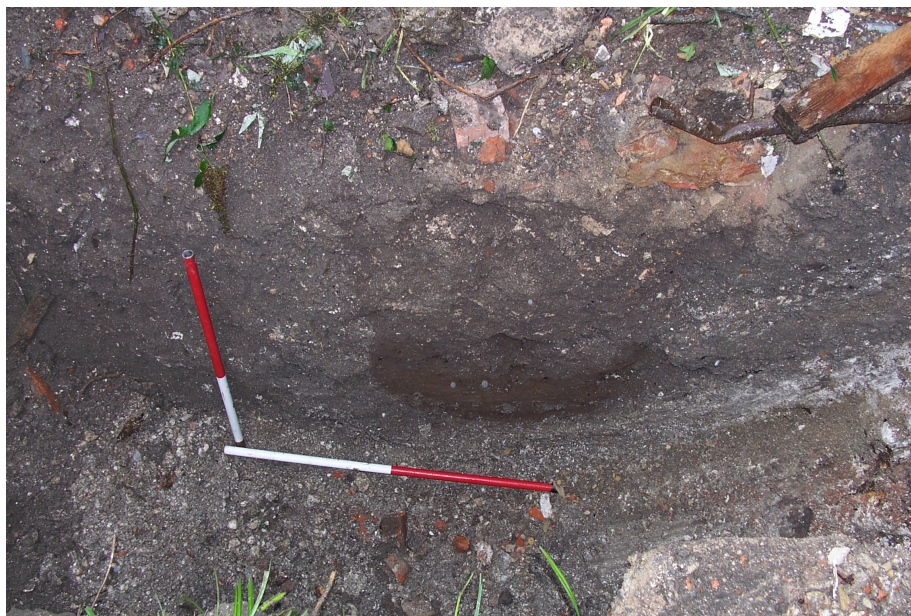
Plate 4: Trench 2 section with pit [112], view N.

Trench 2 measured 2.6m × 0.8m × 2m and was initially intended to connect with Trench 3; however, it was subsequently abandoned as no deposits of the required solidity were encountered within the trench (**Plate 4**).

Running along the length of the trench were the foundations for the now-demolished extension to No. 19 (106). These consisted of chalkstone with limited evidence of working and shaping within a concrete matrix. Underlying this foundation was a linear cut [108] and associated fill (109), the cut being orientated on the same line as (106). The fill was a loosely light brown mixture of CBM, chalk and silty sand with occasional pieces of slate (**Fig. 6**). The relationship of this cut and fill with (106) was unclear and it appeared that [108] may, in fact, have represented a robber trench relating to a foundation predating the laying of (106). This raises the possibility that the current building project would be the third extension to the rear of No. 19 to have been built on virtually the same footprint.

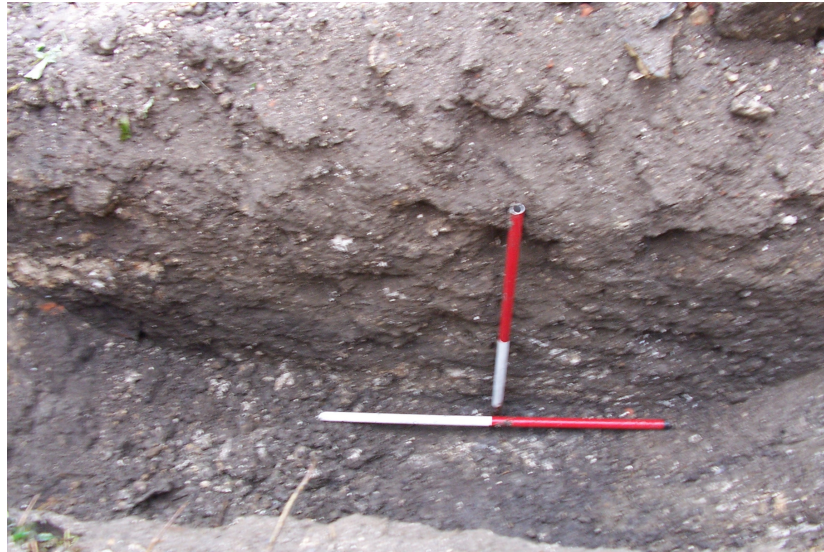
Plate 5: Trench 3 - View looking W.

Trench 3 was orientated N-S and measured 2.3m x 0.8m x 1.14m (**Plate 5; Fig. 7**). Again, this trench was partially excavated but abandoned after Trench 2 failed to locate any suitably stable deposits. Three layers of deposition were revealed, the first of which was (107). This overlay (121), a loose mixture of off-white chalk and light brown silty sand, beneath which was (120), a loose dark brown sandy silt with occasional post-medieval CBM. Context (120) was the same as (116). A single fragment of salt-glazed ware of probable 15th-16th century date was recovered from context (107); no other finds or features were revealed.

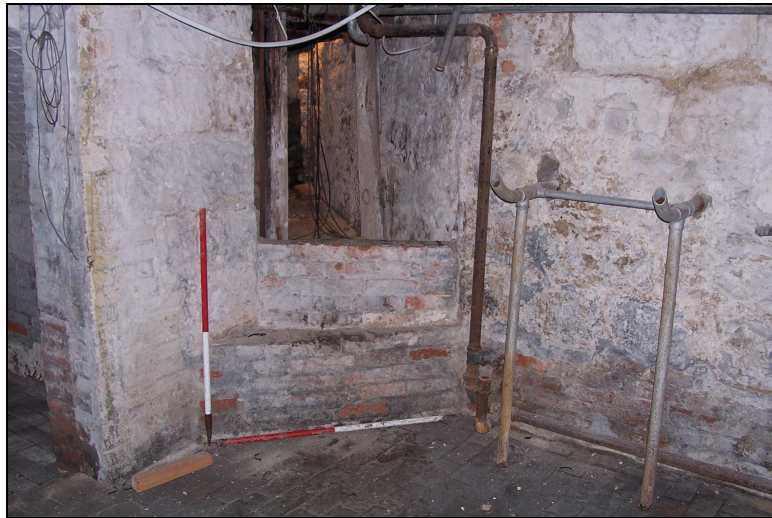
An unusual chalk masonry passage and semicircular chamber were revealed beneath the floorboards of No. 19 (**Fig. 8**). Both structures were incorporated within the later post-medieval cellarge but appeared to predate it. The passage consisted of two chalkstone walls and a later raised brick floor that appeared to have elevated the floor level by at least 0.5m (**Plate 6**).

The exposed masonry of the passage consisted of five courses of rough-hewn chalk blocks, which were bonded with a lime mortar and bore clear evidence of chisel marks (**Plates 6 & 7**). The stones varied in size but were generally quite large with some being more than 0.5m in length; traces of coarse render / plaster were also noted. The passage ran diagonally NE-SW off the cellar, in the SW corner of which was the entrance.

Plate 6: View SW showing entrance from cellarage into passage

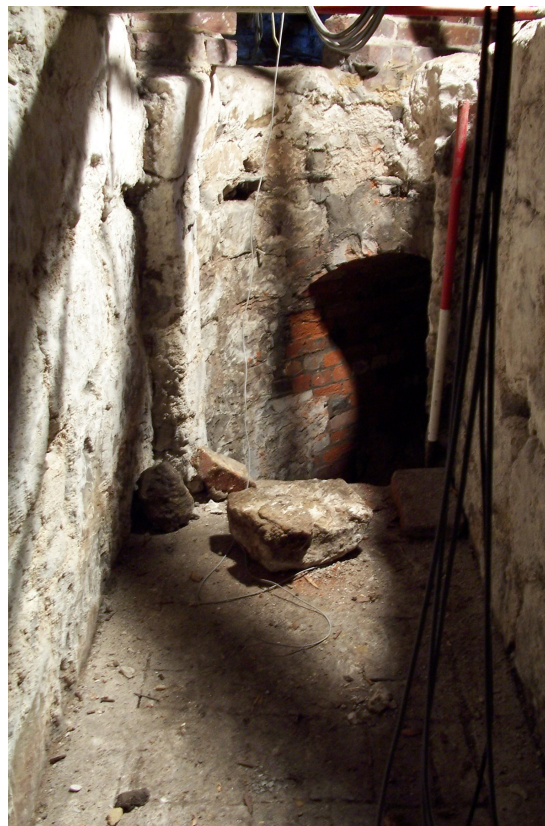
Plate 7: View looking SW along passage from cellarage entrance

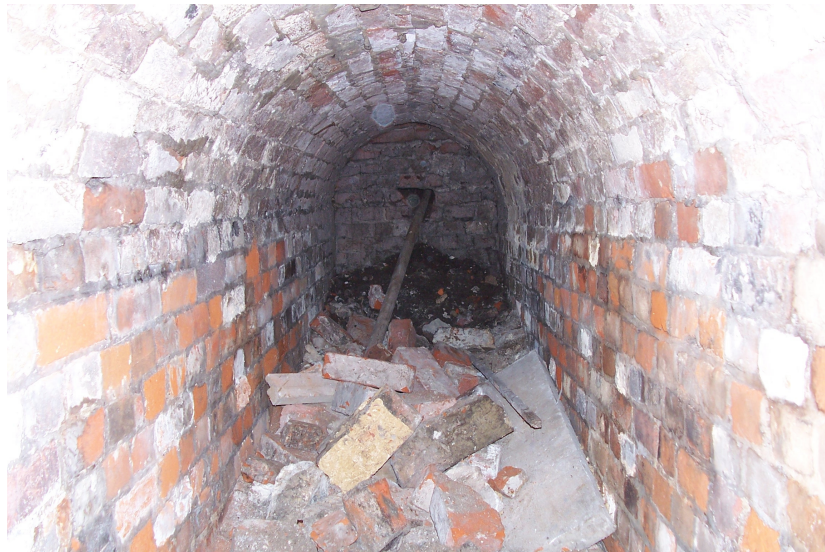
At the SW terminus of the passage was a semicircular chamber of similar rough-hewn blocks, although one side had been modified to incorporate a brick-lined tunnel leading to the western end of the house (**Plate 8**), at the W end of which was a ventilation shaft leading up to ground level. A slight curvature at the top of the chamber suggests that this may have once supported a domed roof. The entrance from the passage into the chamber was slightly recessed and two slots were noted in the walls adjacent to this, which may have held a beam or a door-bar (**Plate 9**).

Plate 8: View looking NW showing brick tunnel from chamber to western side of No. 19.

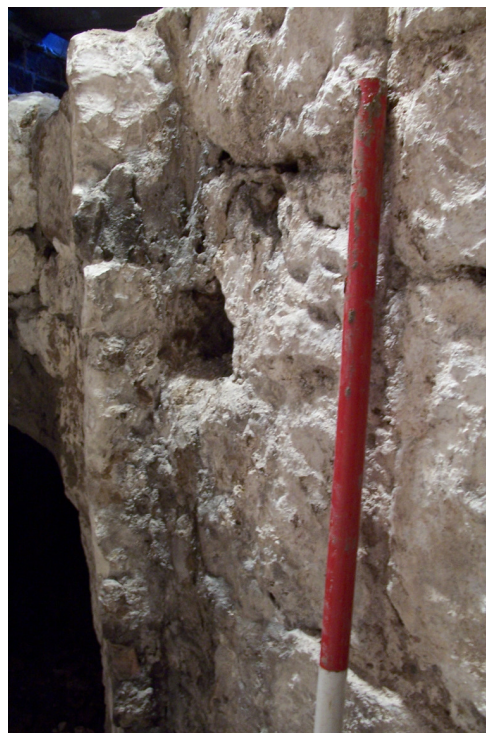
Plate 9: Detail showing slots within masonry wall of passage adjacent to chamber entrance, looking SW
