Archaeological Observation

46-50 Denmark Road Gloucester

NGR: SO 8355 1947 Report No. BA0414MBDR

August 2004

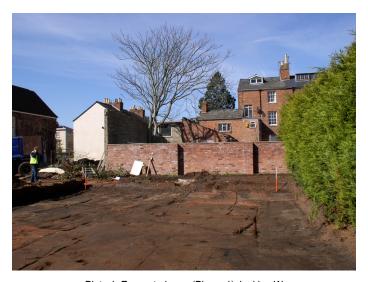
Plate 1: Excavated area (Phase 1), looking W

In general, the site showed evidence of multiple re-use, the ground surface lying approximately 0.5m above the level of the gardens located to the west and north. The trench excavations revealed a build-up of mixed rubble, iron slag, gravel and concrete overlying the natural surface of mixed sand and gravel.

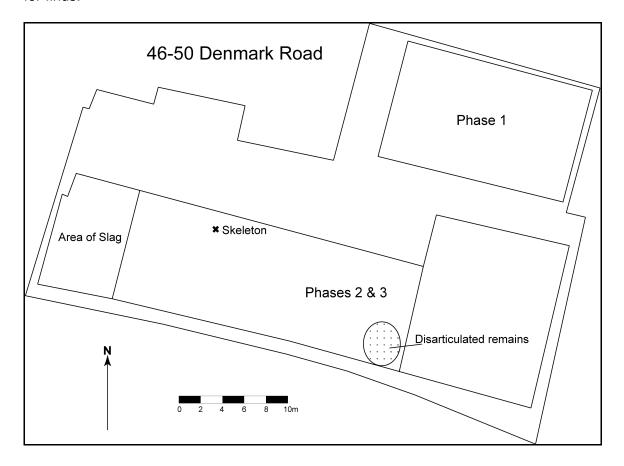
Fig. 2: Plan of site layout

Phase 1 covered an area of approximately 18m x 11.4 m in the NE corner of the site (**Fig. 2**). This area was originally part of a garden belonging to the terraced housing to the W but was more recently used as a sand and gravel storage area.

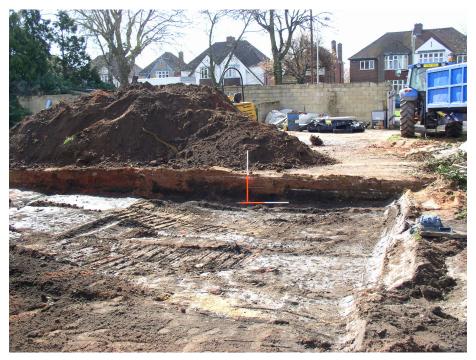
Plate 2: Excavated area, phase 1, looking S

The area was excavated by machine in spits of approximately 100mm, the amount of material removed being approximately 500 mm on the western edge decreasing to none on the eastern edge.

The area was covered by a mixture of red / yellow sand and 10mm gravel mixed with general building rubble and paving slabs to a depth of approximately 250 mm. Beneath this was a dark brown / grey humic soil containing fragments of building rubble and occasional gravel.

A double row of fractured and broken garden edging tiles, approximately 400mm apart, ran E-W across the centre of the area and was left in-situ. The spoil contained several fragments of modern domestic pottery and clay pipe fragments but no features of archaeological significance were found.

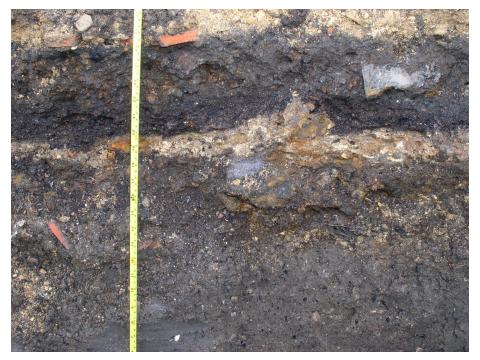
Plate 4: Profile of trench at western edge of the site showing the cast-slag floor

The NW end of the site revealed an extensive area of iron slag that had been cast in-situ to form a floor or working surface (**Plate 4**). This slag contained iron or steel fragments

(1mm to 2mm) and spherical beads indicating that the material had been poured from a furnace or crucible. The slag floor varied between 100mm and 300m in thickness.

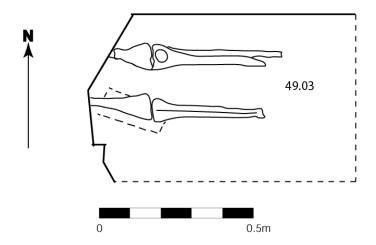
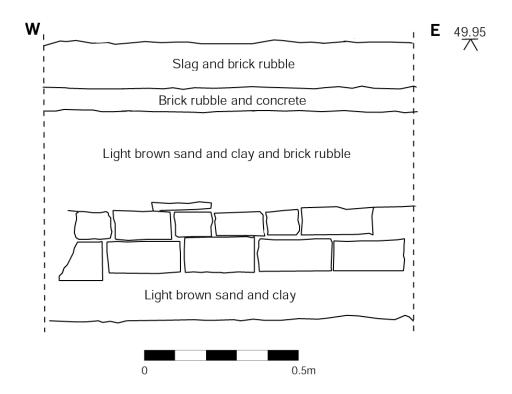
Figures 3 & 4: Human skeletal remains located in central area of site (above) and trench section showing brickwork located immediately S of inhumation

Protruding from the E facing section of the baulk within the central area of the site (**Fig. 2**) were the articulated leg bones of an extended supine adult inhumation orientated E-W, with the head located at W (**Plate 5**; **Fig. 3**). The majority of the skeleton remained undisturbed within the baulk; exposed were the L and R femur (distal end) and the L and R tibia (c.0.30m in length - distal ends removed during excavation). The L fibula was present but broken; the L patella was also present. Recovered foot bones included occasional metatarsals and phalanges. Only the base of the grave cut was visible and no evidence of grave goods was identified.

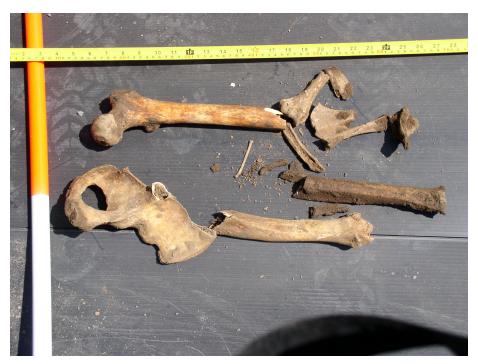
Plate 9: Disarticulated remains found in the SE area of the site

Also found within Phase 3, within the southeastern part of the site, was a quantity of disarticulated human remains (**Fig. 2; Plate 9**).

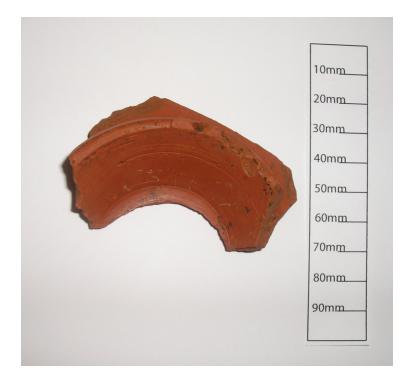
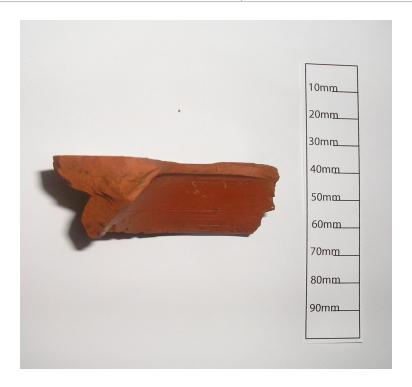
Plates 10 & 11: Sherd of Gaulish Samian consisting of a base/pedestal of a carinated vessel

The R knee appeared to be resting on a small sub-rectangular stone and in close proximity to the remains was a single unstratified sherd of Gaulish Samian consisting of a base/pedestal of a carinated vessel (**Plates 10 & 11**). The diagnostic limitations of the sherd are apparent due to a lack of decoration and potters stamp thus excluding a specific kiln centre or Imperial dynasty. A provisional date may be sought due to the known date range of production and cessation of this type of fine ware, the sherd probably predating the latter part of the 2nd century. The form of the base may be of a type 37, a hemispherical bowl introduced around AD 70.
