# Standing Building Recording Survey

Woodrow Farm Barns  
Hanbury  
Worcestershire

NGR SO 96301 63662  
WSM No. 38545

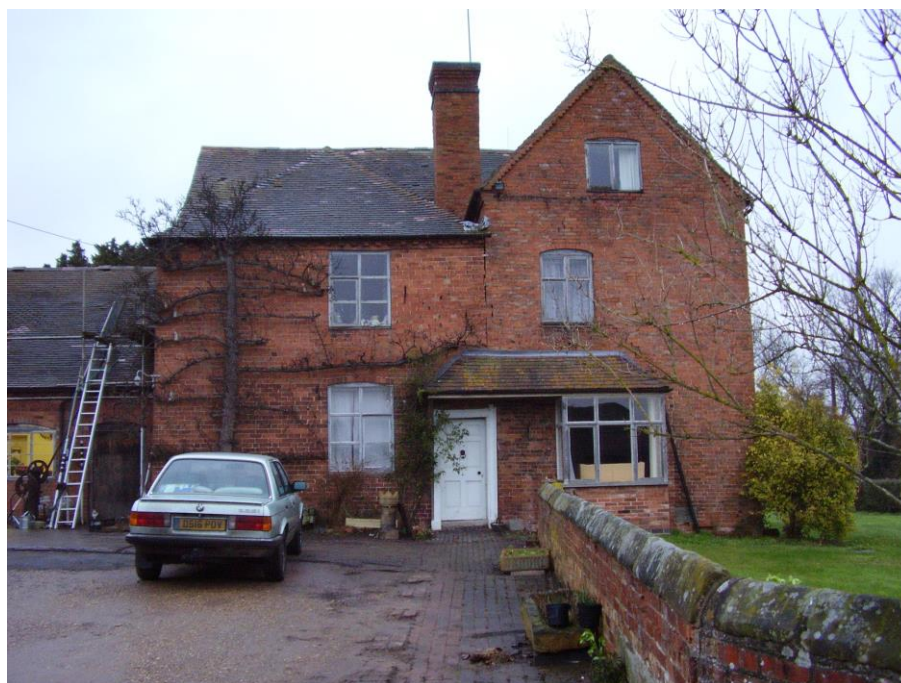
Plate 1: View N showing Woodrow Farm, a late 18<sup>th</sup> century brick farmhouse with later alterations

The complex of outbuildings forming the subject of this programme of standing building recording is located to the S of Woodrow Farm (WSM 32167), a farmhouse of mid 19<sup>th</sup> century date occupying a large, roughly rectangular curtilage adjoining the W side of the B4091 road from Hanbury to Bromsgrove (**Plate 1**).

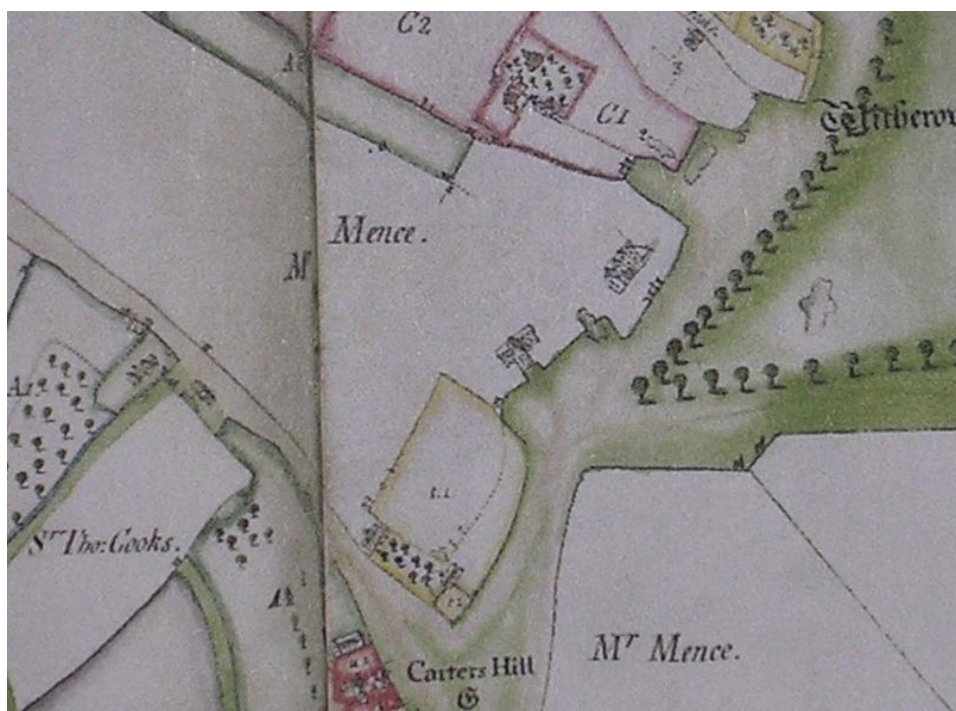
Figure 2: Extract from the plan of the Vernon estates at Hanbury by J. Dougharty (1731)  
 (Reproduced by courtesy of the Worcestershire Record Office)

The earliest cartographic evidence found for occupation on the site of Woodrow Farm is contained in the survey and terrier of the Vernon estates at Hanbury drawn up by the Worcester mapmaker John Dougharty in 1731, which shows that the topography of the site differed considerably from its present appearance (**Fig. 2**). The 1731 map shows a T-shaped building, of two-unit, baffle-entry type, with a centrally placed chimneystack and entrance wing, which, at that time, appears to have immediately adjoined the N-S road from Hanbury towards Bromsgrove, which appears to have run further to the W of its modern alignment. Significantly, no outbuildings are shown

It is difficult to relate the plan of the building shown on the 1731 plan with the existing farmhouse, which appears to have been substantially rebuilt in the mid 19<sup>th</sup> century, together with the adjacent complex of outbuildings. However, it is likely that the central block of the farmhouse incorporates fabric from an earlier building and large pieces of worked masonry are visible in the walls of the farmhouse and the adjacent complex of outbuildings.

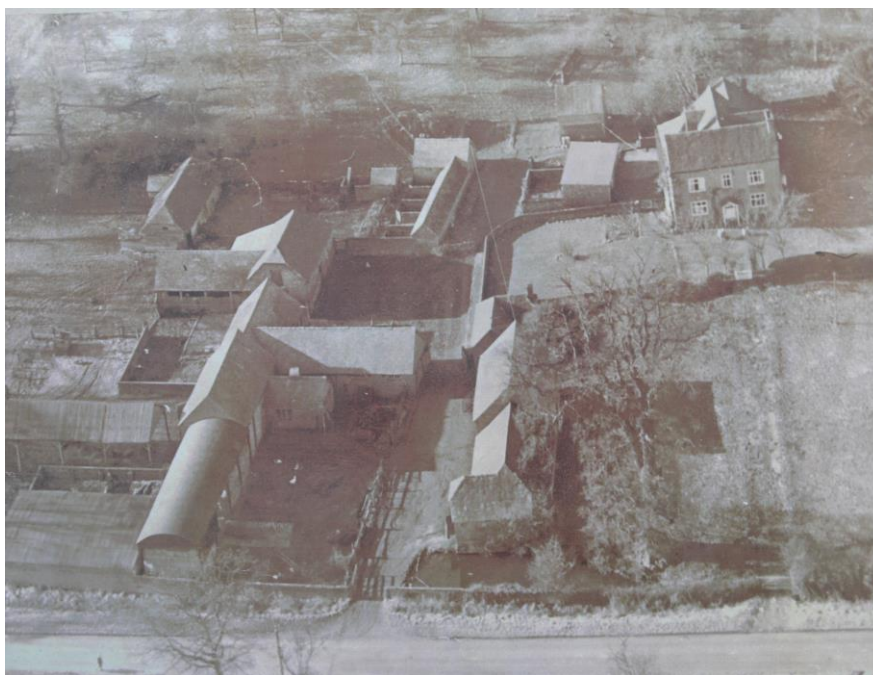
Plate 2: Aerial photograph of c.1960 looking W showing the farmhouse and outbuildings at Woodrow Farm  
(Reproduced by courtesy of the owner)

The complex of outbuildings is shown as relatively unchanged on the OS 3<sup>rd</sup> edition map of 1928 (**Fig. 6**), with the exception of a small extension added to the N of Barn 2. An aerial photograph of Woodrow Farm taken c.1960 provides important information about the layout and appearance of the farmhouse and outbuildings prior to the alterations carried out in the mid to late 1970s (**Plate 2**).

Of particular interest is the barn aligned E-W and situated apart from and to the SW of the main complex of outbuildings, which has been demolished in recent years.

This barn, significantly, is shown as weatherboarded, in contrast to the other buildings, which are uniformly of brick construction. This would imply that this barn predated the other outbuildings and, indeed, a building of similar plan is shown in this location on the Hanbury tithe map of 1838.

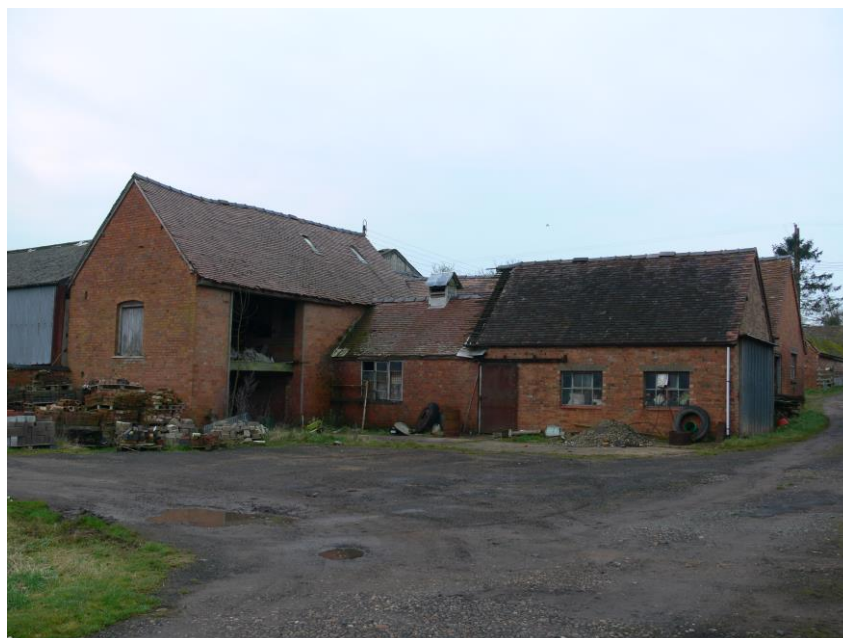
Plate 3: View SW showing Barn 2, with Barn 3 adjacent to rear

- Plate 3: View SW showing Barn 2, with Barn 3 adjacent to rear
- Plate 4: View SE showing Barn 3 with Barn 5 adjacent to W
- Plate 5: View E showing detail of N end of W-facing principal elevation of Barn 3, showing dentilled eaves

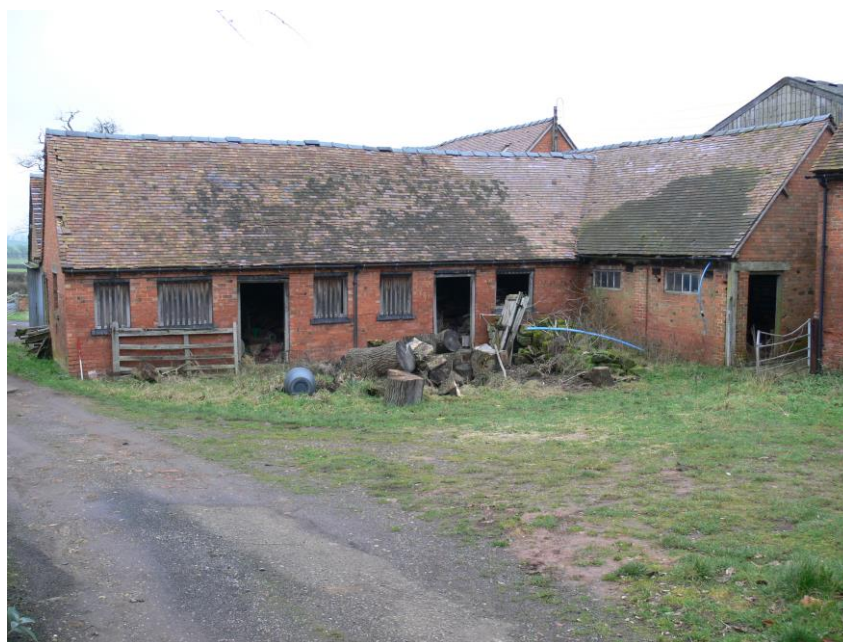
Plate 4: View SE showing Barn 3 with Barn 5 adjacent to W

The northern range of Barn 3 (**Plate 4**) was a single-storey gabled building, four bays long and aligned N-S, constructed of brick (in an irregular English Garden Bond, bonded with a light brown sandy mortar with frequent rounded stones) with a hipped, tiled roof with a dentilled eaves cornice, partially concealed by modern guttering (**Plate 5**). The principal W-facing elevation consisted of five window- and two door-openings, all of which appeared to have been renewed quite recently, indicated by the use of Staffordshire blue bricks (commonly used in the 1960s-70s) for the window and door lintels and angled blue bricks for the window sills.

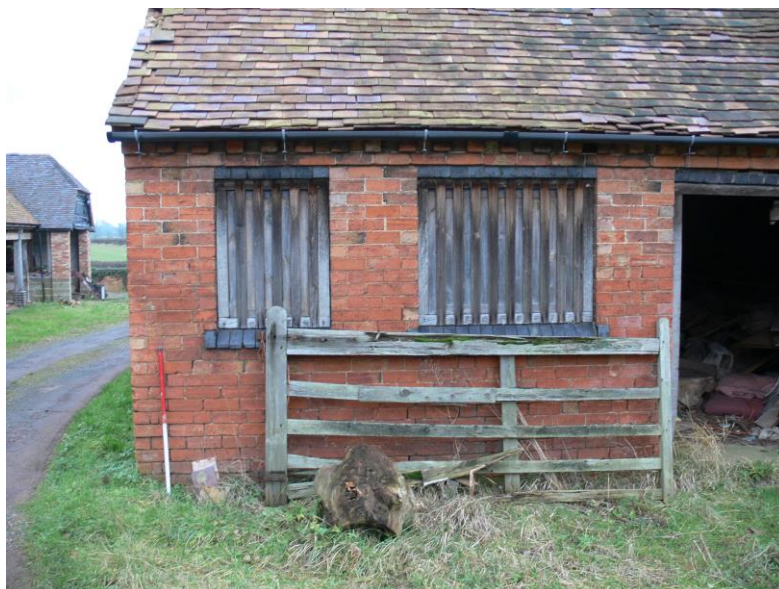
Plate 5: View E showing detail of N end of W-facing principal elevation of Barn 3, showing dentilled eaves

The N-facing gable elevation exhibited the same dentilled decoration evident in the W-facing elevation. A doorway was inserted in the E end of the elevation, which also appeared to have been renewed with a blue-brick lintel; immediately to the right of this doorway was a flat-headed, eight-light window, metal-framed with a concrete lintel and sill, which appeared to be a later addition. The E-facing external elevation of Barn 3 had been obscured by the building of the N extension to Barn 2 in the early 20<sup>th</sup> century and the subsequent construction of a workshop in the late 1970s (**Plate 6**). The dentilling visible in the W-facing elevation was also reproduced here. This elevation also had four narrow flat-headed window openings with brick lintels and sills inserted just below eaves level, which appeared to be later additions.

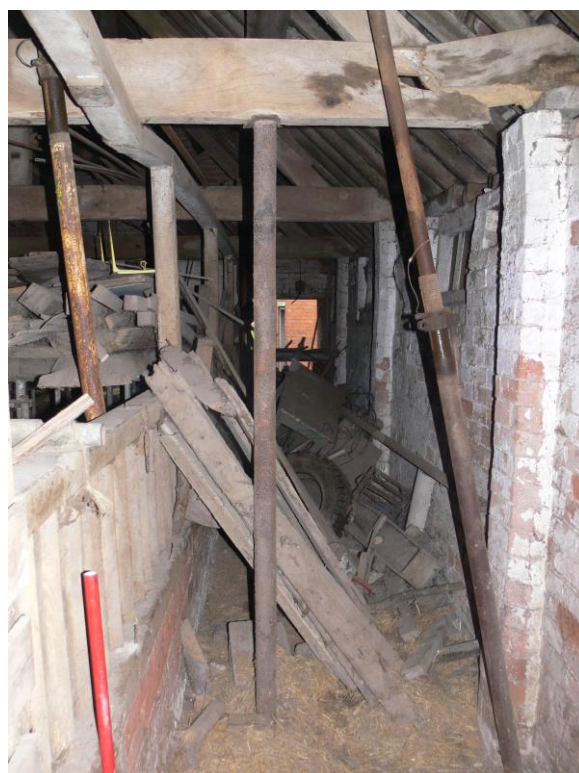
Plate 8:View N showing passageway along E side of Barn 3, with livestock stalls to the left

Internally, the barn was arranged into four separate stalls for livestock, with a narrow passageway running along the E side of the barn. The passageway was clearly demarcated from the livestock stalls by plank-and-batten partitions extending up to the height of the tie beam, resting upon a low mortared standard-gauge red-brick wall (**Plate 8**).

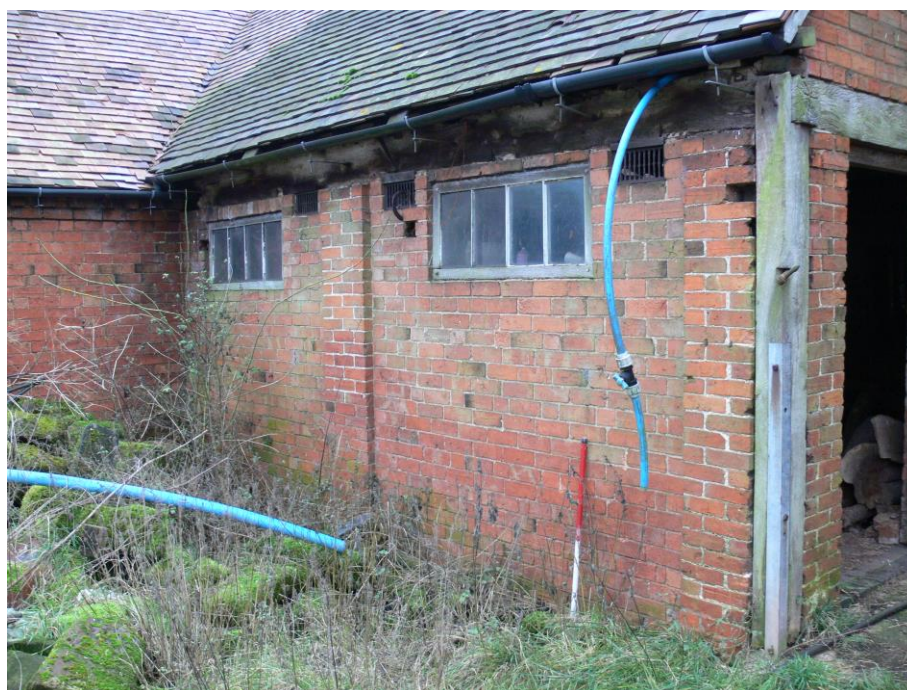
Plate 9 View looking SE showing N-facing elevation of southern range of Barn 3 showing original eaves cornice replaced by timber wall-plate

The structural evidence suggests that the southern range of Barn 3 was originally a self-contained unit, separate from and possibly preceding the construction of the northern four bays, which appear to be built up against the southern range. However, the cartographic evidence appears to indicate that both structures were in existence by the late 19<sup>th</sup> century and are shown on the OS 1<sup>st</sup> edition 25-inch map of 1884. The original relationship between the northern and southern ranges is difficult to determine, owing to the fact that the southern range has been considerably altered, probably in the mid-late 1970s, when the roofline was heightened and the N- and W-facing external walls were substantially rebuilt.

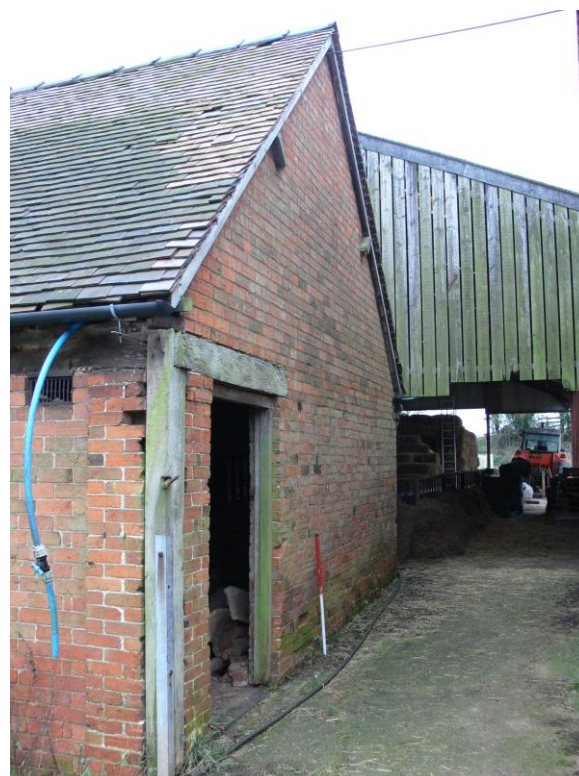
Plate 10: View looking S showing W facing gable of Barn 3

The range was entered via a flat-headed, wooden-framed doorway set at the N end of the W-facing gable elevation, which appeared to be a later addition (**Plate 10**). A modern timber lintel and vertical, square post had been inserted above and to the left of the doorway. It was noticeable that the brickwork in the lowest seven or eight courses of the W-facing gable, to the right (S) of the doorway, showed signs of considerable wear and have not been as heavily re-pointed as those above, perhaps suggesting that this may have represented part of the original construction of the barn.

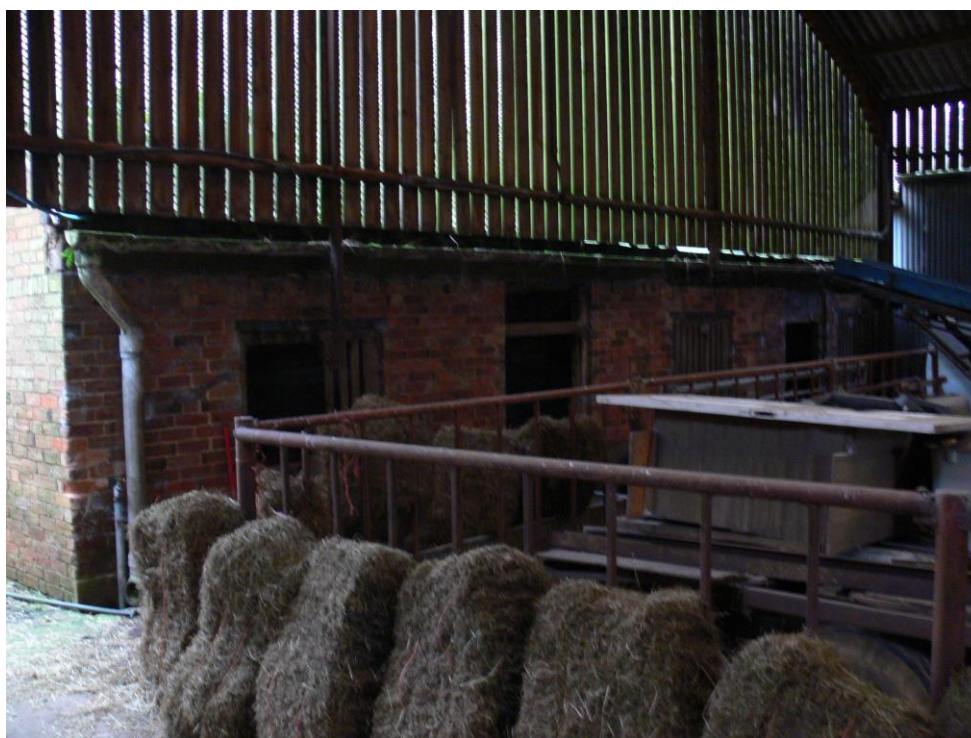
Plate 11: View looking NE showing S-facing elevation of Barn 3

by three flat-headed windows, all with blue brick lintels and sills, very similar in appearance to the W-facing elevation of the northern range of Barn 3 (**Plate 11**). No evidence of a dentilled eaves cornice was noted; however, this may have been due to the insertion of the timber wall-plate contemporary with the reconstruction and heightening of the roof in the mid to late 1970s.

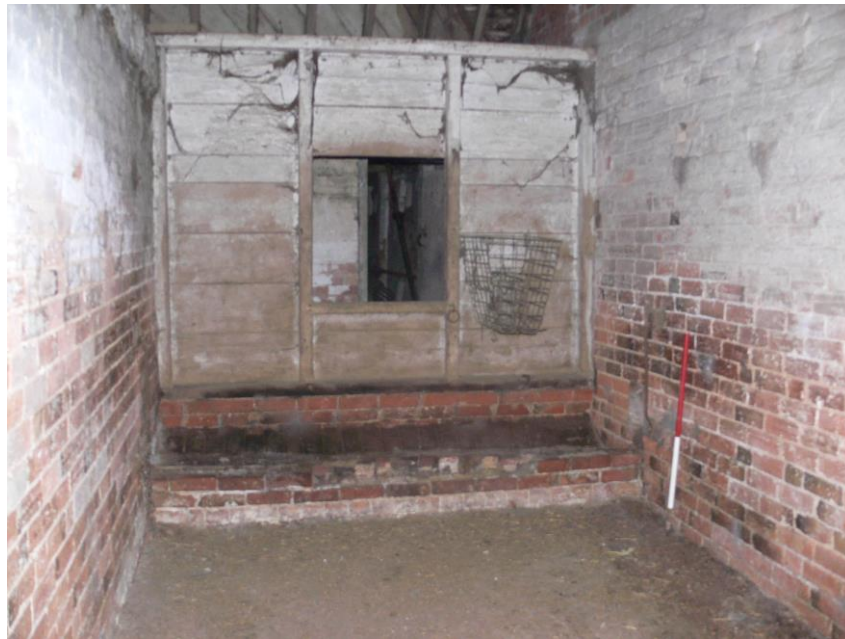
Plate 12: View N showing brick-lined trough and wooden partition wall on N side of southern range of Barn 3

The southern range of Barn 3, like its counterpart to the N, appeared to have been used as a livestock barn, indicated by the remains of a brick-lined animal trough located 0.9m S of the N wall and extending for 10m W of the E end of the barn. The easternmost bay of the barn was separated from the rest of the barn by a mortared brick partition wall, with a plank-and-batten partition wall marking the division between this structure and the northern four bays of Barn 3 (**Plate 12**). Evidence of a blocked segmental arched doorway was also noted in the E gable end of the southern range, which was bricked-up and a flat-headed doorway inserted (**Plate 13**), presumably when the adjacent Barn 2 was built, at some time between 1884 and 1904.

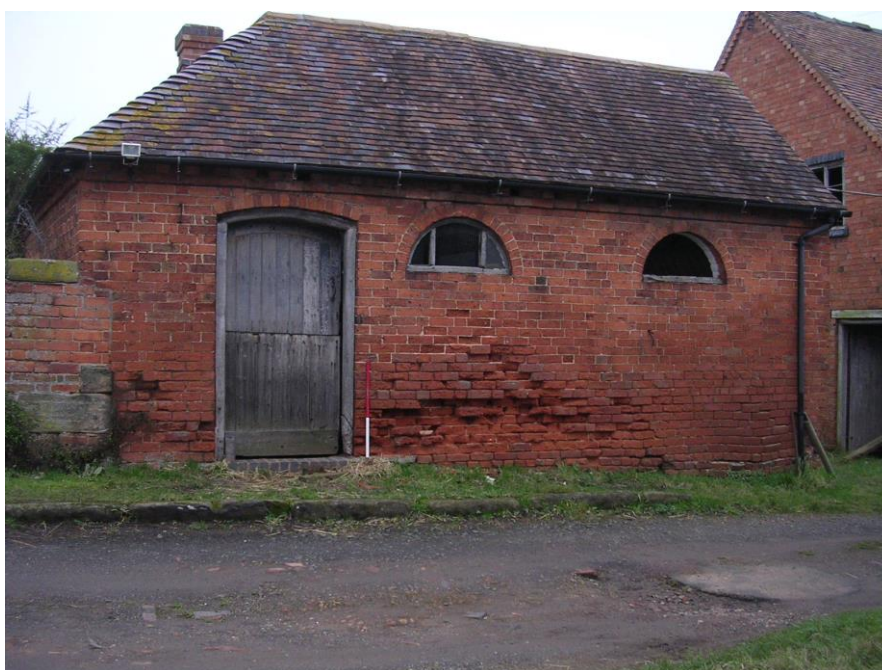
Plate 14: View N showing S-facing elevation of Barn 4

Barn 4, situated immediately W of Barn 1 and opposite Barn 3, was an L-shaped, single-storey structure of brick construction (in an irregular English Garden Bond), with a half-hipped, tiled roof and dentilled eaves, which had been purposely built as a pony-and-trap house. The principal S-facing elevation of the barn (**Plate 14**) was three bays in length, the western bay having a wooden-framed stable door under a segmental gauged brick arch, while two wooden-framed three-light windows within semicircular brick arches were inserted in the central and eastern bays of the elevation. The E-facing gable elevation also exhibited evidence of dentilling but no other features were visible

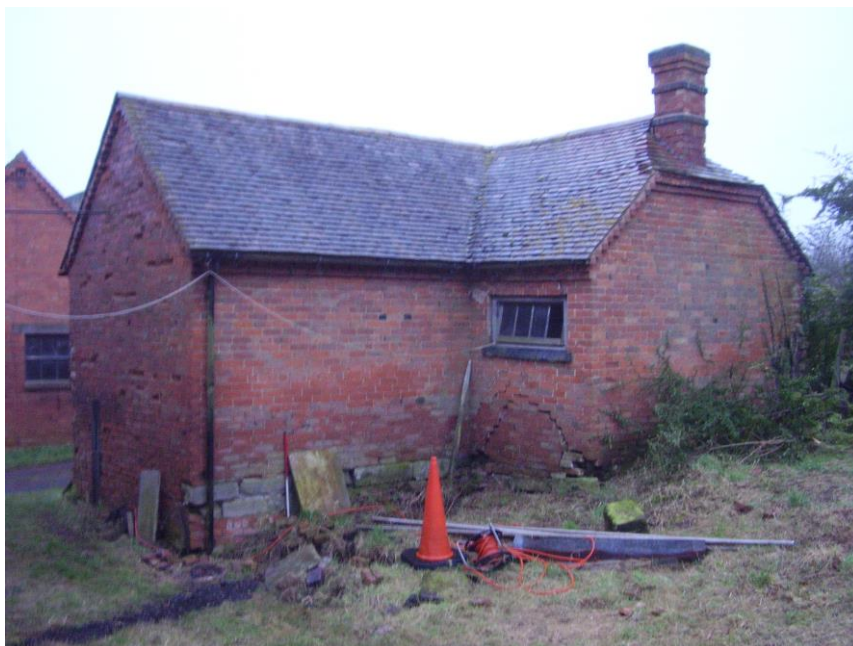
Plate 15: View SW showing rear N-facing elevation of Barn 4 with gabled N wing with half-hipped roof surmounted by chimneystack

Projecting to the rear of the building was a single-bay gabled extension with a half-hipped roof, surmounted by a two-tier brick chimneystack. Inserted in the E-facing wall of the extension was a single flat-headed four-light window with Staffordshire blue angled bricks for the sill, which identified it as a later insertion, probably dating from the 1970s.

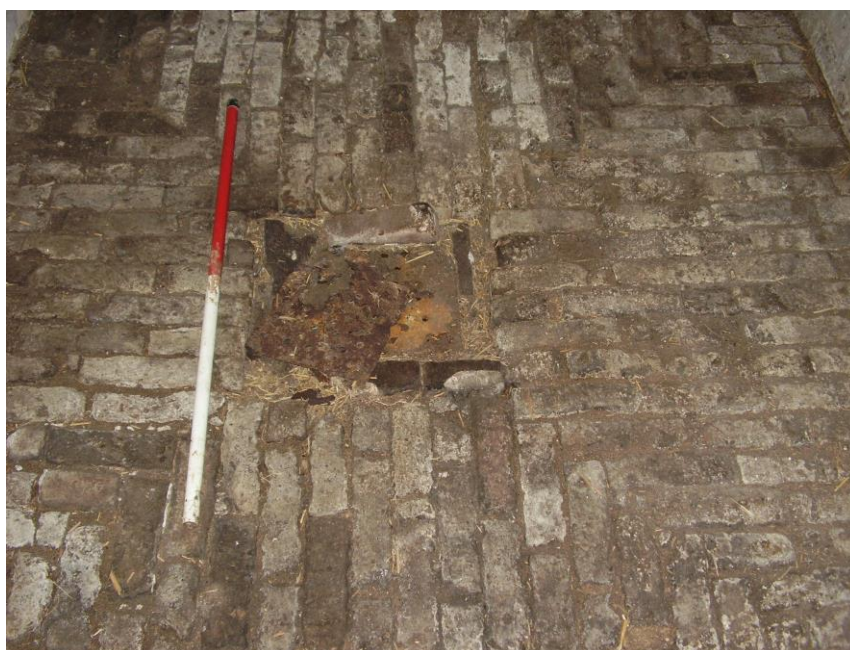
Plate 16: Plan view showing cobbled flooring and drain in L-shaped compartment of Barn 4

The internal arrangements of Barn 4 appeared to have remained essentially unchanged since its construction, which can be dated, based on cartographic evidence, to some time between 1838 and 1884. The interior, which was covered by a thick lime whitewash, had been arranged into three compartments, a large L-shaped room with a plaster barrel-vaulted roof and regularly coursed brick cobbled flooring (**Plate 16**), with a wooden hayrack and trough and a cast iron manger at the N end of the room (**Plate 17**).

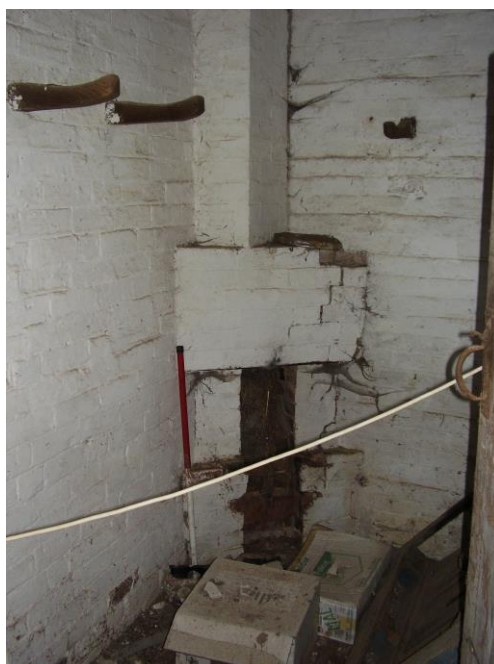
Plate 18: View looking N showing harness room in Barn 4 with fireplace in NW corner

To the E of this room, a segmental gauged arched doorway gave access to a smaller, rectangular room with brick flooring and a central drain in the centre of the floor, with a wooden hayrack and manger mounted against the E wall. The most interesting feature of Barn 4 was the small oblong room containing a fireplace and chimney flue of brick construction, recessed into the NW corner (**Plate 18**). The fireplace appeared originally to have had a cast iron grate. Its function appeared not only to have been to keep the horses warm but also to dry the harness, as indicated by the horizontal wooden posts above and to the left of the fireplace.

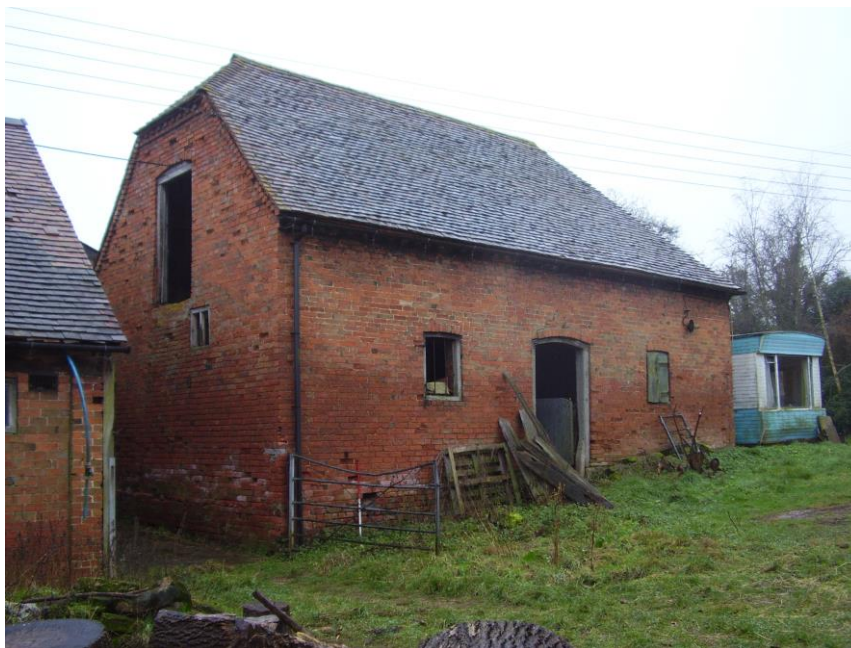
Plate 19: View SW showing N-facing and E-facing elevations of Barn 5

Barn 5 was a four-bay structure, apparently built as a stable, comprising a single-storey with hayloft, of brick construction (in an irregular English Garden bond) with a half-hipped, tiled roof with dentilled eaves partly concealed by modern guttering (**Plate 19**). The principal, N-facing elevation had a central doorway, with a wooden frame under a segmental gauged brick arch, flanked by two segmental arched gauged windows, both wooden framed. The brickwork of the upper storey displayed evidence of having been substantially re-pointed.

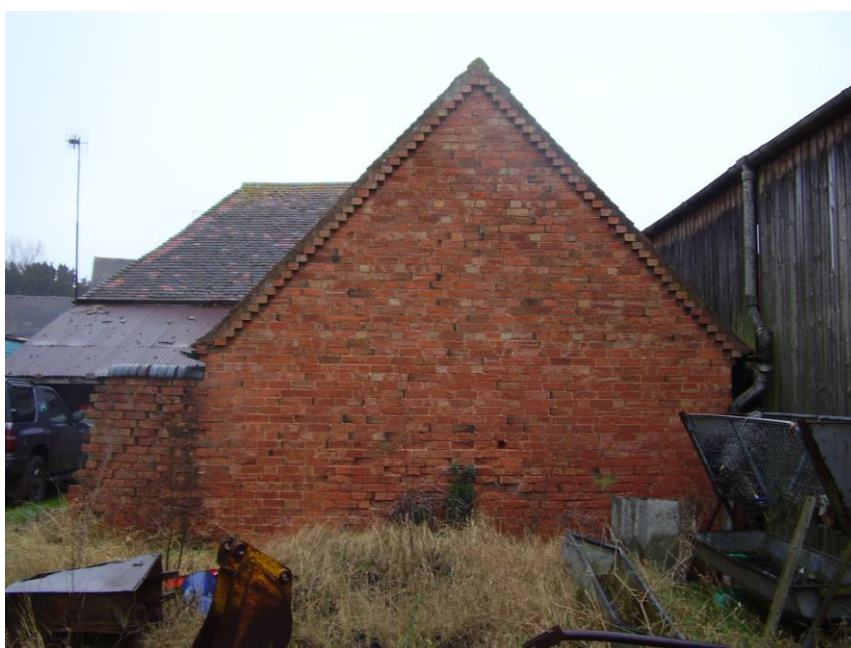
Plate 20: View N showing S gable end of extension to Barn 5

Attached to the S wall of the barn was a gabled extension probably built as a livestock shelter, four bays in length, (**Plate 20**) of brick construction (in an irregular English Garden Bond) with a hipped, tiled roof. The S gable and W-facing elevation were brick-built with dentilled eaves, while the E-facing elevation was completely open, the wall-plate being carried on steel uprights. An aerial photograph of c.1960 shows that the E-facing elevation was originally enclosed by a plank-and-batten wall, with the wall-plate supported by wooden posts.

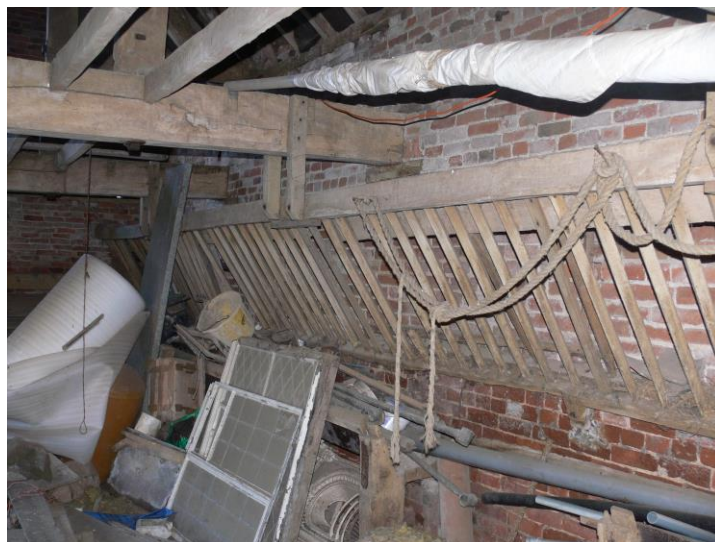
Plate 21: Internal view SE, showing racks mounted along N-facing wall of barn

Other features relating to the use of the barn were also identified, including a large wooden hayrack running along the entire length of the N-facing wall of the barn and connected to each of the tie beams by vertical struts (**Plate 21**). Immediately to the left of the barn entrance were two horizontal wooden posts attached to the S-facing wall, which were evidently used for hanging harnesses (**Plate 22**).

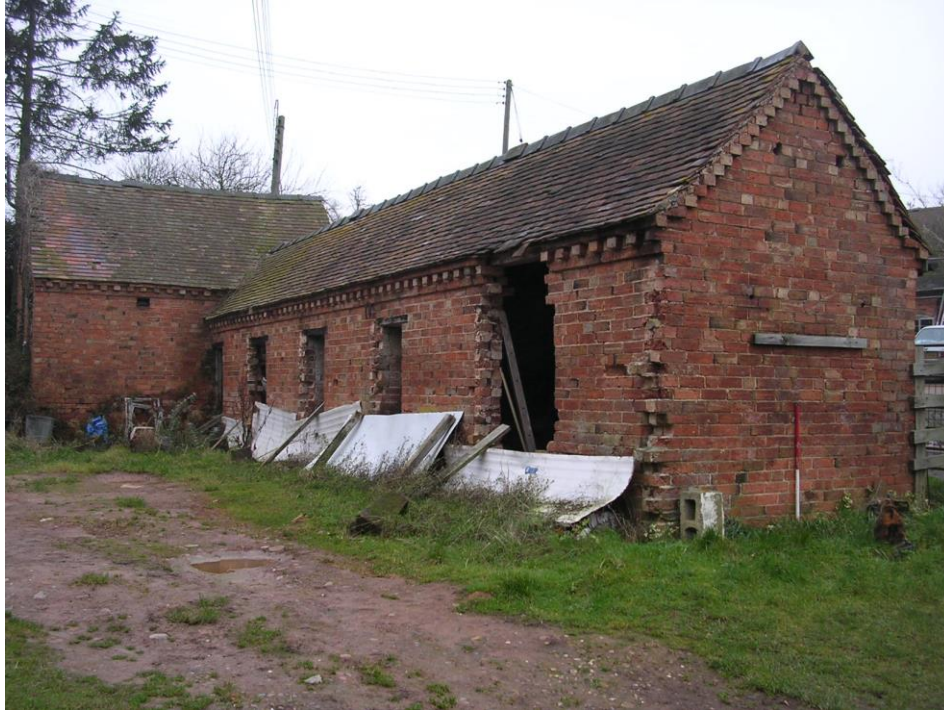
Plate 23: View NW showing gabled pigsty range with projecting wing at the W end built to accommodate a swill house

Also belonging to the principal construction phase was Barn 6. This consisted of a single-storey gabled range, of brick construction (bonded in an irregular English Garden Bond), aligned E-W. It was five bays long with a projecting wing (used as a swill house) attached to the W gable end, also brick-built, and one-and-a-half storeys high, aligned N-S, with a chimneystack attached to the W corner of the S gable (**Plate 23**). The roofs were both tiled with dentilled eaves corncicing, similar in appearance to Barn 4. Four narrow ventilation slits were visible at the apex of the E-facing gable elevation.

Five flat-arched openings were inserted into the S-facing elevation of the gabled range, four of which possessed their original wooden lintels, which originally gave access to individual walled pig-runs. These walls have since been demolished, although the stumps were still clearly visible. The interior of the gabled range, which was originally whitewashed, was divided into five separate compartments or pens, demarcated by four brick partition walls, three of which have been removed, although the footings of the walls were still clearly visible. Evidence for the level of the original floor was clearly indicated by a stringcourse at an approximate height of 0.7m from the base of the wall (**Plate 24**).

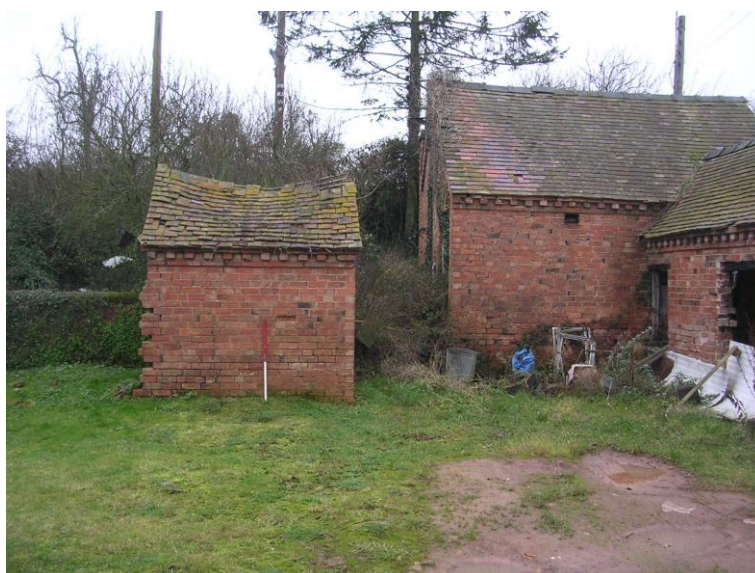
Plate 25: View W showing swill house and freestanding building ('boar pen') situated immediately to the S

The swill house, abutting the W end of the gabled range, has been converted into a garage and few internal features relating to its original use were visible (**Plate 25**). A flight of three stone steps gave access to a flat-arched doorway with wooden lintel inserted into the S-facing gable of the building. A modern carport with a concrete lintel had been inserted into the N-facing elevation of the building, which appeared to have been largely rebuilt (**Plate 26**).

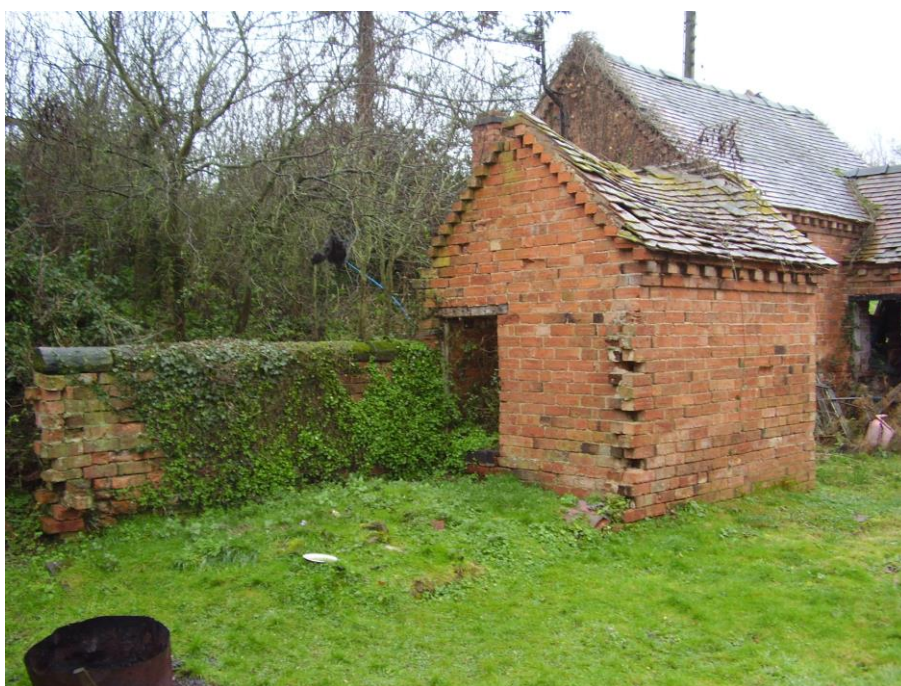
Plate 27: View looking NW showing 'boar pen' and remains of adjoining enclosure wall with 'swill house' to rear

The freestanding structure situated immediately to the S of the pigsty range and swill house, referred to as a 'boar pen', was a rectangular gabled structure with a hipped, tiled roof and dentilled eaves cornice with a single flat-arched doorway with wooden lintel and door-frame inserted into the S-facing gable elevation (**Plate 27**). The heavily truncated remains of brick walls with stone coping projecting from the S gable end represented the remnants of a walled enclosure extending to the S of the 'boar pen'.

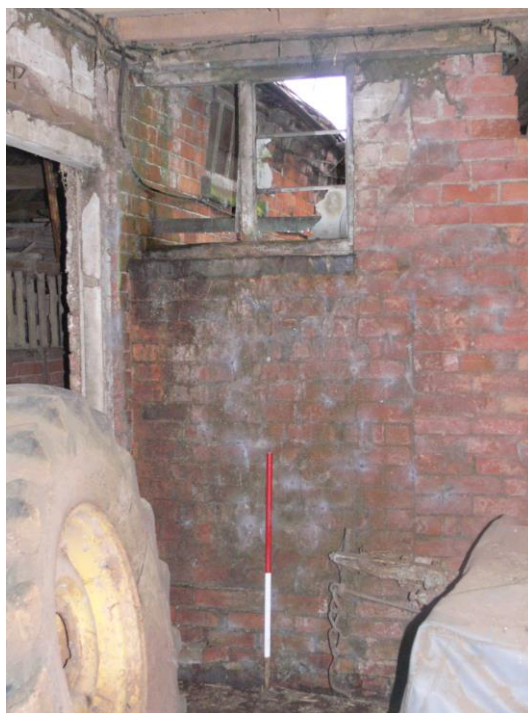
Plate 31: View N showing bricked-up doorway in NW corner of Barn 2

Further alterations were visible in the extreme NW corner of the barn, where the original doorway, with a low, gauged brick arch, had been bricked up and a small two-light, six-pane casement window with a metal frame and brick sill inserted (**Plate 31**). Immediately adjacent to this feature is evidence for a segmental gauged arch window inserted in the N wall and since bricked up (**Plate 32**). The original flagstone flooring in this part of the barn also appeared to have been replaced by standard gauge brick flooring. These alterations appear to be contemporary with the construction of the N extension to Barn 2, at some point between 1904 and 1928.
