Archaeological Evaluation

**Sunnymeade
Back Lane
Weobley
Herefordshire**

NGR: SO 4010 5160
SMR 44394

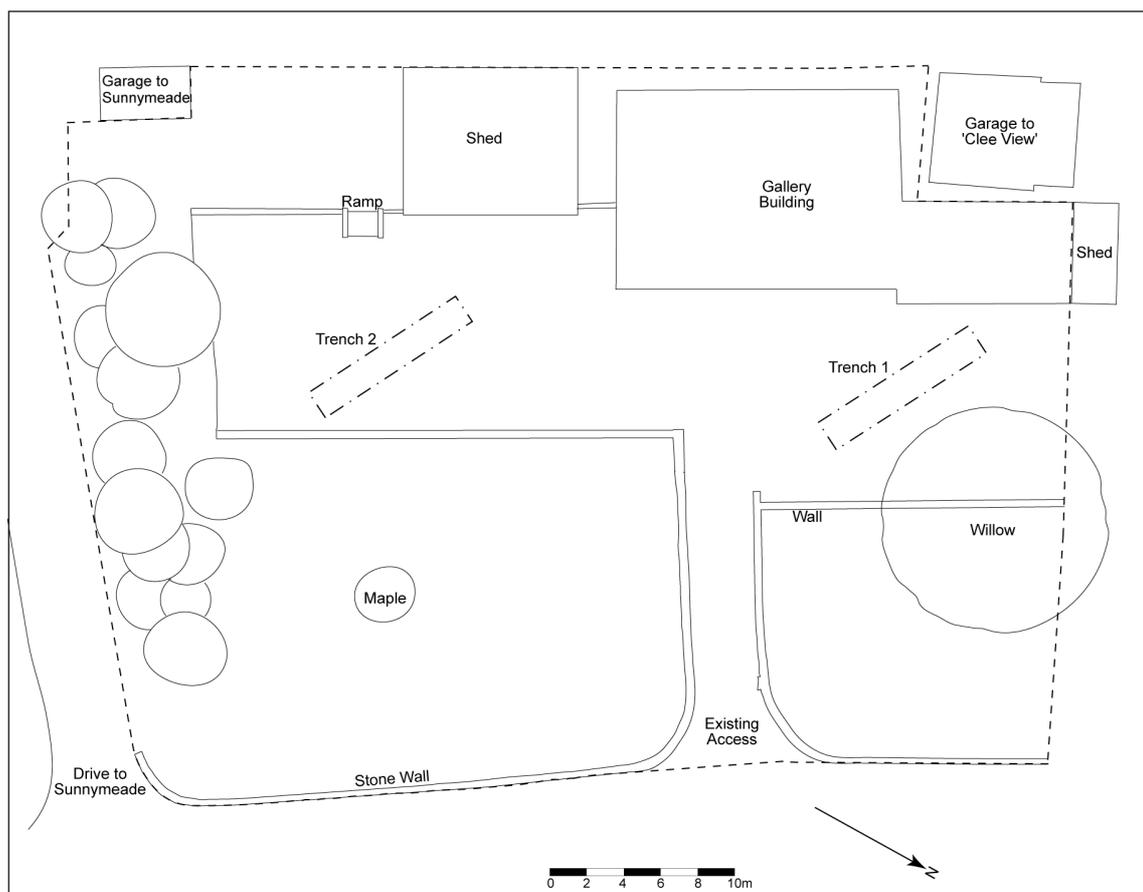
Fig. 2: Trench location plan

Two evaluation trenches oriented NW-SE were opened in specified locations, each measuring 10m x 1.5m (**Fig. 2**). Both trenches were excavated by machine to the uppermost level of archaeological deposits or to the depth at which natural soils were encountered. A 1.2m sondage was excavated at the terminus of each trench in order to confirm the presence of natural deposits.

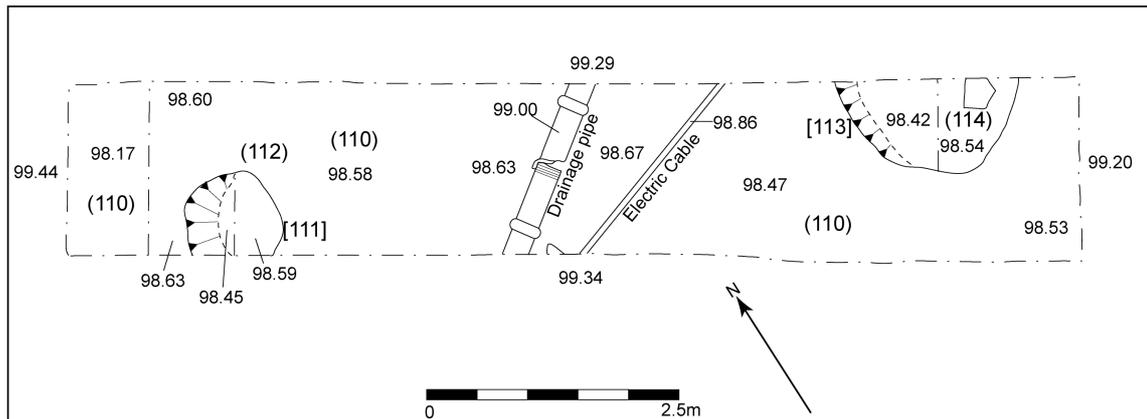
Fig. 3: Plan of Trench 1

Trench 1 was located immediately E of the gallery building and measured 10m × 1.5m (Figs. 2 & 3). The trench revealed 14 contexts, the uppermost of which (101) was a compact bluish-grey stone and gravel deposit extending trench wide to a maximum depth of 0.08m and containing frequent CBM fragments. This deposit is likely to have formed part of a hard-standing surface laid after construction of the gallery building in the 1970s

Underlying (101) was a compact reddish-brown sandy gravel with frequent post-medieval CBM fragments and ceramic sherds and small to medium subangular stones (102). This deposit appeared to extend trench wide to a depth of 0.07m and formed a sub-base for (101).

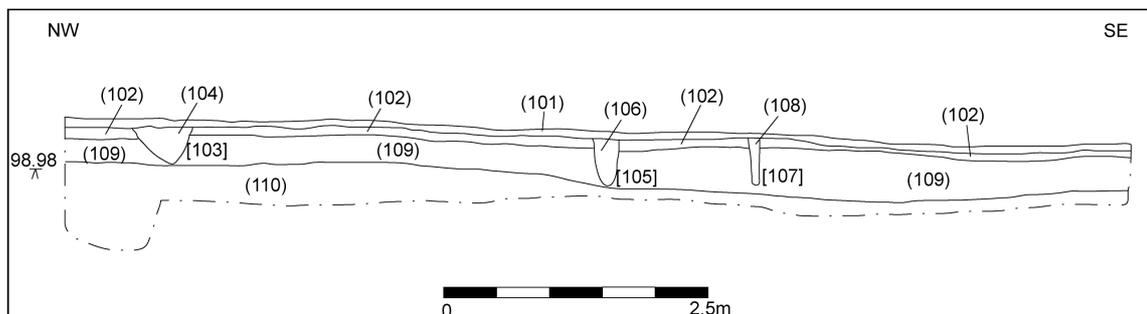
Fig 4: SW-facing section of Trench 1

Cutting through (102) were a series of linear features ([103], [105] & [107]). Linear [103] was located at the NW end of the trench; the feature was oriented E-W and measured >1.5m E-W × 0.55m N-S × 0.38m (Plate 1; Fig. 4). It was filled by (104), a friable mid brown silty clay with moderate post-medieval CBM fragments, occasional ceramic

sherds and c.2% charcoal flecking. Feature [105] appeared as a rectilinear cut aligned NE-SW across the centre of the trench, measuring >1.5m NE-SW x 0.22m NW-SE x 0.4m and filled by a friable mid brown silty clay (106) (**Fig. 4**). Also contained within the cut was a 4-inch ceramic drain, which seems likely to have been laid during or shortly after construction of the gallery building. On a similar alignment as [105] was a rectilinear trench, measuring >1.5m ENE-WSW x 0.06m NNW-SSE x 0.4m [107] (**Fig. 4**). Filling [107] was a friable reddish-brown silty clay (108). Also contained within the cut was a 2-inch electricity cable, again probably associated with construction of gallery building.

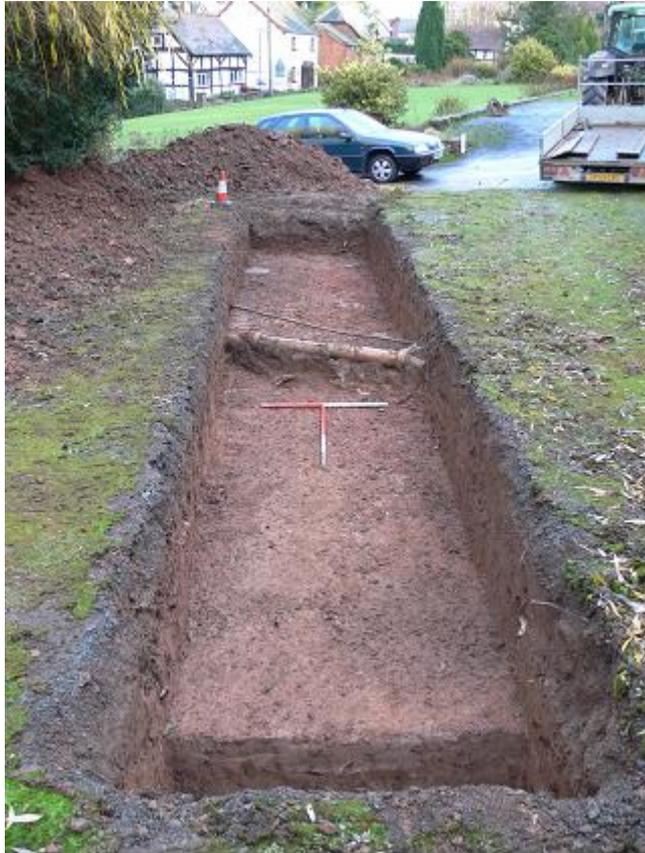
Plate 1: Trench 1 looking SE

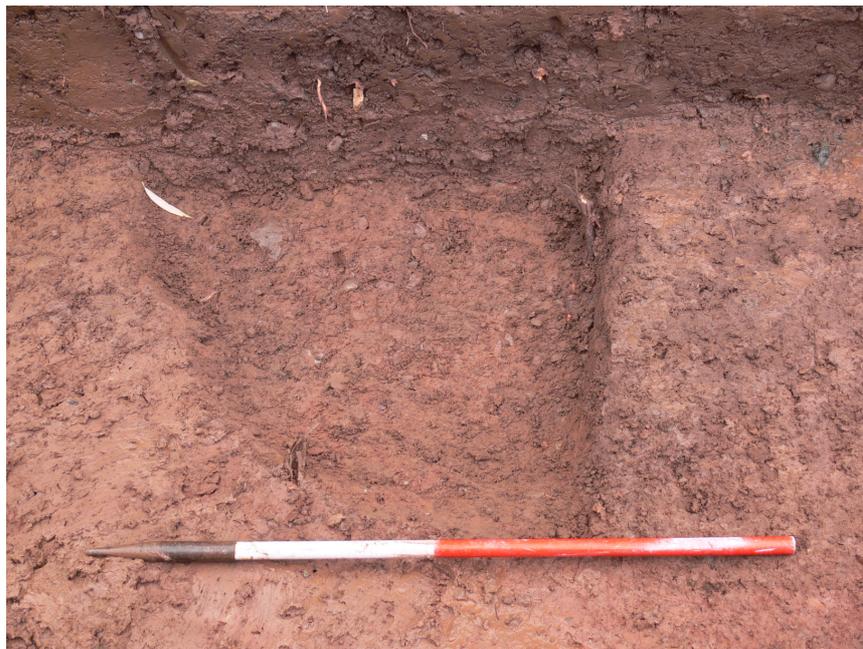
Cutting (110) were two small pits ([111] & [113]). Pit [111] (**Plate 2; Fig. 5**) was located at the NW end of the trench and appeared sub-circular in plan, with a diameter of >0.86m and a depth of 0.16m. Filling [111] was a friable dark greyish-brown silty clay with occasional small rounded pebbles and c.10% charcoal flecking (112). The date and function of pit [111] were unclear owing to a lack of finds from (112). Pit [113] (**Fig. 6**) was located at the SE end of the trench and again appeared sub-circular in plan, with a maximum visible diameter of 1.8m and a depth of 0.12m. Only part of the feature appeared in the trench, the remainder extending beyond the SW-facing section. Filling [113] was a friable dark brown silty clay with occasional small rounded pebbles, c.10%

Plate 2: Pit [111] looking E

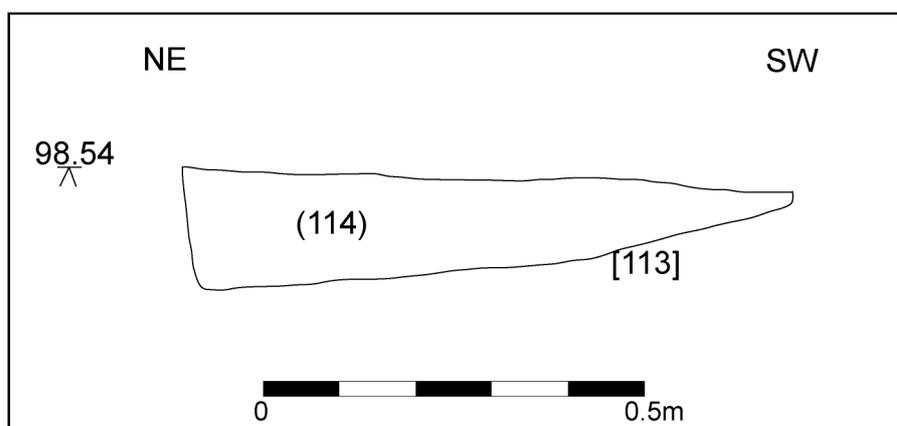
Fig. 6: Profile of Pit [113]

charcoal flecking and one large flat sandstone fragment (114). Again, the absence of any finds makes an accurate interpretation of the feature difficult.

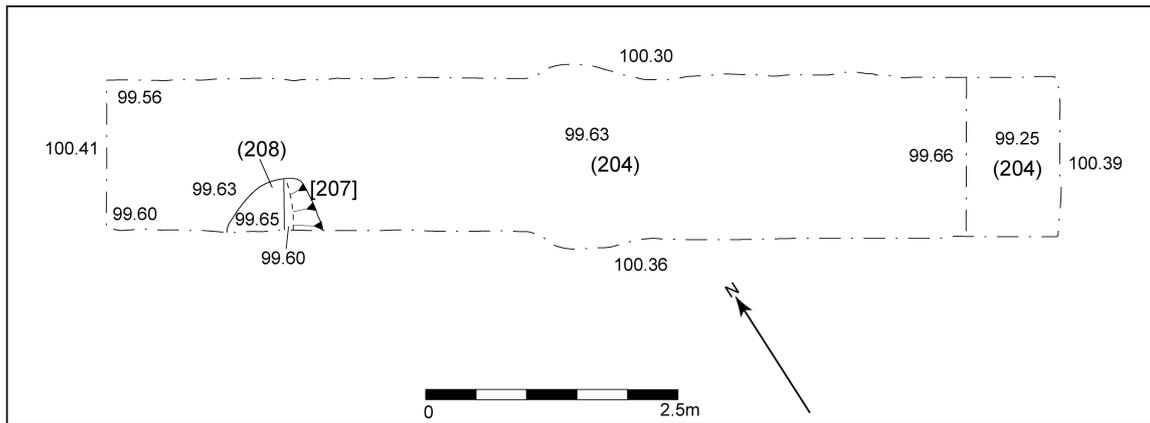
Fig. 7: Plan of Trench 2

The trench revealed eight contexts, the uppermost of which (201) was a compact bluish-grey stone and gravel hard-standing deposit containing frequent CBM fragments and extending trench wide to a maximum depth of 0.08m.

Underlying (201) was a friable orangey-brown aggregate with frequent CBM fragments and small subangular stones (202). This measured 2.5m NW-SE x >1.5m NE-SW x 0.12m and formed an aggregate sub-base for surface (201). Cutting (202) was a rectilinear cut measuring >1.5m NE-SW x 0.82m NW-SE x 0.35m [205] (**Plate 4**). This was filled by (206), a compact concrete and aggregate deposit forming part of a foundation, possibly associated with a greenhouse previously standing in this location.

Partially revealed cutting (204) at the NW end of the trench was an elongated post-medieval pit measuring 0.86m NE-SW x 1m NW-SE x 0.07m [207] (Figs. 7 & 9). Filling [207] was (208), a friable greyish-brown silty clay with c.10% charcoal flecking, occasional small subangular stones and one sherd of post-medieval pottery.

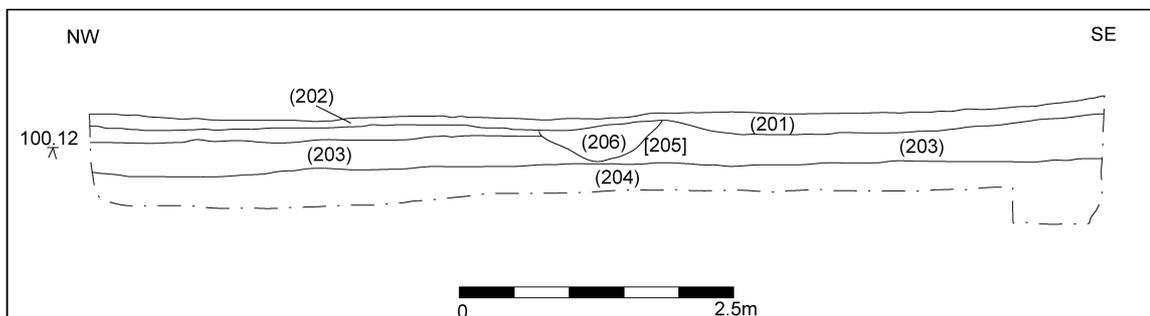
Fig. 8: SW-facing section of Trench 2

A probable post-medieval garden soil consisting of friable dark greyish-brown silty clay with c.5% charcoal flecking (203) extended across the trench and measured 0.26m in thickness. Underlying this was a natural deposit (204), consisting of friable pinkish-brown silty clay with frequent small rounded pebbles.

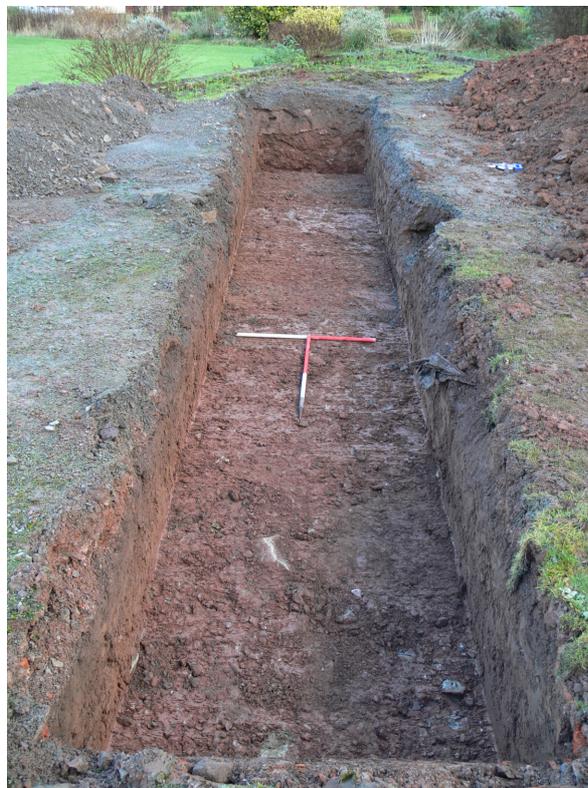
Plate 3: Trench 2 looking SE

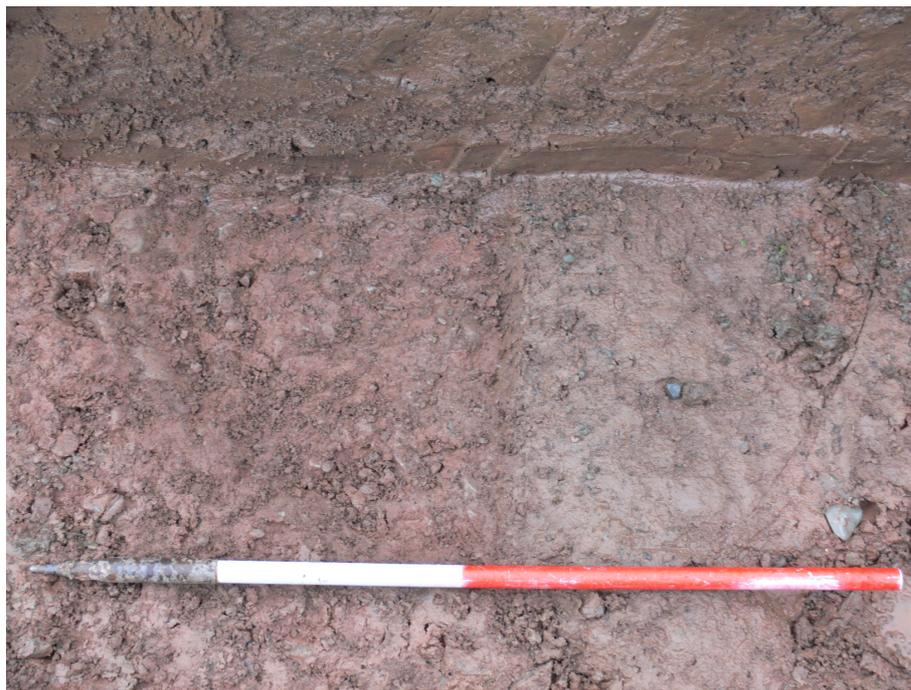
Plate 4: Pit [205] looking SW
