Archaeological Observation

**Sunnydale
Floodgates
Kington
Herefordshire**

**NGR: SO 28870 56953
SMR No.44552**

BORDER ARCHAEOLOGY

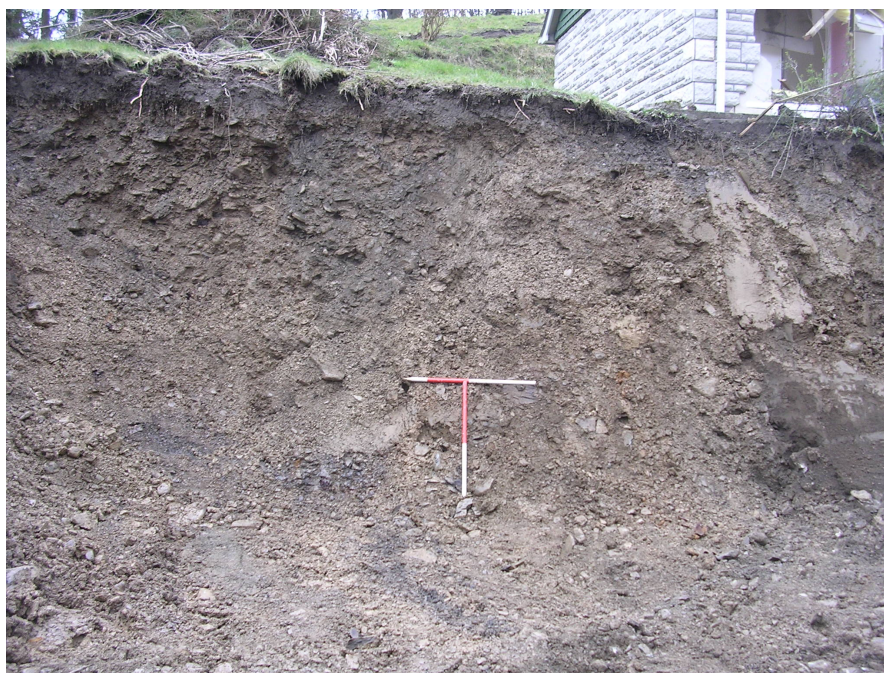
Plate 1: View looking E showing deposits revealed in W facing section

The uppermost context (001) consisted of a moderately compacted dark brown sandy clay topsoil with evidence of frequent root disturbance, containing occasional subangular stones and a small number of residual pottery fragments comprising late 19th-20th century china and blue & white transfer ware. The depth of (001) varied between 0.4m (as visible in the W-facing section) to a maximum depth of 0.85m (in the S-facing section).

Underlying (001) was (002), interpreted as redeposited natural subsoil, consisting of a friable light yellowish-brown sandy clay with frequent gravel and small to medium degraded sandstone fragments, extending to a maximum visible depth of 2.5m.

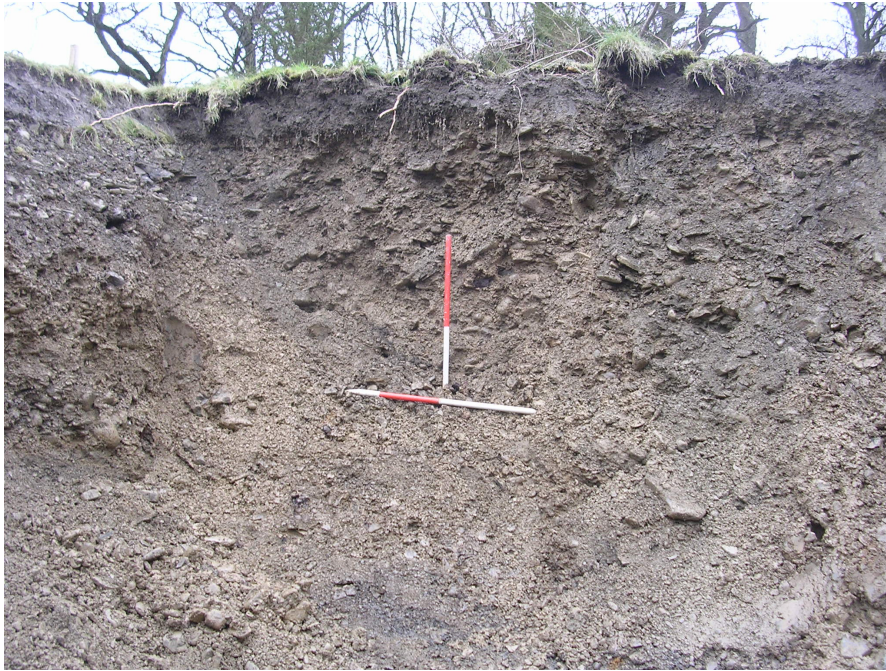
Plate 2: View looking NE showing U-shaped pit feature [003] at N end of W facing section

Located in the far NE corner of the excavated area, at the northernmost end of the W facing section, (**Plate 1**) sealed by (001) and cutting into subsoil layer (002) was [003], a roughly U-shaped cut feature which was filled by (004), a friable, dark yellowish-brown sandy clay with frequent small to medium rounded and subangular stones with occasional charcoal flecking (**Plate 2**). [003] was interpreted as a debris pit presumably associated with post-medieval agricultural or landscaping activity on the site.

During the observation of groundworks, a U-shaped cut feature interpreted as a pit associated with post-medieval agricultural or landscaping activity was revealed in the NE corner of the site, sealed by topsoil containing late 19th/20th century pottery. No artefactual material was recovered from the fill of this feature, which was considered to be of low archaeological significance.

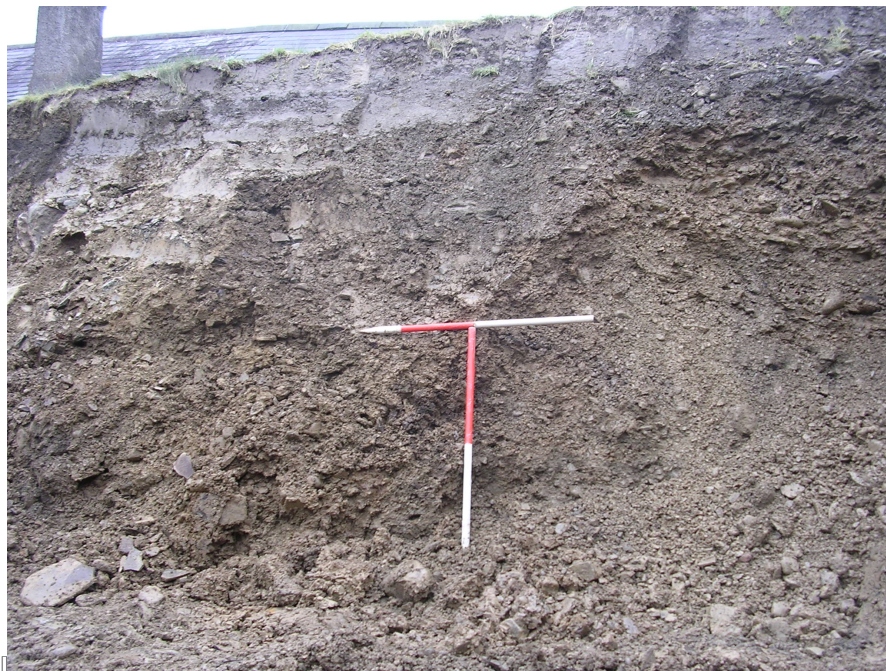
Plate 3: View looking N showing deposits revealed in S facing section

Underlying (002) was (005) a moderate to well compacted dark greyish-brown sandy clay with frequent gravel and fragments of heavily degraded sandstone and shale of assorted sizes. (005) extended to the base of the excavated area (maximum depth 3.8m) and was interpreted as natural deposition.
