Archaeological Observation

**Southways
Eardisley
Herefordshire**

**NGR: SO 31285 49201
SMR No: 48018**

BORDER ARCHAEOLOGY

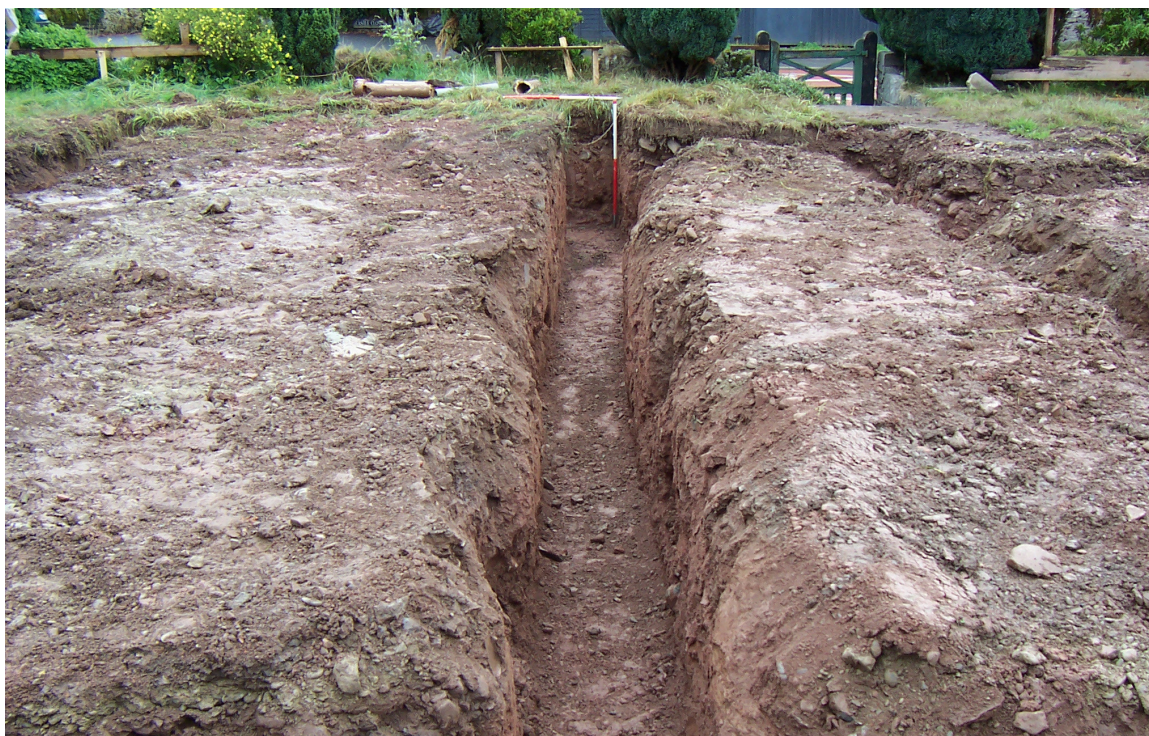
The trenching revealed a soil profile comprising three contexts, the first of which was a moderately compacted, mid brown silty topsoil measuring approximately 0.30m in thickness (001). Underlying this was a pinkish-brown clayey-silt with occasional small stones measuring approximately 0.60m in thickness (002). Underlying this deposit was a yellowish-brown silt extending to the base of the trench (003).

Plate 2 View of trenching looking W

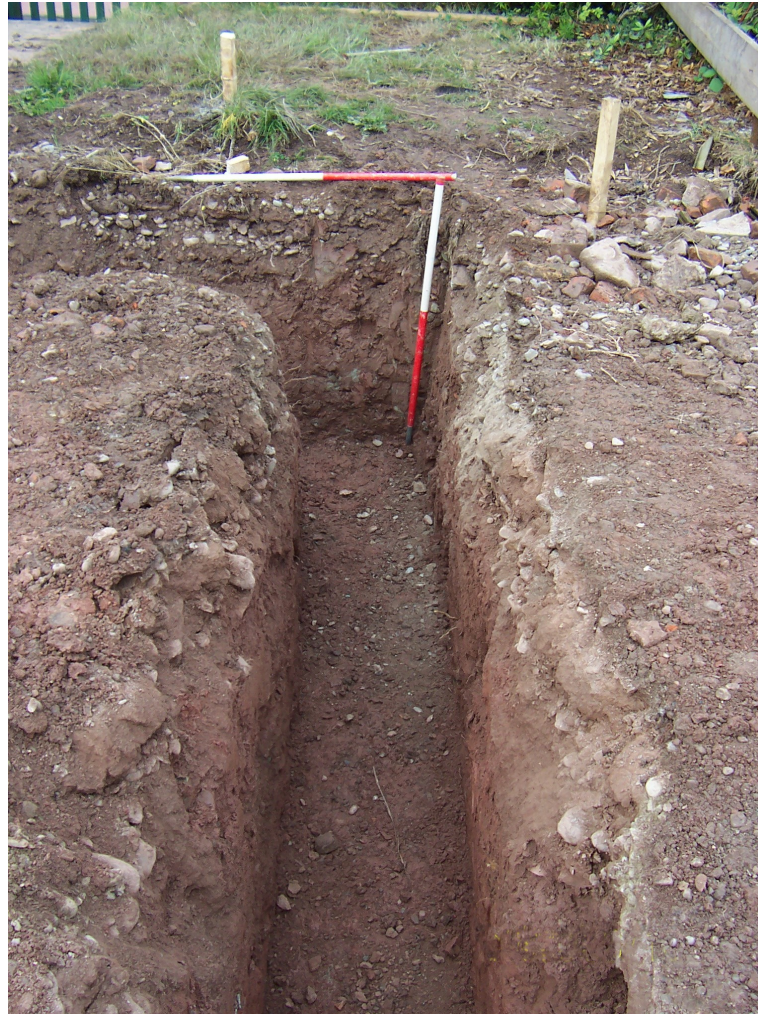
Plate 3 E-facing trench section
