Heritage Impact Assessment

**27 Fitzroy Square
London W1T 6ES**

Advent Life Sciences

January 2021

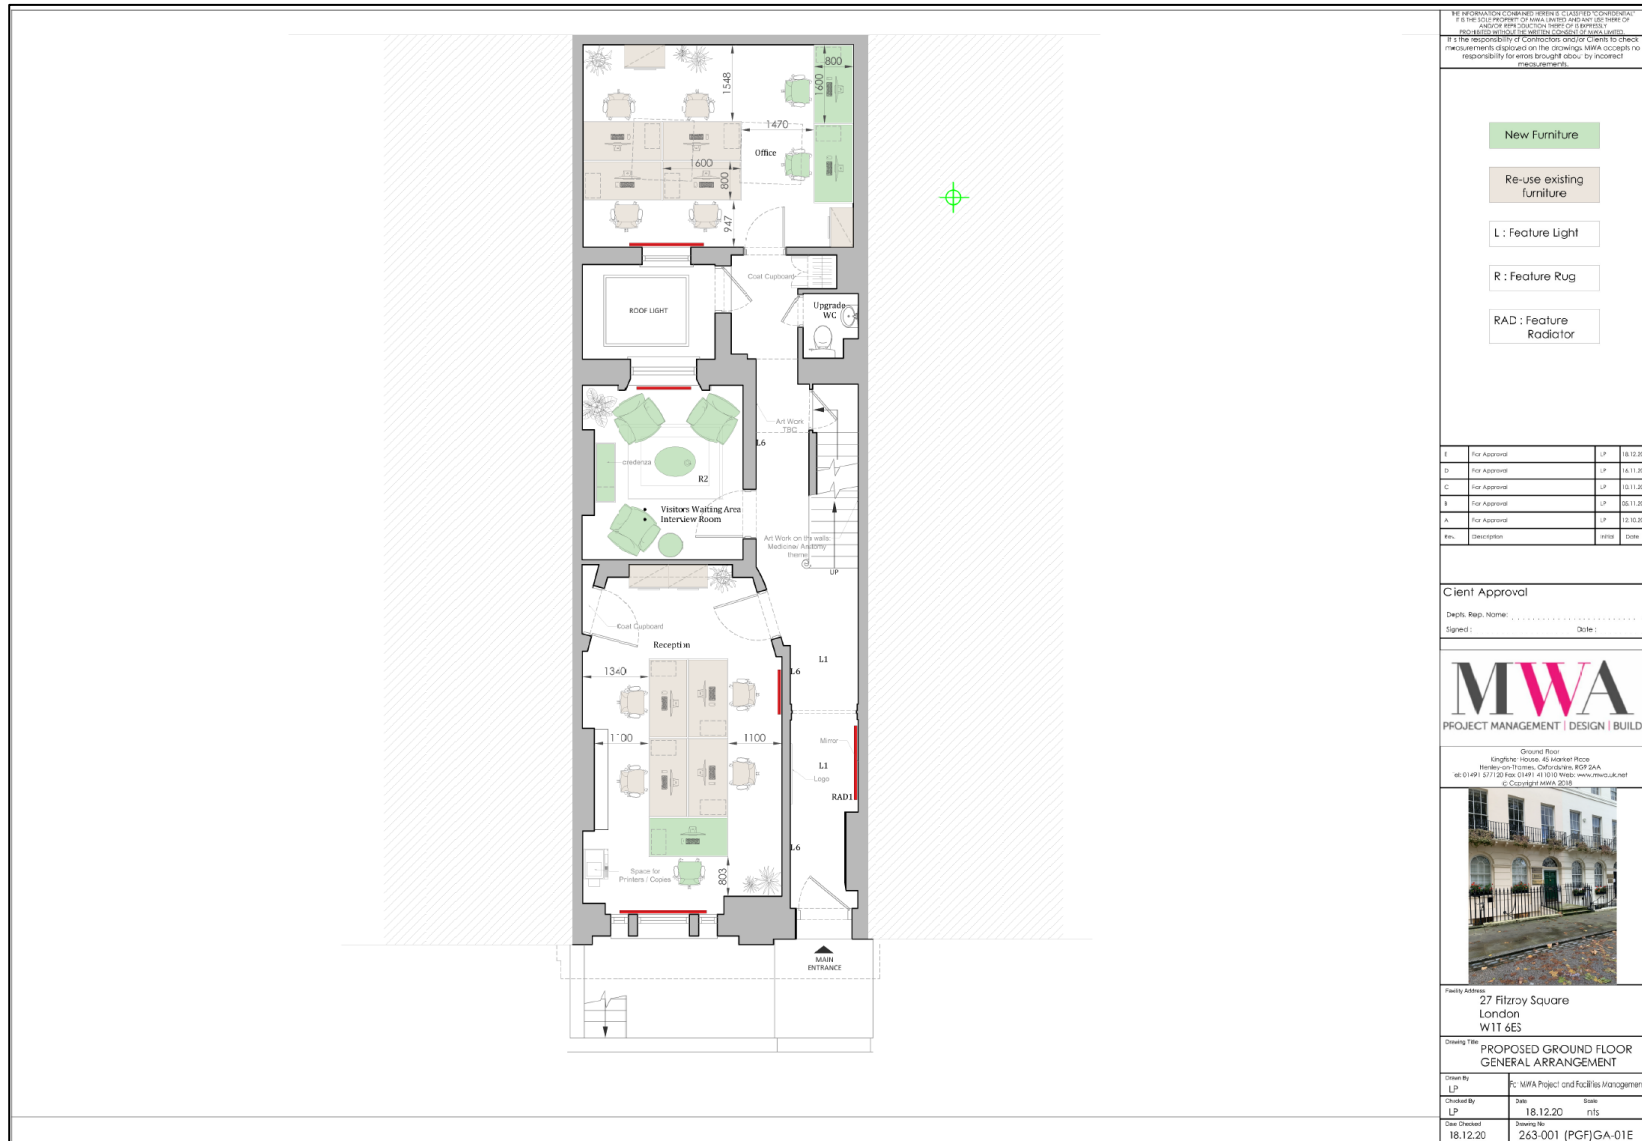
Fig. 8: Ground floor plan as proposed

Drawing Title: PROPOSED GROUND FLOOR
GENERAL ARRANGEMENT

Air conditioning is to be installed to two rooms using indoor wall mounted units. Existing radiators in the entrance hallway and corridor and to be replaced with period style radiators. Ceiling lighting to be replaced throughout with feature pendants from the entrance to the 1st floor landing and replacement wall lights installed in the entrance hallway. The office area lighting to be replaced using LED suspended linear lights. Existing power and data to remain

It is recommended, however, that the existing timber floor within the ground floor hallway and landing should be retained. While the existing flooring may well have been subject to a degree of modern repair, it is likely that, historically (based on comparison with neighbouring properties) there has always been a timber boarded floor within the entrance hallway.

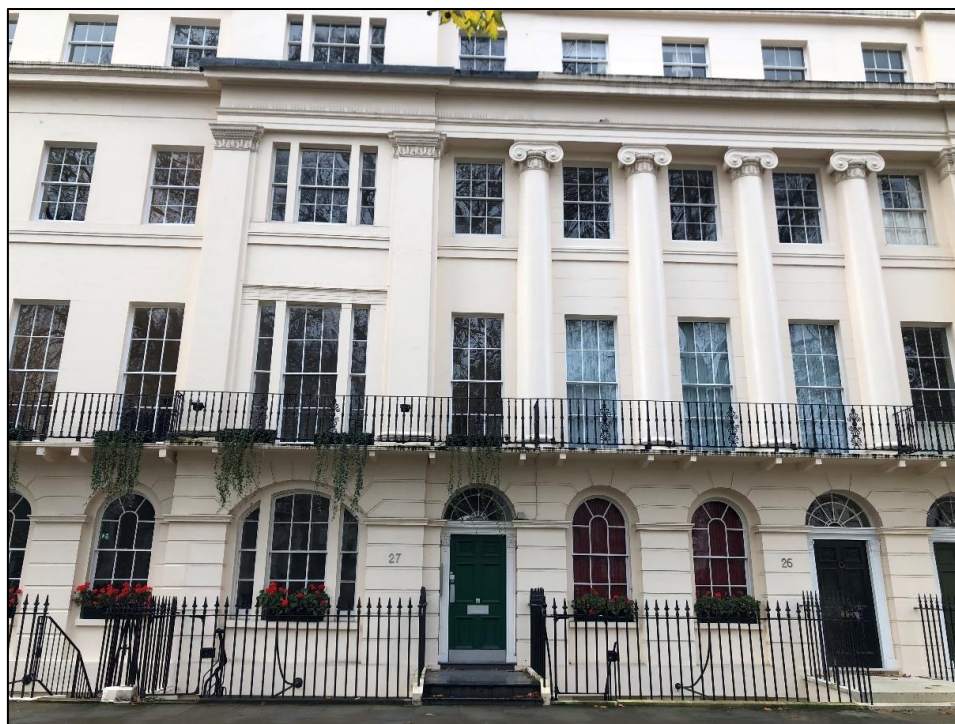
Plate 2: View looking W showing the front elevation of No. 27 Fitzroy Square

The ground floor has a rusticated façade with a round arched entrance approached by steps flanked by cast-iron railings which appear to be original (*Plate 2*). The doorcase comprises a moulded entablature flanked by Corinthian pilasters, above which is a semi-circular, radial glazed fanlight. To the left of the doorway is a recessed tripartite sash window set within a segmental arched opening. The fenestration at first and second floor level consists of a 6/6 flat-arched sash window flanked to the left by a flat-arched tripartite sash window (with a projecting cast-iron balcony on the first floor), while on the uppermost floor the fenestration comprises a 3/3 sash window again flanked by a tripartite sash window.

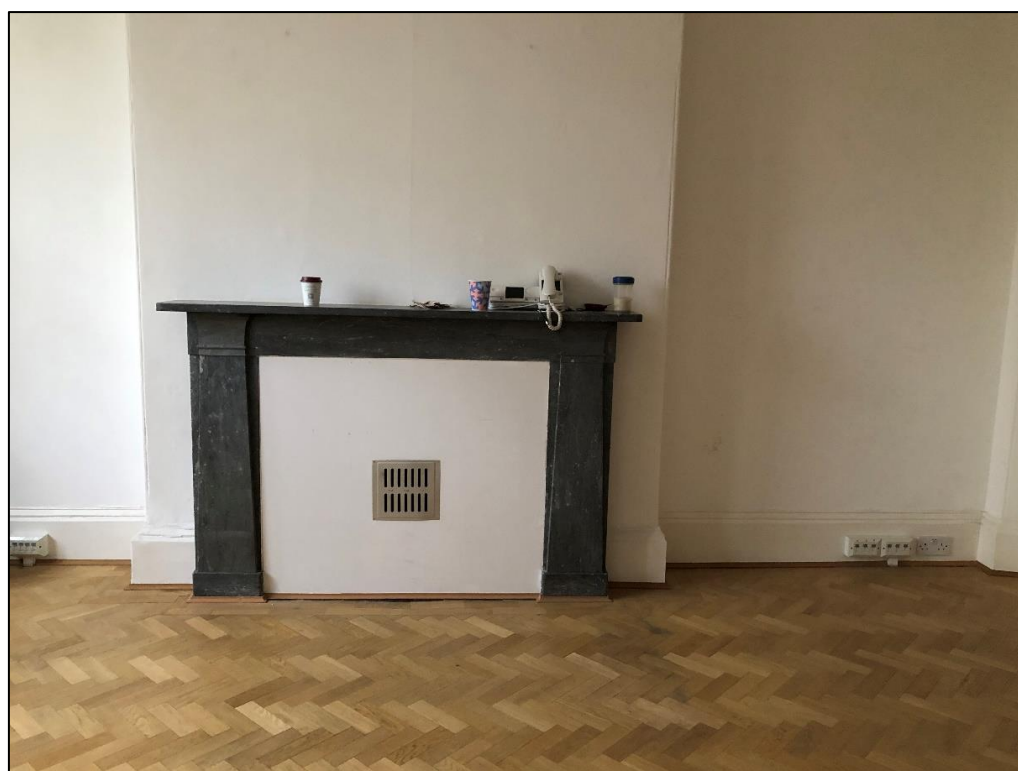
Plate 8: View looking S showing fireplace in ground floor front room

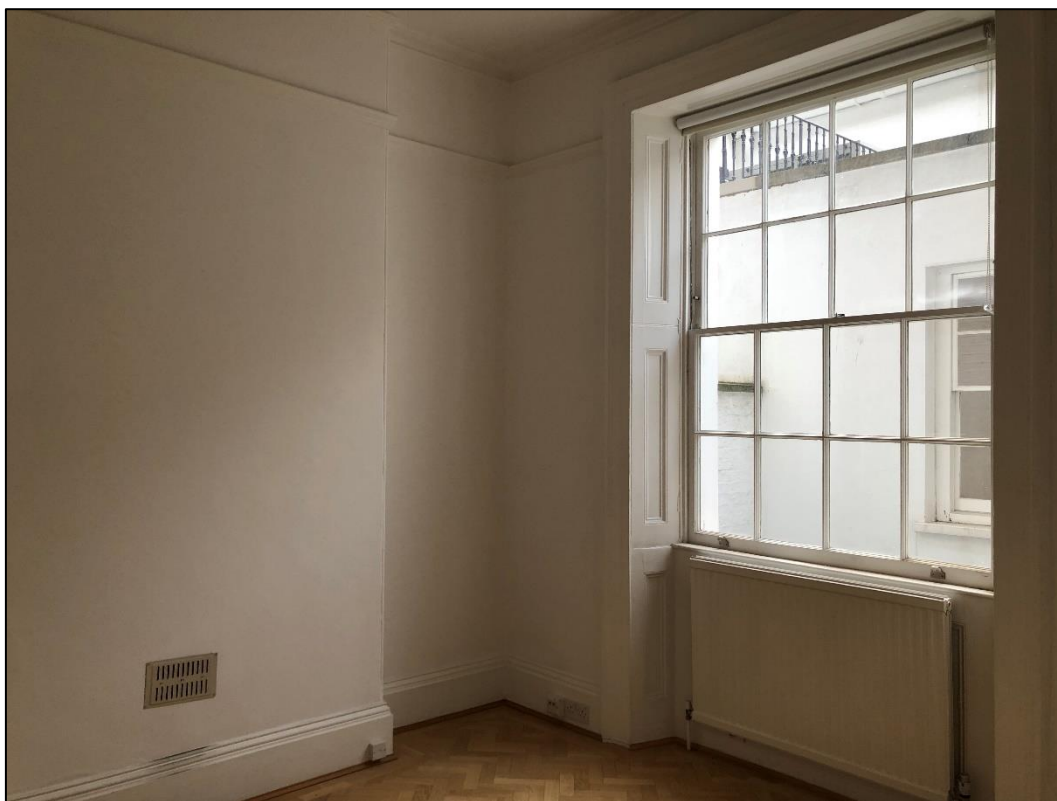
Plate 9: General view looking SW showing first floor back room with blocked fireplace and sash window

A passageway off the ground floor landing provides access to the back room which is lit by an 8/8 sash window and is again largely devoid of decoration apart from a plain moulded cornice (*Plate 9*). A projecting chimneybreast is visible in the S wall although the fireplace has been blocked up (*Plate 10*). The passageway to the side of the ground floor staircase leads to a large room to the rear which has been subject to extensive modern refurbishment as evidenced by the two large square rooflights in the ceiling (*Plates 11 & 12*). No features of architectural interest were noted in this room.

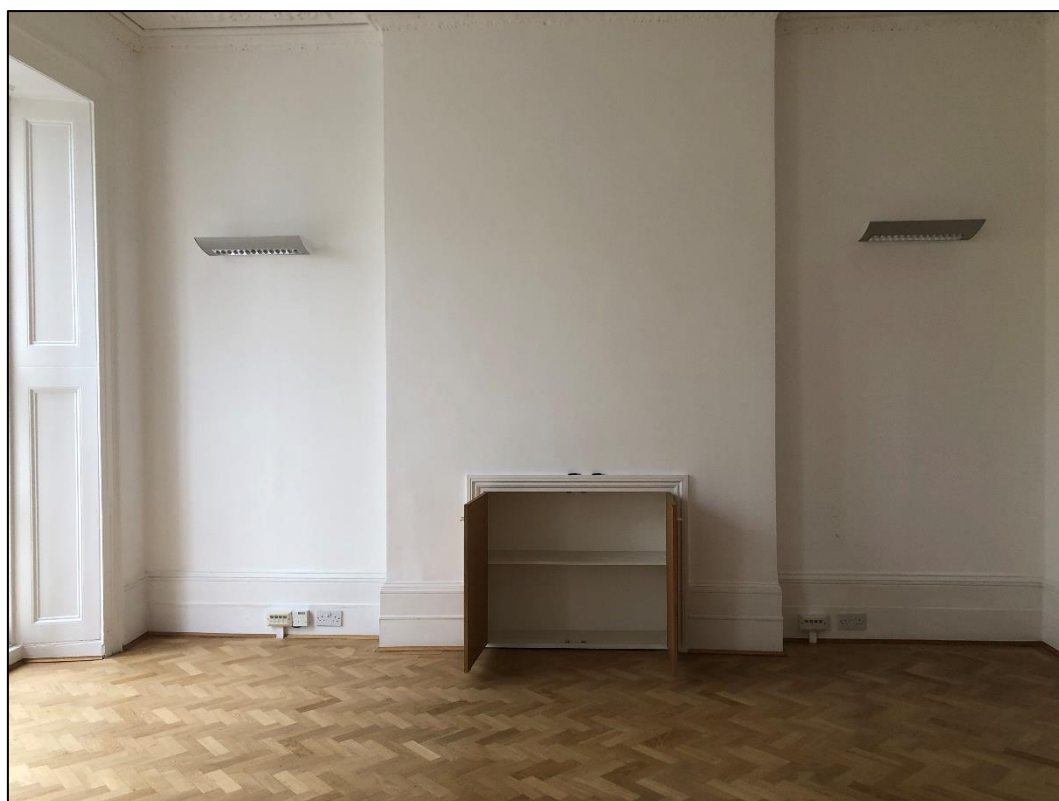
Plate 20: View looking S showing former fireplace (now wall cupboard) in S wall of first floor front room

The staircase from the ground floor leads up to the first-floor landing which has a moulded cornice and a ceiling frieze with 'Greek Key' decoration (*Plates 13-15*). To the E of the landing is a six-panelled door leading into a large front room with parquet floor, lit by a tripartite sash window and an adjoining 6/6 sash window (*Plates 16 & 17*). The room has a moulded cornice (similar in form to that in the ground floor room) and ceiling frieze with elaborate scrollwork decoration and a central plaster rosette (*Plates 18 & 19*). The fireplace in the S wall has been removed and replaced by a cupboard (*Plate 20*).

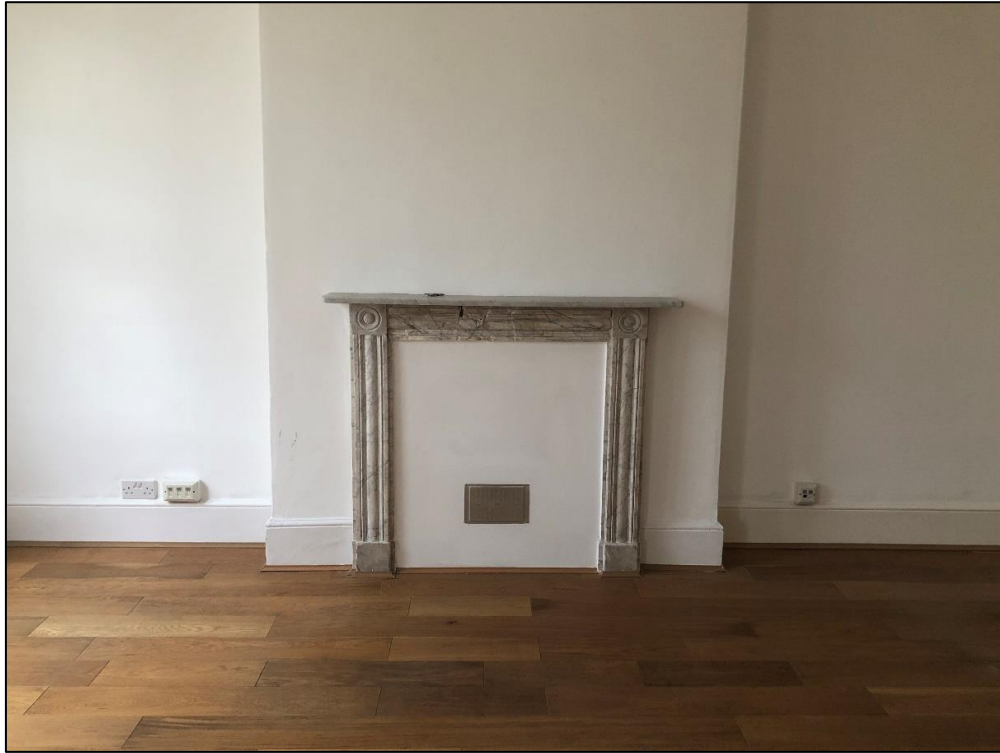
Plate 31: View showing marble fireplace in S wall of second floor front room

Relatively few fixtures or fittings of note were observed. Several of the fireplaces have been removed or replaced at a later date although the marble fireplaces in the front rooms at ground and second floor level appear to be original. Much of the flooring (where not concealed by carpeting) appears to have been renewed in recent years; the parquetry of the ground and first floors has been subject to extensive repair and renewal. A brick barrel vaulted cellar with paved floor survives at the eastern end of the basement (beneath the street frontage).

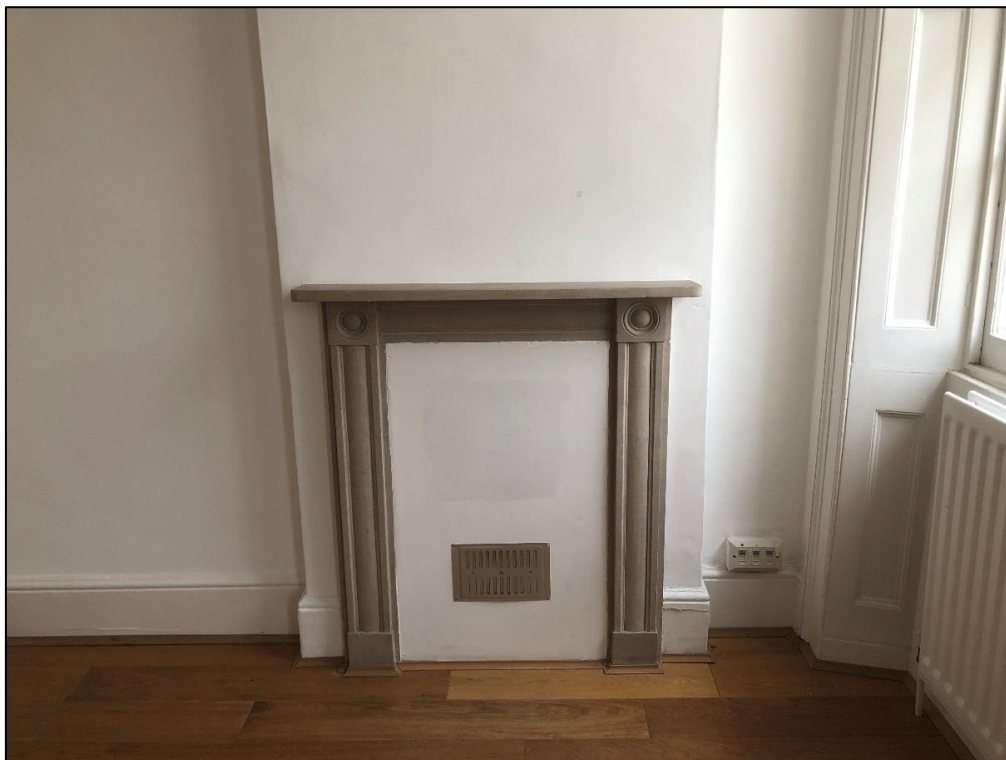
Plate 33: View looking N showing marble fireplace in second floor front room

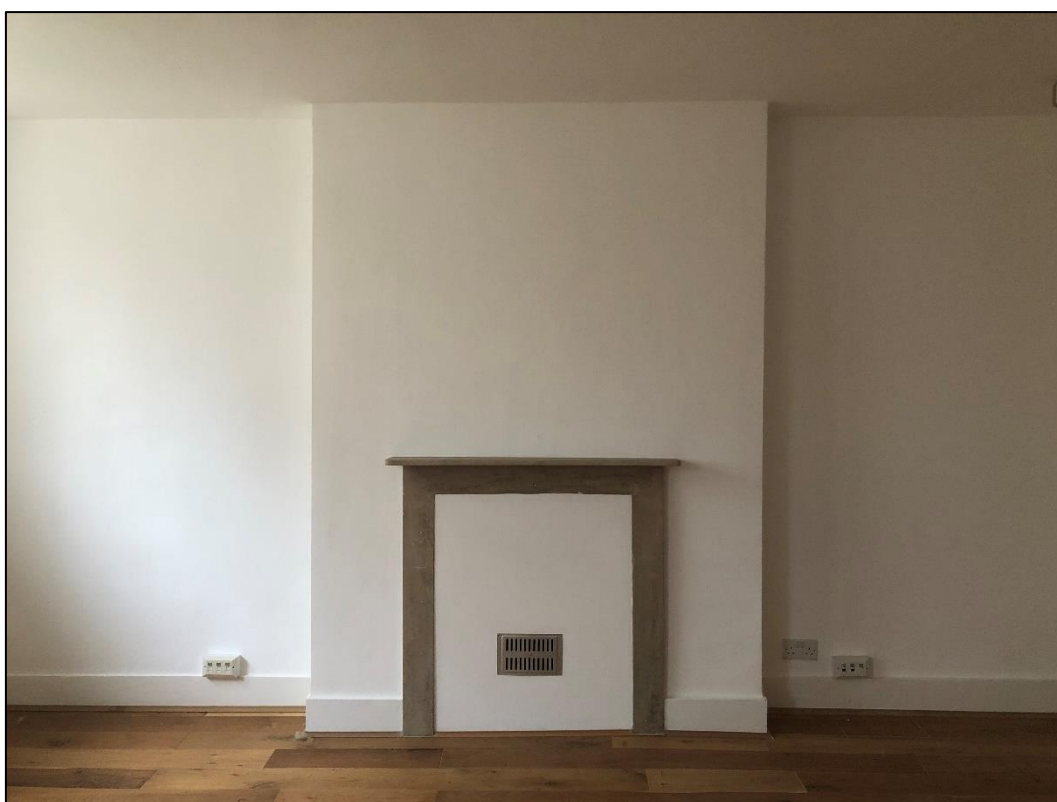
Plate 40: View looking S towards blocked fireplace in third floor front room

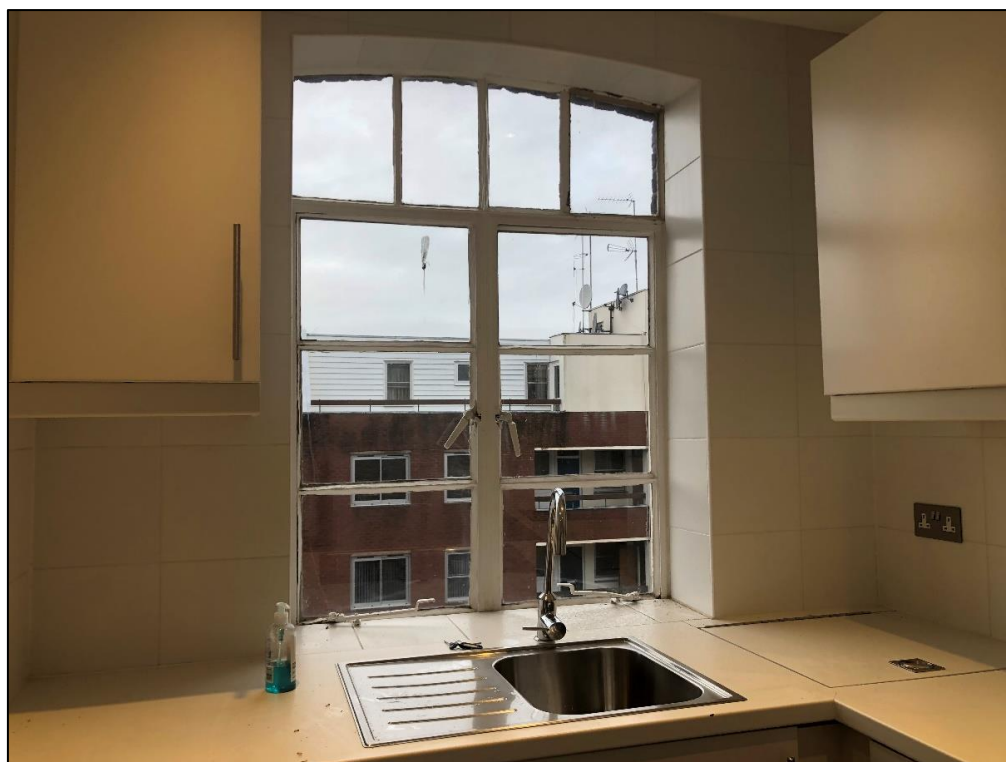
Plate 46: View looking W showing casement window in third floor kitchen

A wooden staircase with moulded balusters leads up from the second floor to the third-floor landing (*Plates 37 & 38*). At the E end of this landing is a large room lit by a tripartite window and a 3/3 sash window (*Plate 39*) which originally appears to have been subdivided into two separate unequal-sized rooms, as evidenced by a wall-stub between the two windows and two plain fireplaces (both of which have set in the S and N walls of the room respectively (*Plates 40-& 41*). No other fixtures or fittings of note were observed in this room. The back room is accessed from a doorway off the landing and is lit by a 4/4 sash window (*Plates 43 & 44*); the only noteworthy feature was a fireplace I the S wall (*Plate 45*). At the W end of the third-floor landing is a glazed door leading to a small kitchen compartment with a segmental arched casement window (*Plate 46*).

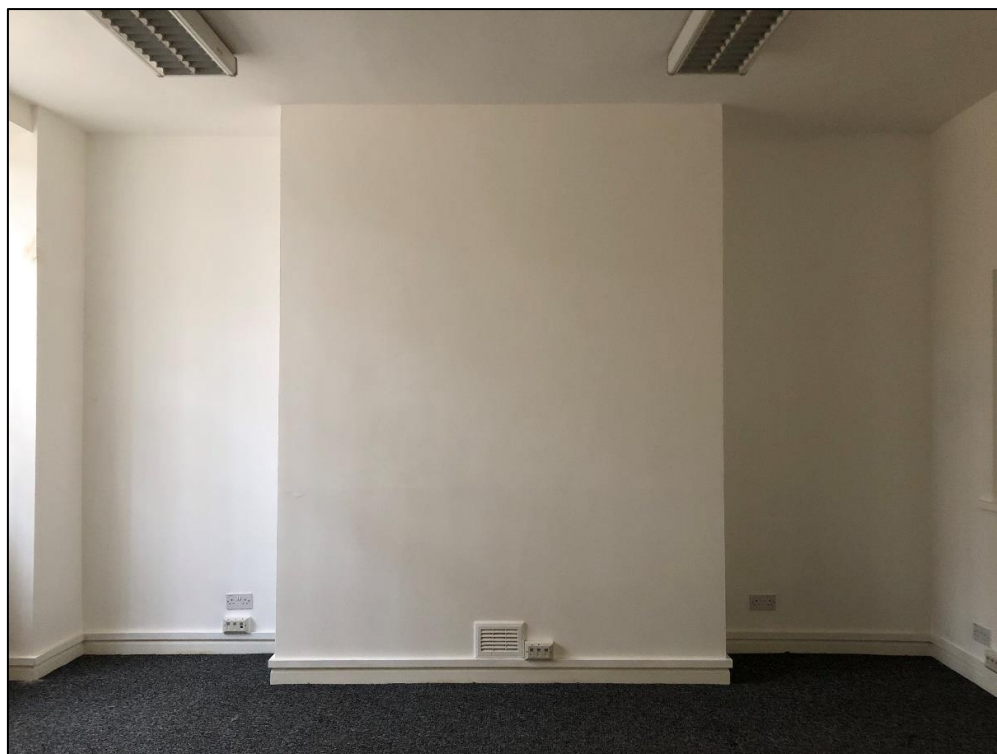
Plate 50: View looking S showing blocked chimneybreast in basement front room

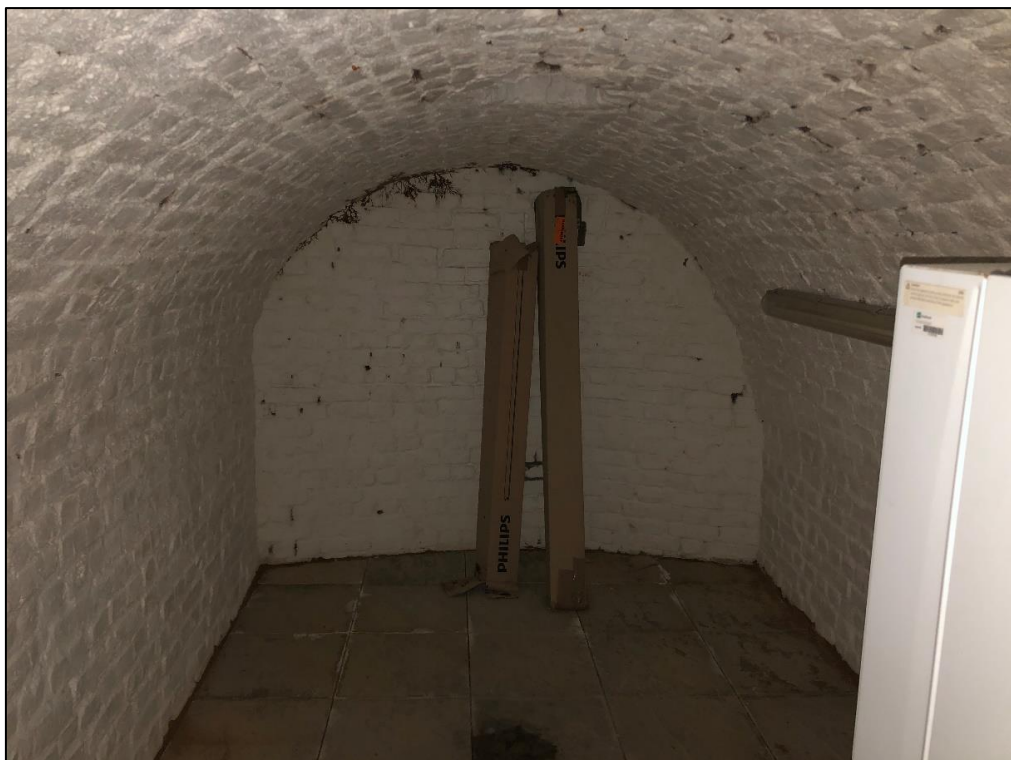
Plate 52: View looking E showing barrel vaulted roof in basement

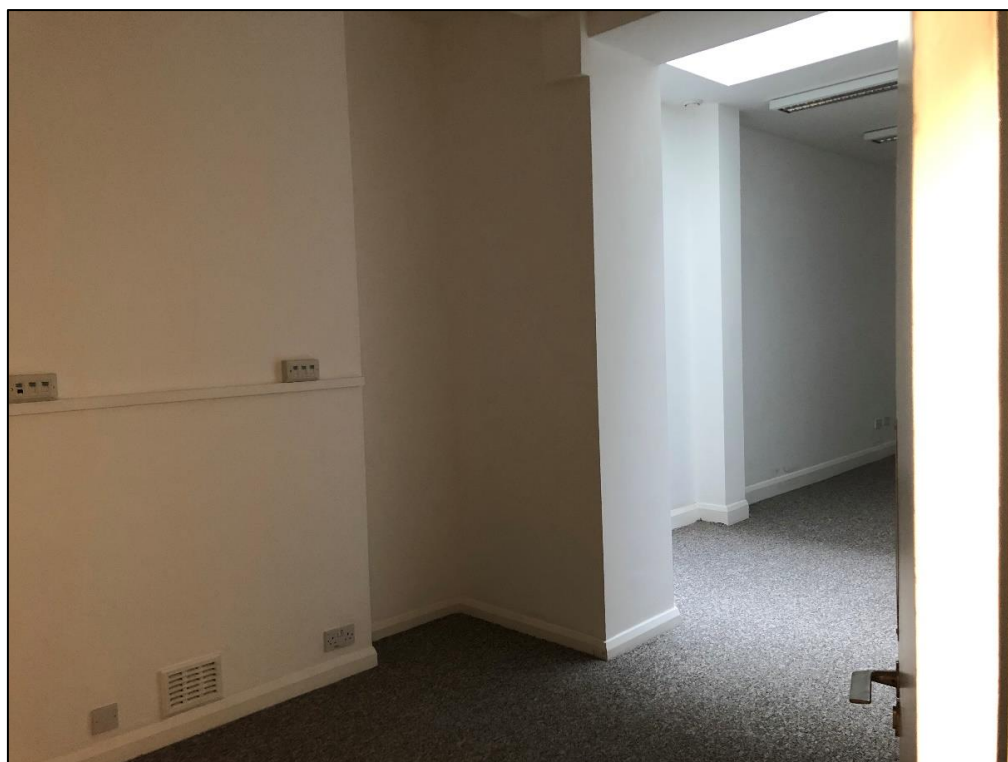
Plate 54: View looking SW showing blocked chimneybreast in S wall of basement room
