Archaeological Standing Building Recording

**Furnace Farm
Shelsley Walsh
Worcester
WR6 6RP**

Firemitre Limited

February 2022

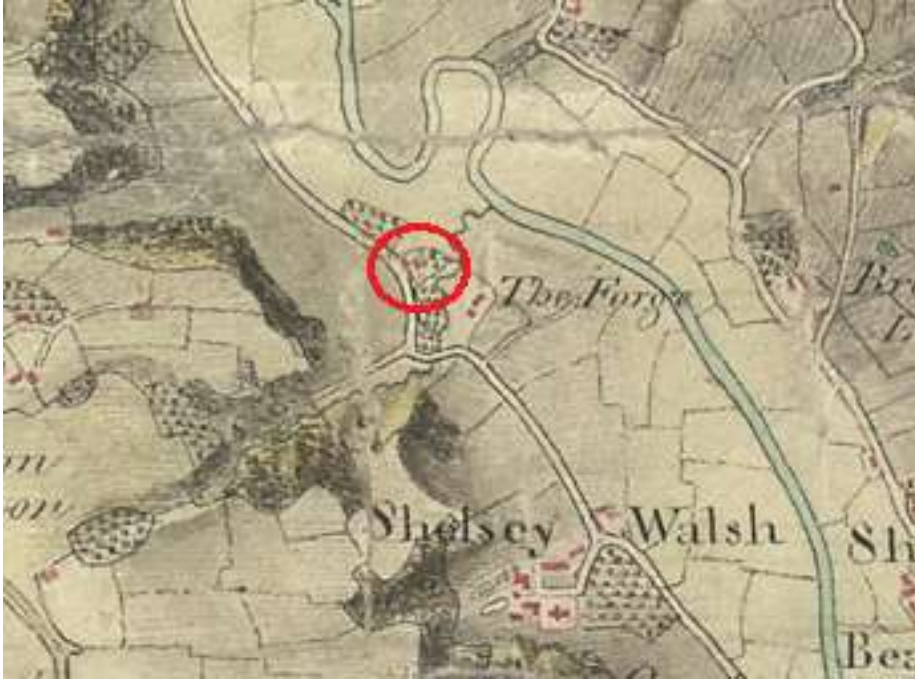
Fig. 3: Extract from the OS Surveyor's Drawing of 1813
(Reproduced by courtesy of the British Library)

The origins of the farmstead at Furnace Farm are unclear but it could possibly date back to the 17th or 18th centuries. An Ordnance Survey drawing of 1813 (*fig. 3*) depicts an unnamed cluster of buildings adjoining the lane to Shelsley Walsh which appear to represent the farmstead of Furnace Farm. To the E of the farmstead, the 1813 map depicts a separate group of buildings which may represent limekilns associated with two nearby quarries situated in woodland to the W and SW of Furnace Farm (Hwiccian Archaeology 2019). It is possible that the name of 'Furnace Farm' was derived from these kilns; however, it could also be associated with charcoal burning activity connected with an iron forge which is marked on the 1813 map about 300m SE of the farmstead on the opposite side of the River Teme (Mawer & Stenton 1927, 79).

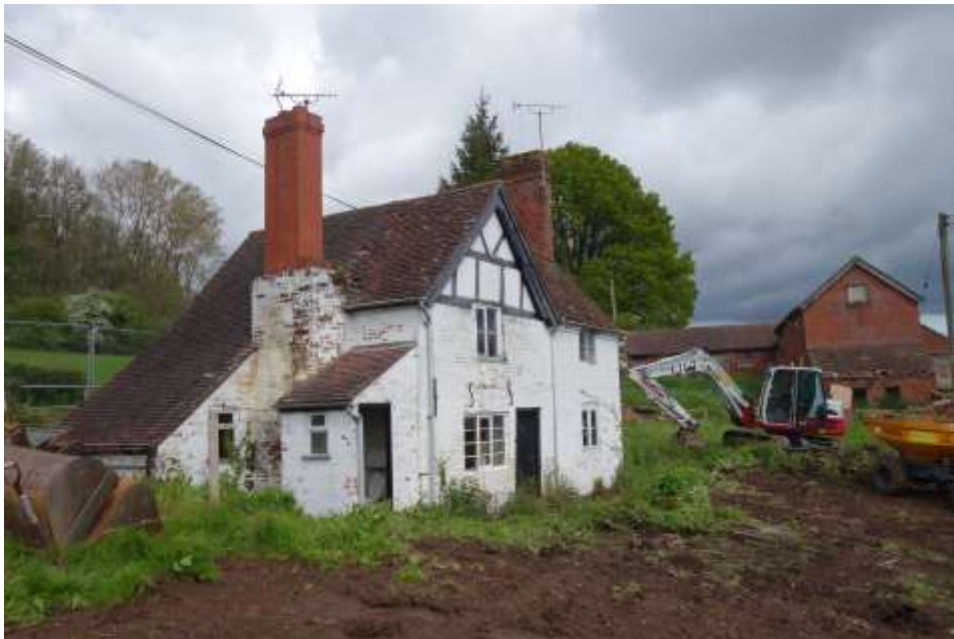
The farmhouse, which is set within a sloping bank noticeably beneath the existing level of the adjacent road, is two storeys in height and roughly L-shaped in plan, comprising a two storey block and gabled cross-wing at the S end (aligned E-W). The building is predominantly of red brick construction, mostly laid in English Garden Wall Bond (with some timber-framed elements, in particular the exposed timber-framing in the E and W gables) and externally whitewashed, with a cross-pitched clay tiled roof with tall red brick chimneystacks at the N and S ends. The upper portion of the southern chimney flue appears to have been rebuilt quite recently.

Plate 1: General view NNW showing the rear of the farmhouse with range of brick outbuildings to the N

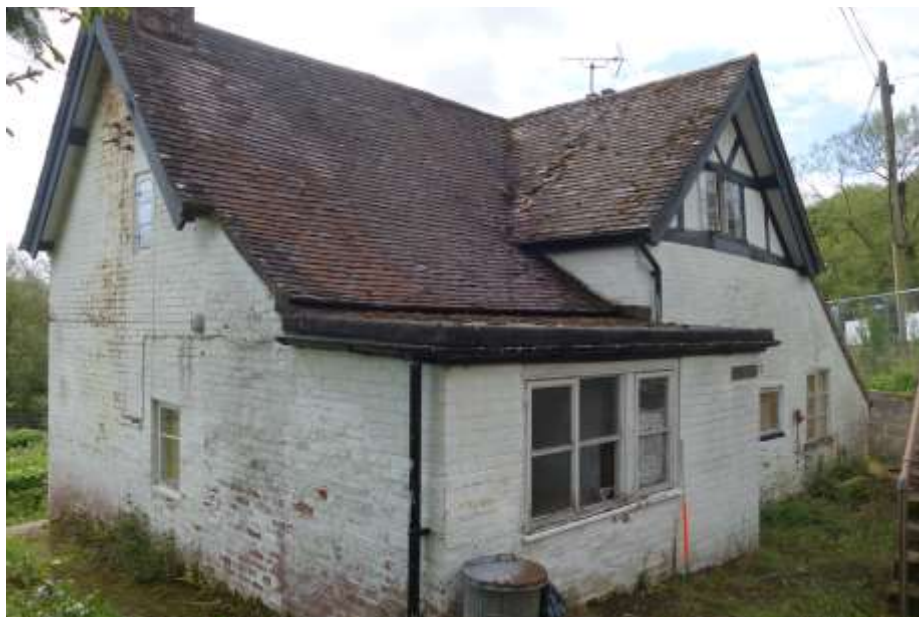
The W-facing elevation fronting onto the lane has a two-storey gabled wing at the S end (*Plate 2*), the upper portion of which has a bargeboarded gable with exposed thick-scantled timber framing with brick nogging and diagonal braces at the apex of the gable (*Plate 3*). A modern 6-paned casement window with thin glazing bars has been inserted in the timber-framed upper portion of the gable (*Plate 4*). The main entrance at ground floor level is placed within the gabled wing and consists of a broad plank and batten door set within a segmental arched opening, a rectangular single-light window with a wooden sill to the immediate right of the doorway appears to be a 20th century insertion (*Plate 5*).

Plate 2: Oblique view SSE showing front elevation farmhouse with gabled crosswing and modern flat-roofed extension

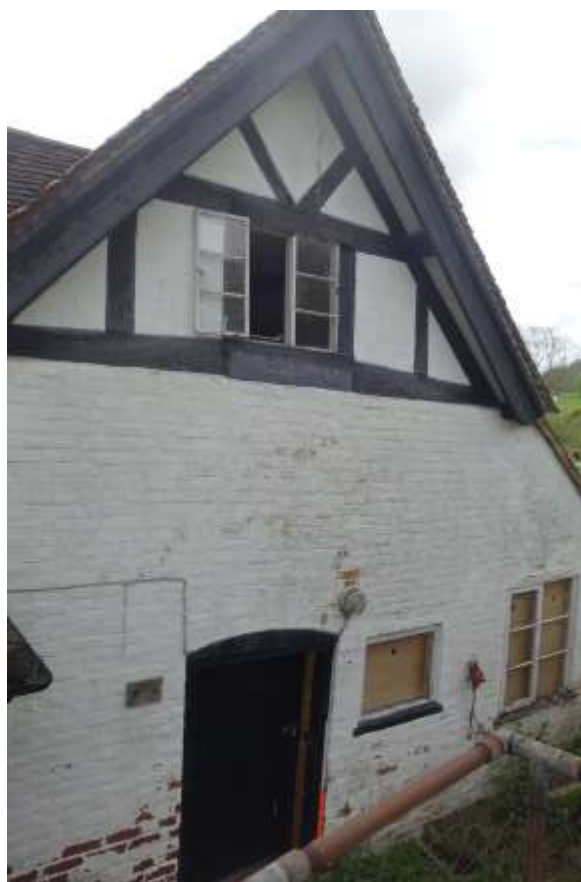
Plate 3: View looking ESE showing W gable of crosswing with segmental arched door and exposed timber framing in the apex of the gable

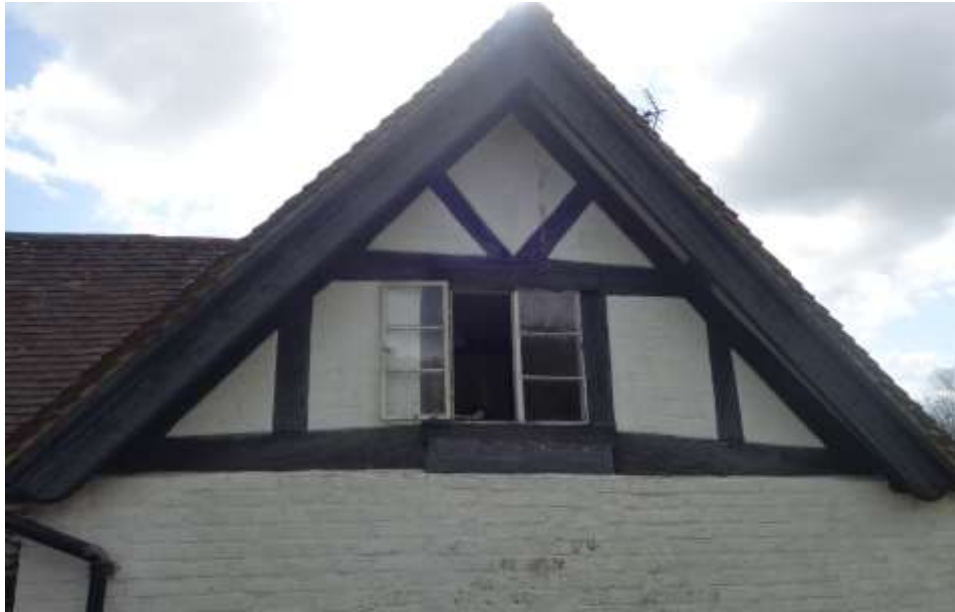
Plate 4: View looking E showing detail of exposed timber framing with brick nogging in W gable of crossing

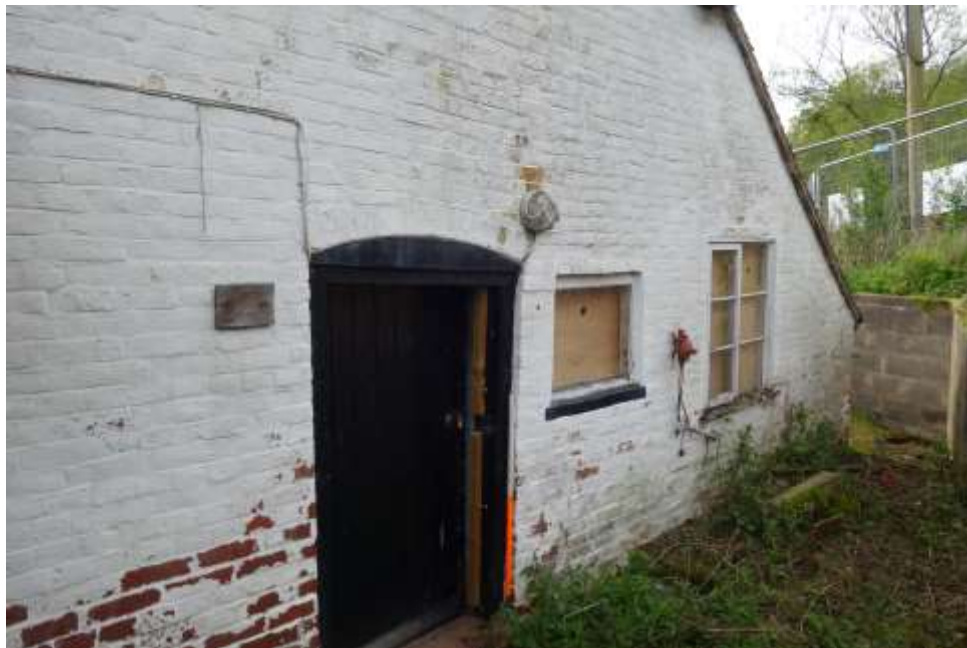
Plate 5: Oblique view ESE showing W-elevation with doorway at ground floor level with lean-to kitchen extension to right of picture

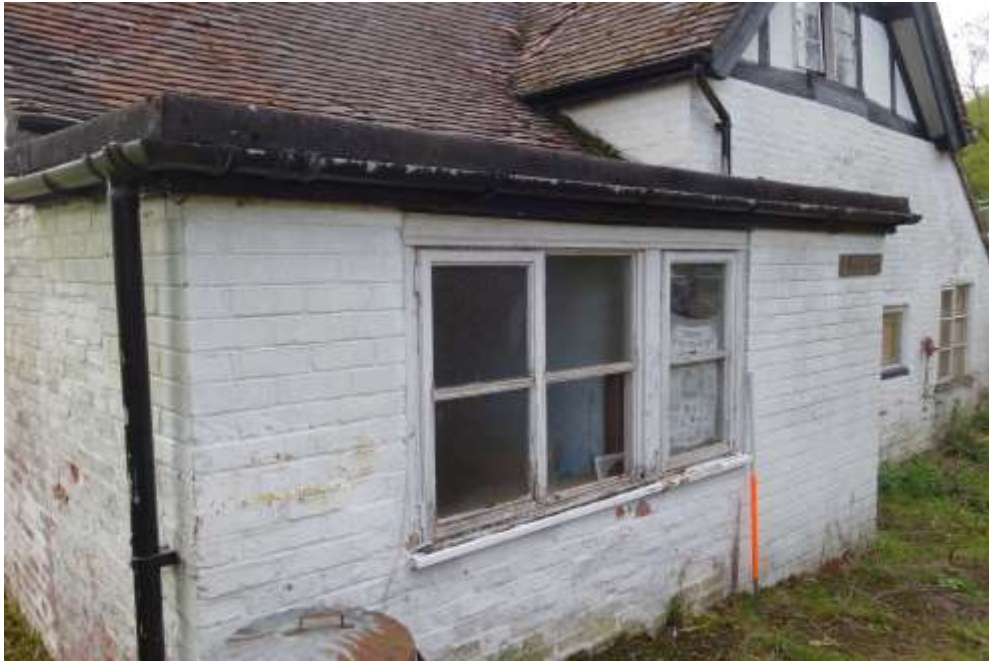
Plate 6: Oblique view looking SE showing modern single storey flat-roofed extension

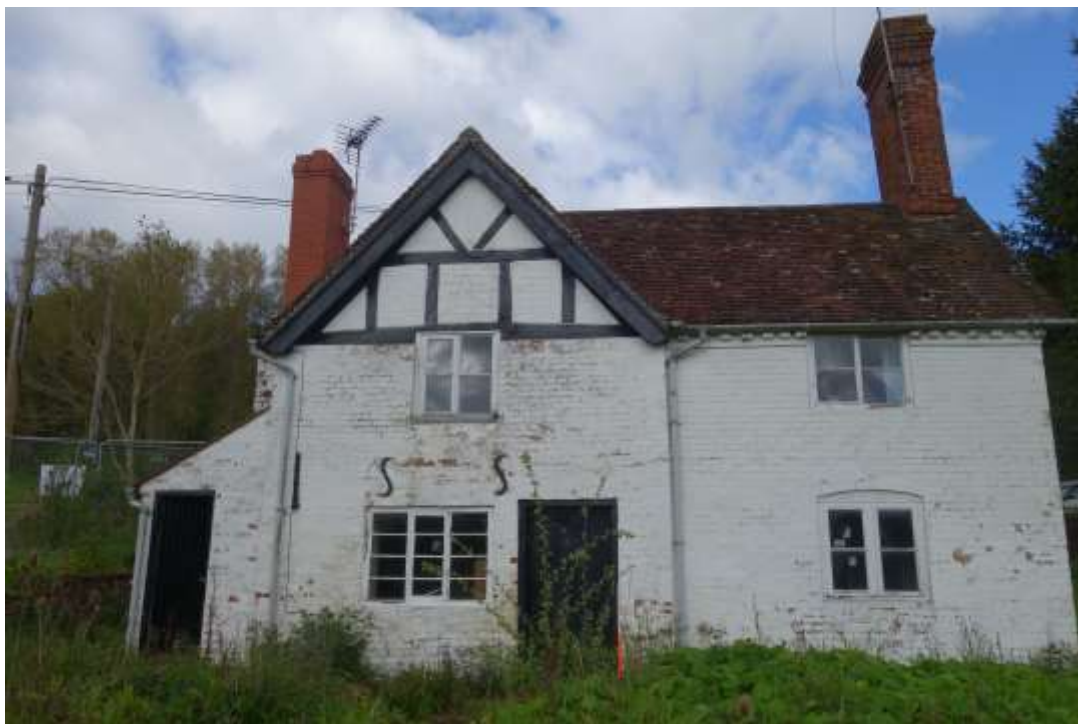
The rear (E-facing) elevation of the farmhouse comprises two distinct elements, consisting of the gabled two-storey crosswing oriented E-W with exposed square timber-framing with diagonal braces in the apex of the gable (*Plate 7*) and the attached rectangular two storey gabled range aligned N-S. A flat-arched plank and batten door is set off-centre at ground level within the gabled crosswing, to the left of which is a broad flat-arched window with a modern 12-pane casement. Above the window are two S-shaped cast-iron ties set into the thickness of the wall, while at first floor level is a four-paned casement window inserted into the timber-framing of the gable.

Plate 7: View looking W showing rear (E-facing) elevation with exposed timber-framing in the apex of the gable

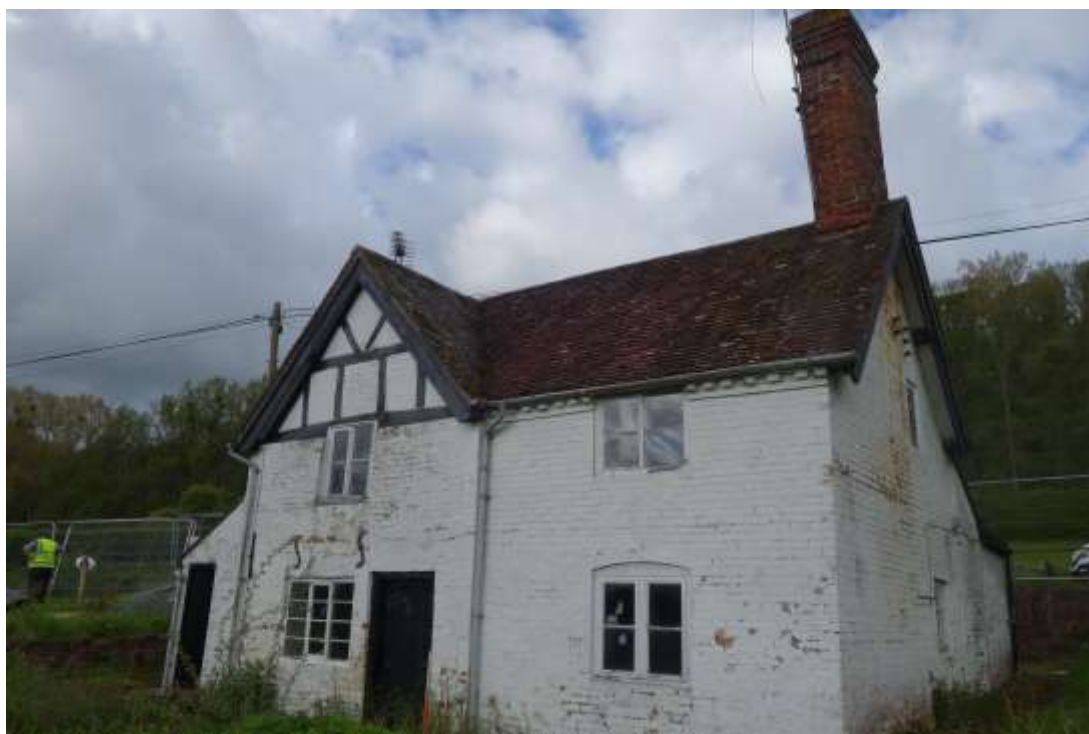
A vertical construction break was noted between the gabled crosswing and the adjacent two-storey range and this is evidenced by a distinct change in the bonding of the brickwork, suggesting that the gabled crosswing is probably of an earlier date (*Plate 8*). The adjacent two-storey gabled range has a dentilled eaves cornice, with a segmental arched two-light casement window on the ground floor and a four-paned casement window extending to eaves level.

Plate 8: View looking SW of the rear elevation of the farmhouse, showing the two-storey range with dentilled eaves cornice attached to the gabled crosswing

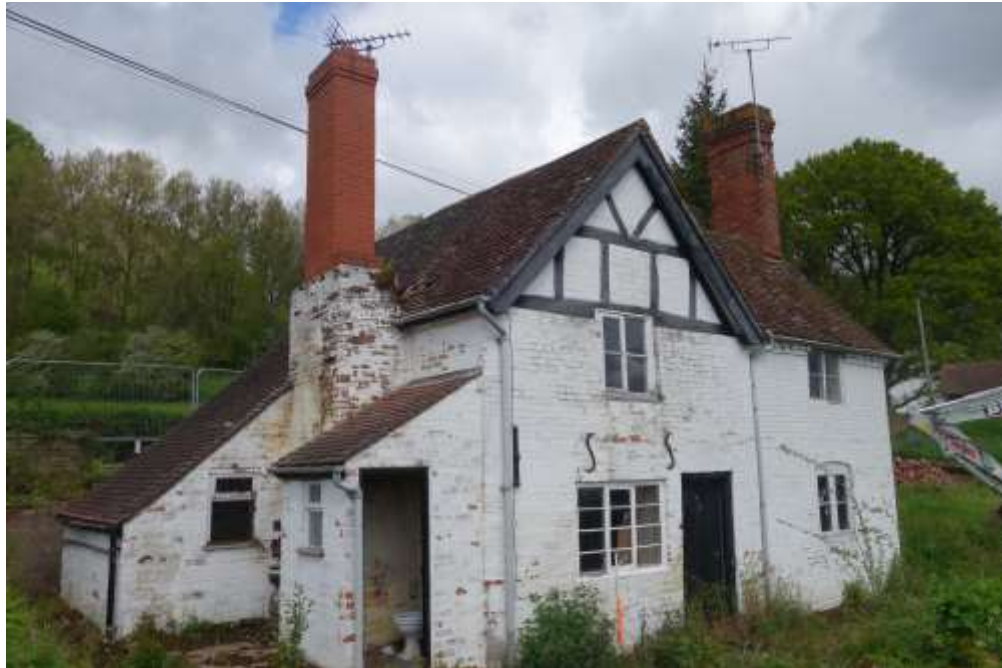
Attached to the S end of the rear elevation is a lean-to outhouse of brick construction with a catslide roof which appears to be of late 19th century date (*Plate 9*). Attached to the S end of the building is a projecting square brick chimneystack, the lower portion of which appears to be original while the upper portion has been rebuilt in the late 20th century.

Plate 9: Oblique view looking NW showing the chimney at the S end of the farmhouse flanked by lean-to outhouse and kitchen extensions

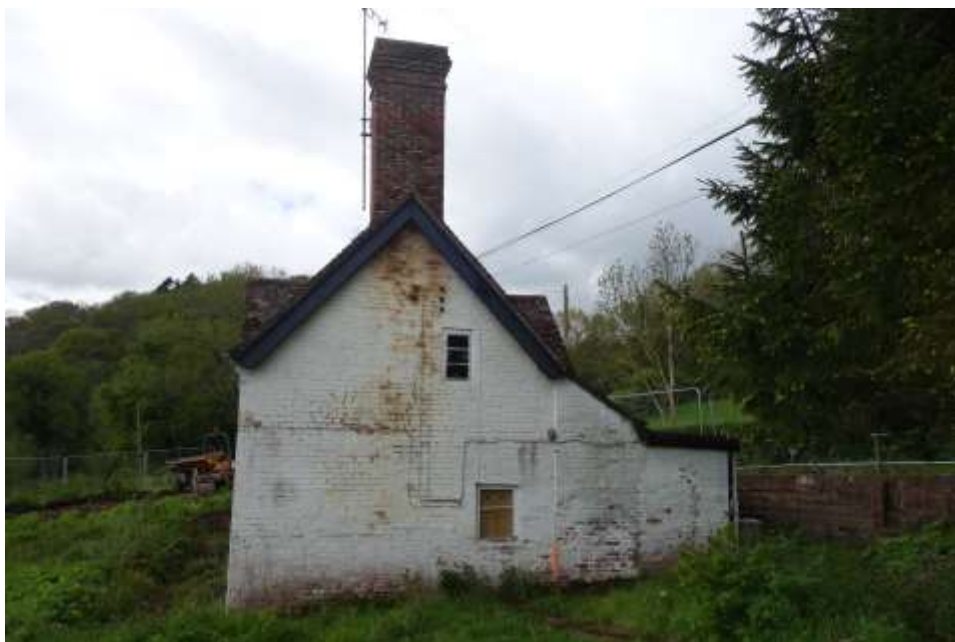
The N-facing elevation of the two-storey range has a bargeboarded gable surmounted by a tall brick chimneystack. The fenestration consists of a two-light casement at ground floor level with a narrow three-light casement on the first floor, both set to right of centre within the elevation. The construction breaks for the lean-to structure to the W (probably of late 19th century date) and the modern flat-roofed extension are clearly discernible.

Plate 10: View looking S showing the N-facing gable elevation of the farmhouse

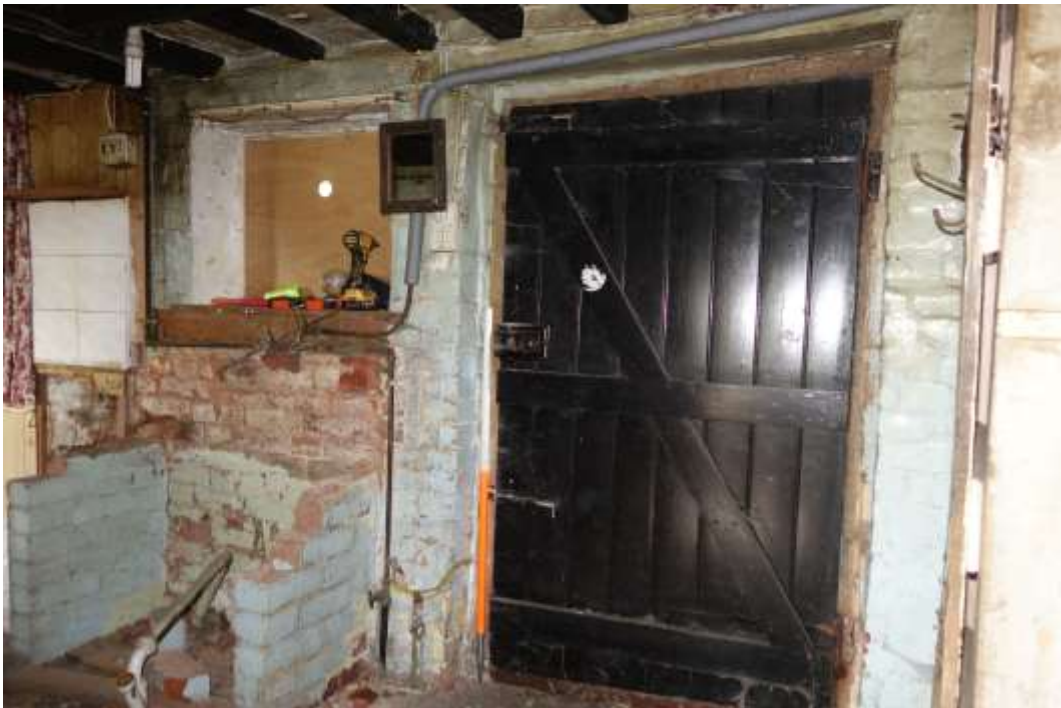
The principal entrance to the farmhouse, accessed via a plank and batten door in the W elevation of the building (*Plates 11 & 12*), leads into a narrow rectangular entrance lobby with tiled floor aligned N-S. At the N end of the entrance lobby is a brick partition wall with a narrow, planked doorway providing access to a dog-leg staircase leading up to the first floor (*Plates 16 & 17*). The ceiling joists in the entrance lobby are roughly hewn and chamfered, with evidence for a square hatch located in the centre of the ceiling with hooks inserted in the joists (*Plate 13*)

Plate 11: Internal view looking W showing ground floor lobby and main entrance

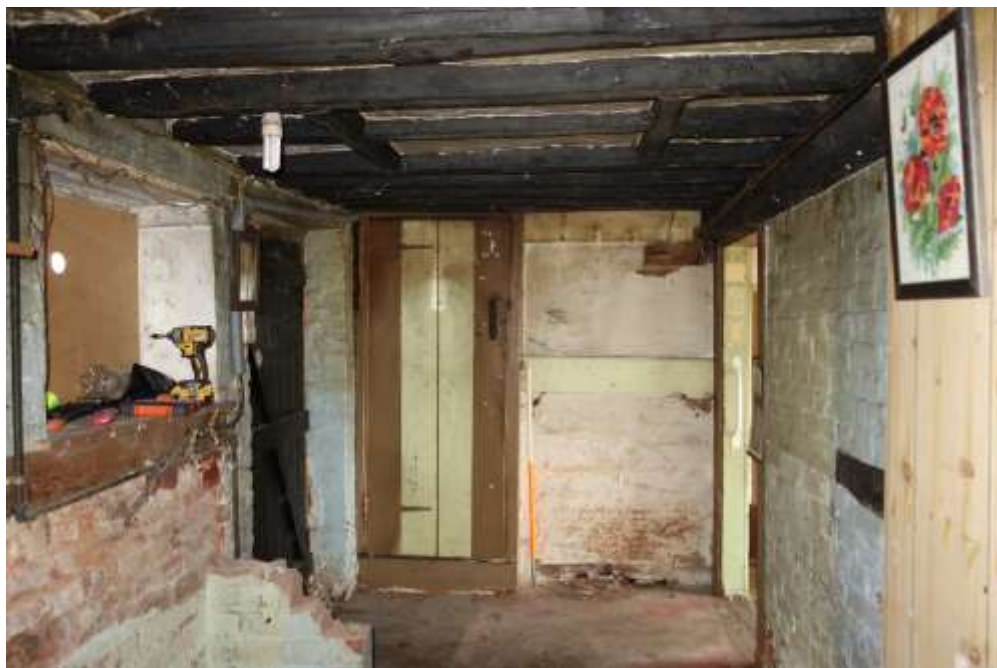
Plate 12: Internal view looking N towards staircase in ground floor lobby with exposed ceiling joists and blocked hatch in ceiling

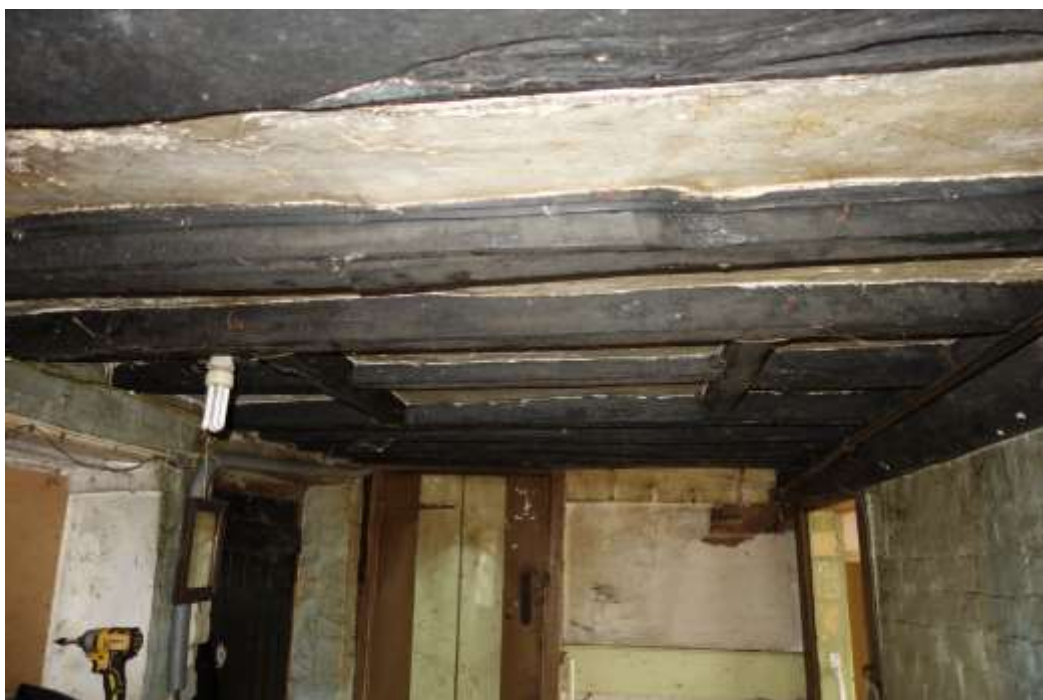
Plate 13: Internal view looking N showing detail of exposed ceiling joists and hatch in ceiling of entrance lobby

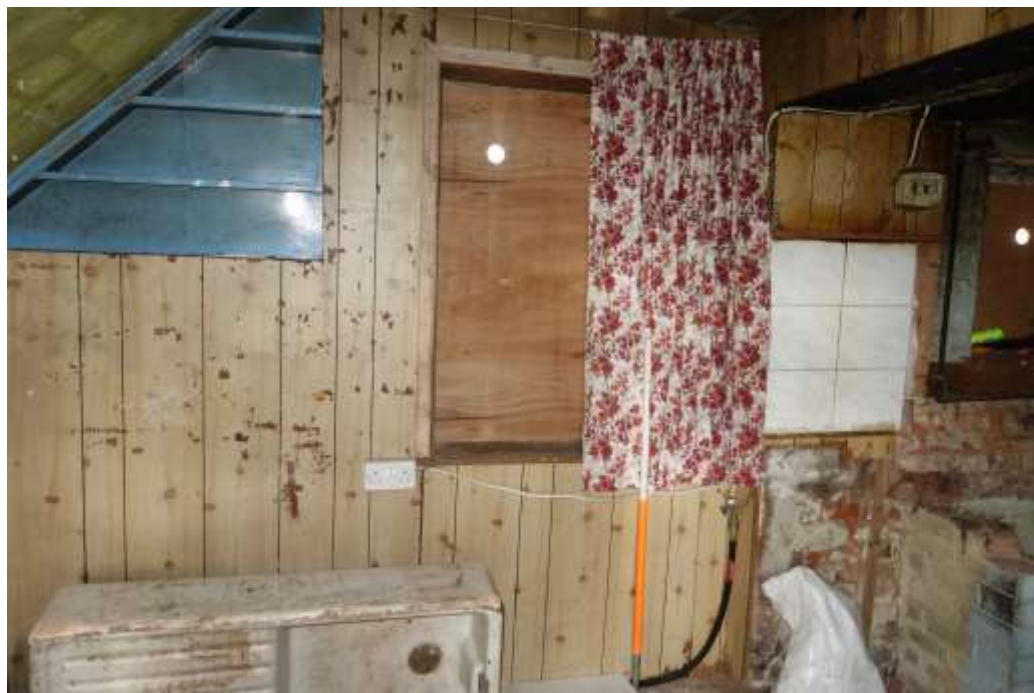
The truncated remains of a low brick wall stub mark the former position of a partition wall separating the entrance lobby from the kitchen extension to the S, the walls of which are lined with tiles and pine panelling (*Plate 14*). The kitchen is lit by casement windows in the E and W walls; the rear (E) wall appears to have been substantially rebuilt to accommodate a modern stove (*Plate 15*).

Plate 14: Internal view looking W showing W wall of kitchen extension with wooden panelling

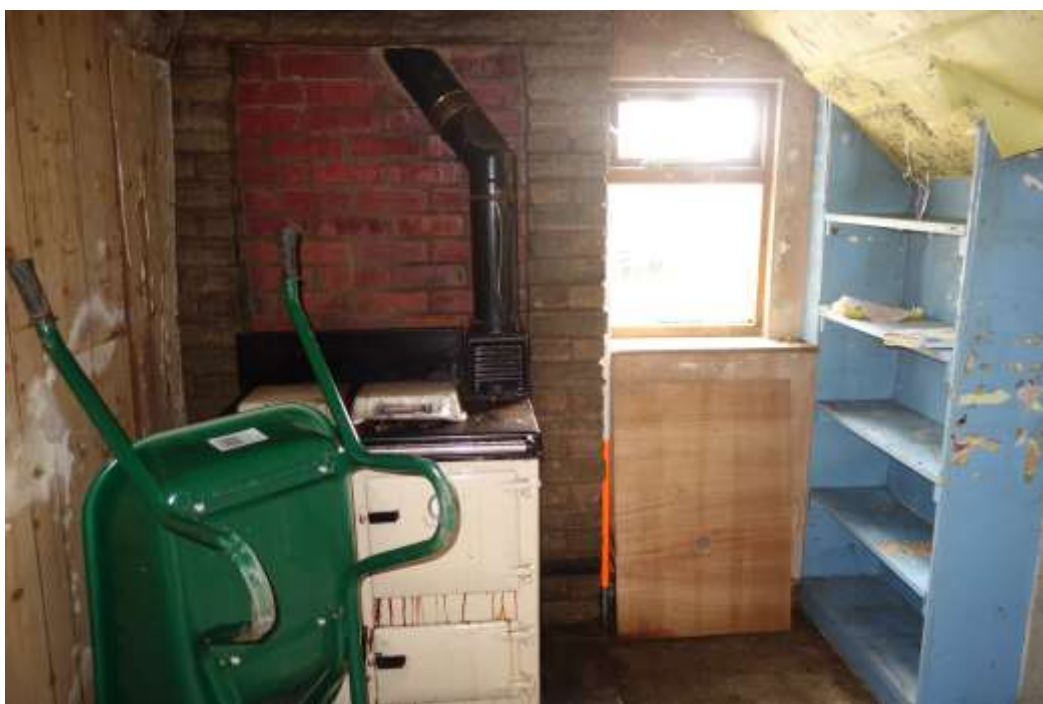
Plate 15: Internal view of kitchen looking E showing renewed brickwork in E wall to left of window

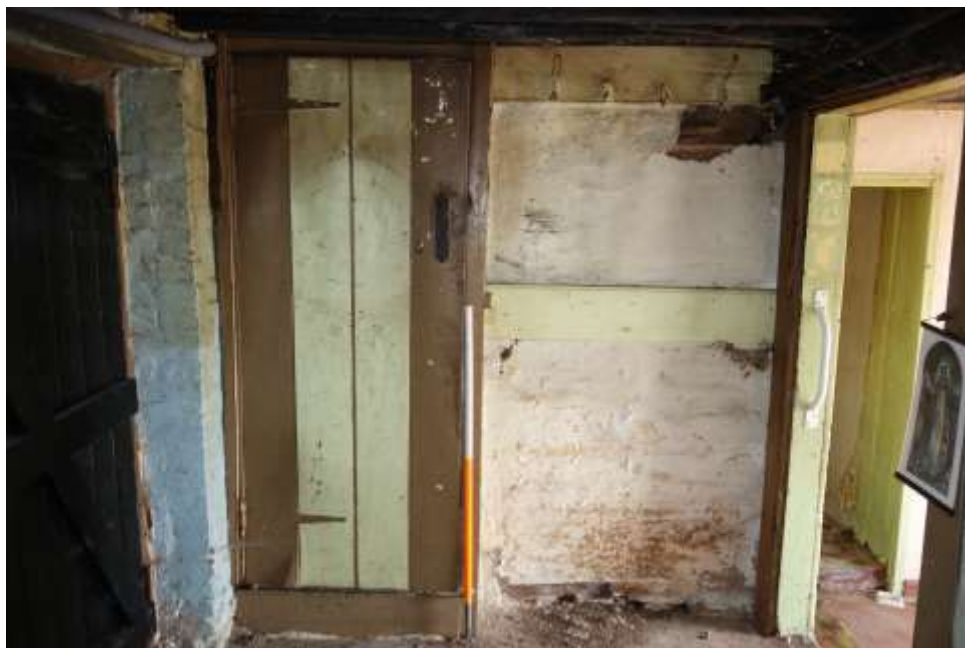
Plate 16: View looking N showing detail of narrow planked door at N end of lobby leading to stairs to first floor

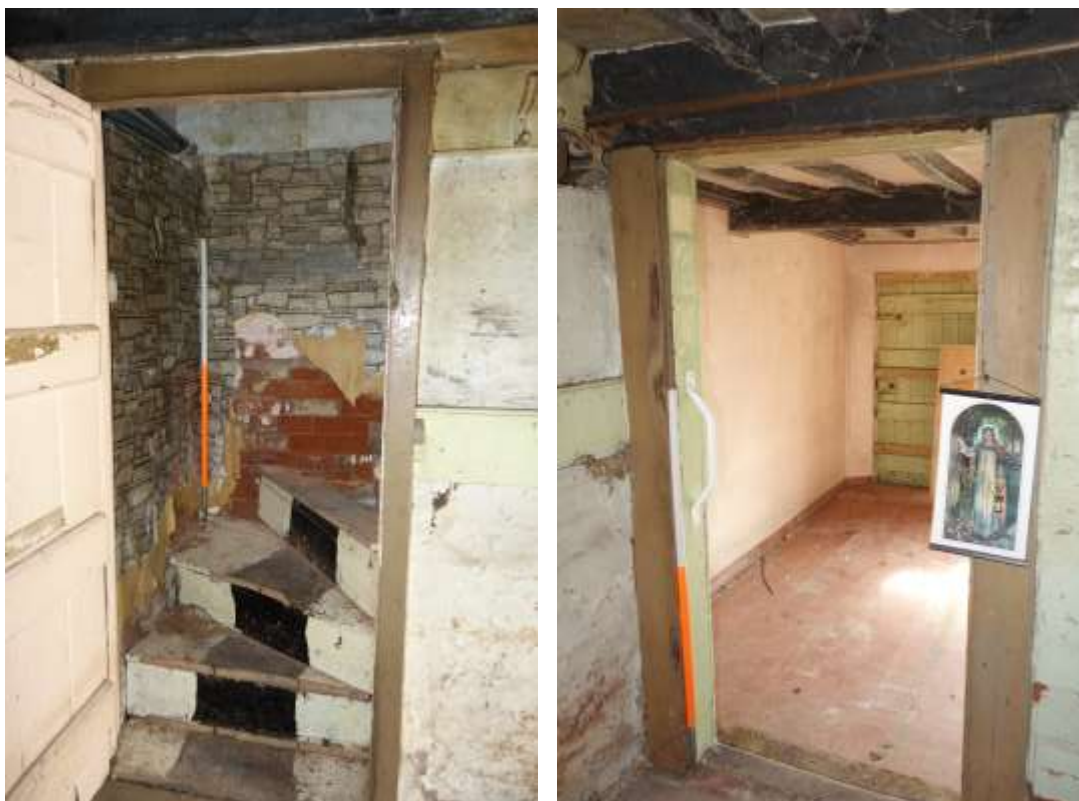
Plate 17: Internal view showing detail of wooden dog-leg staircase leading up to first floor with brickwork concealed by stone-patterned wallpaper

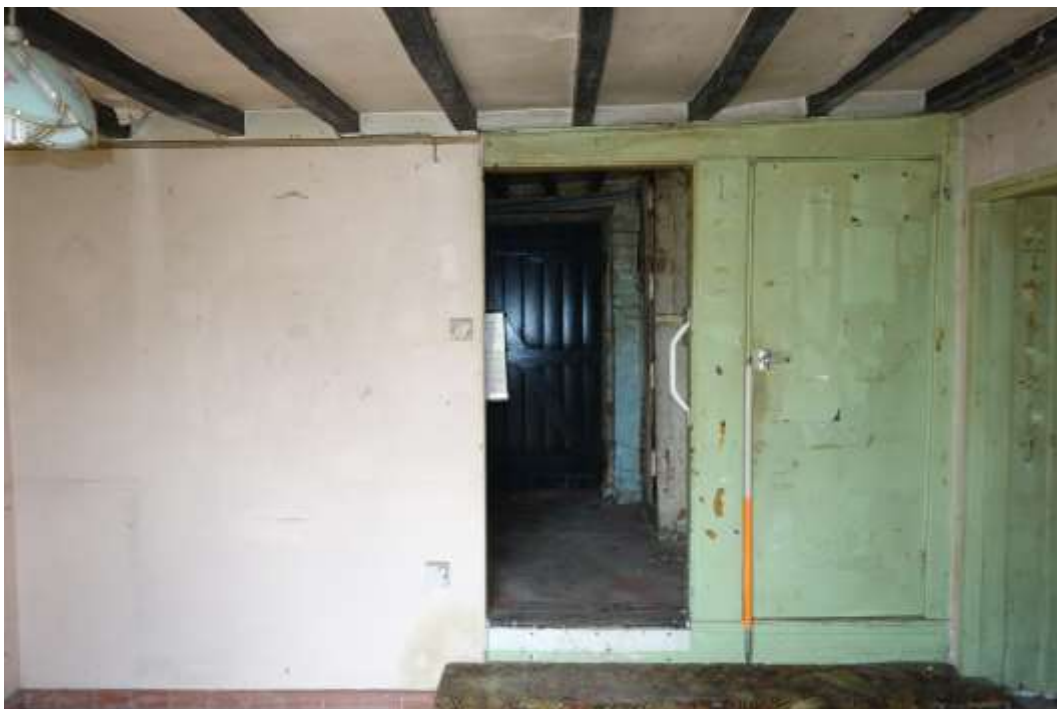
A brick partition wall separates the entrance lobby from the dining room to the E which is accessed via a flat arched doorway with a wooden lintel (*Plates 18 & 19*). This room has exposed ceiling joists and a chamfered ceiling beam aligned N-S and a red quarry tiled floor; it is lit by a modern casement window set within a large, splayed opening. To the left of the window is a plank-and-batten door which appears to be 19th century in date (*Plate 20*). Set within the S wall of the dining room is a fireplace with a stone and brick surround which appears to be 20th century in date although the position of the fireplace appears to be original (*Plate 21*). A narrow corridor leads N from the dining room and provides access to the living room and bathroom (*Plates 22 & 23*).

Plate 19: View looking W showing interior of dining room with exposed ceiling joists

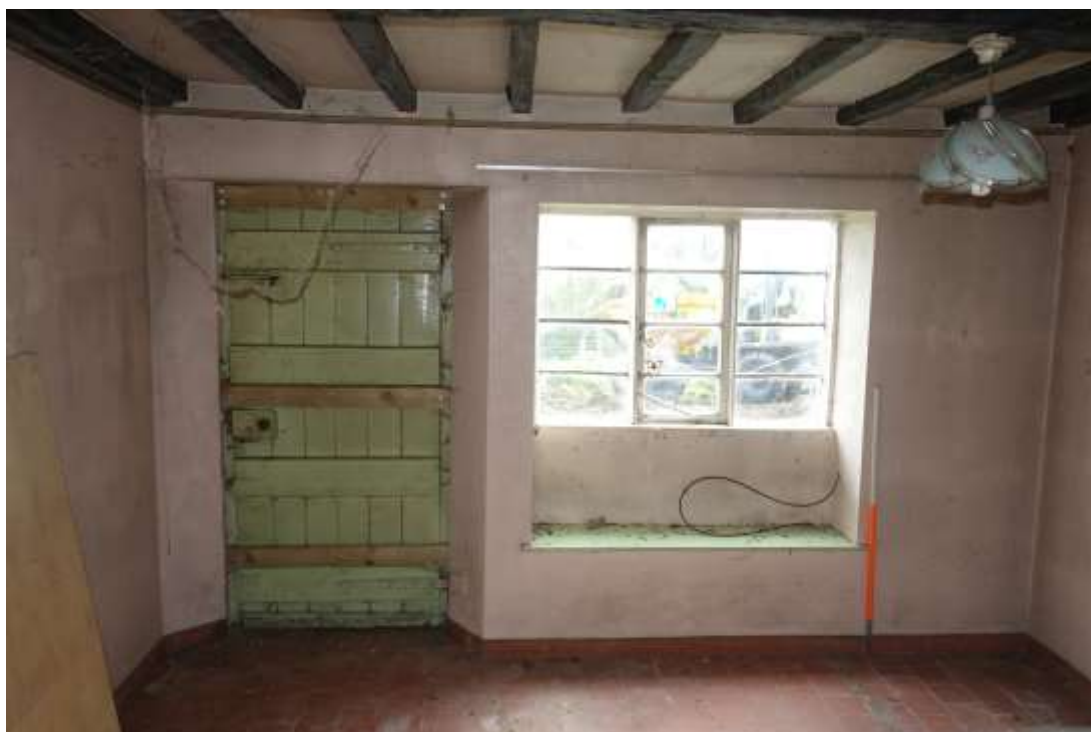
Plate 20: View looking E showing interior of dining room with 19th century quarry tiled floor and plank and batten door to left of splayed window with modern glazed casement

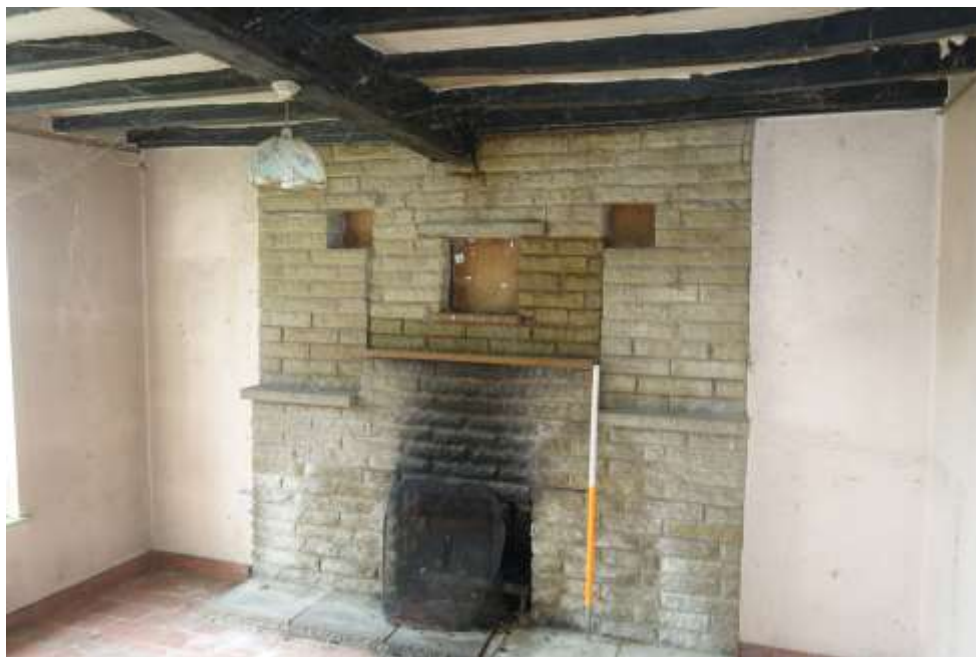
Plate 21: Internal view looking S showing fireplace in S wall of dining room with modern stone surround and exposed chamfered ceiling beam

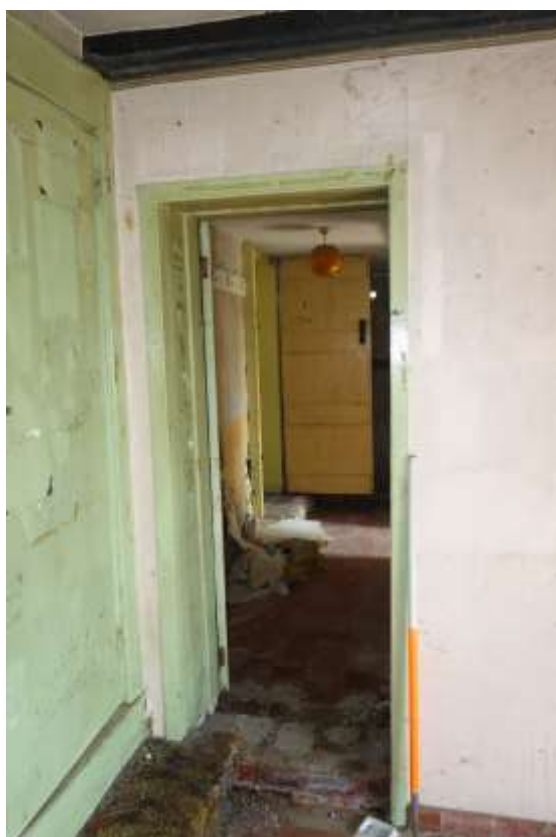
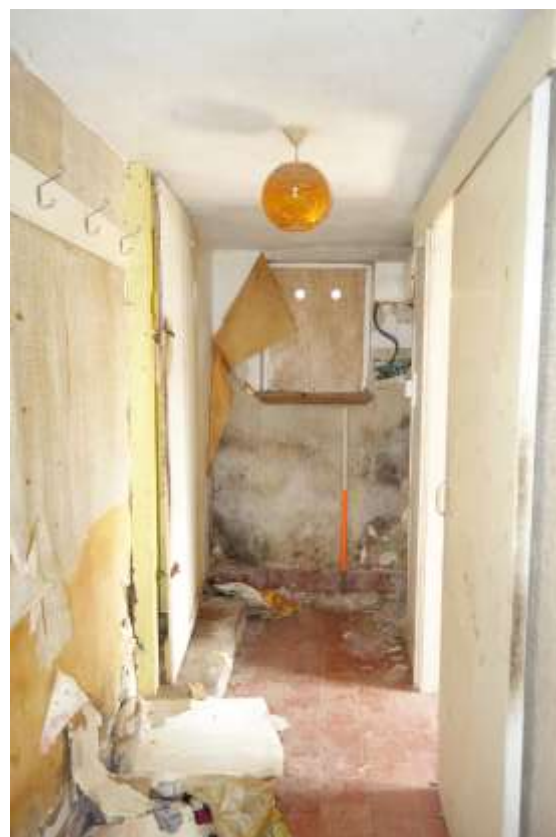
*Plate 22: Internal view looking N showing corridor leading from dining room to living room and bathroom
Plate 23: View looking N showing N end of corridor to living room and bathroom, lit by a blocked window*

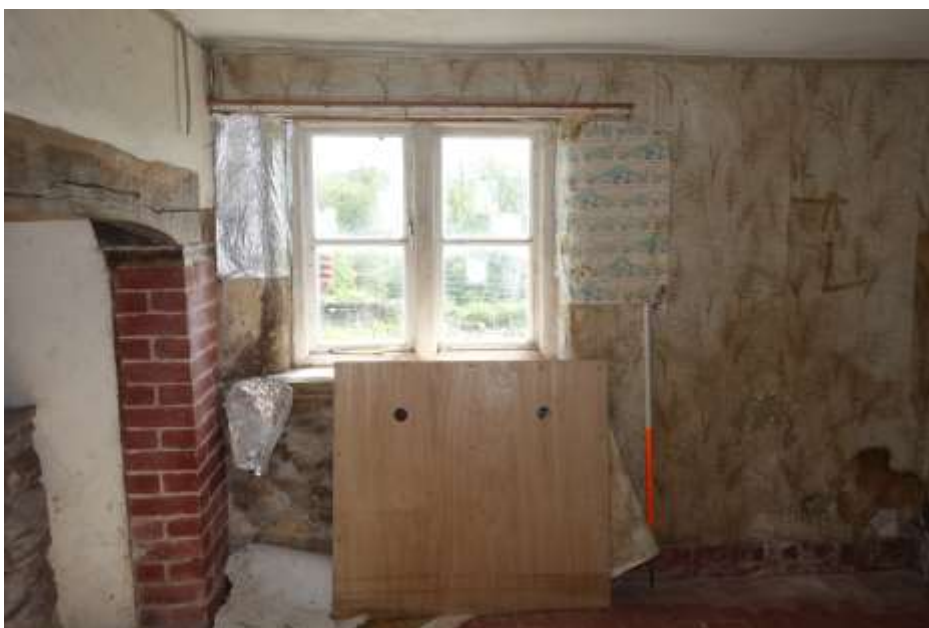
The living room is located to the right (E) of the corridor and has a red quarry tiled floor and is lit by a 4-paned casement window (*Plate 24*). The most notable feature in this room is a deep inglenook fireplace with a stone flue and brick jambs supporting a broad, substantial timber lintel (*Plate 25*). A cupboard is located within a shallow recess in the SE corner of the room (*Plate 26*).

Plate 24: View looking E showing interior of living room lit by 4-pane casement window

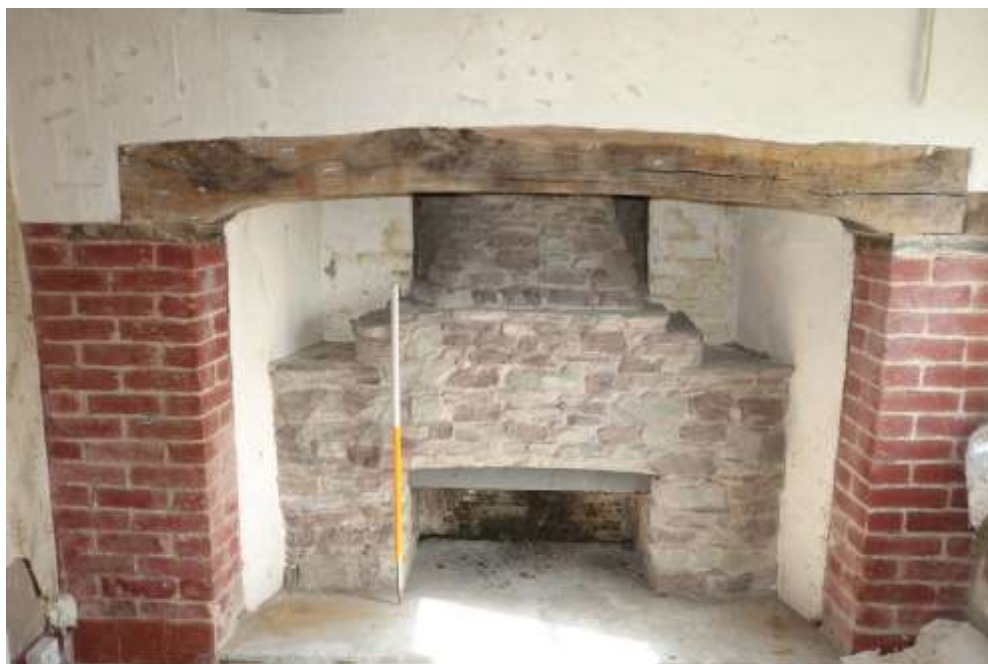
Plate 25: Internal view looking N showing inglenook fireplace in living room with stone flue flanked by brick jambs with a broad wooden overmantel

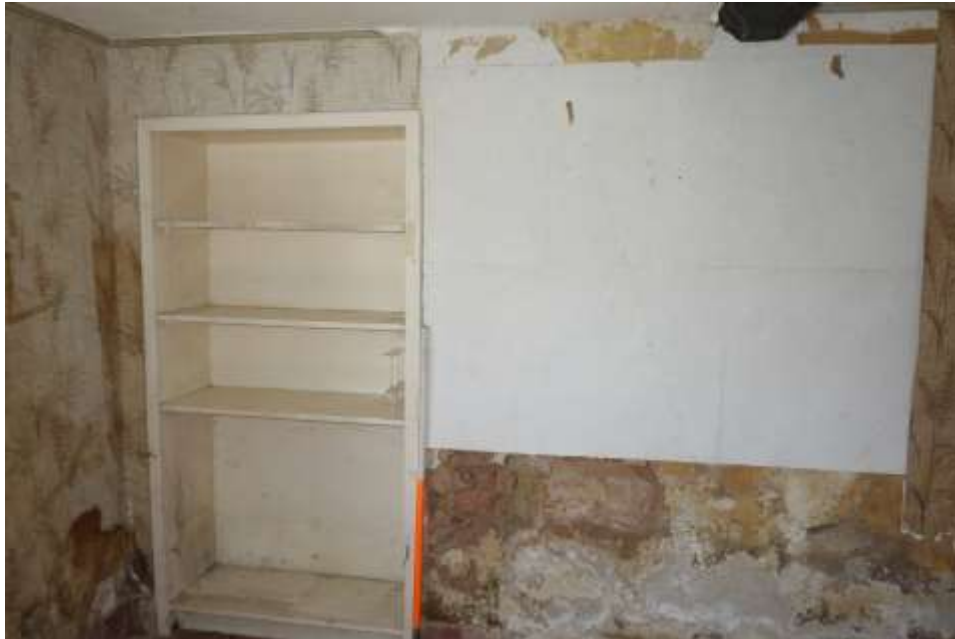
Plate 26: Internal view S showing S wall of living room with cupboard situated in recess to left of picture

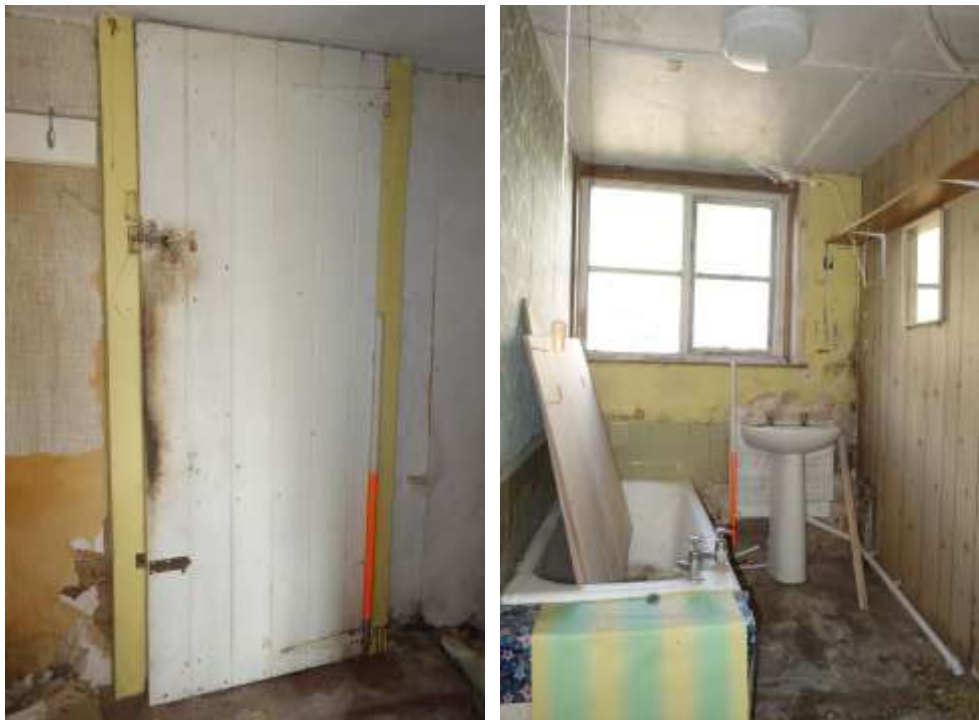
The wall to the W of the corridor appears originally to have been an external wall, suggested by the tall whitewashed plank and batten door with strap-hinges which provides access to the flat-roofed bathroom extension (*Plate 27*). No features of architectural interest were noted within this modern extension (*Plate 28*).

Plate 27: View looking W showing plank and batten door leading to bathroom extension
Plate 28: View looking W showing interior of bathroom lit by casement window

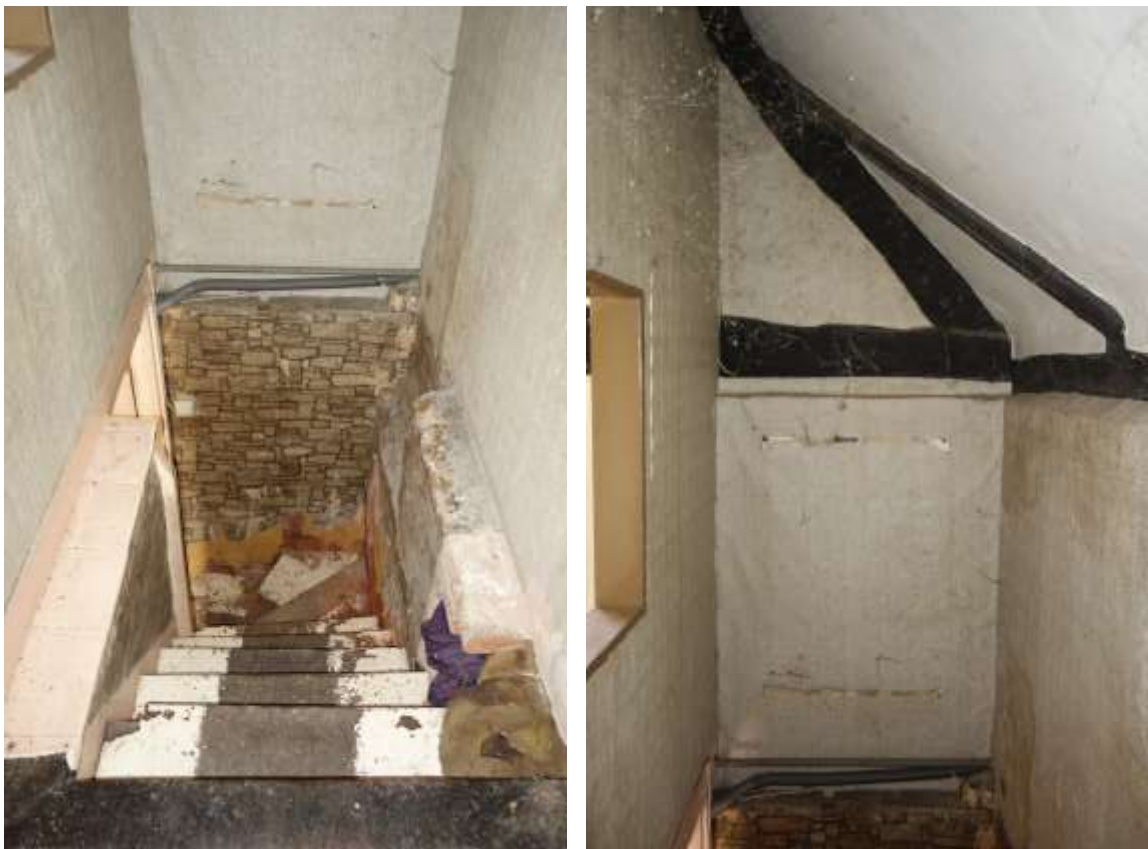
The first floor is accessed from a dog-leg staircase at the N end of the entrance lobby to the left of the main entrance (*Plate 29*). This staircase appears to be a later addition indicated by the presence of exposed timber-framing in the W wall (comprising a wallplate, square panels and principal rafters) which has been truncated by the insertion of a partition wall to create the stairwell and a separate room overlooking the staircase (*Plate 30*). The room adjoining the staircase (which probably served as an unheated bedroom or storeroom) is lit by a casement window inserted in the central timber-framed panel (*Plates 31 & 32*) and has a separate hatch in the partition wall overlooking the stairs (*Plate 33*).

Plate 29: Internal view looking W showing detail of staircase viewed from first floor landing

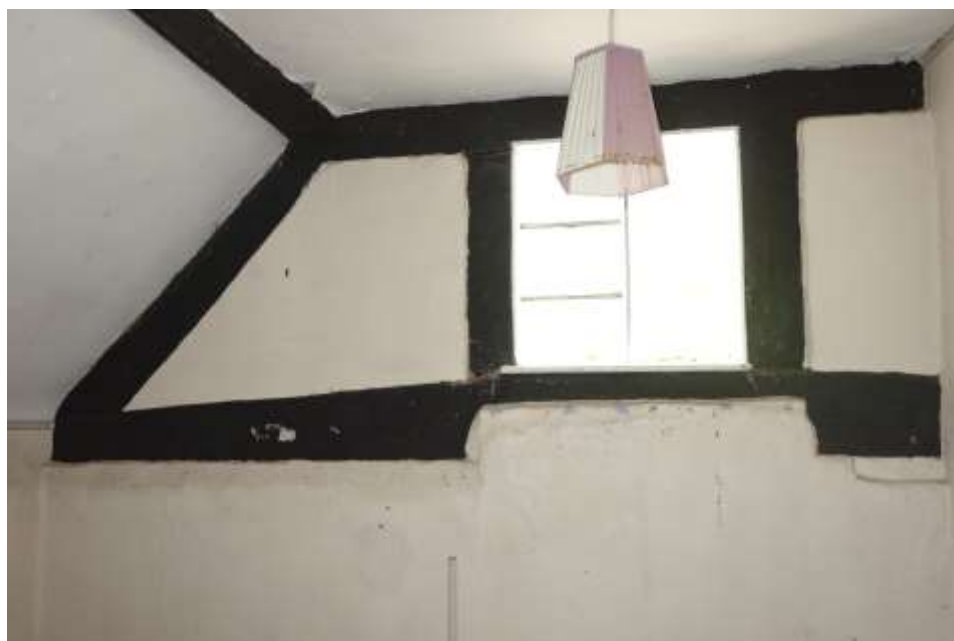
Plate 31: Internal view showing exposed timber framing and casement window in W wall of first floor room overlooking the staircase
