Archaeological Standing Building Recording

**Furnace Farm
Shelsley Walsh
Worcester
WR6 6RP**

Firemitre Limited

February 2022

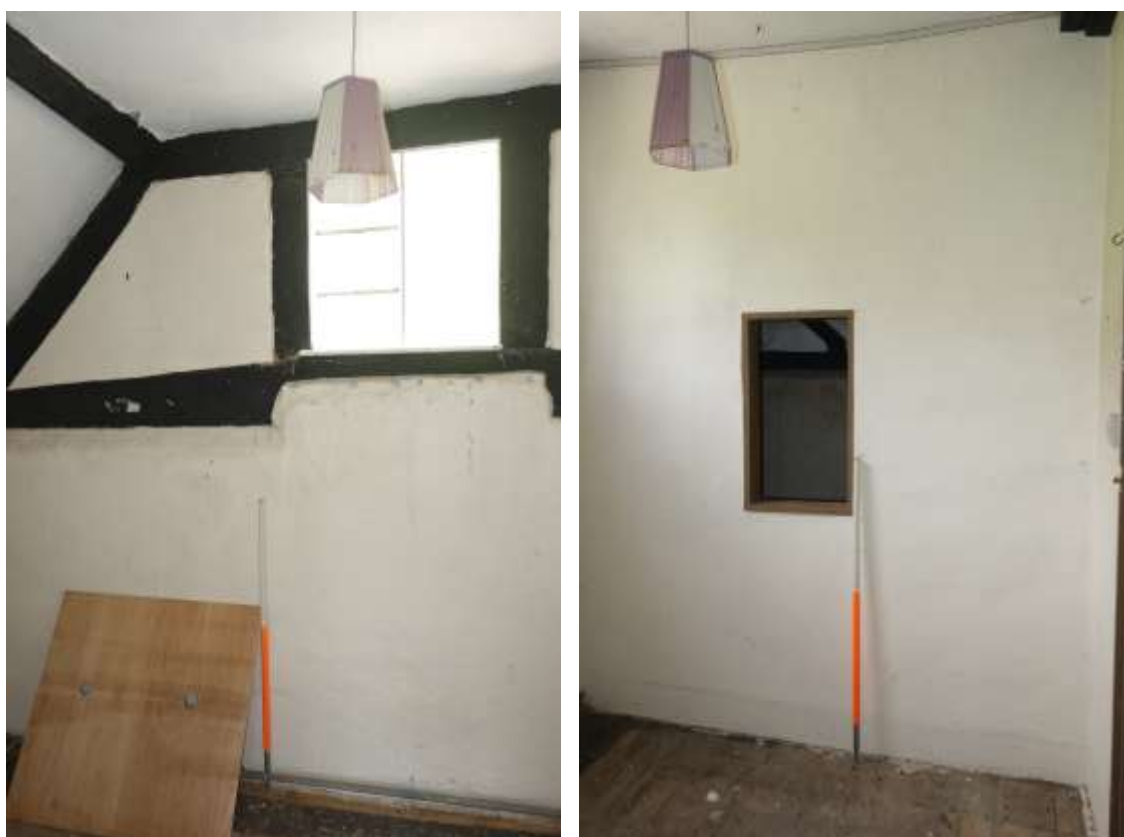
Plate 32: Internal view showing detail of timber-framing in W wall of first floor room
Plate 33: Internal view looking S showing hatch in partition wall of first floor room overlooking staircase

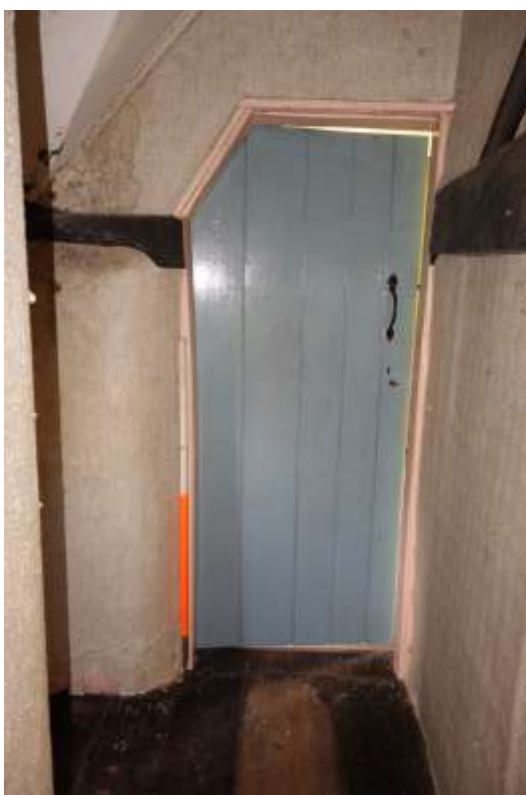
Further evidence of exposed, thick-scantled timber-framing (most likely with lath and plaster infill) was observed within the N, S and E walls of the first-floor landing, suggesting that this represents the core of the original structure, probably of late 17th or 18th century date, prior to the remodelling of the farmhouse and addition of the two-storey (N-S) range in the mid-19th century (*Plates 34-36*). This interpretation appears to be confirmed by the fact that the insertion of the doorway leading to the NE bedroom has truncated the original timber-framing (*Plate 34*).

Plate 34: Internal view looking N showing first floor landing with exposed timber framing and doorway leading to master bedroom

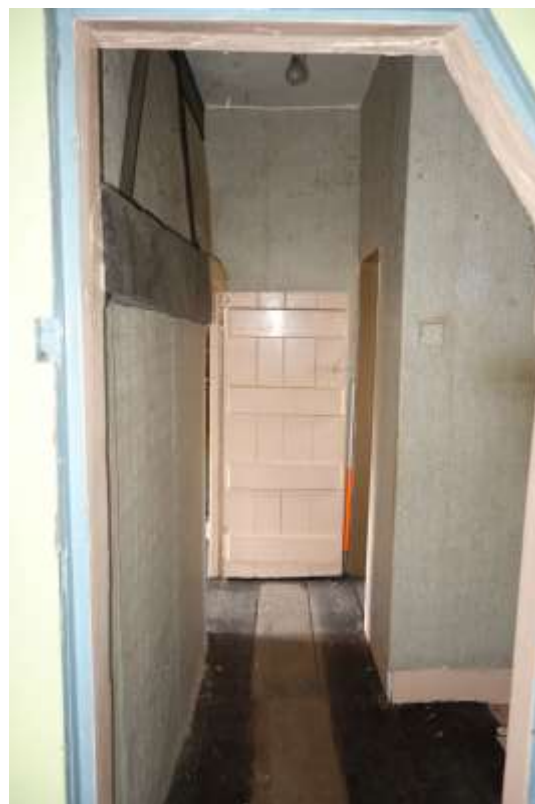
Plate 35: Internal view looking S showing first floor landing with exposed timber framing

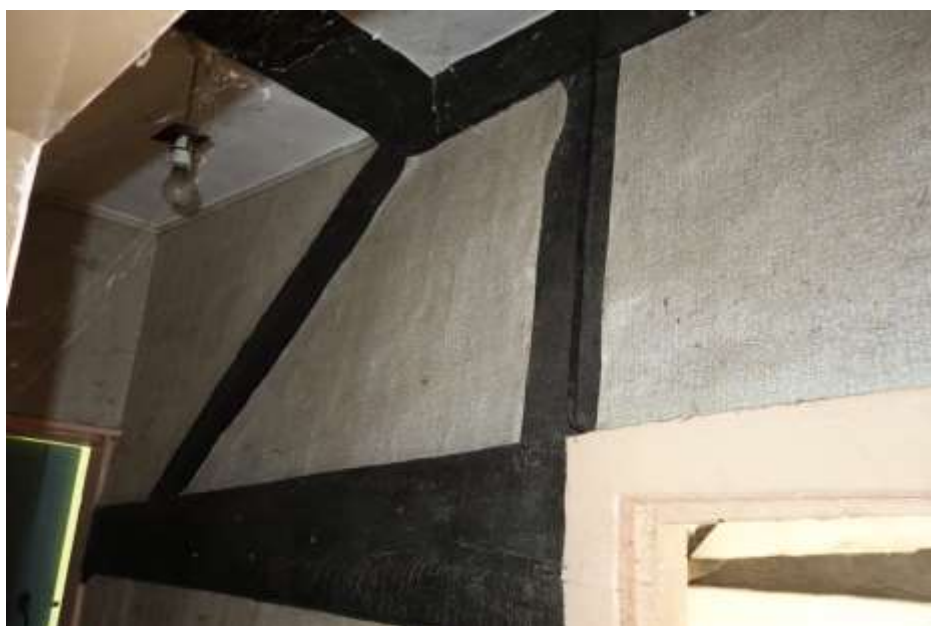
Plate 36: Internal view looking NNE showing detail of timber-framing in E wall of first floor landing

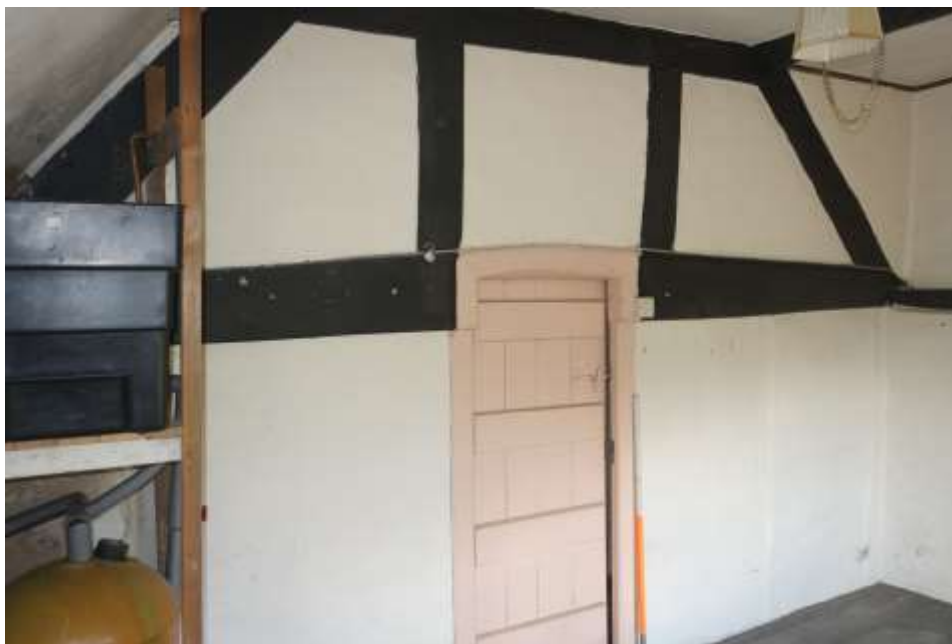
The smaller, SE bedroom is accessed from a low-arched opening with plank-and-batten door, set centrally within a timber-framed partition with exposed thick-scantled square panels and rails (*Plate 37*). The room is lit by a four-paned casement window and has a planked floor (*Plate 38*). No evidence for a fireplace was observed in the S wall of this room and no other fixtures and fittings of interest were noted (*Plate 39*).

Plate 37: Internal view looking NW showing W wall of first floor SE bedroom with exposed timber framing and central low-arched plank and batten door

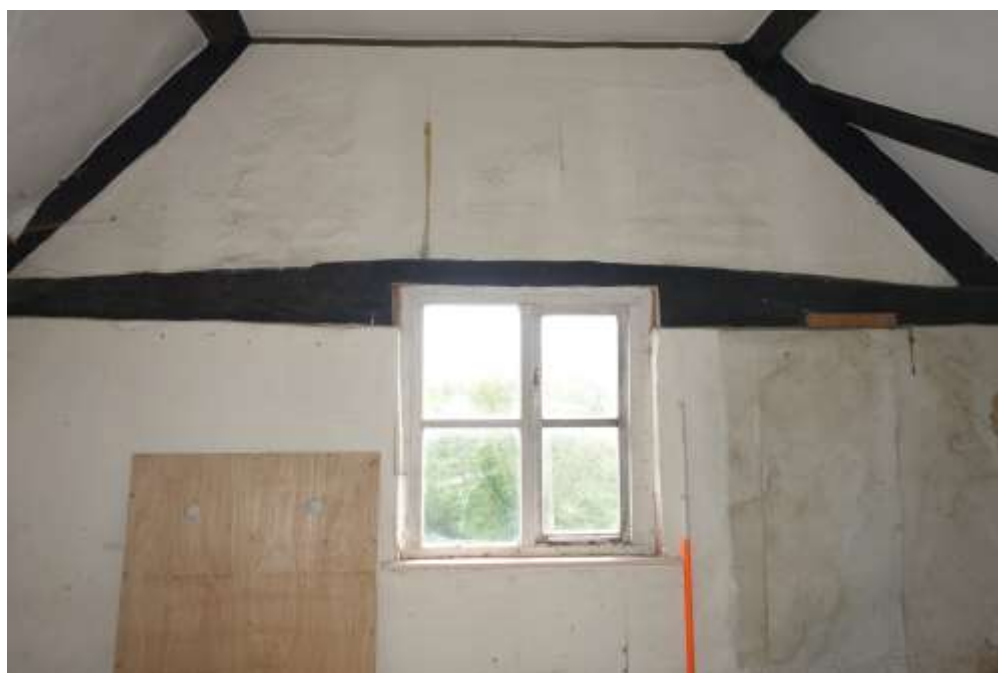
Plate 38: View E showing E wall of first floor SE bedroom with casement window inserted in exposed timber framing

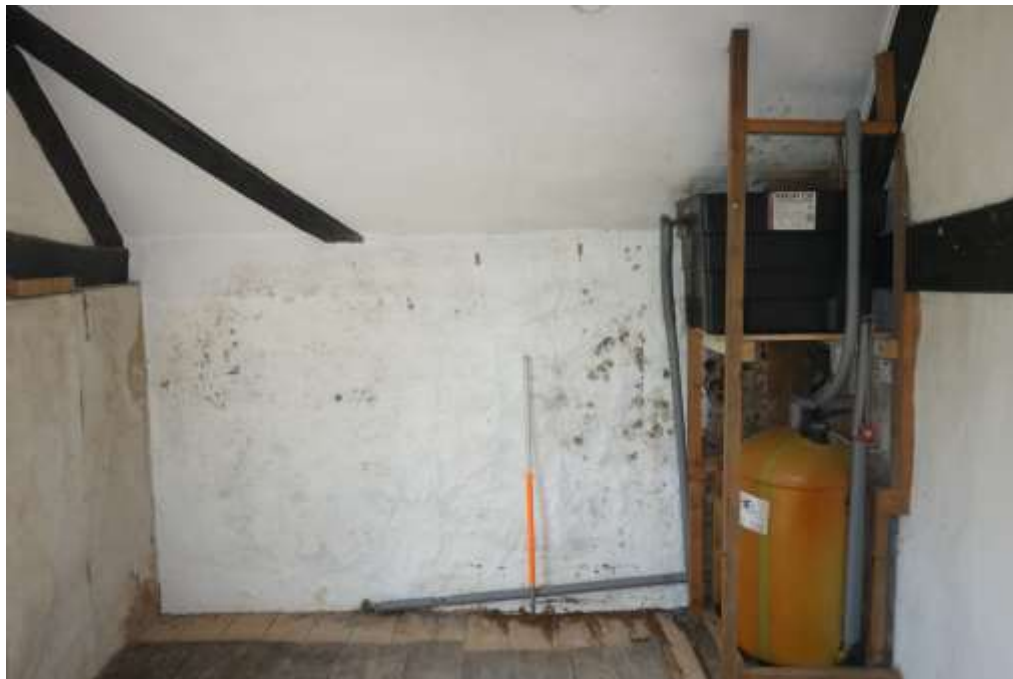
Plate 39: View S showing interior of first floor SE bedroom with planked floor and modern boiler in SW corner of room

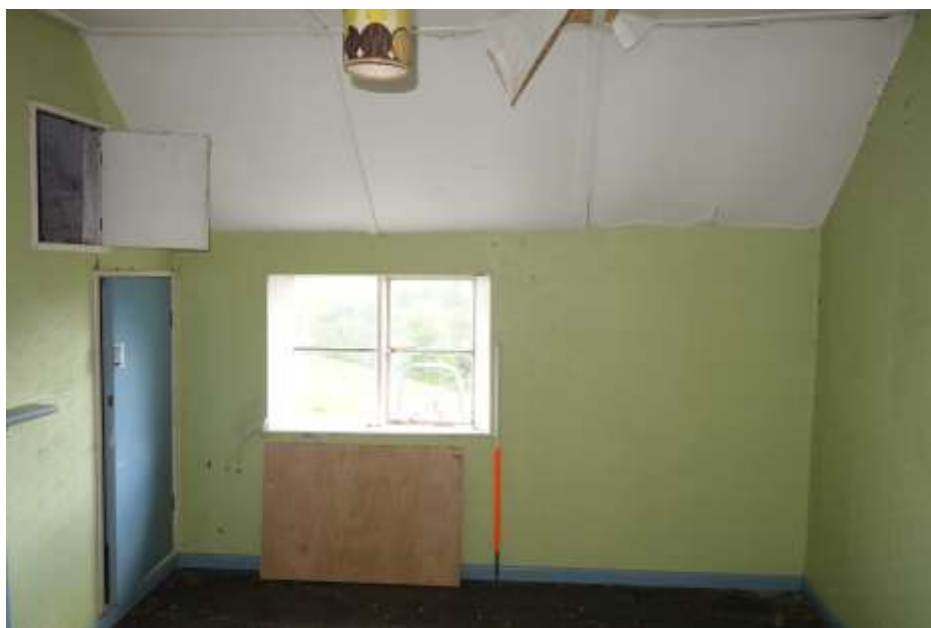
The NE bedroom on the first floor appears to be a later addition, probably of mid-19th century date, it has a coved ceiling and planked floor and is lit by a four-paned casement window in the E wall and a narrow modern casement in the N-gable wall (*Plate 40*). It appears to have been intended to be the principal bedroom as evidenced by the presence of a fireplace in the N wall; the surround has survived although the iron grate has been removed (*Plates 41 & 42*).

Plate 40: View E showing interior of master (NE) bedroom on first floor, lit by casement window in E wall

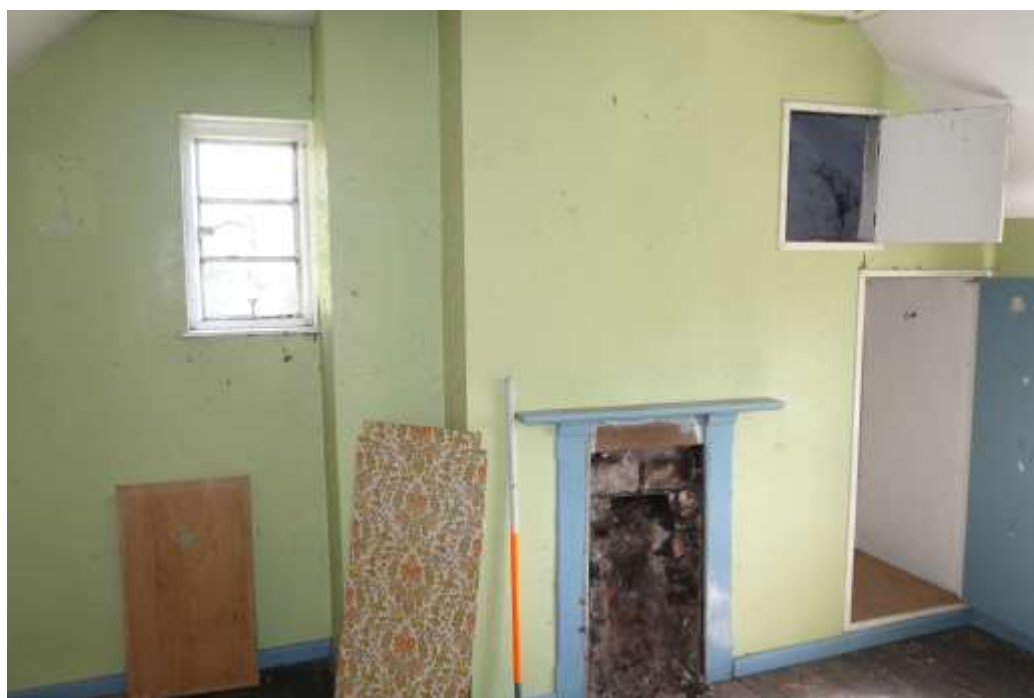
Plate 41: View looking N showing interior of master (NE) bedroom on first floor, with central fireplace flanked by cupboard to right and modern casement window to left

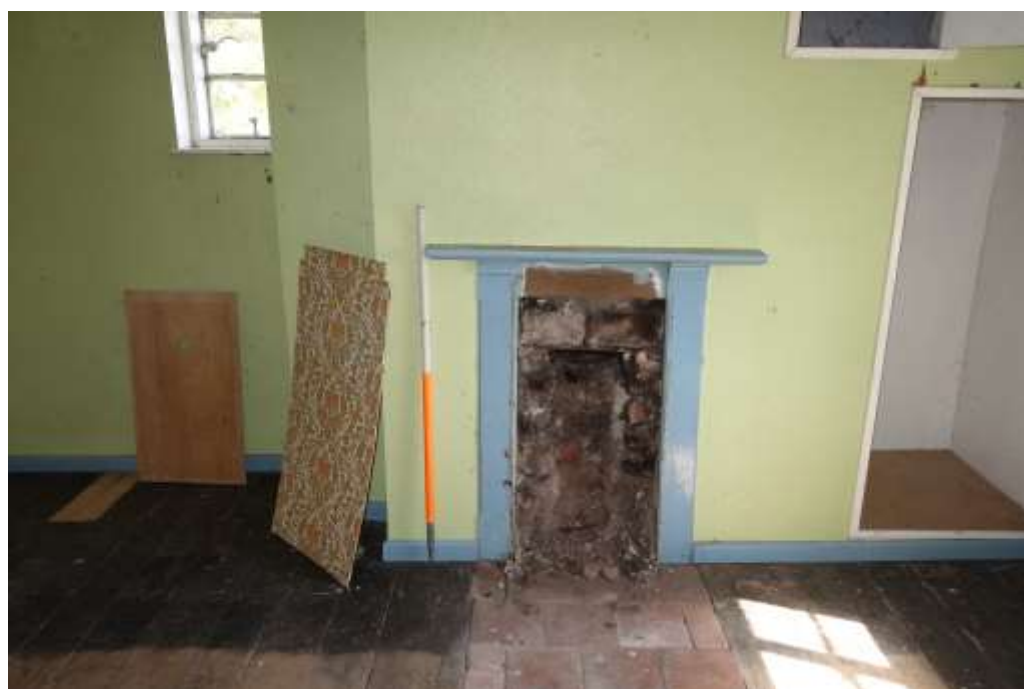
Plate 42: View looking N showing detail of fireplace in master (NE) bedroom
