Archaeological Observation

Newbridge Community Centre St Andrew's Church Bridge Sollers Herefordshire

NGR: SO 4141 4269

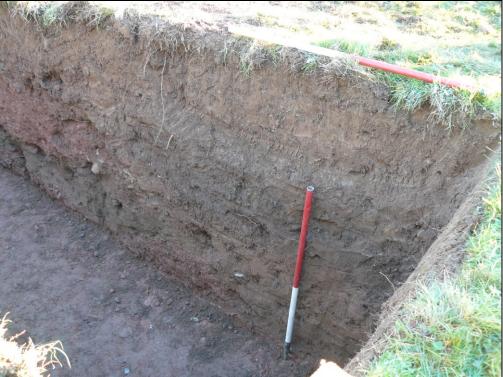
5.1 Trench 1 was located in the northern most area of the field to the north of St Andrew's church, the ground level in this area measured 79.52m OD. The trench consisted of 0.12m of a firm mid-brown, clayish silt, topsoil (101) overlying 0.30m of moderately compacted mid brown subsoil. Beneath this lay an early soil horizon consisting of 0.14m of friable brown clay-silt and degraded sandstone (102). Cut into this early soil horizon was a linear ditch [105] of unknown use running N-S (Plate 1).

Plate 1: North facing section showing topsoil (100), subsoil (101), early soil horizon (102), ditch [105], its two fills (103) and (104), and natural (106).

6.18 The ditch located at the west end of trenches 1, 2 and 3 appears to be Roman in date, although the pottery within the ditch can only give a date of mid 1^{st} century to 4^{th} century. When all three excavated sections of the ditch are placed together (Appendix 1), it becomes apparent that the northern most section (that from Trench 1) is much

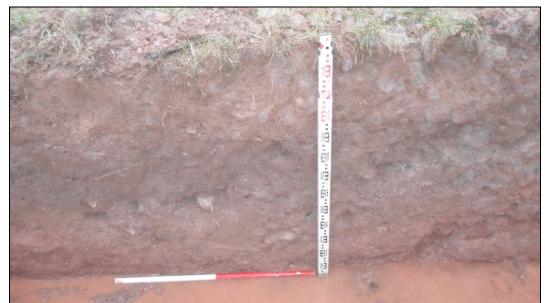
5.2 Trench 2 consisted of a firm, mid brown clay-silt topsoil 0.12m deep (109) overlying a cohesive mid brown clay-silt subsoil (110) 0.30m deep. Beneath this was ditch [111] and its fill (112), 0.70m deep which is likely to be a continuation of ditch [105] from Trench 1. This hypothesis is substantiated by four sherds of Severn Valley Ware

found within (112), which indicate ditch [111] is of the same date as [105]. Ditch [111] was cut into the reddish sandy-clay natural deposits (113) (Plate 2).

Plate 2: North facing section showing topsoil (109), subsoil (110), ditch [11] and its fill (112) cutting into natural (113)

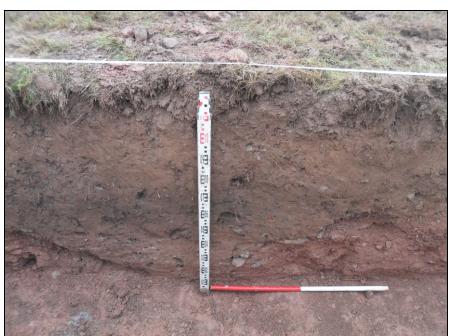
5.3 Trench 3 comprised of mid brown, clay-silt topsoil (118) 0.20m in depth, overlying friable yellowish brown silty subsoil (119). Beneath this was ditch [122], 0.68m deep, and presumably the same feature as seen in Trench 1 [105], and in Trench 2 [111]. Ditch [122] was cut into a compacted reddish-brown natural (123) (Plate 3).

Plate 3: Ditch [122] and its fills (120) & (121) cut into natural (123) and overlain by topsoils (118) & (119), south facing

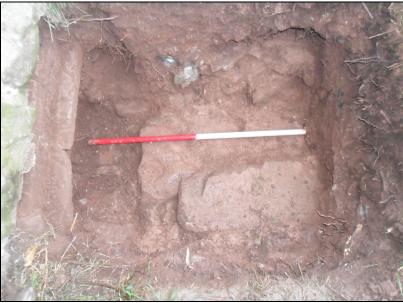
5.4 Trench 4 consisted of a loose mid brown topsoil (131) 0.42m in depth. To the south of the trench, (131) overlay stone wall [114] (Plates 4 and 5); part of an E-W wall running parallel to the churches north aisle [116]. Wall [114] was built of irregular coursed grey local sandstone blocks which were, on average, 0.60mx0.25mx0.12m. Beneath wall [114] was cemetery soil (132), a firm, reddish brown silty clay at least 0.68m in depth.

Plate 4: West facing view of wall [144]

6.20 Wall [114] was truncated by that of the present north aisle [116], which was built in about 1330, suggesting wall [114] is part of an earlier phase of the church. Although it seems no early plans of the church survive, the Sites and Monuments Record (SMR) for the church states that the north aisle was originally built in 1180-1190, and was largely rebuilt *c*.1330 (SMR, 2010). This evidence suggests that wall [114] is the remains of the *c*.1180 north aisle wall, and [116] is the subsequent rebuild. No explanation is given as to why it needed to be rebuilt, or why the original foundations were not reused when it was. It is very possible that the wall [114] collapsed, which was not uncommon in medieval churches. The most common reasons for church walls collapsing were the overloading of foundations, or building on unstable subsoil, an example of which is Bordesley Abbey, Hereford (Greene, 1994, 101-102; Hirst, Walsh & Wright, 1983, 225).

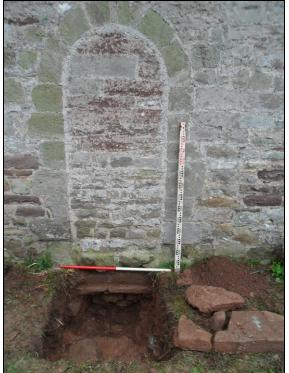
Plate 5: South facing view of wall [114] in relation to wall [116]

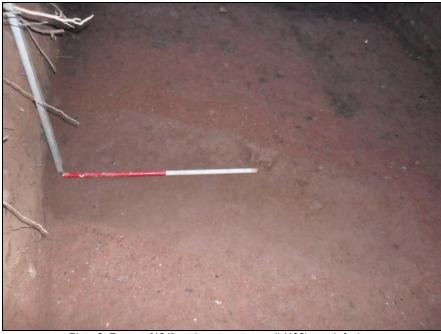
5.5 12.30m north of the church within Trench 4 was rectilinear feature (124) which was cut into cemetery soil (132). The feature was not fully excavated, as it continued deeper than the base of the trench, it is possible from the size, shape and orientation that it is an early grave cut (Plate 6).

Plate 6: Feature [124] cut into cemetery soil (132), north facing.

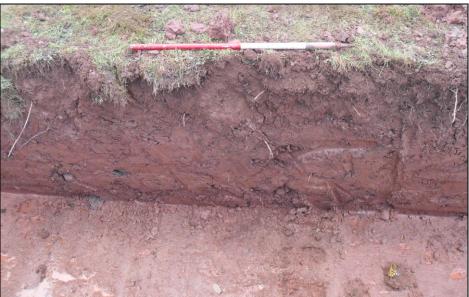
5.6 Trench 5 consisted of a loose, mid-brown sandy-silt topsoil 0.30m deep (125) which overlay a firm reddish-brown cemetery soil 0.80m deep with frequent stones (130). The excavation ceased at 1.10m and natural was not observed (Plate 7). Cut into the cemetery soil (126) were two in situ burials (128) and (129). Both were supine, extended and orientated E-W, which is consistent with Christian burial practices.

Plate 7: Topsoil (125) overlying cemetery soil (126), south facing section.

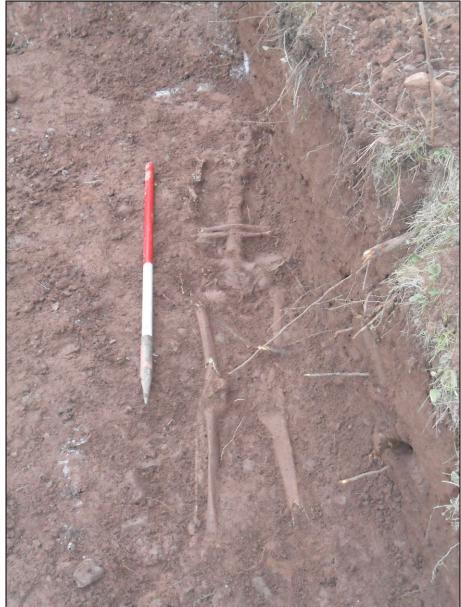
5.12 Burial (134), located in the north-western corner of Trench 6, was of an adult, and was in relatively good condition compared with those found in Trench 5. The whole body was present, with the exception of the skull and left humerus, radius and ulna which were within the north section, and so beyond the scope of this excavation. The body measured 1.70m in length and was located at 78.04m OD. As with the previous burials, no evidence of a coffin or coffin fittings were found with the body. Directly beneath burial (134) were three of the Malvernian unglazed ware (B1) pottery sherds which date to the late $12^{\text{th}} - 15^{\text{th}}$ centuries. Although the pot can not date the body for the reasons discussed in 5.12, it does tell us that the body must be later than, or contemporary with, a medieval date.

Plate 8: Burial (134) with the right arm crossed over the chest.

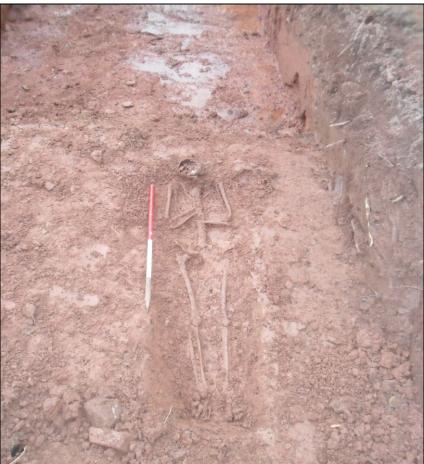
5.15 Burial (144) was very well preserved, with only the right hand absent. As with (134), the arms were located across the chest and there was no evidence of a coffin, (plate 9). The body measured 1.80m long and was located at 78.08m OD.

Plate 9: Burial (144) with arms crossed over chest

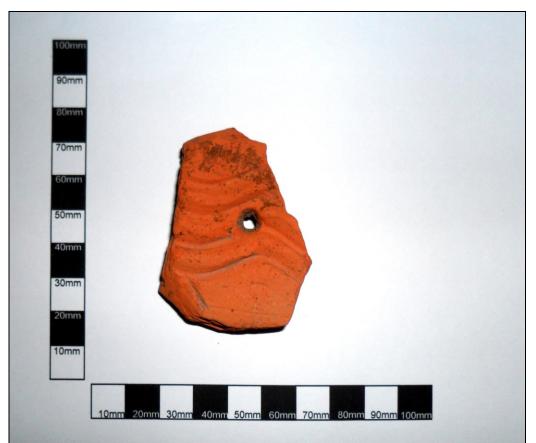
Pottery from the primary fill (104) of the ditch consisted of two rim sherds of oxidised Severn Valley Ware, which has a wide date range of mid 1st century to 4th century. Severn Valley Ware is the most common Roman pottery type found in Herefordshire, and is part of a widespread regional tradition which spreads along the Severn Valley from Shepton Mallet to Wroxeter (Bryant, V. 2004). A fragment of a Roman ceramic box-flu/ hypercaust tile was also found within (104). The tile is made of an oxidised orange fabric with a waved combing on one side, which would have helped the adhesion of wall plaster. This tile would have been used to build part of the heating system within a bath house or villa complex, such as that at Bishopstone, less than a

mile from the site. The tile contained what appears to be a post-firing hole which may indicate its re-use, possibly as ether a roof tile or a loom weight (Appendix 2, Plate 10), adaptation and re-use of ceramic tiles have been noted at both the former County Hospital Site in Dorchester and at Clayton Manor, West Sussex (Brown, K, 2008, 1; Butler, C, 2002, 6-8).

Plate 10: Roman ceramic box-flu/ hypercaust tile from context (104)

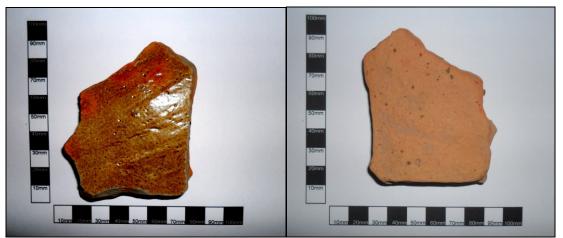
5.11 Several sherds of pottery were recovered from the cemetery soil (136), these consisted of three sherds of a hard, smooth fabric with few obvious inclusions except for sparse, rounded red pellets. The sherds are oxidised to a bright orange on the inside, with a reduced grey surface, upon which is a light yellowish-green glaze (Appendix 2, Plate 11). The fabric is similar to that of Herefordshire glazed fine micaceous ware (A7b), which dates to the 13^{th} – early 16th century. Four sherds of probable Malvernian unglazed ware (B1) were also found within (136). B1 type occurs in the late $12^{th} - 15^{th}$ centuries, but was most common in the 13^{th} . This fabric type was mainly used for cooking pots (Vince, 2002, 80).

Plate 11: Herefordshire glazed fine micaceous ware (A7b) from context (136)

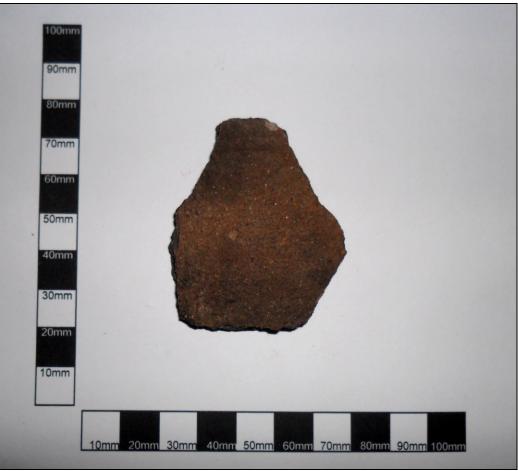
Plate 12: Malvernian unglazed ware (B1) from context (136)
