CONTRACT NAME / No. SUNNYSIDE FARM/ 11025
 DRAWING No. / SCALE: FIG A2.1 / 1:200
 TITLE: LOCATION PLAN WITH FIGURE REFERENCES

DRAWN BY / DATE: C.M. / 10/05/07
 CHECKED BY / DATE: I.J.S. 01/06/07
 DEPT. ARCHAEOLOGICAL SERVICES:

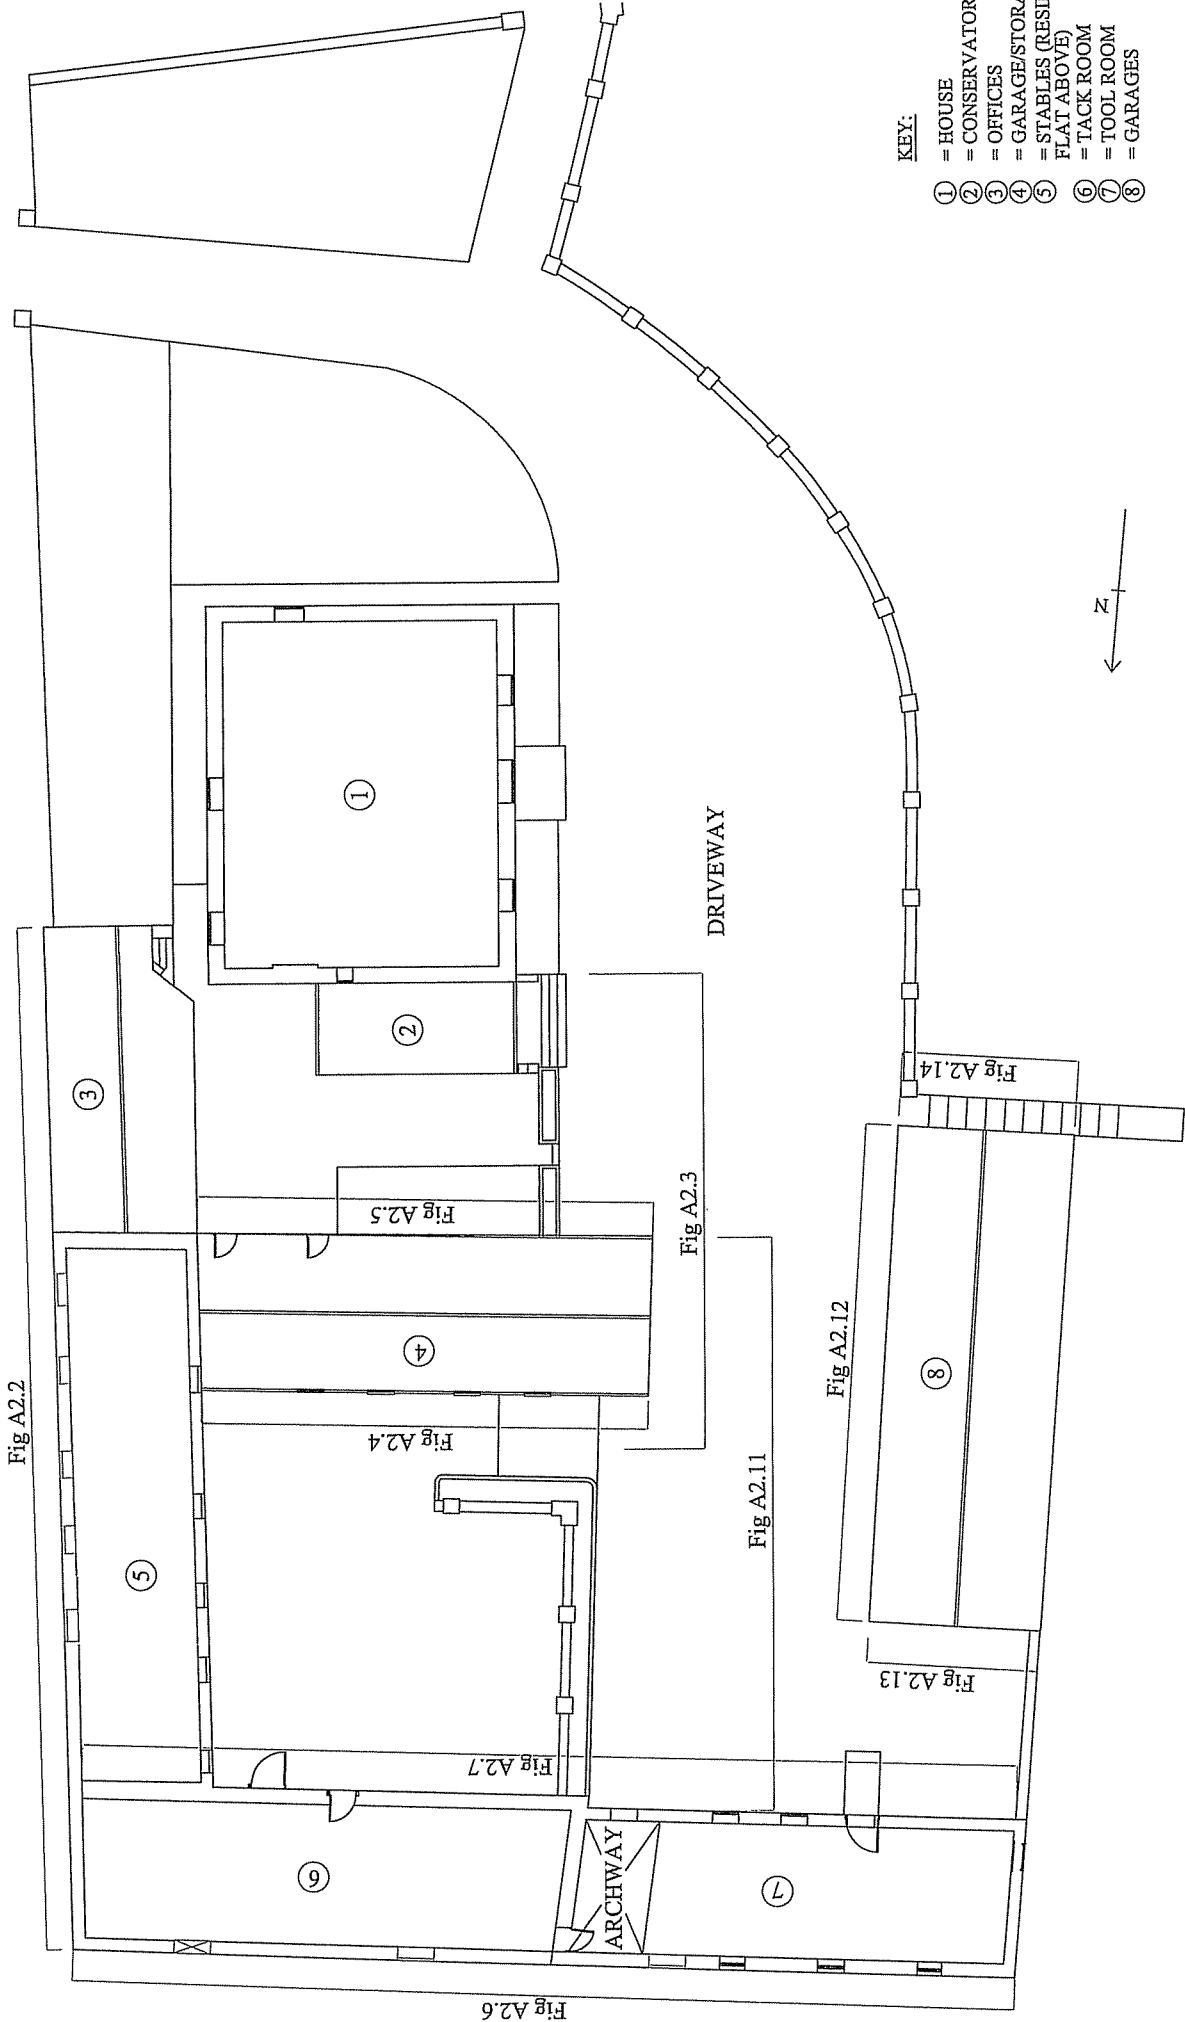
- ① = HOUSE
- ② = CONSERVATORY
- ③ = OFFICES
- ④ = GARAGE/STORAGE
- ⑤ = STABLES (RESIDENTIAL FLAT ABOVE)
- ⑥ = TACK ROOM
- ⑦ = TOOL ROOM
- ⑧ = GARAGES

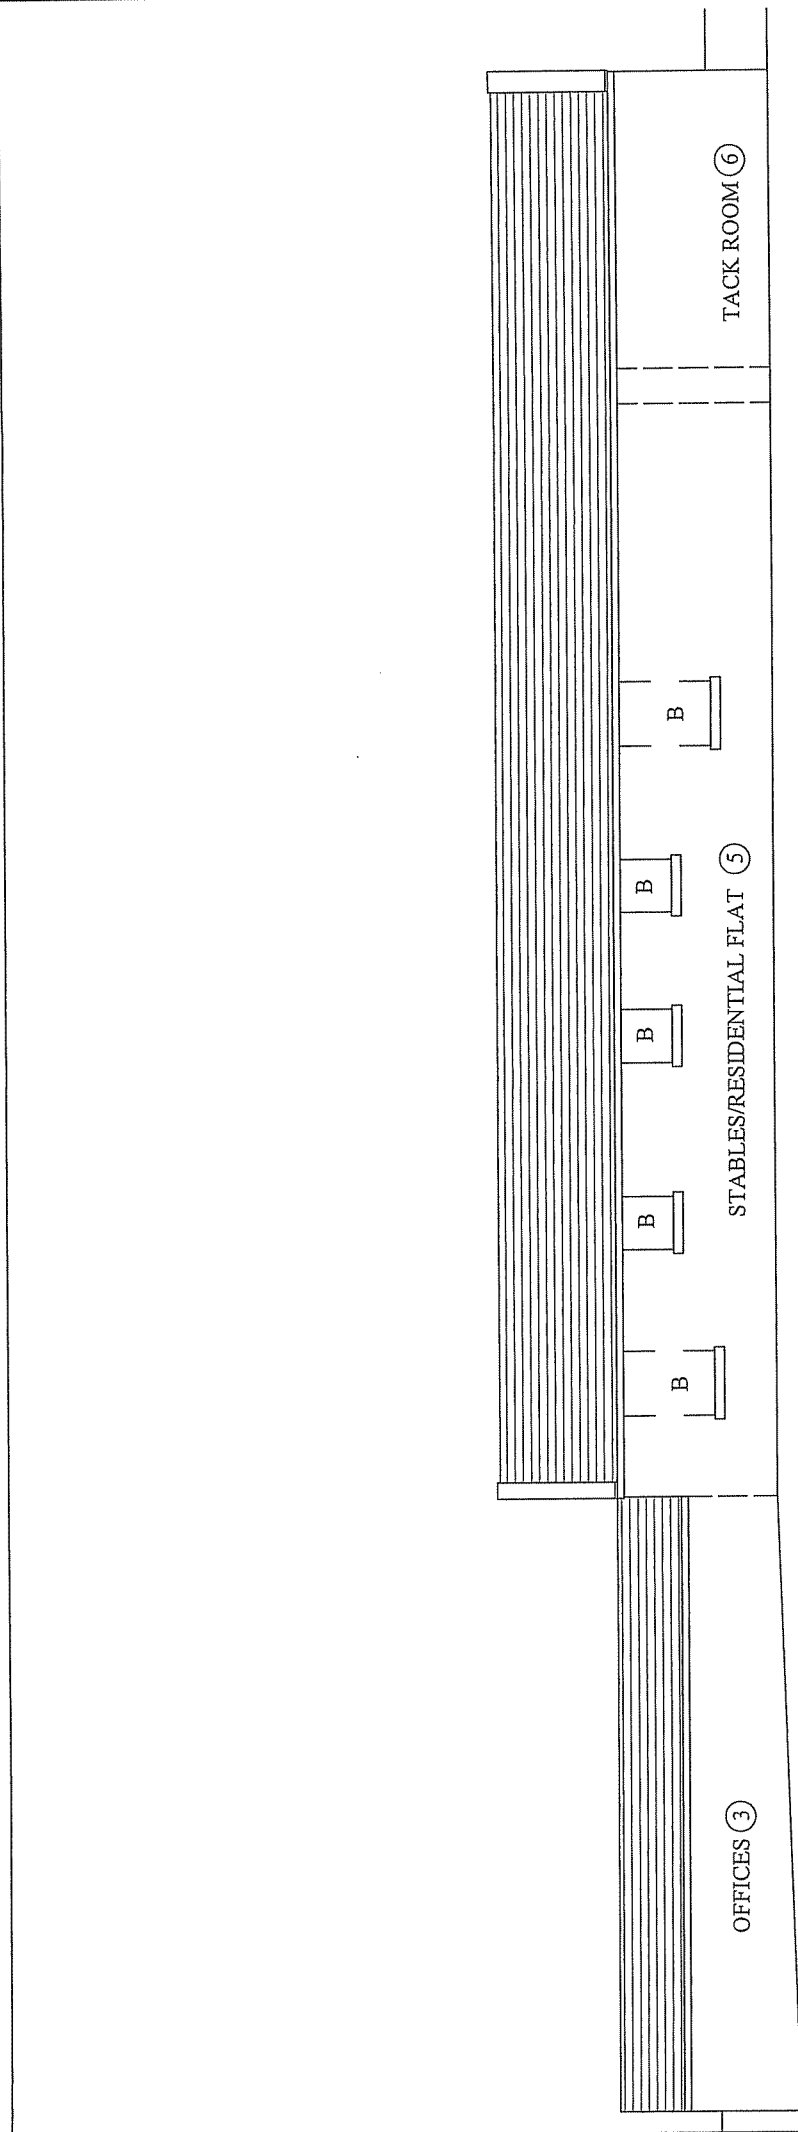
FIG A2.2
EAST ELEVATION OF EAST RANGE

CONTRACT NAME / No.	SUNNYSIDE FARM/ 11025
DRAWING No. / SCALE:	FIG A2.2/ 1:100
TITLE:	EAST ELEVATION OF EAST RANGE (FIG A2.2)

NOTES:	1. WELSH SLATE ROOF THROUGHOUT 2. RANDOM COURSED MAGNESIAN LIMESTONE WALLS THROUGHOUT B = BLOCKED WINDOWS
--------	---

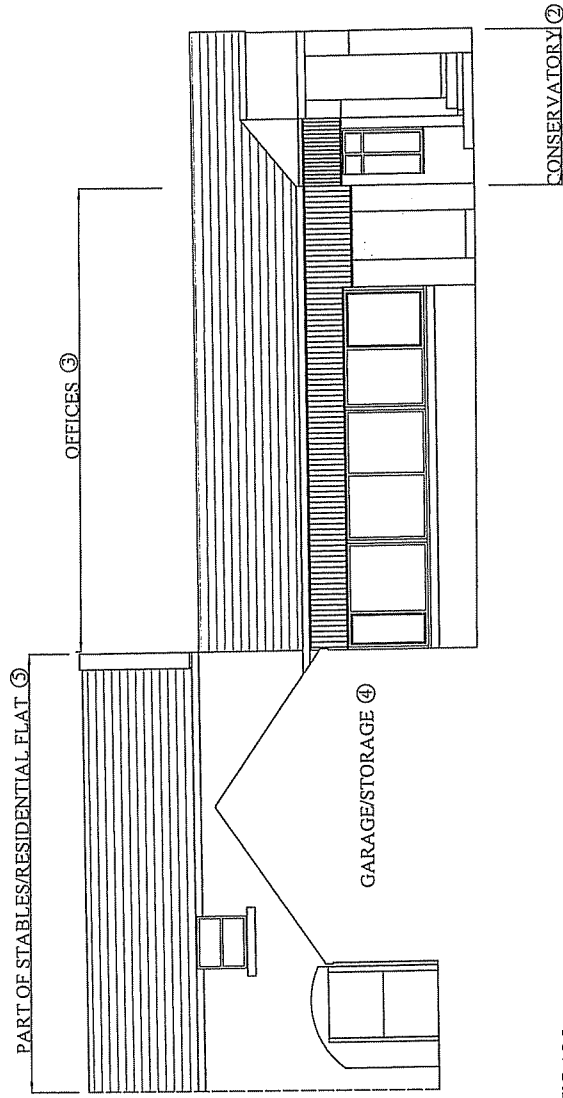
FIG A2.3
PART OF WEST ELEVATION OF EAST RANGE

NOTES:
1. WELSH SLATE ROOF THROUGHOUT
2. RANDOM COURSED MAGNESIAN LIMESTONE WALLS THROUGHOUT
3. QUOINS AT BUILDING CORNERS

CONTRACT NAME / No. SUNNISIDE FARM/ 11025
DRAWING No. / SCALE: FIG A2.3/ 1:100
TITLE: PART OF WEST ELEVATION OF EAST RANGE (FIG A2.3)

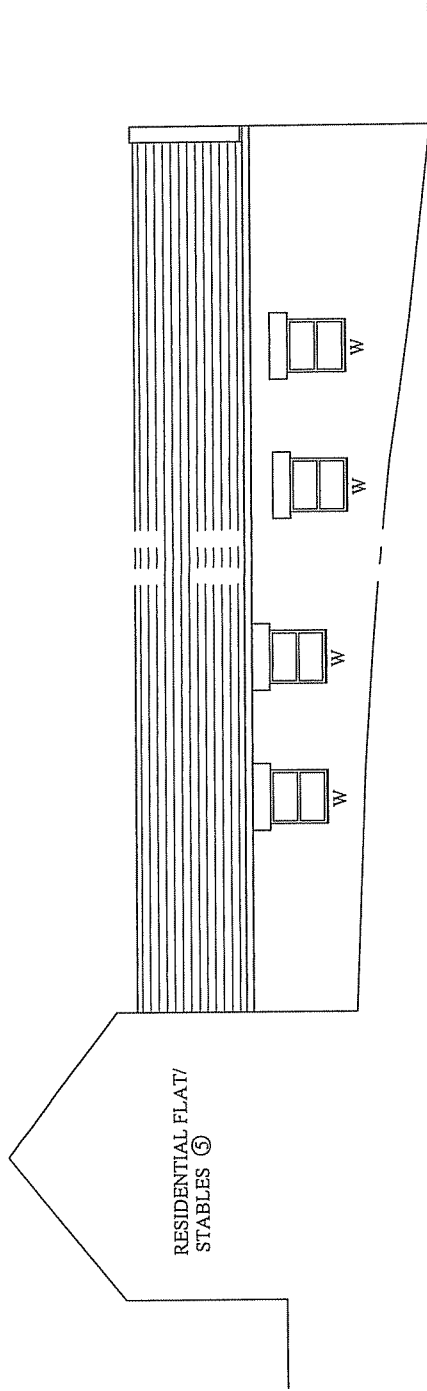
Fig.A2.4
GARAGE/STORAGE 4
NORTH ELEVATION

1. WELSH SLATE ROOF THROUGHOUT
2. RANDOM COURSED MAGNESIAN LIMESTONE WALLS THROUGHOUT
3. QUOINS AT BUILDING CORNERS

TITLE: NORTH ELEVATION OF GARAGE 4 (FIG A2.4)
SOUTH ELEVATION OF GARAGE 4 (FIG A2.5)

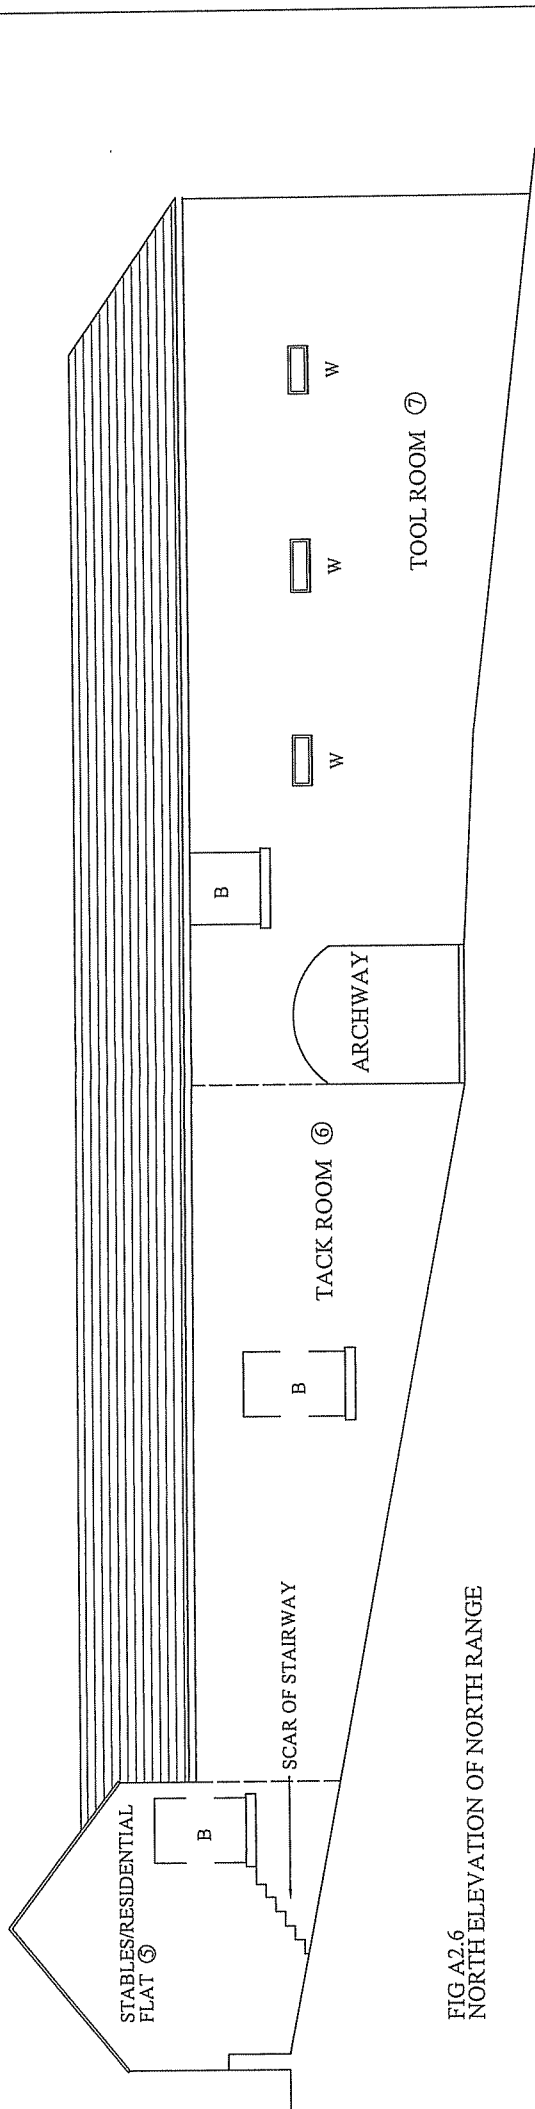
FIG A2.6
NORTH ELEVATION OF NORTH RANGE

IAN FARMER ASSOCIATES Geotechnical & Environmental Specialists	DRAWN BY / DATE: C.M. 10/05/07	NOTES: 1. WELSH SLATE ROOF THROUGHOUT 2. RANDOM COURSED MAGNESIAN LIMESTONE THROUGHOUT WITH OCCASIONAL RED SANDSTONE BOULDER 3. QUOINS AT BUILDING CORNERS	CONTRACT NAME / No. SUNNISIDE FARM/ 1 1025
	CHECKED BY / DATE: I.J.S 01/06/07 DEPT. ARCHAEOLOGICAL SERVICES:		DRAWING No. / SCALE: FIG A2.6 & A2.7 / 1:100 TITLE: NORTH ELEVATION OF NORTH RANGE Fig (A2.6) SOUTH ELEVATION OF NORTH RANGE Fig (A2.7)

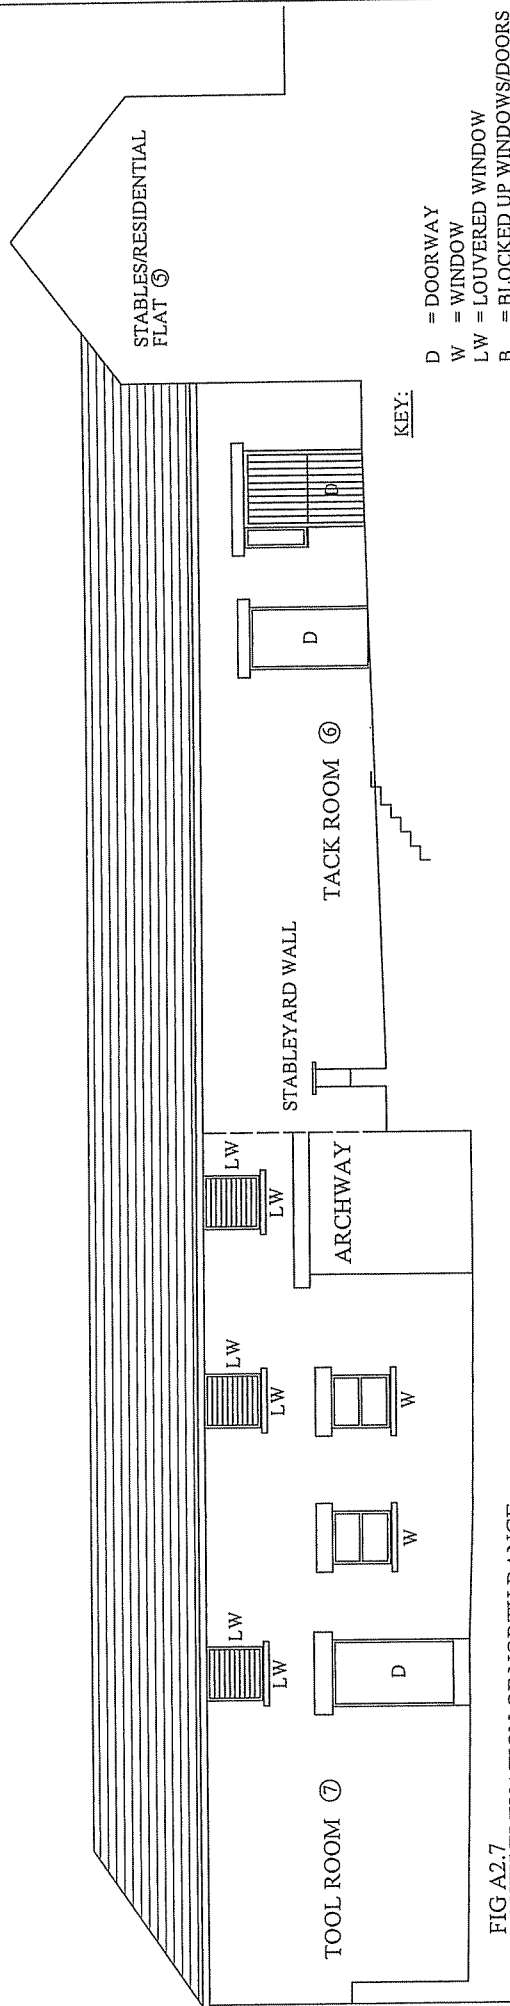
FIG A2.7
SOUTH ELEVATION OF NORTH RANGE

KEY:
 D = DOORWAY
 W = WINDOW
 LW = LOUVERED WINDOW
 B = BLOCKED UP WINDOWS/DOORS

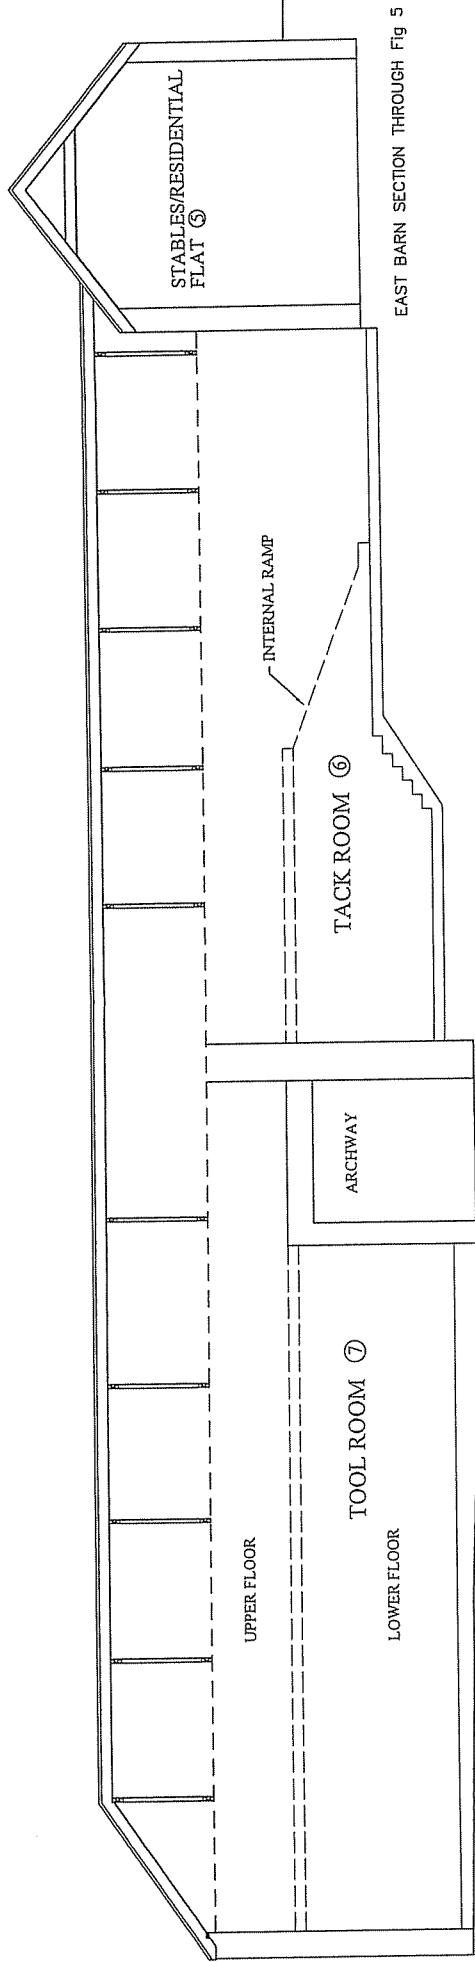
FIG 2.8
INTERNAL SECTION E-W THROUGH NORTH RANGE

CONTRACT NAME / No. SUNNYSIDE FARM / 11025
DRAWING No. / SCALE: FIG A2.8 & A2.9 & 2.10 / 1:100
TITLE: SECTION N-S THROUGH TOOL ROOM (7) (FIG 2.9)
SECTION N-S THROUGH TACK ROOM (6) (FIG 2.10)
INTERNAL SECTION E-W THROUGH NORTH RANGE (FIG 2.8)

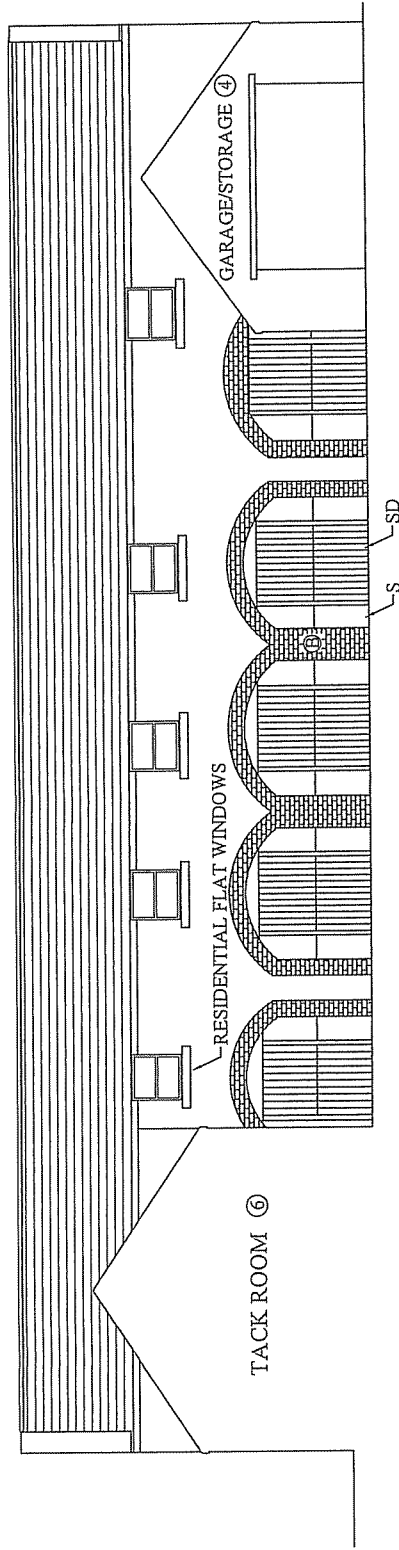
FIG A2.11
BUILDING 6: STABLES/ RESIDENTIAL FLAT

NOTES:
 1. WELSH SLATE ROOF THROUGHOUT
 2. RANDOM COURSED MAGNESIAN LIMESTONE THROUGHOUT WITH OCCASIONAL RED SANDSTONE BOULDER
 SD = SHUTTERED STABLE DOOR
 S = STONE INFILL
 B = BRICK INFILL

CONTRACT NAME / No. SUNNYSIDE FARM/ 11025
 DRAWING No. / SCALE: FIG A2.11/ 1:100
 TITLE: WEST ELEVATION OF EAST RANGE (FIG A2.11)

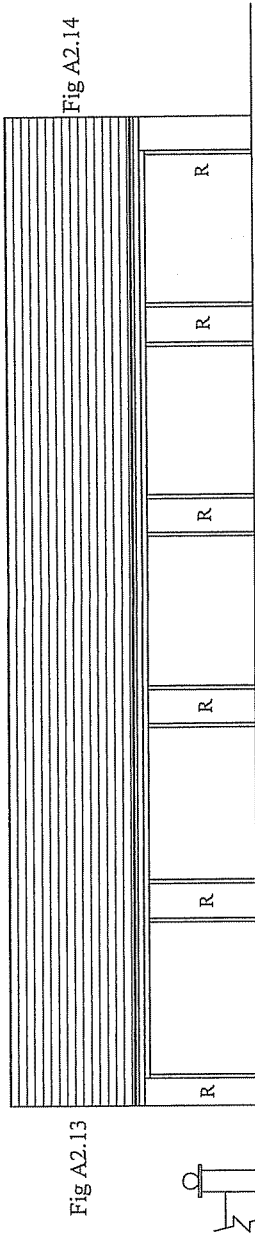
Fig A2.12
EAST ELEVATION OF GARAGES ⑧

NOTES:
 1. WELSH SLATE ROOF THROUGHOUT
 2. RANDOM COURSED MAGNESIAN LIMESTONE THROUGHOUT WITH OCCASIONAL RED SANDSTONE BOULDER
 R = RENDERED BRICK PILLARS

CONTRACT NAME / No. SUNNYSIDE FARM/ 11025
 DRAWING No. / SCALE: FIG A2.12 & A2.13 & A2.14/ 1:100
 TITLE: EAST ELEVATION OF GARAGES (Fig A2.12)
 SOUTH ELEVATION OF GARAGES (Fig A2.13)
 NORTH ELEVATION OF GARAGES (Fig A2.14)
