Victoria North Flood Defence and
Alleviation Scheme
Geoarchaeological Borehole Modelling

Victoria North Flood Defence and Alleviation Scheme
Manchester, Greater Manchester:
Geoarchaeological Borehole Monitoring.

This report presents the results of a geoarchaeological deposit model carried out by York Archaeology at the Victoria North Flood Defence and Alleviation Scheme, Manchester between November 2021 and March 2022. The work was commissioned by RSK ADAS Limited on behalf of Manchester City Council.

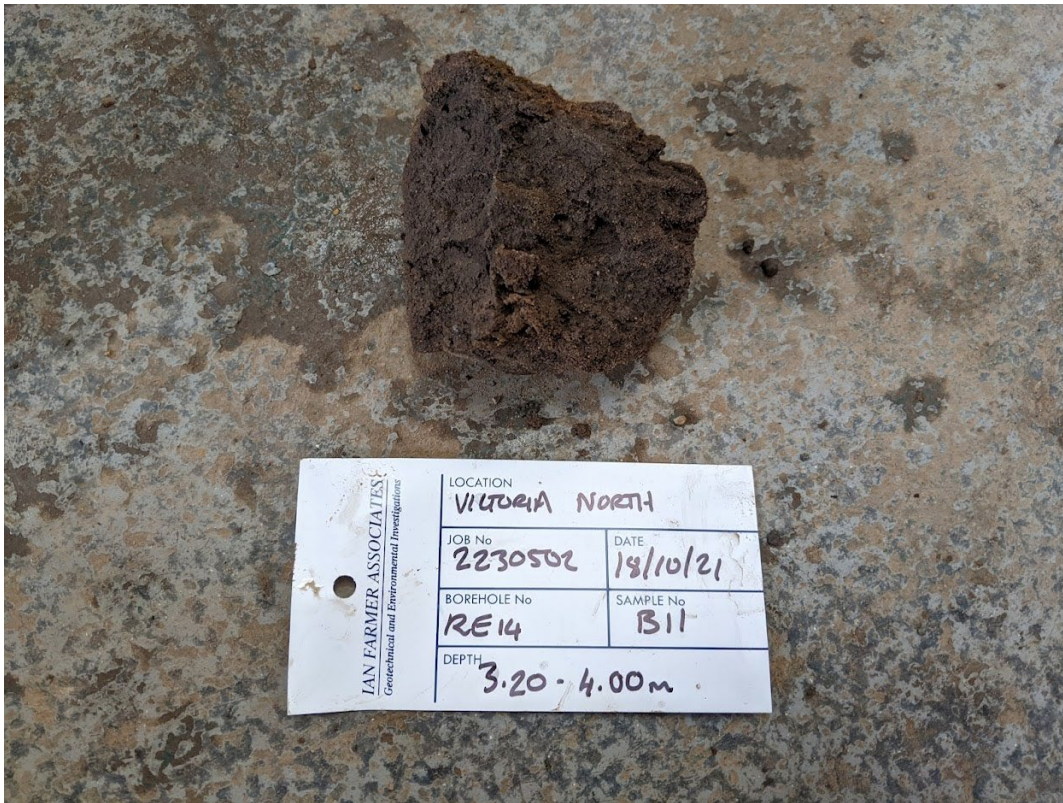
Plate 1: Example of sediment recovery RE14.

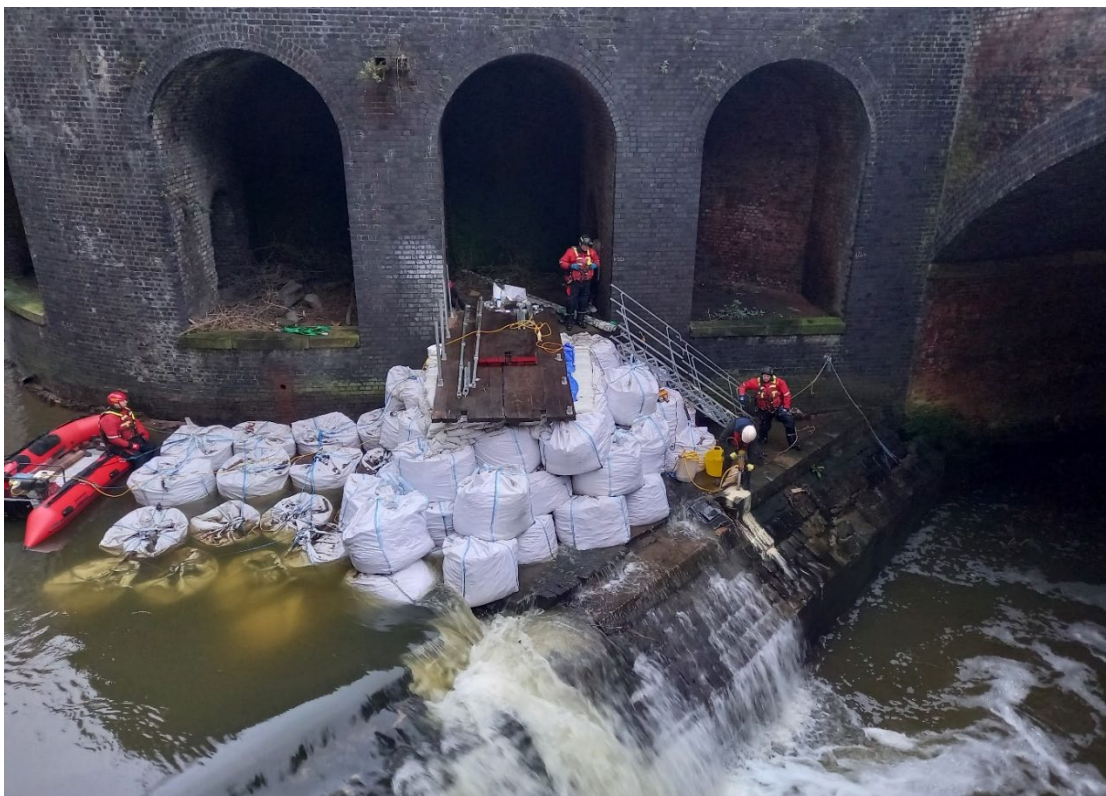
Plate 2: Coring undertaken through the Scotland Weir.

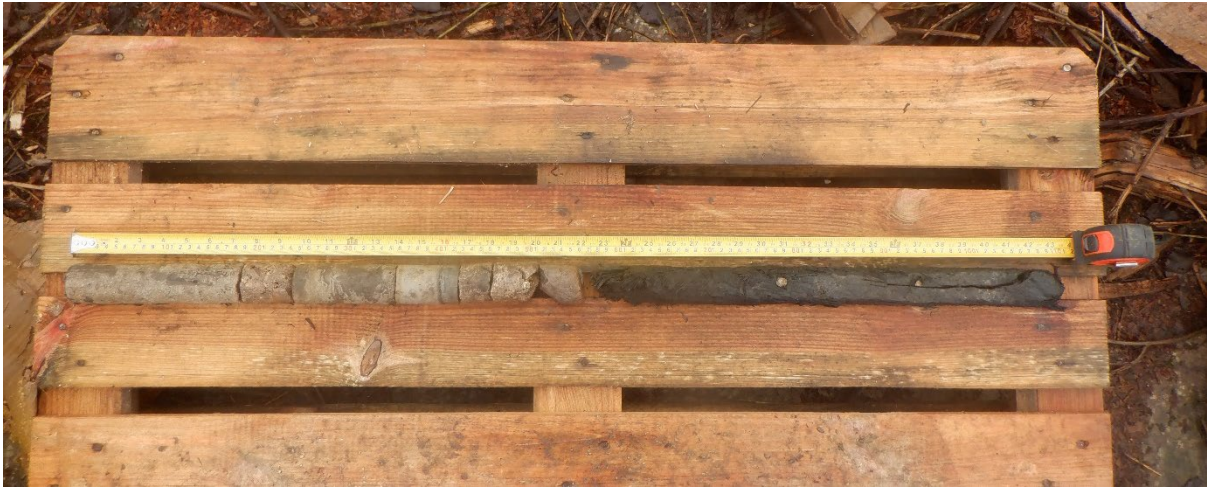
Plate 3: The sample retrieved from coring VC01 through the Scotland Weir. Note that the depth that the wood recovered from is unknown due to coring difficulties.

5.2.2. Both ends of the piece are damaged, likely by the coring process, suggesting that the recovered section represents a central section of a longer piece. As a result, the recovered section's depth below ground level is unknown, but ranges between the base of the concrete (0.53m BGL) and the base of the core (2.40m BGL, Plate 3). It is likely that the top of the piece was soft and degraded, possibly due to loss of waterlogging, resulting in an unknown length being damaged through coring. A similar process may have occurred towards the base of the core, with recovery impeded by soft wood and unconsolidated wet sediments. Smaller fragments of wood were recovered jammed within the coring barrel, demonstrating the difficulty coring the wooden section of the Scotland Weir (Plate 4). In addition the small part of the intact surface containing the nails was badly degraded and as such no toolmarks were preserved.

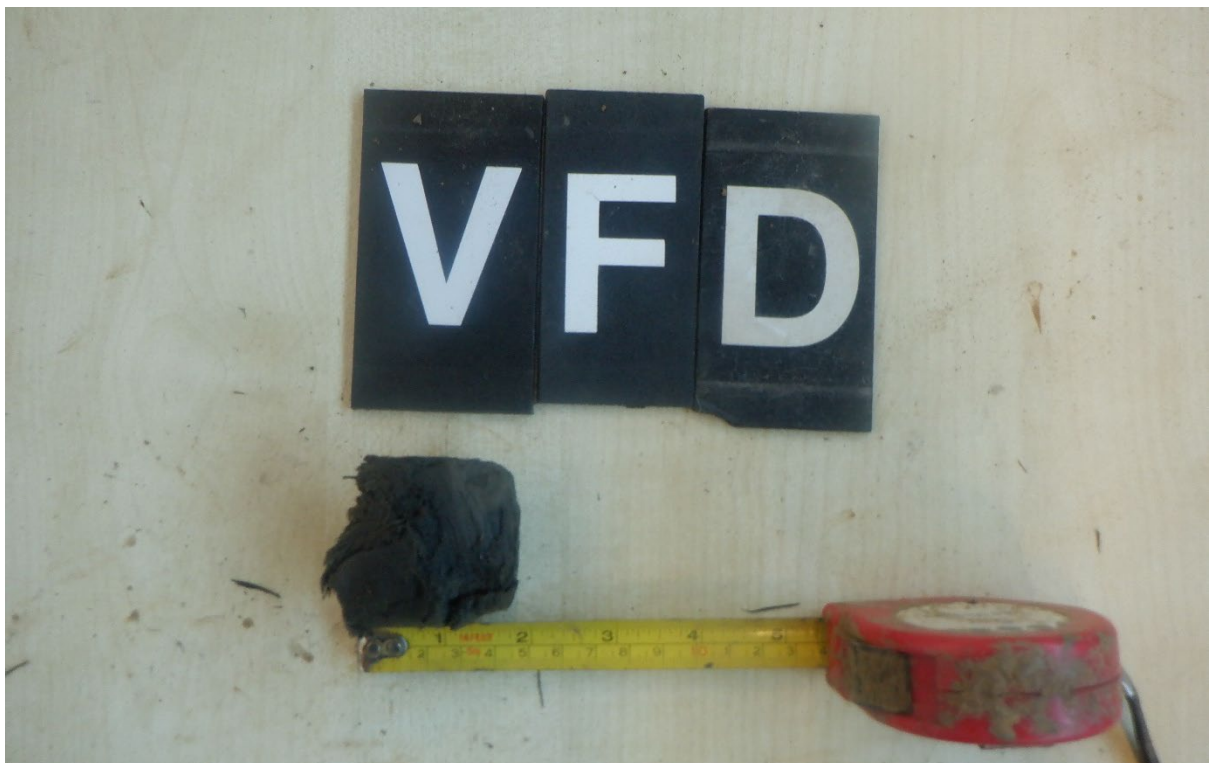
Plate 4: Additional parts of wood retrieved initially stuck within the barrel of the hand coring machine VC01.

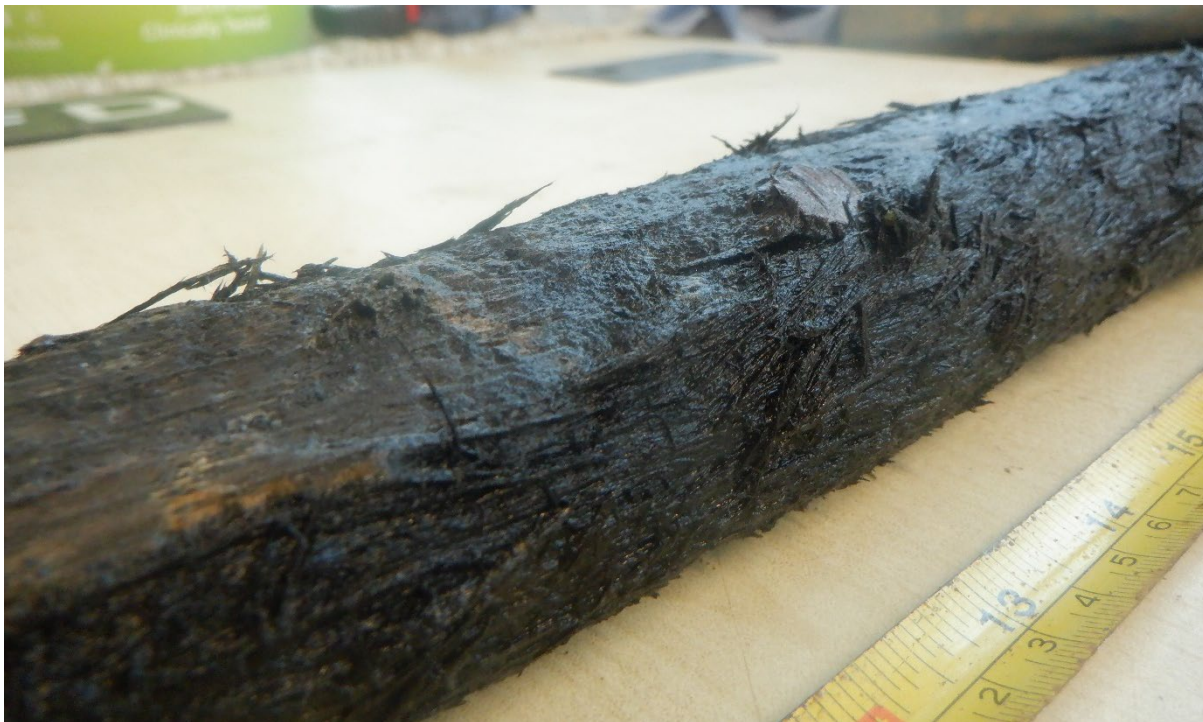
Plate 5: Nails within the wood recovered from the Scotland Weir.

- 5.3.1. The two fragments of iron submitted for identification can both be identified as nails. The lower part survives of a large nail with a square-sectioned shaft, which tapers to a point. It is straight throughout its length, suggesting that it was hit accurately into the wood. The upper part is missing and it is not possible to determine the form of the head. Five different head forms were identified for post-medieval iron nails from the Dockyard at Deptford (Riddler 2004). Most of the nails from that site also had square-sectioned shafts, although in some cases they were rectangular in section.
- 5.3.2. The second nail lacks both its point and its head. It has the same section, but with smaller dimensions, and the shaft is lightly curved.
