SITE	2 and 8 Buckingham Street, York						
CLIENT NAME	Yorkshire Water						
YAT PROJECT #	6290	6290 YAT REPORT # 2022/37					
MUSEUM ACCESSION #	N/A GRID REFERENCE SE 60139 51483						
PLANNING REFERENCE #	N/A	AAI OPS NOTICE #	21009

A watching brief was undertaken by York Archaeology (YA) on behalf of Yorkshire Water between 24th February and 11th March 2022 on sewer repair works at 2 and 8 Buckingham Street, York, YO1 6DW, SE 60139 51483 (Figure 1). The ground works were carried out by Sapphire Utilities Solutions. The objective of the watching brief was to record any archaeological deposits or structures exposed by the ground works.

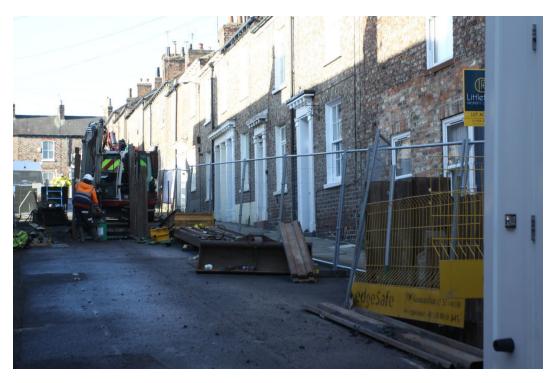
Plate 1 View of works, facing south-west

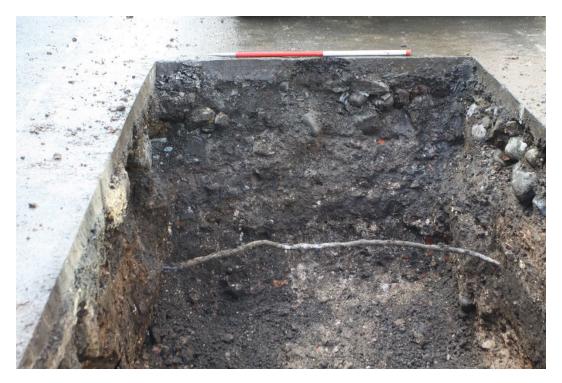
Plate 3 South-east facing section of Trench 2.

In the second trench, a south-east and a south-west facing section were observed and recorded. In the south-east facing section, the earliest context observed was a soft dark-brownish grey silty clay with frequent flecks of charcoal and small fragments of CBM (Context 1015). The upper surface was at 10.23m AOD. It was roughly 0.85m thick, reaching a depth of 9.39m AOD, which was the limit of excavation. One piece of late 11th century white gritty ware jar was recovered, which was small in size.

The next deposit in the sequence was a layer of soft white mortar with occasional small fragments of CBM (Context 1009). The highest point of the deposit was 11.07m AOD and it was roughly 0.87m thick. Some animal bone was found: one piece of sheep or goat bone and one piece of large mammal bone.

Overlying Context 1009 was a soft mid-grey brown clayey silt with orange flecks (Context 1008). It contained frequent flecks of charcoal. The top of the deposit was recorded at 11.17m AOD and it was 0.28m thick. One piece of cattle bone was found in the deposit.

The next deposit (Context 1006) was a soft dark-brownish grey clayey silt, the top of which was recorded at 11.42m AOD and was 0.3m thick. This deposit was truncated by a service cut containing two lead water pipes that ran north-west/south-east across the trench. The fill of this cut (Context 1004) varied in depth, reaching 11.10m AOD at its maximum depth. The top of the deposit was observed at 11.57m AOD. It was a soft mid-brownish grey silt with frequent flecks of white mortar and small-medium flecks of CBM.

Context 1004 was sealed by a soft light-greyish brown sandy silt with frequent fragments of CBM and small irregular shaped stones (Context 1003). The top of the deposit was at 11.75m AOD and it was 0.15m thick. In this context a number of 18th century pot sherds were found: one transfer printed bowl with pedestal base, medium in size and one post-medieval moderately gritted oxidised piece of earthenware with ochre glaze and white and red clay concretions, large in size.

The next deposit in the sequence was a soft light-greyish brown silt (Context 1002) with frequent large rounded cobbles. The average size of the cobbles was 0.14mm x 0.06mm. The deposit was evident from 12.11m AOD and was 0.36m thick. It is likely that the cobbles were remnants of a cobbled road surface that had previously been disturbed when the cut for the original sewer was excavated and later backfilled. One piece of 18th century transfer printed bone china cup rim was found in this context.

The latest deposit observed was a modern tarmac road surface laid at 12.17m AOD that was 0.06m thick.

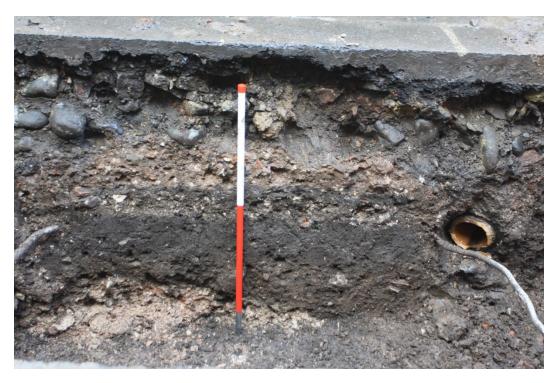
Plate 4 South-west facing section of Trench 2

In the south-western facing section the earliest context present was Context 1012, a soft mid-brown clayey silt with occasional small fragments of CBM and frequent flecks of mortar and charcoal. One piece of sheep bone was found in the context. The top of the context was evident at 9.4m AOD and extended down to the limit of excavation at 8.35m AOD. It was approximately 1.28m thick. This fill was truncated by the sewer cut (Context 1013) which was filled by Context 1014. This deposit was a very dark blackish grey clayey silt with frequent small flecks of mortar, and the upper surface of this deposit

was at 9.4m AOD. It was 1.05m thick.

The next deposit in the sequence was Context 1011, a soft dark blackish brown silt 0.23m thick with frequent small pieces of charcoal, brick rubble and small fragments of CBM and encountered 9.62m AOD. Context 1011 was sealed below by Context (1012) and (1014), and above by Context 1010. This deposit (Context 1010) was a soft mid-brown sandy silt with frequent small CBM and small flecks of mortar, similar to Context 1003 found in south-east section, although it is hard to determine if they are indeed the same deposit given the limited capacity to fully excavate in a single context strategy. Various animal bones were recovered from Context 1014: three cattle, two sheep, four sheep or goat, 1 pig and 4 large mammal bones. Also found were pieces of medieval and post-medieval pottery: one splashed coarsely gritted with reduced core and oxidised surfaces, medium in size, one post-medieval earthenware with lightly oxidised body and brown glaze over break, small in size and one splashed ware lightly oxidised with spot of yellow glaze, also small in size.

The highest point of this deposit was 10.52m AOD and the whole deposit measured just less than 1.00m thick, an estimated 0.90m in total thickness. Both 1010 and 1011 comprised a series of lenses, mostly being redeposited material that were recorded and observed with the excavation of Trench B.

The next two deposits recorded in the south-western section were recorded as Context 1002 (cobbled surface) and Context 1001 (modern tarmac), the same two deposits recorded in the south-eastern section. They were recorded at 10.75m AOD (Context 1001) and 10.60m AOD (Context 1002), and measured 0.12m and 0.15m in thickness respectively.
