# 1EW03 - Enabling Works Central AWHj

## Interim Report

## Historic Building Recording

## The Lodge, Doddershall Buckinghamshire

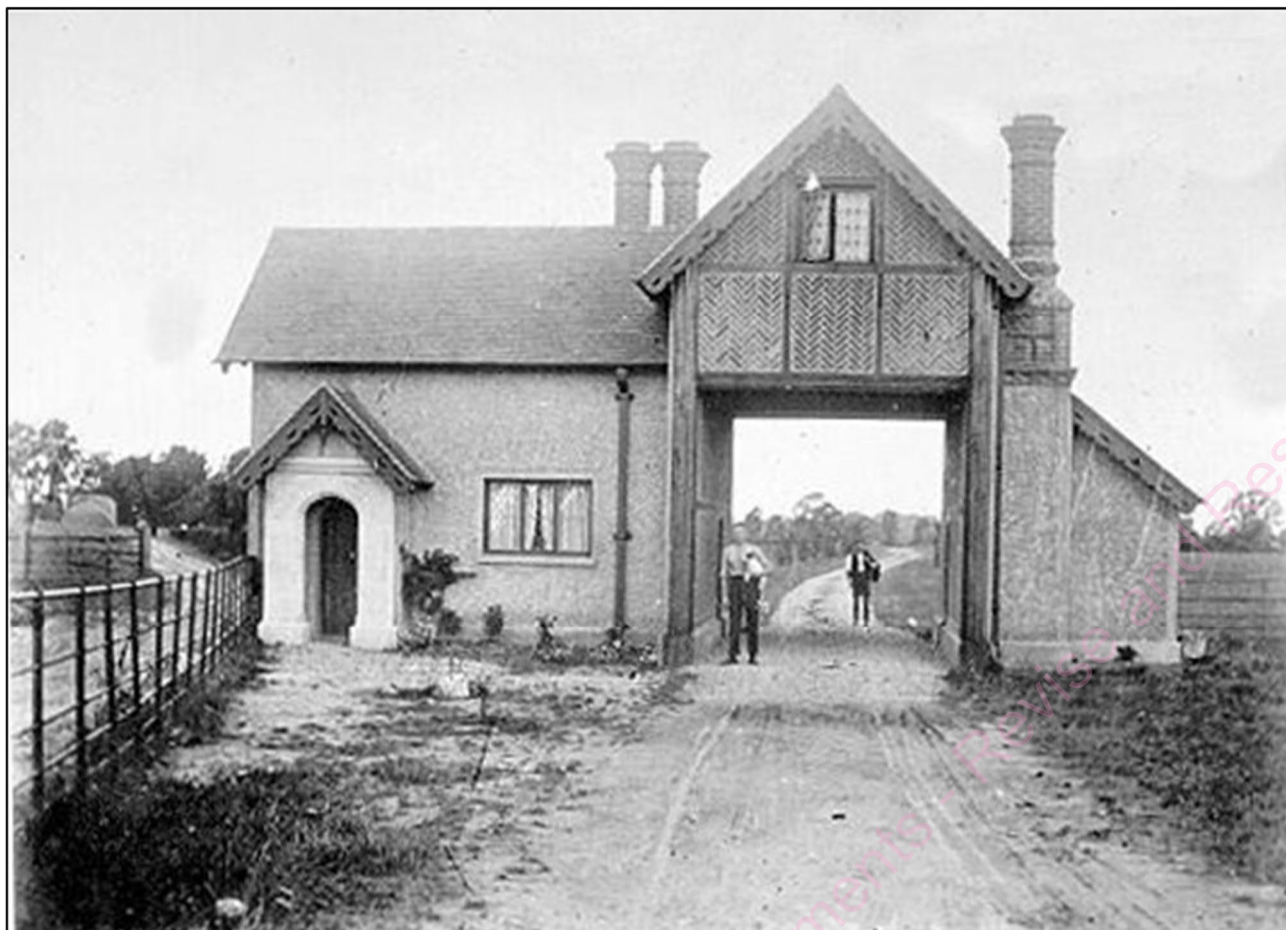
Plate 1: Historic photo pf the Lodge, shortly after construction, c1900

- 3.1.3 The Lodge was built to span the new approach road and though not depicted on the 1899 OS map appears to have been completed shortly after. An undated photograph (Appendix A Plate 1) shows the building shortly after completion, without the south cross wing. It is uncertain whether the current upper floor was present, as no upper floor windows are shown in the photograph. If there was a floor it may have been lit by a window set in the south gable which is not visible. The room over the carriage arch is clearly evident. The date at which the south wing was added is not recorded. The style and quality of the extension matches well with the original portions of the building and the assumption is that the extension was added shortly after the original construction.

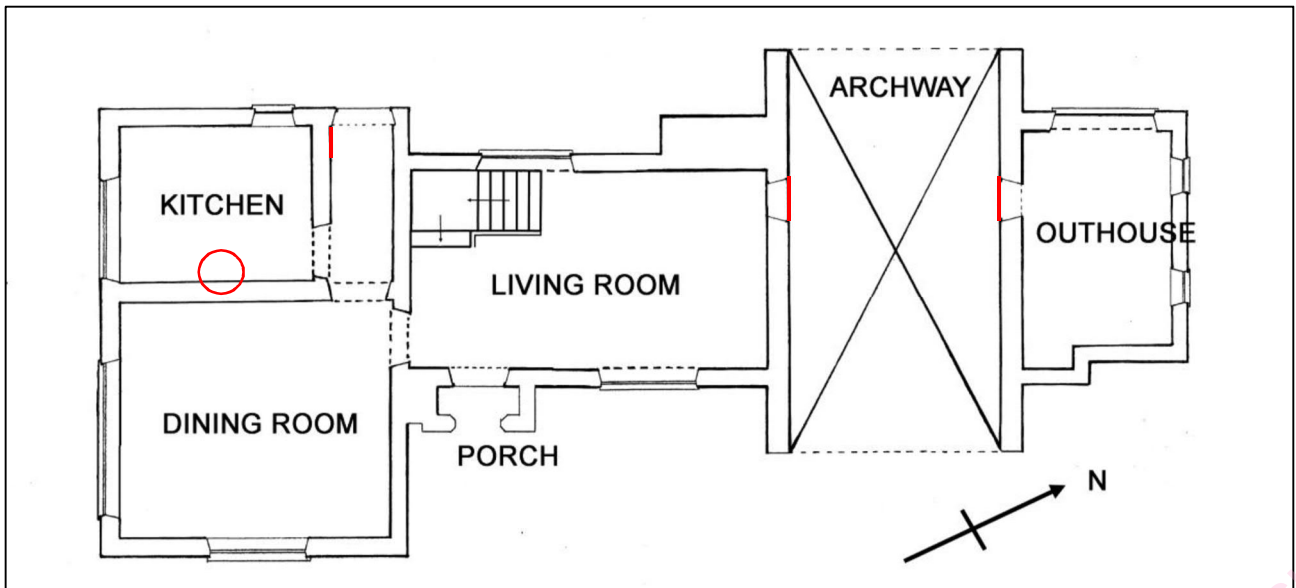
Plate 2: Ground floor plan by BAS, annotation: circle location of blocked fireplaces, line location of blocked doors

- 3.2.1 A simple annotation of an existing floor plan is provided at Plates 2 and 3. A selection of

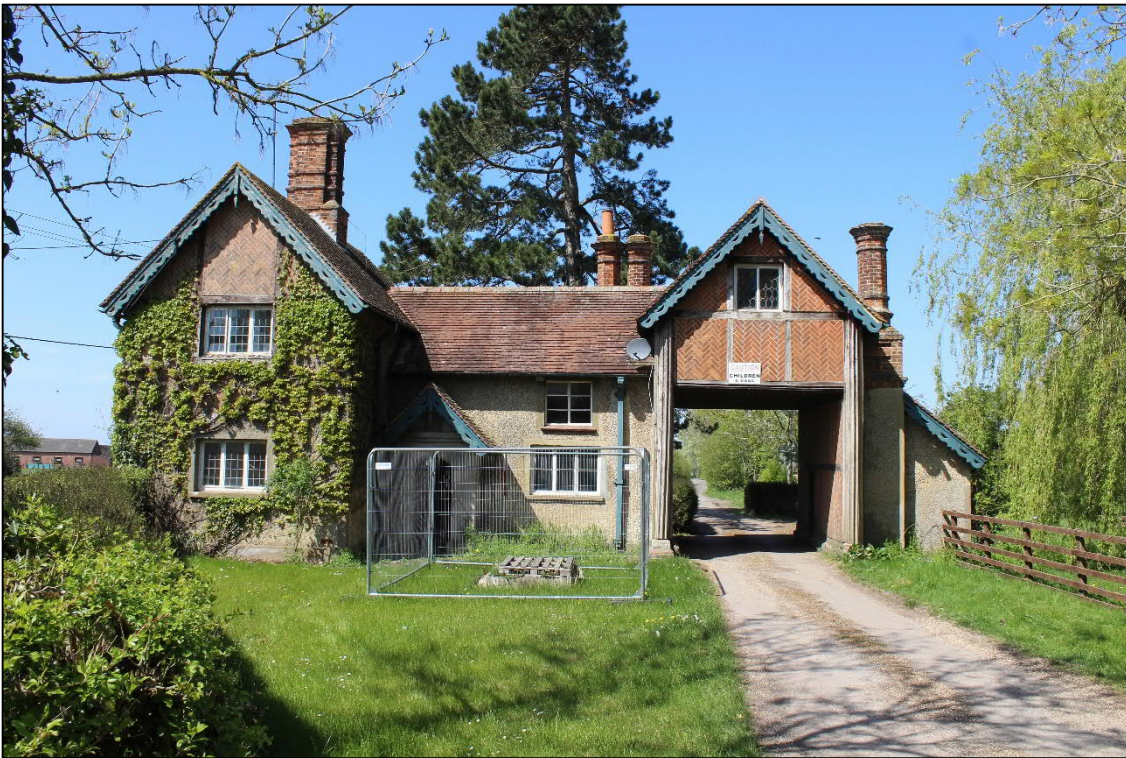
- 3.2.2 The Lodge is a two-storey building in Arts-and-Crafts style, straddling the access road to Doddershall House with a square headed carriage arch in its northern section (Plates 4 and 5). The front elevation faces broadly east. The Lodge is surrounded by a small garden to the north and west. A well is situated to the east of the building. The building comprises three bays: a low 2-storey central bay which is flanked by two full 2-storey gabled cross-wings, to the north encompassing a square headed carriage arch. To the north of the carriage arch is a single storey lean-to, which contains a single room, with a projecting chimney breast and decorative octagonal brick stack. The principal entrance is located within the central range and is set within a gabled porch. A secondary entrance is situated within the rear elevation of the south cross wing.

Plate 4: East facing elevation of the Lodge

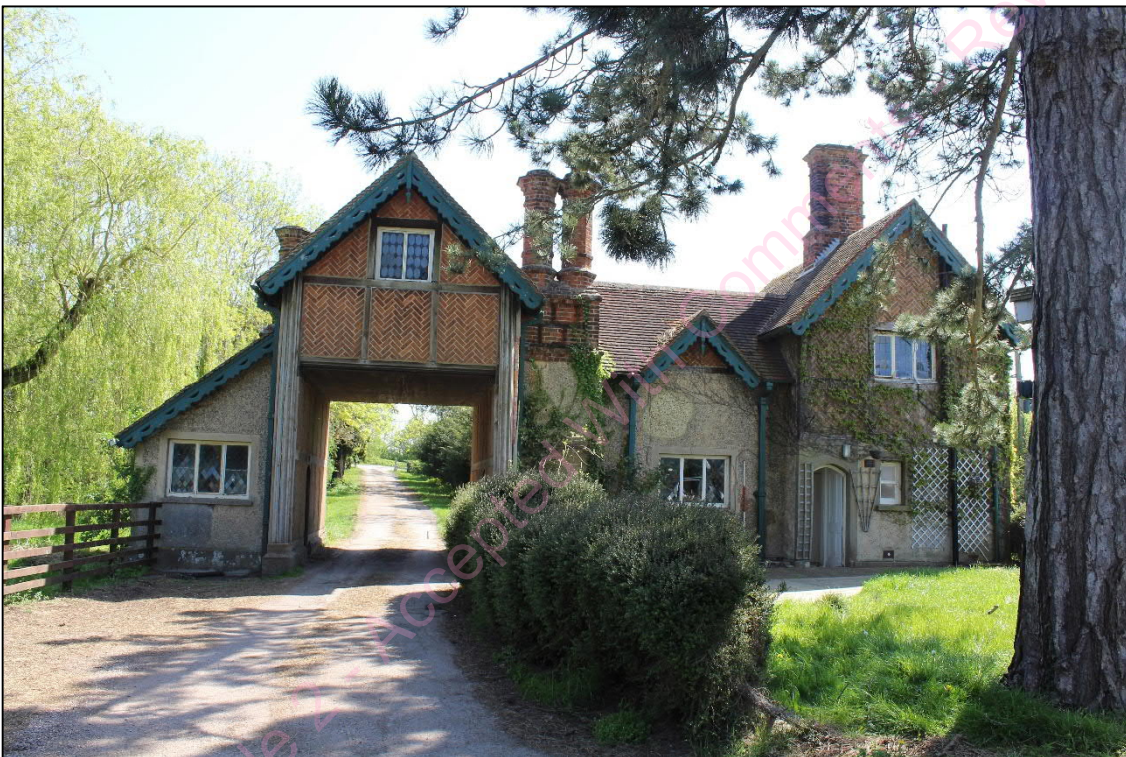
Plate 5: West facing elevation of the Lodge

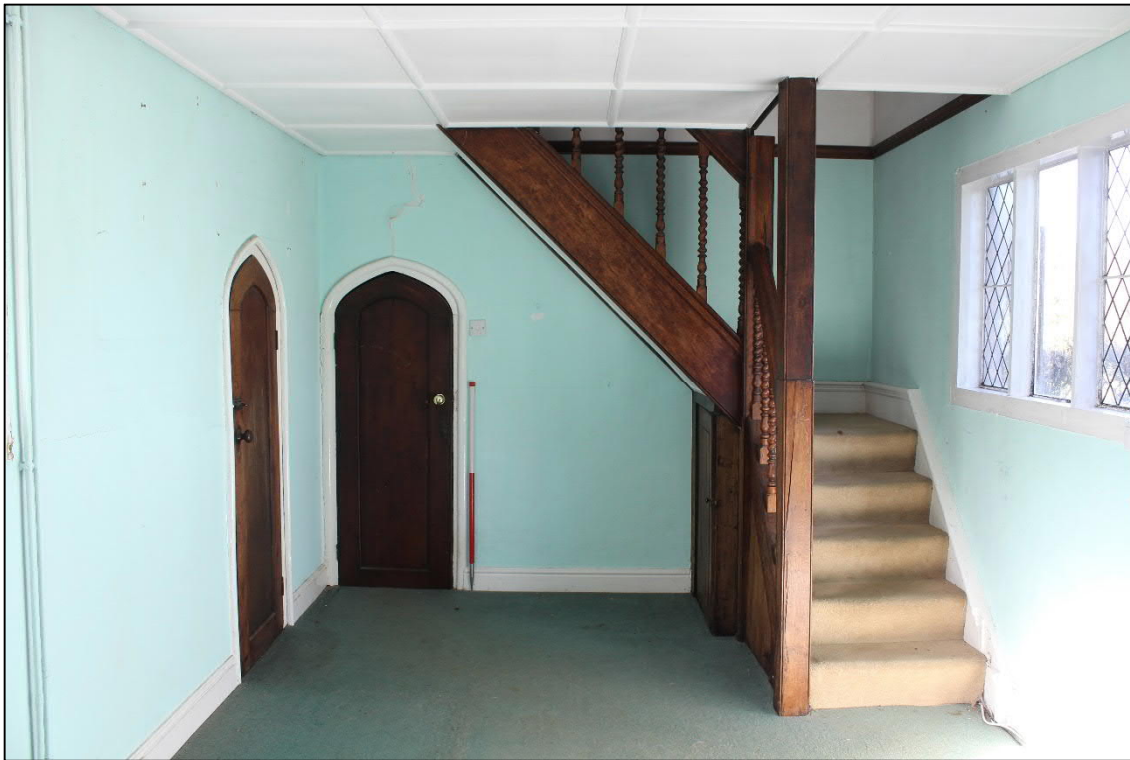
Plate 6: Later inserted, repurposed staircase and potentially later ceiling in the Living Room

- Observe and monitor works of soft strip to remove the stair. Observe and record constructional detail, provide an analysis of original form and date.

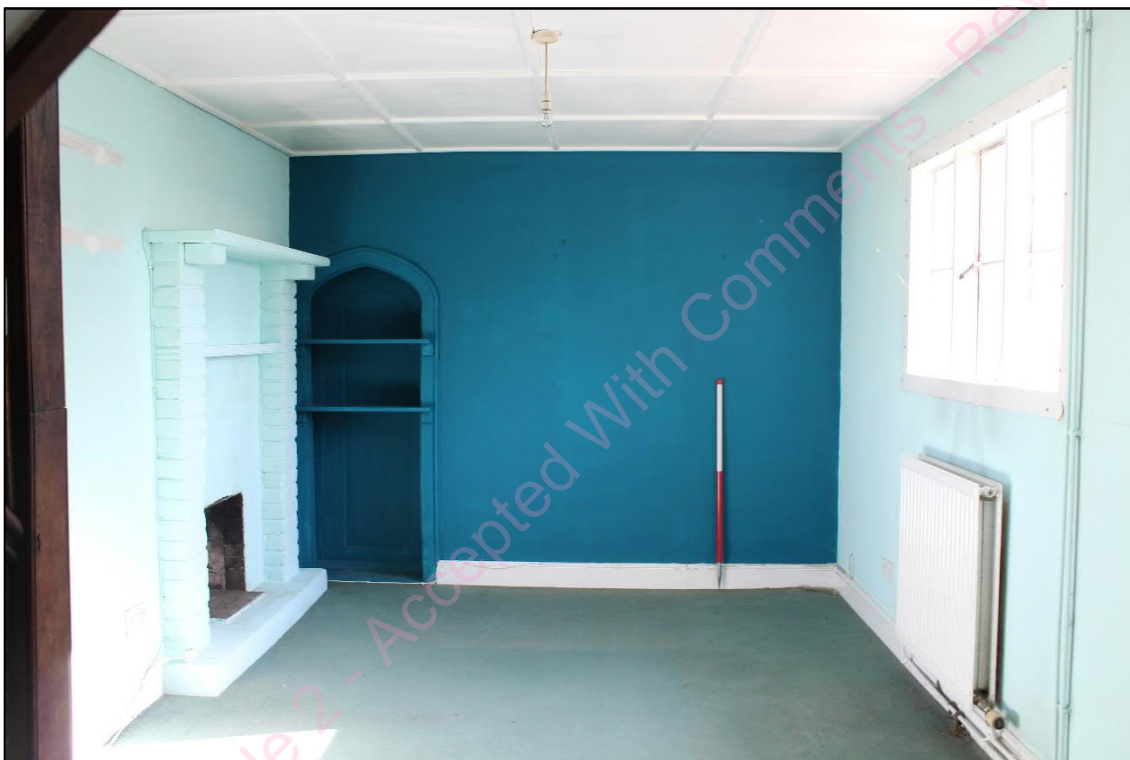
- 3.2.4 The interior of the building is of a simple layout and the rooms are plainly decorated. The ceilings in the greater part of the building have been covered with modern hardboard panelling. The front porch leads directly into the living room. A second external doorway, set beneath the carriageway, has been blocked off. The living room contains a re-used timber dog-leg staircase with a half landing (Plate 6). The staircase has square sectioned newels with barley twisted spindles and a moulded handrail. A simple brick fireplace is situated in the north-eastern corner (Plate 7).

Plate 7: View to blocked door fireplace in Living Room

- Observe and monitor soft strip activities within the building, to inspect and record all currently blocked off elements such as the fireplaces and doors. Observe and record the plan form and features within the store attached to the north of the carriage arch.

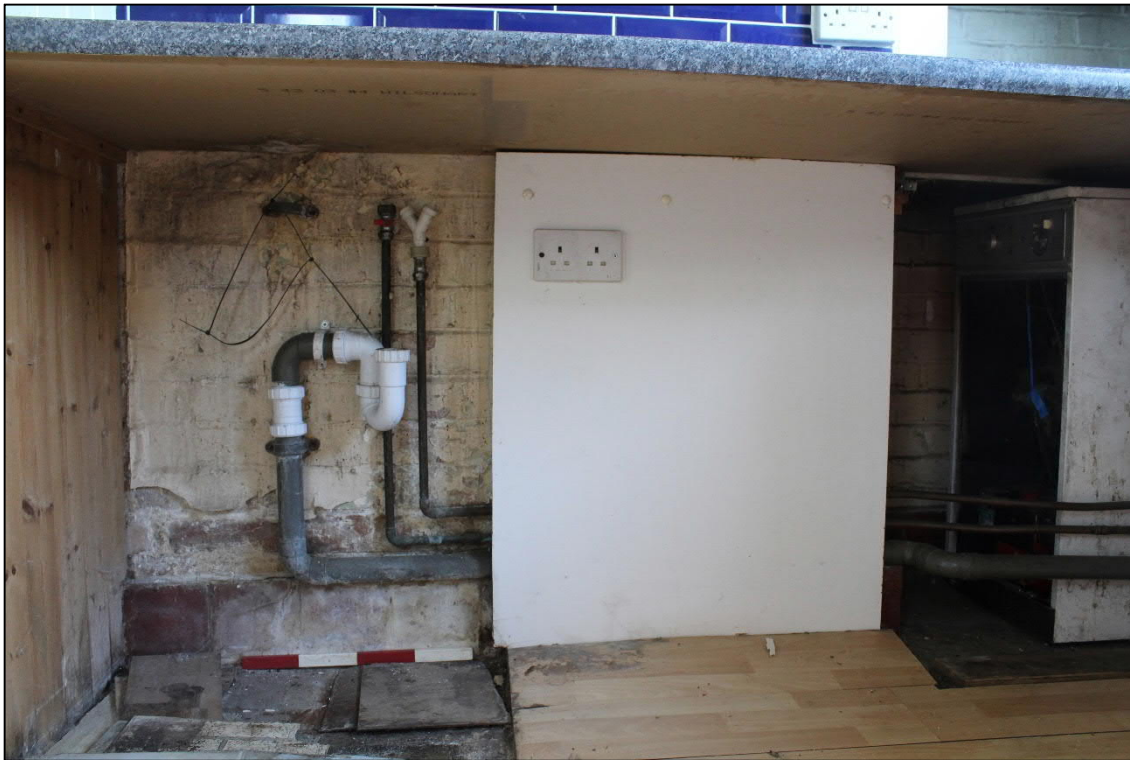
- 3.2.5 Within the south cross wing are the dining room and kitchen on the ground floor, and a bathroom and bedroom on the first floor. Fireplaces have been blocked off in the kitchen (plate 8), bathroom and both upstairs bedrooms. A 1930s style tile fire-surround had been inserted in the dining room (Plate 9). A blocked off doorway was noted in the kitchen. The roof structure is mostly obscured by the modern ceiling panels but would appear to comprise a simple purlin roof.

ion of blocked off fireplace in kitchen

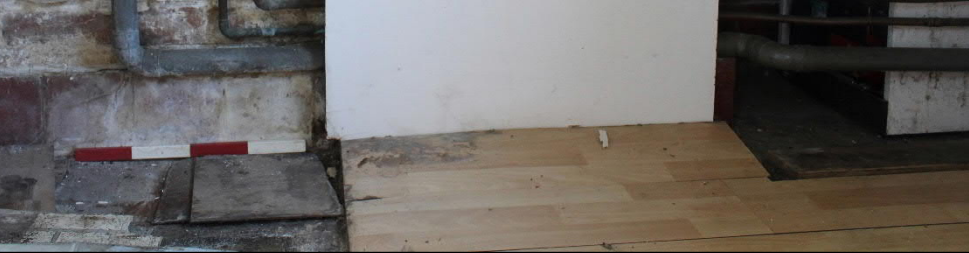
Plate 8: Location of blocked off fireplace in kitchen

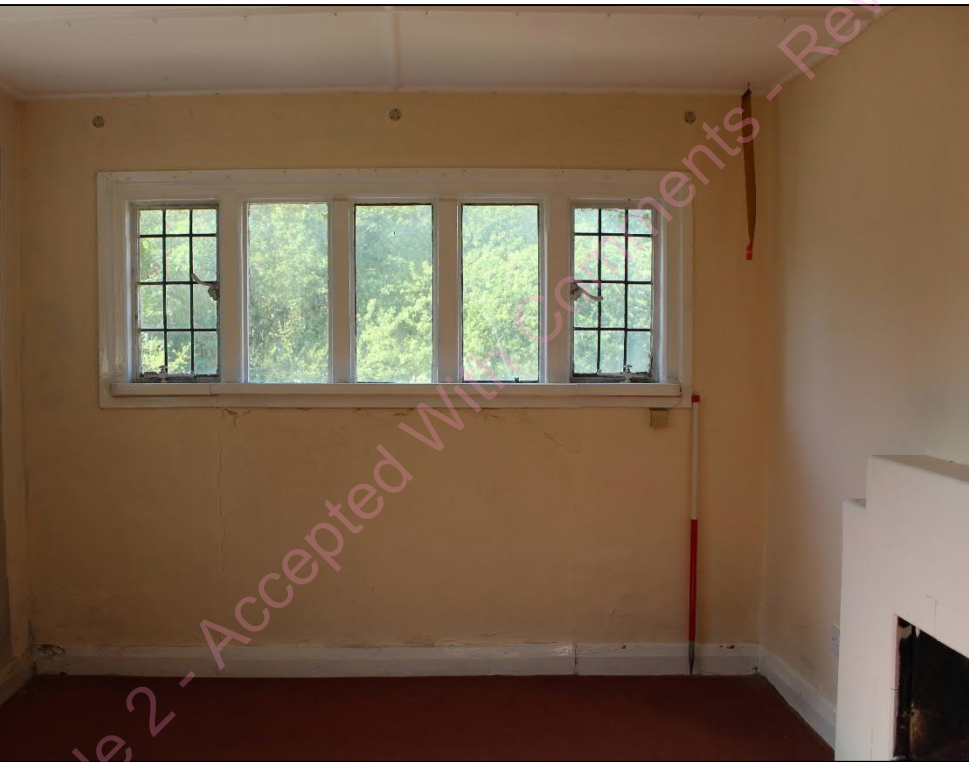
g Room with leaded glass windows and tile fire surround of c. 1930

Plate 9: Dining Room with leaded glass windows and tile fire surround of c. 1930

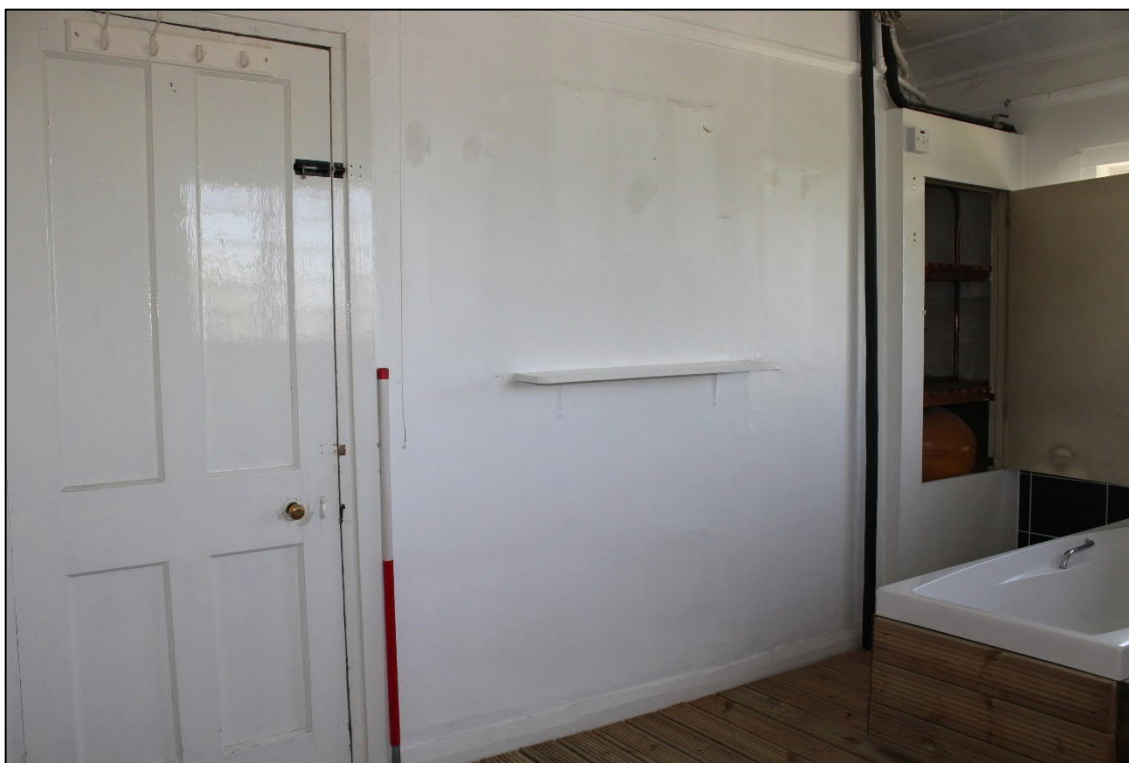
Plate 10: Location of a blocked off fireplace in bathroom

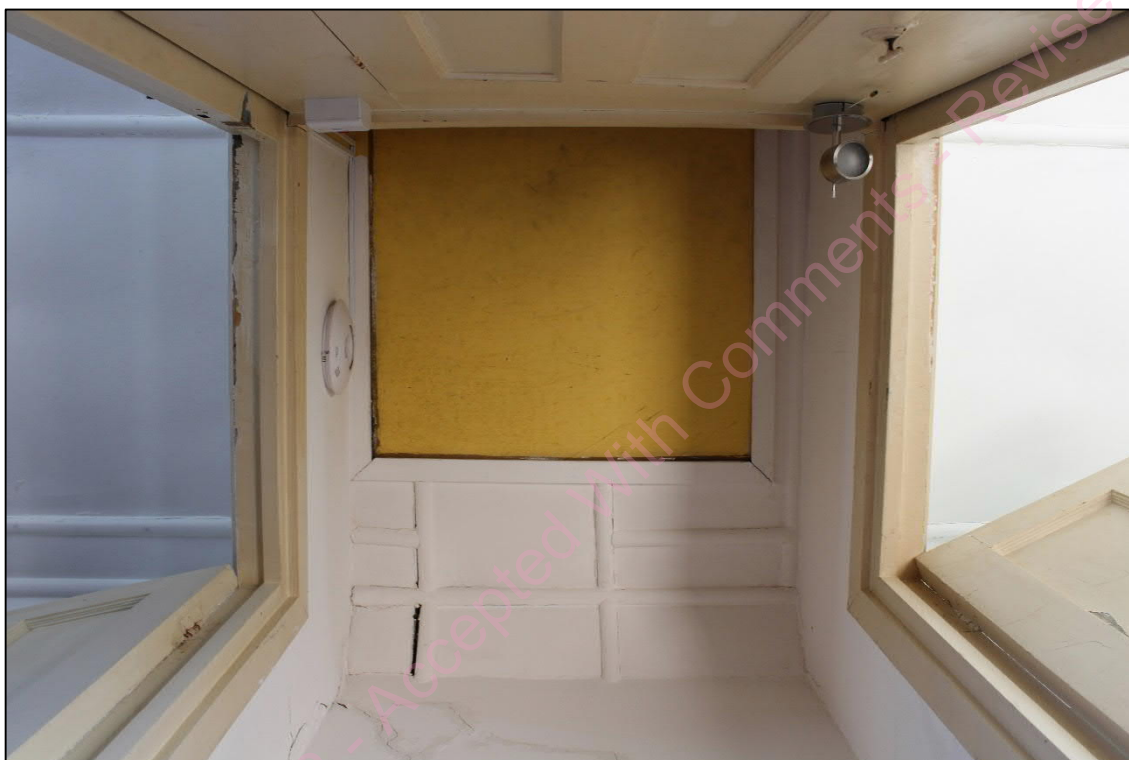
Plate 11: Hatch to the roof space in southern wing

- Observe and monitor the removal of the chimney stacks record their structure and fabric, set aside and analyse the bricks to determine age.
  - Observe and monitor soft strip activities to remove the suspended ceilings throughout the building to observe and record the roof structure and determine the origin and purpose of the moulded timber beams.

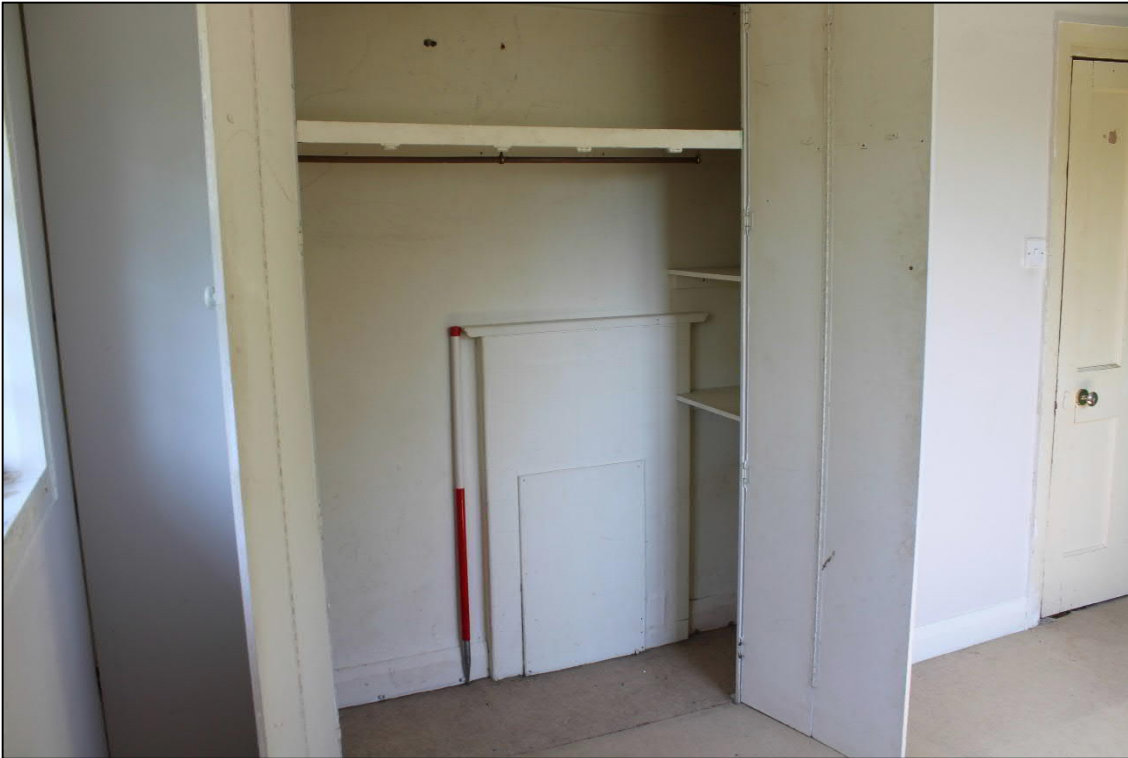
Plate 12: Blocked off fireplace in bedroom 2.

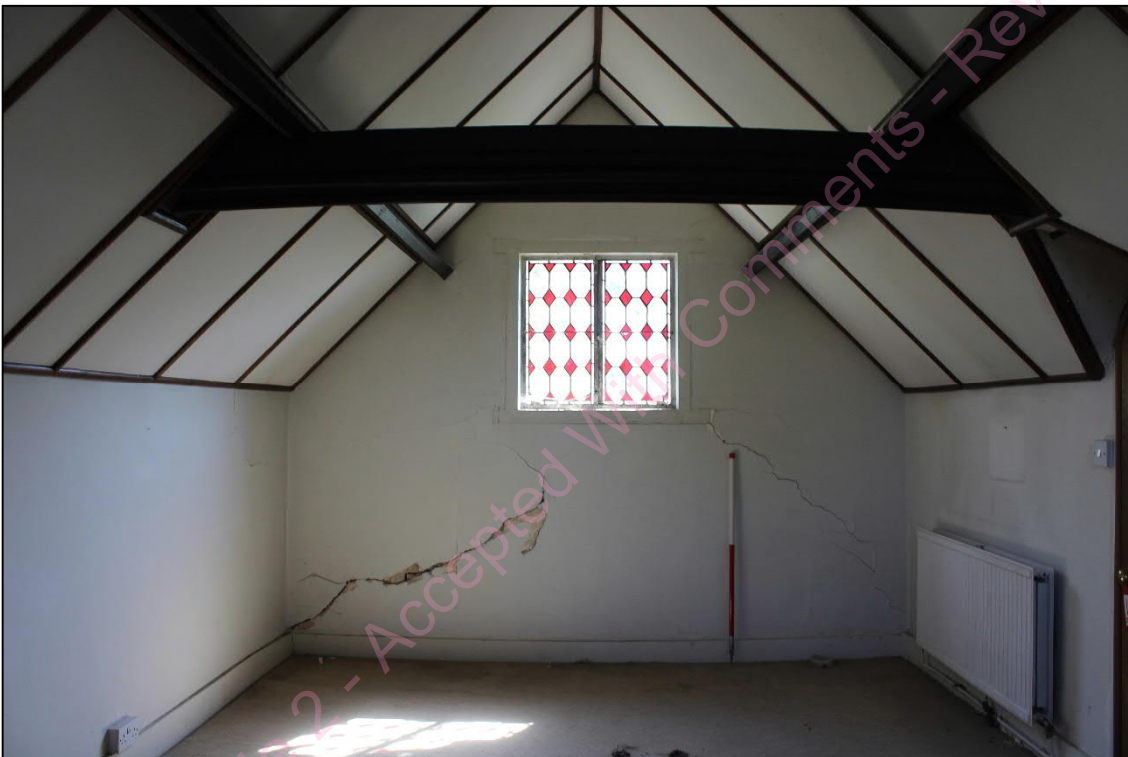
- timber doorframes, doors, and fittings throughout the house, all of a four-centred design
- leaded glass windows with metal fittings, three types observed: square style, diamond style and Queen Anne style (Plate 13),
- Reused timber staircase,
- Original arts and crafts style fire place in living room (plate 7) and slightly later fire place of c 1910/1920 in upstairs bedroom (Plate 12), 1930s fire place in dining room (plate 9)
- Blocked off doors in living room and kitchen,
- Timber flooring on first floor,
- Deeply moulded cross beams to first floor roof (plate 13 and 14).

Plate 13: Main bedroom, with leaded glass window in Queen Anne Style and large crack in fabric

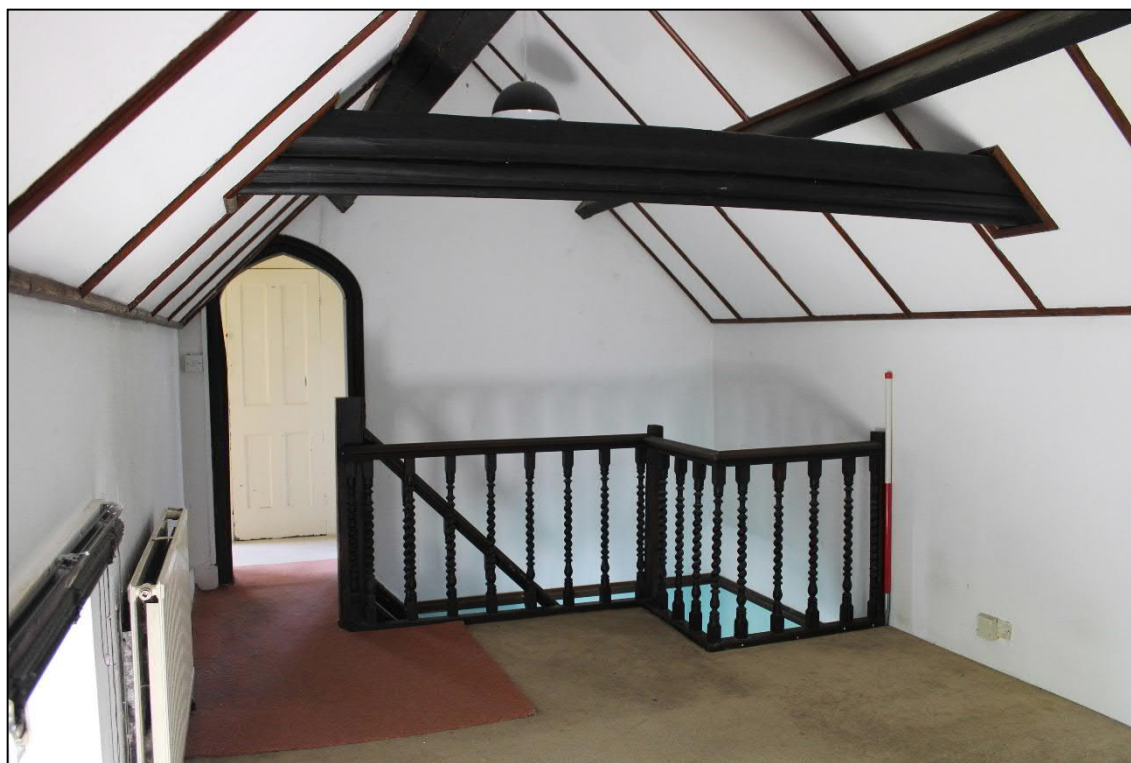
- 3.2.6 The two deeply moulded cross beams noted in the first floor study and northern bedroom appear not to be part of the structure of the roof and their mouldings match the pillars that frame the exterior of the carriageway. The roof within the south cross wing appears to be of modern construction but is only observable via a small hatch (Plate 11). Noticeable cracks in the fabric were noted in the room above the archway, as well as above the doorway between the dining room and living room.

Plate 14: General view of the study, with roof truss and inserted staircase
