23 Granaries and cart sheds in the East of England Region Until the 18th century it was usual on most farms to keep the threshed grain in the farmhouse. As output increased purpose-built granaries were built, typically as part of a combination cart shed/granary. A and B are 18th-century buildings (although A was extended from four bays to eight bays in the 19th century). C is a mid-19th-century example. Free-standing timber-framed granaries raised on plinth walls (D) or standing on staddle stones are characteristic of southern East Anglia and the

24 Hay barns and other crop buildings

25 Cattle housing

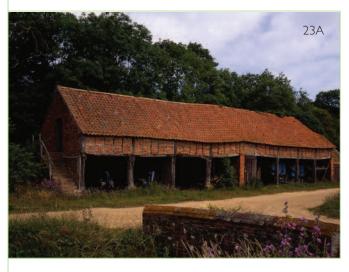
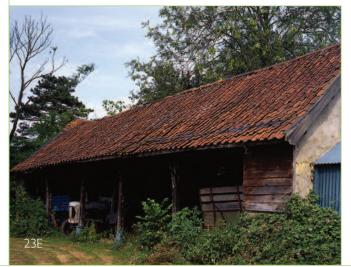
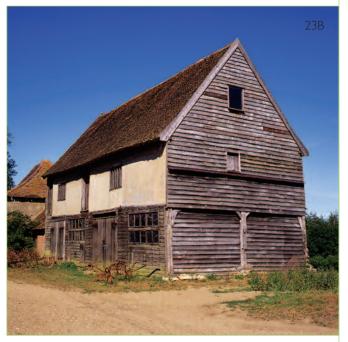
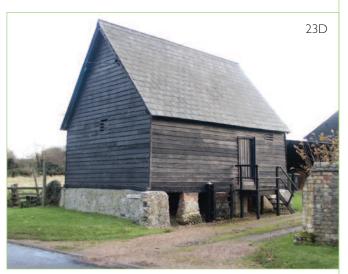
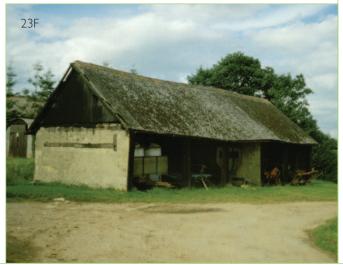
south-east of England.

Single-storey cart sheds (E & F) built in timber frame, brick or, more rarely, in earth are found on many farmsteads.

(A North West Norfolk; B Breckland; C North West Norfolk; D East Anglian Chalk; E South Norfolk and High Suffolk Claylands; F South Suffolk and North Essex Claylands) All © English Heritage / Michael Williams except D © Bob Edwards; F © Susanna Wade Martins

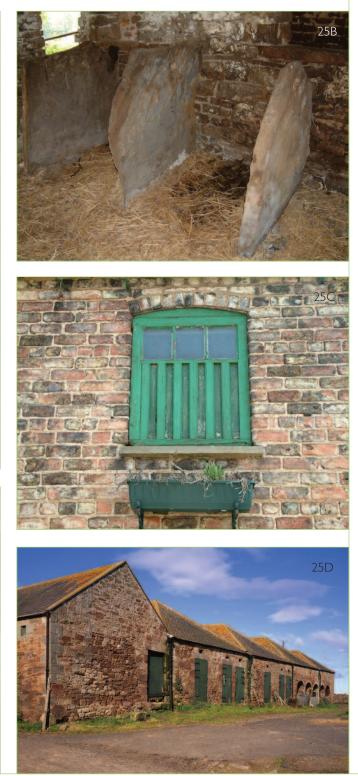
- A & B Wooden cow stalls and slate cow stalls, the latter as found throughout the northern uplands. (A Durham Coalfield Pennine Fringe; B Yorkshire Dales)
- C Cow houses needed to be well ventilated, by either slits in the wall or windows. Horizontal sliding hit-and-miss ventilators, as here, achieved wide popularity in the mid- to late 19th century. (Vale of York)
- 25A 25E

- D A range of looseboxes, easily distinguishable by its rows of doors providing access to individual cubicles for fattening. (North Northumbrian Coastal Plain)
- E The interior of a covered yard, on a home farm of the mid-19th century. (Shropshire, Cheshire and Staffordshire Plain) A–C © Jen Deadman; D & E © English Heritage / Michael Williams

7.1.1.7 Looseboxes (Figure 25D)

Mostly dating from the 1850s, these served as accommodation for sick or calving beasts, bulls or most commonly fatstock. They comprised individual boxes or more usually a row of boxes with a central or rear feeding passage. The latter were usually distinguished externally by continuous rows of doors. There was often a feeding passage along behind them, with a feed store at one end. If used for fatstock, the floor of the boxes was sunken and the manure would build up in them during the winter. They reflected a realisation that warm and dry conditions would promote weight gain (through minimising heat loss) and retain the quality of the manure. Double rows would have a central feeding passage and were to be found on many farms by 1860.

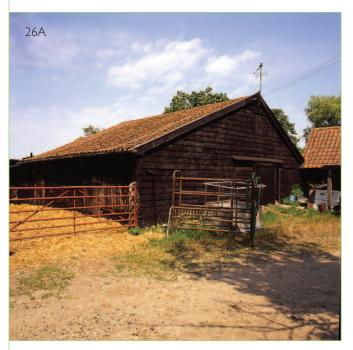
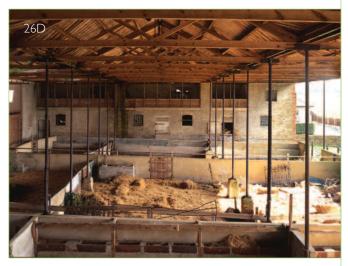
26 Cattle housing in the East of England Region A Pre-18th-century buildings for cattle are rare. This timber-framed cow shed or neathouse was built in the 16th century but may have originally served as a stable. Timber-framed structures were often replaced by more robust brick buildings (South Suffolk and North Essex Claylands)

- $B\$ Across much of the Region buildings for cattle consist of open-fronted shelter sheds, often attached to a barn and forming part of a larger yard. Large examples of shelter sheds with mixing barns could be arranged to form E-plans as in photograph C, creating two cattle yards where straw and manure would be trampled by the animals. Such planned farmsteads are usually associated with 19th-century improving estates. (B Mid Norfolk; C The Fens)

- D & E The covered cattle yard was the final development in cattle housing. The earliest covered yards date from the 1850s but spread in popularity in from the 1870s and again in the early 20th century. (D Bedfordshire and Cambridgeshire Claylands; E South Suffolk and North Essex Claylands)

- F A specialist cattle-fattening building found only in the Flegg and Broads of the north-east of the Region. Cattle were housed in the side aisle with fodder (mostly turnips) stored in the central area. (North East Norfolk & Flegg)

with pantiles and supported along the open front with brick, cast-iron or wooden piers. Sometimes looseboxes formed part of the range. There were troughs and racks along the back wall, the troughs sometimes supported on chains so that they could be lifted as the level of litter in the yard rose. These regular U- and E-plan yards are to be found across the predominantly estate-owned areas of the Region such as north Norfolk where new farms were built on newly enclosed land. They are also found in the areas where brick and stone building predominated but are less usual in the timber-framed parts of the Region and are unusual in the claylands of South Norfolk, Suffolk and North Essex. In these areas free-standing buildings were roughly grouped around a yard and linked by walls or temporary hurdles to form an enclosure.

Specialist fattening buildings. Where cattle were being reared for their meat, fattening was a main consideration and buildings were designed primarily for efficient feeding. Specialised buildings took advantage of specific landscapes and opportunities. An example of this can be found in the cattle houses on the edge of the grazing marshes of the Norfolk Broads. Only a few examples of these sheds survive as evidence for a very localised system in which cattle were housed down side aisles, separated by a central feed-storage area entered through double doors at either end (Figure 26F). This specific type of building has only recently been recognised and it is likely that significant local variations are awaiting identification elsewhere.

Covered yards, which are documented throughout the Region from the 1850s. Some covered yards were still being built as the depression in grain prices focused attention on livestock production. They were expensive and were mostly found on estate farms. The Chelmsfordbased architect, Frederick Chancellor, produced designs for Essex, Cambridgeshire and Hertfordshire landowners. At a meeting of the Surveyors' Institution in 1883 Chancellor, 'who has had very extensive experience, having erected forty or fifty covered homesteads during the last thirty-five years', was reported as saying that, 'after a great deal of thought and experience, he did not think there was any homestead equal to a covered homestead' (Clarke 1899, p.85).
