The Old Castle, Bridge Street,
Tutbury, Staffordshire:

An Archaeological
Watching Brief 2006

Project No. 1333
October 2006

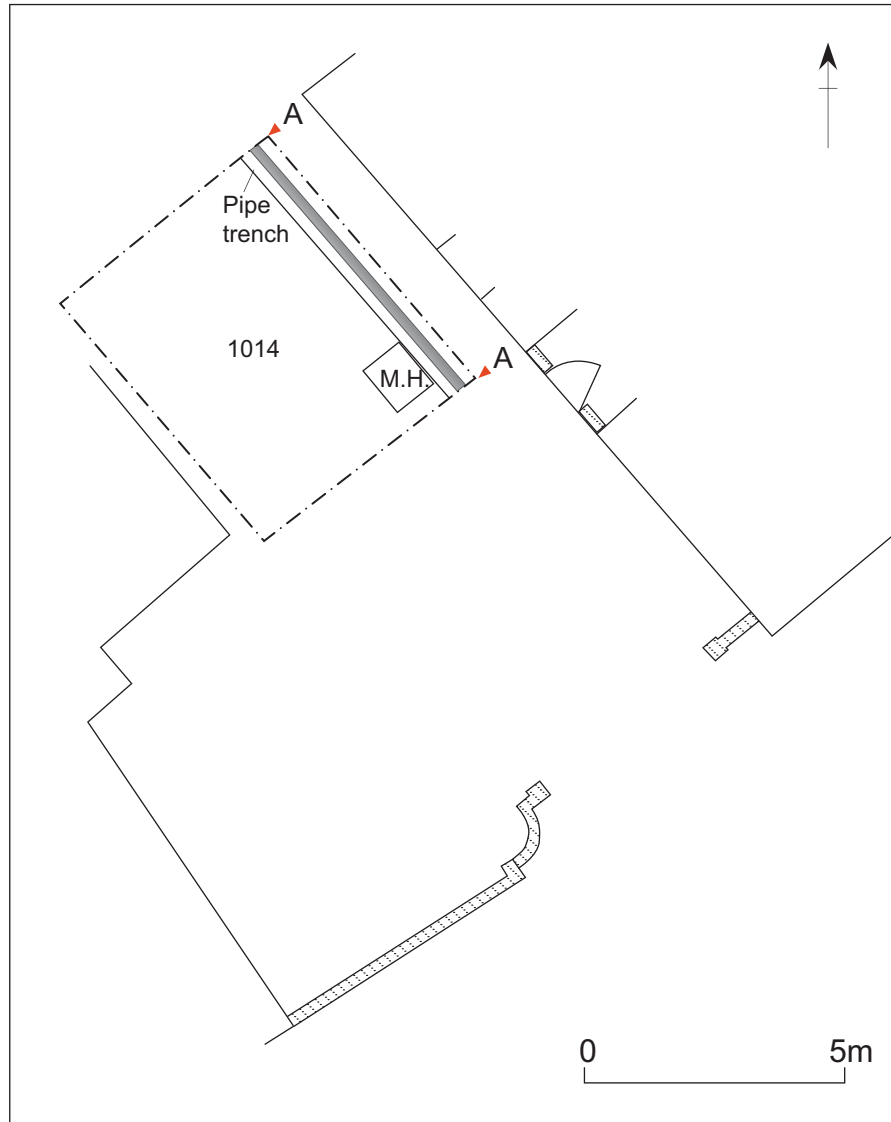
Fig.3

The trench for the foundation slab of the garage was 6m x 5m (Fig. 3). This trench was mechanically excavated with a mini- digger and the excavated surfaces were cleaned by hand. The main area of the trench was excavated to an average depth of 0.20m below existing ground level, consisting of the stone-paved surface of the driveway. The margins of the trench, at the SE and NW sides, were excavated to depths of between 0.27m and 0.40m. The deepest excavations were at the NE part of the trench. Here the cut of a water pipe trench was excavated by machine in order to expose the extent and direction of the pipe-work.

A natural subsoil of reddish brown finely laminated sandy clay (1015), 0.30-0.35m below the existing ground level, was revealed in the deeper excavations, at the margins of the trench. Overlying layer 1015 was a uniform sterile layer of reddish brown sandy clay interleaved with grey sandy clay (1014), 0.10-0.15m thick and 0.20m below the existing ground level. Layer 1014 was interpreted as the uppermost layer of natural subsoil. These two natural layers extended throughout the excavated area and were cut near the NE limit of excavation by a modern water pipe trench (1016), 0.50m wide and 0.57m deep, and a brick-built manhole. Beyond pipe trench 1016, to the NE, layer 1014 was not present, but a reddish brown sandy clay (1013) that survived here between later cuts, appeared to be identical to natural subsoil 1015.

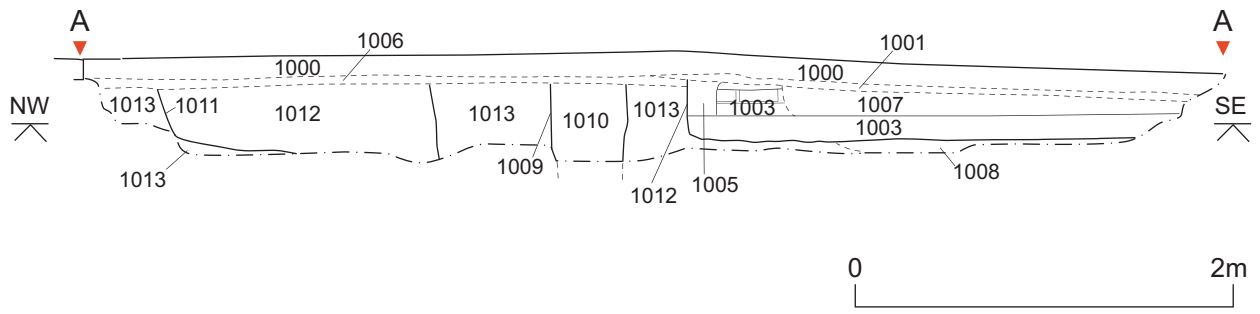
Fig.4

The stratigraphy recorded in the SW-facing section (Fig. 4) of the trench was more complex, probably because of the proximity of the house, but nothing of archaeological significance was encountered. Most of the stratigraphy consisted of cut features and foundations for a former porch (1002, 1003 and 1005), all but one of which were demonstrably modern, based on the composition of the fills. The only possible exception was a vertical-edged cut (1009). This was 0.40m wide, greater than 0.40m deep (as revealed and recorded in section) and back-filled with material derived largely

from the natural subsoil (1010). This feature probably represented the cut of a drain connected to the manhole that lay near the SE corner of the trench but no dating evidence was retrieved from it. Another cut (1011) that appeared to be a trench aligned N-S was probably the cut for a drain running from the rear of the house to the manhole. The backfill of this included a few fragments of fairly modern-looking roofing tile and a few fragments of mortar, which appeared to be a Portland cement mix.

Over the majority of the excavated area the natural 1014 and 1015 was sealed by a bedding layer (1001 and 1006) for the stone paving (1000) of the driveway.

N.B. Contexts 1000 – 1013 inclusive were only revealed in NE section. (Fig. 4). Contexts 1014 – 1017 were revealed in plan and section. Context 1014 did not appear in NE section.
