BLOOMFIELD ROAD, TIPTON

AN ARCHAEOLOGICAL
EVALUATION AND WATCHING
BRIEF, 2007

Bloomfield Road, Tipton
AN ARCHAEOLOGICAL EVALUATION AND WATCHING BRIEF, 2007.

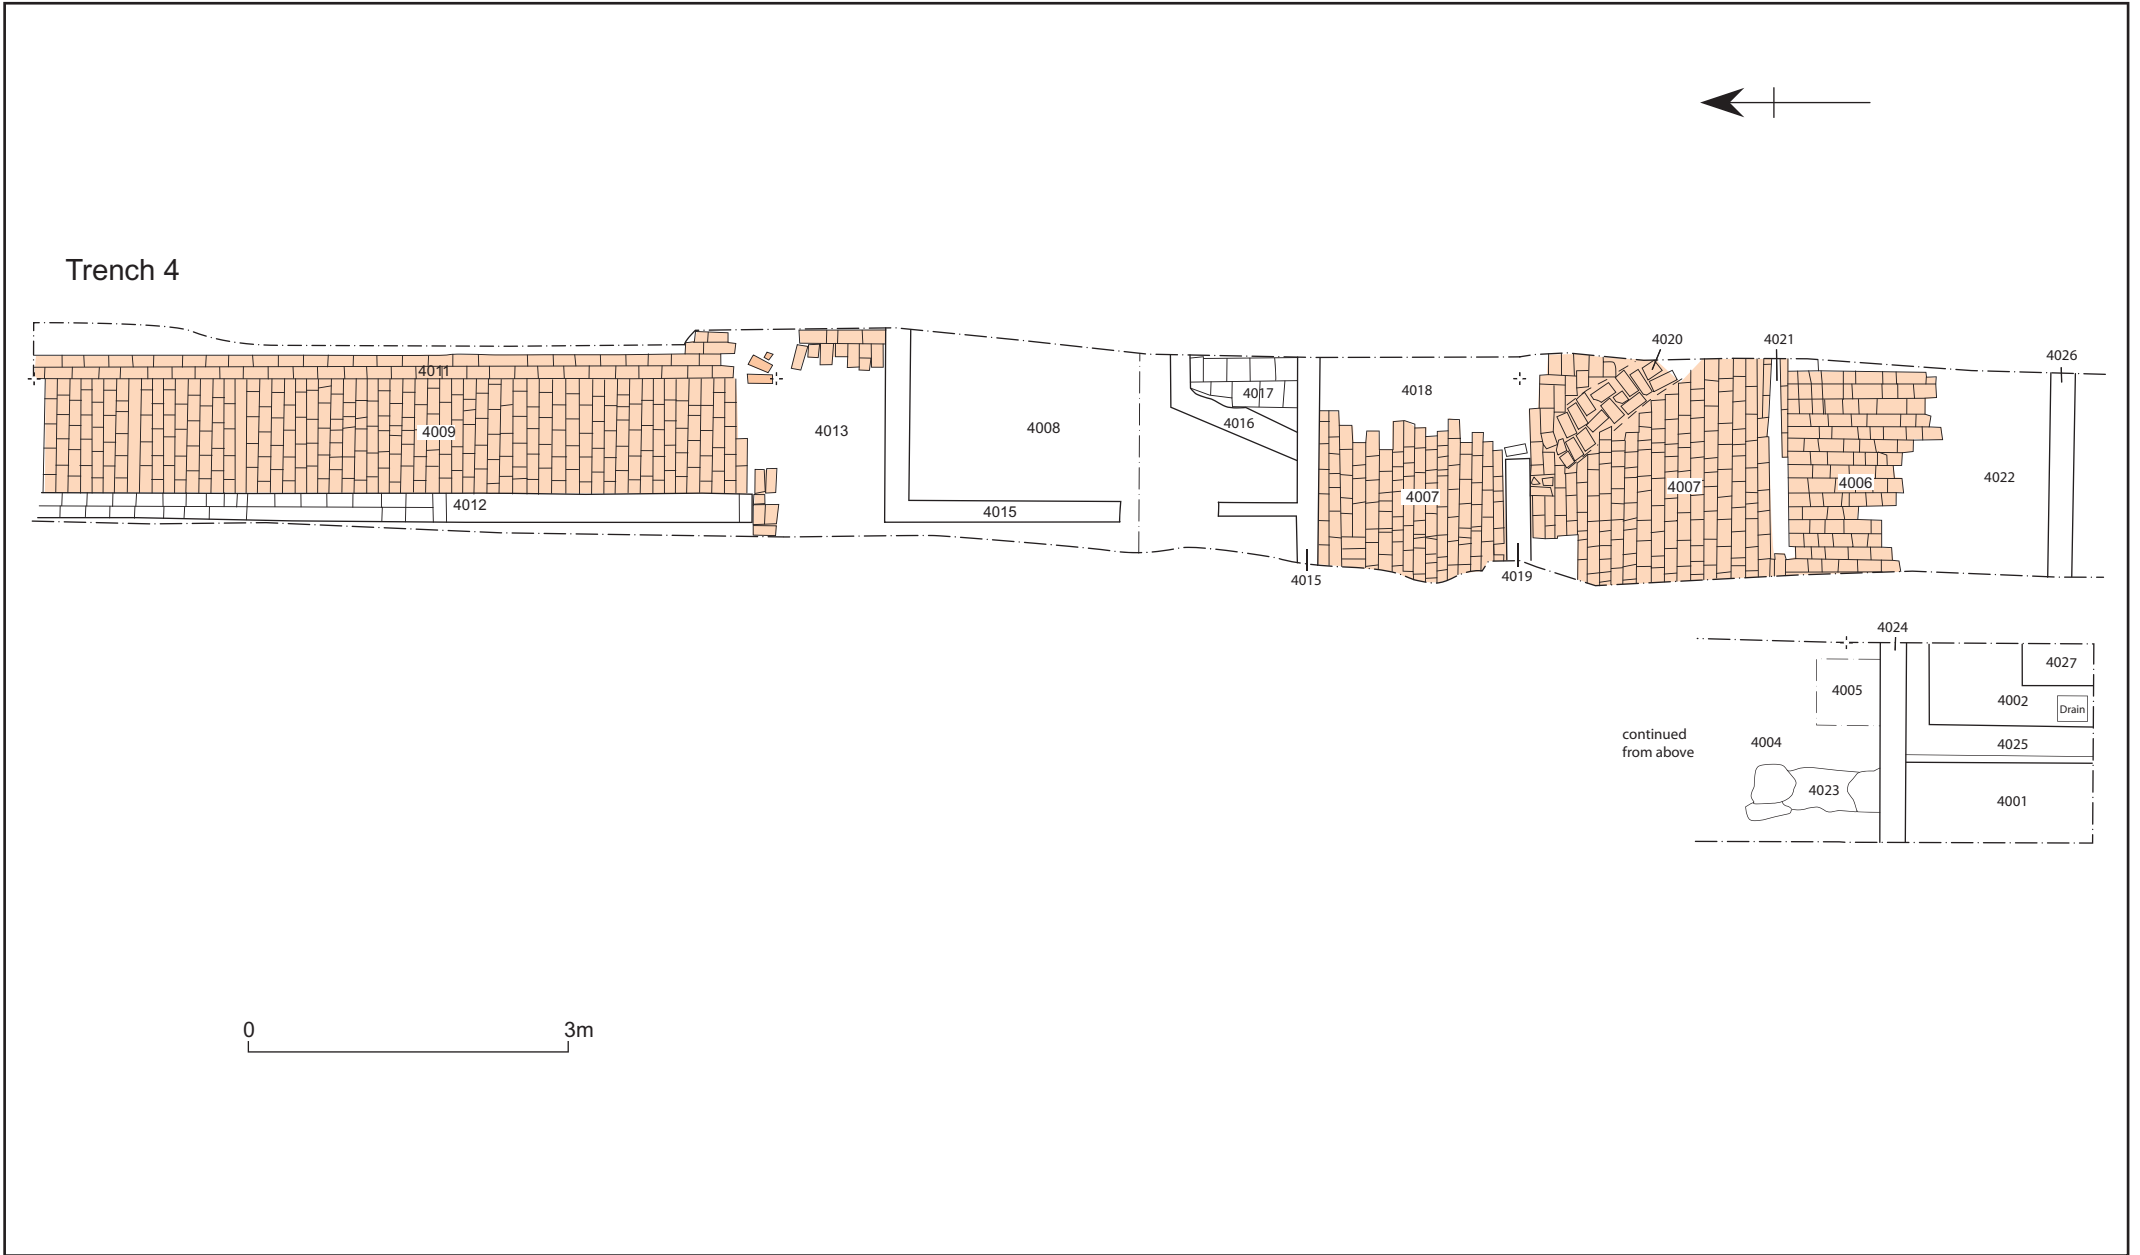
Fig.4

In the centre of the trench the natural subsoil was identified at a depth of 2m below the existing ground surface, overlain by 1.6m of clinker (4018), which was in turn sealed by a brick surface 4007 (Plate 6). Similarly a layer of clinker containing large slag inclusions (4022), located towards the south end of the trench, was overlain by a brick surface (4006).

Several brick surfaces were identified within the trench, associated with walls and drainage gullies. At the northern end of Trench 4 a brick surface (4009) was identified (Plate 7). This had a mix of red and blue engineering bricks and was laid in a random stretcher-type bond. To the east of surface 4009 was a gully (4011) made up of blue engineering brick, and was constructed flush with 4009, which sloped eastwards towards it. To the west surface 4009 was bounded by a brick wall footing (4012). The brick surface had been disturbed and truncated towards the south (4013) close to its junction with a red brick cellar (4015).

On the south side of the cellar was what appeared to be the upper section of the cellar stairway (4016), consisting of a red brick step and possible staircase support. This appears to be a quarter turn stairwell with red quarry tile floor (4017) at the summit. The cellar was filled with brick rubble (4008).

To the south of the cellar the brick floor surface (4007) was recorded. This surface was made up of red and blue engineering brick. A brick footing (4019), aligned east-west was recorded at the centre of 4007.

The brick surface 4007 appeared to have been cut by a later drain infilled with brick (4020). A brick lined gully (4021) aligned east-west divided 4007 from another brick surface (4006) made up of blue engineering brick. A brick wall footing (4026) with 2 courses surviving and aligned east-west, was recorded to the south, overlying layer 4004.

To the south a brick surface (4005; Plate 8), made up of red, blue and yellow brickwork was identified, and this was sealed by layer 4004, which consisted of black clinker with some ash inclusions. The 'L' shaped brick footing 4025 appeared to be contemporary with surface 4005 and had two courses of brickwork surviving, sealed by clinker layer 4004.

A north-south aligned arrangement of stone (4023), possibly served as a wall footing overlay layer 4004. This butted against an east-west-aligned wall 4024. A further layer of black clinker (4001) was present to the south and west of wall 4024, whilst 4002 to the east was a similar clinker layer with frequent ash inclusions. A drain overlay 4002 to the south, whilst 4027

appeared to be a brick plinth, also post-dating 4002, which extended beyond the edge of excavation.

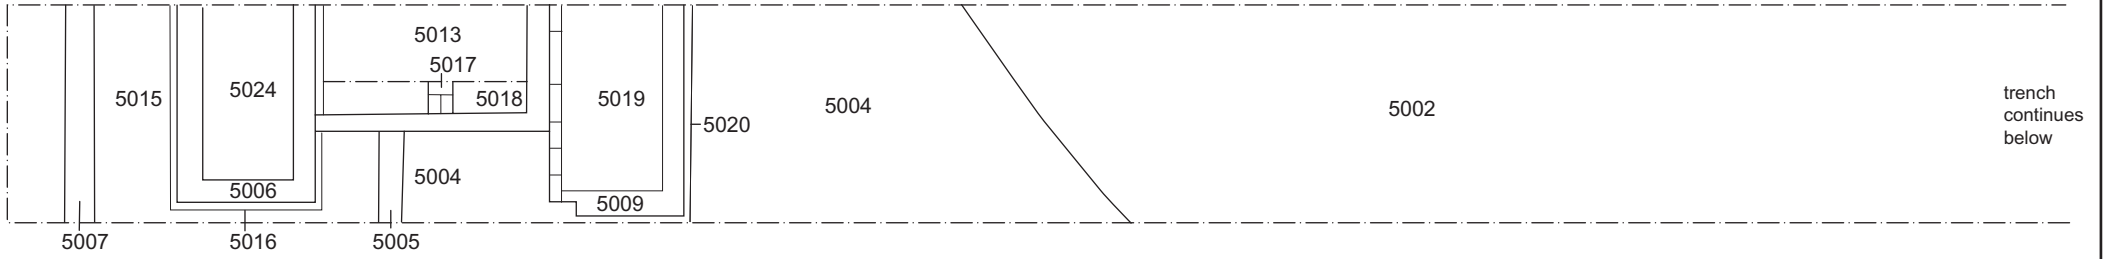
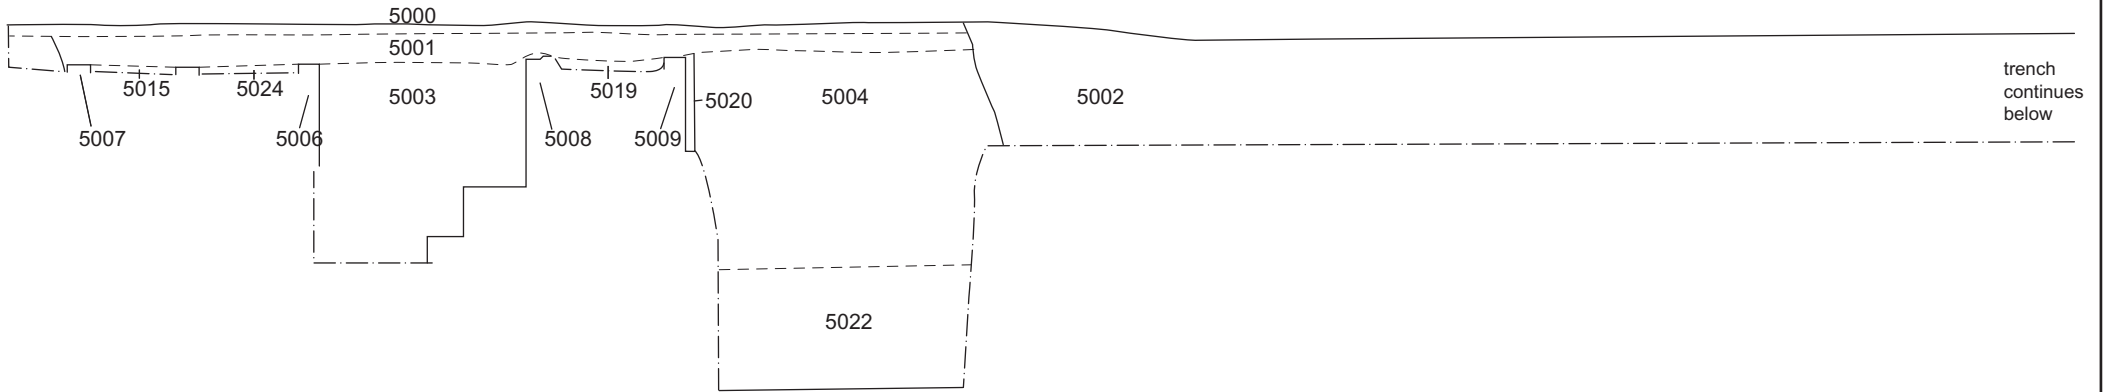
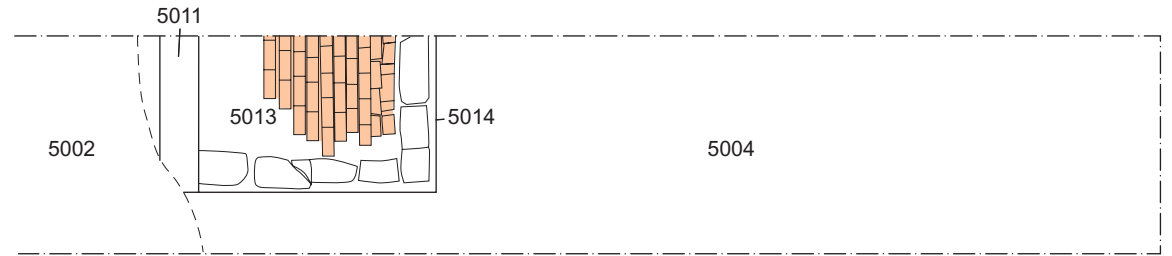
Fig.5

The natural subsoil, a sandy clay was located in the sondage dug in the middle of the trench. This was sealed by a layer of grey silty clay that contained flecks of charcoal throughout, which in turn was sealed by a layer of clinker (5004). Cut through 5004 to the south of the trench was a brick lined tank or coal bunker (5014) that measured 2.5m in width by 0.8m in depth. This consisted of an orange brick wall (5011) measuring 0.35m in width with bricks measuring 9"x4"x3" to the north of the structure, and coal built walls (5011/5012) measuring 0.3m in width and consisting of large blocks of black coal/stone to the south and west sides. Within this structure was the remains of a red brick floor surface (5013) measuring around 0.8m in width. Filling 5014 was a brown clinker/rubble fill (5010) that was around 0.8m in depth, and sealing this was a layer of mixed black/orange sandy rubble (5002) around 1.2m in thickness that was the result of the demolition works in the area.

Cut through 5004 to the north of the trench was a red brick structure (5008, Plate 9) that appeared to be the remains of the foundations of a cellar, and measured 2.15m in length by 1.15m in width. This structure contained two features in the west wall (5017/5018) that consisted of grey engineering bricks and although step-like in appearance seemed the basis of another function, possibly the formation of shelves in this part of the building. Butting 5008 to the west and running on an E-W alignment was a similar red brick wall (5005) that measured 0.30m in width, although this did not appear to form part of the same building and may have been a later phase of activity. Sealing these walls was a layer of brown/black clinker and rubble infill (5003) measuring 1.87m in thickness.

To the immediate south of 5008 was a brick lined pit (5009) that consisted of red and grey bricks measuring 9.5"x4"x3" and which was bonded by a cement mortar. 5009 measured 1.10m in width by 1.85m in length and was filled by a black rubble infill (5019) consisting of rubble and clinker.

Cutting the northern side of 5008 were the foundations for a small structure, possibly an outhouse or coal bunker (5006). These consisted of grey brick walls measuring 1.30m in length by 0.30m in width, with the bricks themselves measuring 9"x3.5"x9" in size. Filling this structure was a brown/black demolition rubble (5024). To the north of 5006 was an E-W aligned wall (5007) that measured around 0.22m in width and was seemingly unrelated to the other foundations in the trench, the bricks here measuring 8"x4.5"x1.5" in size. This was filled by a dark grey/black rubble infill (5015).

Sealing these wall foundations was a layer of cream stone hardcore (5001) 0.4m in thickness, which in turn was overlain by the surface for the car-park in this area, a black tarmac (5000) which measured 0.1m in depth.

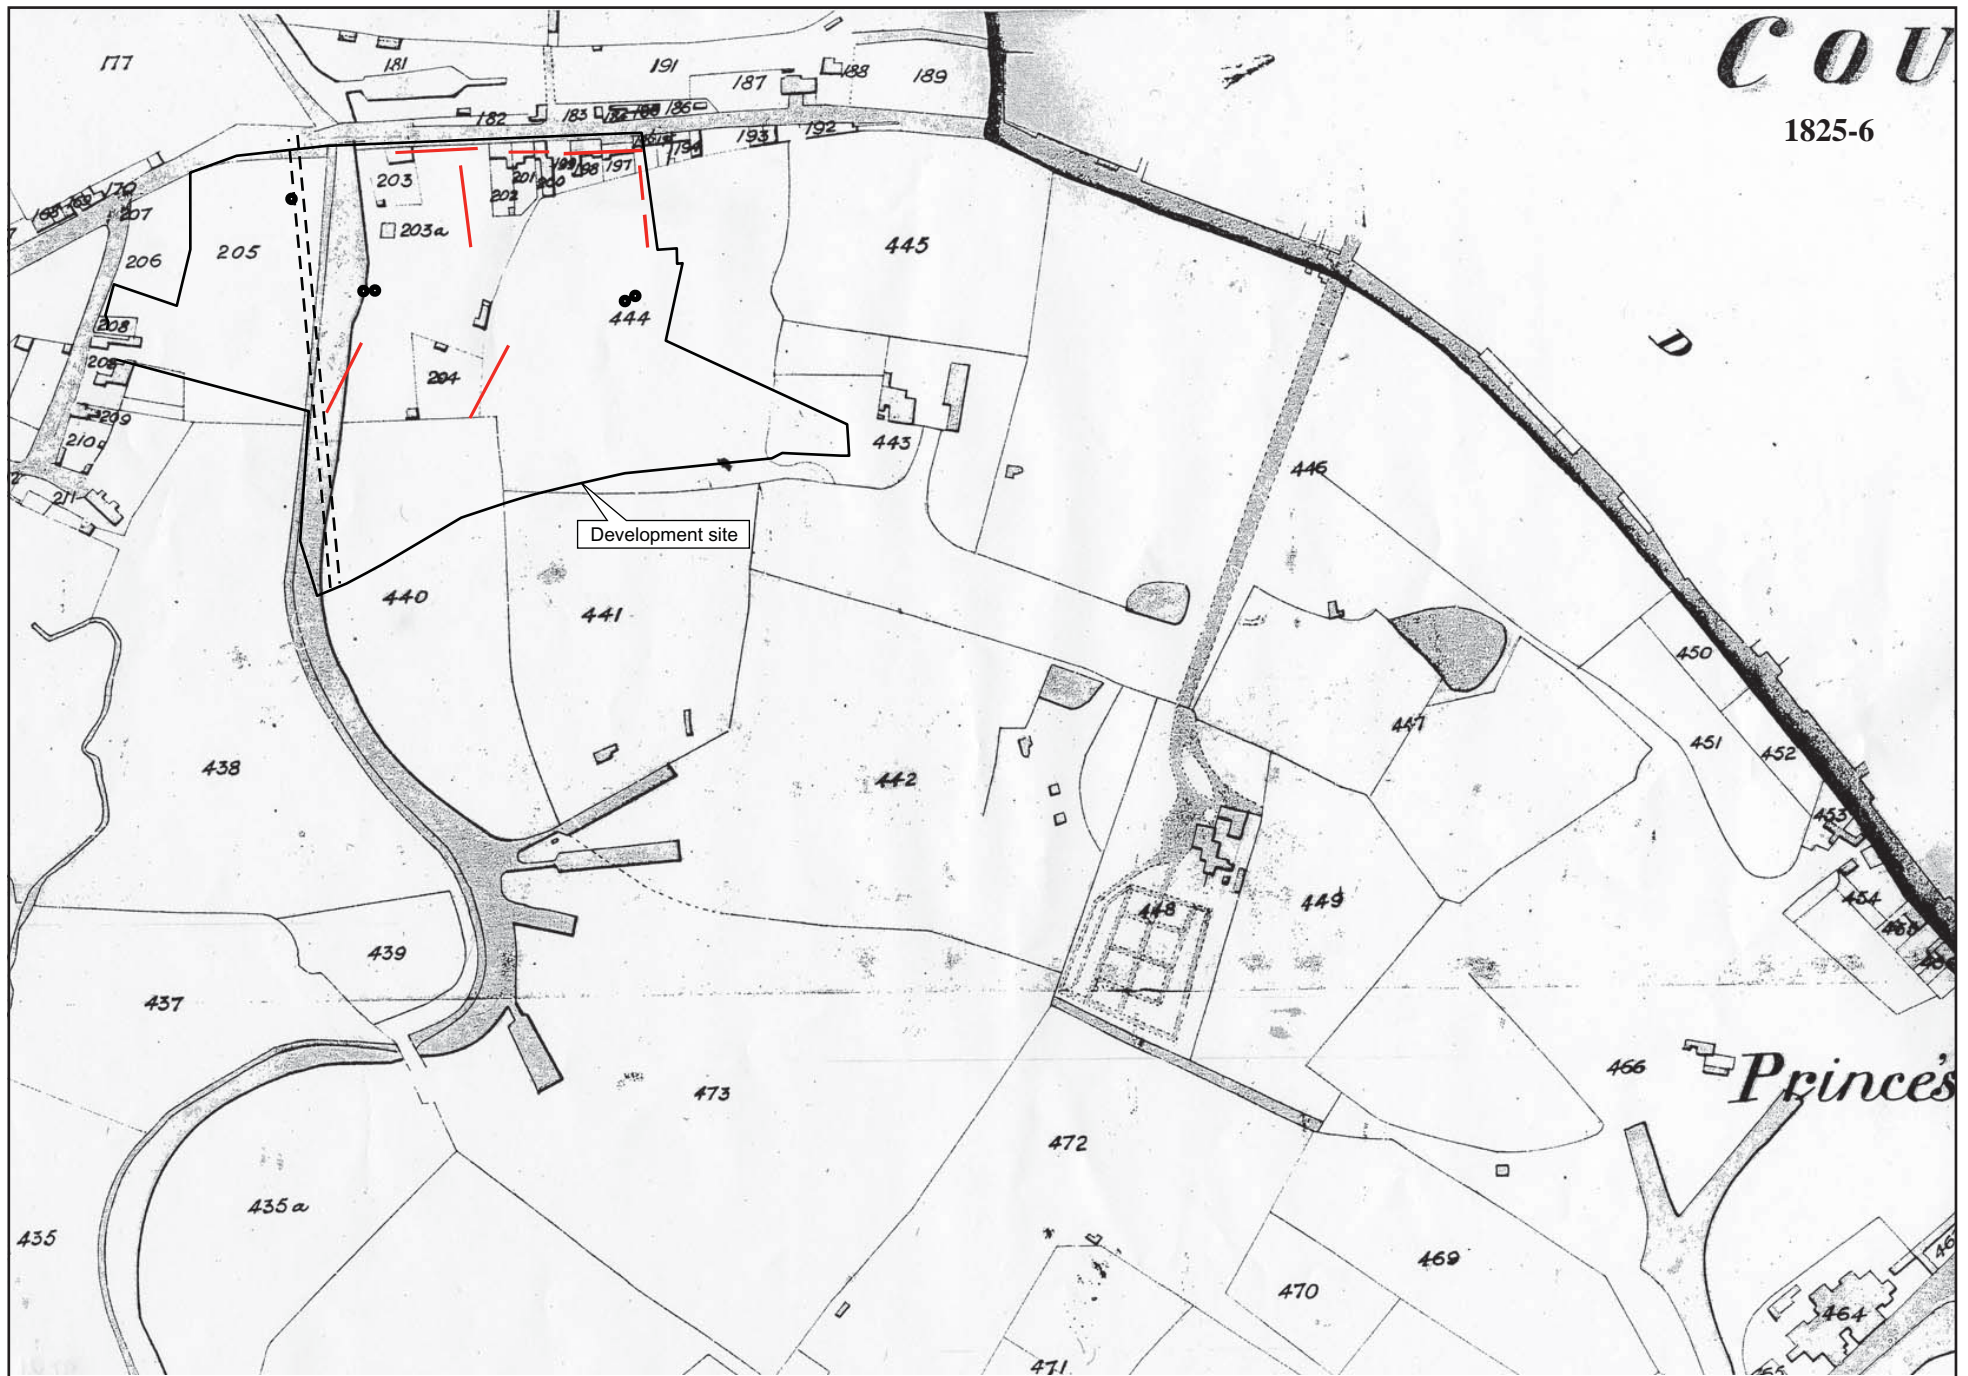
Fig.6

boundary depicted on Piggot Smith's map of the area (Fig. 6) dated 1825-6, to the rear of properties fronting onto Bloomfield Road. This field boundary appears to have influenced the siting and alignment of a later presumably industrial structure shown on the 1848 map of the area (Fig. 7), also to the rear of properties fronting onto Bloomfield Road. It is possible that the feature recorded in Trench 3 formed a boundary between the properties on Bloomfield Road, and industrial activity to the south.

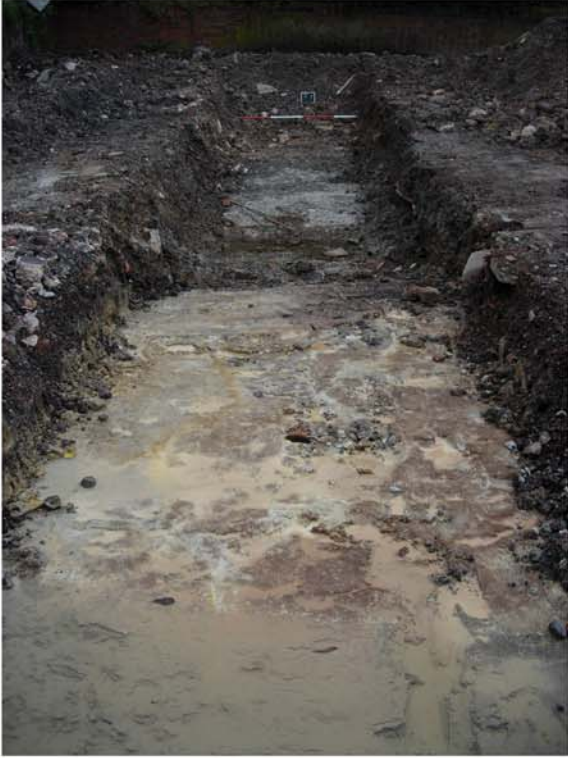
Plate 1

Trench 2a was excavated on an east-west alignment at the northwestern area of the site. The natural subsoil was encountered close to the west end c.0.4m below the present ground surface (Plate 1). Cut through this at the western end of the trench was the eastern edge of a large pond-like feature identified which also extended into Trench 3 (see below). The remainder of Trench 2 was made up of modern overburden and rubble, excavated to a depth of c.1.2m from the present ground surface. This overburden clearly truncated the natural ground surface here and relates to the former presence of an office building in this area, which had been recently demolished and removed.

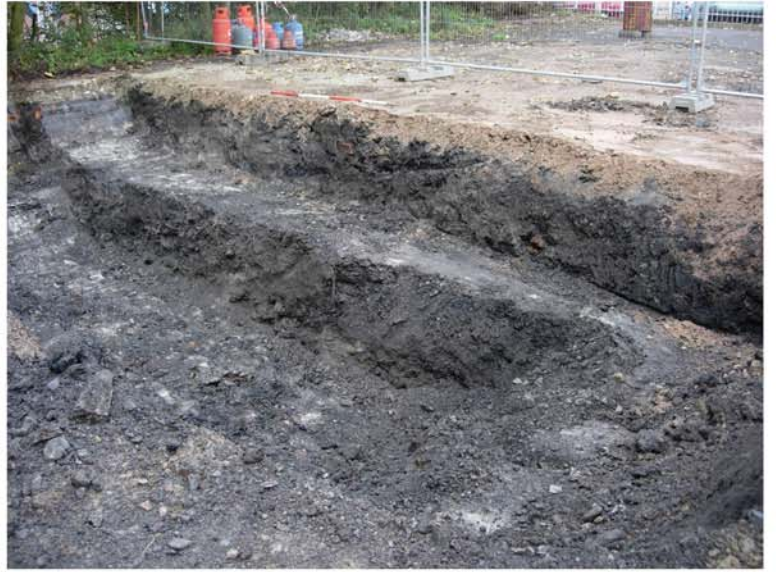
Plate 2

Trench 2b was excavated to the east of Trench 2a, over an area of raised ground (Plate 2). The trench was machine excavated to a depth of 2m through possible colliery slag and modern overburden. Some brick rubble was present in the upper horizon of overburden but this did not appear to represent in-situ brick structures. A modern hardcore layer sealed these deposits.

It is likely that the brick rubble uncovered in the upper level of Trench 2b was deposited following the demolition of houses on Brown Lion Street in the late 1950s. The bank here is likely to relate to mining spoil or waste relating to ironworking, from the vicinity. A raised area is depicted on the 1904 map (Fig. 8) to the south of structures fronting onto Brown Lion Street, and it is therefore likely that the spoil relates to late 19th or early 20th century activity here, and may, at least in part, be contemporary with the Ironworks depicted on the same map.

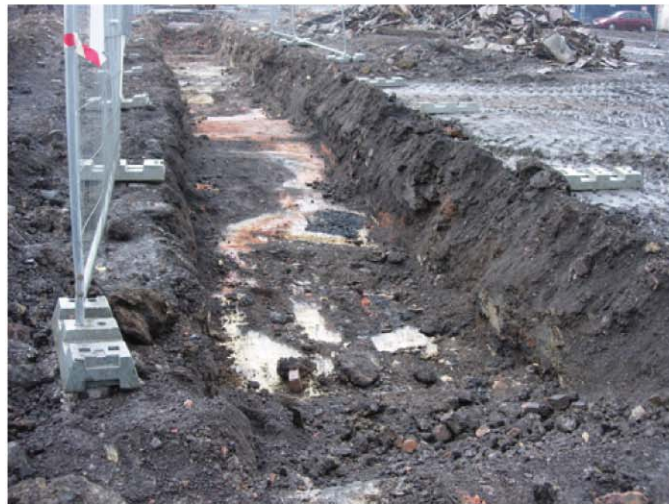
Plate 10

To the far east, the makeup of the trench changed to a series of layers and industrial deposits (Plate 10). To the east of 6010 was a band of yellow clay (6012/6014) into which an area of black silt (6013) was cut. To the east of 6013 was a crude floor surface (6015) consisting of brick rubble, although there was no clear construction pattern to the feature. Lying east of 6015 was a layer of grey-black clinker industrial material (6018) into which both a band of orange-red burnt clay (6016), and a patch of light grey clay (6017) had been cut.

Sealing these layers at this end of the trench was a layer of grey-black coal/clinker material (6011), which in turn was again overlain by the demolition material 6001 and the concrete surface 6000.

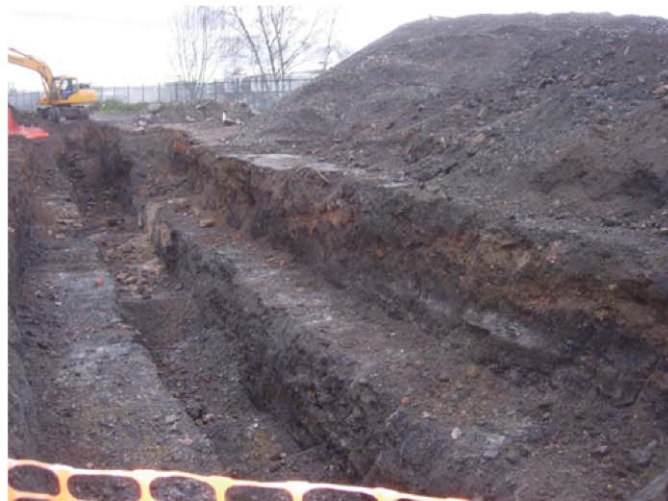
Plate 11

Trench 10 was excavated to a depth of c.3m, although the natural subsoil was still not located at this point. The eastern end of the trench was made up of predominantly colliery waste, whilst the western end was made up of a series of layers (Plate 11). The earliest of these was a black-yellow silt layer that was overlain by a thin band of grey ash, suggesting a probable industrial background. Overlying the grey ash was a black silty clay, which in turn was overlain by a red crushed brick-rubble layer, perhaps evidence of an early phase of demolition in the area. The trench was sealed by the modern demolition rubble, which was around 0.5m in depth.
