The Assembly Hall,  
Wellcroft Street,  
Wednesbury

Historic Building Recording  
and Archaeological  
Evaluation

Project No. 1580

April 2007

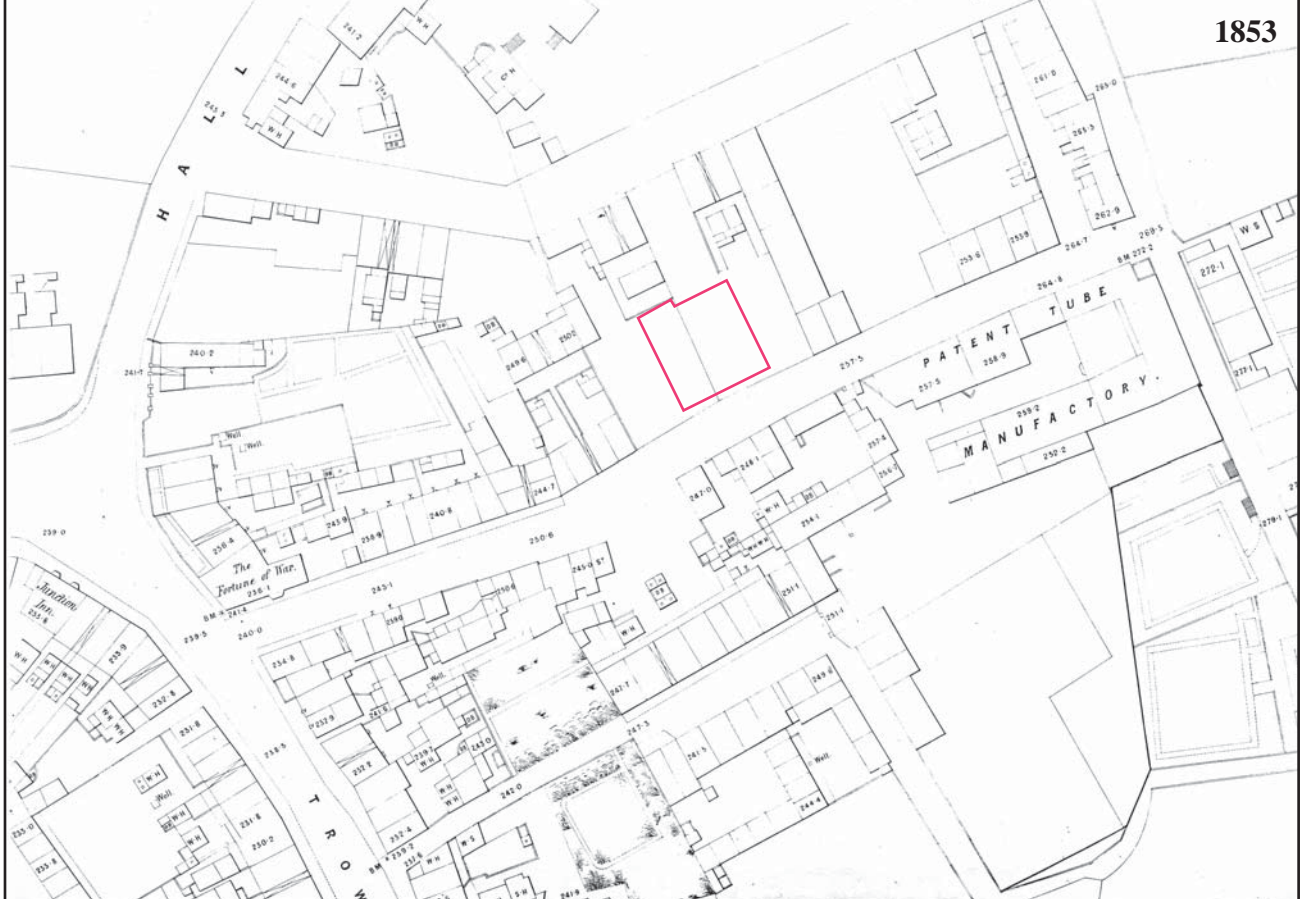
Fig.3

1846

1853

End, the land is relatively clear of development and is recorded in the Wednesbury Tithe Terrier as croft, under arable cultivation in the ownership of John Russell of the successful gas tube manufacturing family. The corner plot of Wellcroft Street and Ethelfleda Terrace was occupied at this date by John Russell's Gas Tube Manufactory (apportionment no. 439), commonly known at the time as the 'Top Works' to distinguish it from the Crown Tube Factory ('Bottom Works'). This layout is seen in more detail in the large scale (44in/ft) 'Plan of the Town of Wednesbury' prepared by William White Fereday in 1853 for the Health of Towns Act (Figure 3b).

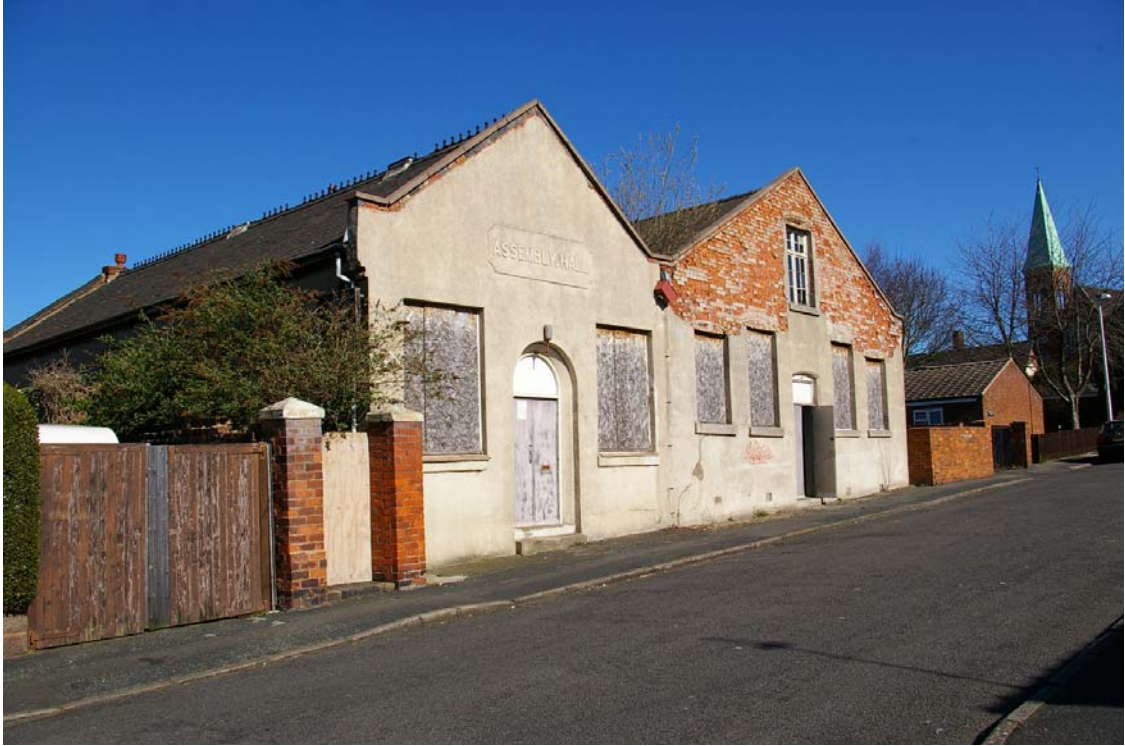
**Plate 1:** General exterior view from the south-west.

The south elevation (Plate 1) faces onto Wellcroft Street, and has twin gables reflecting the two range plan. Each gable end is accessed via a central doorway, that to the west being round headed and that to the east, segmental headed, both in brick with chamfered jambs and head. To each side of the western door are simple rectangular window openings, with a moulded sign reading 'Assembly Hall' over. To the east, the doorway is flanked by paired windows with segmental heads to each side, those immediately adjacent to the door being slightly taller. A fifth window is set high in the gable, immediately above the door. The elevation is rendered, though some render has fallen away from the apex of the eastern gable, revealing the underlying brickwork. To the western eaves, an original moulded detail can be seen (Plate 2), which would have originally been repeated on the south-eastern corner of the primary structure.

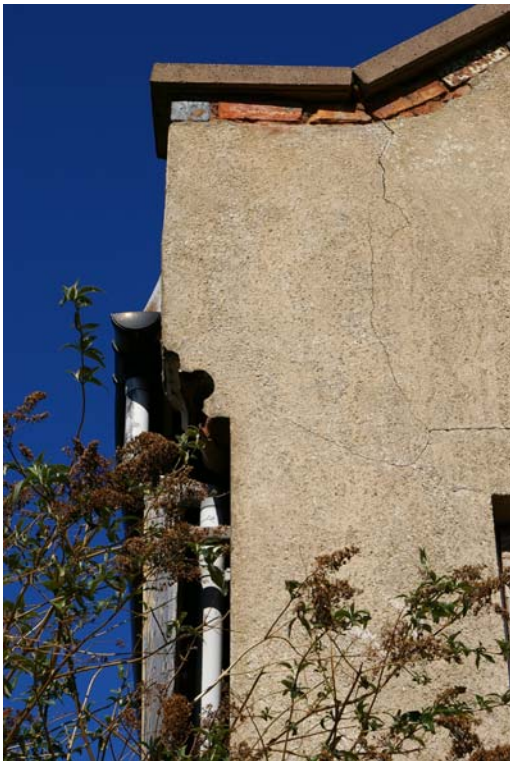
**Plate 2:** Detail of moulded brick eaves.

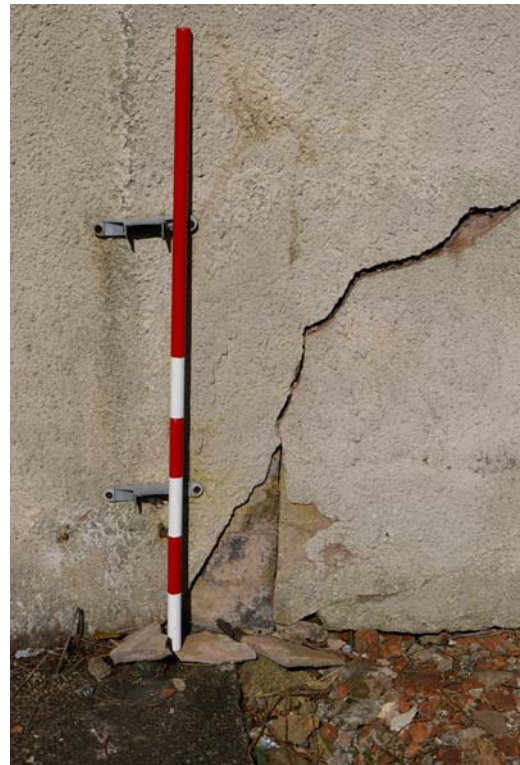
**Plate 3:** South elevation, straight joint.

A clear straight joint is visible at low level where the cement render has come loose (Plate 3).

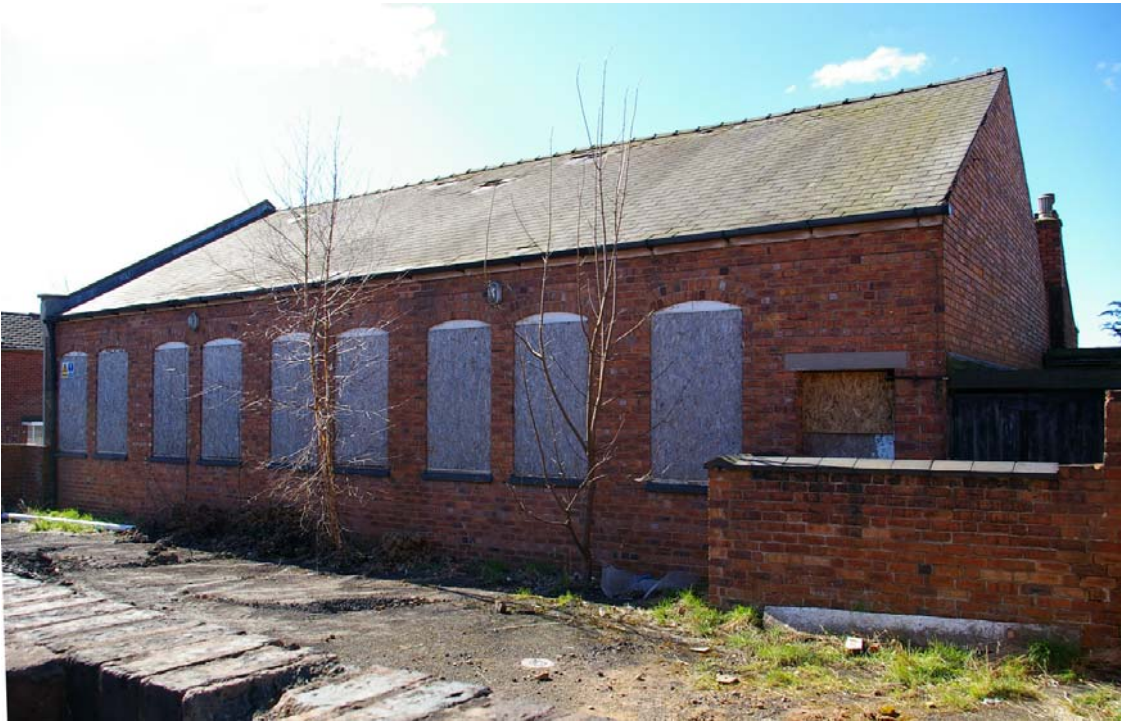
**Plate 4:** East Range, east elevation from the north-east.

The eastern elevation (Plate 4) is of exposed brickwork, laid in English garden wall bond with three courses of stretchers between header courses. The elevation displays regular fenestration of five paired window openings, save for the northernmost example, where the northern opening is a door. Windows are rectangular with segmental heads, the arches comprising two courses of headers. Cills are sloping and in grey engineering brick. The roof of the east range is slated with a plain ridge and has renewed, plastic guttering.

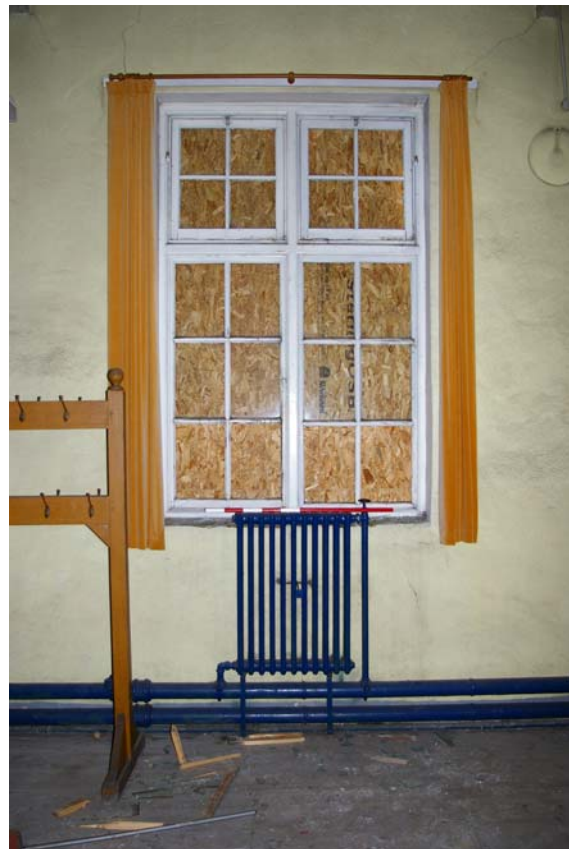
**Plate 10:** West Range; fenestration detail.

The range is lit by two large, rectangular window openings in the south front and four similar openings in the west elevation (Plate 10). Within the 'back room', the western wall contains a single doorway with semi-circular head and glazed fan-light, while within the north wall are two multi-pane iron-framed windows with four pane opening light, set to either side of a central fireplace which currently houses a 1960s gas fire. The eastern of the north wall windows has been extended to form a doorway serving the rear extensions, the original jamb of the window being clearly visible to the eastern side of the door.

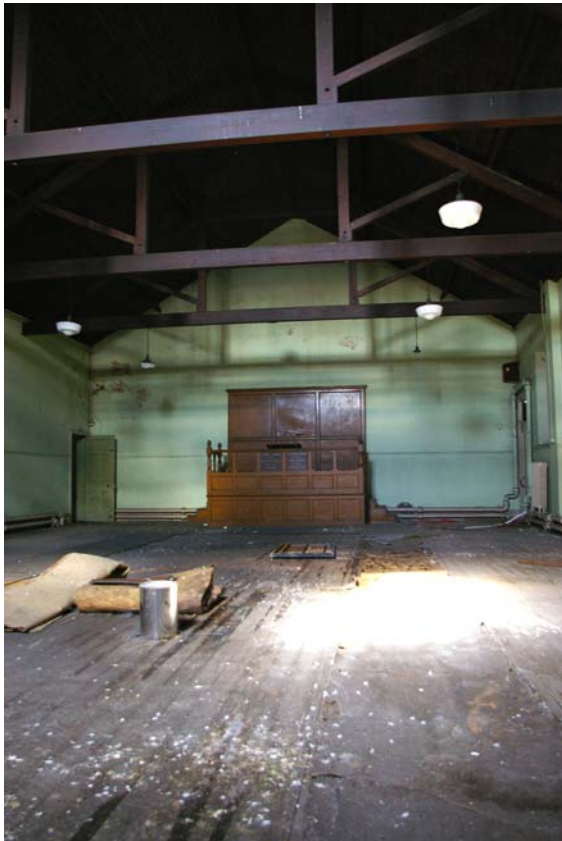
**Plate 11:** East Range, looking north.

The eastern range of the Assembly Hall was added at some point between the Ordnance Survey map of 1919 (Figure 4c) and the photograph showing the twin gabled structure in 1936 (Plate 16). It comprises a single, open range, measuring 16.1m long (N/S) x 9.9m wide (E/W), and stands 7.1 m tall to the apex of its ridged roof (Plate 11).

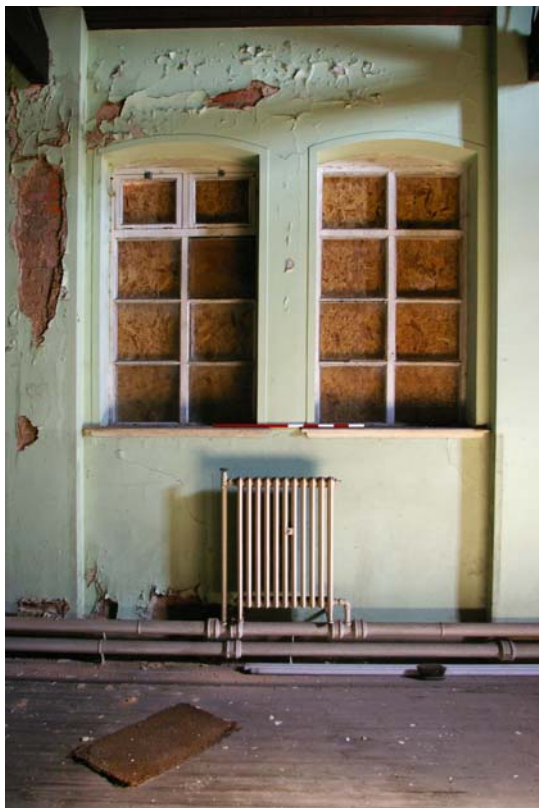
**Plate 13:** West Range; detail of fenestration.

The range is lit by five windows in the south gable, two to either side of the door with a further window high in the gable above the door, which is shielded from the body of the hall by a timber screen with lateral doors (Plate 12). The east wall displays regular fenestration, two windows to each bay, save for the northernmost bay, where a window is paired with a door opening to the exterior. All window openings have segmental heads with wooden framed casements with upper, bottom-hinged opening lights in the northern example of each pair (Plate 13).

Paired heating pipes run the full length of the range at low level, rising above the door at the north-east corner, and across the northern end wall. Iron three-column radiators are located centrally beneath each pair of windows in the east wall (Plate 13), and below the eastern windows of the south elevation.

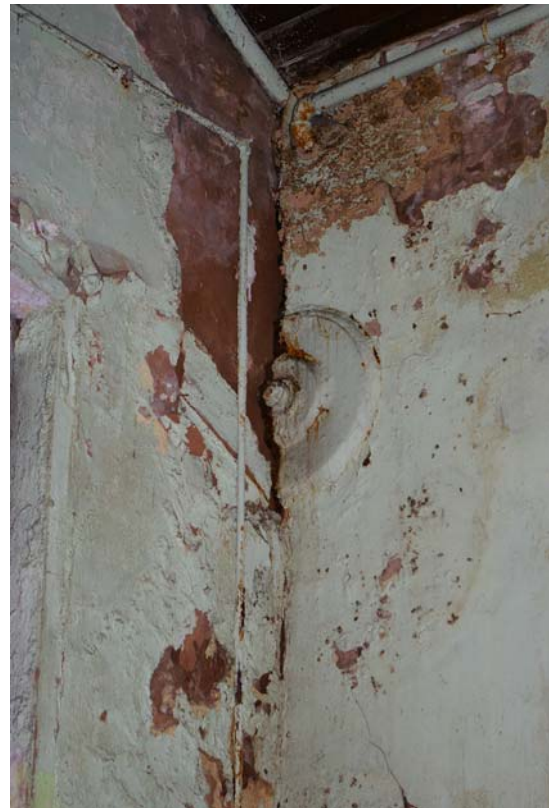
**Plate 14:** West Range brickwork butting against endplate of tie of earlier east range.

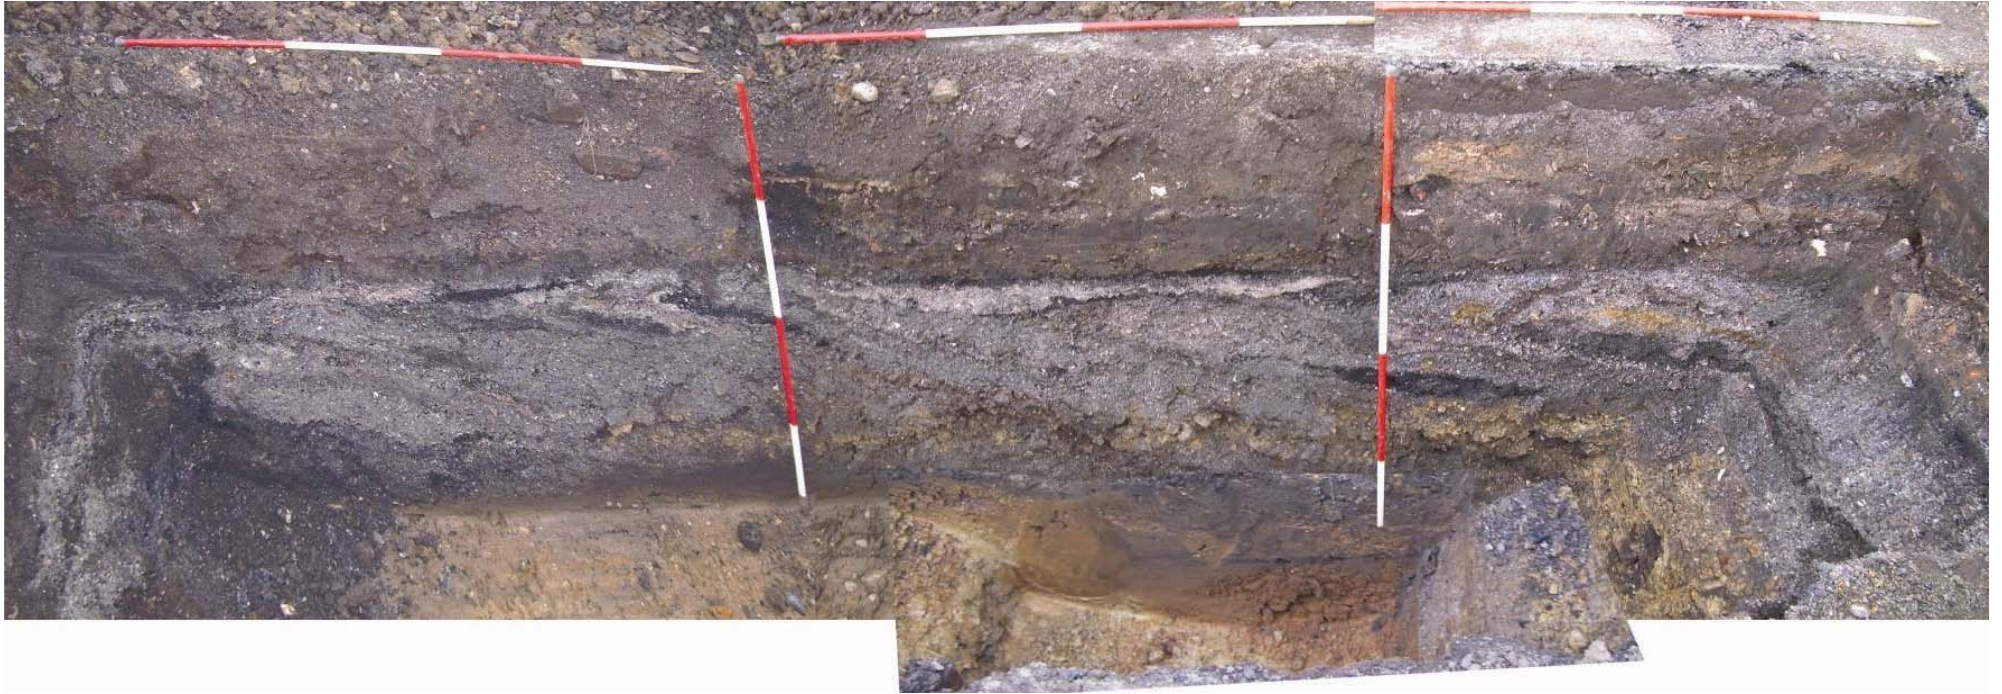
**Plate 17:** Composite photograph of east facing section of Trench 1

Trench 1 was oriented approximately north-north-west to south-south-east, and measured 6.00m x 1.70m (see Figure 5 for location, Figure 8 for plan and section, Plates 17-19). It varied from 2.00m to 3.00m in depth.

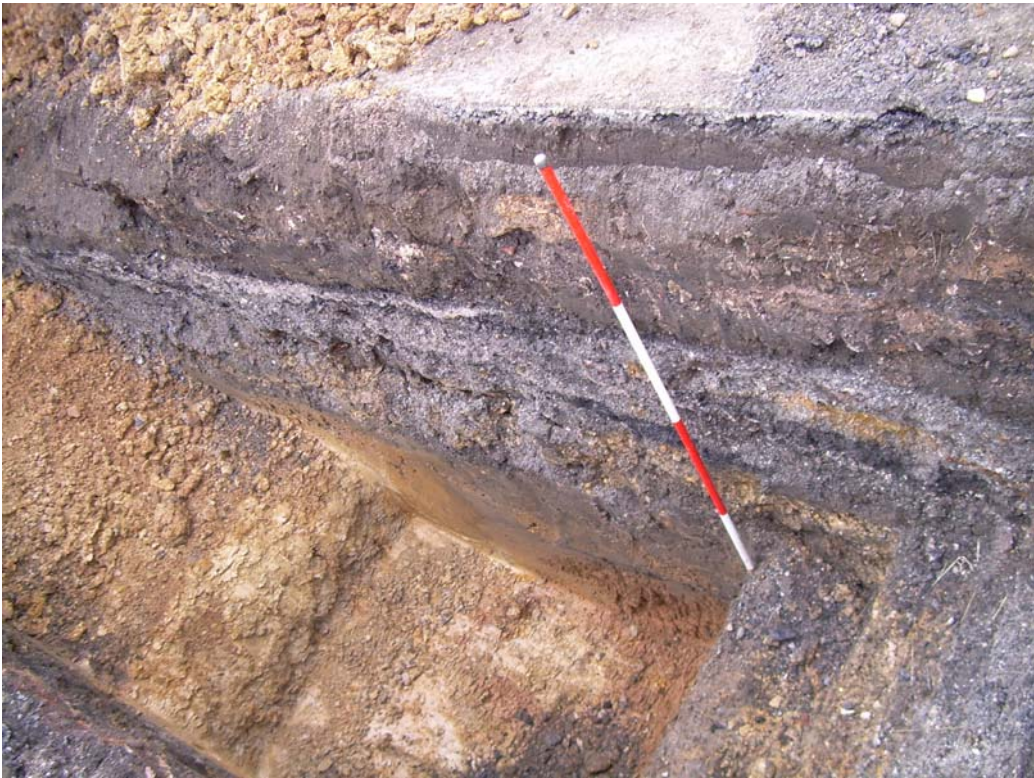
**Plate 18:** View of Trench 1 from the north-east

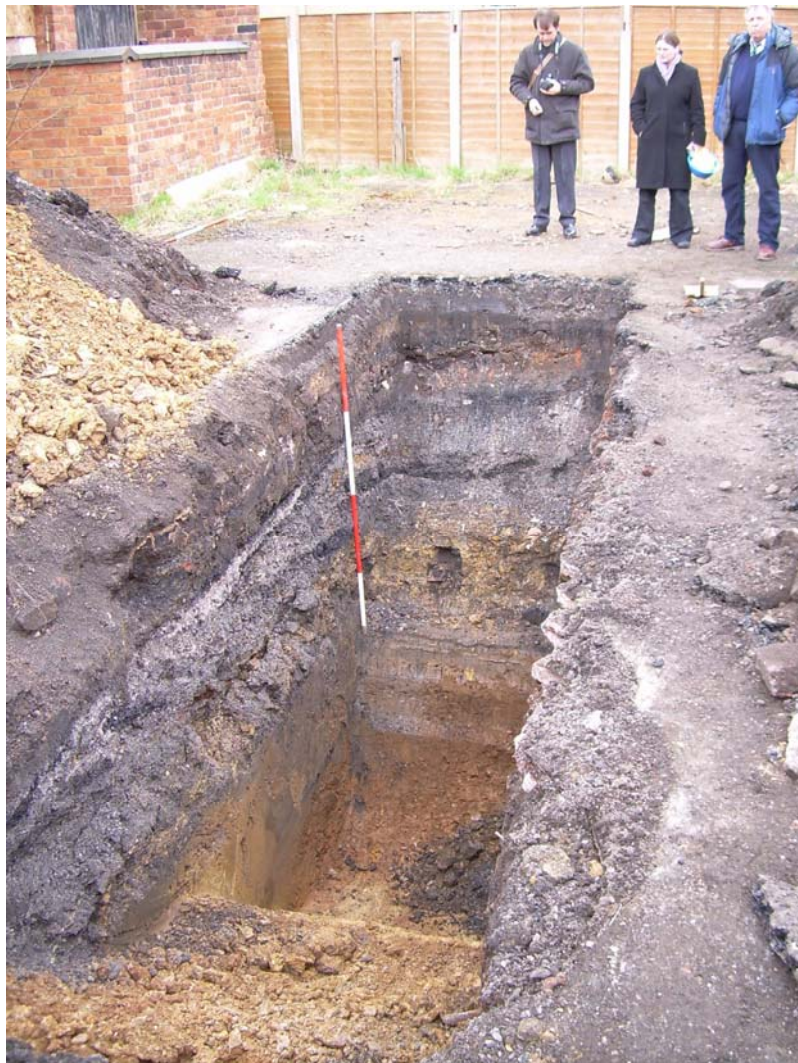
**Plate 19:** View of Trench 1 from the south.
