The Old School House,  
Seaton, Rutland, Leicestershire.

An Historic Building  
Photographic Survey  
2006

**The Old School House, Seaton, Rutland.**

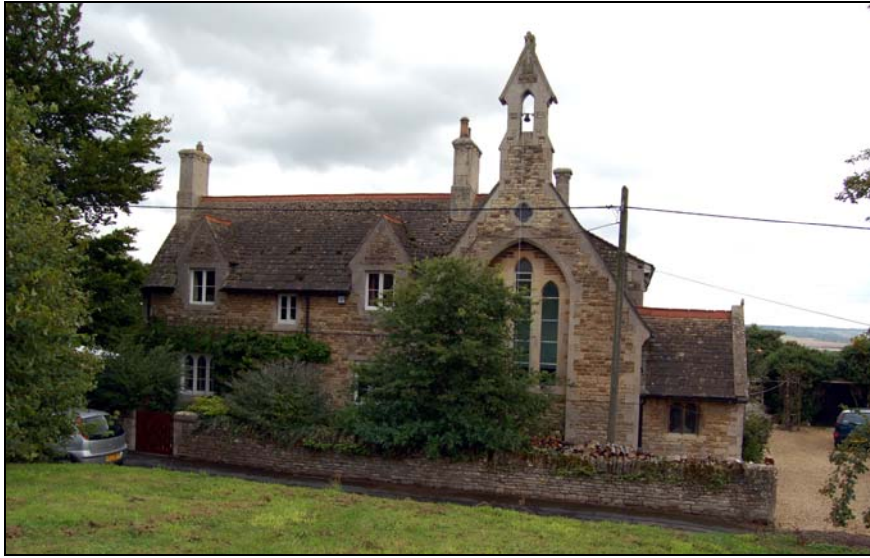
Plate 1

1. The Old School House from north.
2. The Old School House from north and west.
3. West façade lower.
4. West façade upper.
5. Porch west façade.
6. 19<sup>th</sup>-century extension from west.
7. Timber framing west façade.
8. West porch south return.
9. North Façade of schoolroom.
10. North façade of schoolmaster's house.
11. North doorway.
12. East façade.
13. Old School House from south.
14. South façade (east).
15. South façade (west).
16. 20<sup>th</sup>-century extension from east.
17. 19<sup>th</sup>-century extension from south.
18. Window 19<sup>th</sup>-century extension.
19. Blocked doorway 19<sup>th</sup>-century extension.
20. Hallway from south.

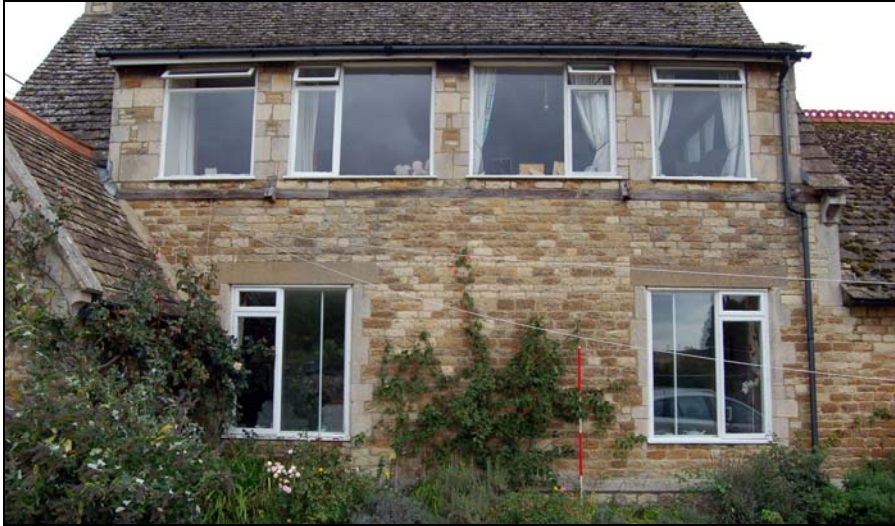
Plate 3

The west side of the schoolroom has a gabled porch with a board door in a chamfered stone arch, and a two light side window with shaped arches. The remainder of this west side was altered in the mid 20<sup>th</sup>-century to incorporate fenestration and an inserted attic storey. There is evidence here of timber framing.

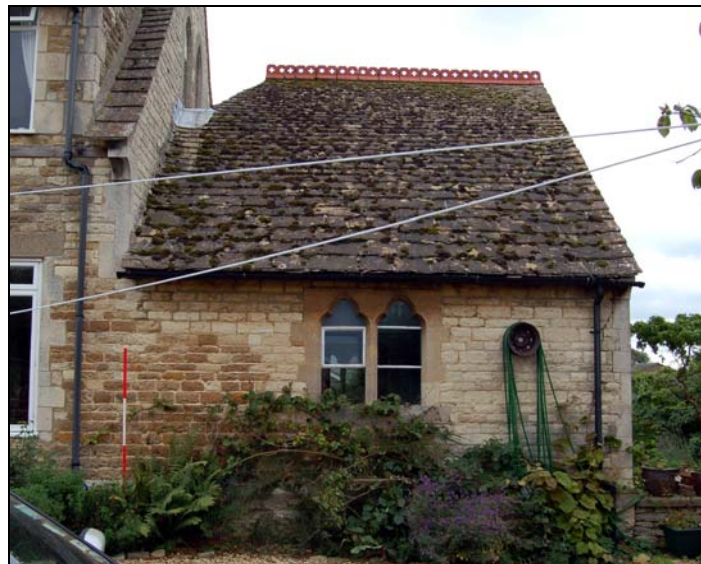
Plate 6

The fenestration scheme of the south façade of the schoolmaster's house is similar to that of the north apart from the flat-headed central doorway and a patio door to the east. To the rear of the schoolroom is a mid/late 19<sup>th</sup>-century addition, which has a mid 20<sup>th</sup>-century flat roof structure to the east.

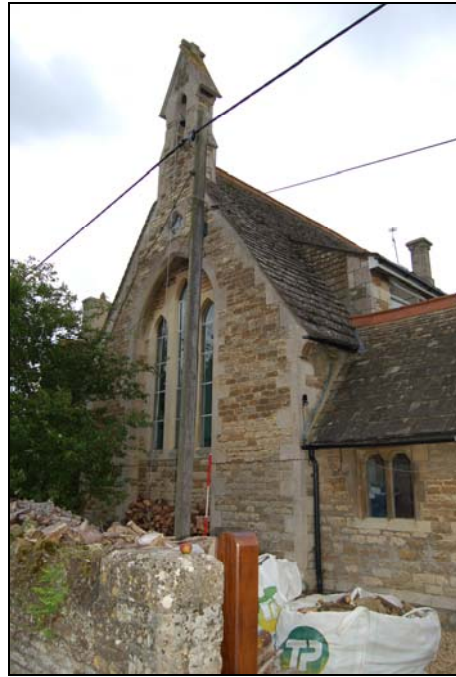
Plate 9

The gable end of the schoolroom has a triple lancet stone window with a taller central light and arched surround. Above this are a small quatrefoil window and a tall gabled bellcote. Each of the gables has shaped kneelers.

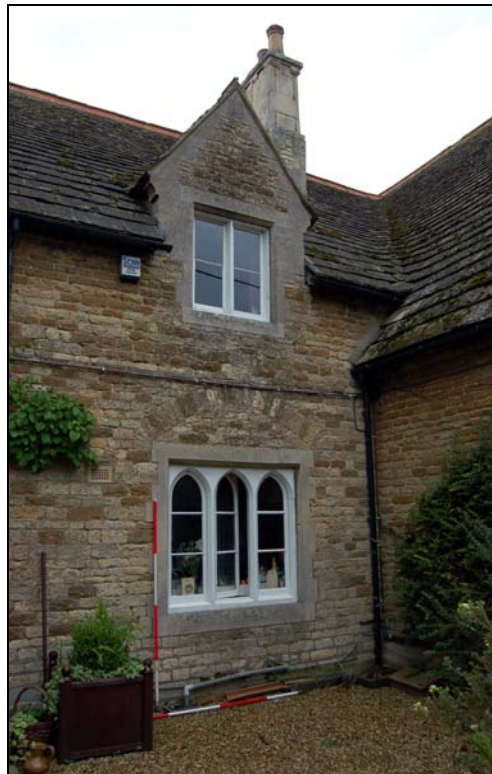
Plate 10

The schoolmasters house is of one and a half storeys and has two bays. Each bay has a wooden ground floor window of three arched lights with a relieving arch above, and a two-light wooden casement in a gabled semi-dormer. To the centre are an arched four-panelled door and a smaller two light casement below the eaves.

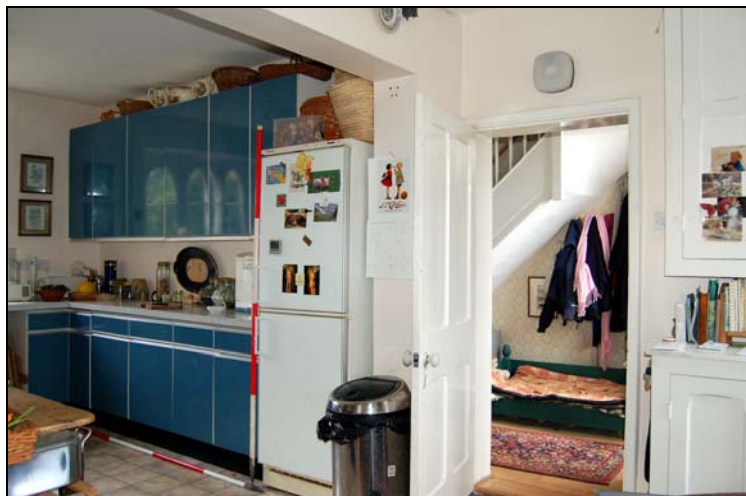
Plate 22

21. Hallway from north.
22. Kitchen east wall.
23. Kitchen north wall.
24. Kitchen west wall.
25. Living room from south.
26. Living room from north.
27. Living room ceiling.
28. North window from living room.
29. Living room first floor.
30. Dining room east wall.
31. Dining room north wall.
32. Dining room west wall.
33. Landing from north.
34. Landing from south.
35. First floor corridor (1) from east.
36. First floor corridor (1) from west.
37. First floor corridor (2) from south.
38. Bedroom 1 from south.
39. Bedroom 1 from east.
40. Master bedroom from south.
41. Master bedroom from north.
42. Master bedroom from east.
43. *En suite* from south.
44. *En suite* from north.
45. Ashlar chimney.
46. View to south.
47. All Hallows Church from south.

It is proposed that a new two-storey extension will be built to the west of the current dining room. The current kitchen will be converted for use as a dining room with the doorway in the east wall widened to accommodate double doors. The existing dining room will be converted for use as a kitchen with the new two-storey extension extending off this to the west with a new opening in the existing wall. The two-light ogee type window to the west is to be removed and reused elsewhere in the building. The mid 20<sup>th</sup>-century one-storey flat roof extension to the south is to be demolished and removed. The mid 20<sup>th</sup>-century windows in the existing sitting room are to be replaced with ones more sympathetic to the structure. The ceiling added above the sitting room in the mid-20<sup>th</sup> century, which converted the schoolroom for domestic purposes, is to be partially removed. The south portion of this is to be retained to form a gallery overlooking the sitting room. To the south of this, at first-floor level, is to be remodelled to include a new bathroom. The mid 20<sup>th</sup> –century window on the west wall, which will not be blocked by the new extension, is to be replaced with a window more sympathetic to the building.

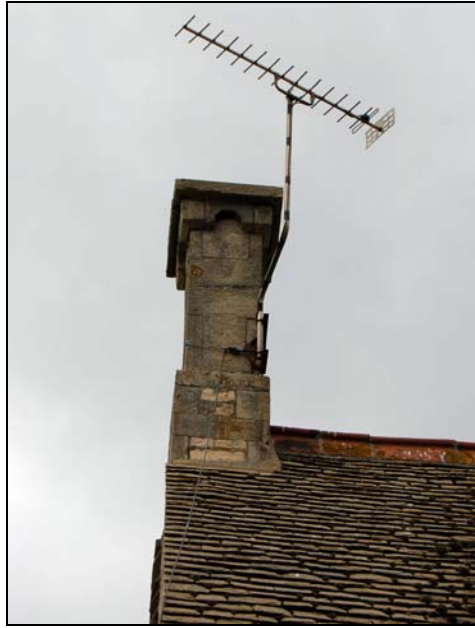
Plate 45

This former school and schoolmaster's house was constructed in 1858 with minor alterations carried out in 1872. It is a grade II listed building and is 'T'-shaped in plan with the schoolmaster's house to the west, and the gabled schoolroom projecting to the east. It is constructed of coursed limestone rubble with limestone dressings. It has a Collyweston slate roof and ashlar chimneys.
