**JAMES GROVE & SONS
BLOOMFIELD WORKS
STOURBRIDGE ROAD
HALESOWEN
WEST MIDLANDS**

**Historic Building Record
And Ornamental Audit
2007**

**James Grove and Sons Ltd, Bloomfield Works,
Stourbridge Road, Halesowen, West Midlands**

**Historic Building Recording
and Ornamental Audit**

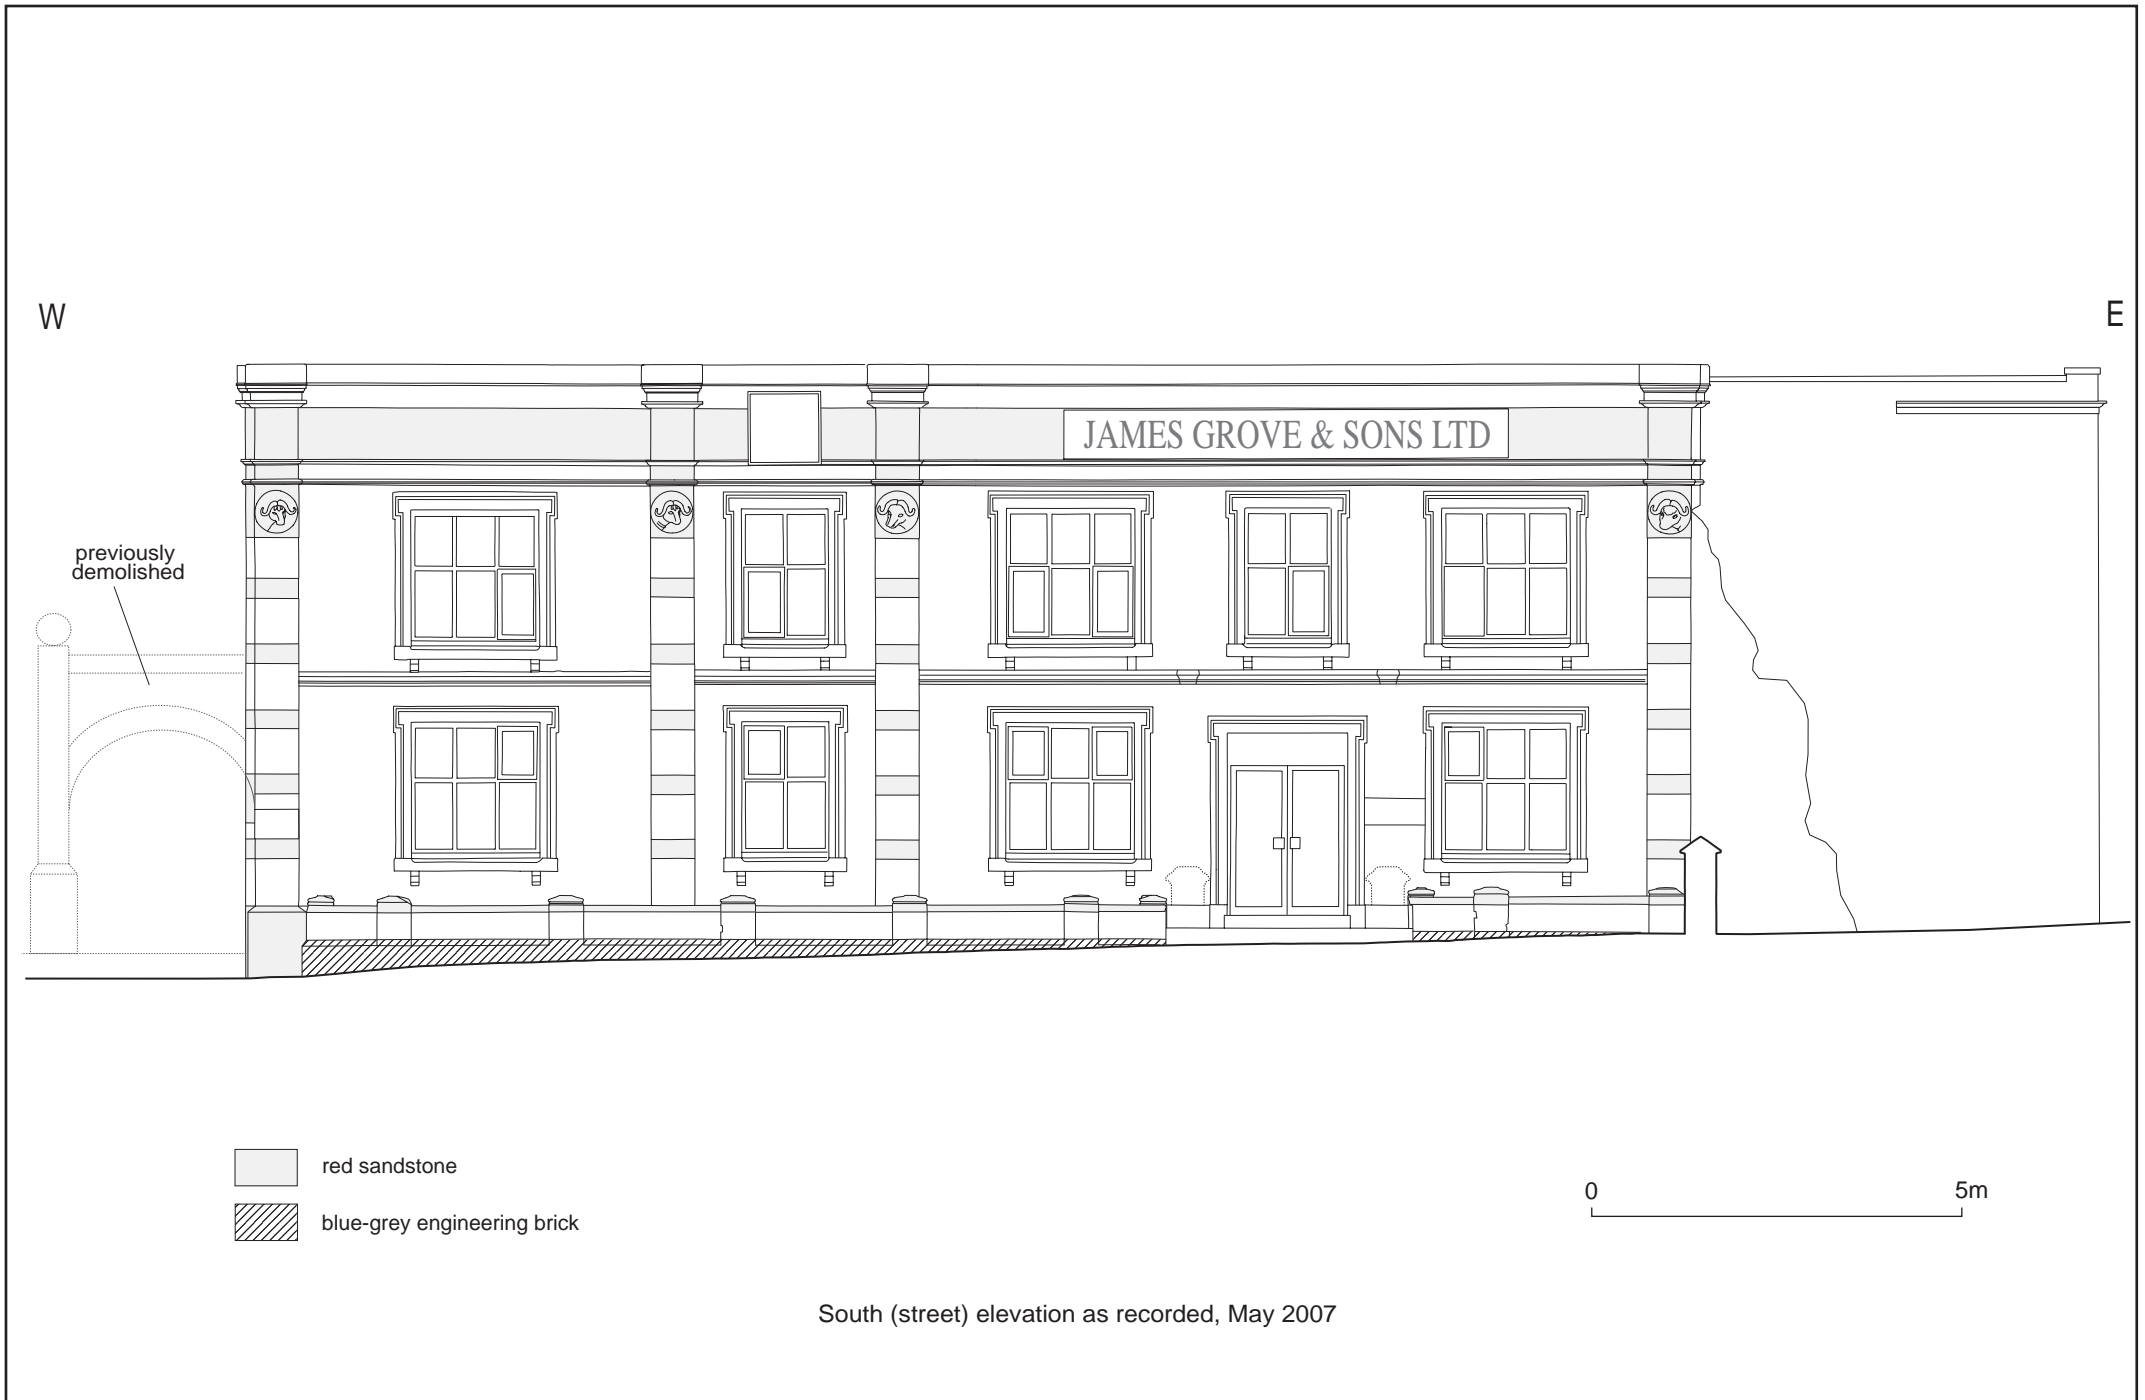
Fig.12

Figure 12: South (street) elevation as recorded.

7.2.1 The South (Street) Elevation (Figure 12, Plate 2)

The main southern (street) elevation of the building is of two storeys and is of red brick construction, laid to English bond, over a low blue-grey brick plinth. The elevation measures c.19m long and stands c.8m tall to the head of its parapet; it is of five bays, alternately wide and narrow, articulated by a series of applied pilasters of brick and red sandstone construction. The pilasters are embellished below the level of the capital by round plaques with animal head motifs in relief (Plate 6), and support an entablature comprising plain fascia and frieze of red sandstone, set between projecting decorative brick strings and cornice. The first floor level is articulated by a moulded stone string course extending between adjacent pilasters. Fenestration is of alternating three and two light windows at ground and first floor level, set within moulded and eared cases with moulded cills, which display small, paired stone brackets beneath each opening. The windows themselves have been replaced with modern UPVC double-glazed units throughout, though reference to the architect's elevation (Figure 7) confirms that the present pattern reflects the original scheme. The original windows included 9-pane upper lights, corresponding with original detailing recorded throughout the interior of the building (see §. 7.3 below). The principal entrance to the building is located in the fourth bay from the west; this bay lacks the flanking pilasters of the rest of the elevation, having originally been furnished with an elaborate porch of flanking Tuscan columns with ball finials (Figure 7). This feature has been previously removed, though the 'ghost' of the pedestals and capitals remain visible within the brickwork to either side of the doorcase (Plates 3 and 4). The architect's elevation indicates that the original doorway was considerably more ornate than its modern, utilitarian replacement, with flanking pilasters and semi-circular fanlight. At the far western end of the elevation, the springing of a former flanking, arched entranceway (Figure 7) survives within the corner pilaster (Plate 5).

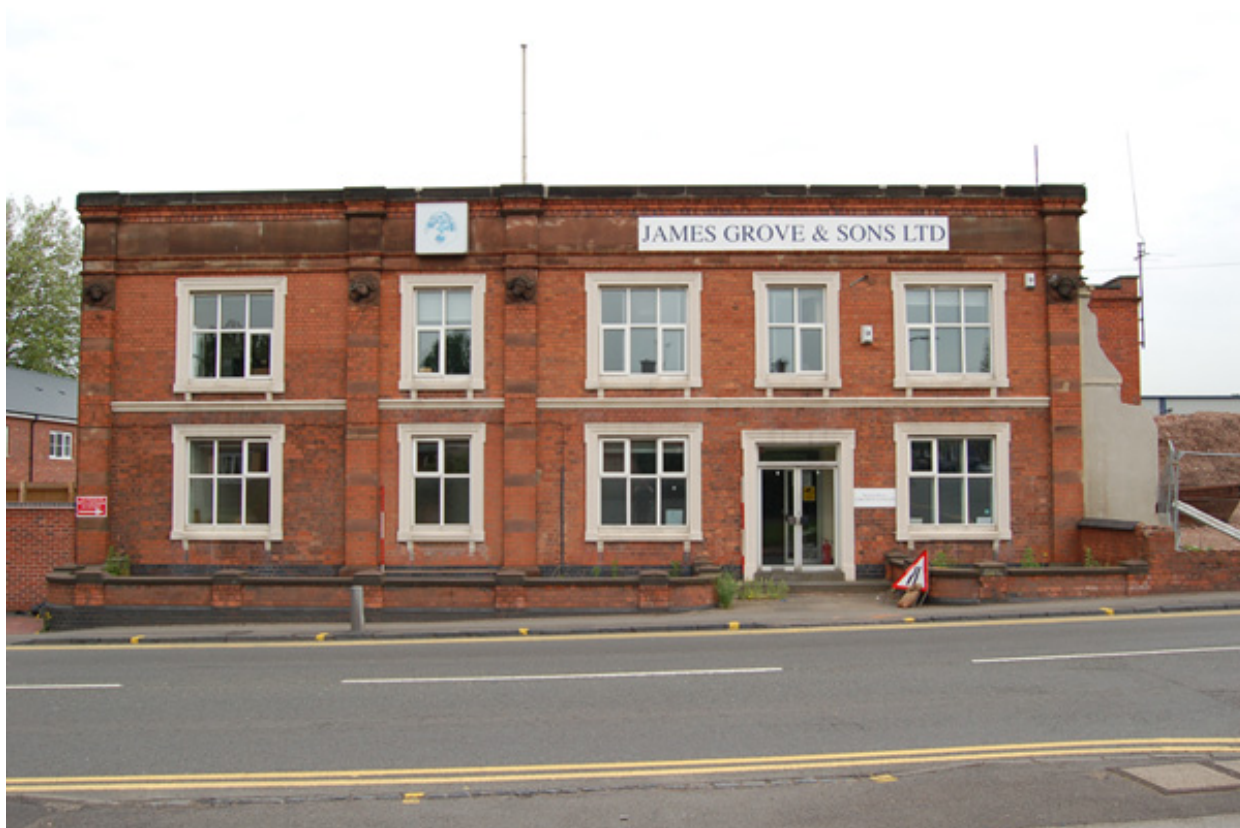
Plate 2: South (street) elevation.

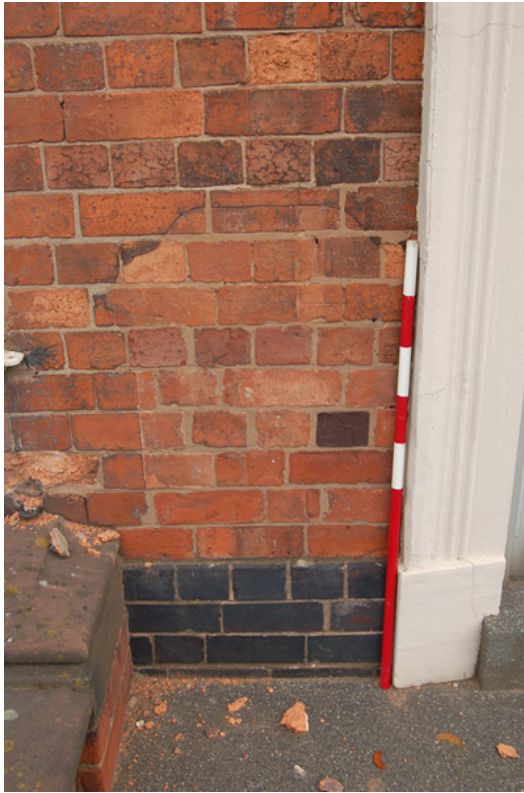
Plate 3: 'Ghost' of former porch pedestal.

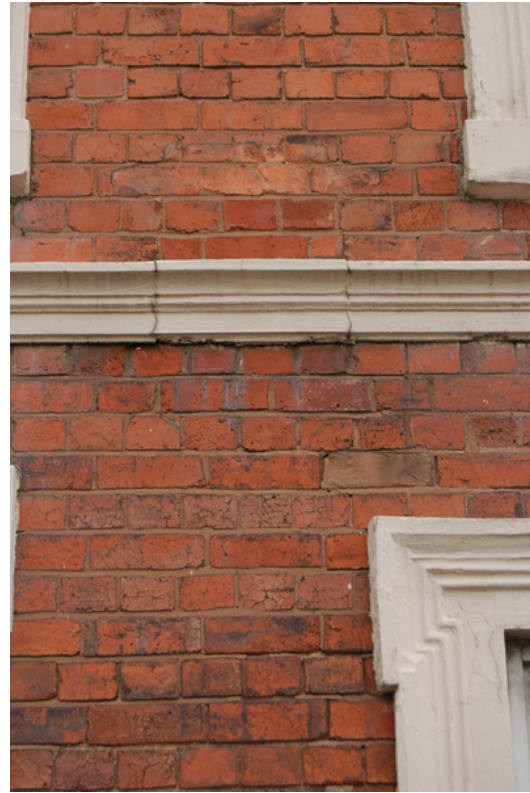
Plate 4: 'Ghost of former porch capital.

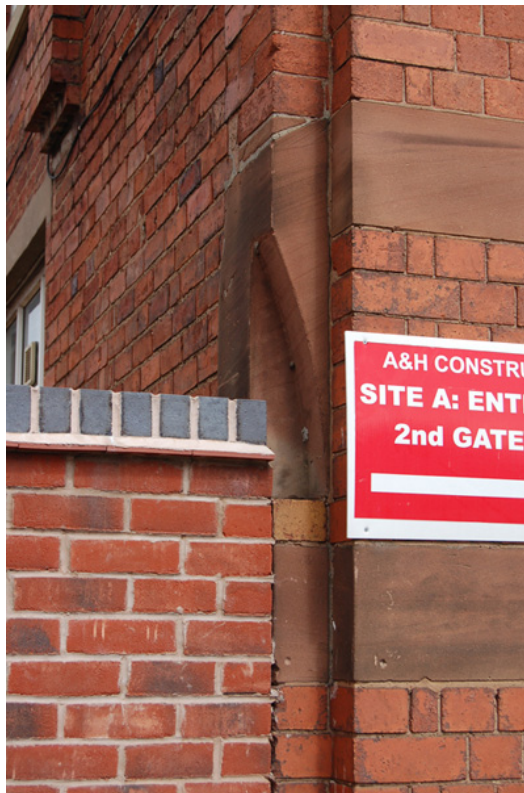
Plate 5: Springing of archway.

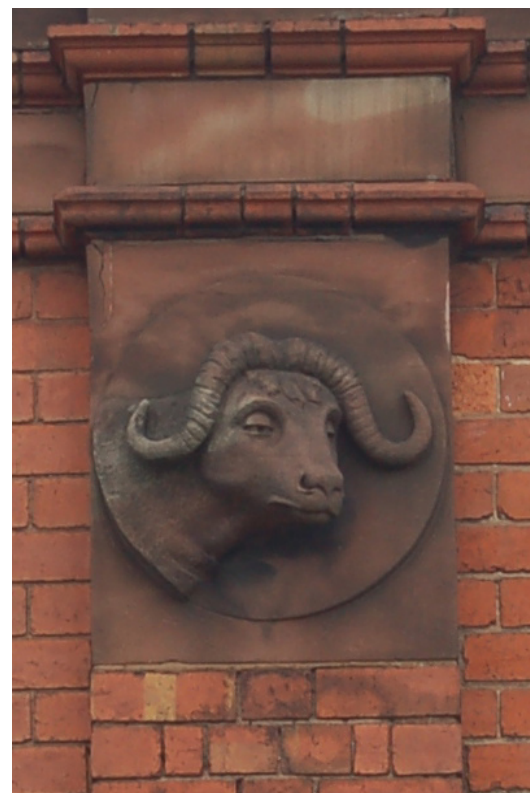
Plate 6: Animal head motif, detail.

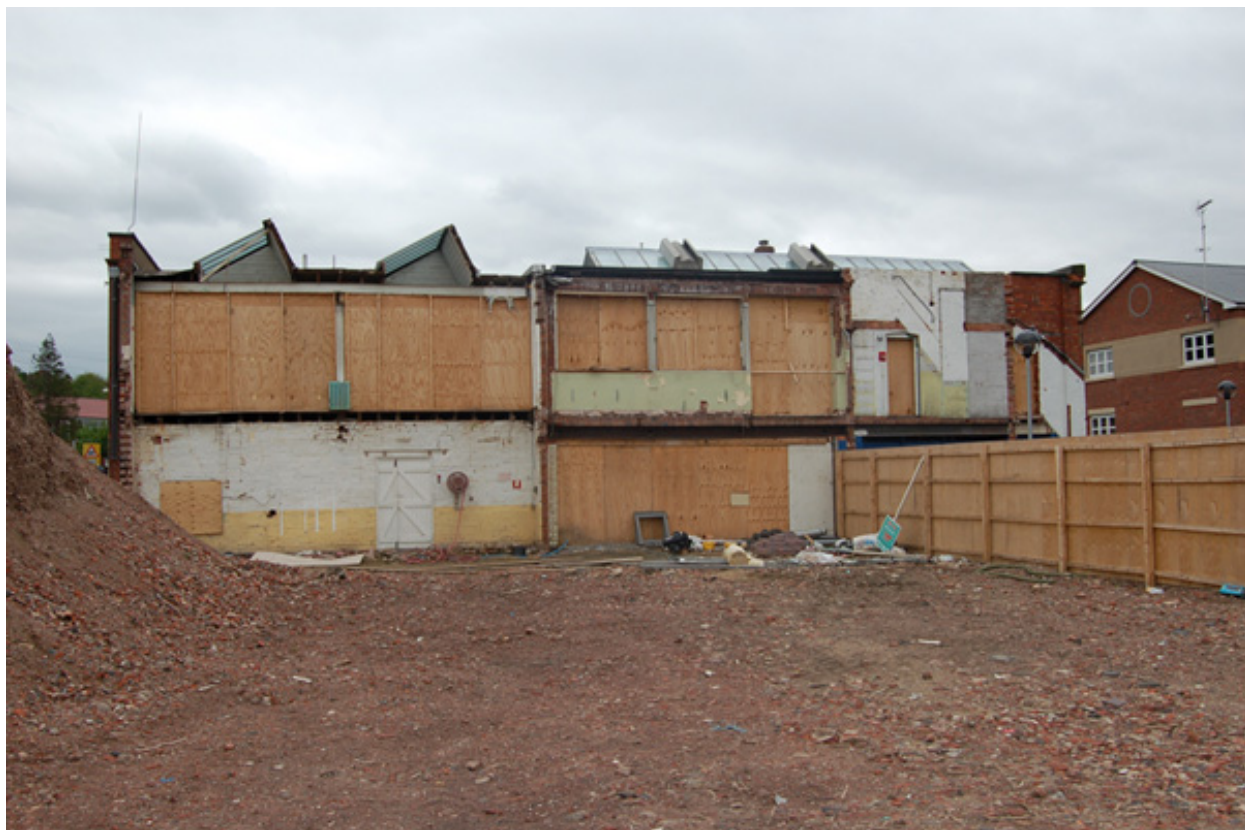
Plate 7: North (rear) elevation.

The rear of the building does not present an elevation as such, representing as it does a party wall between the front range and a series of factory buildings to the north, now demolished. To the eastern side of the standing building (block **D**), the elevation represents the bay division of a block formerly extending further to the north (see Figure 10/11 inset). At ground floor level the elevation is of brick construction, laid predominantly in stretcher bond, with a single double-door to the east and a hatchway to the east. At first floor level, the elevation presents an open bay division with a central RSC supporting a horizontal RSJ. The roof structure itself comprises two asymmetrical, east lit sky-lights.

The central part of the elevation formerly backed onto an (?)open yard. At ground floor level the elevation comprises a metal-framed, part glazed wall with a single, central doorway. At first floor the elevation is divided into three equal bays by steel columns supporting a flat roof; the eastern two bays are furnished with a low brick wall with large window openings over, while the western bay is fully open, with rendered and painted jambs, suggesting a former

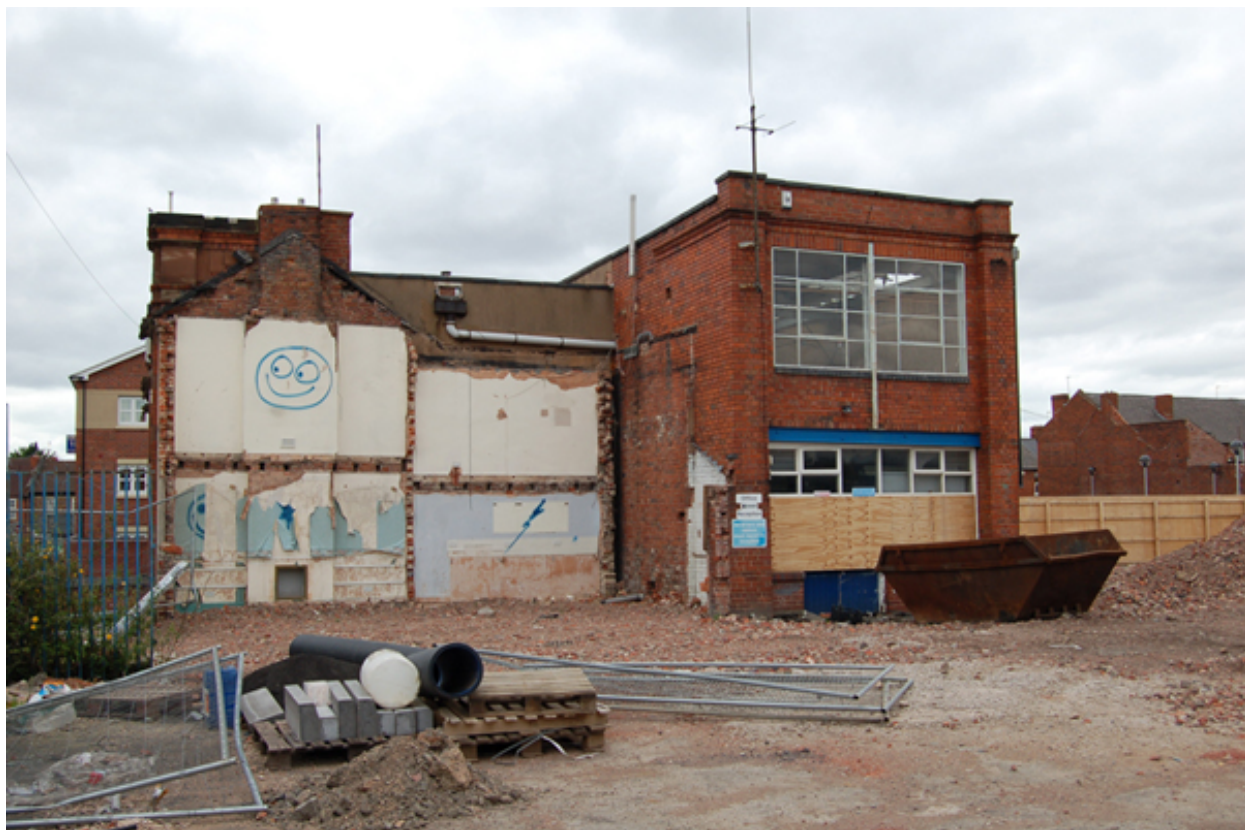
Plate 8: East Elevation.

The east elevation can be broken down into two elements. To the south the end wall of the corner pilaster and northern return wall of the recorded office building can be seen above the internal gable end and ridge stack of the two-storey house formerly abutting the structure to the east. To the west, the elevation represents the remaining bay of a former six-bay block extending to the north (illustrated in Figure 4). The elevation is of exposed brick, laid in Flemish stretcher bond, with internal bays articulated by projecting piers of brickwork and furnished with large metal framed windows at first floor and wooden windows and door at ground floor level. Reference to historic maps and the original architect's drawings suggest that the lower level may formerly have been fully open, forming an entranceway through to the covered yard (G13).

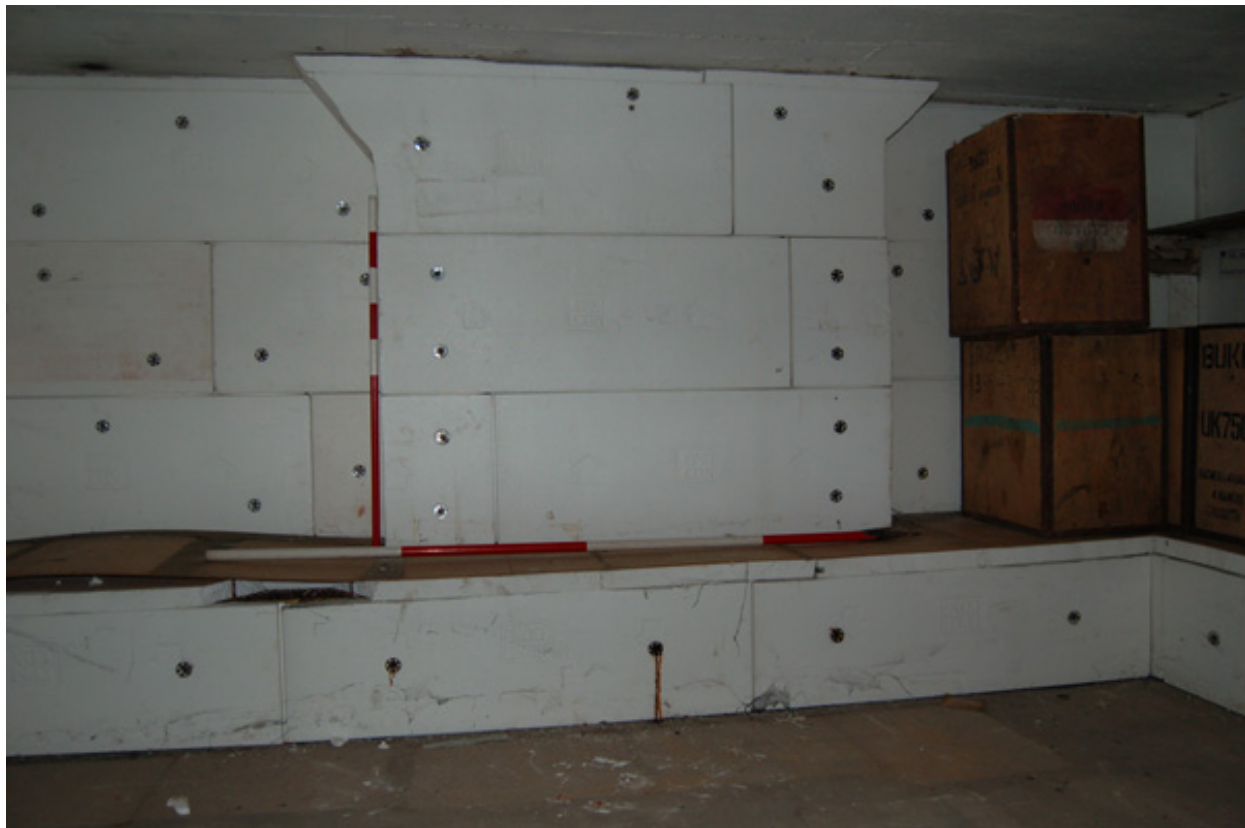
Plate 11: Basement Room B1; central projection within west wall.

by a narrow passageway (B3), aligned north-south and terminating in a small lobby area. The larger of the basement rooms (B1) is accessed to the west via a narrow doorway with semi-circular arched head. It measures 3.7m (E/W) x 4.5m (N/S) and stands 1.85m tall to the underside of a flat concrete floor slab. The north, west and northern part of the east wall have a low (0.37m high) brick ledge against them, while the west wall displays a central projection 0.24m deep x 1.5m wide, splaying outwards just below ceiling level (Plate 11). This projection does not relate to any surviving feature at ground floor level and may indicate that the basement survives from the building pre-dating the present office block, illustrated in Figures 4 and 7). At the time of survey, the room was lined out in polystyrene insulation blocks. Room B2 forms a small store 2m (E/W) x 2.4m (N/S) including its lobby with which it shares a brick barrel vault, aligned north-south (Plate 13).

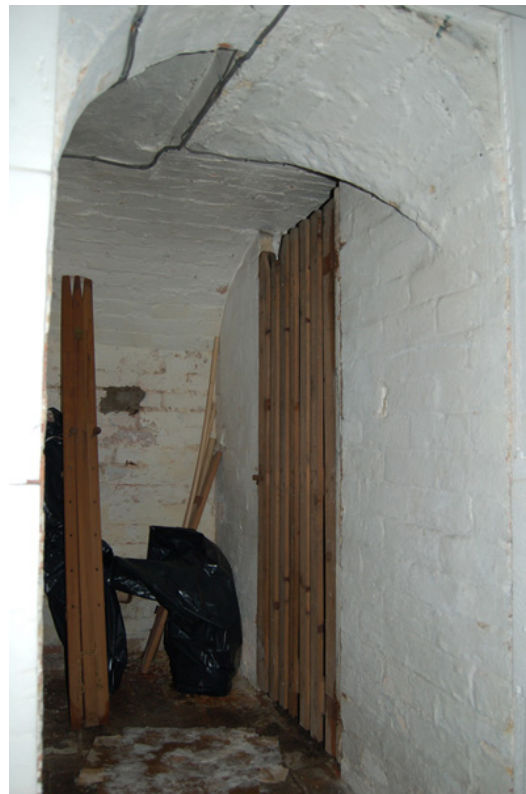
Plate 13: Basement Room B2 and lobby.

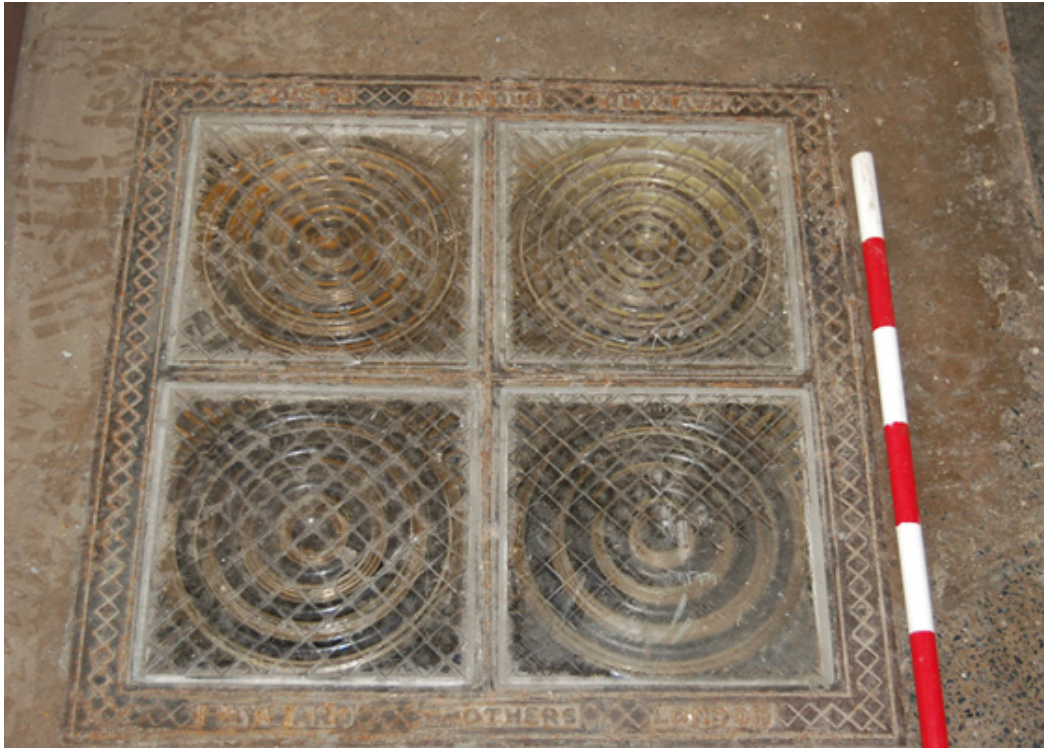
Plate 16: Glazed tiles of landing, lighting G14 below.

F1 represents the upper part of the stair, previously described. The upper flight of the stair rises above Room G14 and a panel of four glazed tiles in the landing (Plate 16) lights the lower room. At the head of the stair a short gallery runs along the north side of the stairwell, up against the brickwork of the outer wall of Block **D** (F9), while a further length of balustrade closes off the eastern side of the stairwell forming a short corridor leading to Room

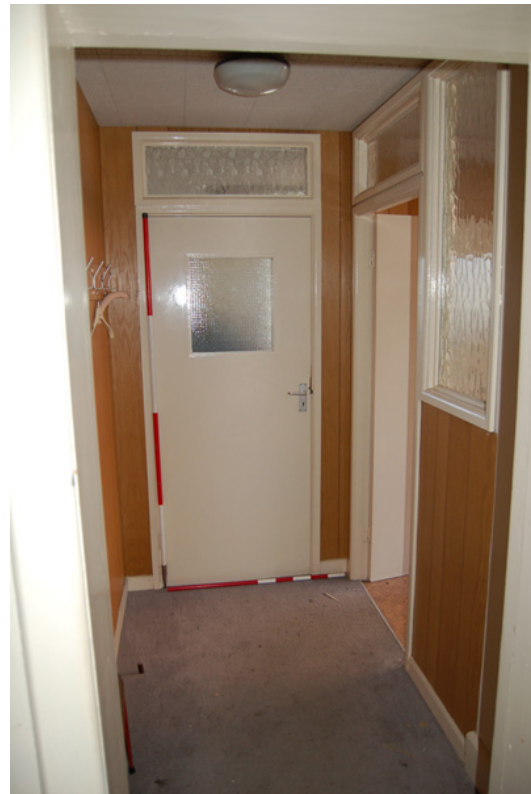
Plate 18: Studwork partitions to W end of range (G5-G8).

- 8.5 Additions to the structure as built include the masonry partition wall between rooms G4 and G5/G6 and the series of ephemeral studwork partitions introduced at the western end of the main office range forming G6-G8. The strong room at the south-west corner of the building also seems to be a secondary introduction. More recent alterations to the building include the removal of the original, ornate entrance porch with flanking columns and the associated main door, being replaced with modern utilitarian, steel-framed glazed doors. The exterior fenestration of the building has been replaced throughout by UPVC double-glazed units.

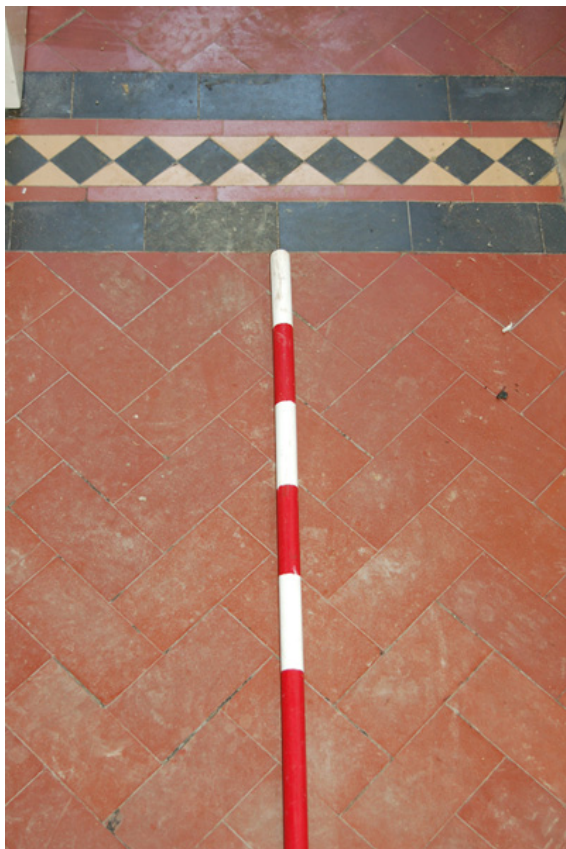
Plate 21: G11, detail of tiled floor.

Located at the far west end of corridor G10, Room G11, 3.3m (E/W) x 2.3m (N/S), contains toilet facilities. The walls are tiled to mid height with white ceramic tiles with black skirting and dado bands, and retains a tiled floor with decorative edging (Plate 21). The eastern part of the room comprises a single space and retains a large, ceramic twin handwash basin mounted on the south wall (taps replaced); to the west, the room is split into two cubicles with WCs, each is lit by a single-light window in the west wall. Outer and inner doors are of four lower, sunk panels below an upper glazed panel (frosted glass) and retain original brass finger plates, door knobs and hinged keyhole covers (Plate 22).

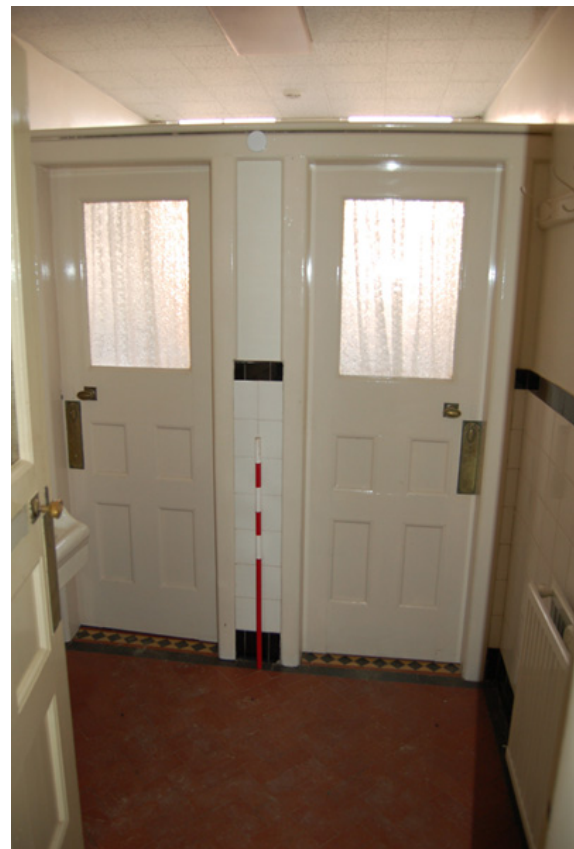
Plate 22: Room G11, original doors.

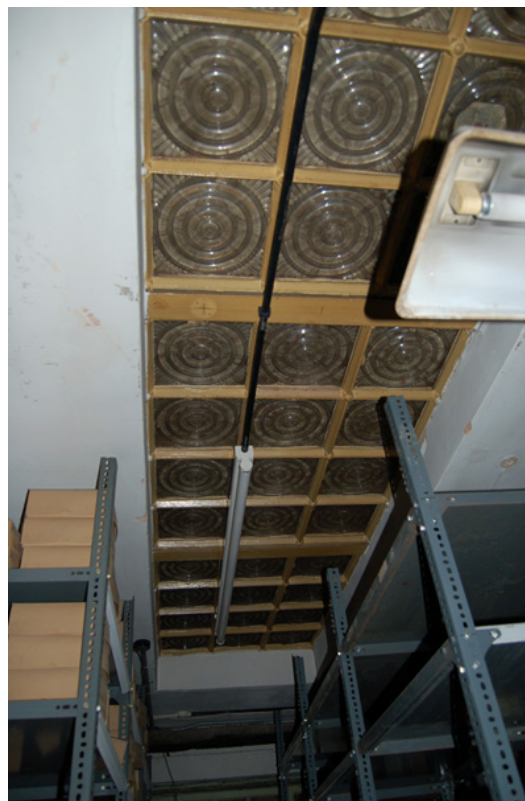
Plate 27: Glazed tiles in ceiling of G13.

Room G13 is located to the north of the main office range and to the east of the dispatch bay G12. The room measures 7.65m (E/W) x 5.65m (N/S) and is currently used for storage (Plate 25). The original architect's plan labels the room as a 'covered yard', and while the north wall currently comprises a metal framed wall, glazed above mid-height, the evidence of window details of the south and west walls, which all have rounded-brick cills and recessed frames, suggests that the space was originally 'external' to the main building, being open to the former yard to the north. Double doors beneath a segmental headed arch within the west wall give access to G12 (Plate 26); the left hand door retains a sign reading 'Despatch Bay'. Two three-light windows in the south wall give onto corridor G10 while a double-light window in the west wall gives onto G12. Within the central bay of the room, the ceiling includes three panels of glazed tiles, each panel containing 12 tiles, similar to those lighting G14 and the basement stair, and formerly lighting G13 from F8 above (Plate 27).

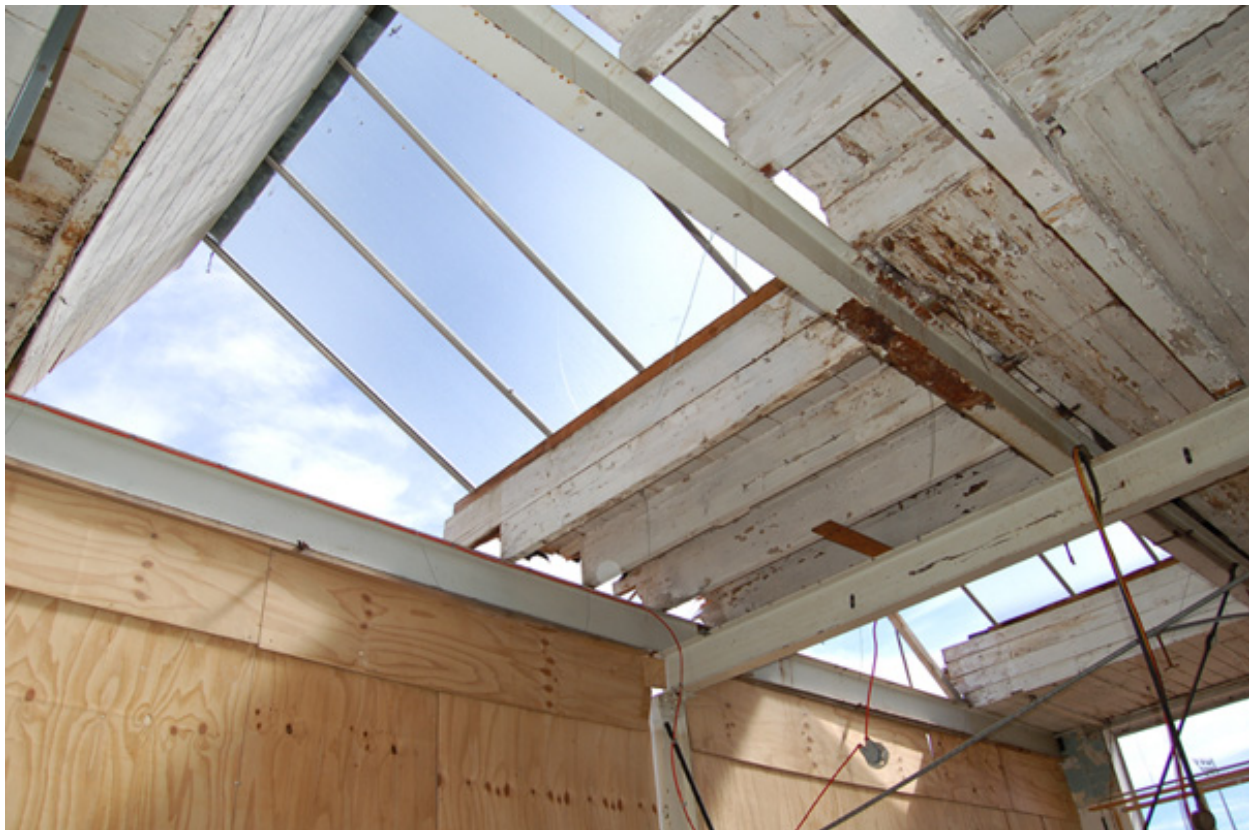
Plate 37: Room F9, roof structure.

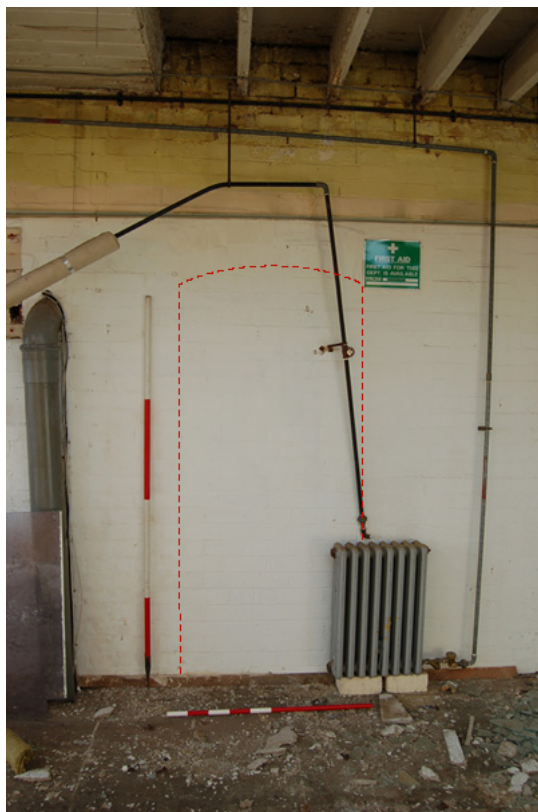
Plate 39: Room F9, blocked door (in red)
