Mill House, Tutbury Mill,
Rocester

Historic Building Recording
2007

Project No. 1558

February 2007

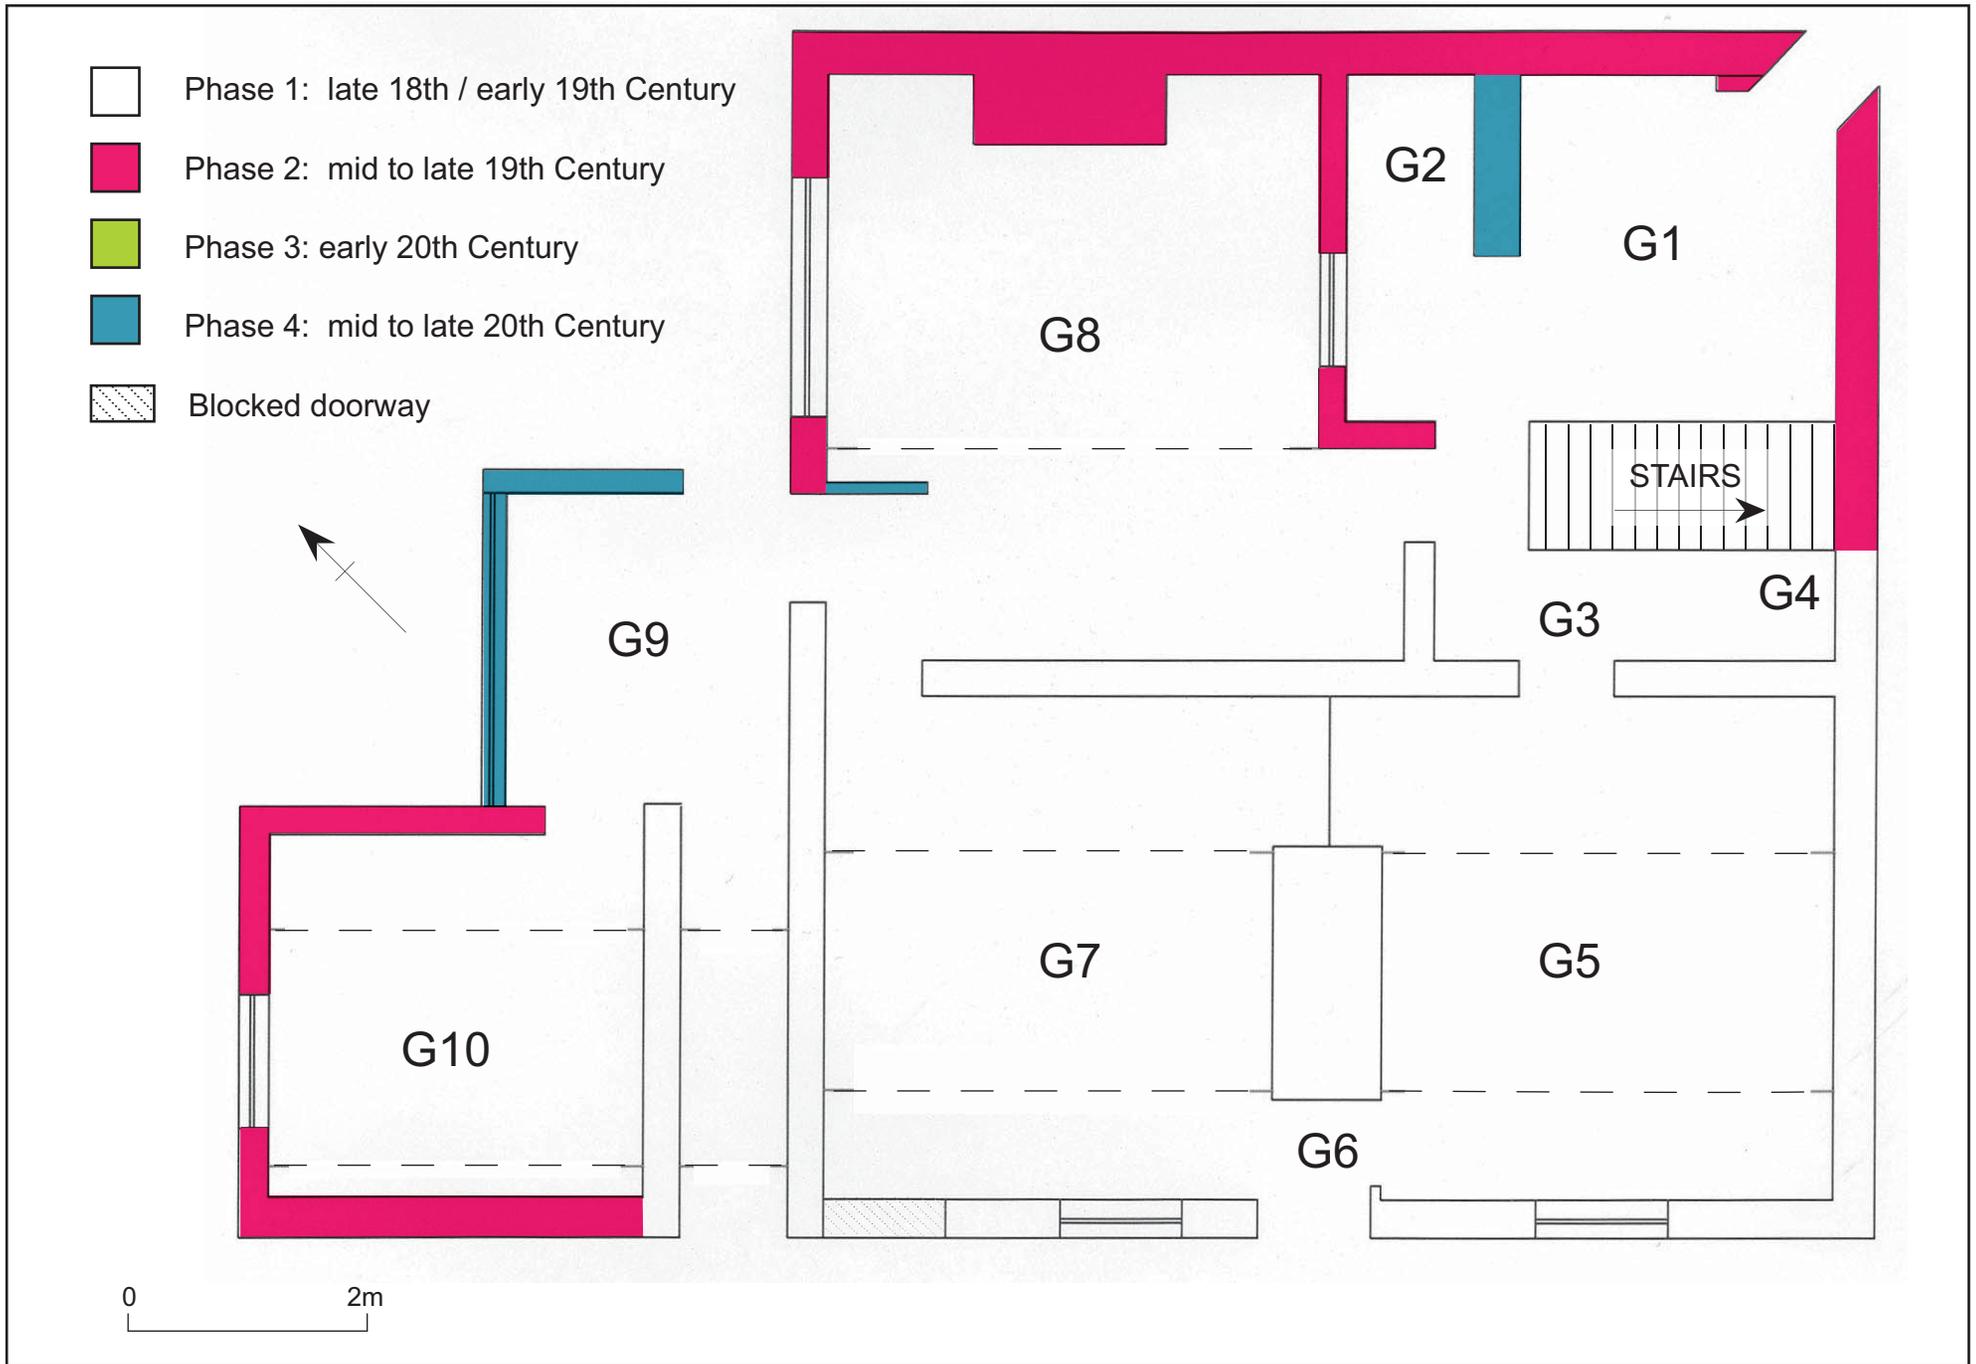
Fig.4

Ground Floor (Fig. 4)

There were four distinct phases of construction, additions, and alterations at Mill House (Figs. 4 to 6). These phases have been identified through a combination of on-site visual analysis, architectural history, and historic cartographic sources (Figs 7 to 11).

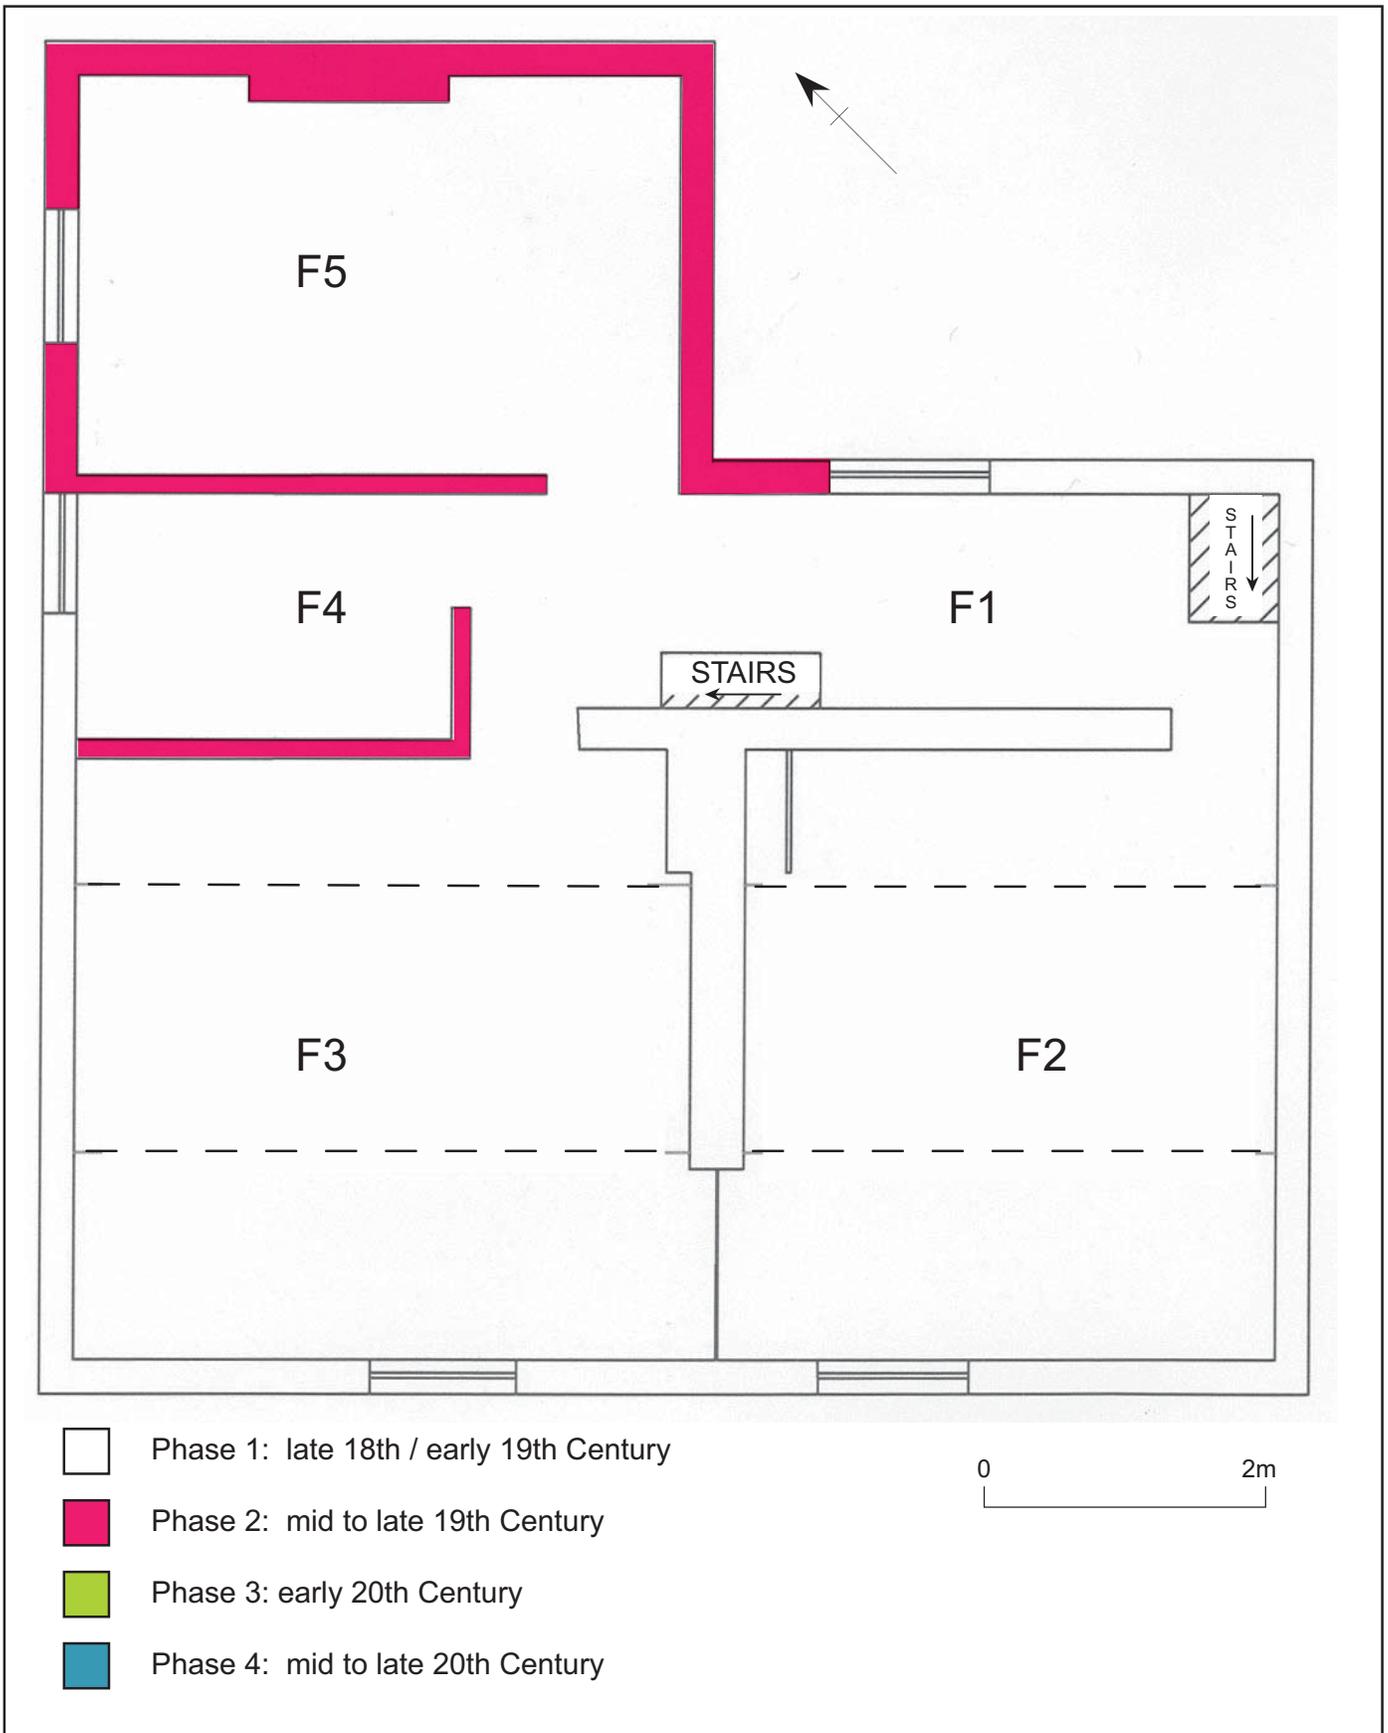
Fig.5

First Floor (Fig. 5)

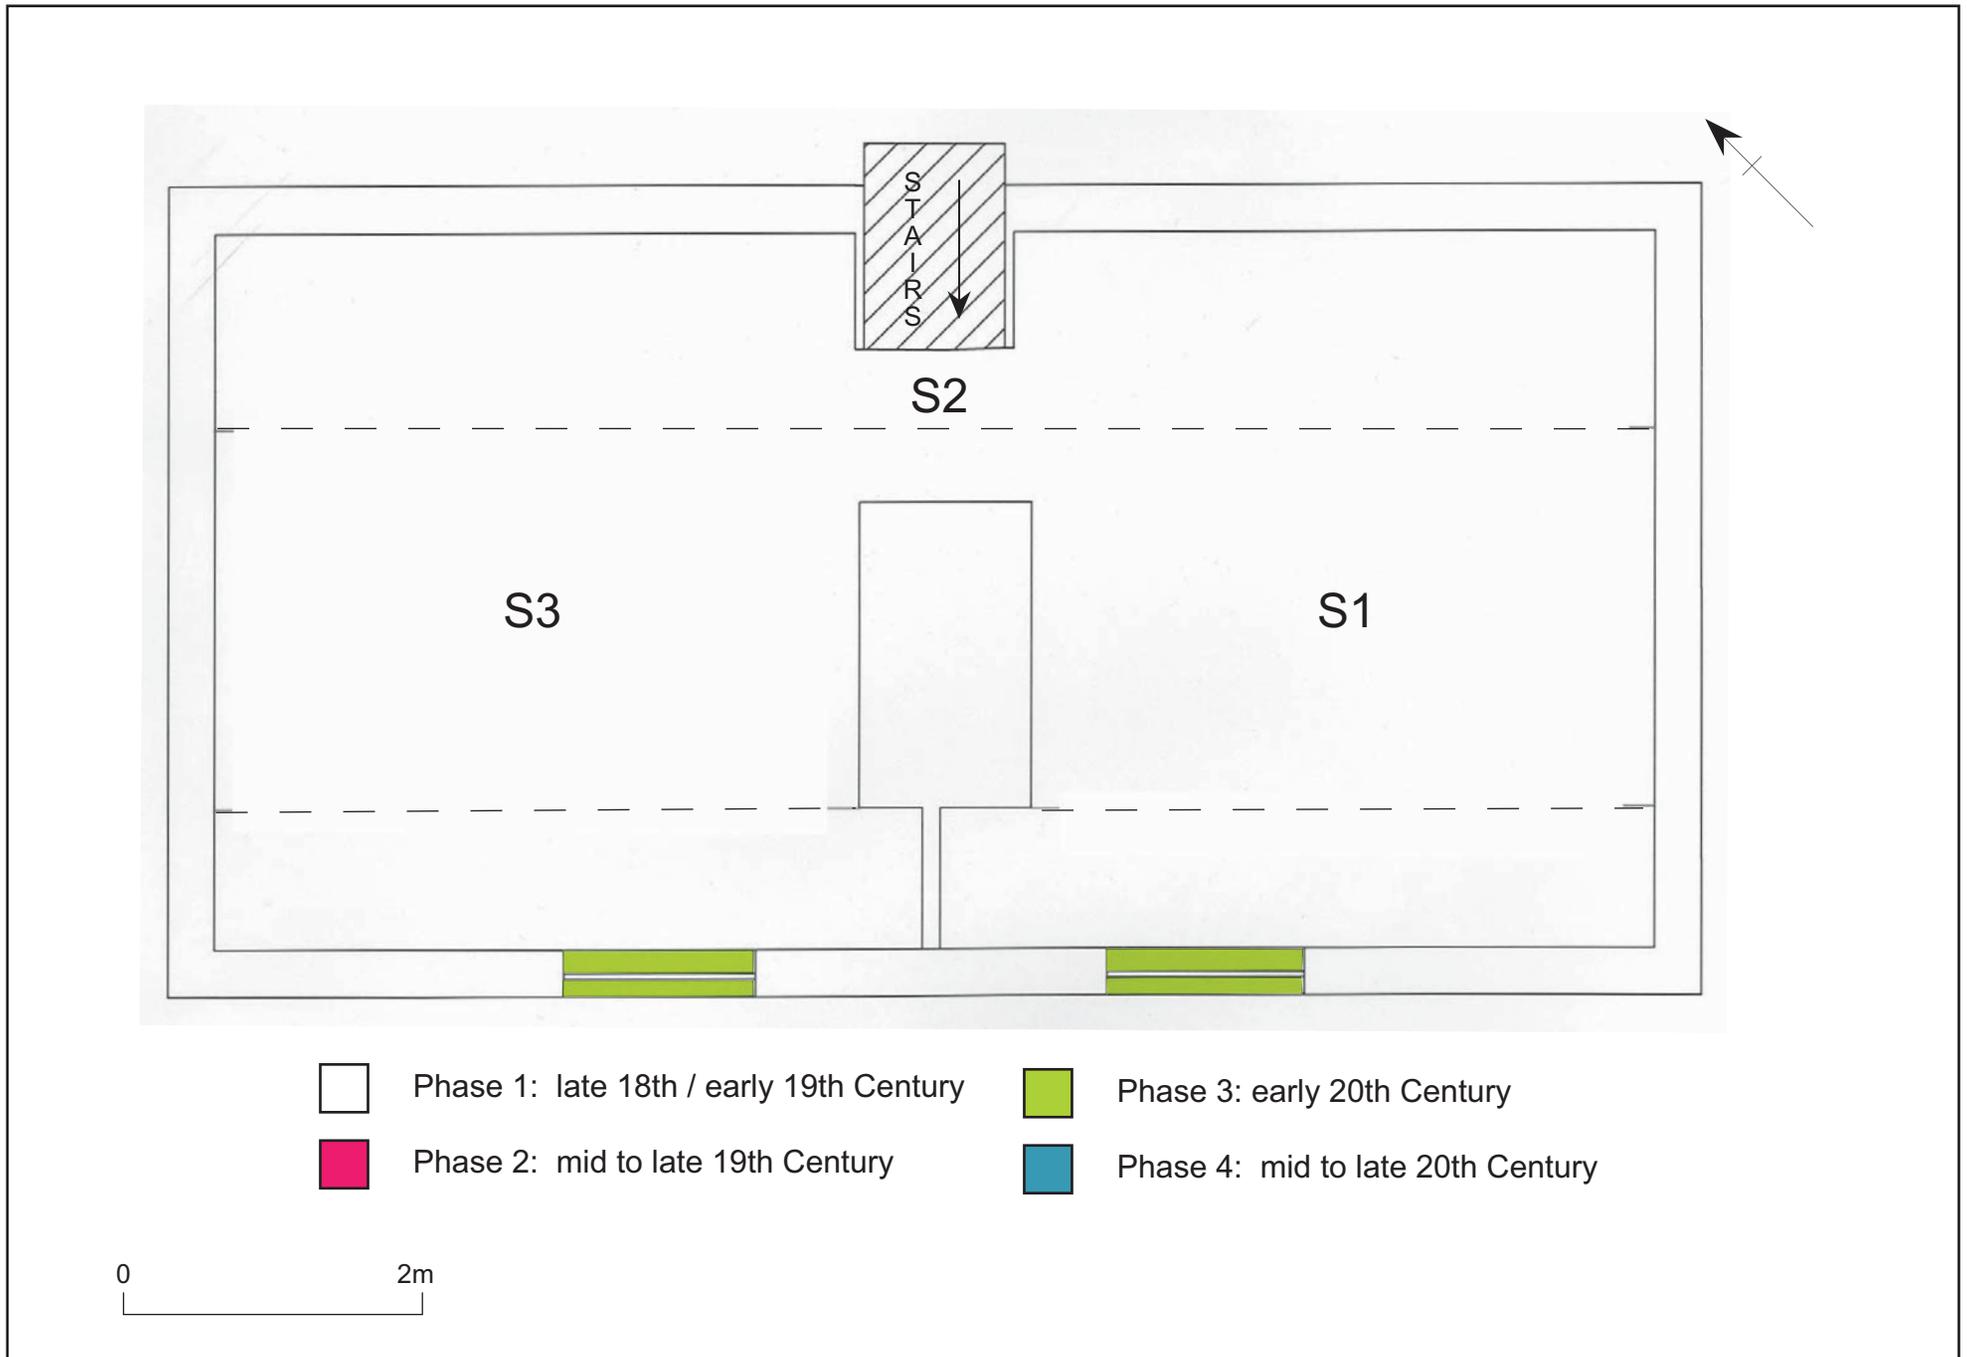
Fig.6

Second Floor (Fig. 6)

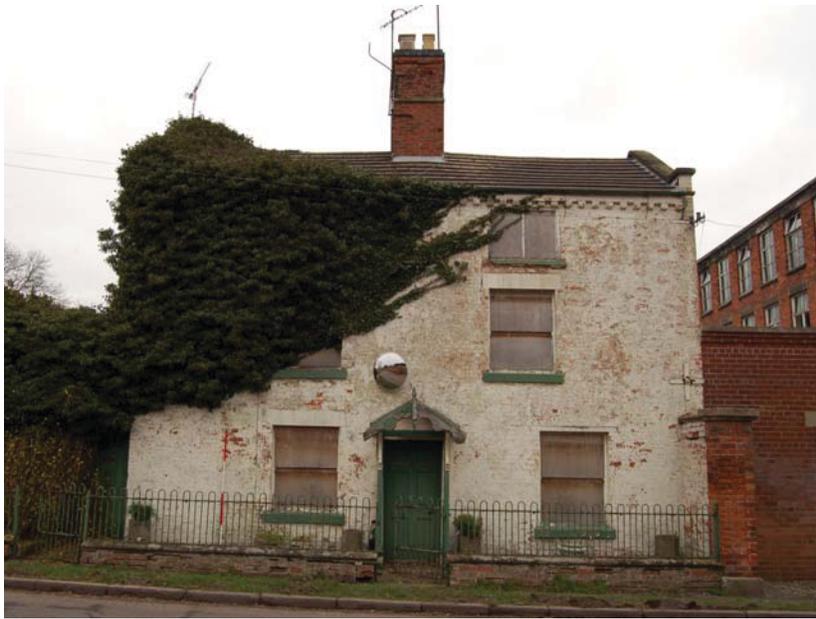
Plate 1

Mill House is bounded off from the road by a low brick and stone wall with wrought iron railings (Plate 1). The main block of this elevation has three bays, and two storeys with attic. It is of painted red brick measuring $8 \frac{5}{8}$ ins x $2 \frac{3}{8}$ ins x $4 \frac{1}{4}$ ins, which is laid in what appears to be Flemish bond, but which is obscured by a thick coating of whitewash. What is particularly noticeable with this elevation is the slight asymmetry of the fenestration pattern, there does not appear to be any discernable reason for this, and none of the windows in question appear to be inserted, nor is there evidence of any blocked windows. At ground floor level two wooden two-pane sash windows with stops flank a flat arched doorway with a timber lintel and a six-panelled door. This doorway is aesthetically augmented with an ornamental wooden porch with decorative bargeboard and spirelet finial; the returns of this porch are trellised. The windows have plain painted concrete/stone sills. The most easterly window has an inserted timber lintel, whilst the other has a concrete lintel. Directly to the west of this western window is a blocked segmental arch doorway (Plate 2). To the west of the main block is a round arched doorway, which forms part of a one-storey structure, which abuts the main facade; this is largely obstructed by dense vegetation. Abutting this main block to the east is a one-storey red brick 20th-century electrical substation. The projecting brick pillar at the junction of this substation and Mill House appears to be the last remaining vestige of the former gateway to Tutbury Mill.

Much of the western side of the upper storeys is obscured by vegetation. There are two timber two-pane sash windows with stops at first floor-level. These have painted concrete/stone sills, and concrete heads, the western one is directly above the ground-floor window, whilst the other is to the west of the eastern ground floor one. To the east of this is a cruciform-shaped wall tie.

Second-floor/attic-level has two metal-framed bipartite mullioned casement windows. These windows, which are shorter than those on the lower floors, have concrete sills, and heads that form part of the eaves. The fenestration layout and positioning follows that of the first floor. The eaves consist of one course of dentilated brick under two courses of oversailing brick. The low-pitched roof is covered in modern roof tiles. There is a central north/south brick chimney.

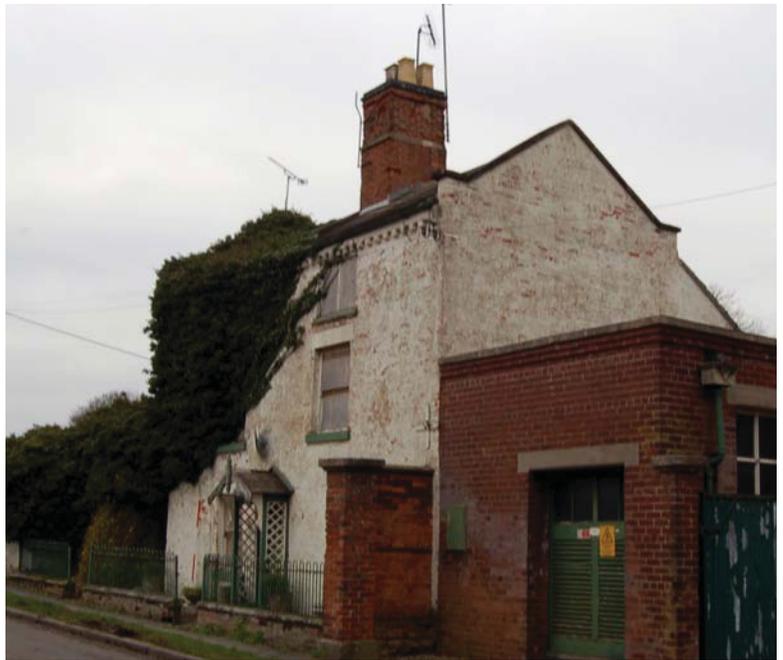
Plate 3

This elevation is largely obscured by an electrical substation (Plate 3). It is of painted red brick, which is laid in what appears to be English garden wall bond. There is no visible fenestration scheme on this elevation. The southern roofline of this elevation consists of a shouldered gable, which is coped with stone or concrete. This appears to be abutted to the north by a steeply pitched roof.

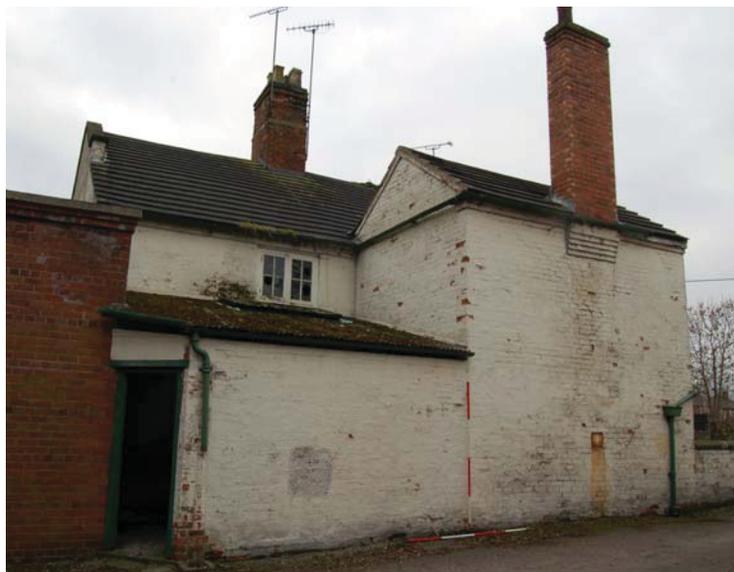
Plate 4

This is a composite elevation, with three distinct sections (Plate 4). The eastern side of ground floor level is of painted red brick measuring 9 ins x $2 \frac{3}{4}$ ins and laid in stretcher bond. This wall supports a lean-to corrugated asbestos roof, and is possibly the remnant of a boundary wall. The chamfered corner for the doorway is an addition/alteration. A straight joint is possibly discernible at the junction of this portion of the elevation and the western portion. This section of the elevation has two storeys and has no apparent fenestration scheme. It is of painted red brick measuring $9 \frac{1}{4}$ ins x $2 \frac{7}{8}$ ins x $4 \frac{7}{8}$ ins and laid in stretcher bond. The eaves consist of

two courses of oversailing brick and central corbelling, from which a north-south red brick chimney rises.

Above and behind the one storey lean-to structure to the east is the first floor of the main block. This is of painted red brick laid in what appears to be Flemish bond. This has a west of centre four-pane casement window. The eaves are of one course of dogtooth brick above one course of oversailing brick.

This two-storey gable end is obstructed at ground-floor level by the lean-to structure to the southeast (Plate 4). It is of painted brick laid in an indiscernible brick bond. There doesn't appear to be any fenestration scheme. The gable has oversailing brick eaves, which rise on oversailing brick kneelers.

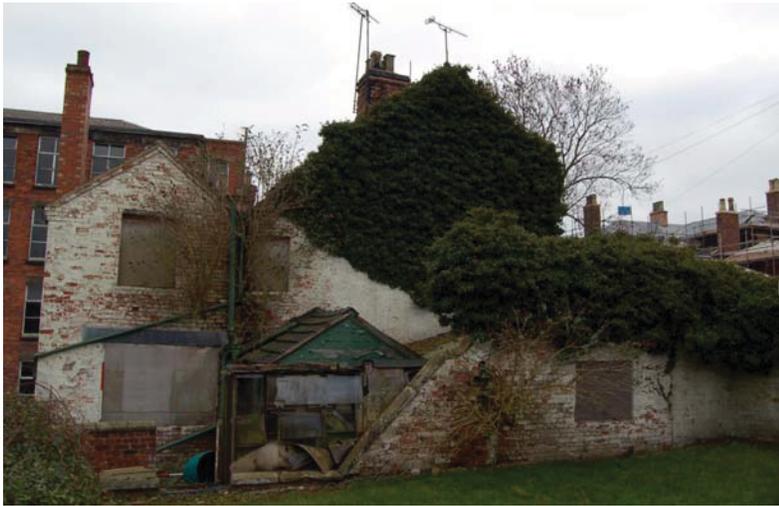
Plate 5

This is also a composite elevation, with four distinct sections (Plate 5). The most northerly section is a two storey, one bay elevation in painted red brick measuring $9\frac{1}{4} \times 3\frac{5}{8} \times 4\frac{1}{2}$ and is laid in Stretcher bond. This has a large ground floor window (now obscured with plywood), which has a lead lined lintel. This section has a central window (now obscured with plywood) at first floor level with a gabled roof with oversail brick eaves, which rise on oversail brick kneelers. The junction between this section and the main block of the house/southern section is demarcated by cast iron rainwater goods and down pipes. There also appears to be a straight joint where these sections meet. This section of the main block is obscured at ground level by later additions and in the upper storeys by dense vegetation. This is of painted red brick laid in what appears to be English Garden Wall bond. The only visible window is at the northern side of first floor level (now obscured with plywood). The most northerly addition is a wooden planked gable ended structure with tiled roof; all windows and doors are obscured with plywood. The addition to the south of this was largely inaccessible from the exterior. Its west wall would appear to be the remains of a stone coped painted red brick wall measuring $9\frac{1}{4} \times 2\frac{7}{8} \times 4\frac{5}{8}$ laid in what appears to be Stretcher bond boundary/garden wall. A square headed window has been inserted to provide light. The remainder is of red brick with a corrugated steel pitched roof.

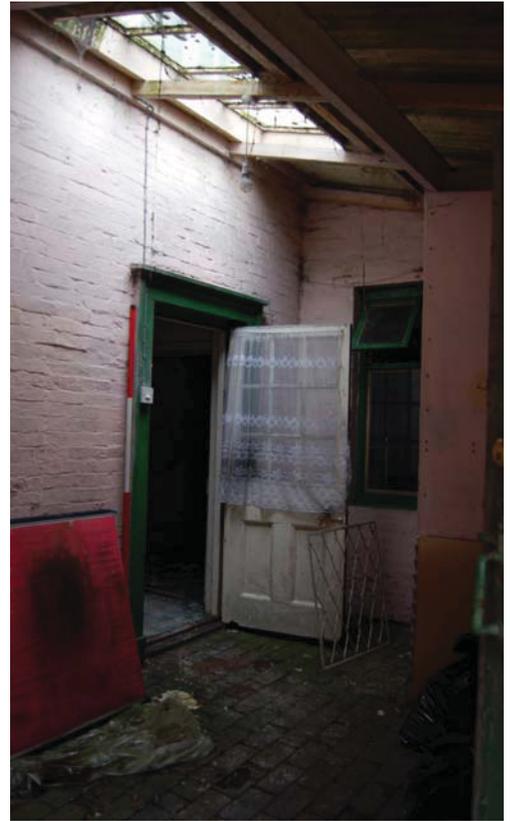
Plate 6

G1 This room is entered through a chamfered doorway in the east corner (Plate 6). It appears to be a courtyard, which was later covered with a mid to late 20th-century corrugated asbestos roof with skylight. All of the walls are of painted red brick, whilst the floor is of blue brick paviours, which were possibly an original feature. Access to G3 is through a doorway on the southwest wall. This doorway has a half french door and a plain wooden architrave and hood.

The courtyard is overlooked by a multipane awning window in the northwest wall. G2 is located in the north corner.

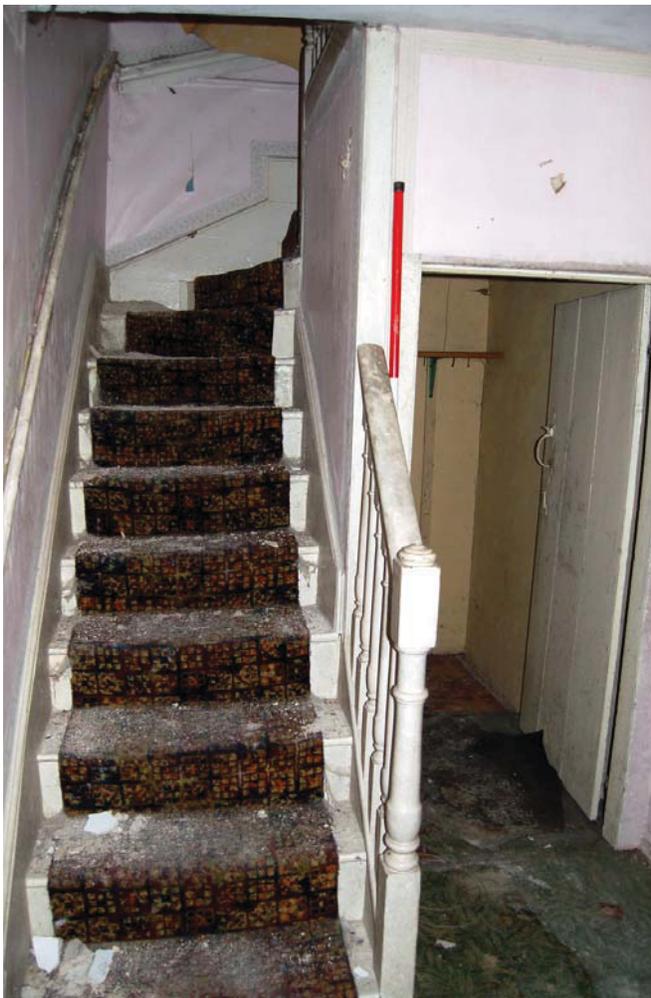
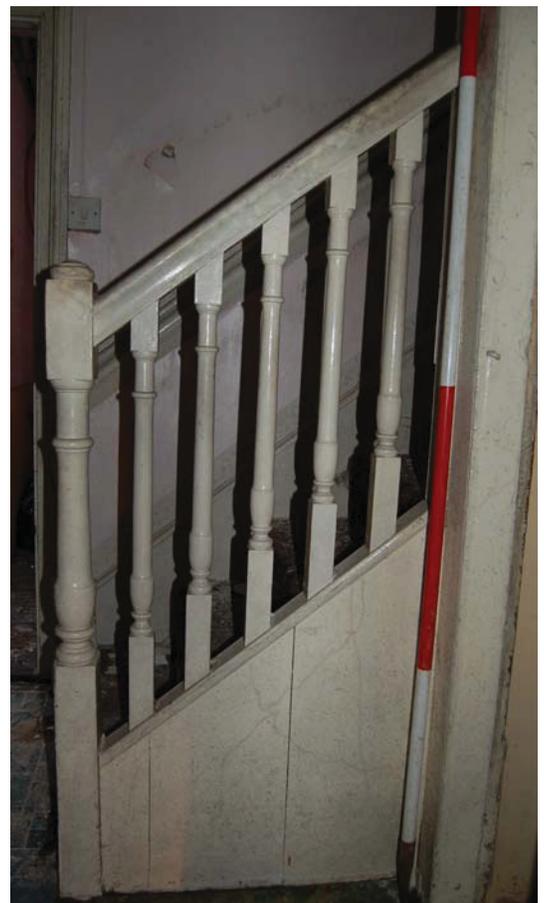
G3 (Plates 7 and 8) is a hallway/lobby providing access to G1, G5, G8, and the first floor via a staircase. This room has a lino covered quarry tile floor. All walls have a high moulded skirting which is likely to be of a late 18th/ early 19th-century date, whilst the northwest and southwest walls have plain dados and picture rails which were used for hanging coats. The doorway to G1 has a lightly moulded architrave, whilst the doorways to G5 and G8 have heavily carved architraves with panelled doors. The ¼ turn staircase in the east corner has turned balusters and newel post. This appears to be of a late 18th/ early 19th-century date and style. This has moulded timber steps, which are now partially covered with carpet.

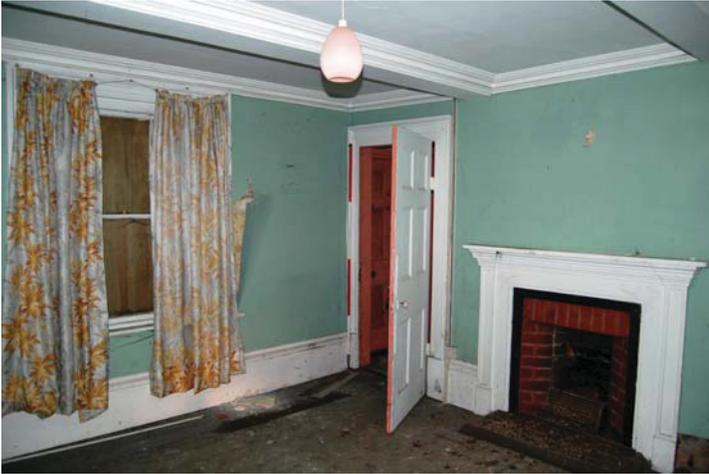
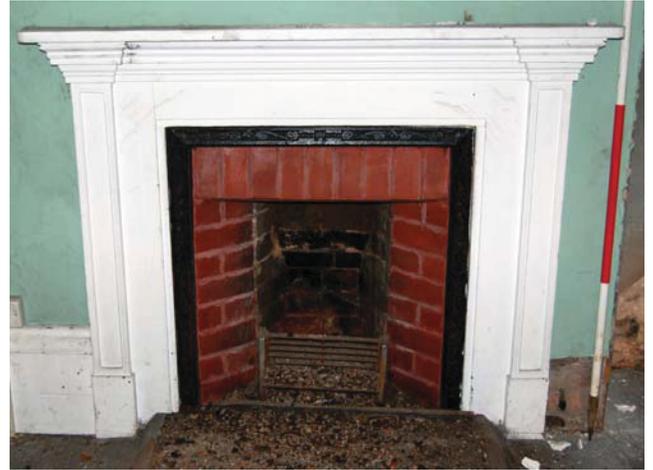
G5 (Plates 9 and 10) This living room has high moulded skirting board and ornate moulded cornice (apart from the southeast wall). Stylistically these appear consistent with a late 18th/ early 19th-century date. The doorframes to G3 and G6 have heavily moulded architraves. These have six-panelled doors. There is an early 19th-century moulded timber neoclassical style mantelpiece with brick fireplace with a cast iron ornamental surround with vitruvian scroll-like pattern. Scarring in the alcove to the northeast of this suggests the recent removal of a cupboard. The window on the southwest wall is a vertical tripartite sash window with moulded architrave and shelf sill. There are two southeast-northwest running beams covered with ornate cornice.

The chamfered and stopped beams in G5 and G7 are much earlier in appearance, and are more akin to a 16th or 17th-century building, however, it is likely that these have been removed from an earlier building. There is no likelihood that Mill house contains remnants of an earlier structure, as there is no evidence of one on the 18th-century map. Cartographic evidence suggests that there was no development on the site of Mill House in the mid to late 18th-century.

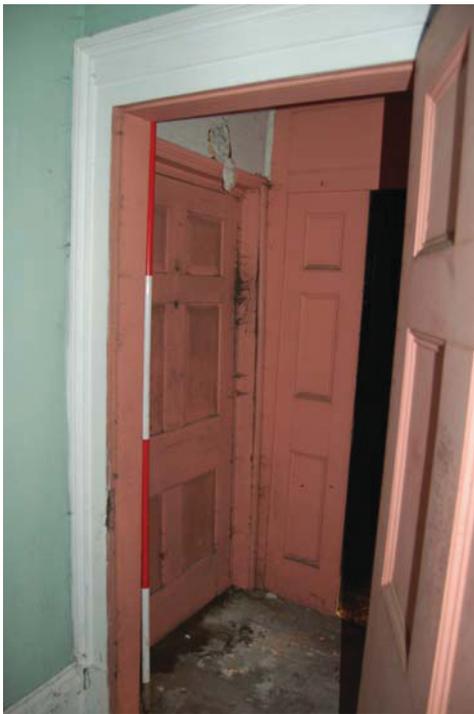
Plate 11

G6 The lobby/ baffle entrance has a quarry tile floor (Plate 11). Each wall has high splayed skirting boards. The door to the exterior on the southwest wall is panelled. There is a later wooden partition with doorway between this lobby and G7.

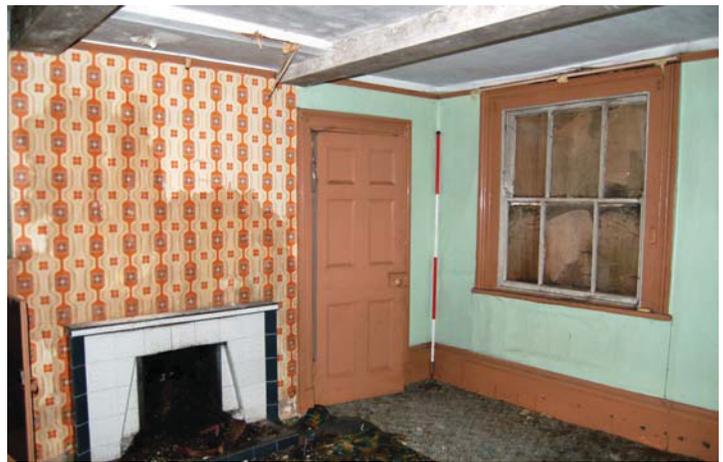
Plate 12

G7 This living room (Plate 12) has a high moulded skirting board as in G5. Each wall has a high moulded picture rail. The southwest window is a replica of that in G5. The fireplace on the northwest wall is a mid/late 20th-century insert. There is a wooden cupboard in the alcove to the northeast. Two southeast-northwest running beams are boxed in with plywood.

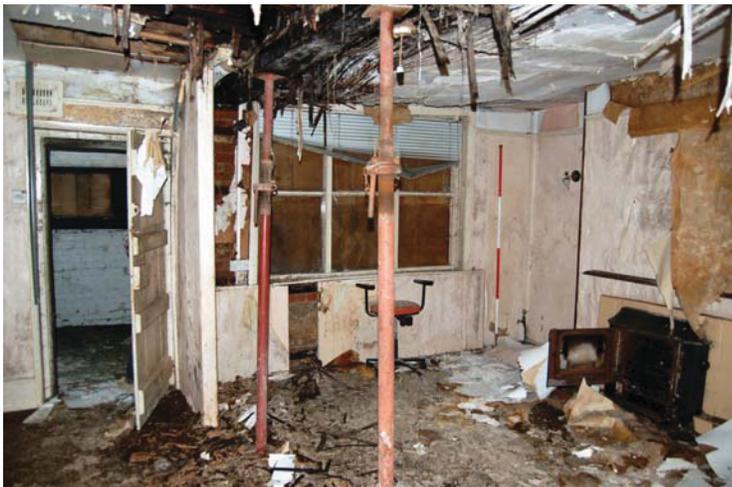
Plate 13

G8 has the appearance of another living room (Plate 13), it is 'L' shaped in plan, and has what stylistically appears to be mid to late 19th-century moulded skirting boards and picture rails. The floor is of chequerboard quarry tiles, which are now covered with carpet. The doorframes to G3 and G9 have lightly moulded architraves. The door to G9 is a batten door, which would suggest that it is an exterior door. The window overlooking G1 to the southeast has a moulded architrave frame with shelf sill as those in G5 and G7. The window itself is a bipartite awning casement, again of a mid to late 19th-century date. The window on the northwest wall is a tripartite window with mullions and transoms. The chimneybreast on the northeast wall has mid/late 20th-century fireplace with cast iron and glass hearth. There is a single northwest-southeast beam, which is now supported with scaffolding.

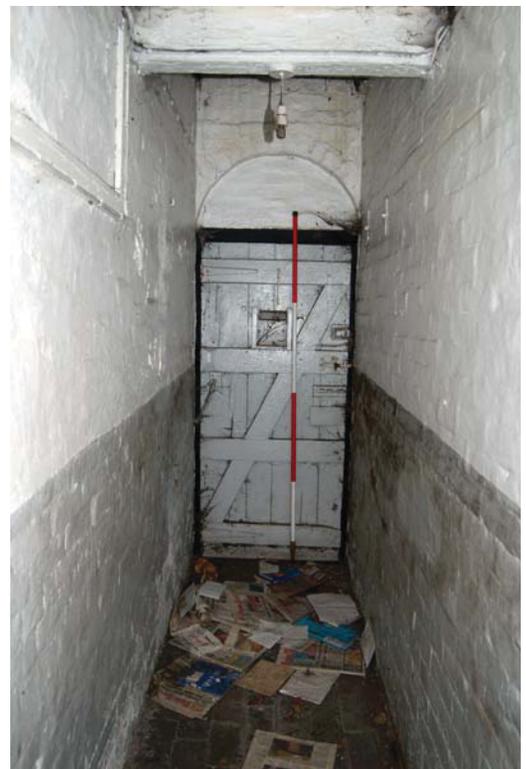
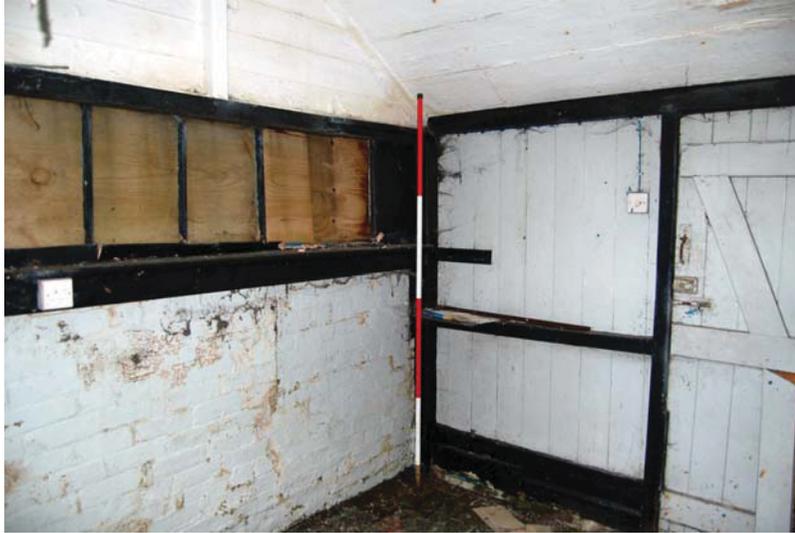
G9 (Plate 14 and 15) is a covered courtyard and alleyway and has a blue brick paviour floor. The covered alleyway has an original round arched doorway to the southwest. A battened door has been inserted and the arch infilled. Two beams run above the alleyway to support the roof of G10. The covered courtyard section is a mid to late 19th-century wooden and brick gabled structure with skylight. This has an external doorway in the northeast wall, and a long, thin window with six sections.

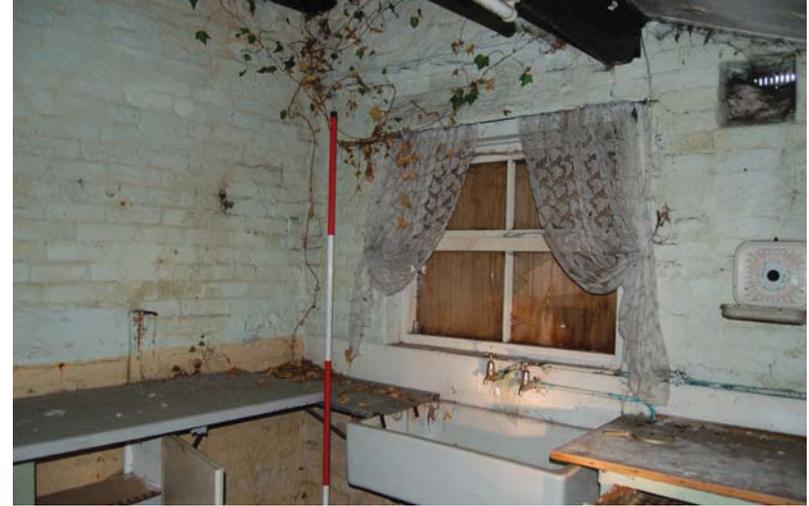
Plate 16

G10 This kitchen (Plate 16) has red and blue brick paviments as flooring. The fixtures and fittings attest to a mid/late 20th-century refit, however a Belfast sink suggests an earlier date for a kitchen function. There is a casement awning window in the northwest wall, whilst the two beams mentioned in G9 are also present here.

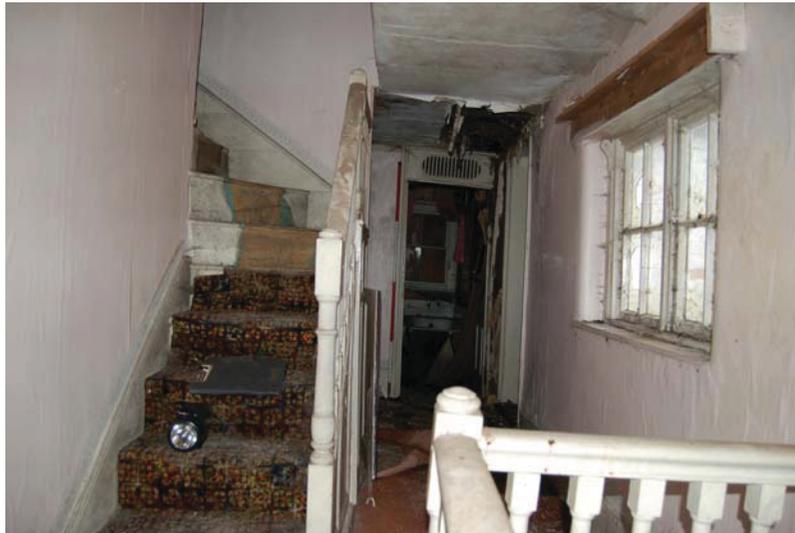
Plate 17

F1 This is the landing/upper hallway (Plate 17). Each wall has a high moulded late 18th/ early 19th-century skirting board. All doorways have lightly moulded architraves and have panelled doors. The door to F4 has a metal ventilation grille built onto the doorframe. The 1/8 turn turned balustraded stairs to ground-floor level are situated in the east corner. The landing/upper hallway is lit by a window in the northeast wall. This has rounded jambs and has a mid to late 19th-century metal bipartite casement style window with mullions and transoms. Situated between the doors to F2 and F3 is a late 18th/ early 19th-century stairwell to the second floor. This half turn stairs is identical in decoration as the other staircase.

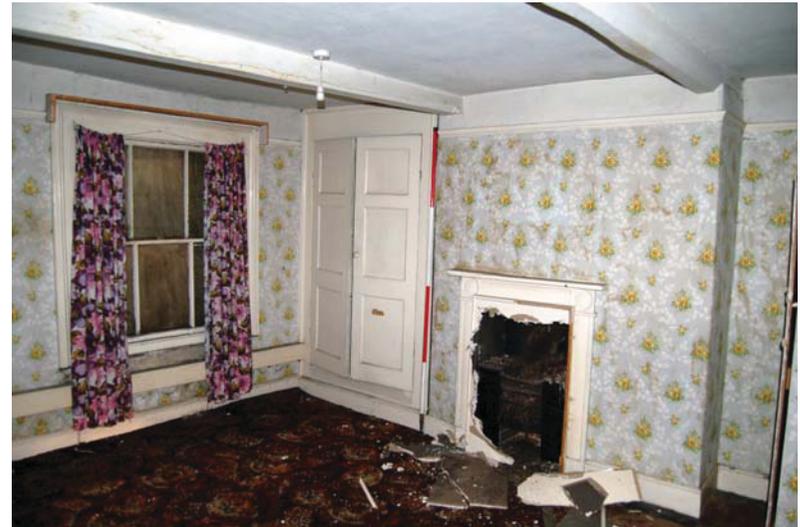
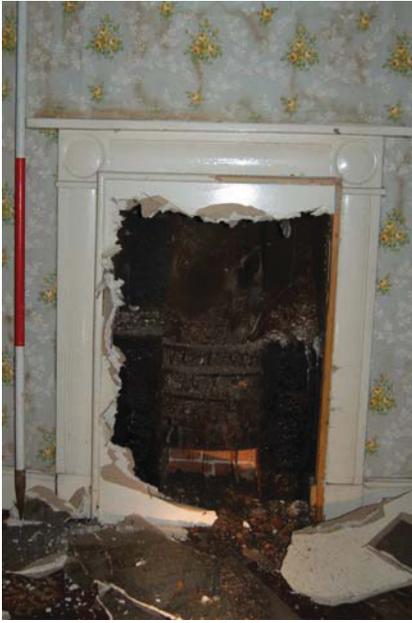
F2 is a bedroom and is entered up a step from F1 (Plates 18 and 19). Each wall has late 18th/ early 19th-century moulded skirting boards and moulded picture rails. The early 19th-century ornate cast iron fireplace on the northwest wall has a wooden neoclassical style mantelpiece. There is a wooden cupboard in the alcove to the southwest of this. There is an understairs cupboard in the west corner. The window on the southwest wall is a tripartite sash window with moulded architrave. There are two splayed and chamfered beams with stops running northwest to southeast.

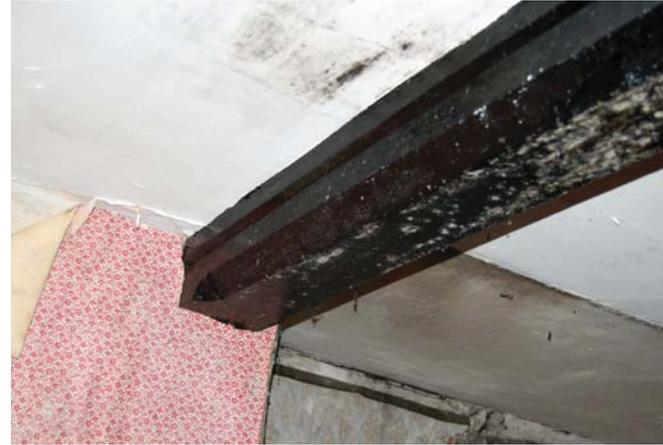
Plate 20

F3 This bedroom has moulded skirting boards as in F2 (Plate 20). It has a window similar to that in F2 in the southwest wall. There is an inserted 20th-century red brick fireplace on the southeast wall. A cupboard has been recently removed from the west corner, whilst there is a wooden cupboard in the west corner. There are two splayed and chamfered beams with stops running northwest to southeast.

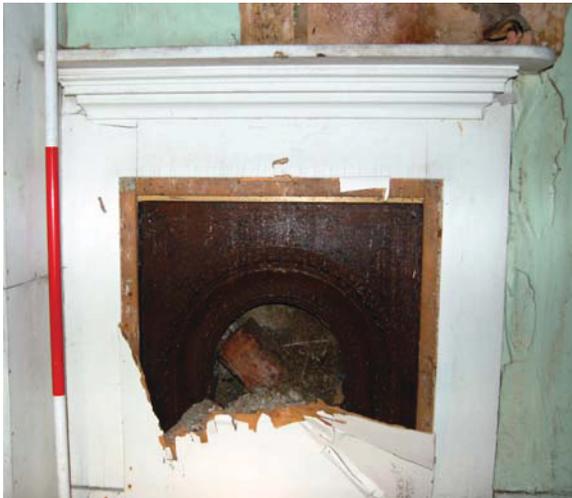
Plate 21

F5 The walls of this bedroom have high moulded skirting boards. The northeast wall has a mid to late 19th-century ornate cast iron fireplace with wooden mantelpiece (Plate 21). The ceiling is slightly coved to the northeast. The northwest window is a tripartite sash with architrave.

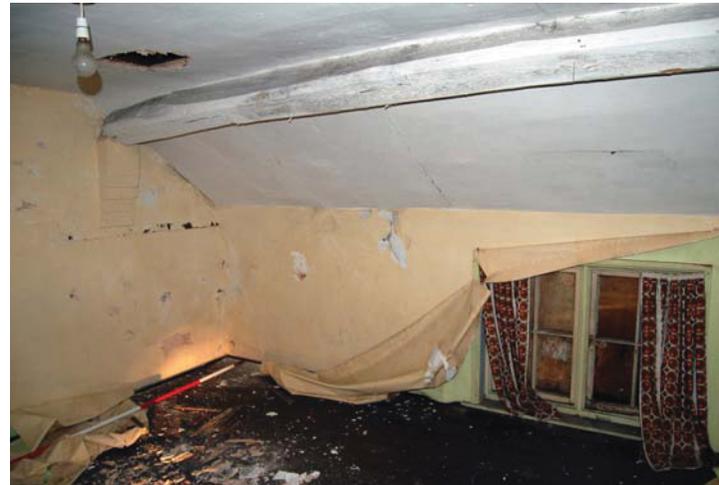
Plate 22

S1 (Plate 22) The doorways to this attic room have been inserted. There is an early 20th-century bipartite timber casement window in the southwest wall. The sill is positioned at floor level. The ceiling is coved at the southwest and northeast sides. There are two undressed beams running northwest to southeast, these are supported on brick corbels.

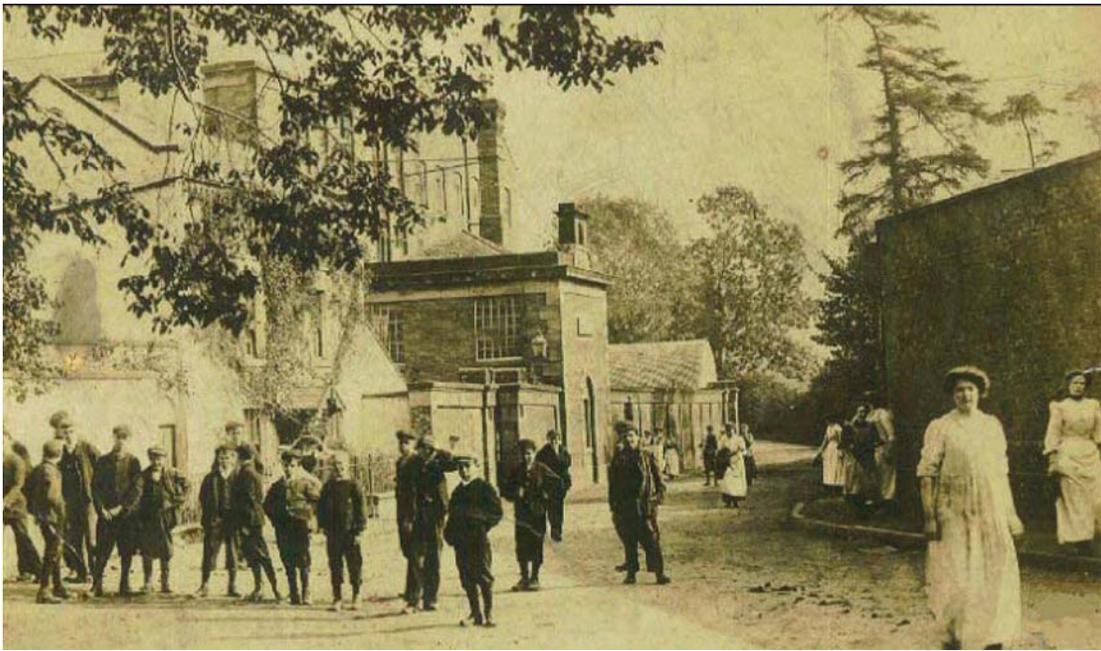
Plate 23

It is also likely that the alleyway section of G9 was also in existence at this time. What is less clear is the function and date of the now blocked segmental arch doorway to the east of this. It is possible that this may have had functional connotations. This would have provided access to G7, and may have been an alternative doorway to this room, which may have had some administrative function for the mill. Historic photographs show that this had been blocked by the early 20th-century (Plate 23).

Rooms G8 and F8 would appear to have been added later than the main block above. Architectural and cartographic evidence suggest that this was added in the mid to late 19th-century. The 1881 OS map is the first source to show this extension along with the addition of the kitchen G10. It is likely that the trellised porch was added in the late 19th-century as part of a late Victorian trend for adding these features for climbing plants. This is shown on an early 20th-century historic photograph (Plate 23).
