**Former Taunton Cider Company
Premises, Norton Fitzwarren,
Somerset**

**Historic Building Assessments
2006**

Project No.1404
February 2006

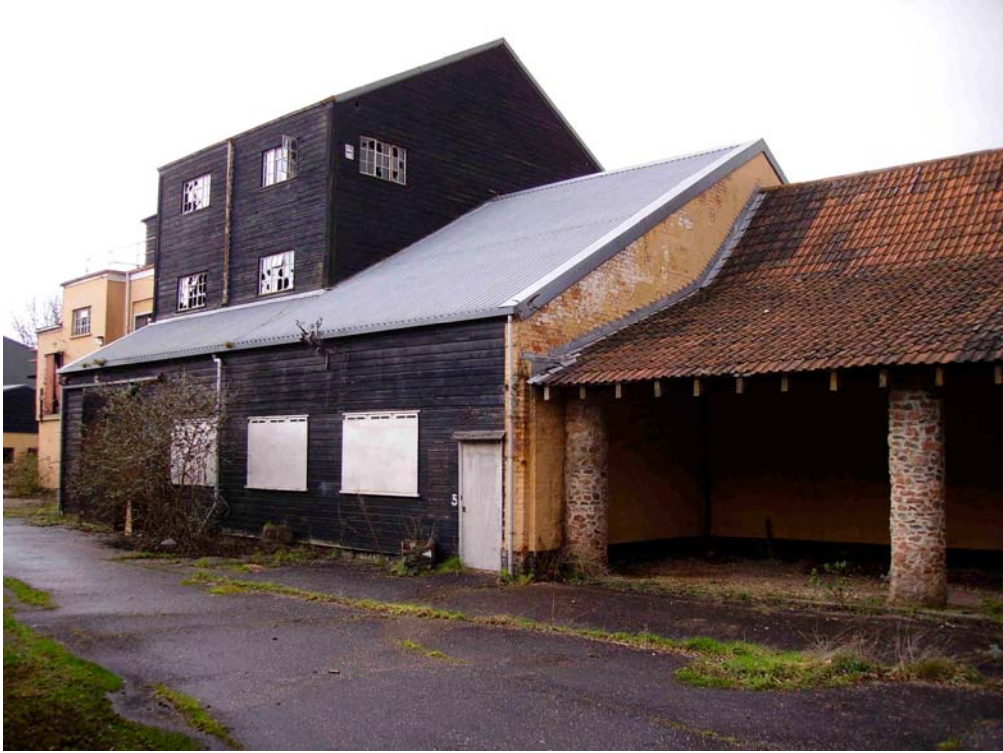
Plate 1

- 1. Building 1 from the northeast
- 2. Building 2 from the northwest
- 3. Building 2, east wing from the southeast
- 4. Building 2, west wing from the southwest

Cider manufactory. Early 20th century with later alterations and additions. Timber-framed and weatherboarded. Three storey main block towering above lower brick and timber-framed extensions. Nothing significant inside.

Of local interest only as the early nucleus of the Taunton Cider Co.

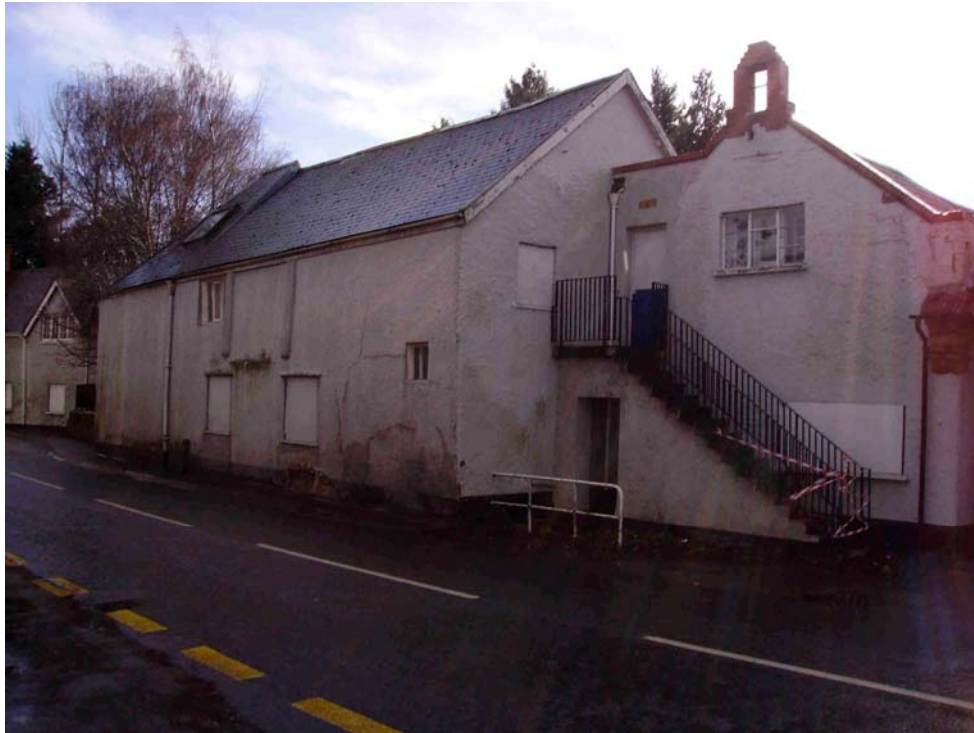
Plate 2

House. 17th-century with later alterations and additions. 17th-century main range aligned east-west and facing onto the road (Plate 2), with 17th-century north-south aligned east wing (Plate 3) and long north-south aligned west wing of uncertain date but mainly 19th-century in its present manifestation (Plate 4). The walls are largely roughcast, but areas of coursed rubble walling are exposed in the north wall of the north range and the south wall of the west wing. Mainly slate roofs but the west wing has a Bridgewater pan tile roof with half hip at the south end. North elevation: Two storeys. Main range to centre with scattered fenestration, and blind hipped end of east wing to the left providing a slightly irregular continuation of the roofline. Gabled west wing set back to the right with doors at ground and first floor level to the left, the former within, and the latter approached by, a flight of steps with plain steel railing. Brick coped gable terminating in a small bellcote. Carriage entrance to the right with pan-tiled canopy. West Elevation (West Wing): Irregular fenestration with wide vehicular access at the right-hand end. A single-storey brick lean-to with pan tile roof has been added to the south end of the west wing. East Elevation: Three window bays

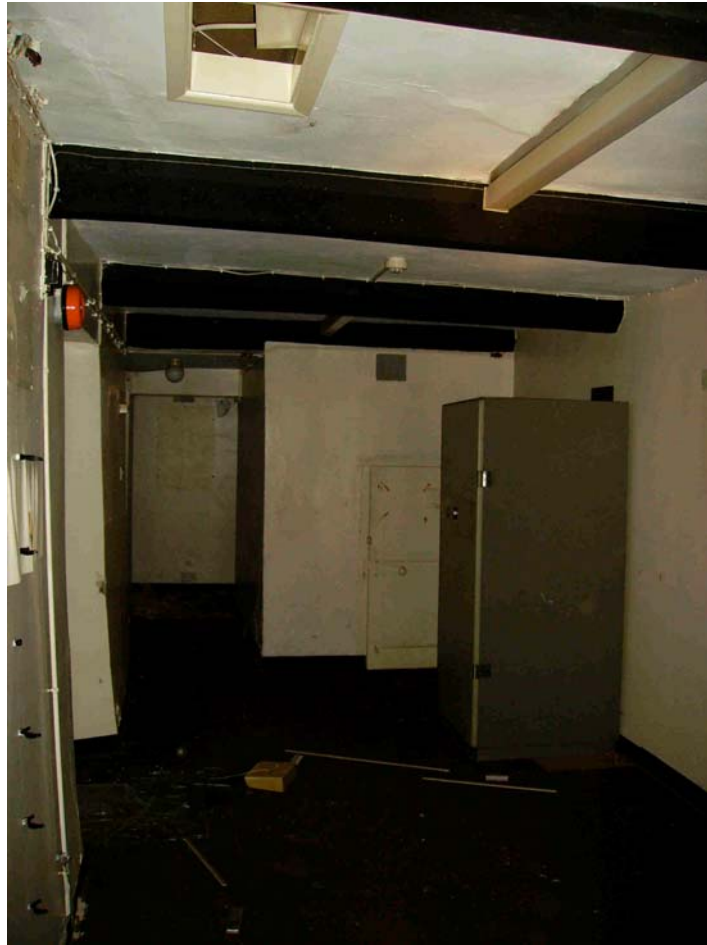
Plate 5

- 5. Building 2, north range ground floor from the east
- 6. Building 2, north range ground floor, inscription from the east
- 7. Building 2, east wing ground floor, recess from the north

The north range contains four transverse ceiling beams with wide chamfers (Plate 5), splayed window embrasures and a blocked doorway towards the east end of the south wall. At the west end of the range is a massive chimneystack, with a tablet bearing the date '1608' and the initials 'VC' or 'WC' flanking an apotropaic mark comprising a star of David within a circle (Plate 6). The inscription appears to be of comparatively recent date but seems to be an attempt to replicate 17th-century lettering, and may be a copy of an original feature. A safe has been inserted into the east side of the stack in the 20th century, presumably into a former open fireplace. Later division and cladding of the interior has obscured the original arrangement, but there seems to have been a large room at the west end of the ground storey, served by the chimneystack, and at least one smaller room at the east end.

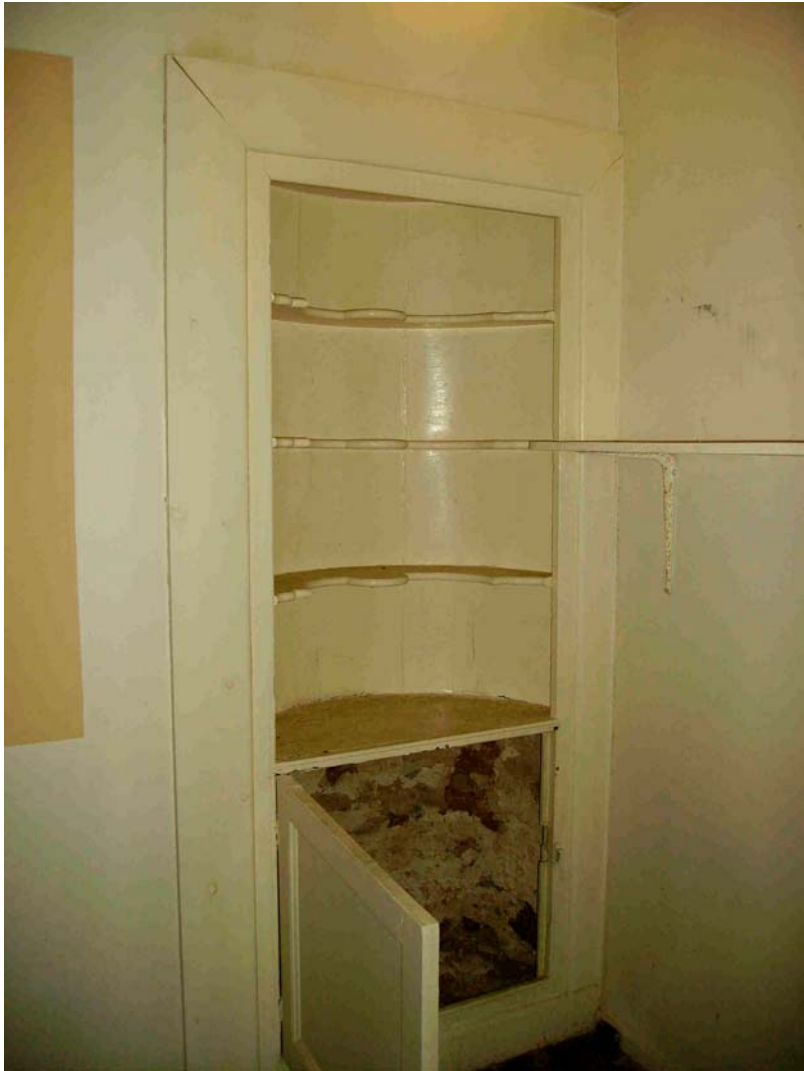
Plate 7

The east range has three splayed window embrasures on the east side corresponding to the three rooms into which the range is divided. Against the south wall of the northern room is a chimneystack with former open fireplace, converted into a recess with shelving. There is also a chimneybreast protruding from the west wall, apparently associated with the north range. There also seems to be a chimneystack against the south wall of the southern room, now much disguised but also apparent on the first floor. On the west side of the stack is a recess containing shaped shelves, probably 19th century, but reminiscent of 17th-century patterns (Plate 7). On the west side of the wing is a newel staircase set within a semi-circular well, presumably a stair turret that protruded from the external face of the wall, but which is now obscured by later additions. The stairs themselves seem to have been renewed but the 17th-century newel with its decorative finial at first floor level survives (Plate 8).

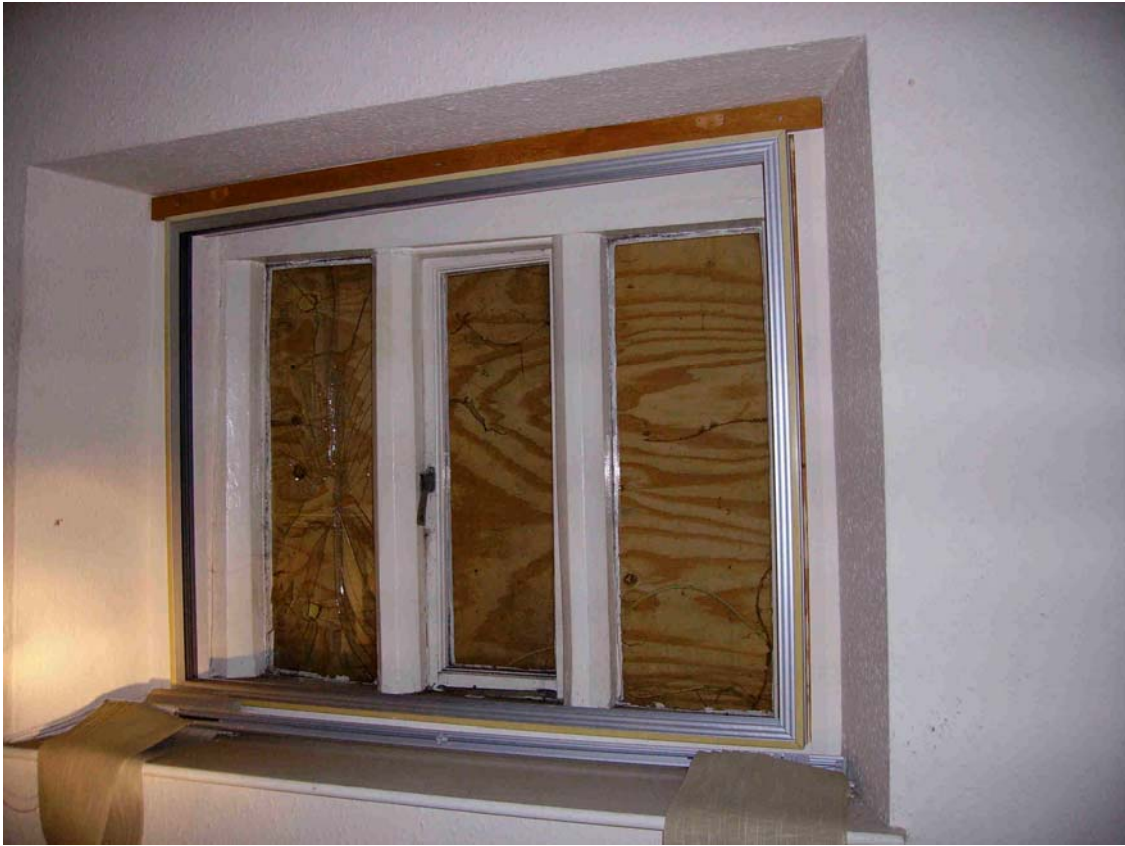
Plate 9

- 8. Building 2, east wing, stair newel from the east
- 9. Building 2, east wing, mullioned window from the southwest
- 10. Building 2, north range, eastern roof truss from the southeast

Both the north and south walls of the north range have splayed window embrasures, of which the easternmost on the north side retains a 17th-century three-light wooden mullioned window, the mullions chamfered to front and rear (Plate 9). The roof of the north range was not accessible at the time of this assessment, but the eastern end truss was partially visible from the roof of the east wing. This seemed to be a 17th-century collar and tie beam truss with studs between the two horizontal members and wattle and daub infill (Plate 10). The principal rafters were cut off just above the collar, possibly indicating that the roof was hipped.

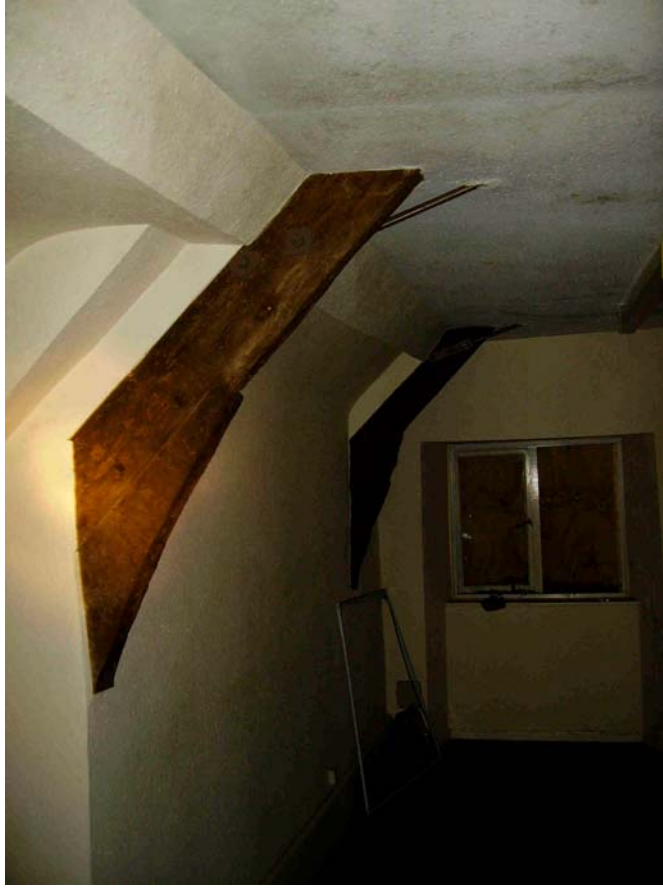
Plate 11

- 11. Building 2, east wing, jointed crucks from the north
- 12. Building 2, east wing, roof truss detail
- 13. Building 2, east range, roof truss from the north

The east wing also has splayed window embrasures at first-floor level, and, like the north range, retains a 17th-century three-light mullioned window. At the south end of the wing are three side pegged, morticed and tenoned, jointed cruck trusses (Plate 11), the

principals of which contain mortices for two pairs of tenoned purlins, though only one is occupied. These trusses are linked by collars, that of the central truss apparently tenoned and pegged, whereas that of the northern truss is jointed with nailed bare-faced tenons (Plate 12). This northern truss is closed with wattle and daub infill, and coincides with a partition wall, which may also be of timber-framed construction (Plate 13).

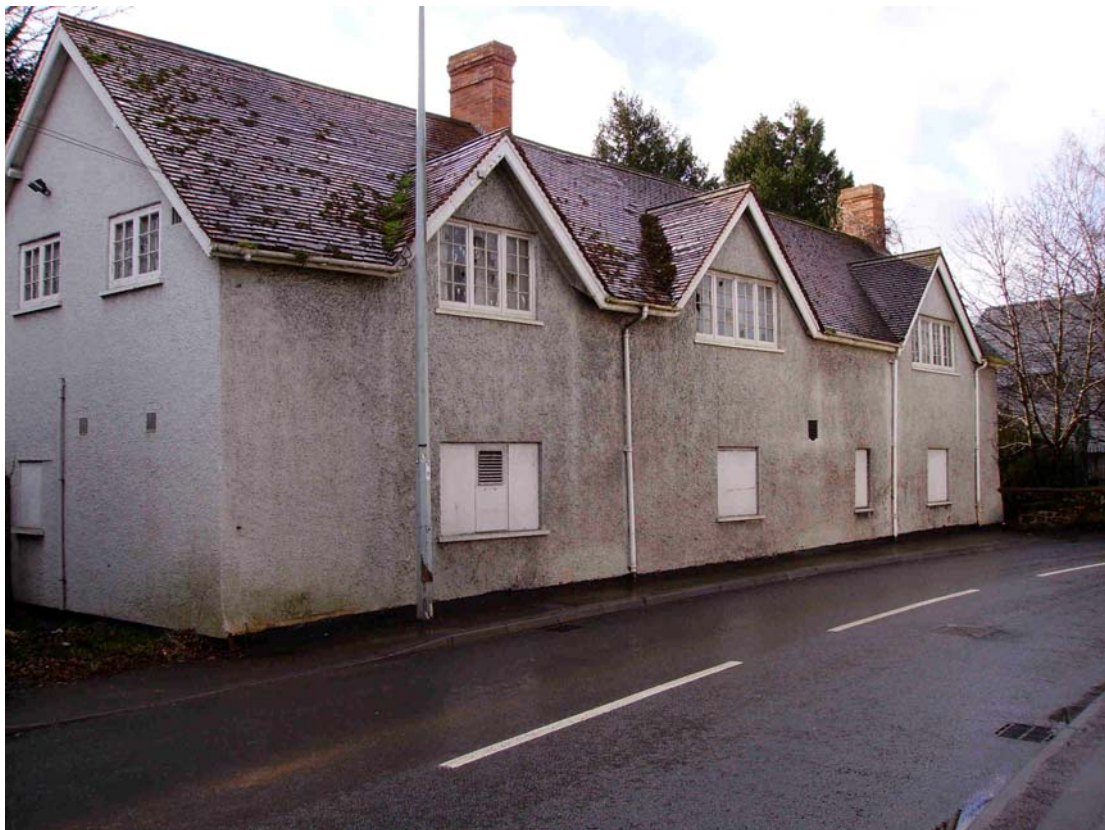
Plate 14

- 14. Building 3 from the northeast
- 15. Building 3 from the southwest
- 16. Building 3, ground floor fireplace from the east
- 17. Building 3, blocked doorway from the south

House. 17th century with later alterations and additions (Plate 14). Roughcast with plain tile roof and brick ridge stacks. Main north range aligned east west facing towards the road with north-south aligned rear wing, and rear extensions to the north range. Two storeys and three window bays, the ground-storey windows boarded over, and the first-floor four-light first floor casements under gablets. To the rear are a number of brick extensions ranging in date from the early 19th century to the 20th century (Plate 15).

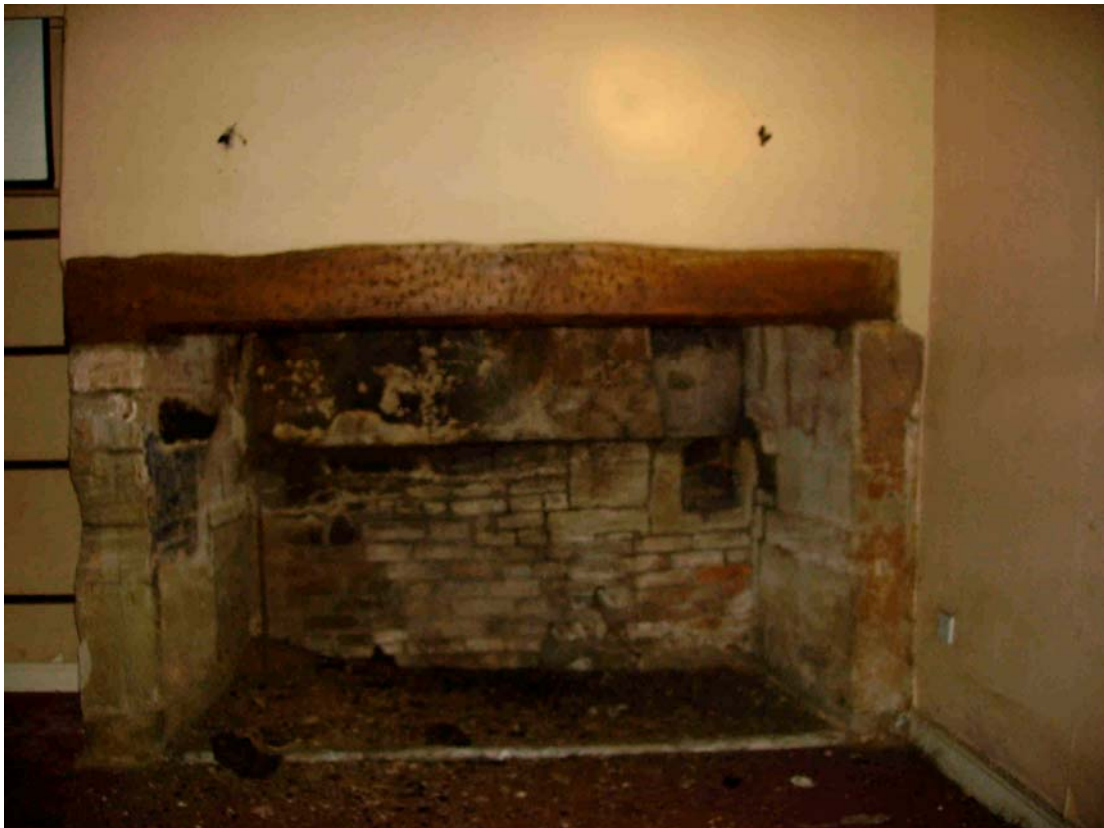
Plate 16

The interest of the interior lies within the north range. This, like the north range of Morse's House contained a large room at the west end, which, also like Morse's House has a large eastern internal chimneystack. However, this one has an exposed large open fireplace with sides of coursed and dressed stone blocks and chamfered and stopped timber mantle beam (Plate 16). In the back of the fireplace is a small oven. South of the fireplace on this wall is a recess and then a small splayed window embrasure. Three

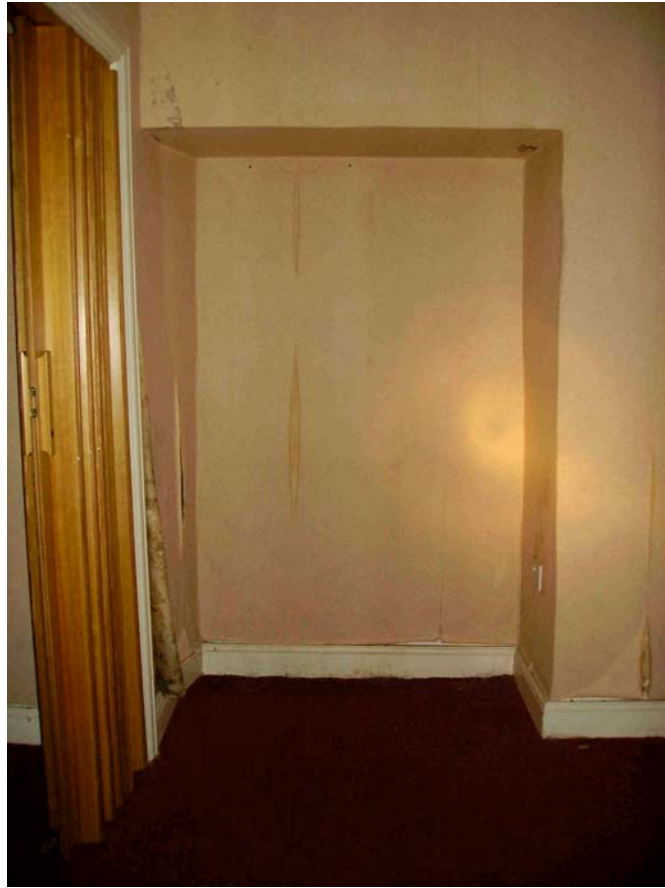
Plate 17

further splayed window embrasures survive in the north wall in this room, and there is a recess for a blocked doorway in between the central and eastern embrasure (Plate 17). In a smaller room to the east, is a splayed window embrasure, and in the south wall a doorway set into a splayed recess, possibly a former window. The first floor was inaccessible at the time of this assessment.

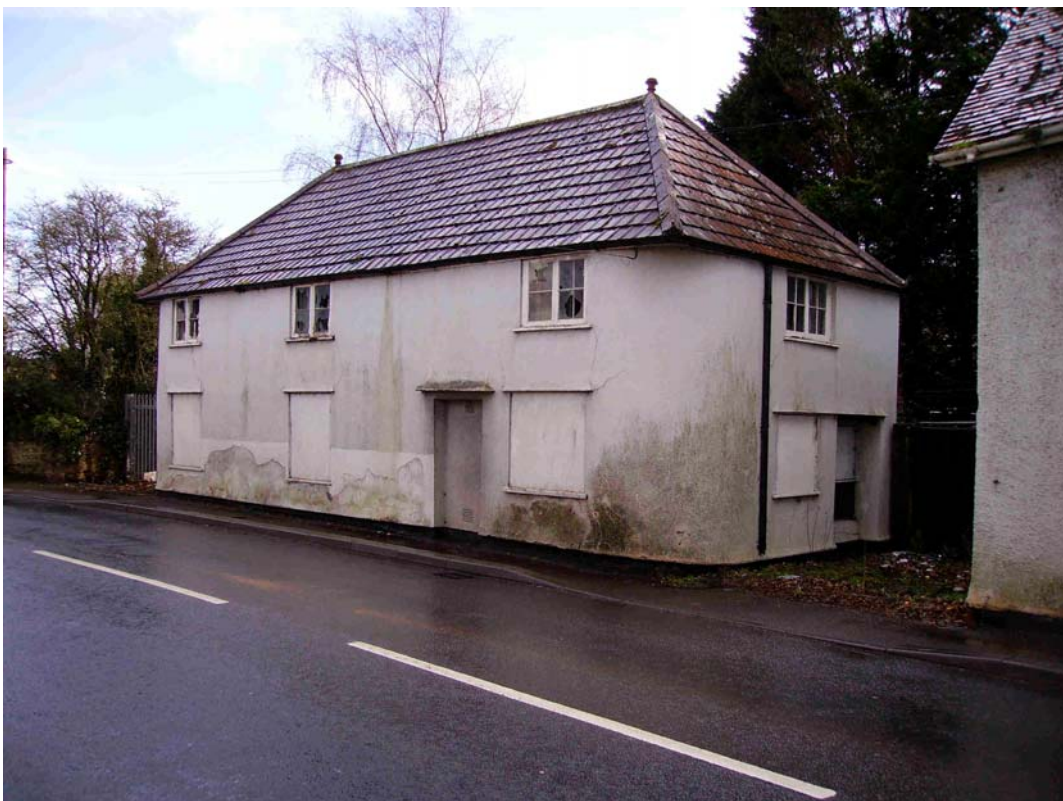
Plate 18

- 18. Building 4 from the northwest
- 19. Building 4, staircase from the southwest
- 20. Building 4 roof trusses from the west
- 21. Building 4 roof truss detail from the southeast

House. Mid to late 19th century, incorporating earlier material, with later rear extension. Rendered coursed rubble walls and hipped interlocking tile roof with hip apex finials. Aligned east-west facing north towards the road with rounded front corners. Two-storey, three-bay building with door to right (west) of centre. Lit by 19th-century casements (Plate 18).

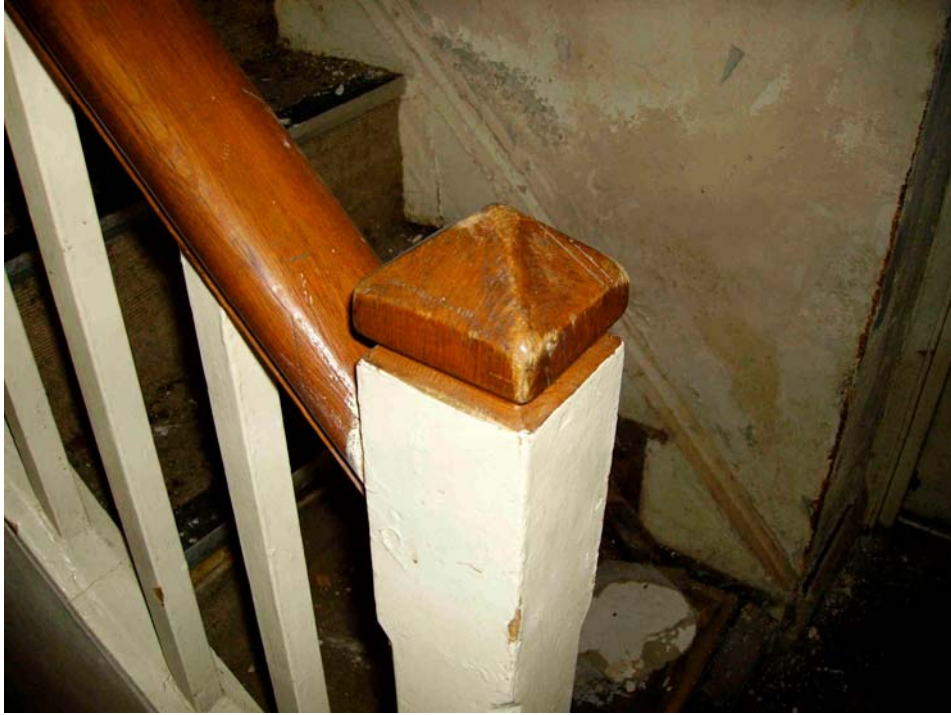
Plate 19

19th-century straight staircase with stick balusters and chamfered foot newel towards the western end of the house (Plate 19). The main interest of the house is on the upper storey, which is divided into five roof bays by four trusses (Plate 20). The principals carry two pairs of tenoned purlins and are tenoned into the stubs of tie beams, which seem to have been cut away flush with the soffits of the principals (Plate 21). These trusses, with their traditional jointing and pegging techniques including tenoned purlins, appear to pre-date the 19th-century range for the house suggested by the map evidence (i.e. between 1840 and 1889), and are probably re-used.
