The Former Royal Brierley Crystal  
Works, Brierley Hill, Dudley,  
West Midlands:

An Archaeological Watching Brief,  
2005

Project No. 1306  
December 2005

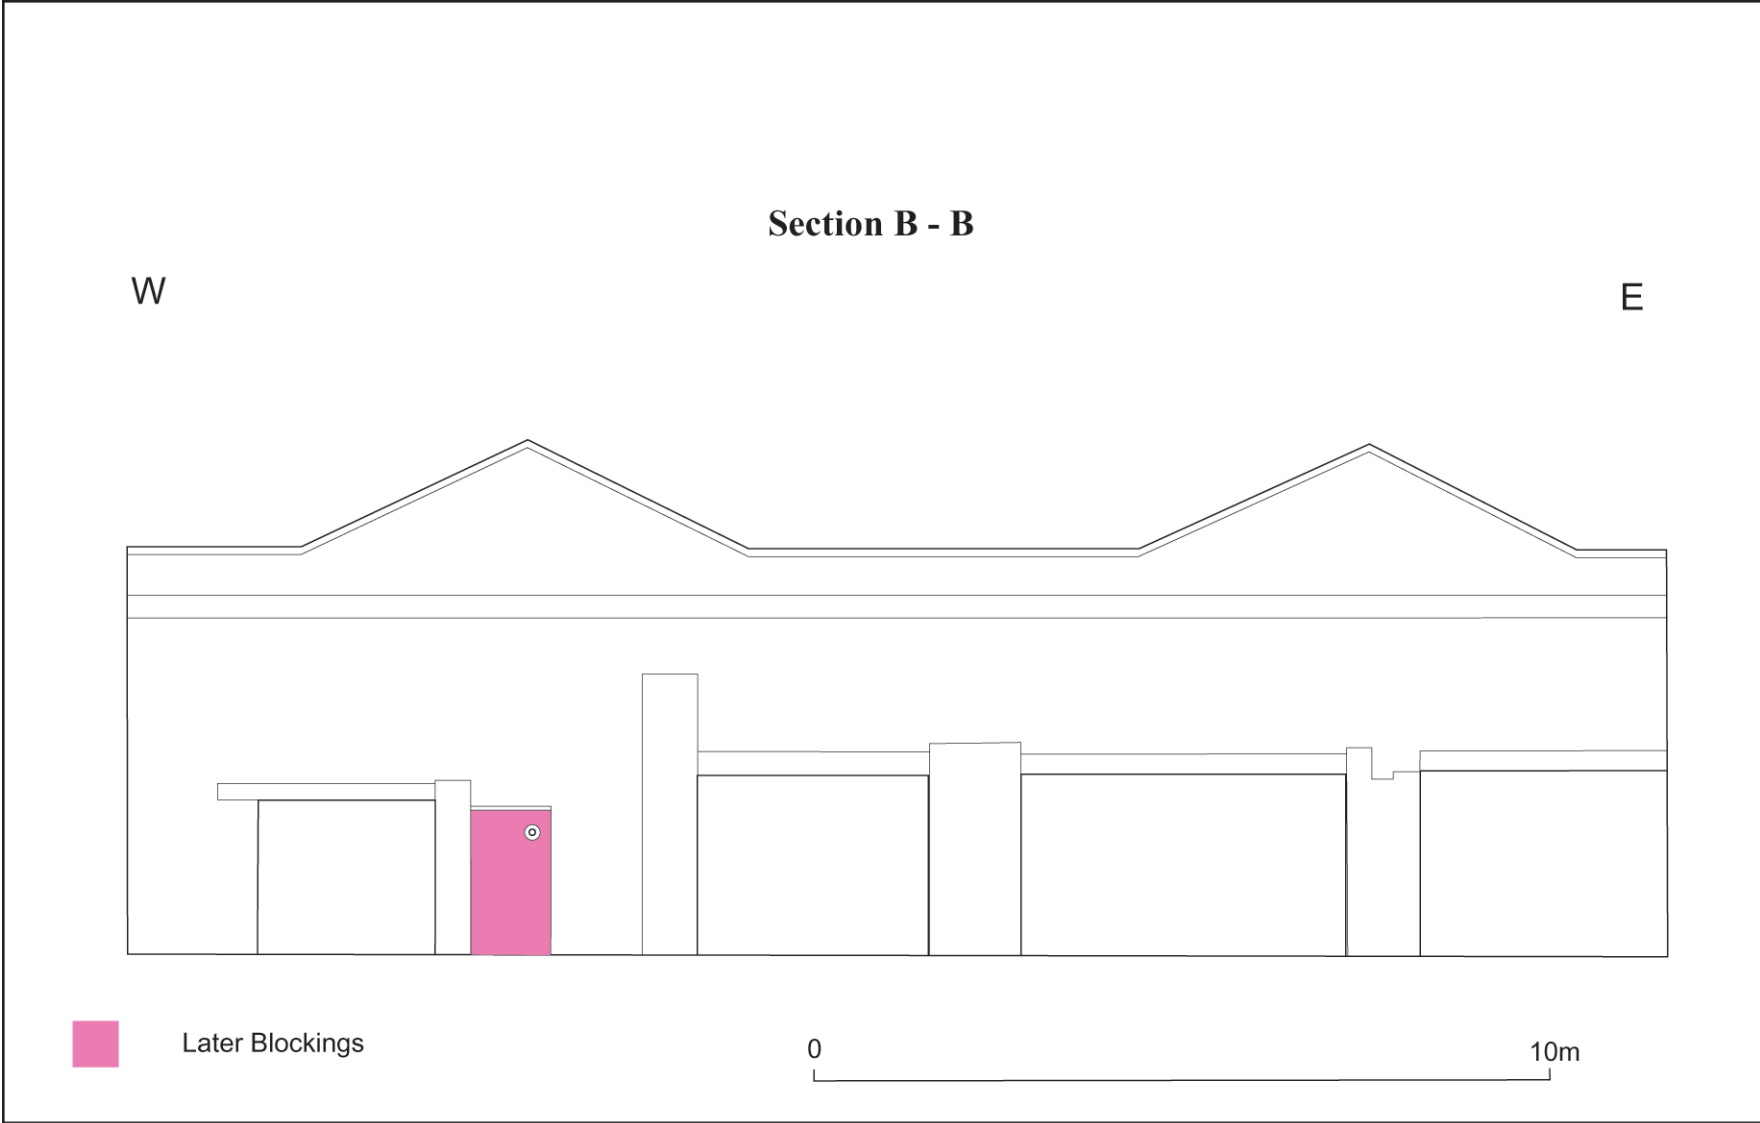
Fig.4

### **South Wall** (Fig. 4, Plate 2)

Removal of the buildings to the south had revealed remains of the twin gables above the recorded eaves level. Later concrete coping lined the top of the gable and wall. Fabric was hand-made bricks in an English Garden Wall bond.

Interior stripping revealed nothing more about the fabric of this wall.

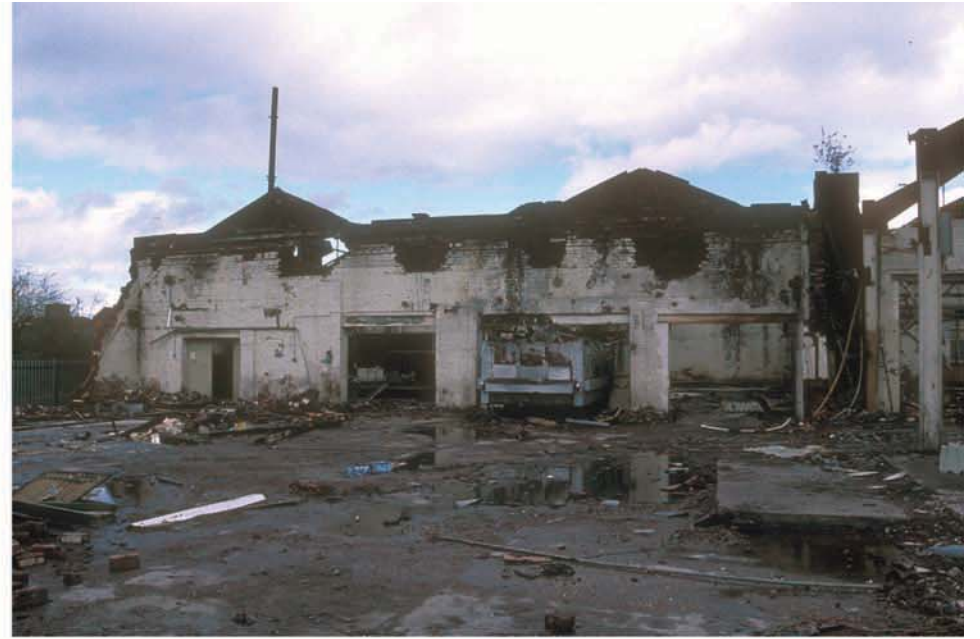
Plate 2

The supplementary recording has revealed some further information about the fabric of the 1870s glass house, in particular the height and nature of the southern wall that had been previously obscured by buildings that stood to the south of the glass house.
