7, 8 and 8A Freeman Street,
Birmingham

Supplementary Historic Building
Recording
2006

Project No. 1528
November 2006

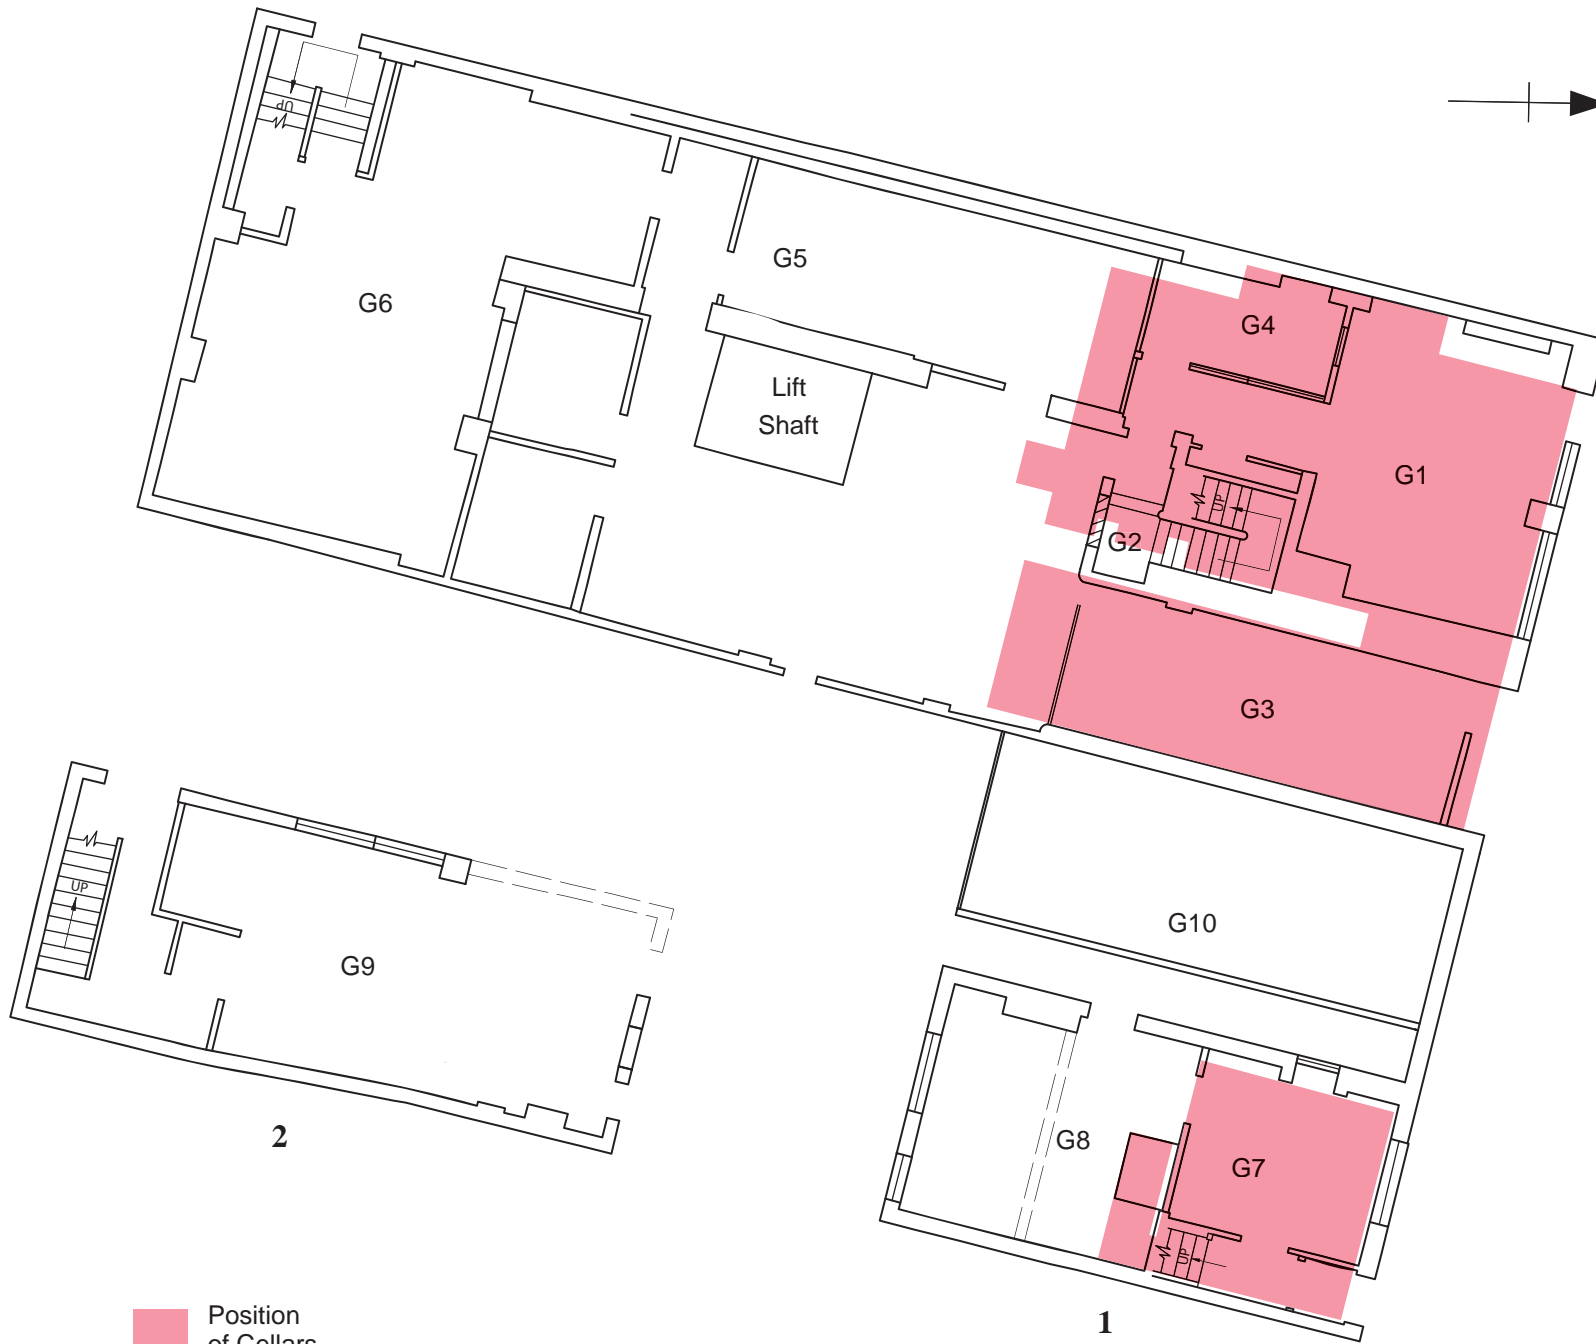
title Ground Floor Plan	fig no. 3
scale	date November 2006

The targeted removal of later cladding has revealed earlier fabric along the east elevation of No. 8 Freeman Street (Plate 1, Fig 3).

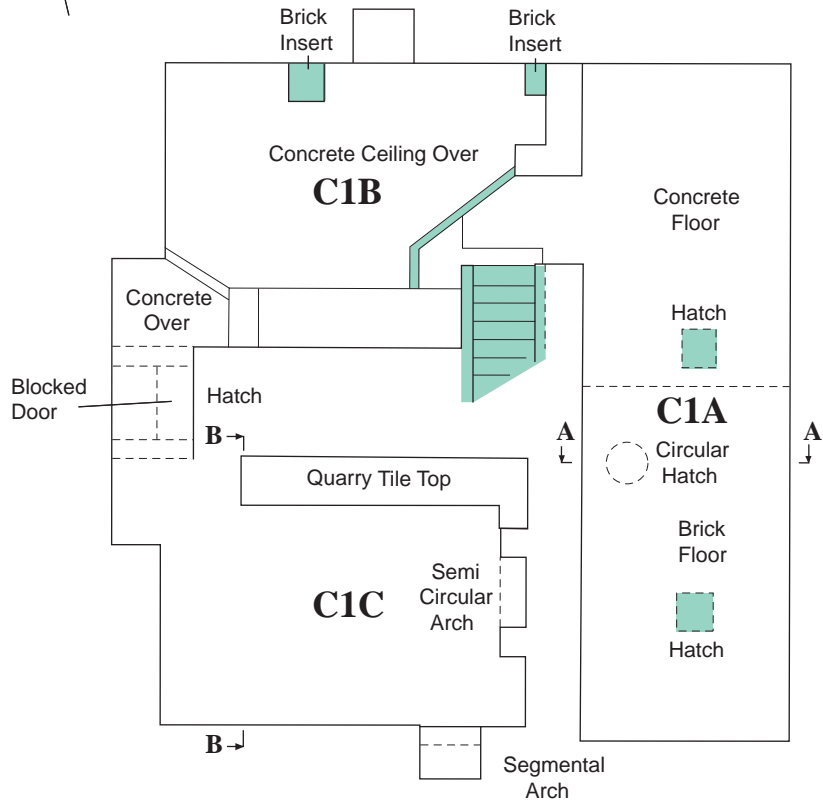
title **Cellar Plan** fig no. **4**

Cellars C1 are found beneath the northern half of No. 7 Freeman Street. They all appear to be of 19th-century date, although the sizes of some of the bricks may indicate that they incorporate 18th-century fabric. There are three separate and distinct cellars within this space, entered through a doorway in the west wall of G3. Access is gained down a flight of mid-20th-century concrete stairs with 13 steps to C1B below. C1A is along the corridor to the east, C1B is to the west (Fig 4).

The cellars appear to be mainly 19th- century in date (Fig 5), although they may retain 18th-century fabric, in which case it is possible that the layout owes something to the original phase of development at this site, which is purported to have been built between 1731 and 1750 (Hislop and Lobb, 2006).

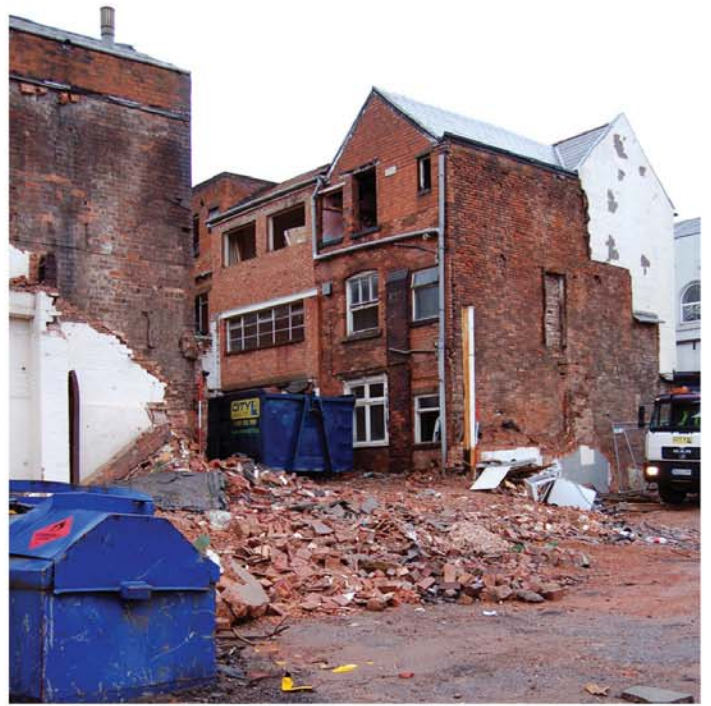
Plate 2

Elevation 1 was the east elevation of the main north range. Stucco-type render was removed here to reveal what may be a section of the boundary wall. This is of red brick (8¾ ins x 2½ x 4 ins) laid in English Garden Wall bond, but the unsatisfactory bonding of this wall with the north and south walls of the building suggest that both these two elevations have been rebuilt, leaving the east wall as a remnant of an earlier structure. The brick size may suggest a date in the late 18th century or early 19th century. There is no evidence for fenestration on this elevation (Plate 2).

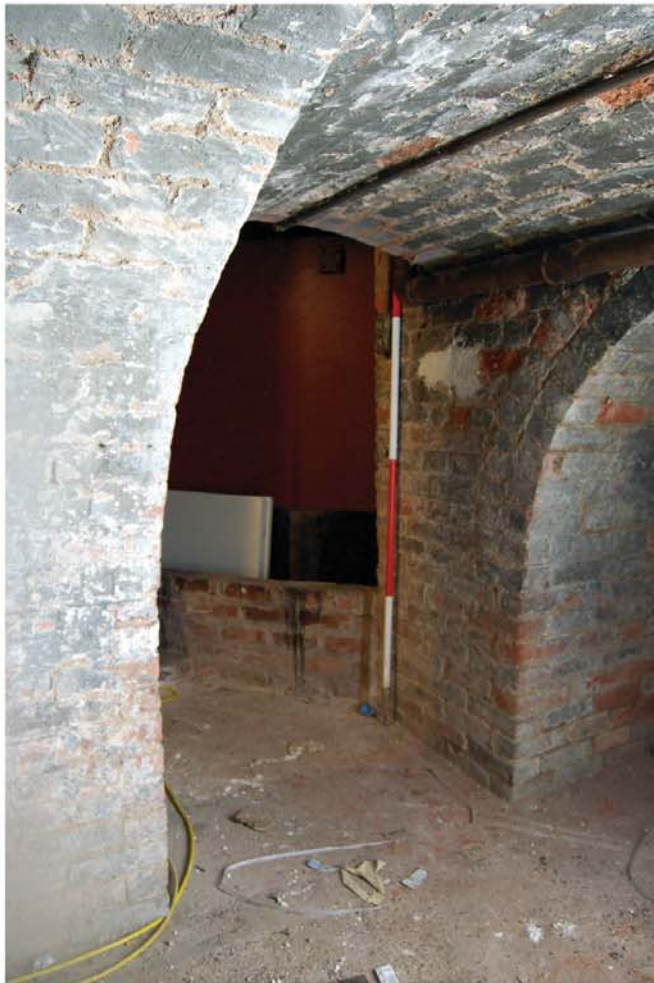
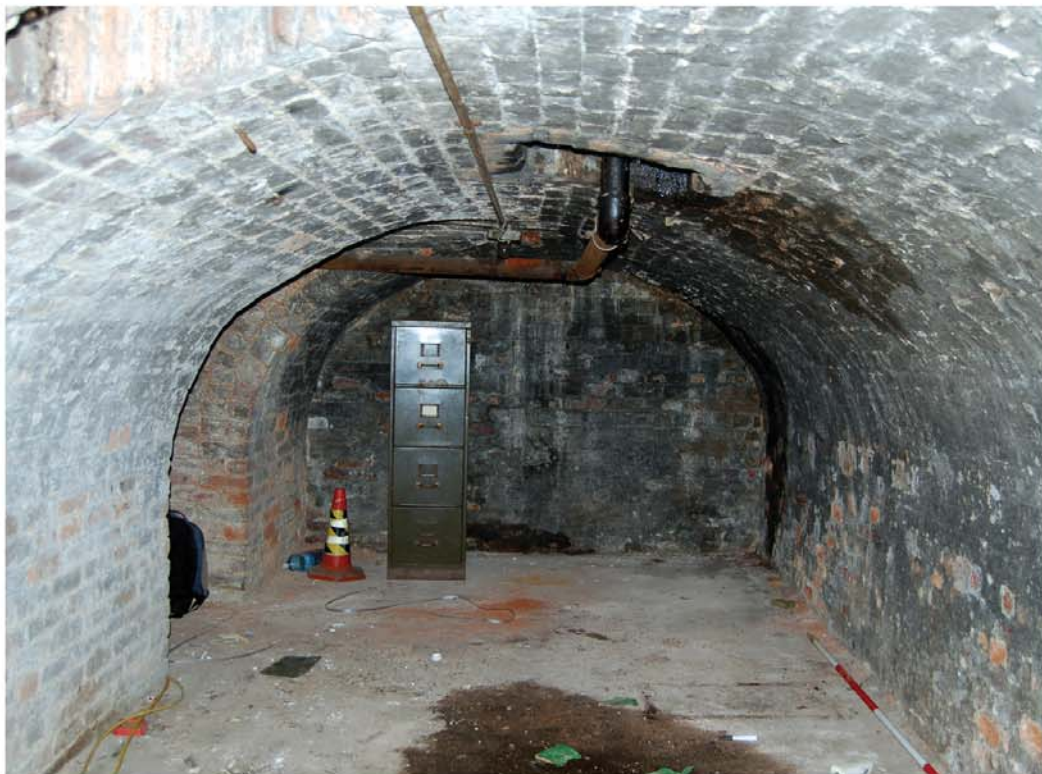
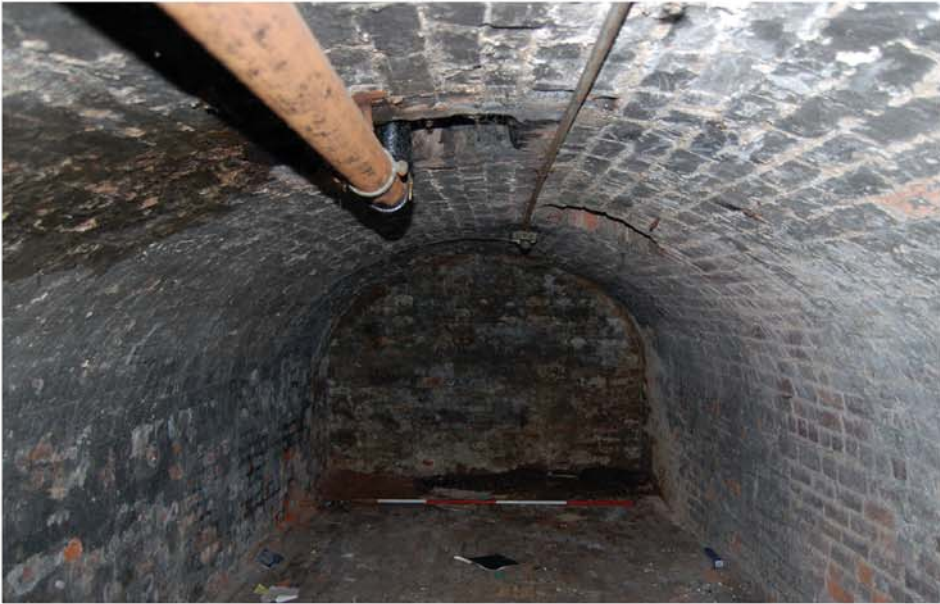
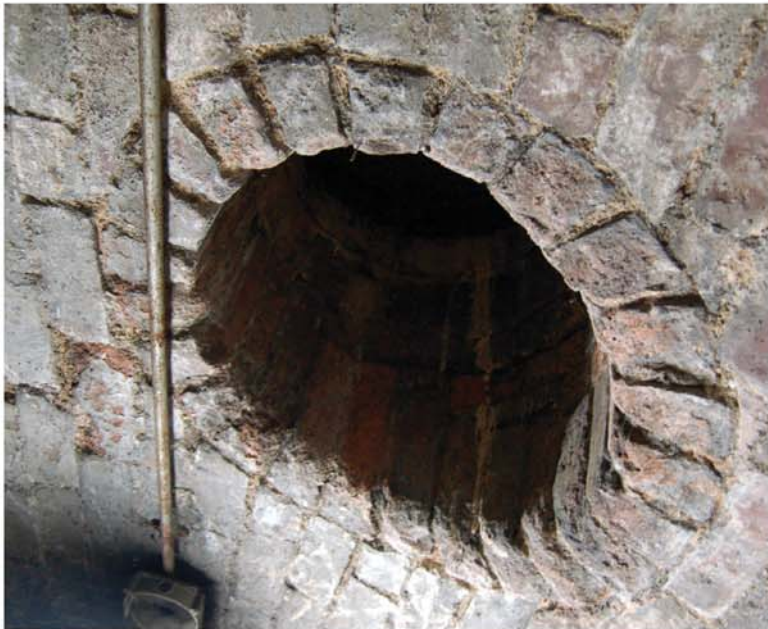
This is entered through a brick segmental-arched entrance from C1B (Plates 5 to 8). There is no evidence of a door here. The two most westerly courses of this arch are inserted, presumably to match the thickness of the wall, following the insertion of the stairwell. This rectangular shaped room has a concrete floor surface to the north and a brick floor surface to the south. These bricks measure $8 \frac{5}{8}$ ins x $2 \frac{1}{2}$ ins and run from north to south. There is a raised line of bricks c. $\frac{1}{2}$ a brick high along the south and east walls. The walls and vault of semi-circular section are of red brick laid in stretcher bond. Interestingly, the brick used in side walls ($8 \frac{1}{2}$ ins x $2 \frac{1}{4}$ ins x $4 \frac{1}{4}$ ins) are thinner than those used in the vault (9 ins x 3 ins x $4 \frac{1}{4}$ ins). The vault contains three traps, the most northerly and southerly of which are later 20th-century inserts being square in profile with concrete sides. The other trap, which is circular and lined with red brick, appears to be an original feature.

The majority of C1A is part of this original phase of construction. The brick floor, semi-circular-arched vault, and the circular hatch all survive from this phase. The concrete floor and square hatches are 20th- century additions.

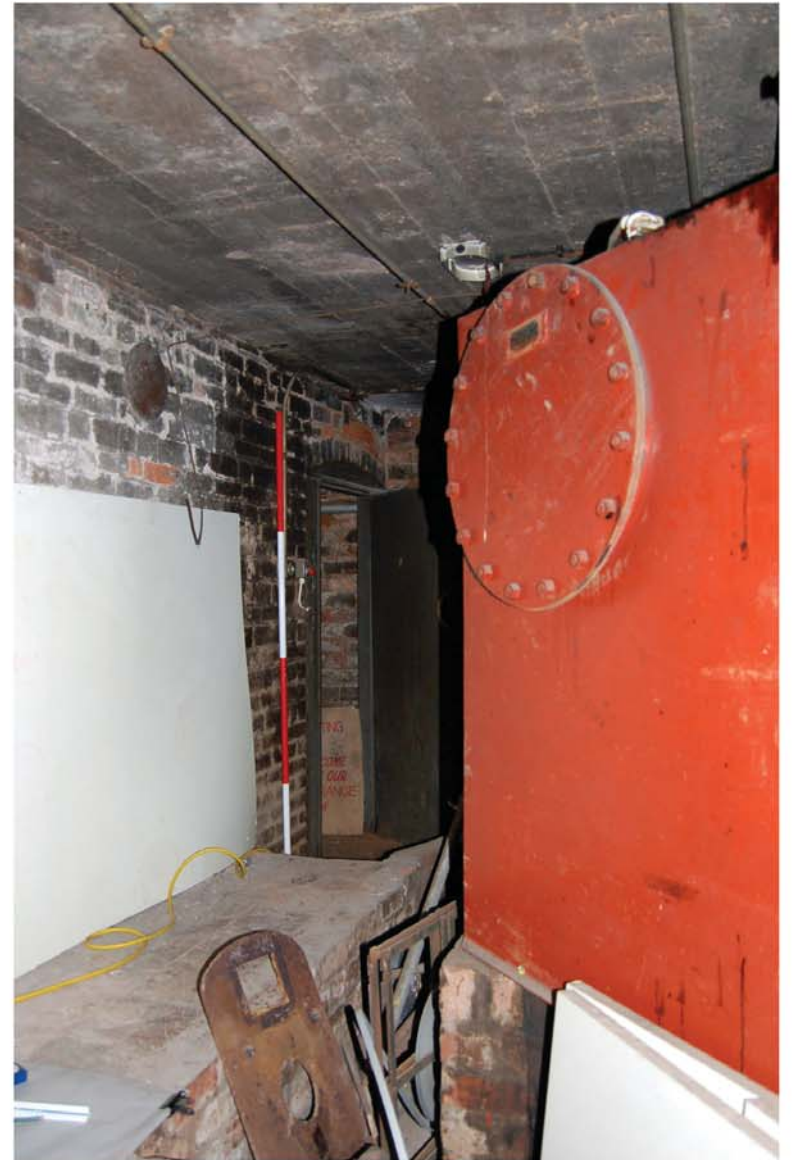
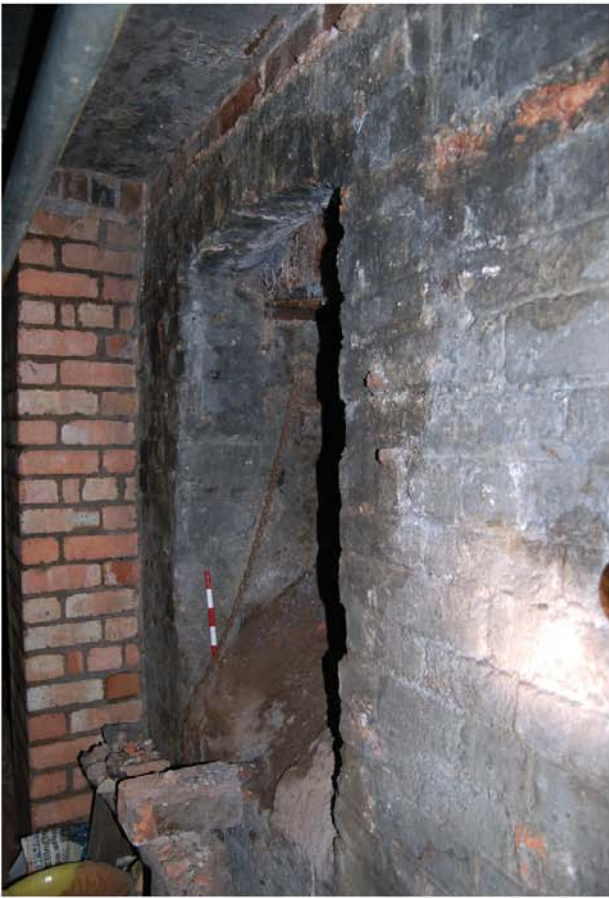
This cellar currently acts as a corridor running east-west under G1 (Plates 9 and 10). It was originally one large room, but has been altered to accommodate the insertion of a large oil tank, which occupies much of the northern half of the space. This cellar has a concrete floor and an inserted poured-concrete slab roof. The oil tank, is raised on concrete piers, and was fabricated and installed by Holyhead Engineering Co Ltd, Meadow Lane, Bilston, Coseley. The segmental arch headed chute on the north wall appears to be an original feature. The red brick piers laid in stretcher bond measuring 9 ins x $3 \frac{1}{8}$ ins x 4 ins to the west of this, and in the northeast corner of the room are inserts, and were probably inserted to support the concrete roof. The upper courses of the pier to the south of this were also inserted to support the roof. The remainder of the east wall, which is built of red brick, appears to be original.

There is a raised brick bench area along the south wall. This is coped with quarry tiles measuring $8 \frac{1}{4}$ in sq. The south wall itself is of red brick measuring $8 \frac{1}{2}$ in x $3 \frac{3}{8}$ in x 4 in, and at the west end is a segmental arch doorway to C1C. The west wall is of red brick in stretcher bond with occasional headers measuring $8 \frac{1}{4}$ ins x 3 ins x $4 \frac{7}{8}$ ins. There is evidence of scarring at roof level where the original segmental arch vaulted ceiling was once situated.

The internal division of space of C1B was altered in the mid 20th-century. Hislop and Lobb (2006) note that No. 7 Freeman Street was gutted and rebuilt at this time. The brick vault was removed or had been removed by the mid 20th-century and replaced by a poured-concrete slab ceiling. The brick piers along the north wall were inserted at this time as supports for the ceiling. The stairwell, and its west wall, are also likely to have been inserted as part of this phase of work, which also saw the installation of the oil tank and its associated brick bund. The quarry tile step/platform to the south of this room may date from this period, however it is also possible that this was altered and was originally similar to the bench in C1C. The addition of two extra courses of brick to the entrance of C1A is related to the insertion of the stairwell during this phase of construction.

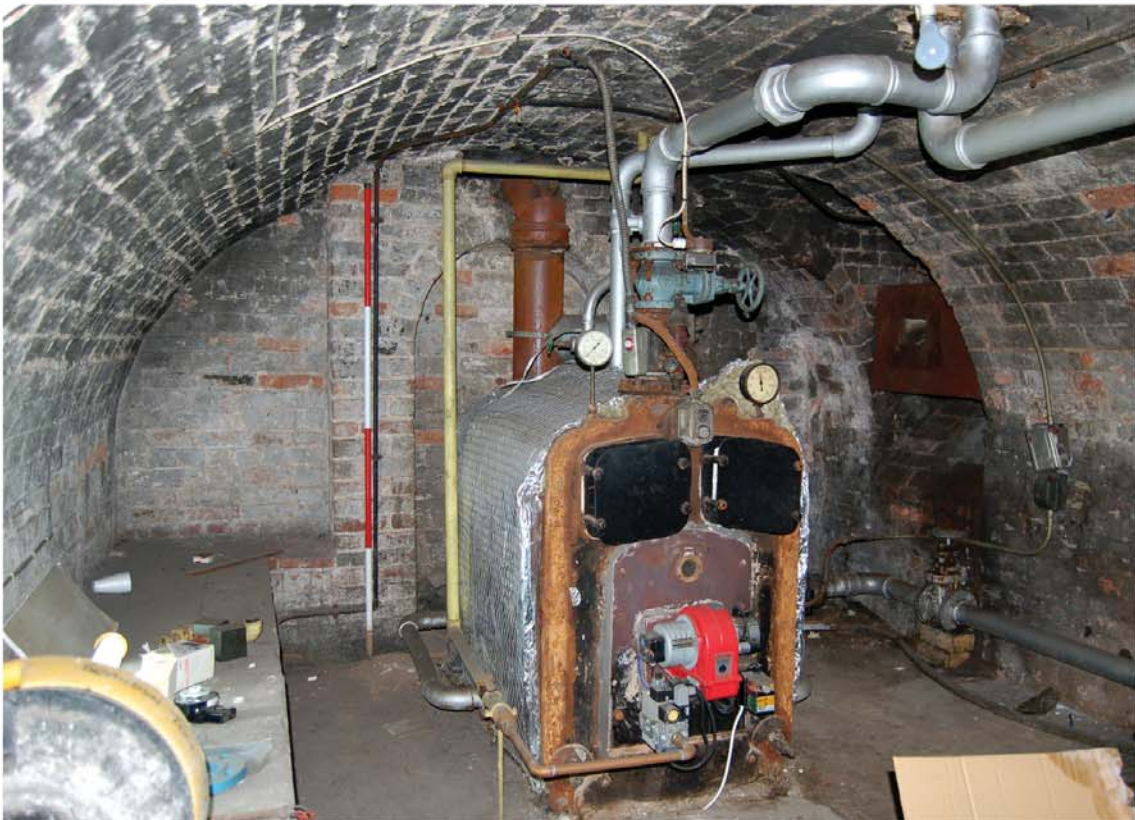
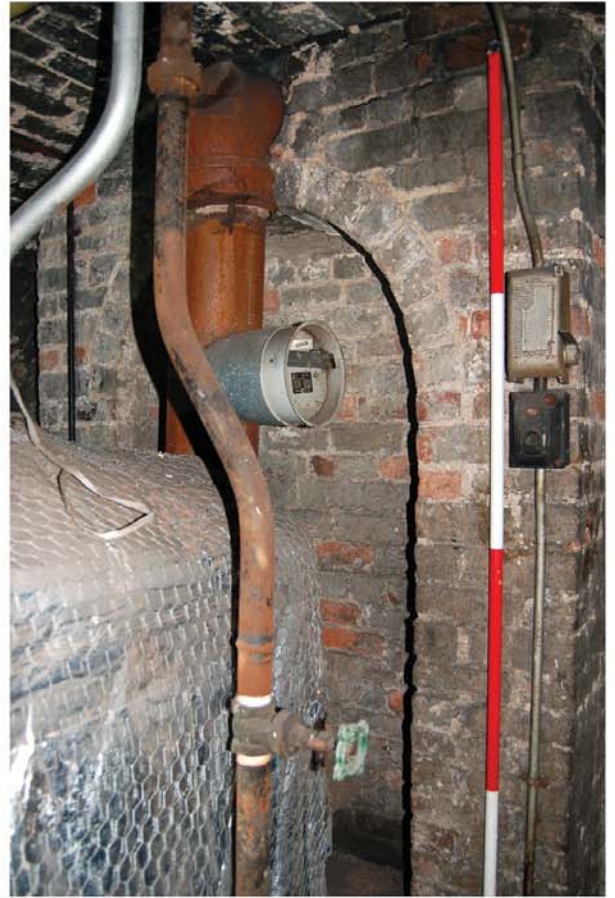
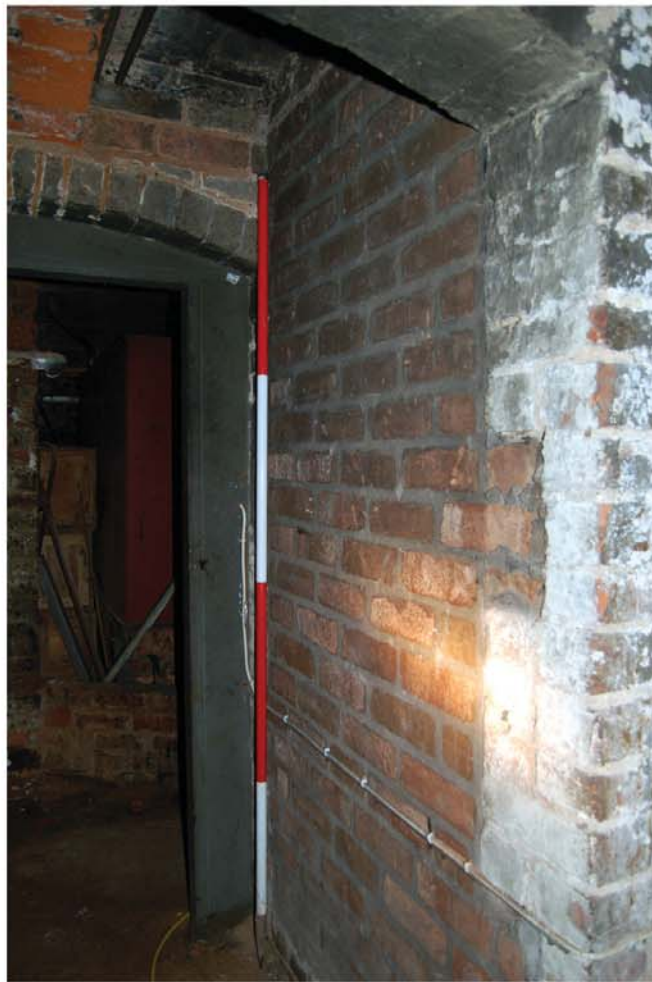
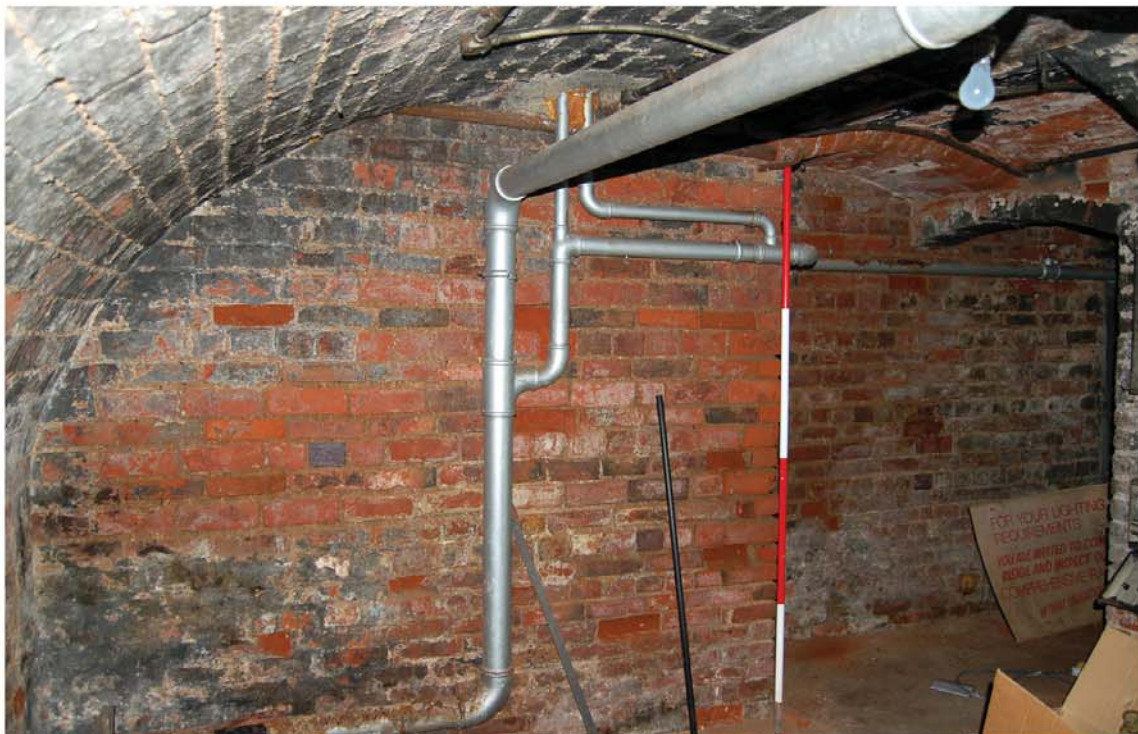
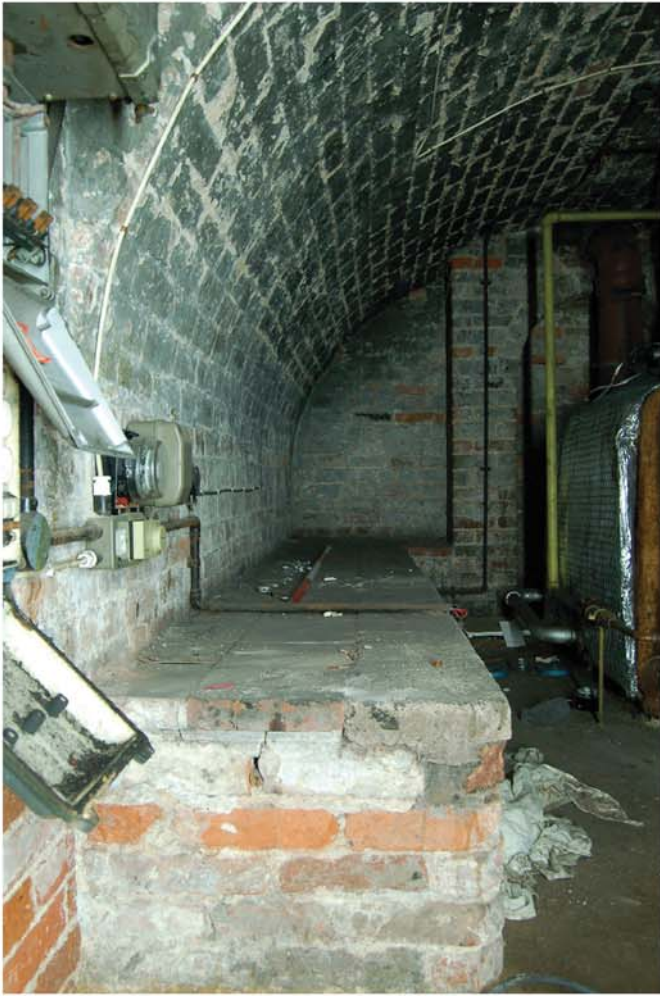
This cellar is entered through a segmental-arched opening from C1B (Plates 11 to 15). On the east side of the lobby between the two rooms is a blocked doorway, apparently to the original staircase, now blocked or removed. There is a red brick arch running north-south, and another bullnose brick segmental arch inside the entrance running east-west inside this entrance.

The cellar space itself is floored in concrete and has a semi-circular-arched vault of red brick laid in stretcher bond. There is a red brick bench/settles along the north wall with a chamfered edge and quarry tile coping. A boiler covers much of the east wall; there is evidence on the floor of further machinery to the west of this. A chimneystack base containing a round-arched alcove projects from the east wall. There is a bullnose brick segmental arch chute near the southeast corner.

The walls are of red brick laid in stretcher bond. As in C1A the bricks of the side walls are thinner ($9 \frac{1}{4}$ ins x $2 \frac{1}{4}$ ins x $4 \frac{1}{4}$ ins) than those of the vault ($8 \frac{3}{4}$ ins x $3 \frac{1}{8}$ ins x 4 ins). The northern section of the west wall is laid in English Garden Wall bond, which may mean that it is not an original feature.

The most interesting feature of note in C1C is the blocked doorway on the east side of the entrance lobby. It is likely that this leads/led to the original staircase to these cellars. It is possible that this may have been blocked prior to the insertion of its replacement in the mid-20th-century. This staircase would have been entered from above through an opening in the wall to the west of the current opening. There is no evidence in this wall for a previous opening; however, there is an I-beam at floor level, which may have been inserted to support the blocked entrance. The cement floor and boiler are also 20th- century insertions. The

remainder of the cellar appears to have been from the original mid-18th-century phase of construction. However, the north section of the west wall may be of a subsequent phase as it is of a different brick bond to the remainder of the cellar, and has an interesting arrangement of brick segmental arches above.

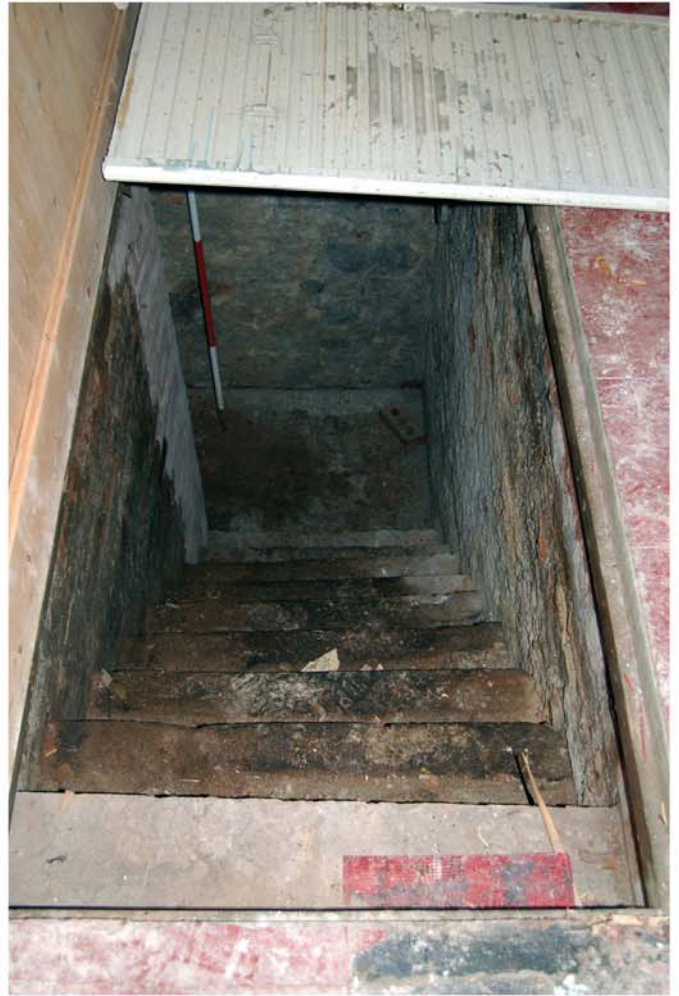
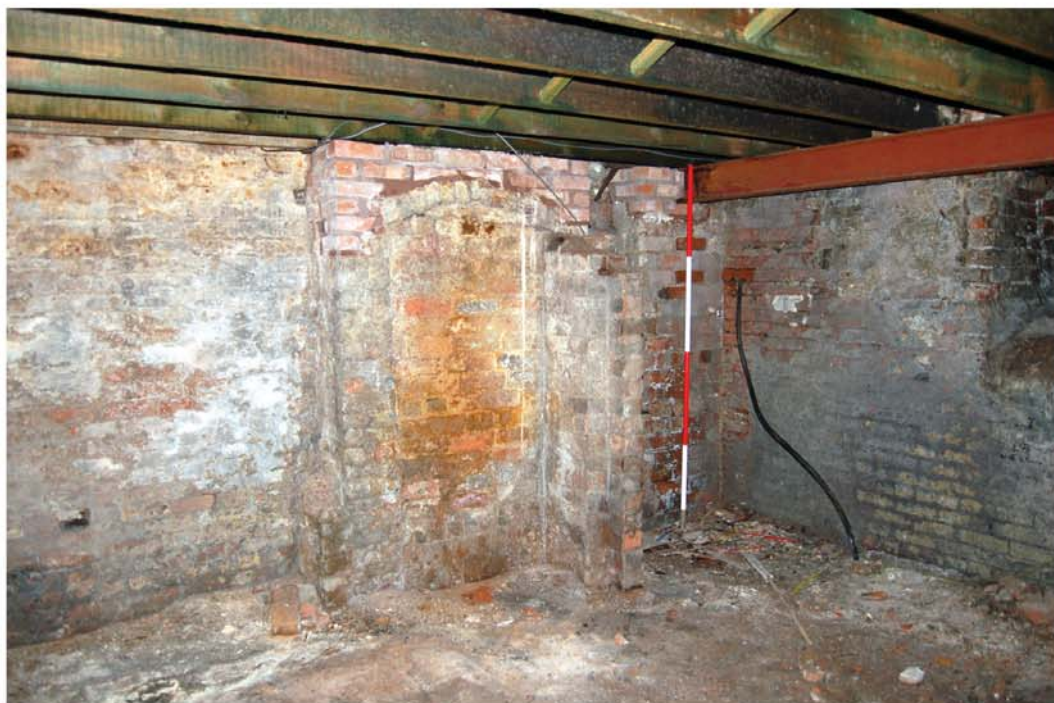
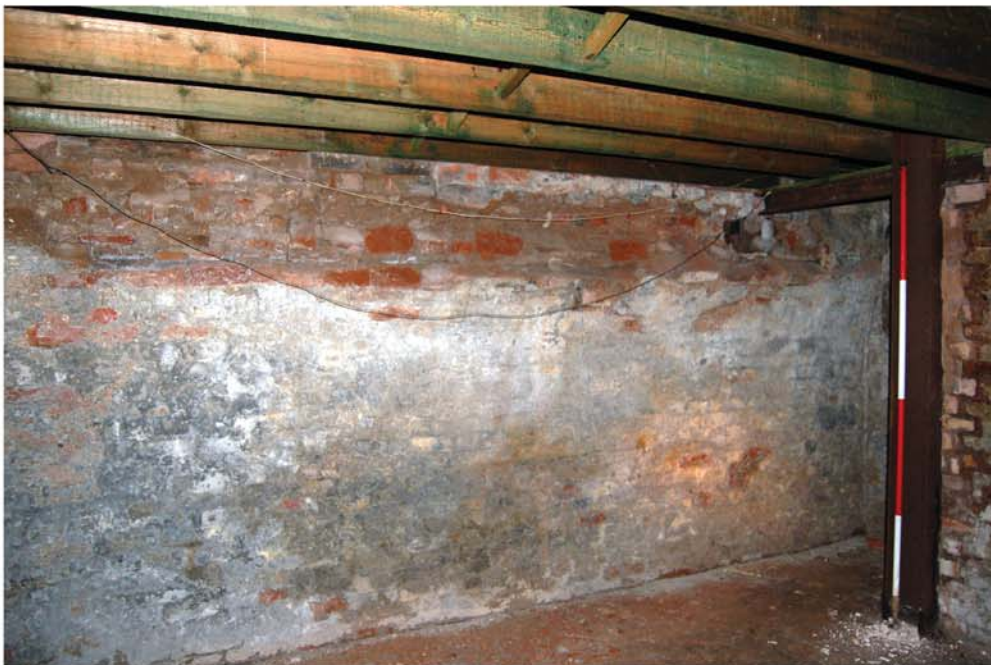
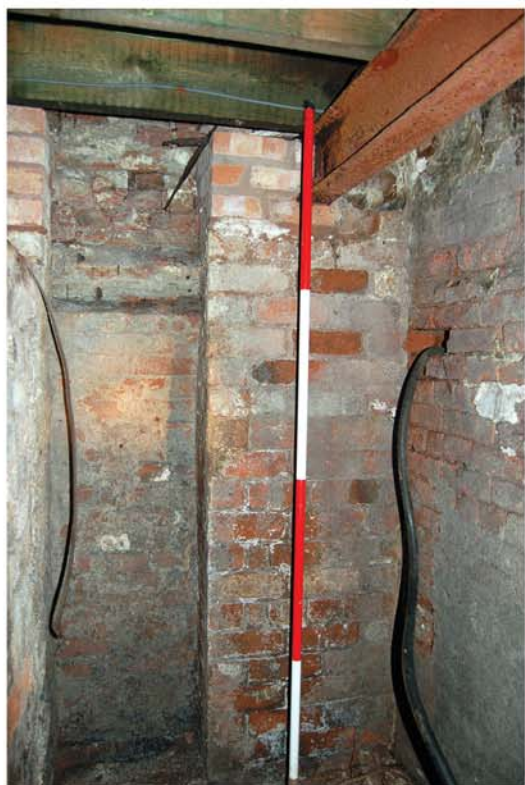
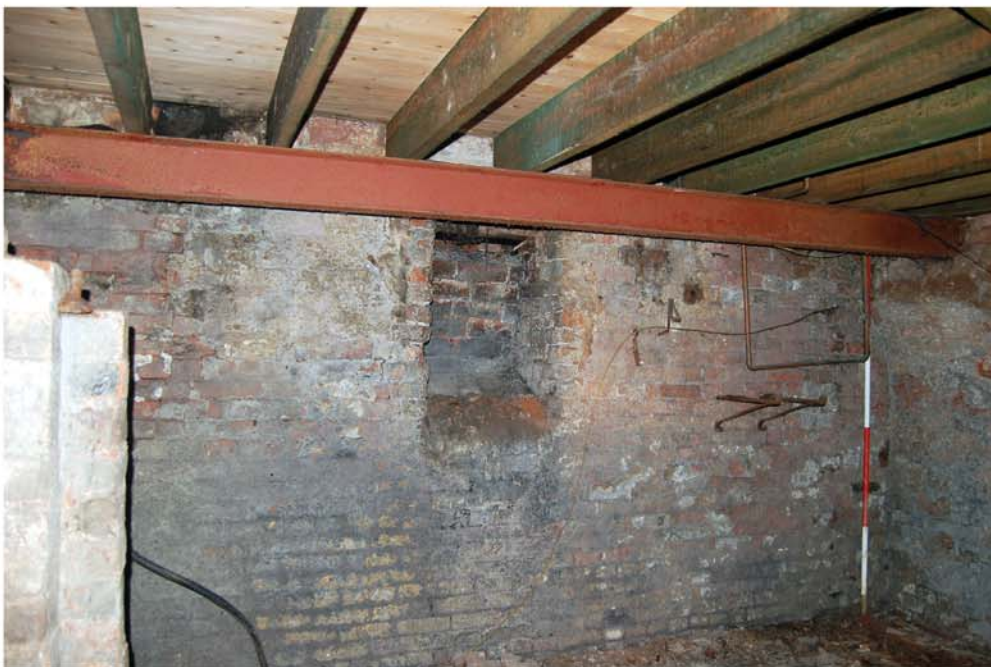
This cellar was uncovered beneath the northern section of No. 8 Freeman Street (Plates 16-20). This square-shaped room is entered through a trapdoor along the north wall of room G8. It is accessed down a flight of 10 steps; the two uppermost have brick coping, whilst the remaining steps are coped with wood planks. The floor is of concrete, whilst the vaulted ceiling has been removed and supplanted by a concrete slab replacement.

The south wall is of red brick measuring 9 in x 3 in x 4 in. the upper three courses have been inserted in order to heighten the wall to accommodate the concrete ceiling. This has been replicated on each of the other walls. There is a wooden plank in this wall at around waist level, which was probably used for levelling purposes during construction. There is an I-beam inserted above the entrance to the cellar. A chimney base projects from the west wall with a central blocked opening. A short length of brick wall projecting eastwards from the north end of this retains a door hinge. The east wall is of red brick; scarring at roof level of this wall indicates that the roof was originally a vaulted segmental arch. The north wall is of red brick and has a central chute. A 20th-century I-beam supports the roof above. There are the remains of a machine/boiler base in the southwest corner.

Whilst No. 8 Freeman Street itself has been much altered to be of a mid to late 19th-century appearance, cellar C2 seems to have been constructed as part of the initial phase of construction on site. The most striking alteration to have taken place is the removal of the original vaulted ceiling. This was supplanted by a poured-concrete ceiling in the mid- 20th-century. The concrete floor was also added at this time. There is also a blocked doorway on the west wall; this may have led to another cellar/room, or to a staircase. The staircase itself however, would appear to be in its original position, the deviation in material for its uppermost two steps is consistent with the raising of the ceiling height. This raising of the ceiling height is also evident where two courses of brick, and an I-beam on the north wall, have been inserted above the original ceiling level.
