**Former Taunton Cider Company  
Premises, Norton Fitzwarren,  
Somerset**

**Historic Building Assessments  
2006**

Project No.1475  
July 2006

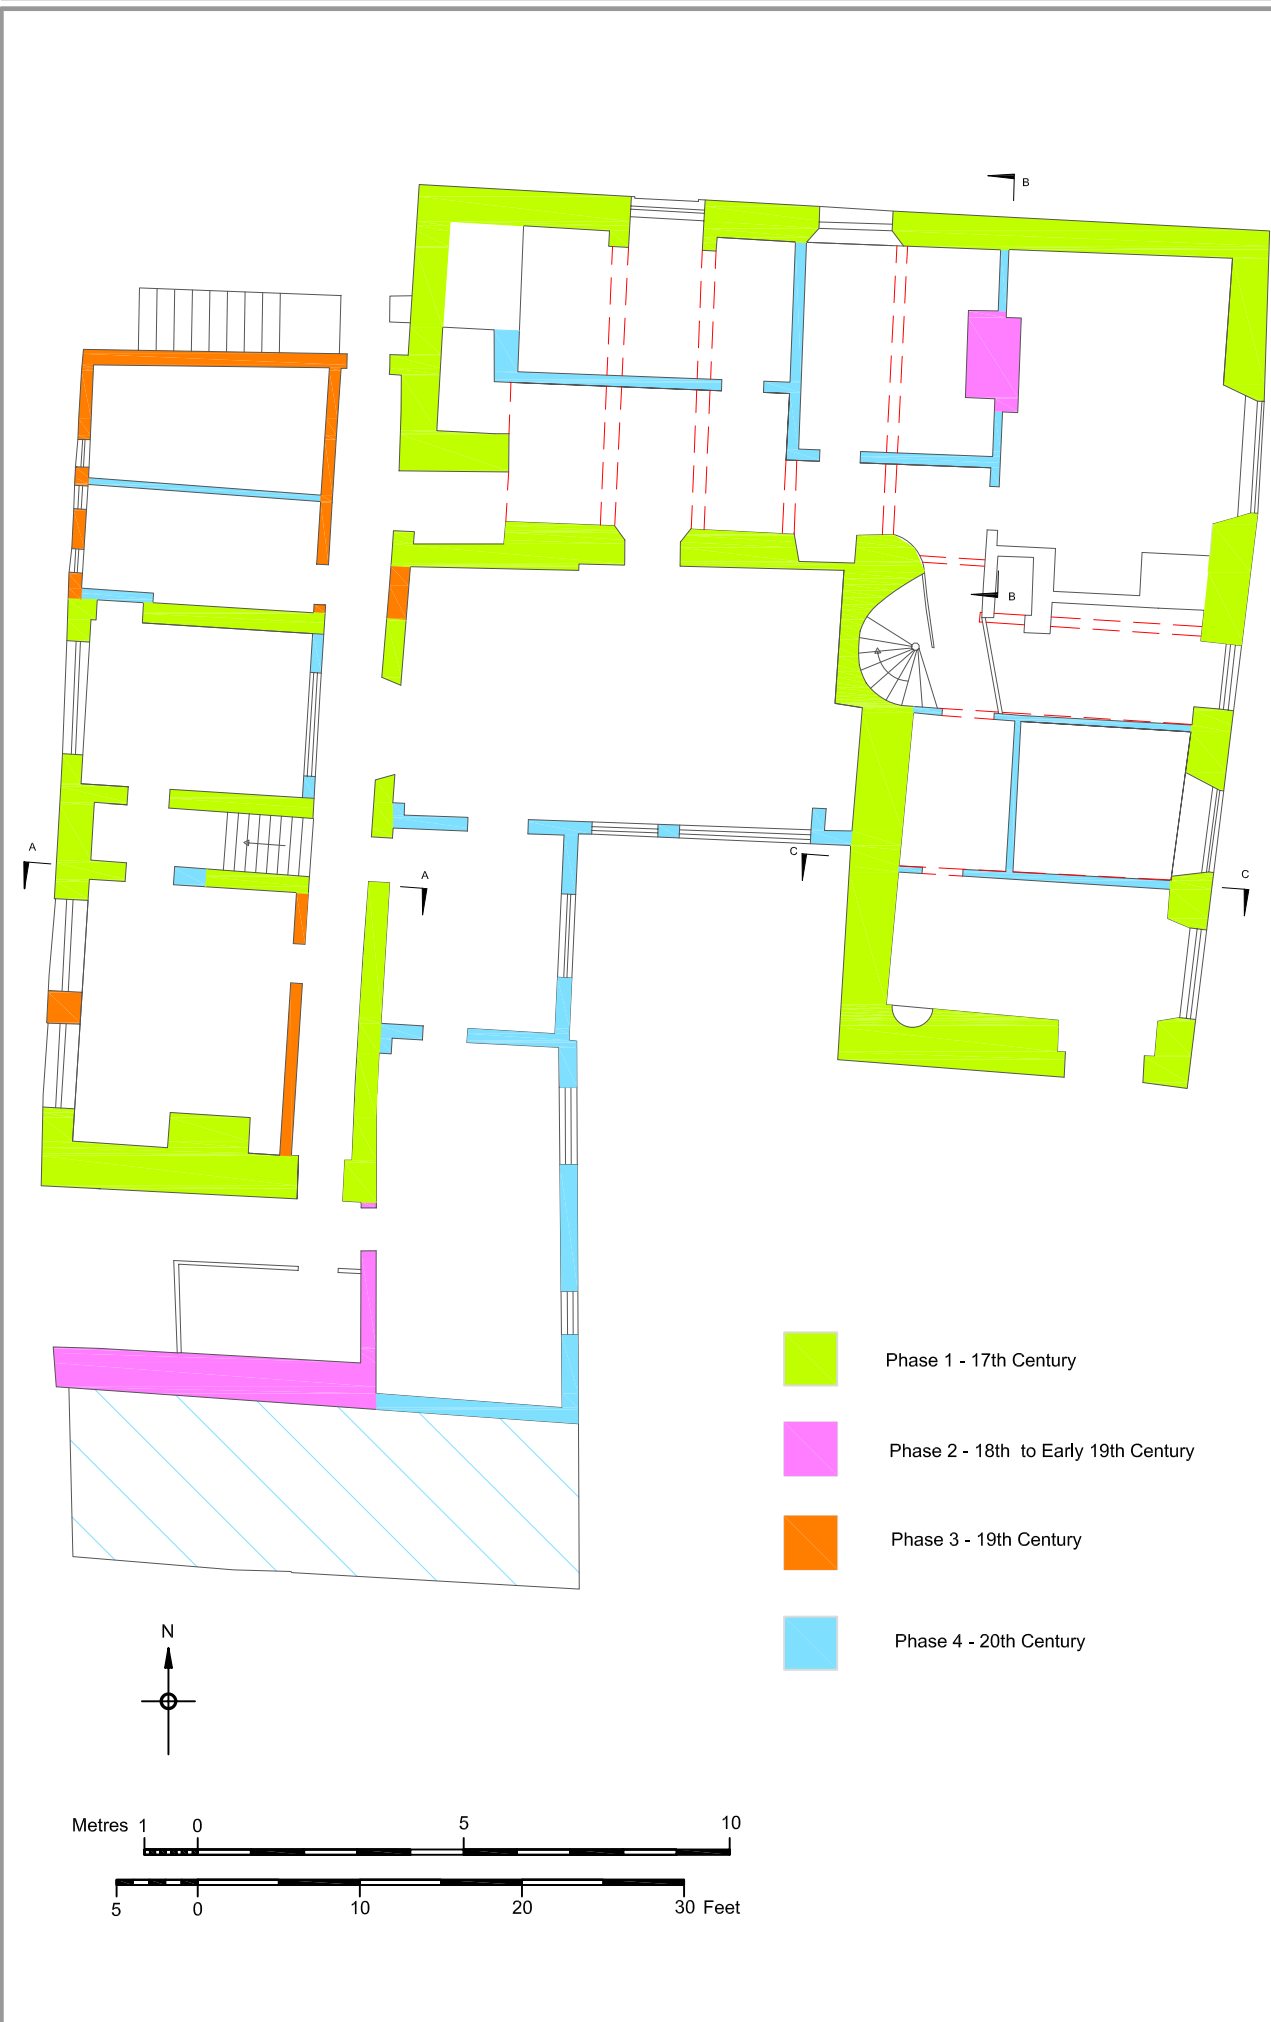
Fig. 3

### *Ground Floor* (Fig. 3)

*North Range:* The ground floor of the range originally had a two-room plan. The thickness of the exterior walls was indicative that they were original and constructed in stone. A north-south wall sub-divided a large western room from an eastern room. Soft-stripping revealed it was constructed in red-brick, but probably replaced an earlier wall in this location.

A series of north-south transverse beams with chamfered edges (five in total, one of which had been replaced) suggested the western room was open. A doorway to the north and street was blocked and converted to a window and was opposed in the southern wall by a doorway with splayed interior jambs.

The western room was served by a massive chimney-stack and associated fireplace at west end of the room. Removal of plaster from the chimney stack at the east end of the principal range revealed the survival of a sandstone jamb and a chamfered timber bressumer (Fig.11, Plate 1), apparently concealed when the fireplace was converted into a safe in the mid-to-late-20<sup>th</sup> century.

Soft-stripping revealed that the remainder of the walls on the ground floor are part of a later sub-division of the interior of the building in brick (plaster obscures exact composition, however, limited testing suggests machine-cut red-brick). The majority of brick sub-division was probably associated with a 20<sup>th</sup> century renovation.

The east room had remains of a substantial but heavily altered chimney-stack in the southern wall shared with the northern wall of the eastern range. A chimney-stack shared with the adjacent west room was less substantial and constructed in red-brick.

*East Range:* The wing extended south from the northern range in an L-shaped plan. Originally the range had a cross-passage with a room to the south (the eastern room of the north range was adjacent and to the north, *see above*). The northern room had evidence for an original stud wall on the soffit face of the northern of two transverse beams in the form of mortices and a linking groove (Plate 4). The wall to south was of later-brick construction beneath the other transverse beam. A doorway was blocked and converted to a window on

the eastern exterior wall. This suggested an east-west cross-passage leading to a stone-built newell staircase on the west side of the range contained within a turret (detail of newell, Fig. 12).

The room to the south was originally open but was later sub-divided with brick and plaster-board. The central transverse beam supported the floor above, but was at a higher level to the two that flanked the cross-passage suggesting this was a later insertion. There were two splayed window embrasures on the eastern exterior wall. A substantial chimney-stack on southern wall was brick built and probably inserted.

*West Range:* The original plan was a two-room layout separated by a central stairwell. The northern of the two rooms had a former cart-entrance blocked and converted to a window on the western façade. Directly opposing this on the eastern wall was a wide cart-entrance with splayed interior jambs. This appeared to have been a through passage to the rear courtyard of the house.

Two east-west stone-built walls flanked the straight central staircase. The walls had clear evidence for access between the two rooms underneath the stairs. The staircase itself was not original but may have been a replacement in the original location.

The southern room was open plan with a chimney-breast at the southern wall. Evidence from the roof space revealed this to be brick built and was a later inserted feature. Two plain casement windows faced west, the design and size suggested they were not typical of the building. The ceiling level within the room was higher than to the north. The north-south corridor was subsequently separated by a brick wall partition.

The southern part of the building was part of an extension of the stone-built range with cart access at the ground floor level and a heightened ceiling.

The northern extension enclosed the space between the west range and north range. The thickness of the walls suggested a brick construction. Clear variation occurred between the window types and heights within this element and earlier elements of the range. However, exterior render prevented detailed examination of the construction material. The ground floor plan was originally open with access to the north range and remainder of the south range, but was subsequently sub-divided with brick-built walls.

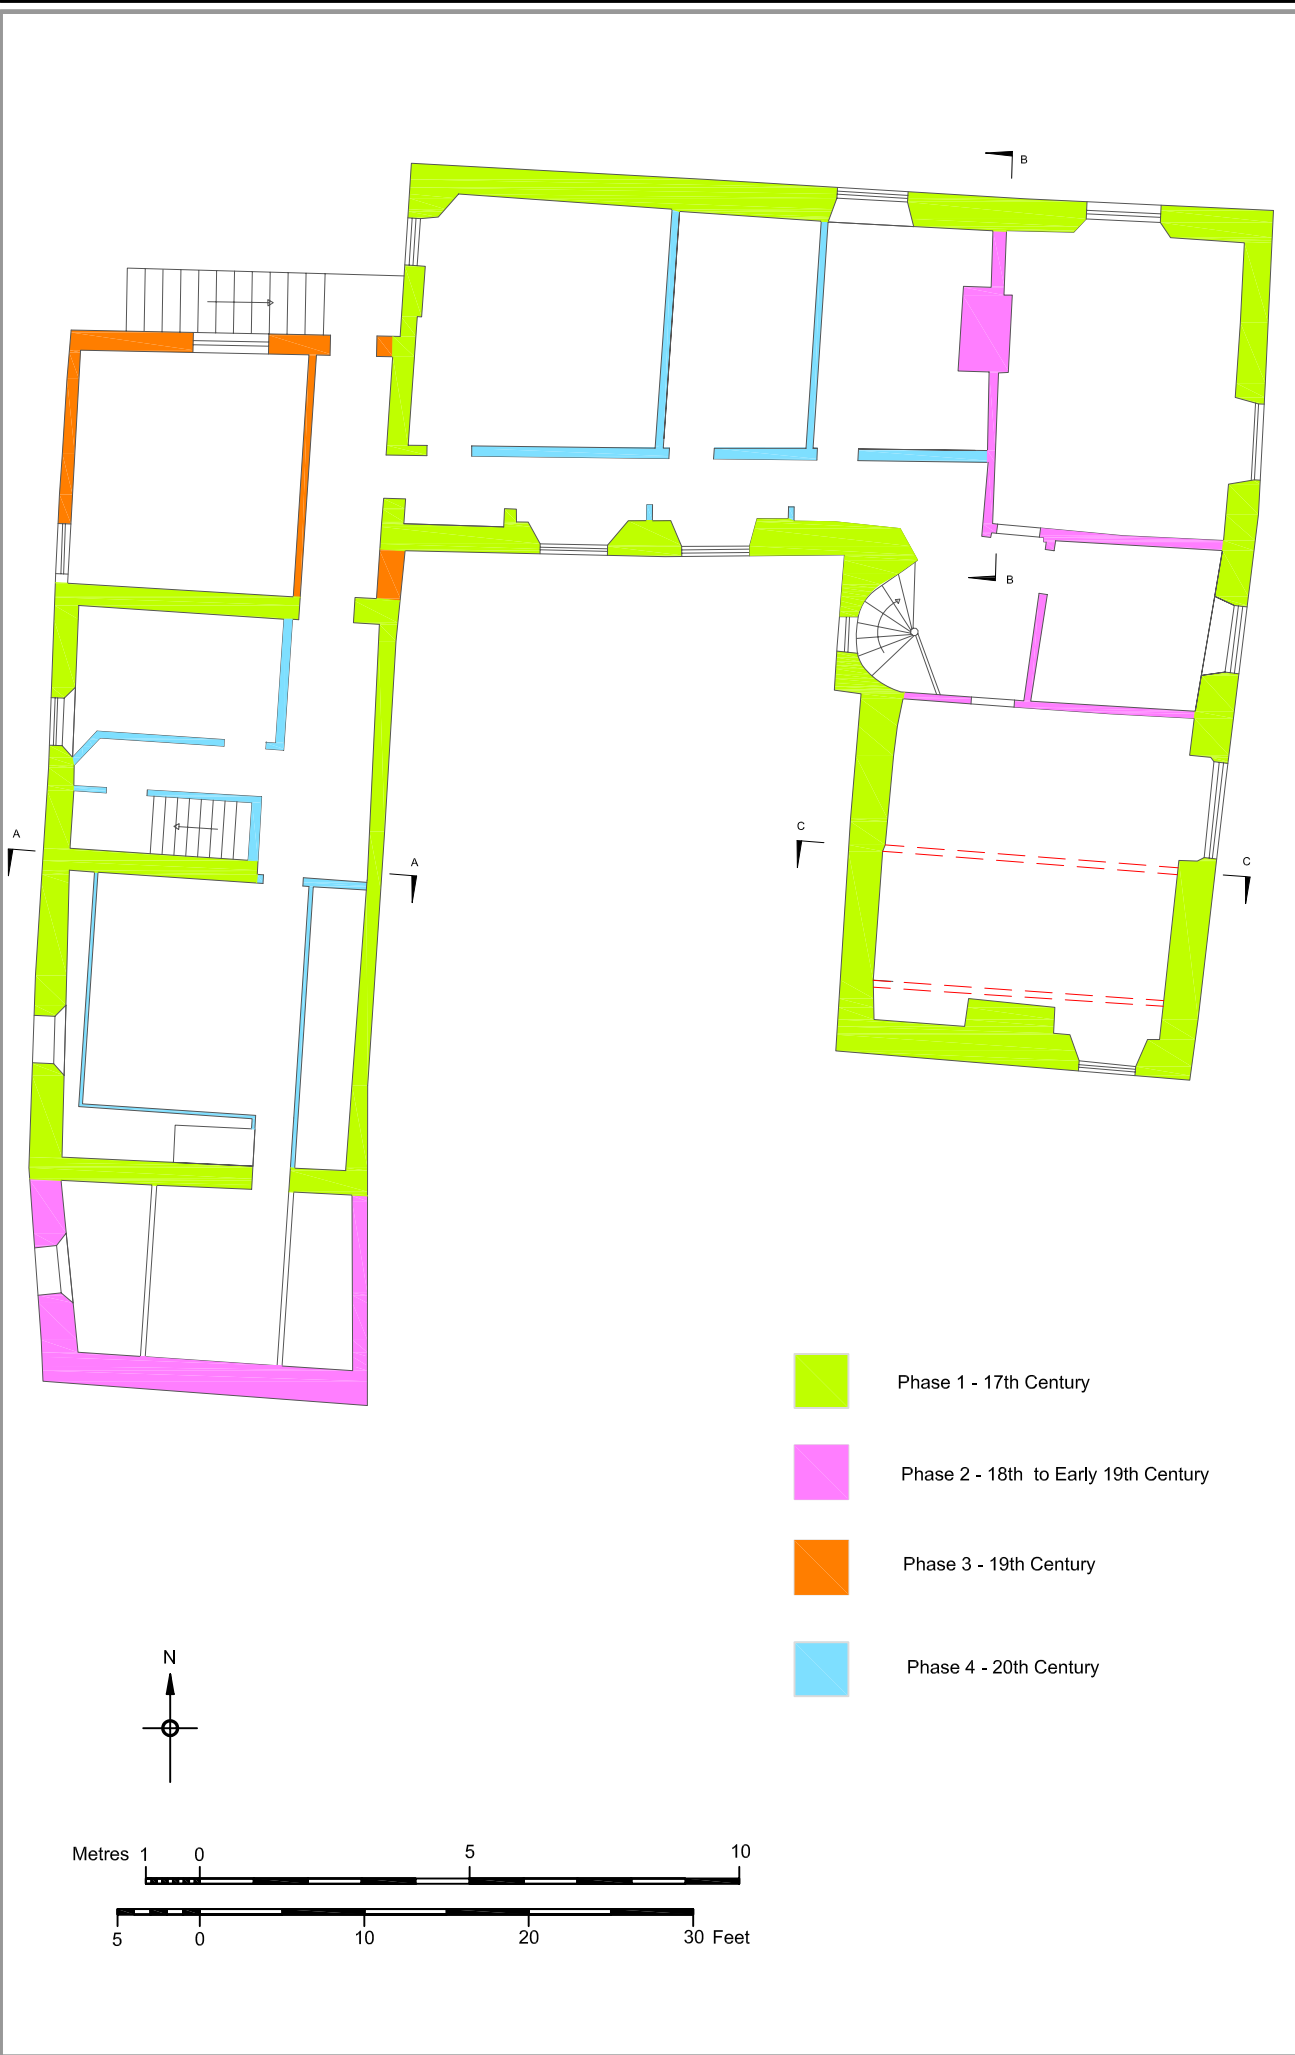
Fig No.  
**Fig. 4**

#### *First Floor* (Fig. 4)

*Main Range:* Soft-stripping revealed the east - west wall dividing the west room from the east room was of stud construction with lath and daub infill built against the chimney-stack (Plate 2). The remainder of the internal walls were of plasterboard construction.

*East Range:* The partition walls were all revealed to be lath and daub in-fill within a stud wall. The floor level was raised in the southern room. The southern room had two evenly spaced jointed crucks side-pegged with mortice and tenon joints (Fig. 9 and 13). A collar with mortice and tenon joints tied the crucks together and the apex was likewise mortice and tenon jointed. The gable supported the roof structure at the southern end of the room, whilst a further truss with stud wall in-fill below the collar enclosed the room. Above the central room there was no evidence for trusses.

*West Range:* The original layout of the first floor was largely identical to the ground floor. The rooms had subsequently been sub-divided by plasterboard sub-division as part of their conversion to offices. The stairwell was open to the north on the first floor, and had been enclosed by a plasterboard and glass partition. The roof structure was a later replacement with simple principle rafters resting directly on the stone-built walls.

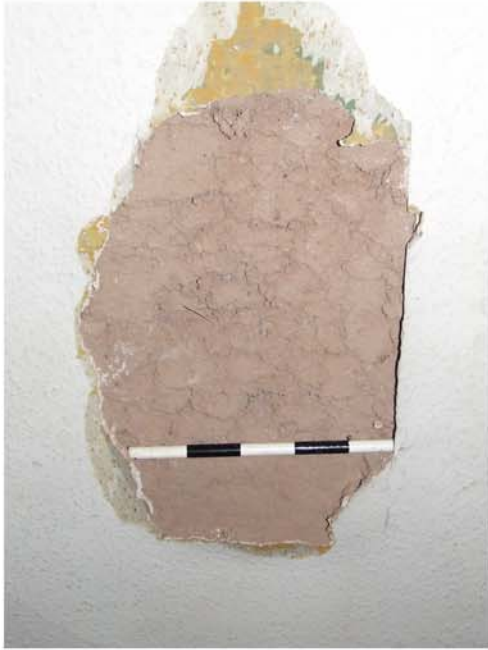
Plate 8

The original layout was unclear. The use of lath-and-daub (including horse-hair) partition walls (Plate 8) and ceiling construction (Plate 9) occurred in the majority of first floor. Five rooms were located to the north and front of the house with a long corridor along the rear wall. The north - south partition walls split the window embrasures and provided shared light for the rooms to either side. The chimney-stack against the western gable continued through the western room (Plate 14). However, there was no evidence for a hearth. Beaded skirting boards (Plate 11) and plain four-panel doors with brass door-handles and cyma-recta moulded architraves (Plate 12) existed throughout the rooms. However, the eastern end of house had plasterboard walls as part of later sub-division to create kitchen and bathroom area.

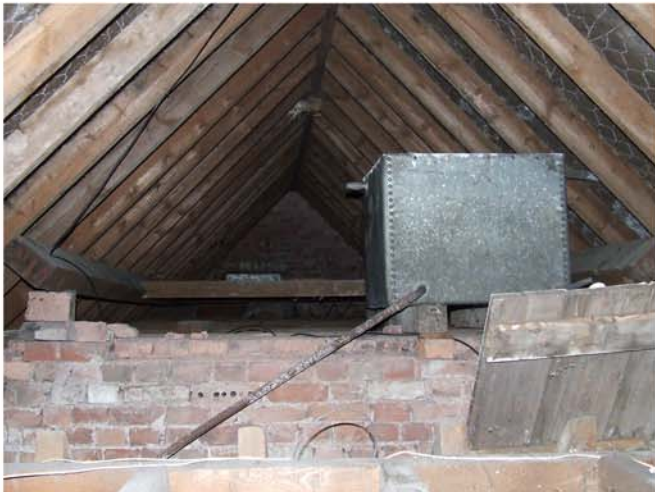
Plate 10

The entire roof space and tile roof had been replaced and no evidence of the earlier roof structure was visible (Plate 10).

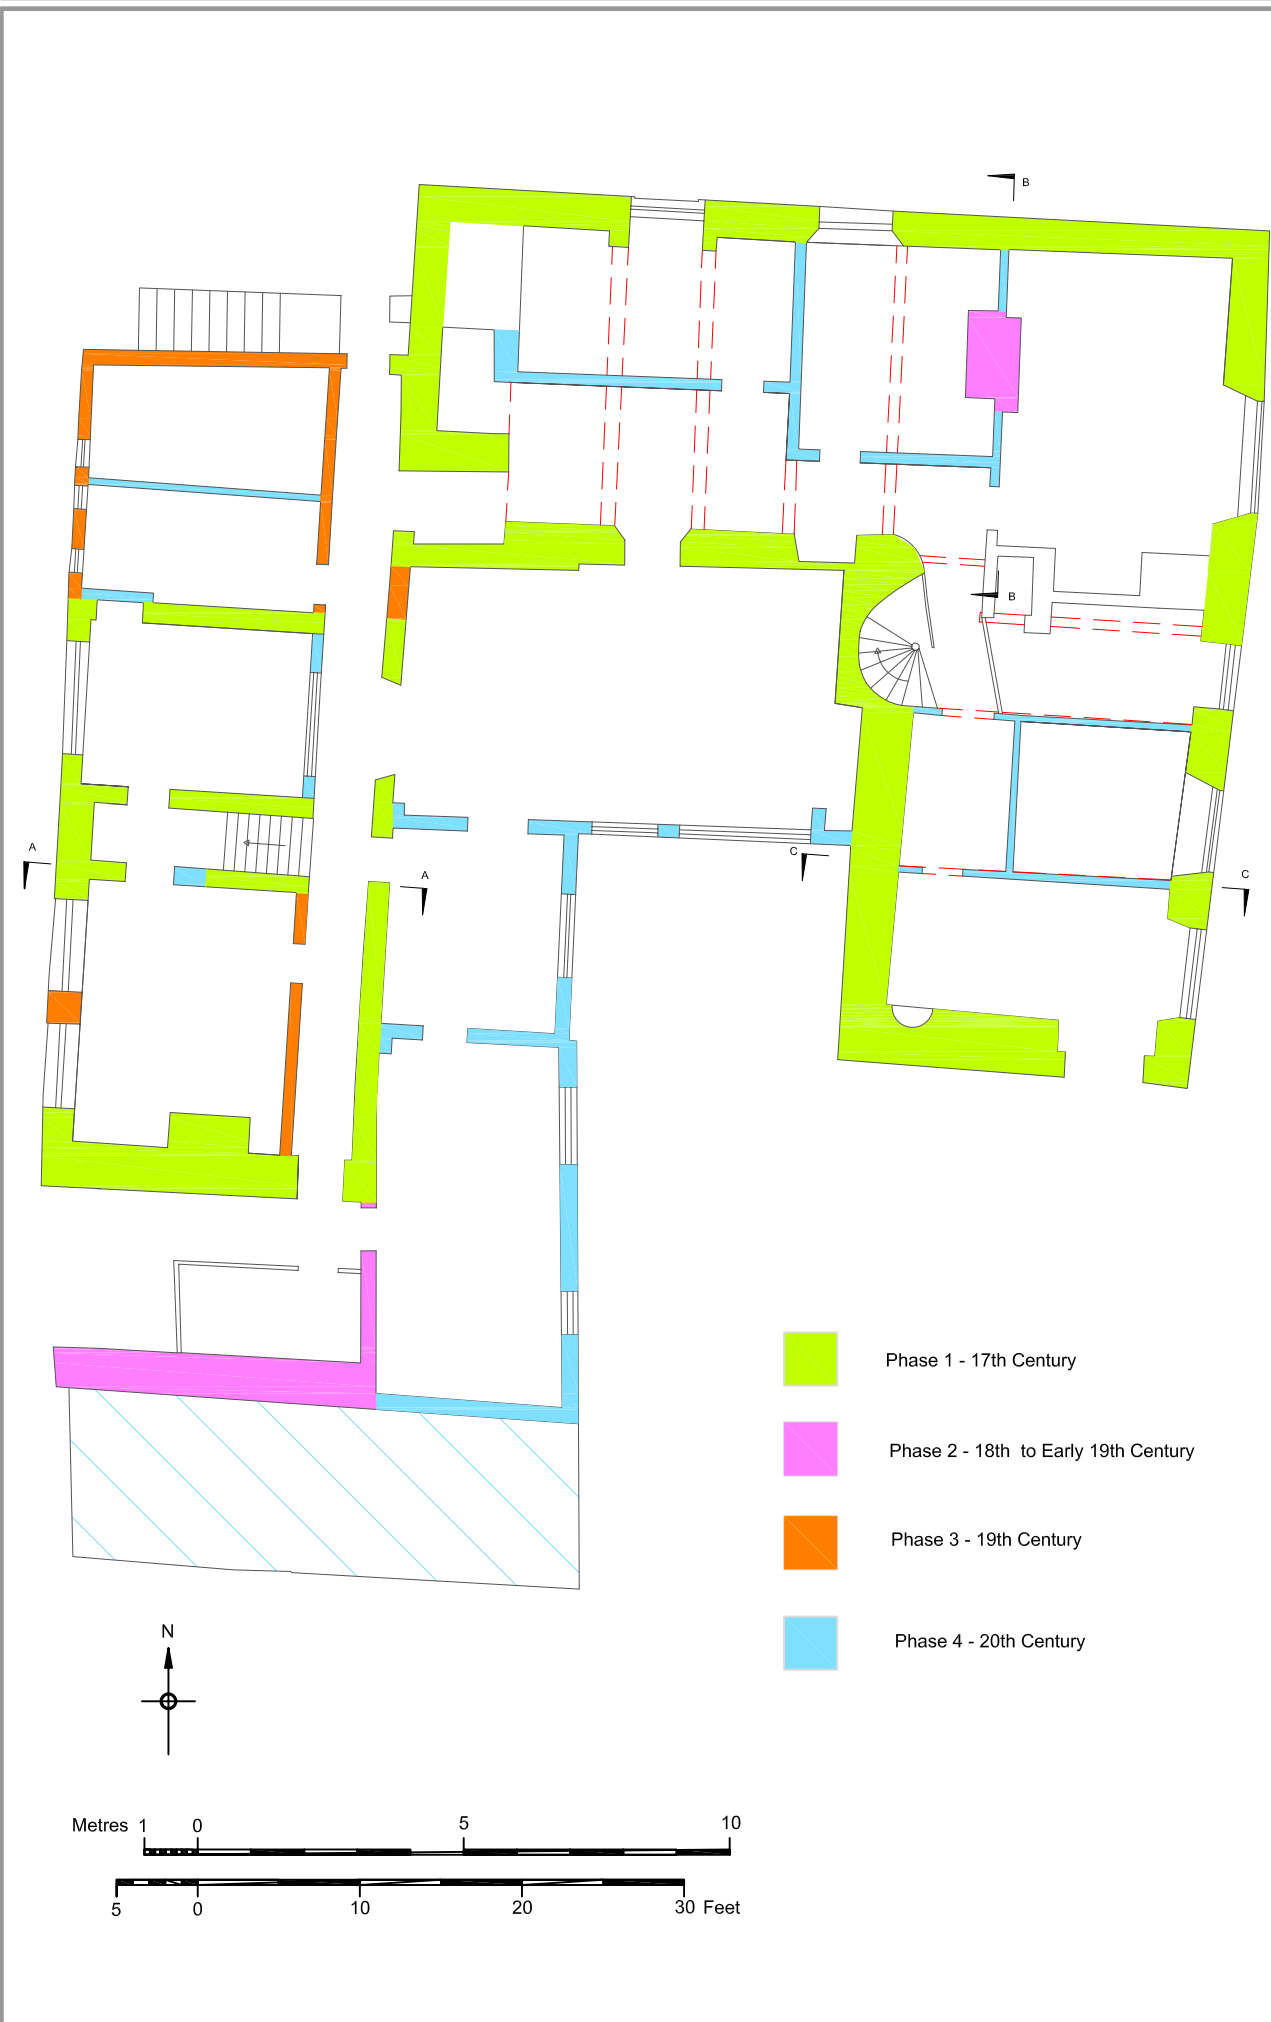
- Phase 1 - 17th Century
- Phase 2 - 18th to Early 19th Century
- Phase 3 - 19th Century
- Phase 4 - 20th Century

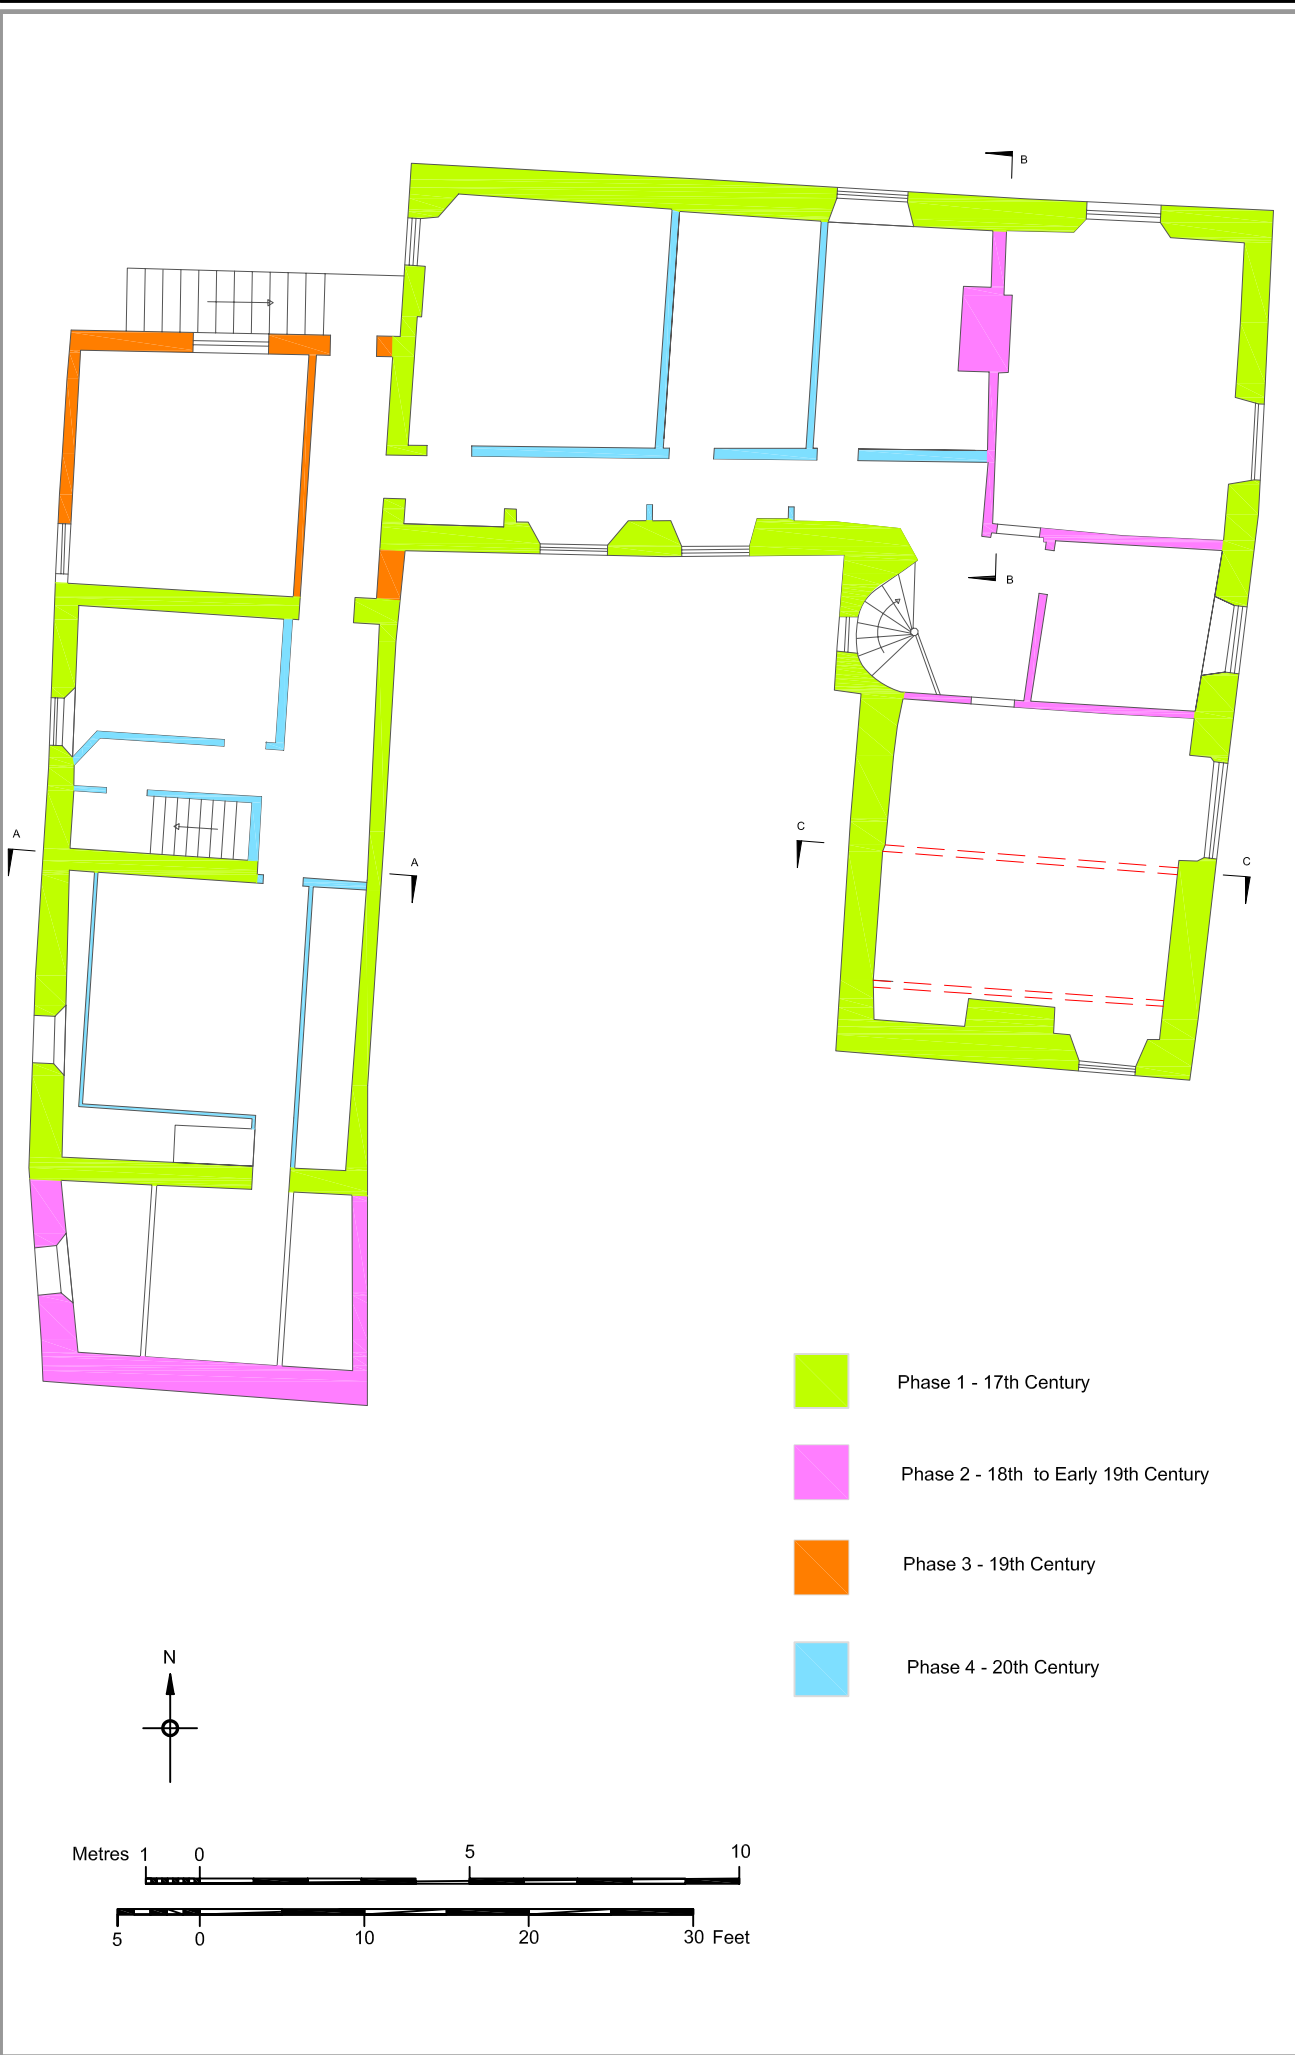
Fig No.  
**Fig. 4**

- Phase 1 - 17th Century
- Phase 2 - 18th to Early 19th Century
- Phase 3 - 19th Century
- Phase 4 - 20th Century

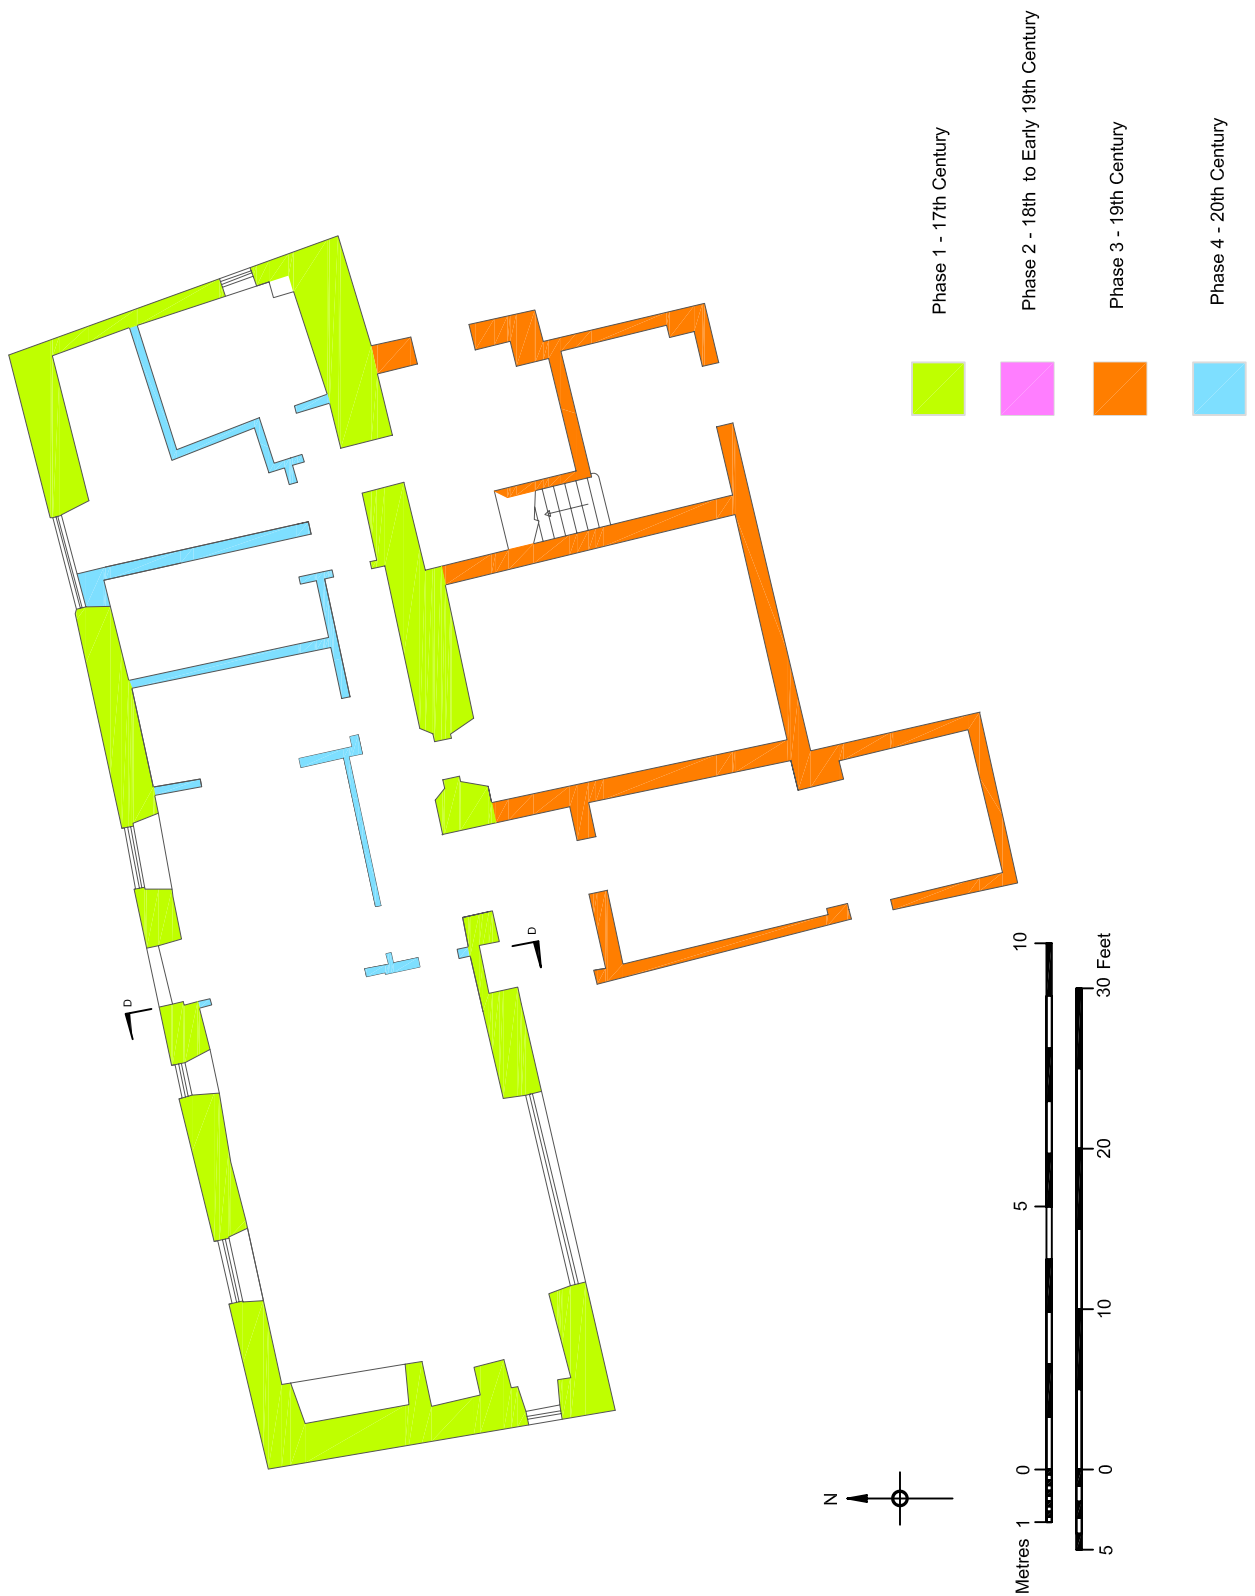
Fig No.  
**Fig. 6**

### *First Floor* (Fig. 6)
