The Mordaunts, Crowle,
Worcestershire

In January 2007, Birmingham Archaeology carried out a programme of historic building recording and analysis at The Mordaunts, Lower Crowle Road, Crowle, Worcestershire. The work was carried out as part of a proposal to convert the currently unused farm buildings to residential accommodation. The group of buildings, which include a Grade II listed barn (Worcestershire HER ref. no. WSM34970) were found to date from the seventeenth century onwards, with the large barn possibly incorporating part of an earlier timber-framed aisled barn. The site also included a late seventeenth or early eighteenth upper cruck building, which are comparatively rare in an agricultural context in Worcestershire. Significantly all timber-framed buildings encountered on site were constructed from elm. It is proposed, given the possible presence of an aisled barn, that below ground archaeological investigation take place prior to any ground works, in an attempt to locate the footings of the sill-beams or outer walls of the aisles of the building.

In January 2007 Birmingham Archaeology carried out a program of Building Analysis and Recording at the Mordaunts, Lower Crow

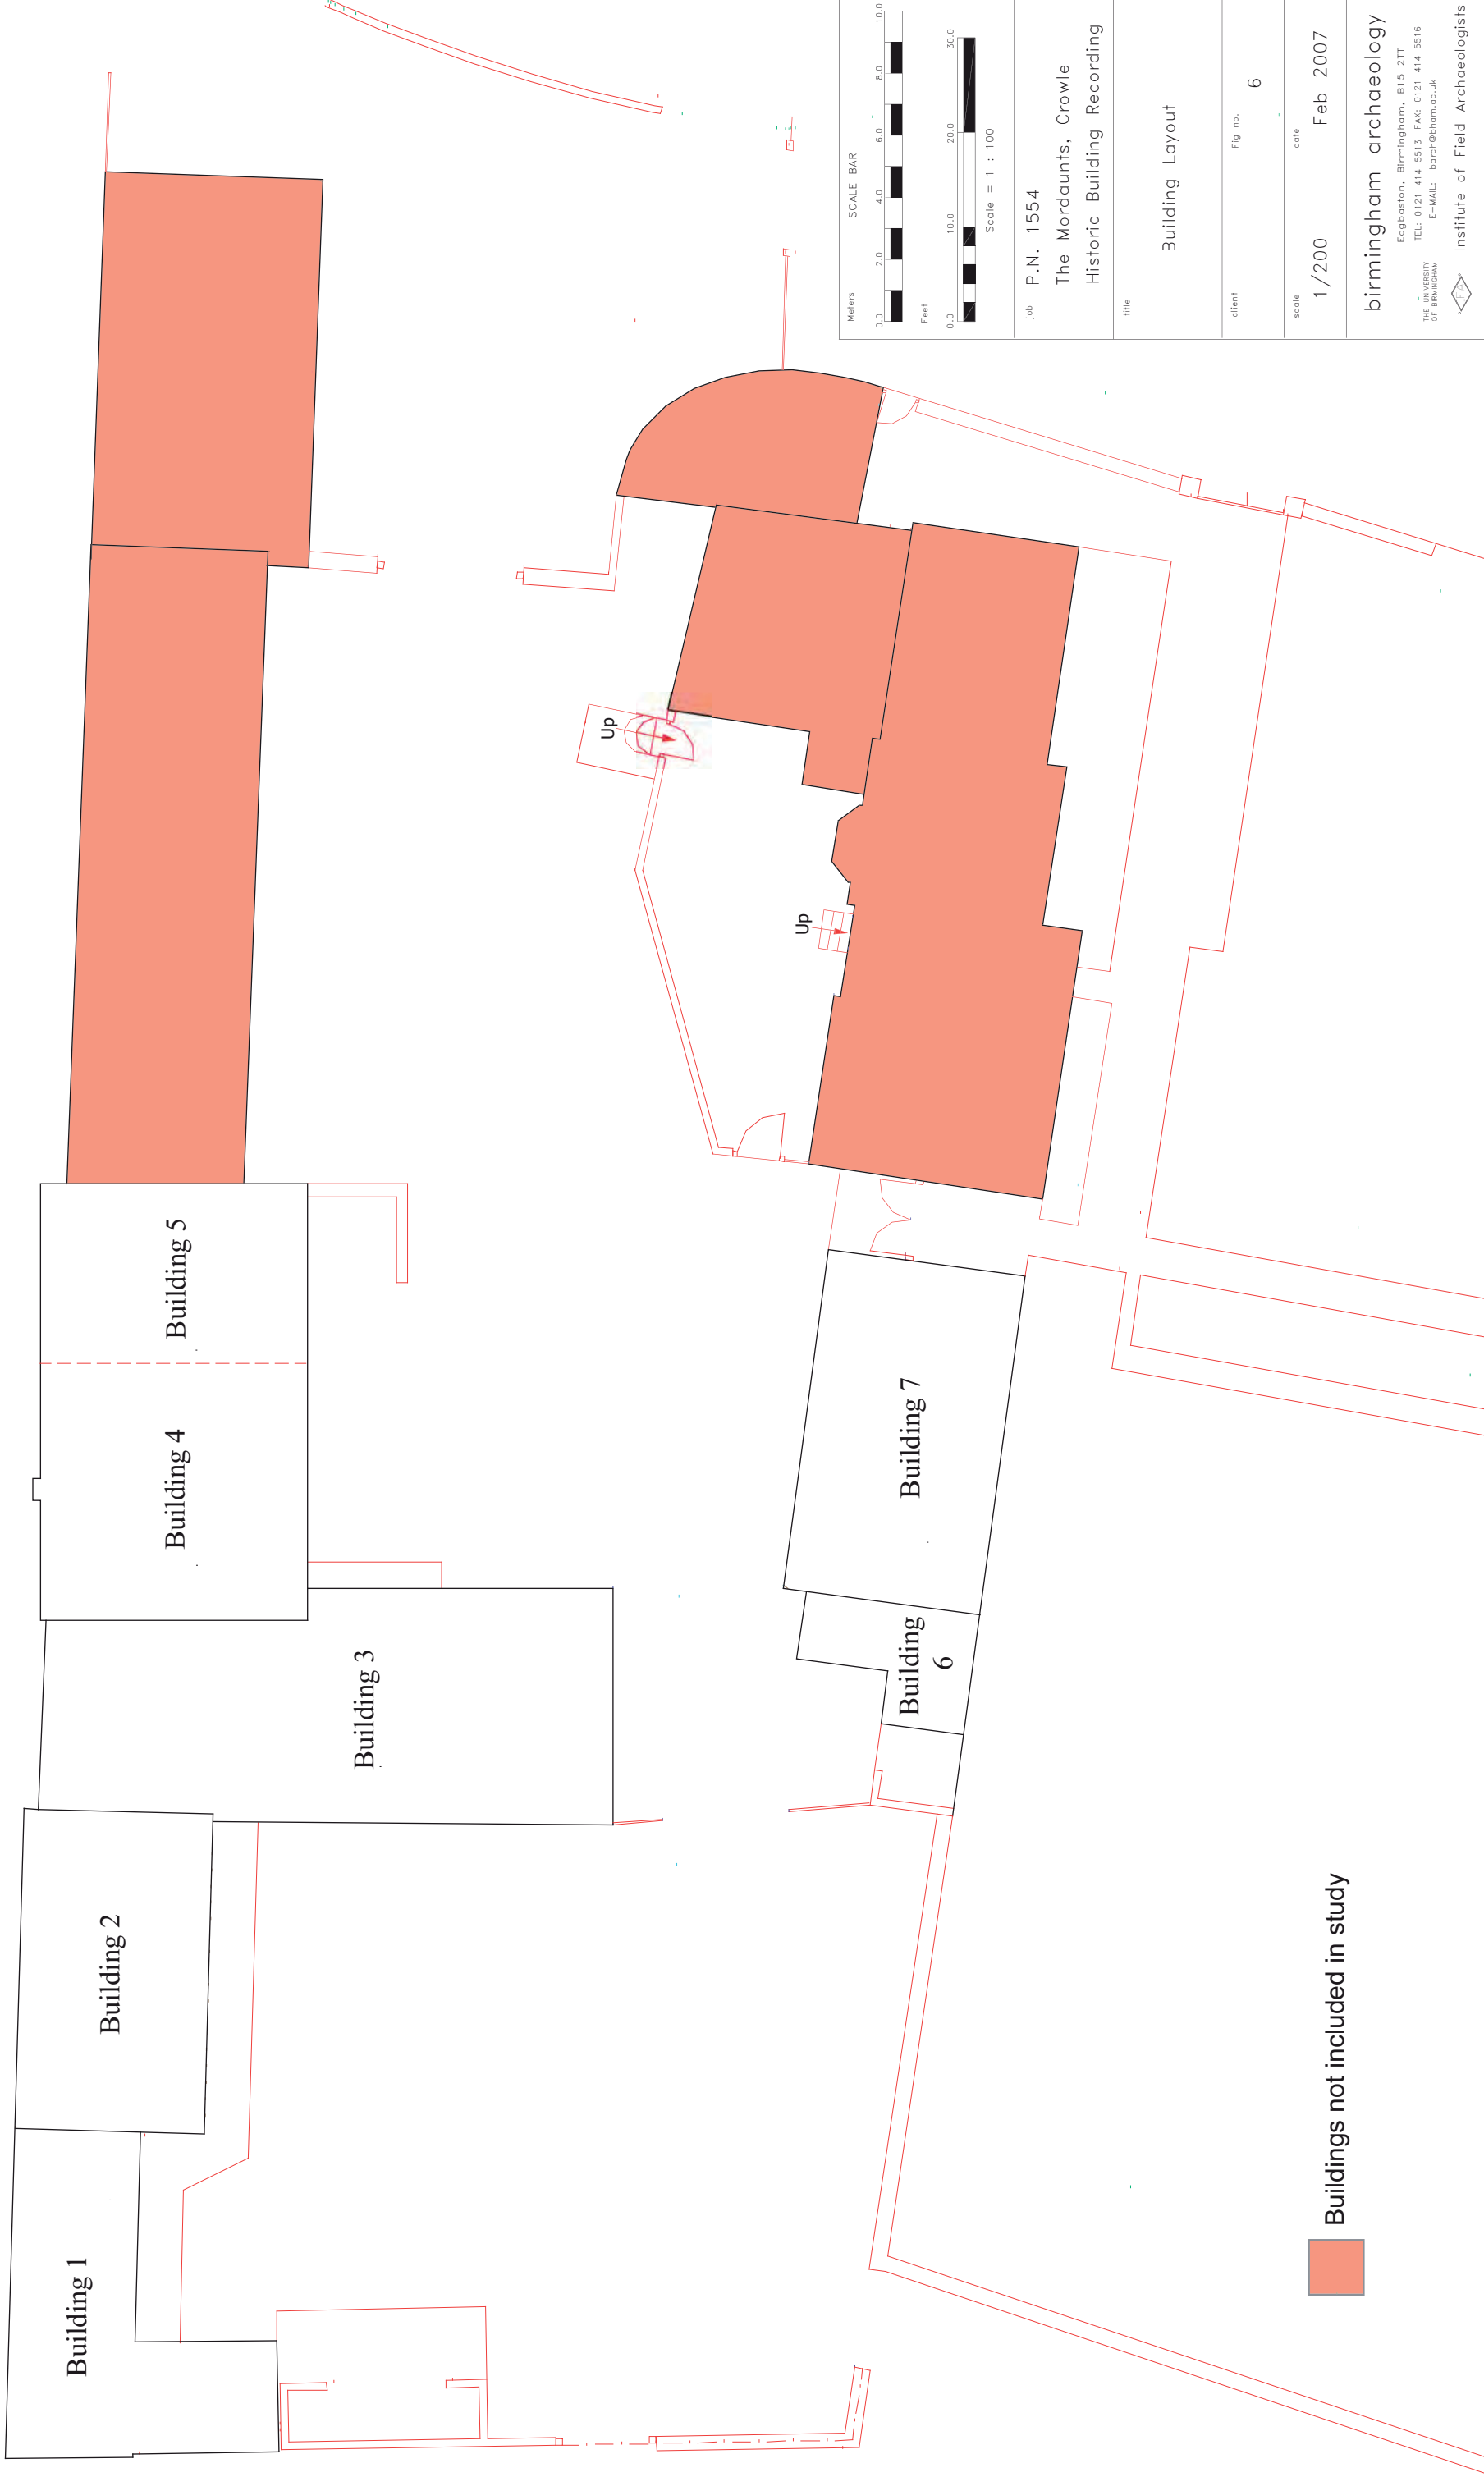
client Fig no. 6

The buildings have been designated numbers (Fig. 6) and names based on those shown on the architect's plans. The locations of the Plates referred to in the text are illustrated on figs. 14-16. The phased plans, sections and elevations of the buildings are shown in figs. 7-13. These are based on the architect's drawings of the buildings.

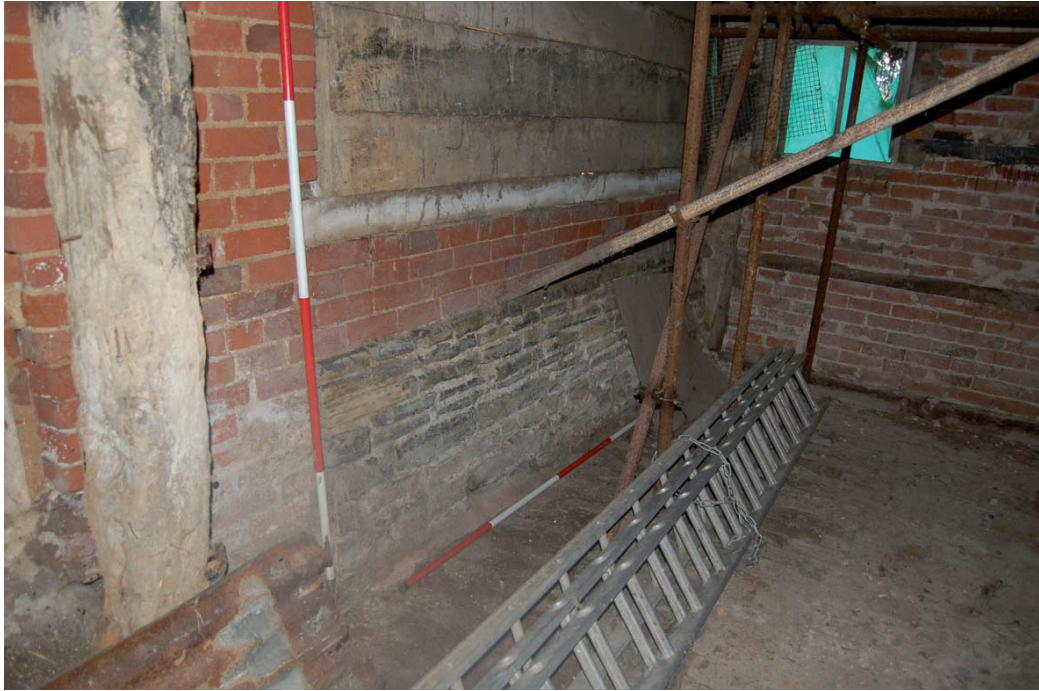
Plate 1

Although from the exterior and in plan form the building resembles two separate structures, Building 1 has at its core a six-bay, timber-framed upper cruck barn. The lower portions of the original structure survive along the north and east walls, and consist of a low random rubble wall of lias limestone, topped by four courses of hand-made brick bats. The wall rises to approximately 0.45m, and was built to support a substantial sill-beam, which supports regularly spaced wall-posts. The supporting stone and brickwork of the east wall survives better, and is best seen from within Building 2 (Plate 1). The wall is weatherboarded on the exterior face with horizontal laid boards to the west and vertical boards to the east, although these may be replacements. The east wall is also weatherboarded on its exterior, but has two intermediate posts, onto which are lapped three short rails at mid-height (Plate 2). The truss of the east wall is again different, being formed from a king-post with two angled braces. This may be for structural reasons, or may be a conscious attempt to mimic the gable walls of the stable block to the east.

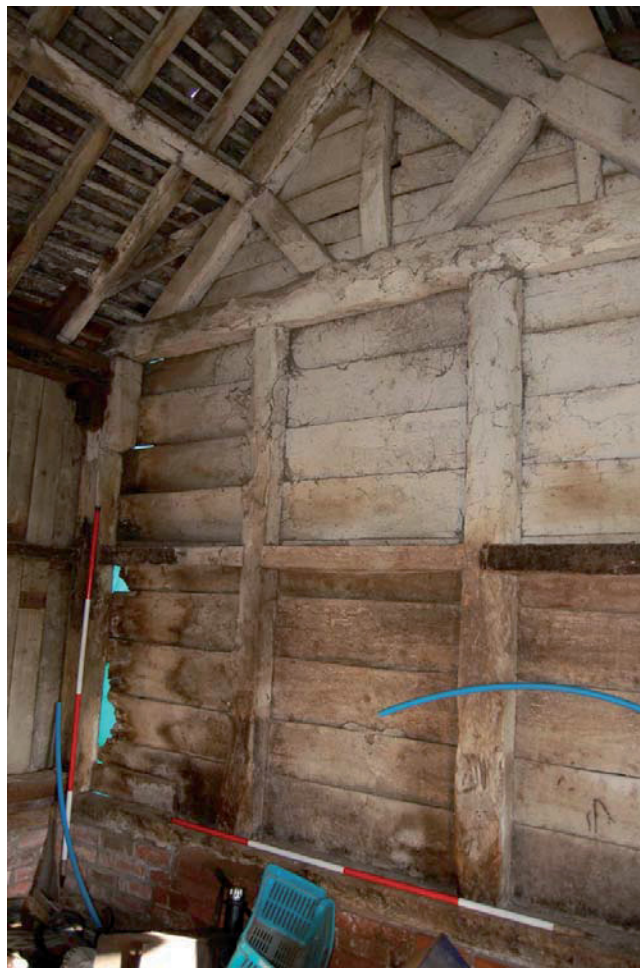
- Plate 1 – Building 1 – E wall from the SE
- Plate 2 – Building 1 – E wall from the SW
- Plate 3 – Building 1 – Interior partitions from the SW
- Plate 4 – Building 1 – Upper cruck truss from the E

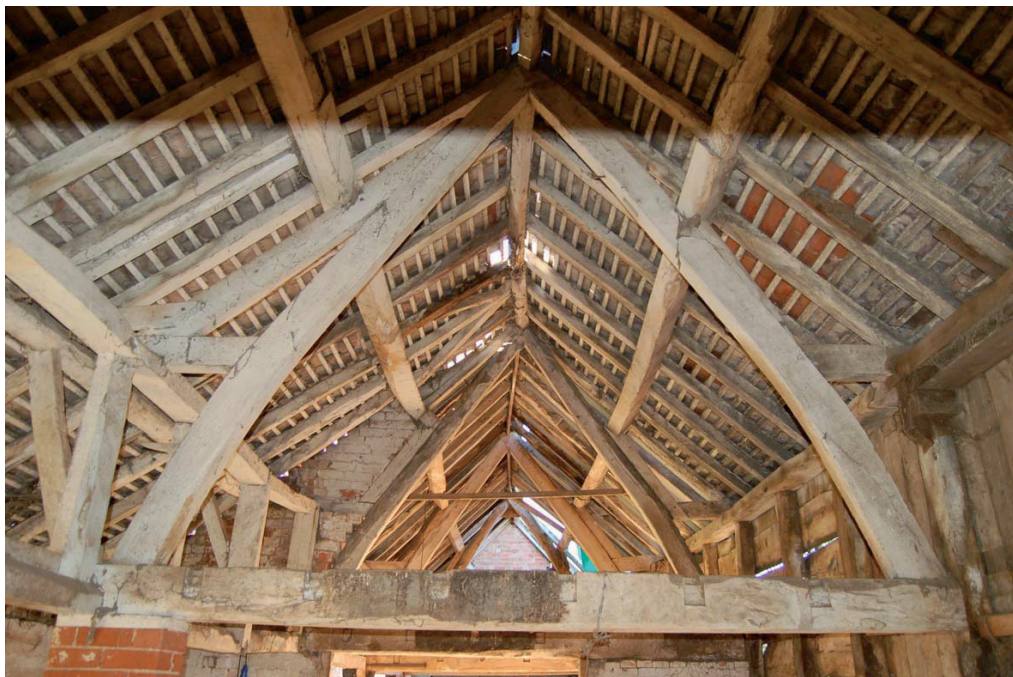
Plate 4

The upper crucks are, like the other timber structures surveyed, comprised of elm, which has been sawn and pegged (Plate 4). The blades rise from a truss cut into the wall-posts, which rise above the level of the truss to about mid-height on the cruck. The wall-plate then forms a secondary support for the slope of the roof, along with a purlin higher up the blade. Unusually, the cruck spurs are pegged into the blades and lapped onto the top of the wall plate. The crucks were originally supported by collars high up on the blades, but these

have all been removed. At the apex, the two blades are lapped, with a notch cut to carry the ridge purlin, which in the west three bays has been replaced by a ridge board. The tie-beams of the building have been notched to accommodate six joists running east-west, indicating the presence of an original first-floor level.

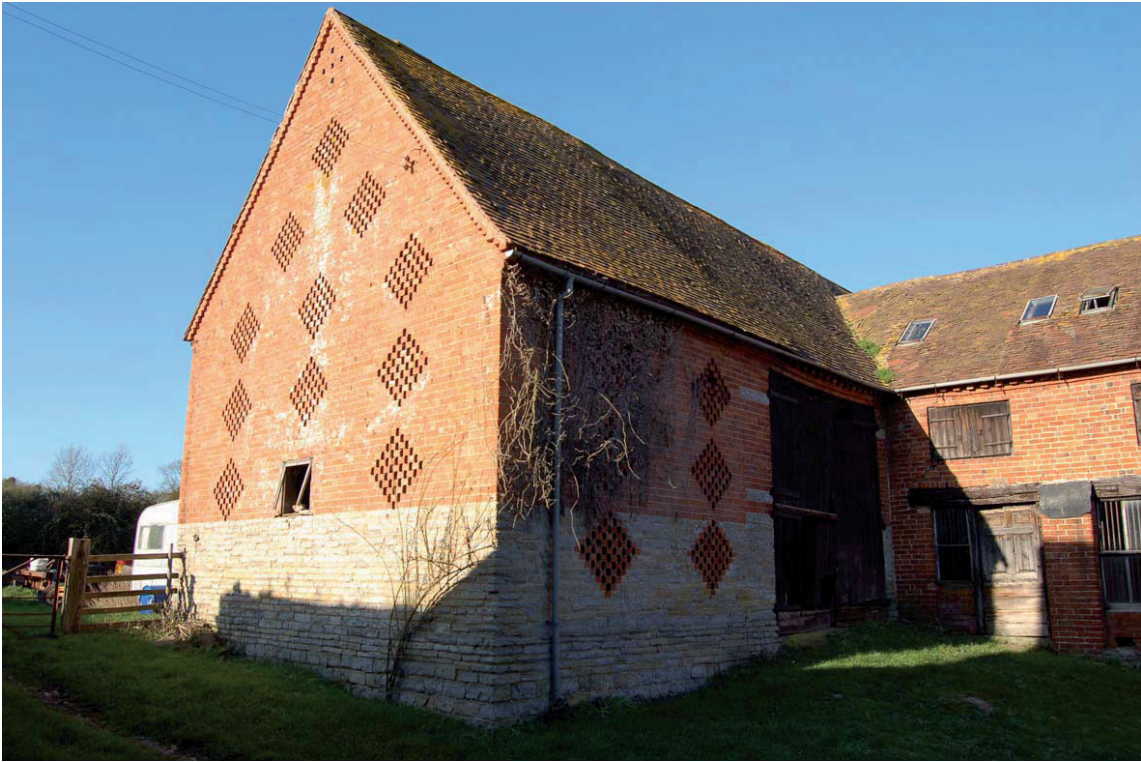
Plate 5

From the exterior Building 2 has the appearance of an eighteenth century brick threshing barn (Plate 5). The walls are built of random rubble lias limestone to c.2m height, with red brick (8¾x2¾x4½”) laid in a raking Flemish Stretcher bond. The walls are perforated with a series of regularly spaced diagonal air vents (Plate 6), some of which have been blocked, and two of which have been opened up to form windows (Plate 7). The building has a set of large opposing wagon doors, which stretch to eaves level, and are supported on large lias limestone hinge blocks (Plate 8). The eaves of the building have the same dentilated design as Buildings 1, 3 and 4, and the roof above is composed of clay tile. The north wall of the building was not viewed from the exterior, but is radically different in form from the other walls of the building, consisting of a square-panelled, brick-nogged timber gable frame.

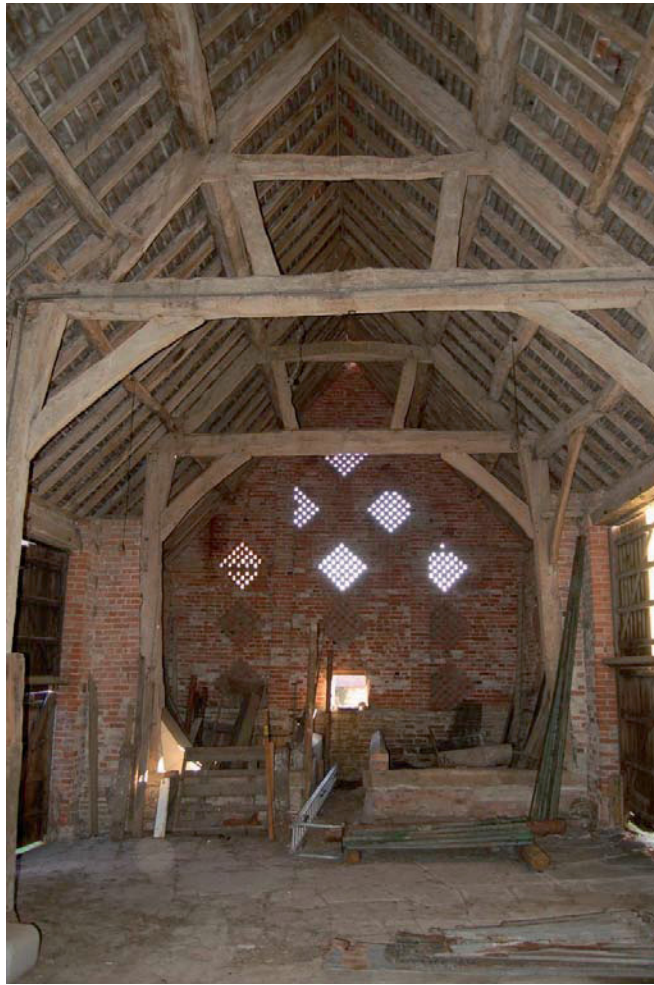
Plate 9

The interior of the building contains an earlier, substantial timber-frame reaching from floor level to support the roof of the barn (Plate 9). This was due to be dated through dendro-chronology, but proved to be composed wholly of elm, for which no sequences exist.

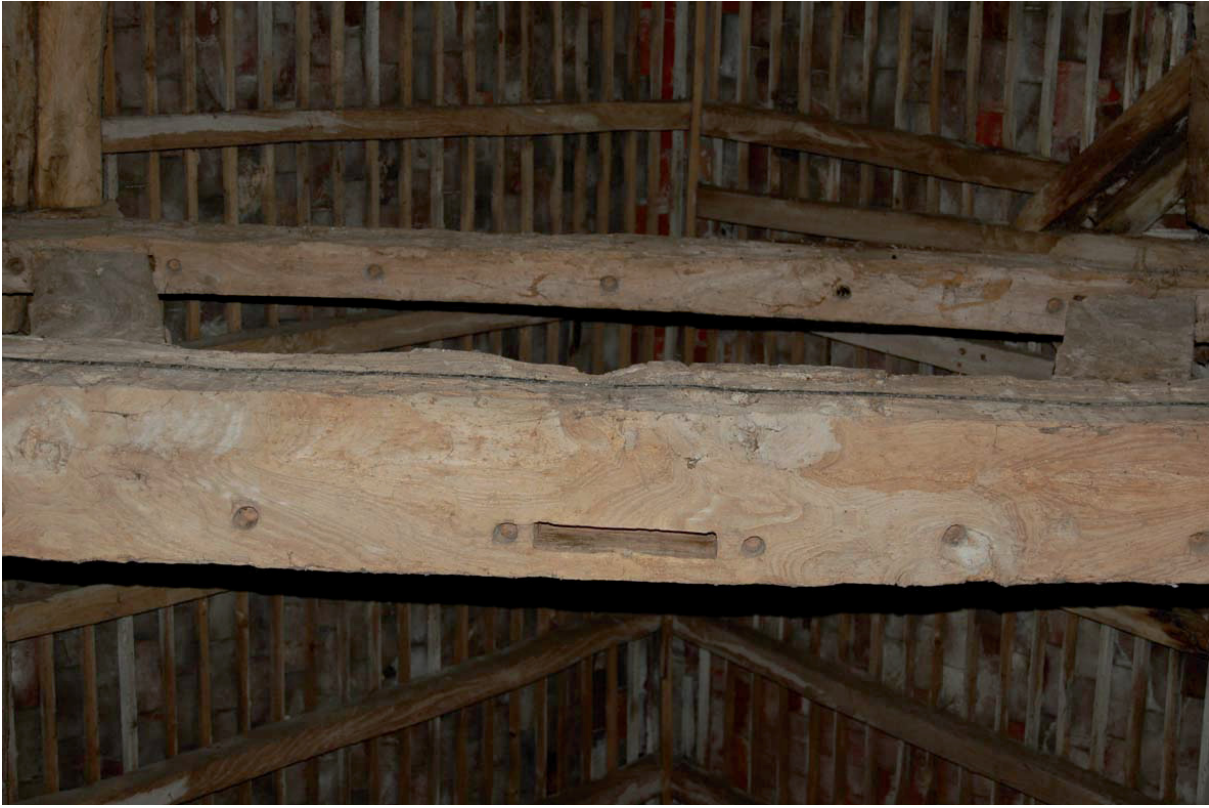
Plate 11

wall-posts, but with a wall scar marking the position of the sill-wall on the floor. The soffits of the tie-beam, collar and arched braces all have wattle-holes (Plate 11), which are not found on any other timbers in the building. The upper portion of the principals, above the height of the collar, have been removed. The east wall-plate has also been cut short to the south of the arched brace (Plate 12).

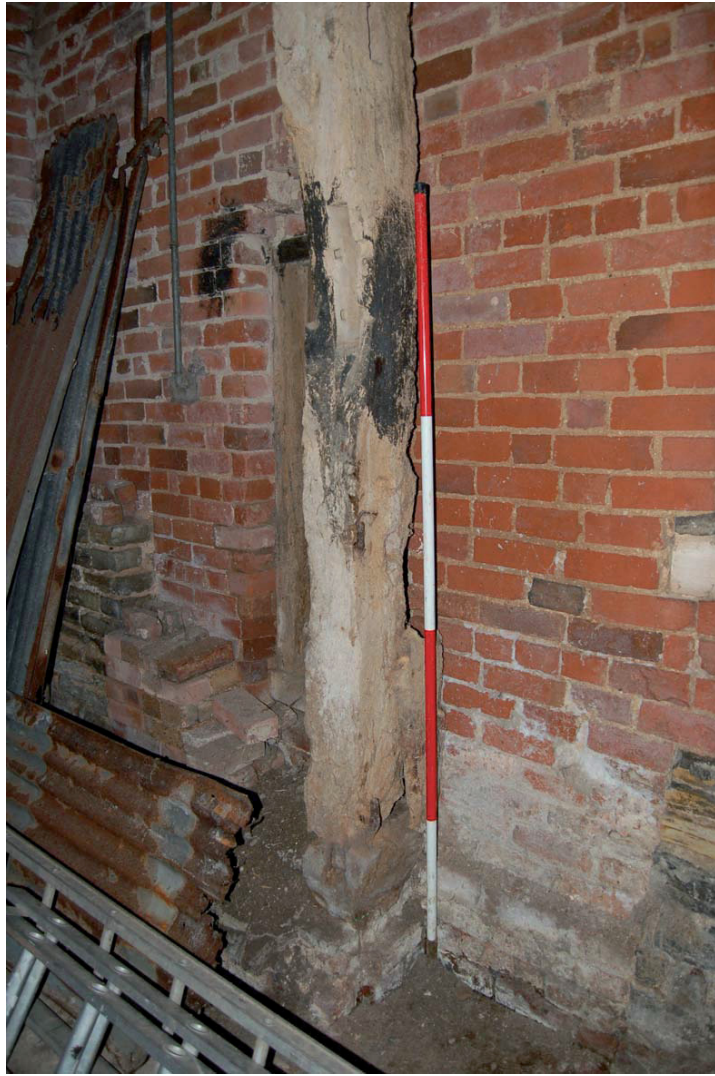
Plate 13

Frame 3 is largely complete, with the exception of the sill-beam, which again has been reduced to wide supports for the wall-posts (Plate 13). The east wall-post has had its north and south running arched braces removed, along with the wall-plates, whilst the west wall-post has had its north running arched brace removed.

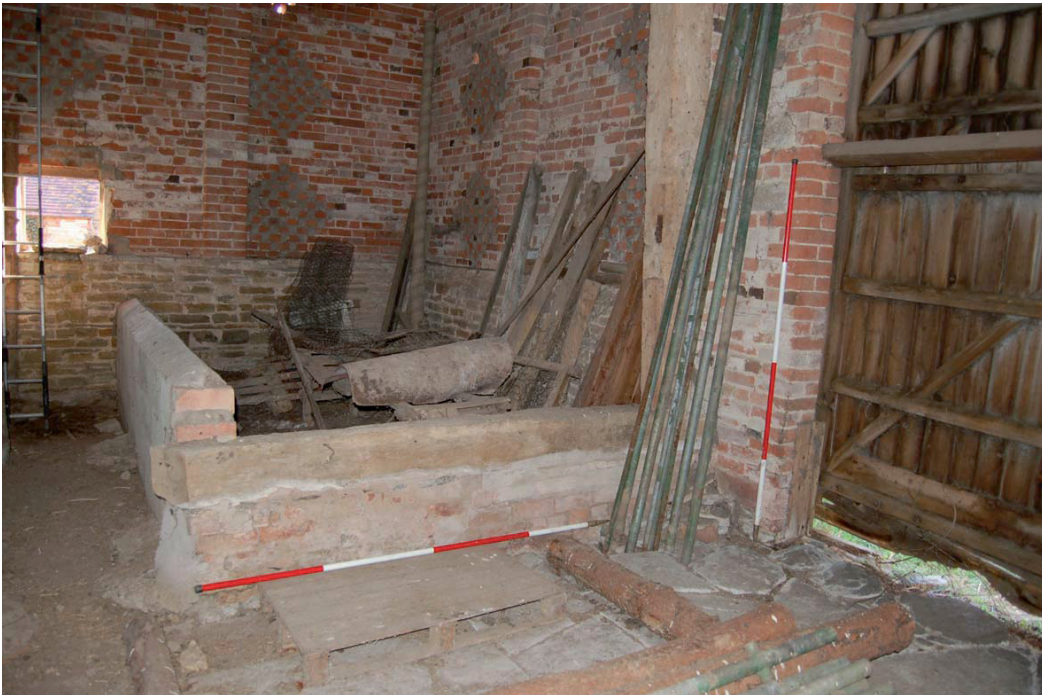
Plate 14

Frame 4 has an almost complete sill-beam, which is cut only slightly in its centre, to allow access to the south bay of the barn (Plate 14). Despite this there are no intermediate posts or rails, suggesting that the barn continued to the south. The collar of Frame 4 has been strengthened by the addition of another timber, as the original timber had warped (Plate 15).

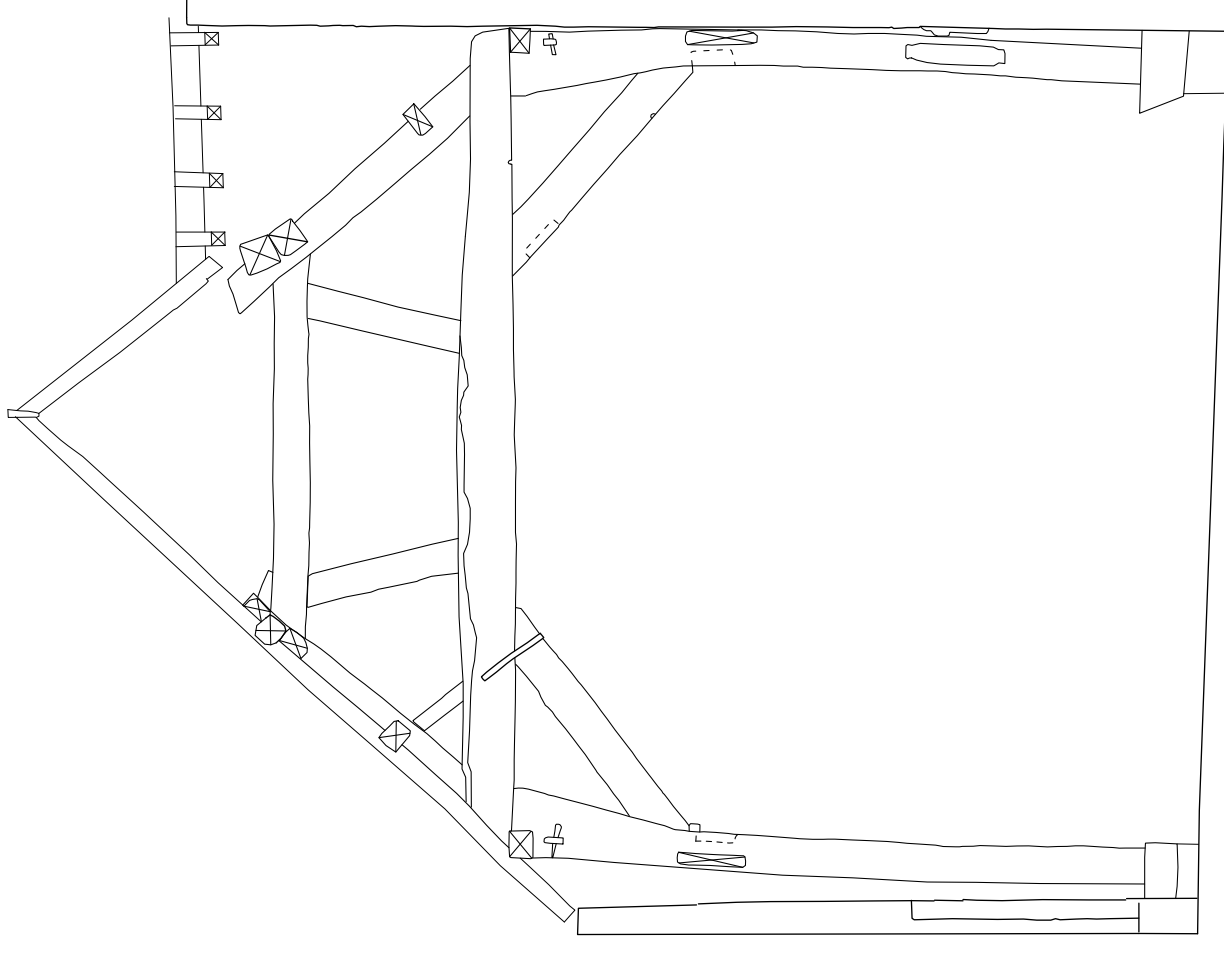
Frames 2 to 4 are completely unrelated to the timber-framing of the north gable frame (Frame 1), which has been crudely tacked on to the end of the building. The north gable frame is attached to the rest of the timber-framing by the wall-plates, which have been slotted through the wall-posts of frame 2 and wedge to stop them moving (Plate 10). The purlins from Frame 1 have also been roughly cut into the principals of Frame 2. Frame 1 also has slots cut for mid-rails running north-south, which do not correspond to any slots on Frame 2. The frame is brick-nogged with handmade bricks.

Frame 2 represents the original north gable wall of the earlier timber-framed barn. Although only the wall-posts, arched braces and truss survive, the frame originally had a central post running downwards from the tie-beam. Along with this the frame had two rails, one at the base of the arched brace, and one mid-way between this and the sill-beam. The sill-beam itself has been almost completely cut away, surviving only as wide footings to the

The intermediate frames (2, 3 and 4) are linked by purlins and wall-plates, but there is no evidence of a longitudinal sill beam ever having existed. The intermediate frames have a queen post truss. The frames have been numbered 1-4 from the north gable wall to the southmost intermediate frame. Drawings of the frames, along with a cross-section through the barn have been appended to this report (Appendix 1).
