Wordsley Hospital, Stream Road,
Stourbridge,
West Midlands

Historic Building Recording

Project No. 1553
April 2007

Malcolm Hislop, Shane Kelleher, and Michael Lobb

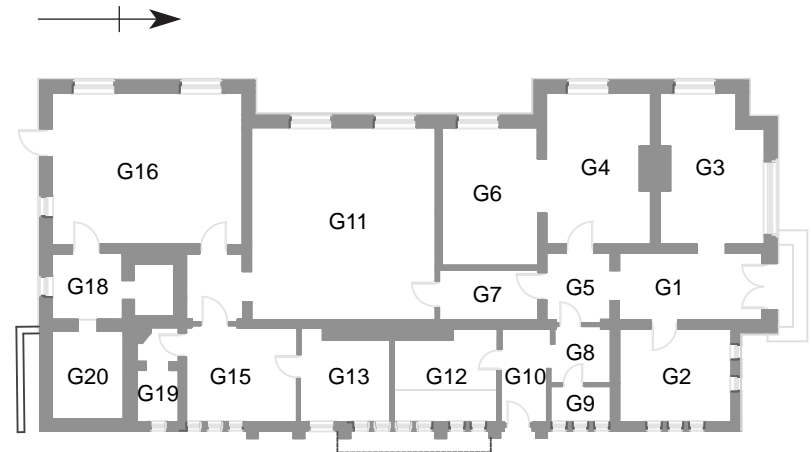
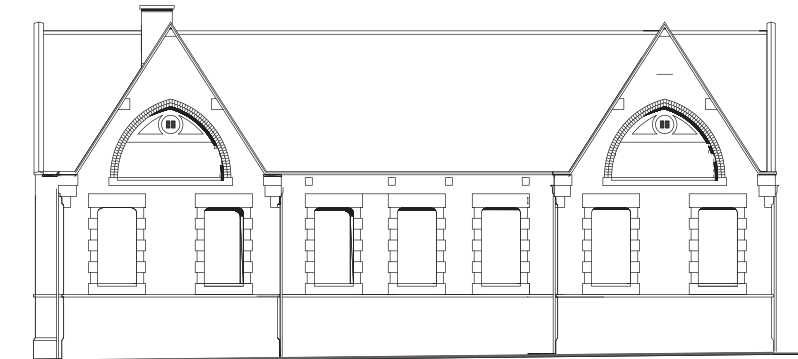
Fig.3

The Guardians' Boardroom (Fig 3), which was built in c.1874 by Smalman Smith, is 'I' shaped-in plan with shallow gabled projections from the north elevation and from the northwest, northeast, southeast, and southwest corners. The building is aligned north-south following the line of Stream Road. The main body of the building is a tall single storey range, with a lower lean-to volume along the east side, which is terminated at either end by gabled projections.

The main body of the Guardians' Board Room building is of a reddish-orange brick measuring 9 ins x 3 1/8 ins x 4 1/4 ins and laid in English bond (Plate 1). The plinth, which is of red and blue brick in no apparent decorative pattern, is stepped out by one brick width. This is coped with a course of moulded blue brick, which is punctuated at every fifth brick by a regular blue brick. There is a stringcourse of blue brick immediately above the moulded plinth course, and three further blue brick strings at intervals above this. Above the uppermost of these is a projecting painted stone/concrete string, which forms the sill for each of the windows. The eaves are coped with concrete or cut stone slabs, and the roof is of alternating bands of red and blue clay tile with red terracotta coping.

This is characterised by two projecting terminal gables and a central range. Each gable-end is identical in detailing (Plate 1). Each has two painted buff sandstone shouldered arch windows with alternate quoin-style jambs, and splayed sillstone. Above these is a large decorative panel of chequered pale yellow and blue brick set in a equilateral pointed arch delineated by two rows of yellow brick and a splayed painted buff sandstone splayed sillstone. Above the uppermost row of chequerwork is a row of blue brick stretchers, which is surmounted by a blind Venetian window of painted cut buff sandstone blocks in relief. Each gable rises on three painted cut buff sandstone kneelers, the lower of which is moulded. The gables also have mid-gable kneelers and painted buff sandstone apices. The southern gable has a cruciform shaped tie rod towards the apex. The gable returns have moulded eaves and cut stone corbels, which support an ornamental cast iron rainwater gutter.

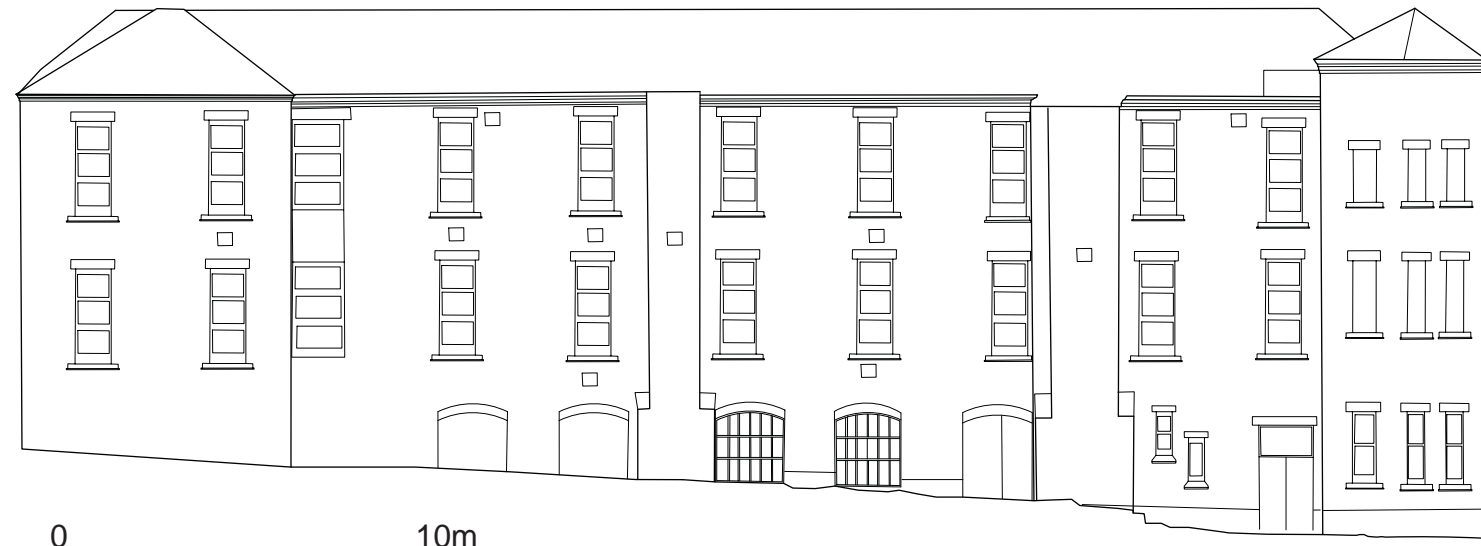
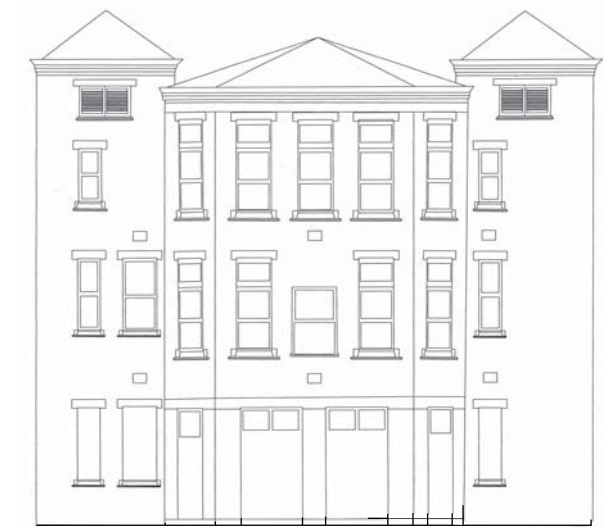
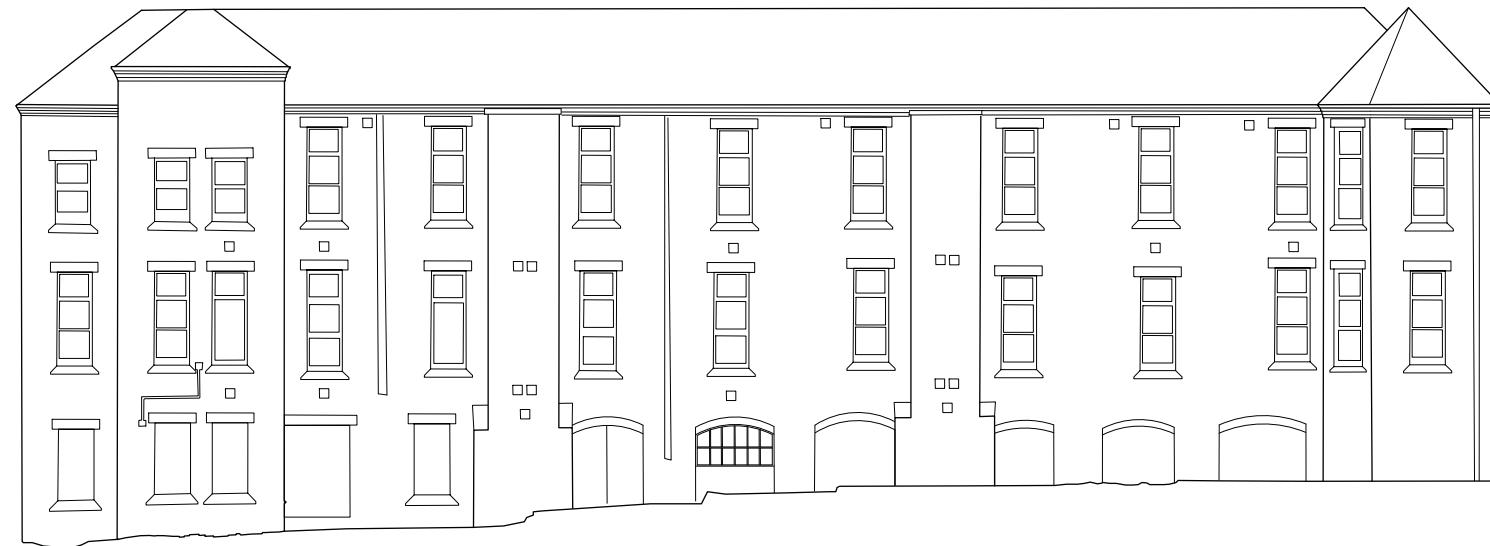
Fig.24

The lower ground floor level of the building was inaccessible at the time of this report (Figs 23, 24, and 25). The ground floor of Building 18 originally had an identical layout to the first floor but has since been subdivided into smaller rooms (Plates 63 to 65). On the ground floor most of the original timber vertical sash windows are *in situ*, whilst on the first floor the frames have been replaced by metal framed pivotal light windows. The main doorways along the central line of the E-W axis of the building have segmental arched overlights above double doors. At first floor level very little alteration. The original form comprises of a large room at the W end with a canted five bay W wall. To the N and S of this are two projecting towers containing smaller rooms, which from the layout of windows appear to have always been toilets. Both towers have a half height attic room above, which is reached by means of a hatch in the ceiling of the first floor rooms. Around half the length of the building is taken up by a large open room which stretches the full width of the structure. To the E of this is a corridor with several smaller rooms on either side, which leads to Building 19. At the E end of the block is a staircase to the south of the corridor leading up to the first floor.

Two-storey irregularly shaped block (Figs 23 and 24) (Plate 66). At ground floor level the E end has been extended at some point during the mid to late-20th century. To the N of the block is a small multi-angular extension with an original dividing wall splitting it, on both floors, into two smaller rooms. These appear to have always been toilets. The main room at ground floor level forms a long open ward and appears to be the original space, to the W of this a corridor leads past a number of smaller rooms to the junction with Building 18. At first-floor level the E end has been subdivided into a number of smaller examination rooms during the late 20th century. To the W the original room layout survives. The building has a good level of survival, with the original layout still easily discernible and most of the original timber vertical sash windows *in situ*. On both floors the corridor which leads through to the main wards has a large segmental arched overlight above double doors. At the W end of the building, on both floors, the junction with Building 18 has been largely obscured by the addition of rooms in the mid to late 20th century, and the original N-S corridor running through this junction connecting it to the other buildings. At roof level a narrow hipped roof stretches out over the area of the W corridor to meet the roof of Building 18, suggesting that the original corridor ran directly into the E wall of building 18.

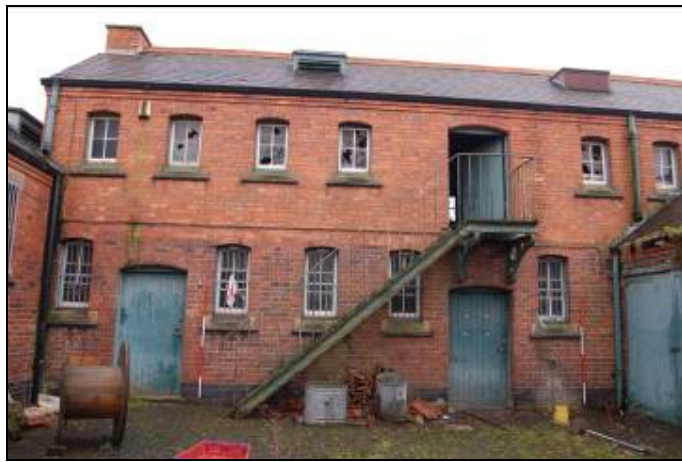
Plate 4

The workshop range building is a one-storey building with occasional dormers (Plates 4 and 47). It is of an orangey-red brick measuring 9 ½ ins x 3 ins x 4 ½ ins which is laid in Flemish bond. Each elevation has a blue brick plinth course of c. 4 bricks high. The windows are on the whole identical. These all have splayed blue brick aprons, sandstone sills, and multipane timber casement windows with sandstone lintels. The doors have stone steps and lintels. The eaves are of two courses of oversailing brick with red tiled hipped roof with terracotta coping.

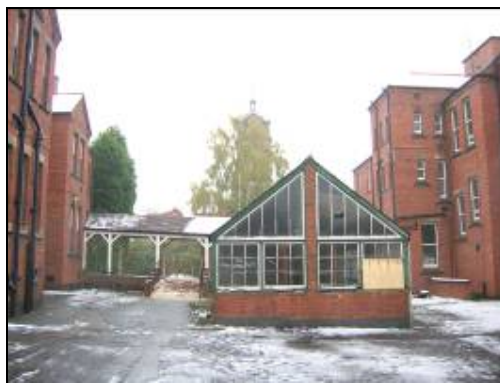
Plate 5

The stable block is of a reddish orange brick measuring 9 1/8 ins x 3 ins x 4 1/4 ins and laid in Flemish bond (Plates 5 and 50). Each elevation has a blue brick plinth. All windows have splayed blue brick aprons, sandstone sills, with segmental arch brick heads. The eaves are of oversail brick, while the tiled roof has terracotta coping.

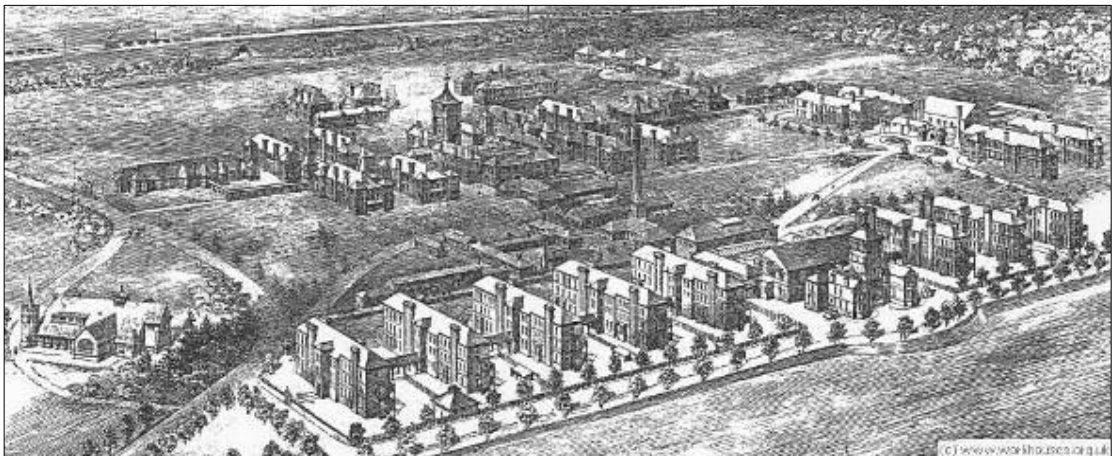
Plate 11

As noted above, the Stourbridge workhouse complex at Wordsley was rebuilt to the plan and design of the Nottingham architect Arthur Marshall. Marshall, who had previously constructed workhouses at Nottingham (1898-1903) (Plates 11 and 12) and Wolverhampton (1901-1903) (Plates 13 and 14), favoured the use of the 'pavilion' or separate block plan. It would appear that Marshall had a particular schemata, decoration scheme, and plan which he favoured for his workhouse buildings. The three complexes that he designed at the turn of the 19th-century have very similar architectural footprints and are very obviously from the pen of the same author. The ground plans of the three workhouses "bear marked similarities, suggesting that standard designs were used for individual building types, and that only the number of each building type he constructed, and their juxtaposition on the available sites varied between the three institutions" (Upson 2004, 5.1.5). The similarities do not stop with plan type, Marshall utilised a similar palette of materials and design techniques. He stopped short of totally plagiarising his previous work by introducing and using differing external decoration, ornamentation, and architectural styles for his 'landmark' administration buildings, whilst retaining his previous proportionality and plan forms.

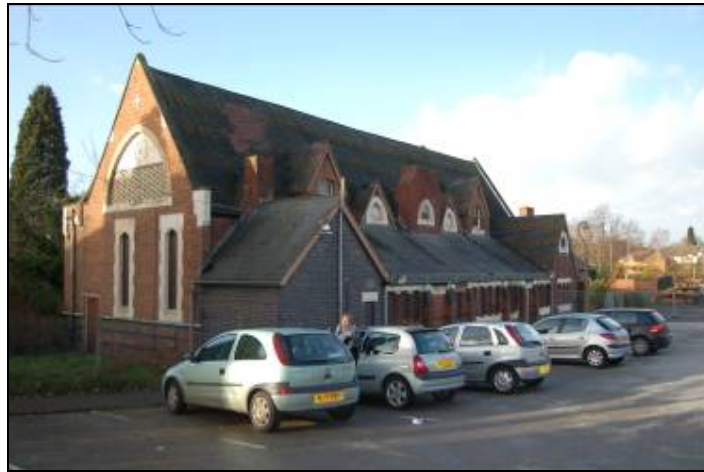
Plate 16

This is a composite elevation with three distinct sections (Plate 16). The most westerly portion is the return of the southern gable-end of the west wall. This is similar to the returns of the other gables. This return is bonded into the central section, which is a gable end with high Caernarvon arched windows with alternating quoin-style jambs. The gable and chequerwork panelling is identical to those on the west and north elevations. Bonded into this to the east is a later gabled extension of blue brick measuring (9 ins x 3 ins x 4 ¾ ins) and laid in English bond. At basement level, which is of red brick, there is a segmental-arched doorway, which leads to the boiler room.

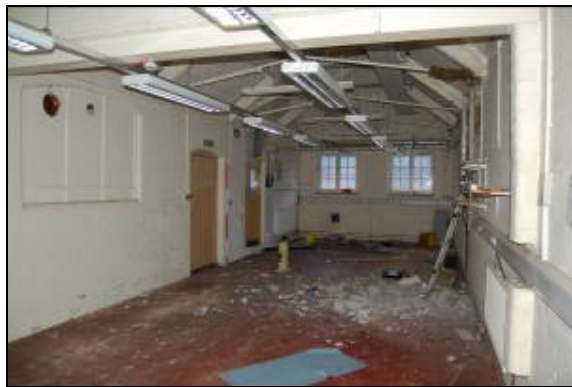
Plate 48

Each workshop was accessed separately from the courtyard and divided internally into a series of distinct rooms (Plates 48 and 49). Whilst the two large workshops in the western range were connected internally, the rest of the rooms originally were not. Most of the internal fixtures and fittings have been removed, however it is known that each workshop had its own fireplace (Upson 2004, 13). The floors are all concrete and either left painted, exposed, or covered in lino or carpet. The dormers noted above were used to provide ventilation. All of the windows are segmental arch awning casements and bullnose-brick sills and jambs. The 1930s plan delineates what each room was used for.

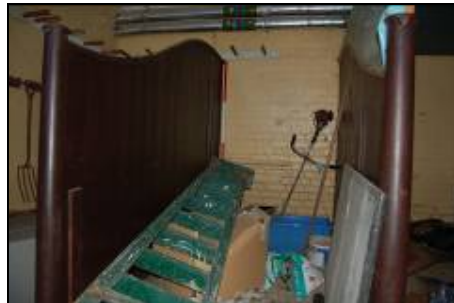
Plate 51

G1 The floor of the stables is of narrow yellow bricks set on-edge (Plates 51 and 52). This gently slopes from east to west with a drainage gully feature also running east to west. There is raised timber decking in the southwest corner, this is a later addition. The doorway on the north wall has a double batten door. There are two windows to the east of this and one to the west, which have moulded and chamfered jambs, and a moulded heads. There is also a similar type window on the west wall. The walls are all of original painted brickwork. There are six blocked air-vents along the south wall. There are three horse stalls along this wall at the east end. These have decorative trevises. These are of wood and have cast iron posts/stanchions and top rails. All internal fixtures and fittings have been lost. There are scars on the back walls of these where hooks/fittings for horses once hung. The floor in each of these stalls runs north to south to accommodate urine run-off. The first of these is a double stall, and cut off cast-iron posts provide evidence of further stalls to the west. A segmental arch doorway on the east wall leads to G2.

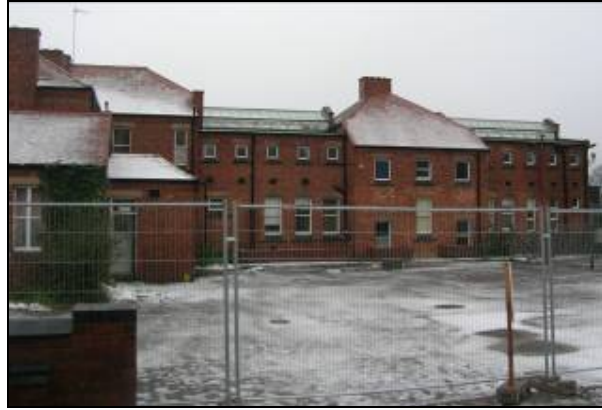
Plate 53

F1 is accessed through a segmental arch doorway at bay 5 and 6 of the north wall (Plate 53). Each other bay on this wall has segmental arch casement windows. There is a projecting chimneybreast on the east wall; however, there is no evidence for a fireplace. A cupboard occupies the southern alcove side of this chimneybreast, within which is the access to G5 of

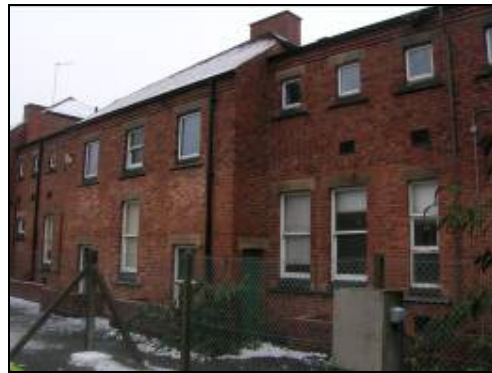
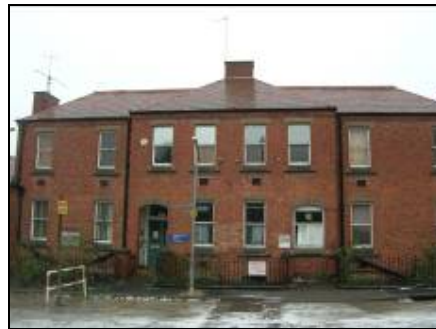
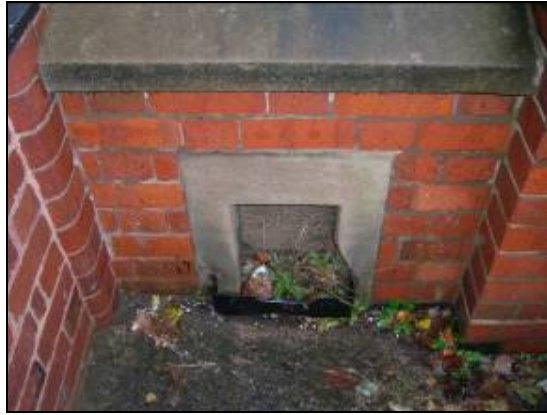
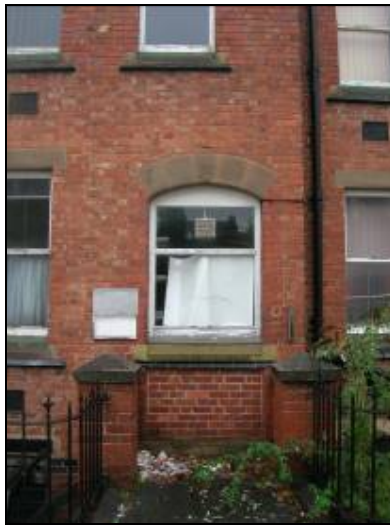
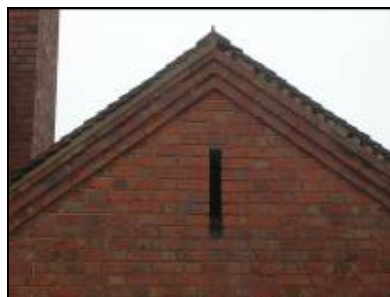
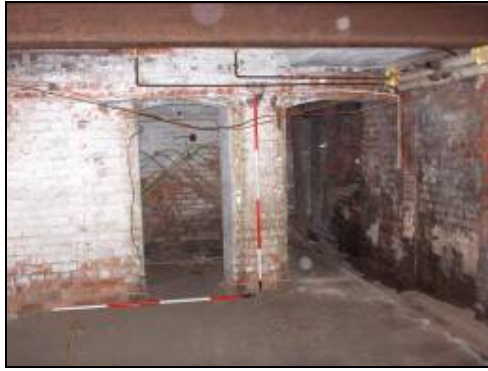
Building 17 has a T-shaped plan, the main body of which is orientated N-S with the crossbar being formed by an E-W aligned block at the S end (Figs 21 and 22) (Plates 54 to 62). The building is three storeys in height with a complex of basements beneath, accessed from both the exterior and interior. The N-S block has a hipped roof and two wings on each side running to the N and the S. Each wing has a flat roof with a raised central lantern running down the middle, visible from the outside but obscured internally by a suspended ceiling. The wings to either side of this central block have five narrow windows on both E and W walls, on both floors, which have all been subsequently replaced but which mark out the original separation of the space into a series of narrow cell-like rooms. None of these original spaces survive, but have instead been knocked through into larger rooms, for later usage as offices. The central block originally contained two separate staircases, one to the N and one to the S, but these have been removed, and no internal evidence remains. Externally the windows of these rooms (F13 & F15), which would have provided light to the stairwell, have been visibly reduced, the windows of the rooms below still sit below the level of the other ground floor windows. An original staircase at the S end of the N-S block now provides access between floors.

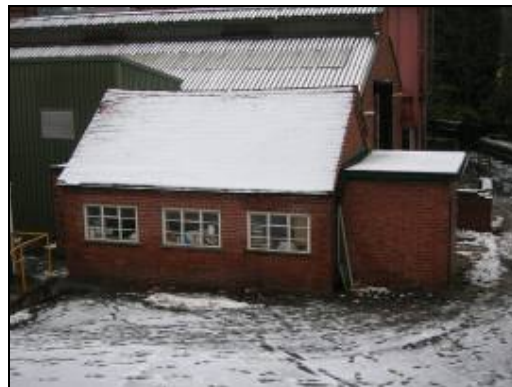
Plate 67

The evidence of the historic maps suggests that the Pump Room (Fig 27) was built in two phases, the later phase being in existence by 1919 (Upson 2004, Building 47 Data Sheet). The roof of the building is visible above ground level and comprises a flat concrete surface with glazed light (Plate 67, 73, and 74). The pump room itself is a rectangular subterranean brick-walled structure aligned east-west and approached by a flight of steps descending from east to west along the south side of the building. At the foot of the steps a segmental arched door gives access to the easternmost of two rooms divided by a brick partition wall, each containing a well. The eastern room, which is the earlier of the two chambers, retains the original steel safety fencing around the cylindrical well. In each case, although pipework survives within the well shaft the pumping mechanism has been removed.

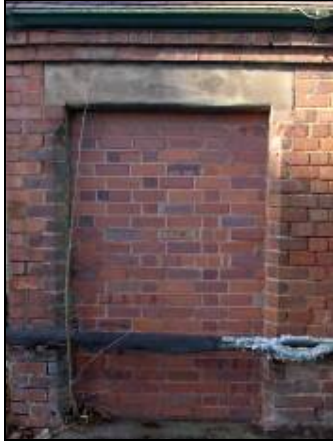
Plate 68

Building 48 is a small single-storey building to the south of the boiler house, proposed by Upson (2004) as the 'post-mortem' room mentioned in documentary sources (Plates 68 to 71). However, tracings of the original plans show the 'post-mortem' room as being contained within the mortuary (now lost).
