**GOODYEAR TYRE FACTORY  
STAFFORD ROAD  
WOLVERHAMPTON  
WEST MIDLANDS**

**Historic Building Record  
2007**

**Project No. 1673**

**Historic Building Recording**

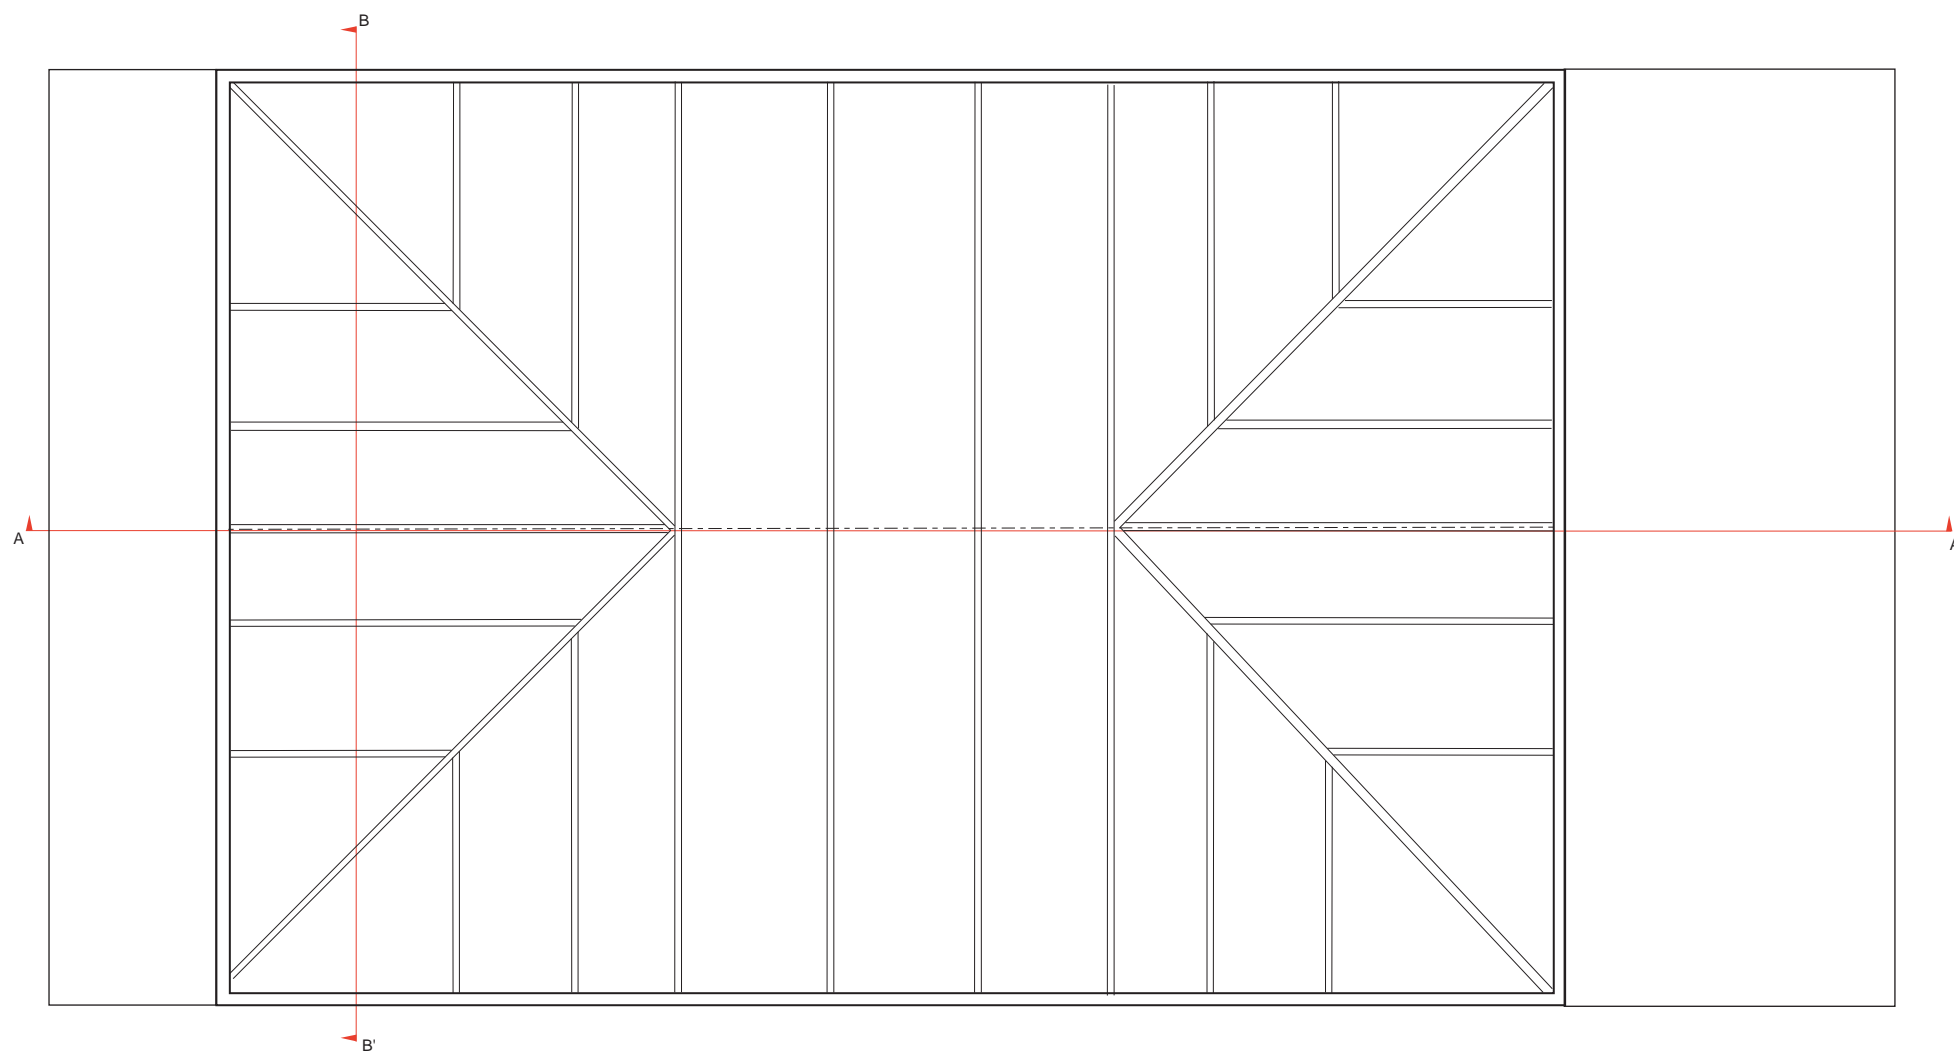
Figure 15: Building 1, Roof plan and sections

(b) Roof plan

- 6.1.6 The roof structure of the office building is complex, comprising steel trusses of modified double-fink pattern and fairly steeply cambered, tripartite lower chords (Figure 15). The complexity of the roof is heightened at the hips, where five, end half-trusses of similar design are employed. The roof is supported on a total of ten tiers of timber purlins and has longitudinal skylight-glazing to the northern and southern slopes; a number of the lower purlins are stop chamfered, suggesting that the roofspace was once fully open to the office area below, an arrangement confirmed by an early photograph of the interior (Figure 18)<sup>4</sup>. The office space is currently ceiled by a suspended ceiling of relatively recent date (1980s?).

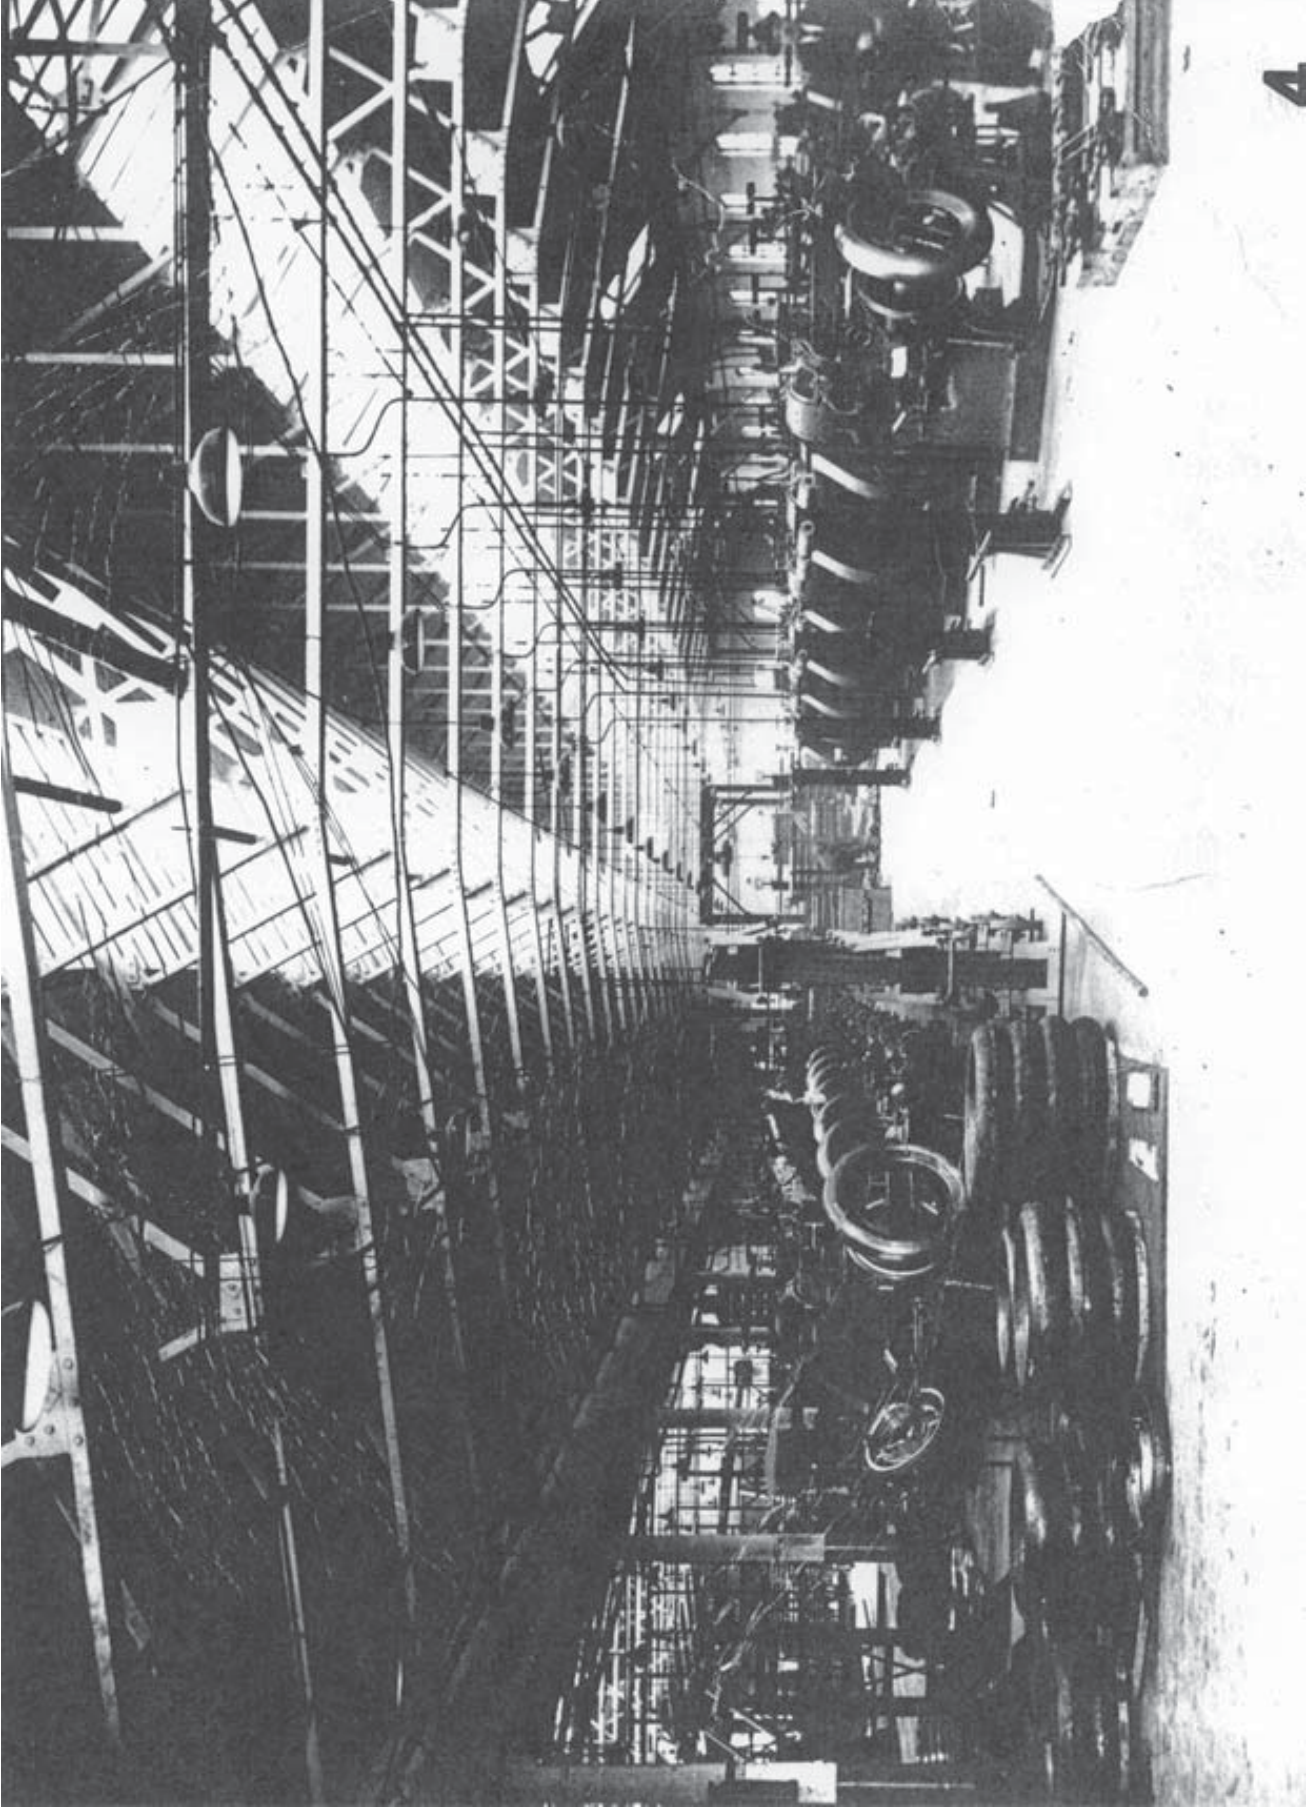
**Figure 20:** Interior of Building 8, west range, looking south, undated c.1926?. Note form of windows to exterior elevation (right).  
Original photo: C A Eisenhofer, Arcade Studios. Source WAL5 ref. DB/20/F82

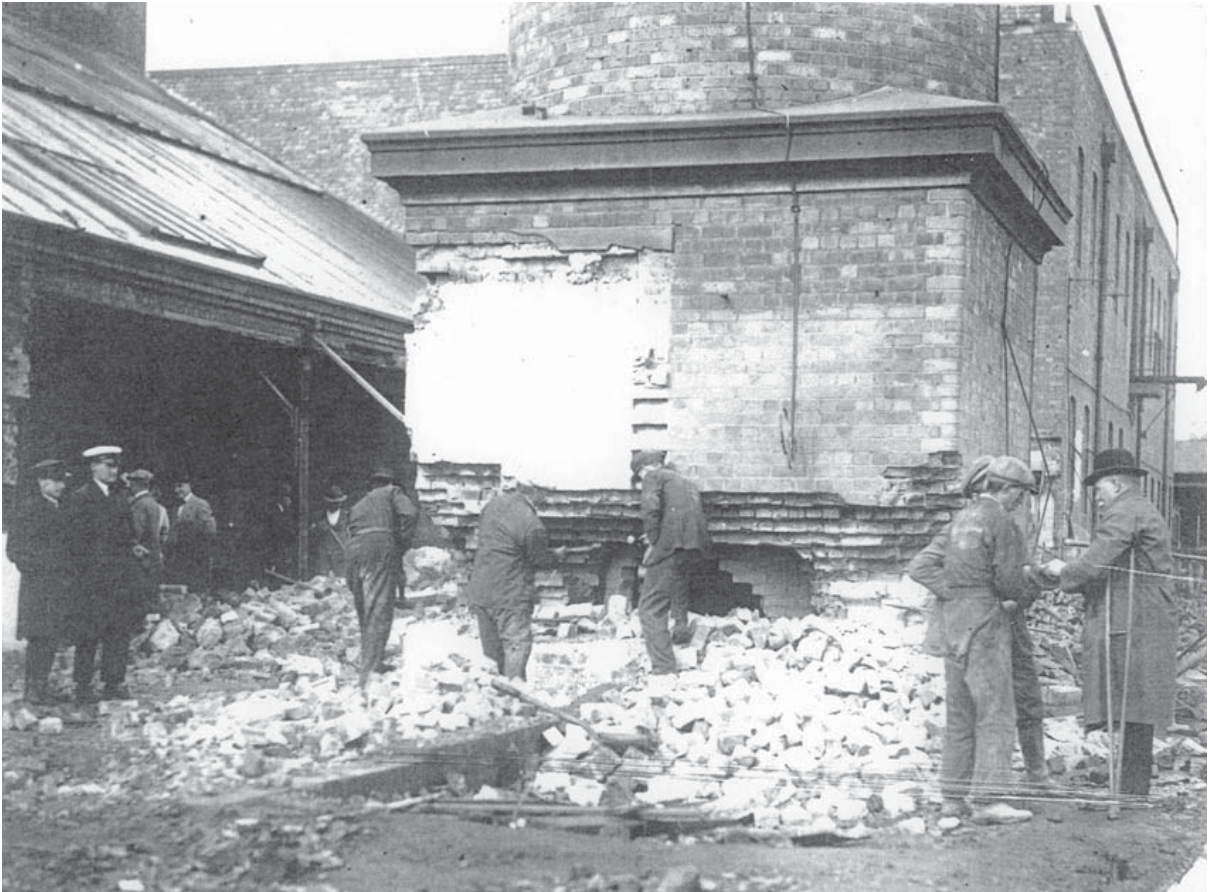
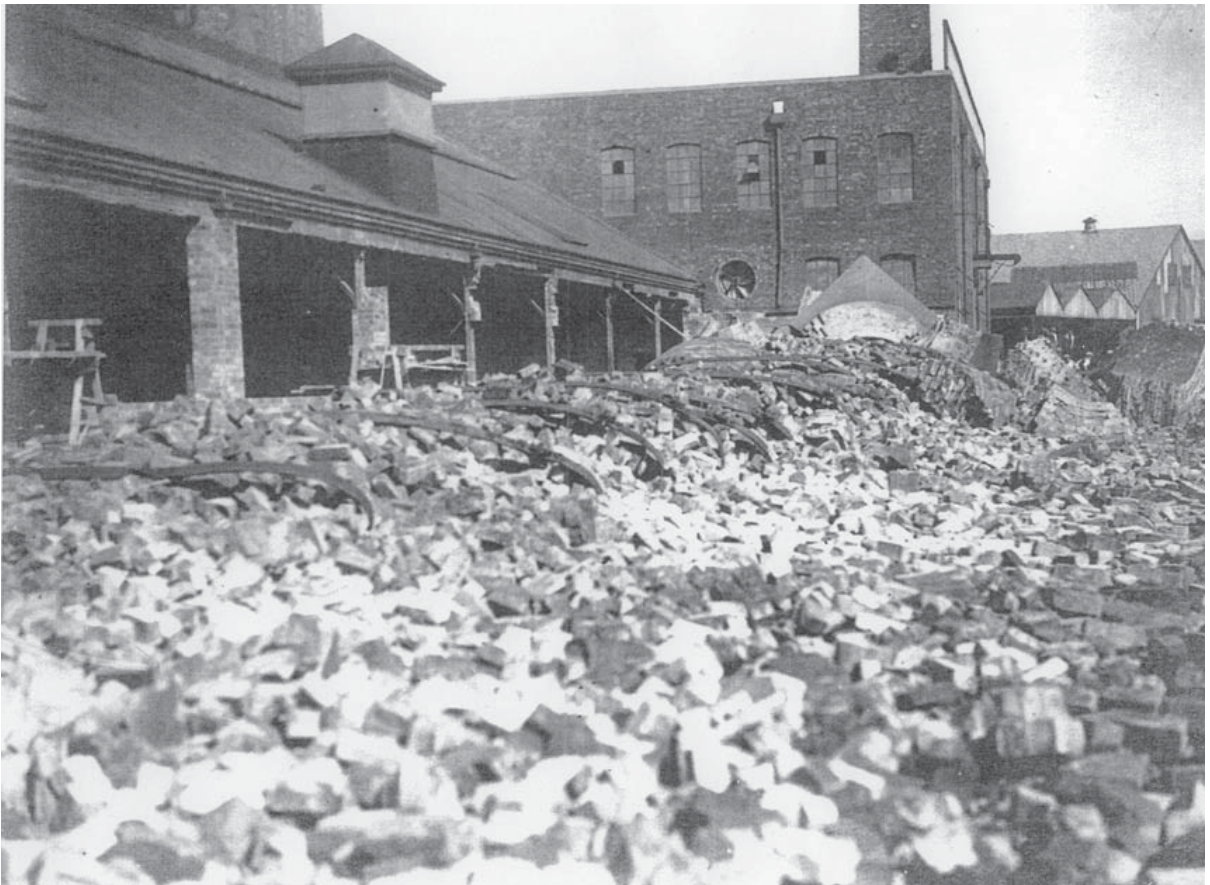
**Figure 21:** Two undated (c.1926?) photographs showing demolition of former stack prior to erection of Building 21 (Boiler House) in 1927. Note removal of brickwork to Building 8, east elevation. Also details of Building 10 to north.  
Original photographs C A Eisenhofer, Arcade Images. Source WAL5 DB/20/F82.

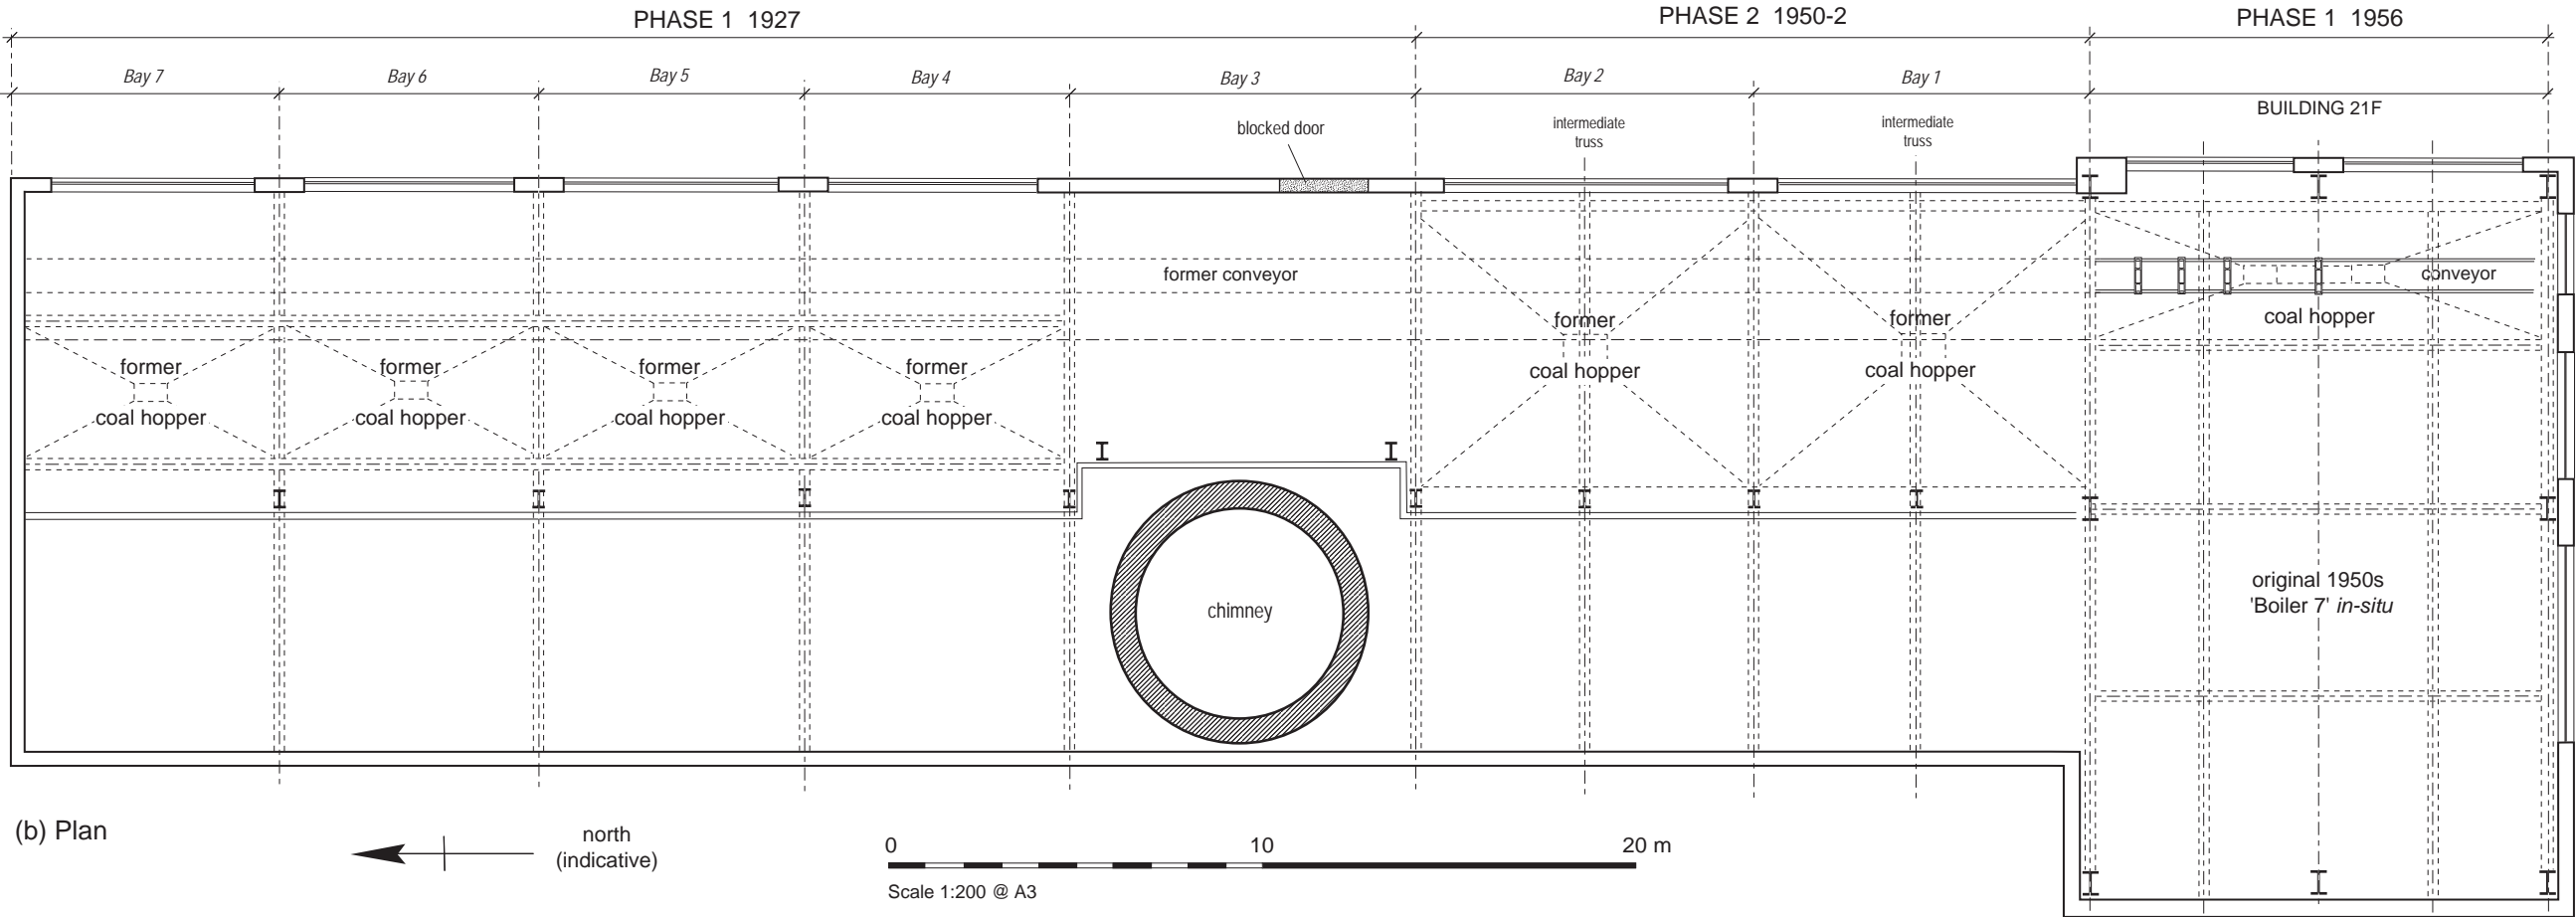
Figure 25: Building 21 (Boiler House)

(a) Representative longitudinal cross-section

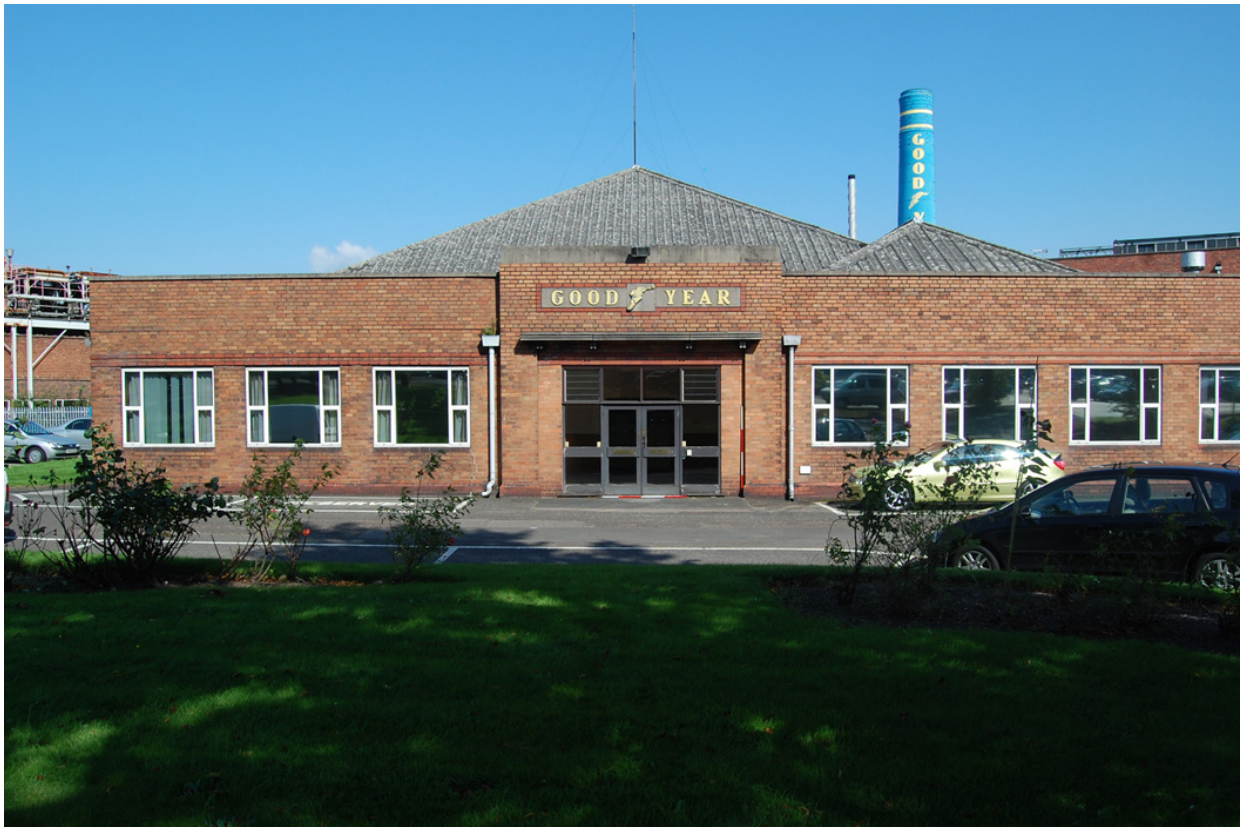
**Plate 01:** Building 1, south-west elevation.

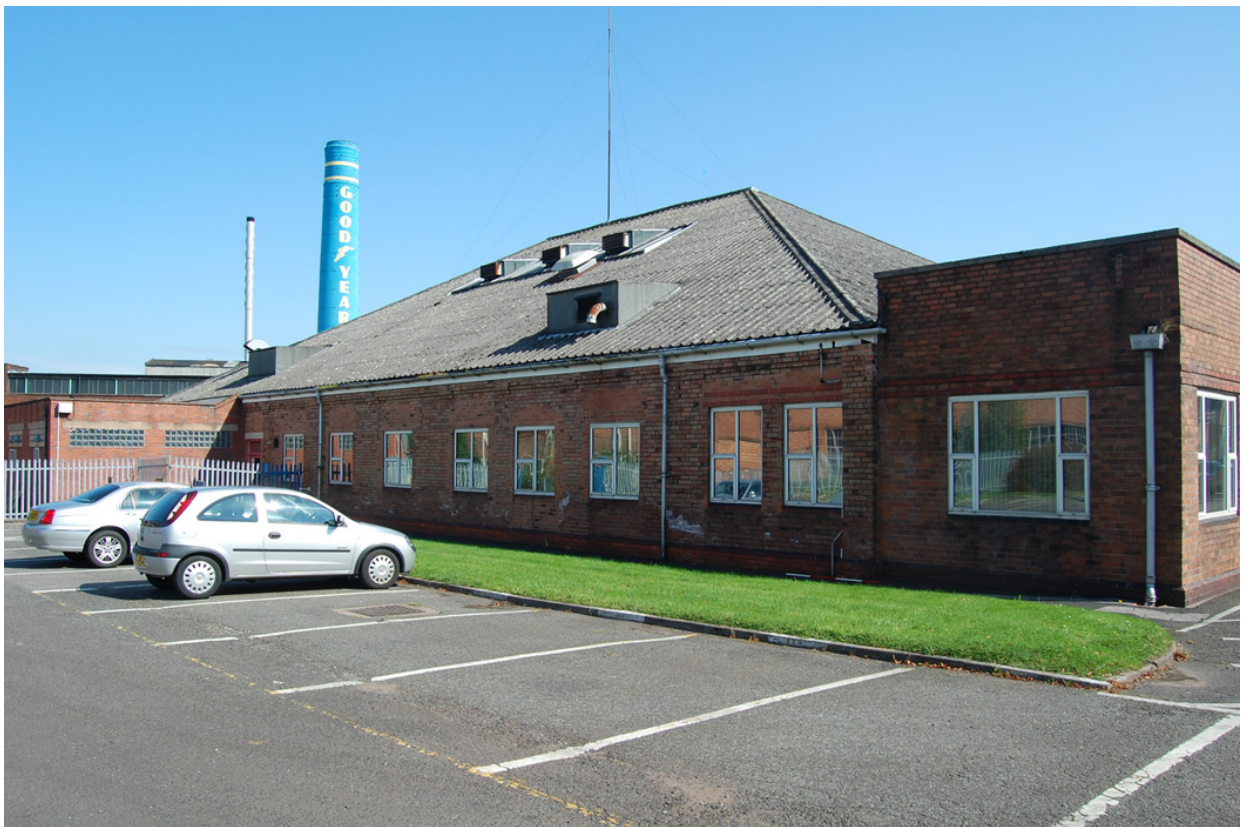
**Plate 02:** Building 1, north-west elevation.

- 6.1.4 The northern elevation of Building 1 (Plate 02) has been much altered, again principally by the insertion of modern UPVC window frames which are here set within area of patching

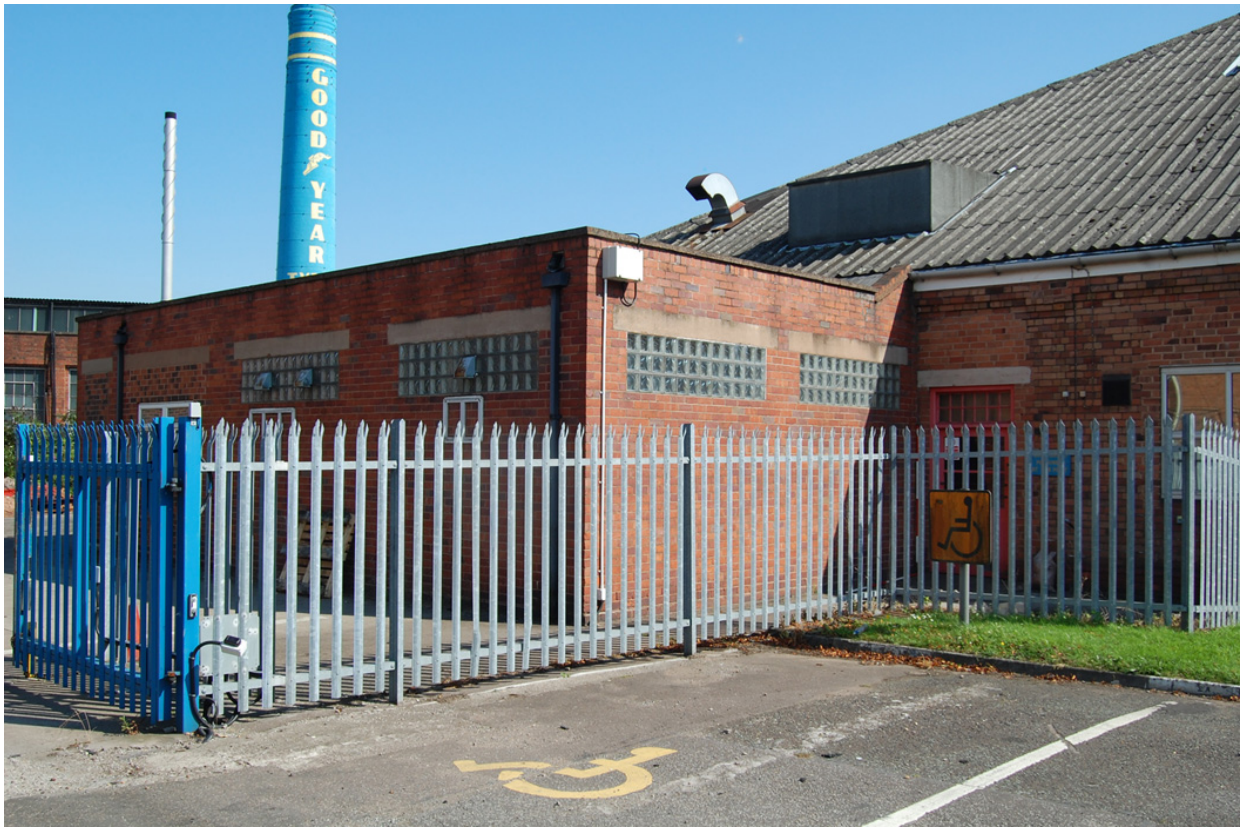
**Plate 03:** Building 1, north-west extension (boiler house chimney in background).

implying that the original openings may have been somewhat larger. To the western end of the elevation is a single-storey extension (Plate 03) of recent date (?1970s).

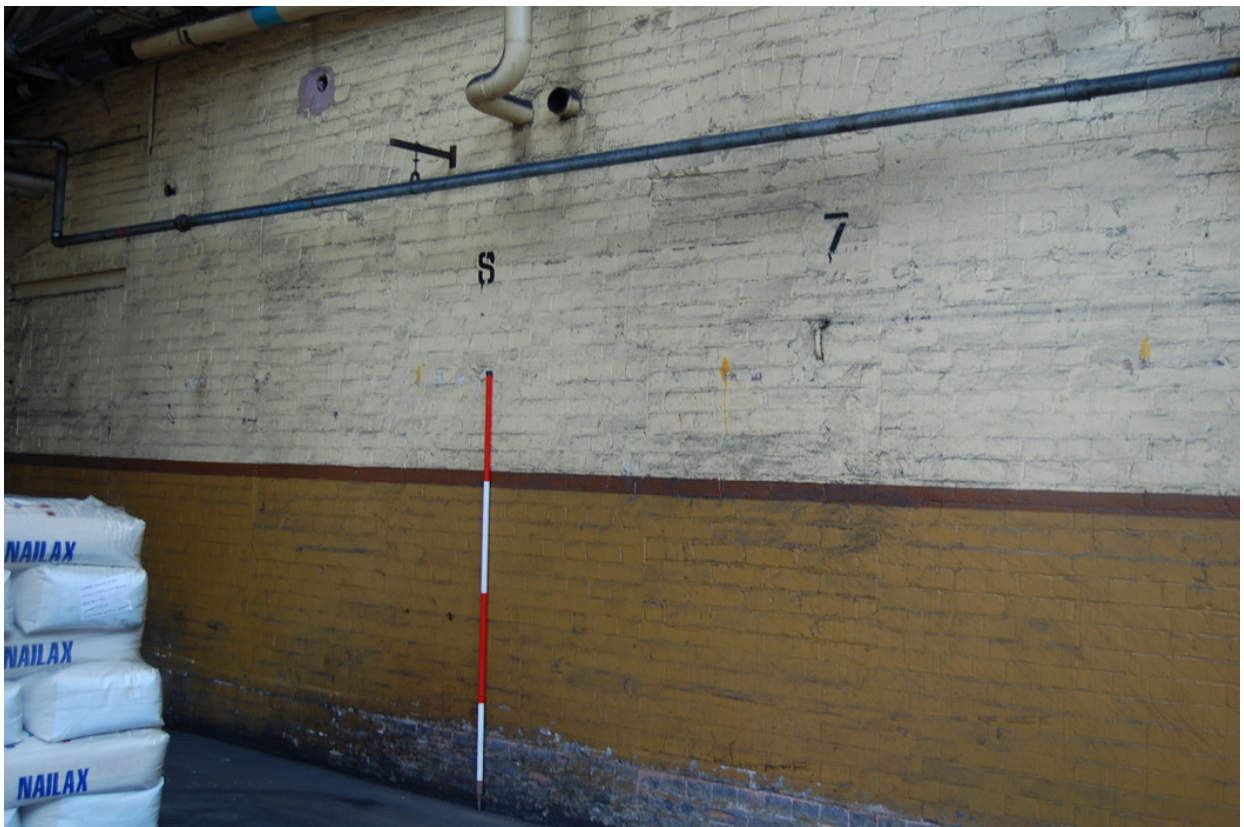
**Plate 13:** Building 8; east range south elevation, blocked segmental headed windows.

- 6.2.2 The southern and eastern exterior walls only of the building survive, to the north it abuts buildings 9B and 10, while to the west, the building has been extended resulting in the loss of any original exterior fabric. The surviving walls are of red-brick construction throughout, laid to English bond. The south wall of each range displays a wide, vehicular access door to the west. These are more recent introductions however, and of particular interest are a series of blocked windows with segmental-arched heads (Plate 13) and two high-level circular vent holes within the gables (Plate 14). Each range also retains a central blocked door.

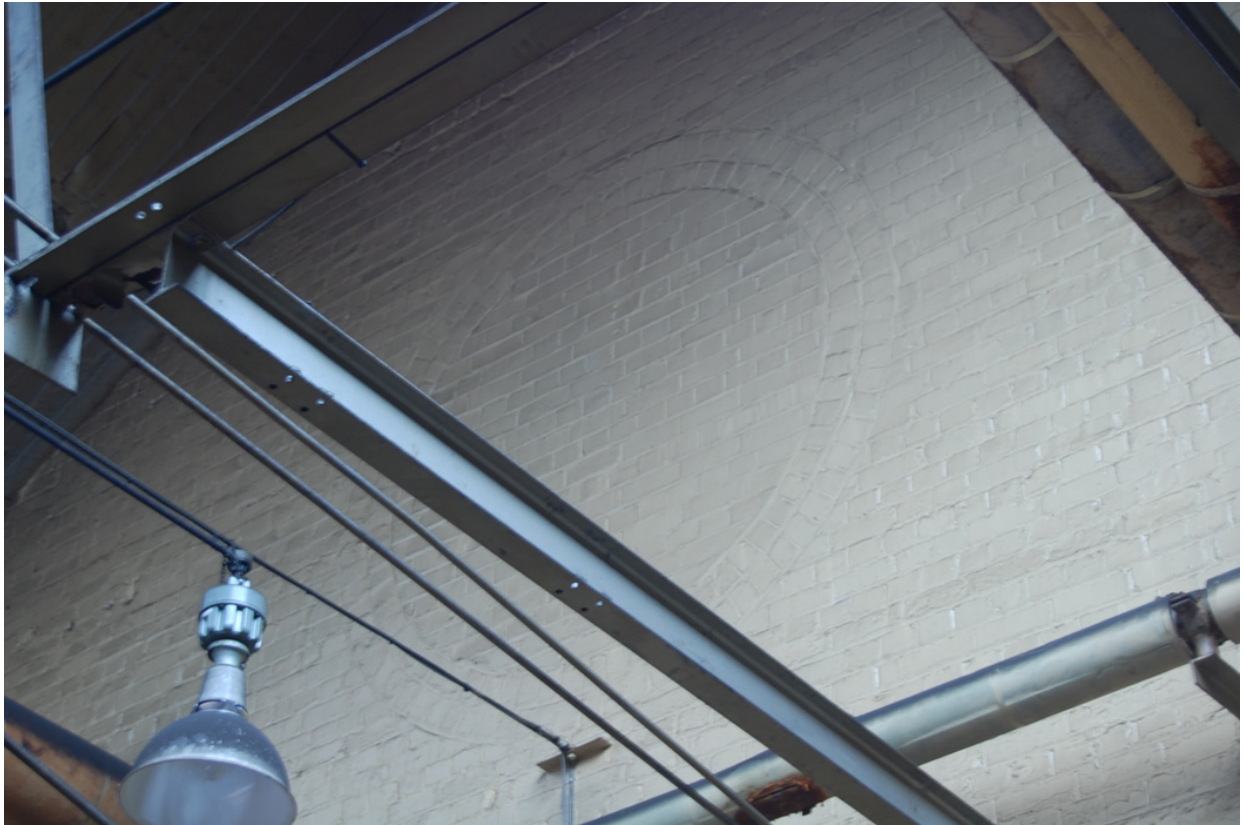
**Plate 14:** Building 8; east range south elevation gable, blocked circular opening.

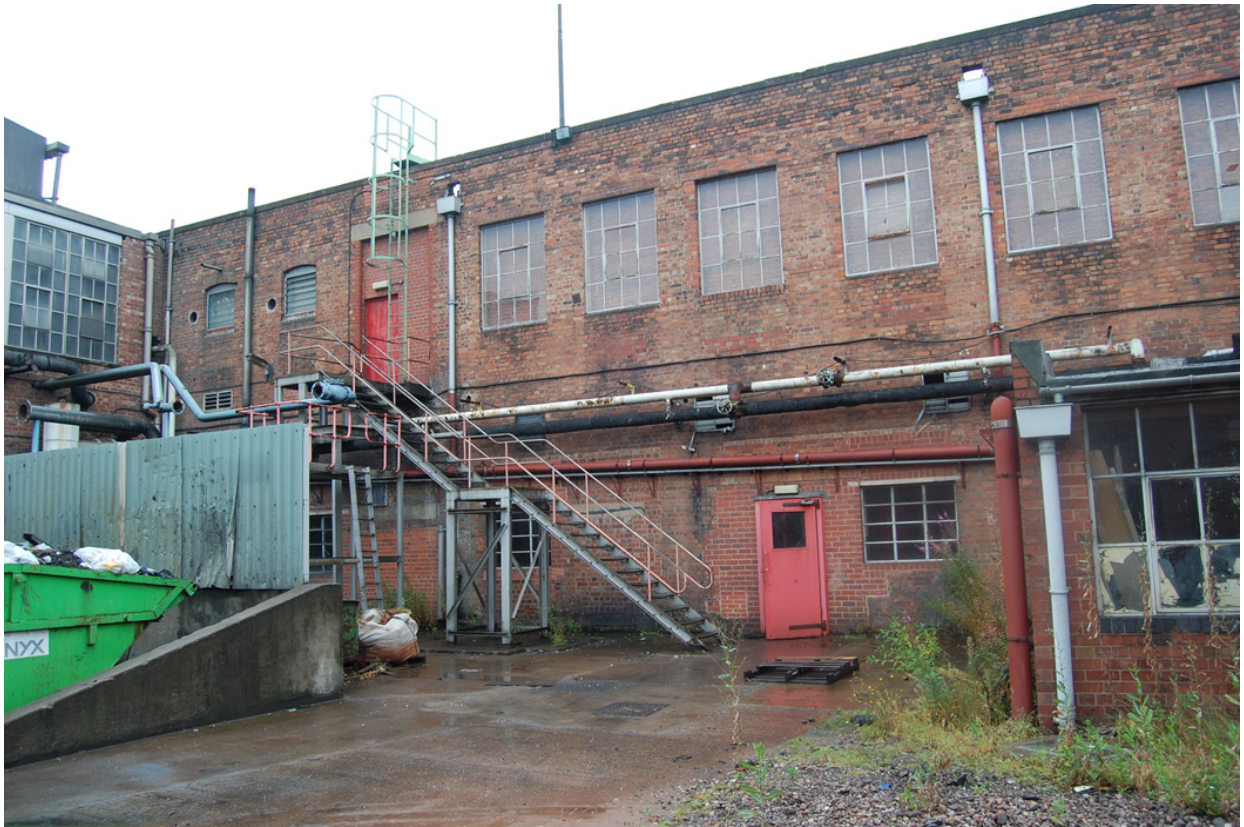
**Plate 27:** Building 10, east elevation.

- 6.4.2 The east elevation (Plate 27), as observed from the exterior, has been subject to much alteration, evidenced by extensive brick patching, particularly at ground floor level. To the south end of the elevation, however, a series of segmental headed windows survive (Plate 28) at ground and first floor level, and further openings on the same model are visible behind pipework in the section of external wall visible from within Building 22 to the south (Plate 29). Northwards of these features are a series of large rectangular windows (Plate 27) which appear to be either insertions or adaptations of earlier openings. An early, undated photograph<sup>8</sup> (Figure 21) of demolition works prior to the construction of Building 21 (1927) seems to show that the windows of the east elevation were originally all of similar height to those of the south elevation (see below), but is inconclusive as regards the original form of the northern windows due to the oblique view.

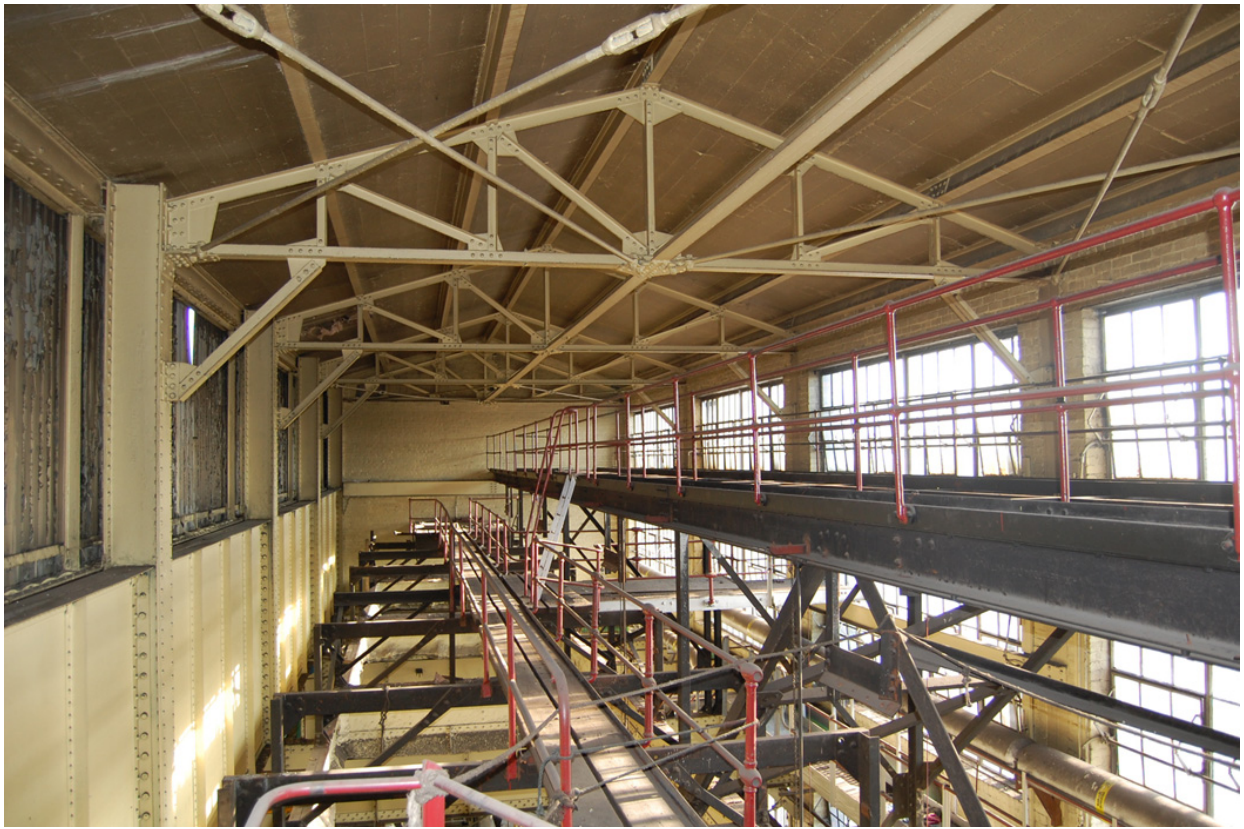
**Plate 35:** Building 21A; Roof structure over Bays 4 – 7.

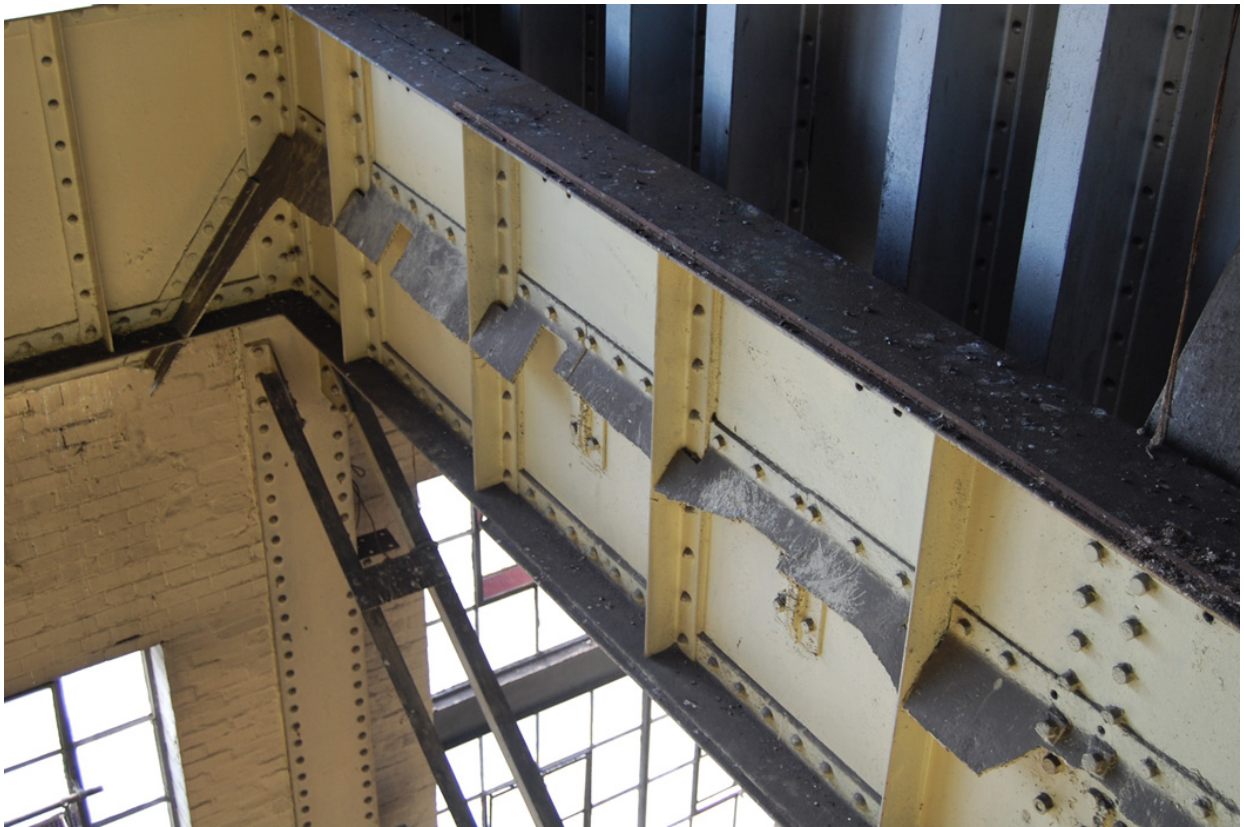
**Plate 36:** Building 21A: Evidence for former coal hoppers, Bay 2.

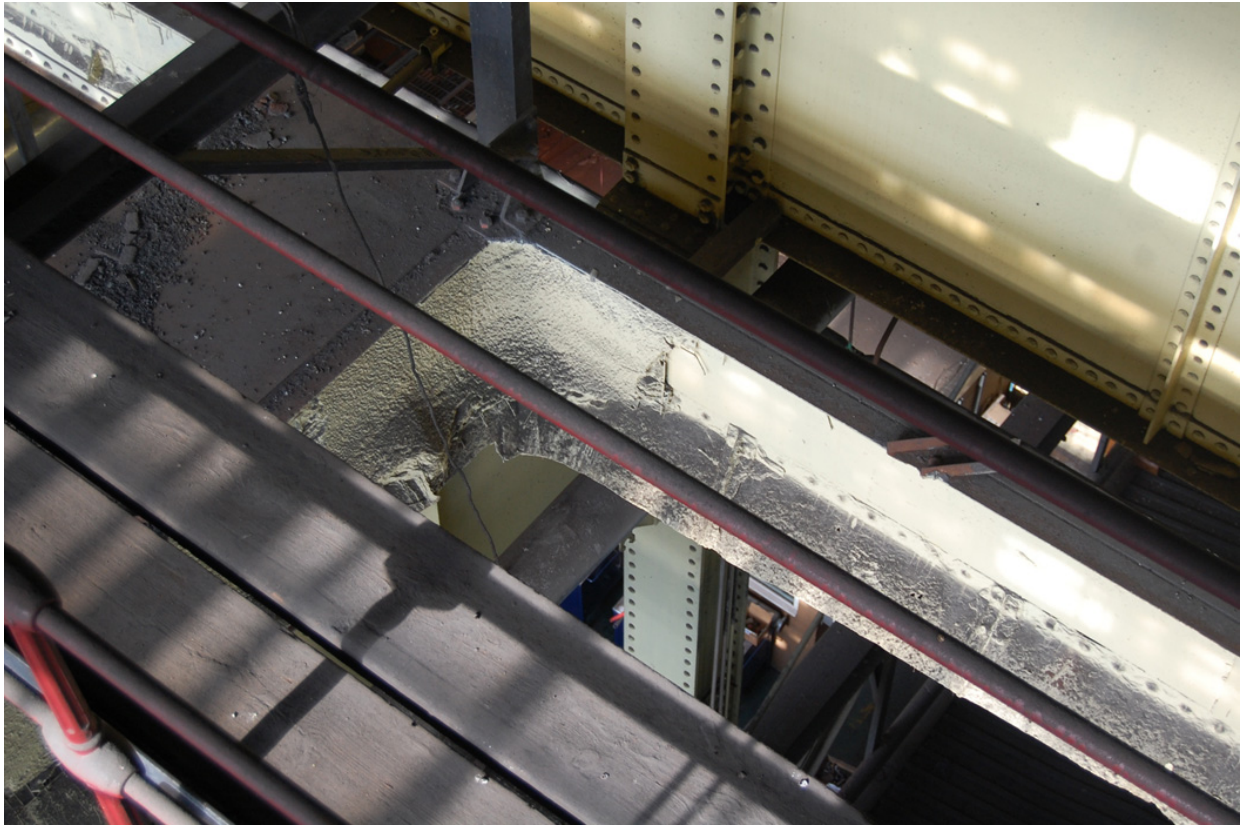
**Plate 37:** Building 21A: Evidence for former coal hoppers, Bay 5.

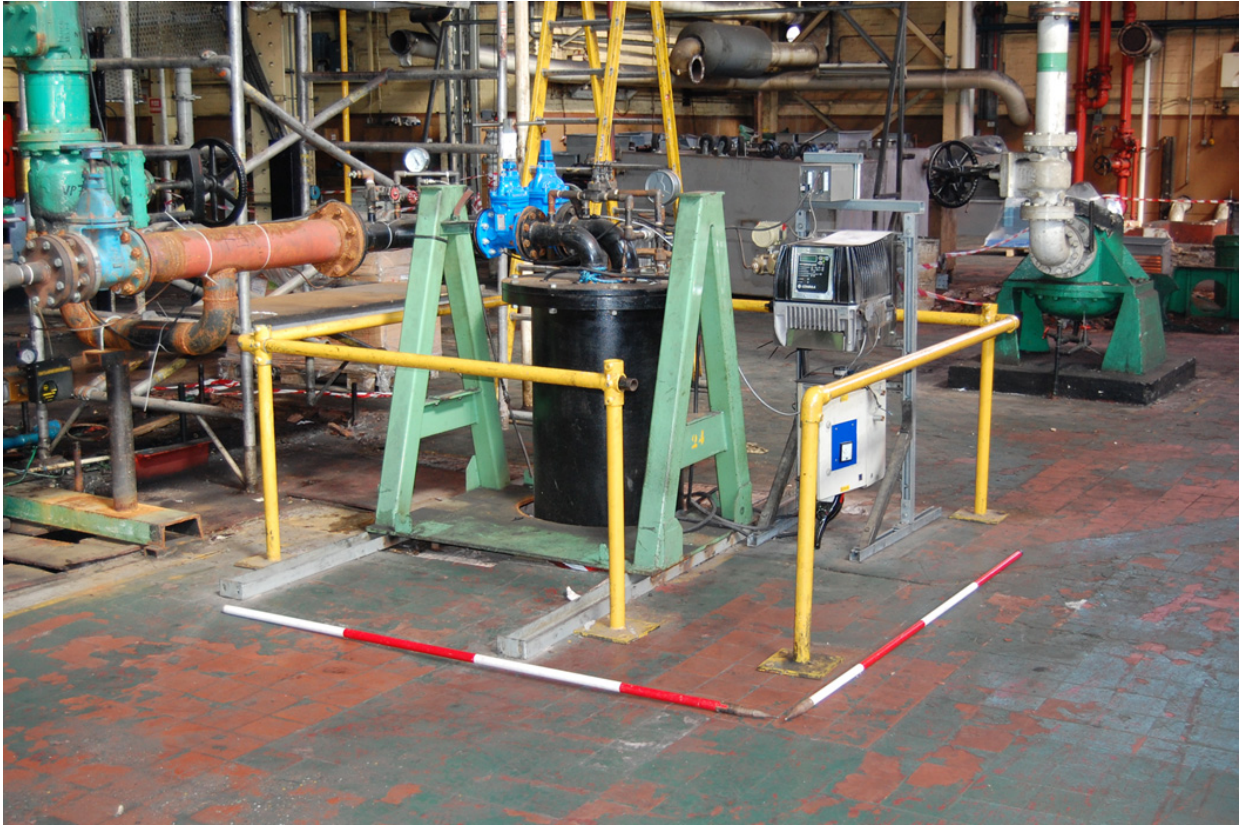
**Plate 69:** Head of bore-hole No.1 within Building 22.
