**Former Corus
Steelworks, Birmingham
Road, Oldbury, Sandwell
(Phases 2 & 3):**

**building recording and
archaeological evaluation
2006 - 2007**

**Project No. 1496
June 2007**

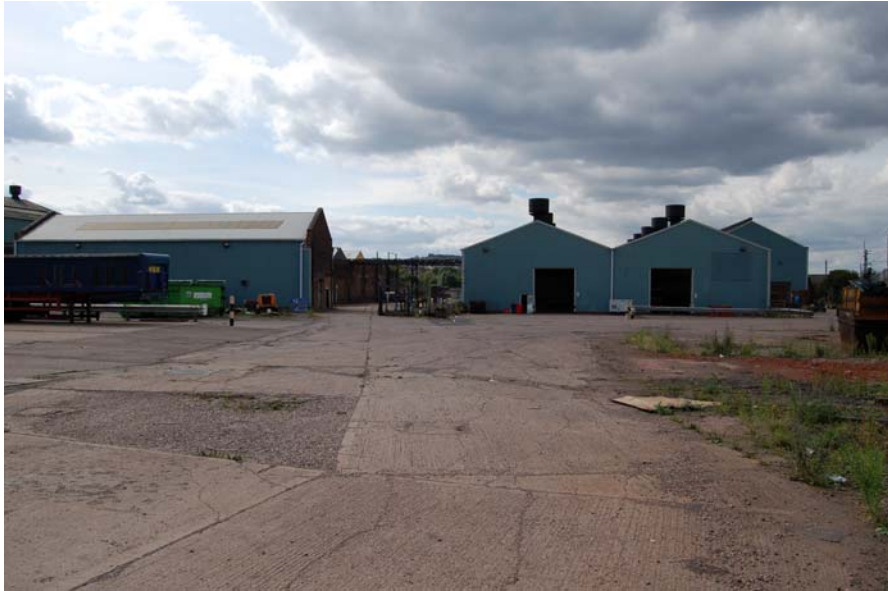
Plate 1

Building recording was carried out on a former Victorian railway building converted for use as an electrical substation (Building A) and a building associated with steel-working (Building B, Plate 1).

This is a former Victorian railway building converted for use as a steelworks in the mid to late 20th century (Plate 1).

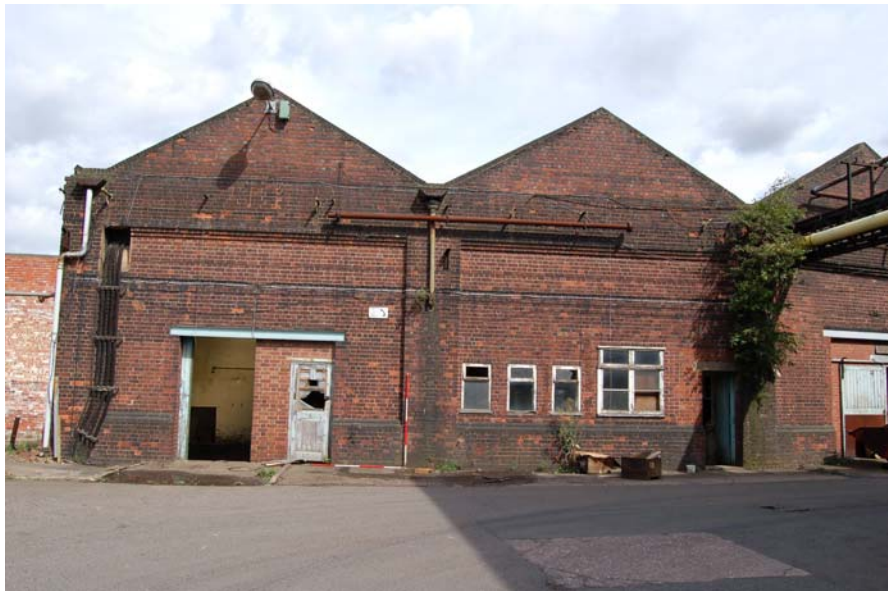
Plate 2

The south facing section (Plate 2) of this is of painted red brick in stretcher bond with occasional headers measuring $9 \frac{1}{8}' \times 3' \times 4 \frac{1}{4}'$. To the west is a bullnose brick pier which has been partially taken away, above this is a cut I-beam. To the east are two large segmental arch windows with timber frames and sills. To the east of this is a bullnose brick pier and another cut I-beam which is to the west of a segmental arch window. To the east of this is a large doorway to provide access to the electrical substation, this has a timber lintel. To the

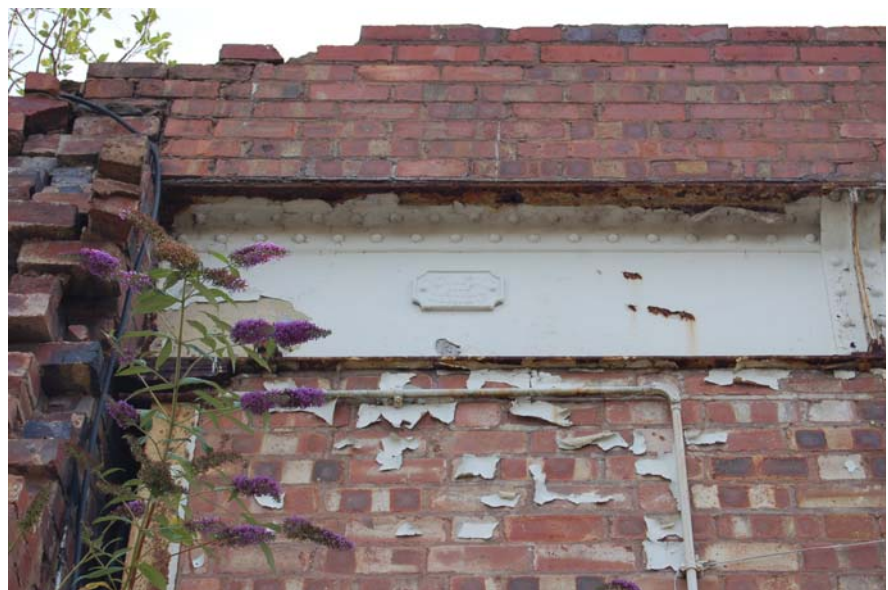
Plate 3

The west elevation is part of the interior of a now demolished structure which extended westwards. It has one storey and is in red brick in stretcher bond measuring 9' x 2 ¾' x 4 ⅛'. Brickwork has been cut off and exposed on the northern corner and west running I-beams have been cut and exposed. This elevation has a doorway to the north with an iron lintel. To the north of this is a vertical section of iron framing. Beneath eaves level is a large exposed I-beam bearing a plaque PATENT CRAFT ANNETREE AND CO LTD 1886 ENGINEERS WEDNESBURY (Plate 3).

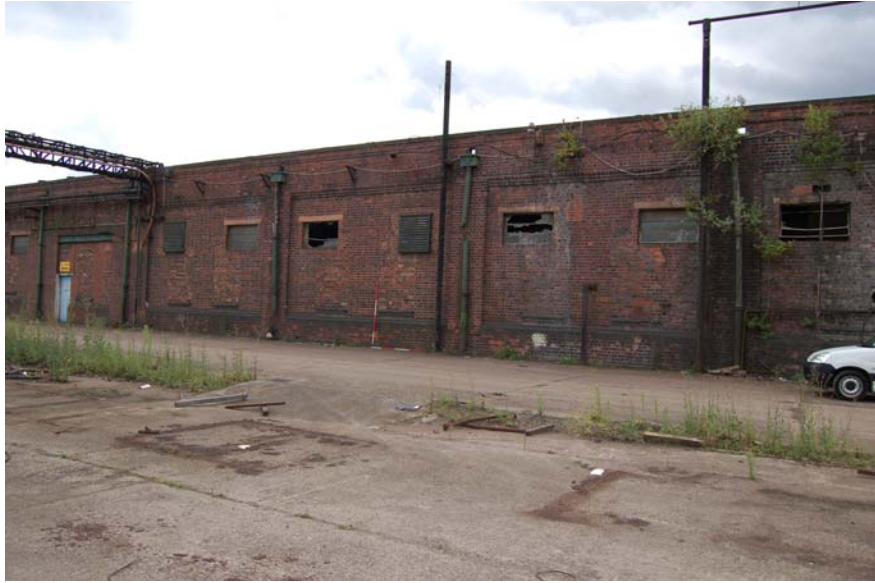
Plate 4

The remainder of the north elevation is a one storey fifteen bay elevation (Plate 4). This is in red brick in English Cross bond with occasional burnt headers and stretchers in no apparent pattern, measuring 8 ⅝' x 3' x 4'. This elevation is similar to the central elevation on the south wall in that it has a series of piers with recessed sections in between. There are cast iron rainwater goods on each pier. The splayed blue brick string is also present here. The west corner of this elevation has been cut off leaving exposed brick. It is apparent that the bay between each pier had two segmental arched windows. These have all been blocked, some of which have been cut by tripartite steel windows and louvered air vents. The eaves are coped with brick on edge.

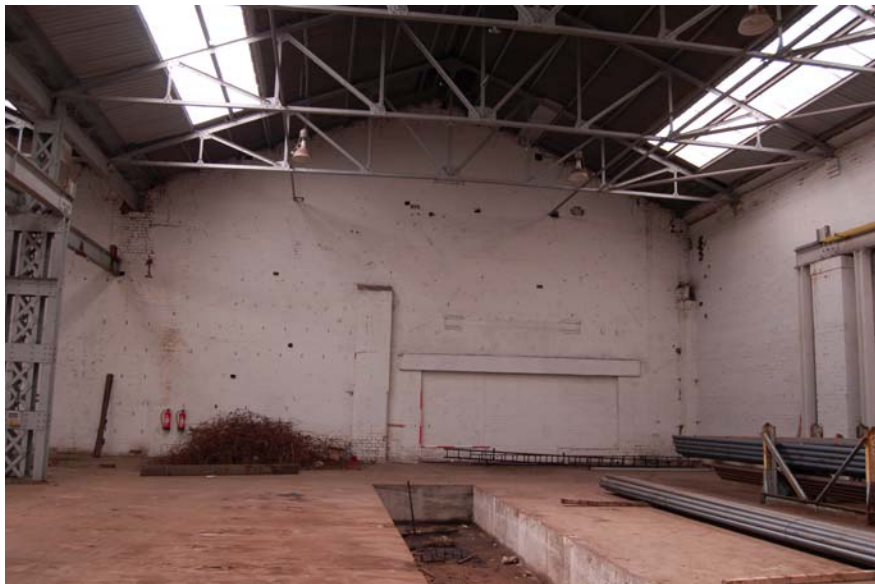
Plate 6

The west wall comprises of two gable ends (Plate 6). These are of painted red brick in English Cross bond measuring 9' x 3' x 4 1/2'. The south gable has a large blocked segmental arched doorway. This is cut by two blocked large rectangular doorways; the most southerly of these is blocked with painted breeze block and has a riveted I-beam lintel. The other is blocked with painted modern brick in stretcher bond. The roof structure cuts the area between the gables at two points. The northern gable on this elevation has a bullnose brick pier with chamfer stops to the south of centre and a large blocked opening with a lintel head.

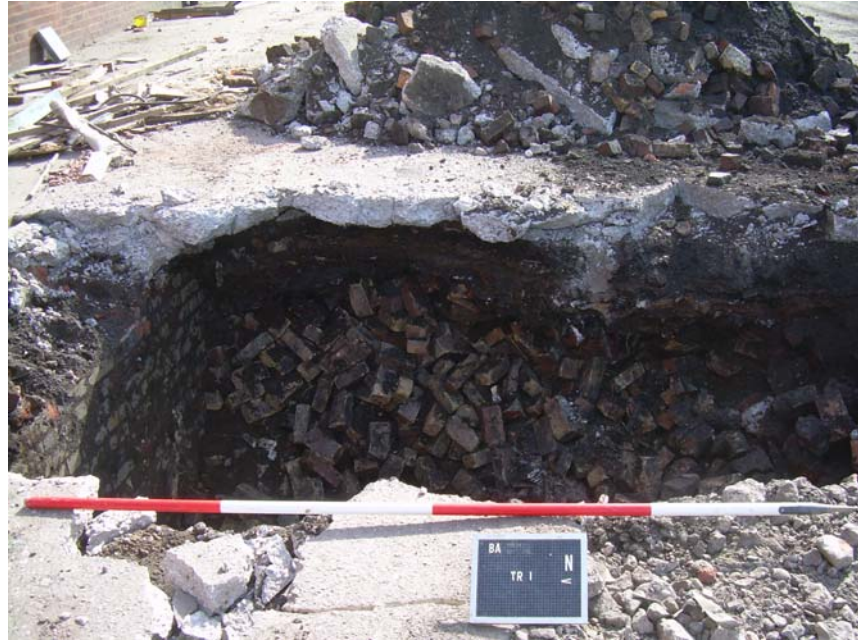
Plate 8

The natural subsoil was not reached and the earliest feature revealed was a red brick wall [6003, Plate 8] at the north end of the trench on a northwest-southeast alignment. Wall 6003 was at least 1.20m high. Wall 6003 was sealed by a surface made of a single course of blue engineering brick [6002]. Abutting 6003 and 6002 was a layer [6001] of dark grey-brown silt and clinker, at least 1.70m deep, containing frequent red bricks and metal piping. Layer 6001 was similar to layers 4004 and 5003 in Trenches 4 and 5, and was thought to be backfill of a former canal basin. It was excavated to a depth of 1.70m, but its full extent was not recorded. Layer 6001 was sealed by modern overburden [6004] that consisted of dark grey-brown silty clay with clinker, brick fragments and mortar. Contexts 6004 and 6002 were sealed by a surface of modern concrete [6000].

Wall 6003 may be part of the canal basin wall associated with the a 19th century canal branch, now filled in, and the overlying surface 6002 could perhaps have been associated with a towpath or wharf.

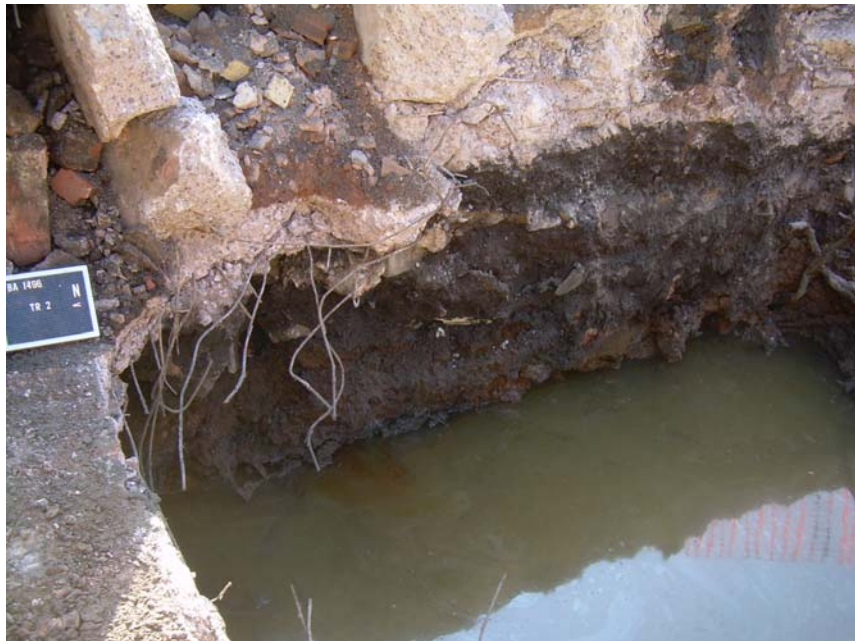
Plate 9

Natural subsoil was not encountered in this trench and the earliest deposit located was a layer [5003] consisting of possible hydrocarbon contaminated material mainly brick rubble, stone and clinker containing metal piping, tar, and miscellaneous corroded metal objects. Layer 5003, similar to layer 4004 in Trench 4, was thought to be backfill of a former canal basin, was excavated to a depth of 1.5m, but its full extent was not recorded. Rapid seepage of potentially contaminated groundwater meant it was not possible to fully excavate this layer. To the north layer 5003 was cut by a concrete surface [5002, Plate 9], at least 5m wide and

0.75m deep. Surface 5002 was overlain by a layer of modern overburden [5001] that consisted of mostly brick rubble. These Layers 5001 were sealed by a concrete surface [5000] 0.70m thick, that increased in depth to the north.

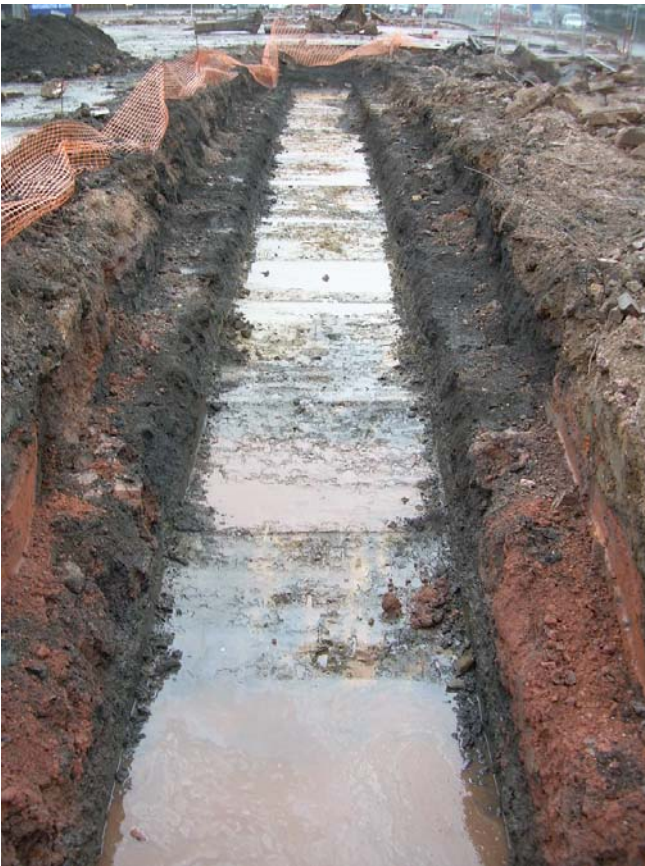
Plate 12

Trench 9 was orientated north-south and measured 49m x 2m x 1.8m. A 3m length of the trench was not excavated as a flood prevention method. The northern and central parts of the trench were subject to rapid seepage of groundwater, making excavation difficult even with a pump in operation.

A mid orange brown natural clay **[909]** was encountered at a depth of 1.50m (in the south) sloping down to 1.80m (in the north) from the present ground surface.

In the middle of the northern half of the trench the natural surface dipped down to form a hollow. No definite cut was located and it is thought that the hollow may be a possible palaeochannel or former watercourse. While the northern edge of the palaeochannel was not found, by a process of elimination it must lie within the unexcavated portion of the trench as natural was encountered to the north. The width of the palaeochannel is estimated at about 11m.

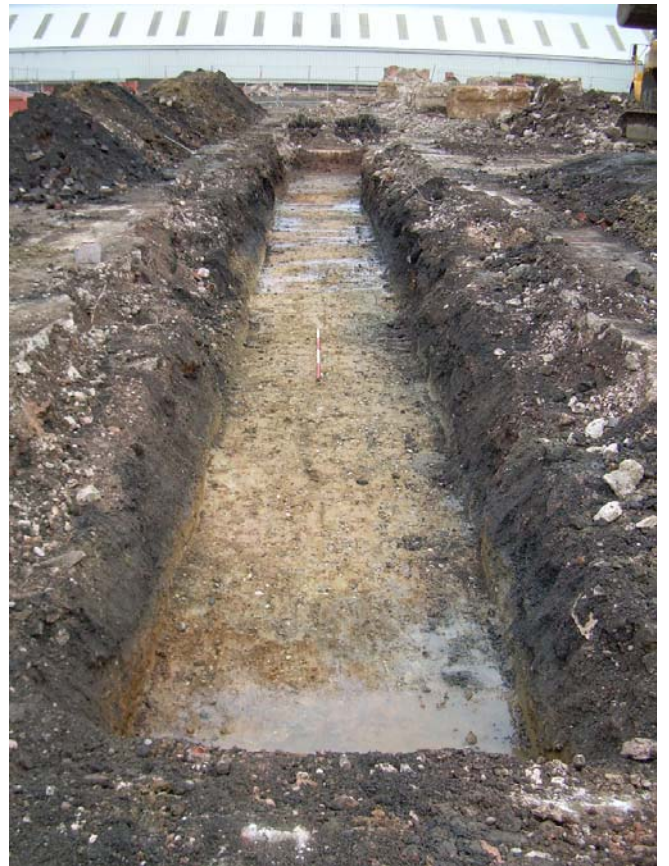
Plate 13

Trench 10 was orientated east-west and measured 43m x 2m x 1.30m. The intended 50m length had to be foreshortened to avoid large concrete stanchions at the eastern end.

Natural mid orange brown clay with pebbles **[1004]** was encountered at a fairly uniform depth of 1.10-1.30m from the ground surface right across the trench.

The natural clay 1004 was cut by curvilinear gully **[1006]**. There were no finds in the fill **[1007]** and given its irregular sides it is probable that the feature is of natural origin. Also cutting the natural were two north-east to south-west orientated field drains.

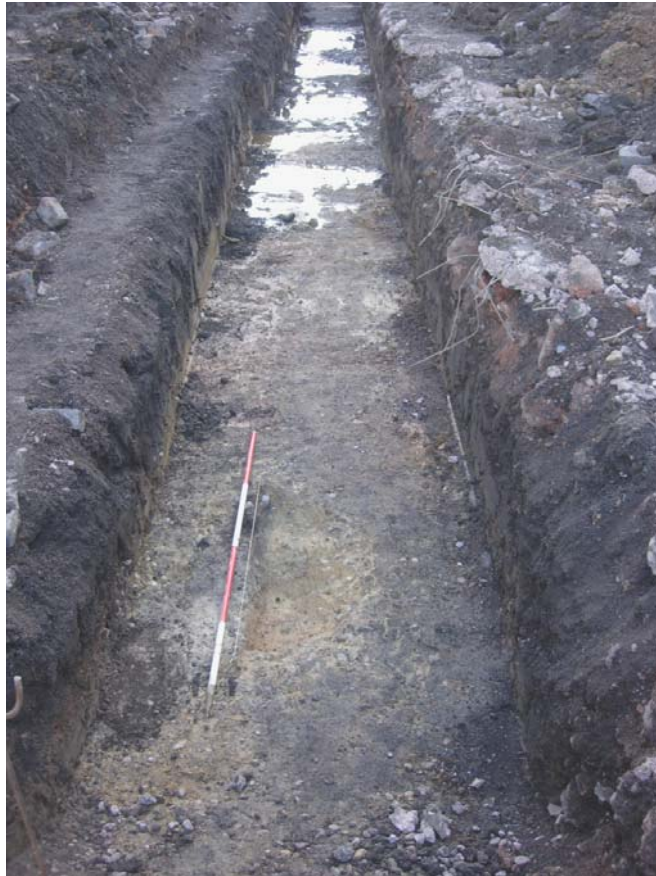
Plate 14

Trench 11 was orientated north-south and measured 50m x 2m x 2m.

Natural yellow and blue clay **[1106]** was encountered at an average depth of 1.20 – 1.40m for most of the trench, though modern disturbance had truncated it to an unknown depth for a stretch of 5m at the northern end and 12m in the southern half of the trench.

Cut into the natural 1106 was an undated possible shallow furrow **[1109]**, filled by light grey-blue clay **[1110]**. Also cutting the natural was a shallow irregular pit-like feature **[1111]**, filled by a mid grey silty clay **[1112]** which contained no finds.

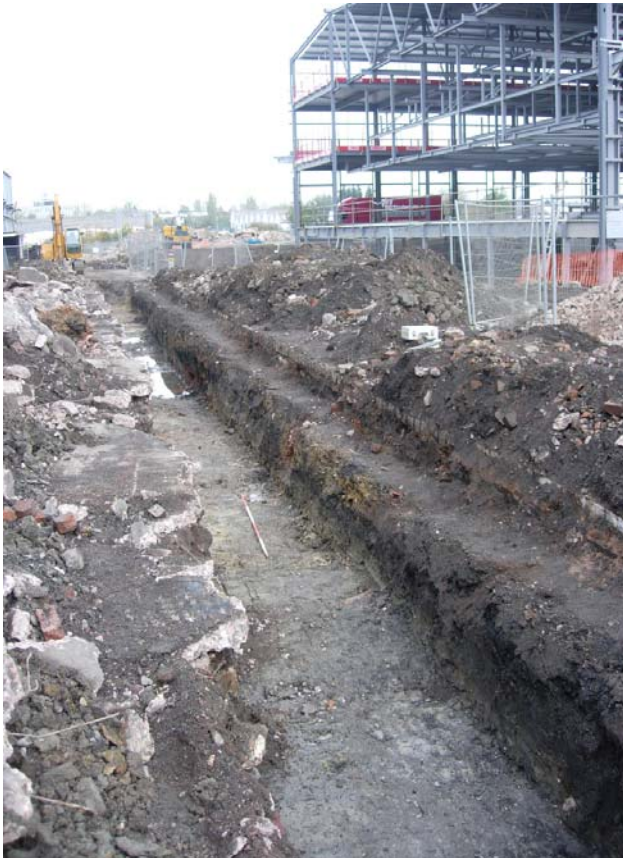
Plate 15

Trench 12 was orientated north-south and measured 50m x 2m x 1.20m.

The yellow sandy clay natural **[1205]** was encountered at an average depth of 1.20m. Above the natural was a dark grey gritty clay sand **[1204]**, which could be a buried former topsoil, but for which no dating evidence was found. All the layers above were of modern origin. Sealing 1204 was the very dark grey silty clay **[1203]** containing Victorian pottery and glass. Above 1203 was the grey layer of ash and clinker **[1202]**. This layer was cut by two pipe trenches running roughly north-south from a manhole cover in the north of the trench. Layer 1202 was covered by a brick surface **[1201]** which in turn was sealed by concrete **[1200]**. There were no archaeological features in this trench.

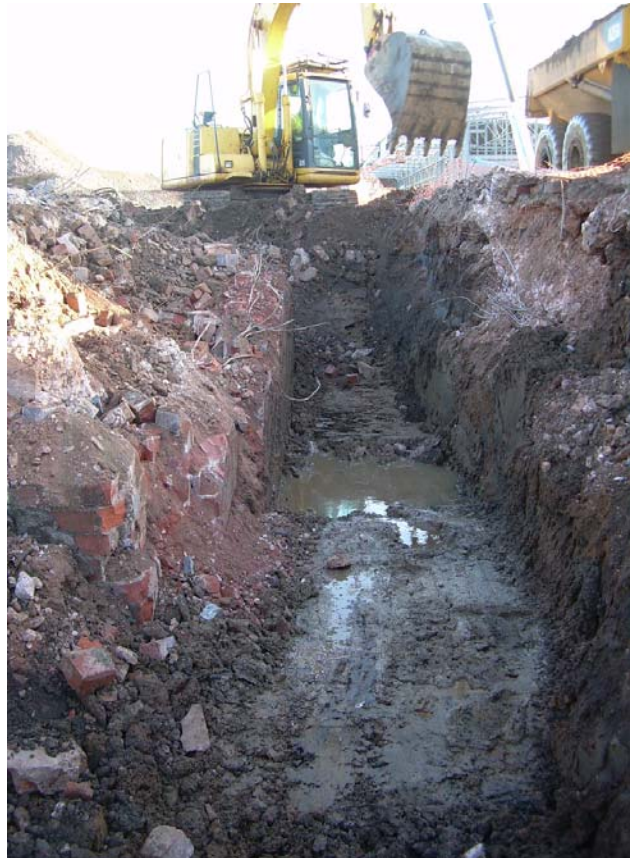
Plate 16

Trench 13 was orientated east-west and measured 34m x 2m x 2m, with a sondage at the eastern end excavated down to 3.2m. Natural was not encountered in this trench, and excavation revealed heavily made-up ground in this part of the site.

In the central part of the trench the earliest layer was a black silt layer **[1324]** overlaid by brown clay **[1323]** which was overlaid by mid grey sandy clay **[1318]**. All these layers dipped downwards towards the west, either as part of a natural slope or into a watercourse or some other deep hollow. Above 3018 was a continuation of the same pattern or sequence of layers: - brown clay **[1317]**, grey clay **[1312]**, brown clay **[1311]**, black silt **[1310]**, brown clay **[1309]**, black silt **[1308]**, brown clay **[1307]**, black silt **[1306]**, brown clay **[1305]** / **[1316]** and black silt **[1304]**. The alternating nature of these layers indicates they were all deposited at roughly the same time as part of the same making-up process – probably in connection with the construction of the steelworks.
