Bluntings Farm House,  
Chaddesley Corbett,  
Worcestershire

Historic Building Recording and  
Interpretation, 2007  
(WSM 37550)

Project No. 1647

By Christopher Hewitson

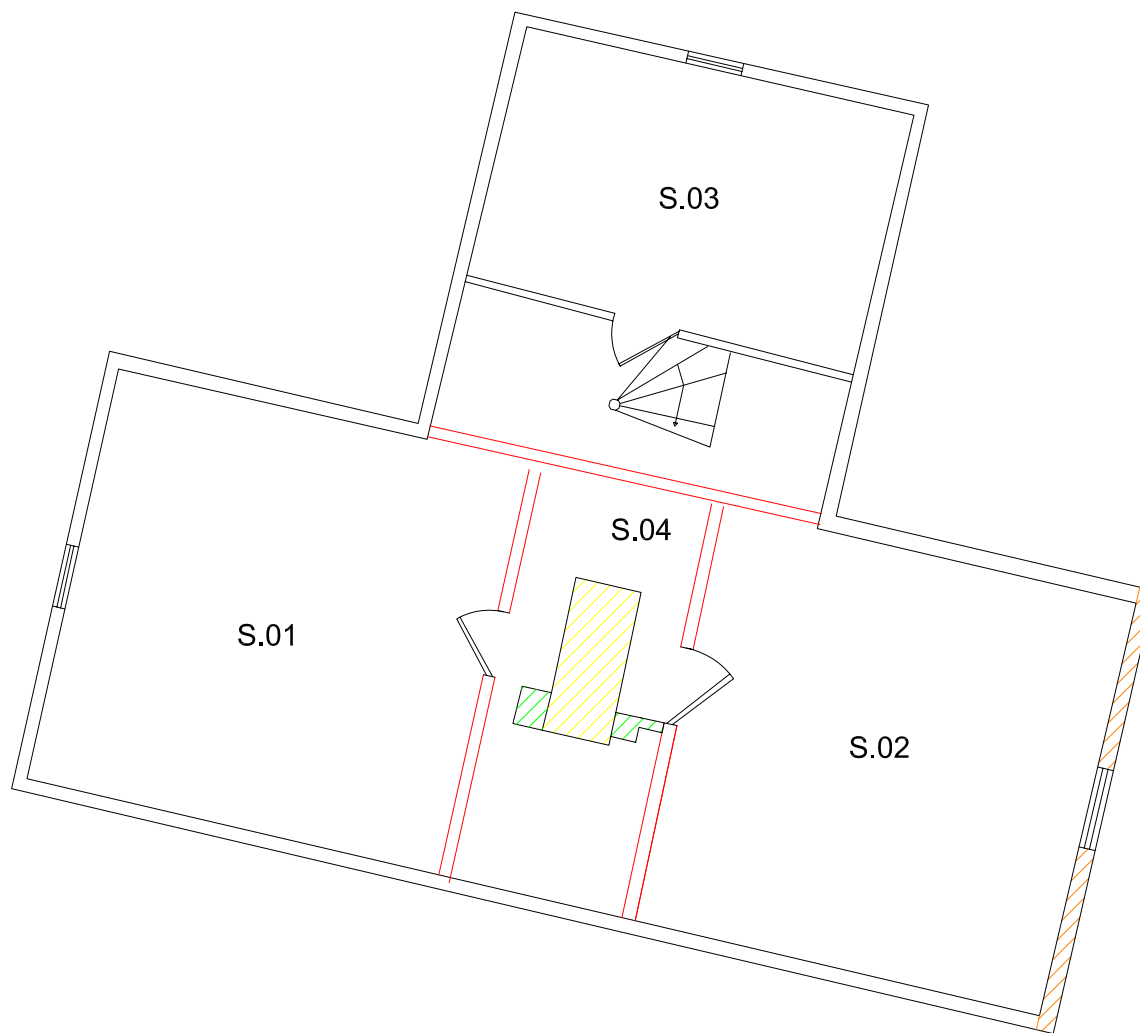
Fig. 10

The western room on the first floor (Fig. 10) was sub-divided by a series of plain oak panels (Plate 8). The panels were an agglomeration of designs and had been removed from elsewhere and subsequently erected. This was probably contemporary with the extension to the west as they acted as a corridor with access to the upper storey of the extension. The panelled door to the extension had been cut at the base and removed from elsewhere. It had distinctive cockshead hinges (Plate 11).

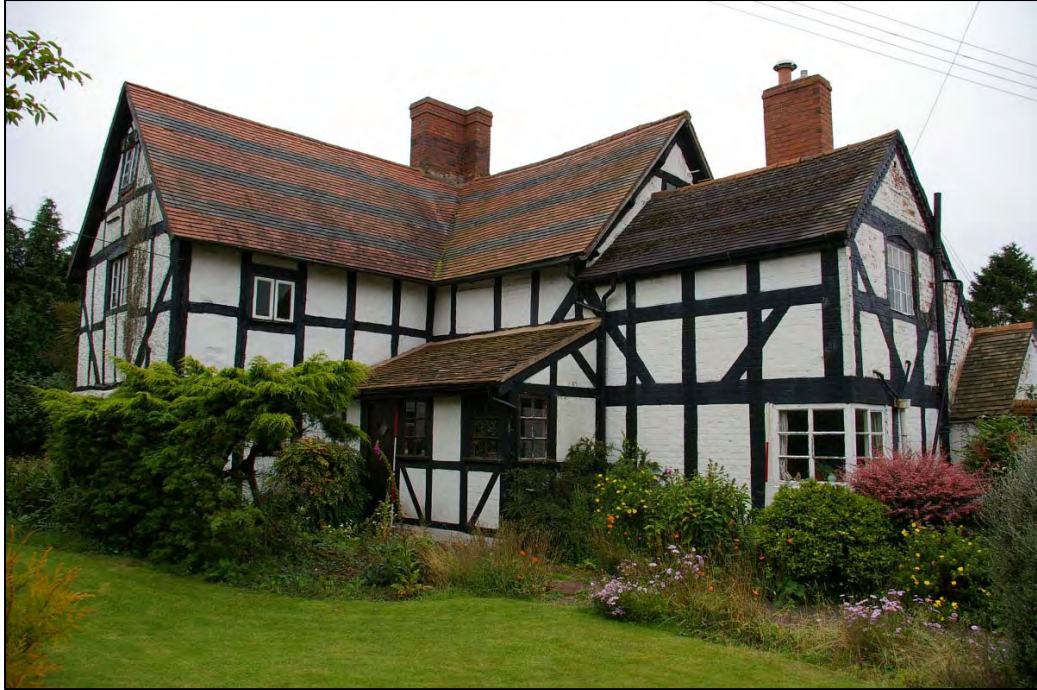
**Plate 1**

At the time of the survey the building consisted of three main parts (Plate 1). The main range was a two-bay, timber-framed structure with internal stack between the two bays. A northern entrance wing to the north had a base in red sandstone and timber frame above. The timber-framed building was two-and-a-half stories in height. Attached to the west of the main range was a later two-storey brick built extension with later addition lean-to one storey extensions to the south.

To the west of the gable of the main range (Figs 05, 07 and 08, Plate 1 and 6) was a two-storey brick-built extension dating stylistically to the late-18<sup>th</sup> or early-19<sup>th</sup> century. It was built in clamped red brick (brick size 8½"x4¼"x2½") in the Flemish Garden Wall bond. The surface was painted black and white to mimic the timber-frame of the main house. The roof was pitched with red ceramic tile. A single chimney stack was placed below the ridge-line and was later reduced and then heightened. A single light is present on the ground floor placed in the corner and may be an alteration. On the first floor a single segmental arched light with wood casement was placed on the western gable. The interior plan was a single room with access to the main range to the west.

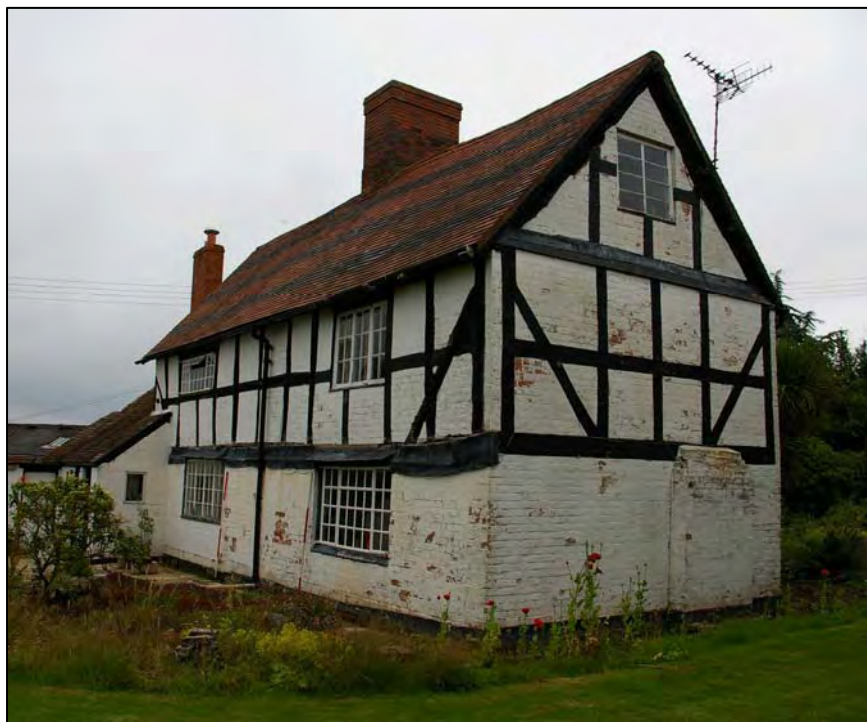
**Plate 2**

This was a two-and-a-half-storey building (Plate 2) constructed originally of oak timber-frame with original wattle and daub in-fill later replaced in clamped brick. The roof was pitched and clad in ceramic tiles that were entirely a late-20<sup>th</sup> century replacement.

The southern façade (Plate 2) was split into two bays (Fig. 05). On the southern façade the lower ground floor had been entirely replaced in clamped red brick in the English Garden Wall bond (brick size 9"x4¼"x2¾"). Above this the building retained the oak timber-framed construction with tension-braces at either end of the range. The wattle and daub in-fill had been largely replaced by brick noggin throughout (2¾" width bricks). Two lights on the ground floor and two lights on the first floor were 19<sup>th</sup> century replacements in the location of the original lights.

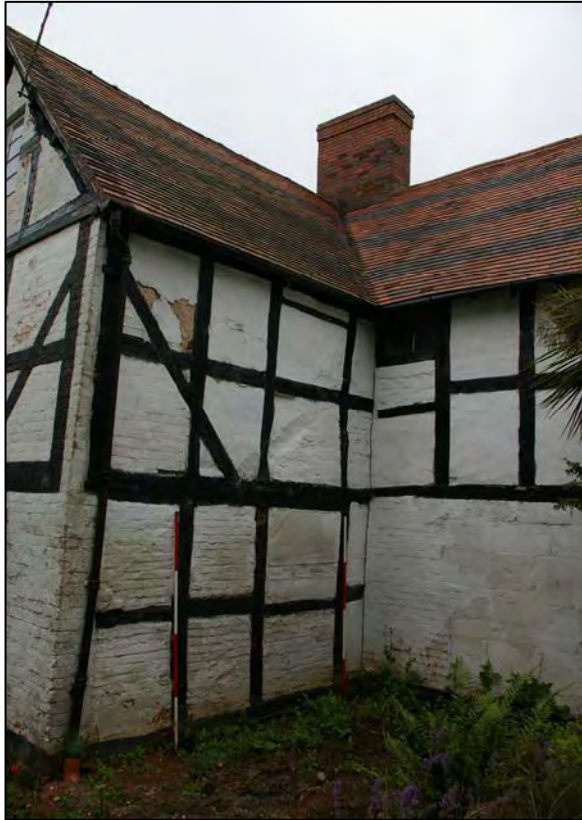
**Plate 3**

The northern façade (Fig. 07, Plate 1Plate 3) was visible either side of the north wing. It was constructed predominantly in timber-frame with downward tension-braces in common with the southern façade. Although the sill-beam had been almost entirely removed (some evidence for its survival can be seen in room G.05) the majority of the timber-frame survived on the ground floor. On the western side this had been obscured by a 20<sup>th</sup> century lean-to porch that sought to mimic the main range and failed. However, it was visible in the interior of the porch. The stone sill had been replaced by blue engineering bricks (again survival occurred in room G.05). In places the lathe and daub in-fill survived but had been replaced elsewhere in two stages in brick-nogging in clamped brick (brick size (9¼"x4½"x2½"). The location of the original lights was visible within the timber-frame arrangement on both ground and first floor. These had been subsequently in-filled.

The eastern façade (Fig. 06, Plate 3) continued the pattern of the northern façade. On the ground floor the red sandstone had been replaced extensively in clamped red brick in the stretcher bond on the eastern side (brick size 9"x4¼"x2½"). A single original light with ogee moulded jambs was blocked with clamped red brick. Directly above on the first floor a further timber framed original light was likewise blocked. A single light was placed in the southern frame and appeared to replace an earlier light in the same location.

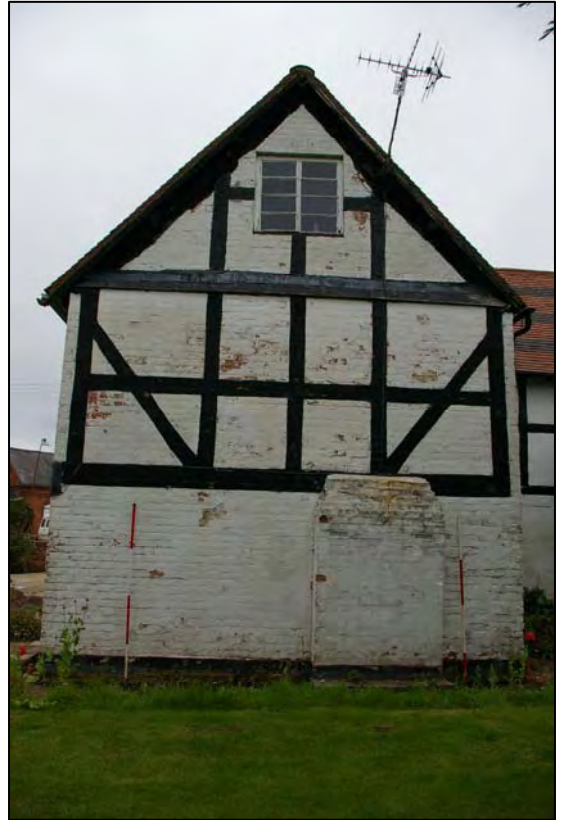
**Plate 4**

The eastern façade (Fig 06, Plate 4)) had been entirely replaced in clamped red brick in the Flemish Garden Wall bond (brick size 9¾"x4½"x2¾"). The original timber-frame only survived as the principals and tie-beam of the gable truss. The through-purlins projected from the façade. A single light was located within the gable on the second floor. A later projected brick storey may have replaced an earlier doorway located within the reworked brick gable.

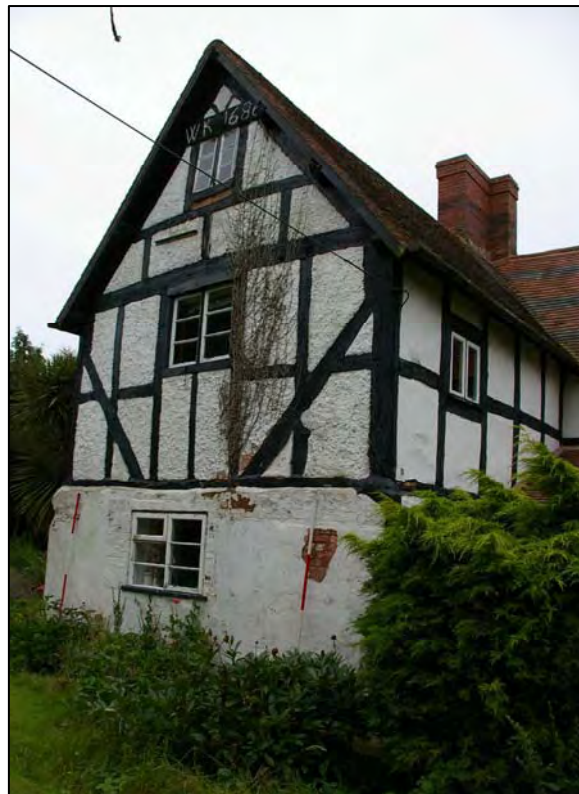
**Plate 5**

The two-and-a-half storey wing (Plate 5) projected north from the main range and was gabled on its principal northern façade. The ground floor was original constructed in faced red sandstone ashlar blocks. This had been heavily replaced on all three façades with clamped red brick (brick size 8¾"x4¼"x2½"). The first floor was carried up in timber-frame in common with the main range with full length studs from the rail and boxed with mid-rails. The posts displayed gunstock heads with downward tension-braces extending from them. The in-fill was predominantly original wattle and daub. Mortice and tenon joints were secured mostly with single pegs, often only on the upper tenon.

The northern façade (Fig. 07, Plate 5) was gabled and decorated with curved upward braces to the gable and a decorative collar inscribed 'WK 1686'. It had a single light centrally placed on all three floors. Extensive alteration had occurred to the ground floor with an entire replacement of the light. The lower ground floor was rendered obscuring the build of the wall. However, the visible elements suggested that the light had replaced a full length doorway. The first floor light was a wood casement replacement in the original location. The second storey light was original with a chamfered wood mullion.

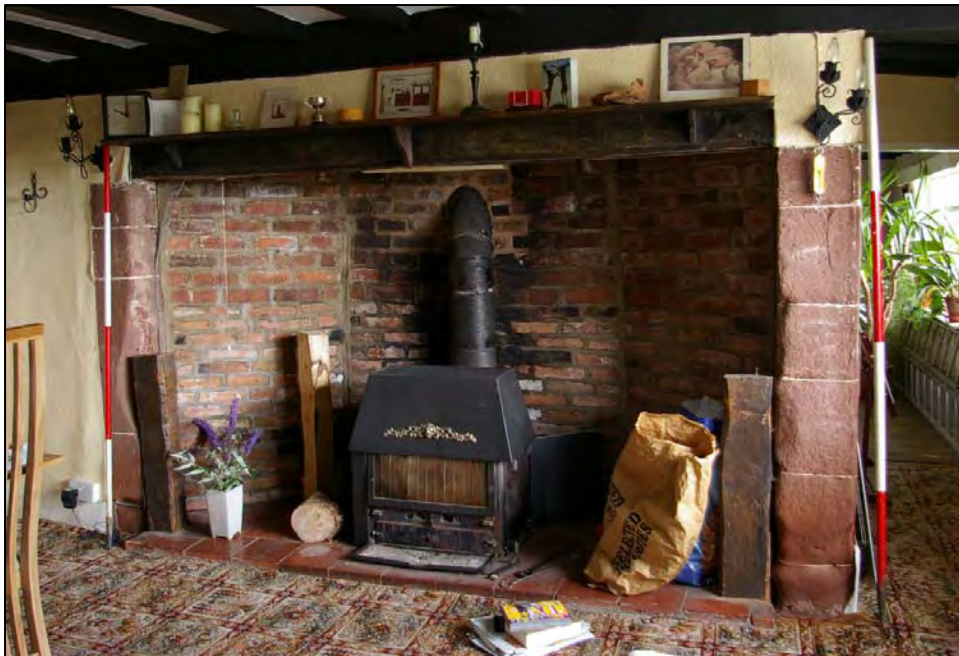
**Plate 7**

The ground floor (fig. 09) of the main range was dominated by the centrally placed framed fireplace with hearths (Plate 7) to both eastern and western rooms. The jambs were of red sandstone with splayed brick interiors (2¼" bricks). These infilled the original barrel vaulted layout. Large beams acted as the mantels in both rooms. In the western room the fireplace was originally framed by two studs but these had been truncated. A single passage ran between the two rooms on the southern side with plain joists running between the hearth and the exterior wall.

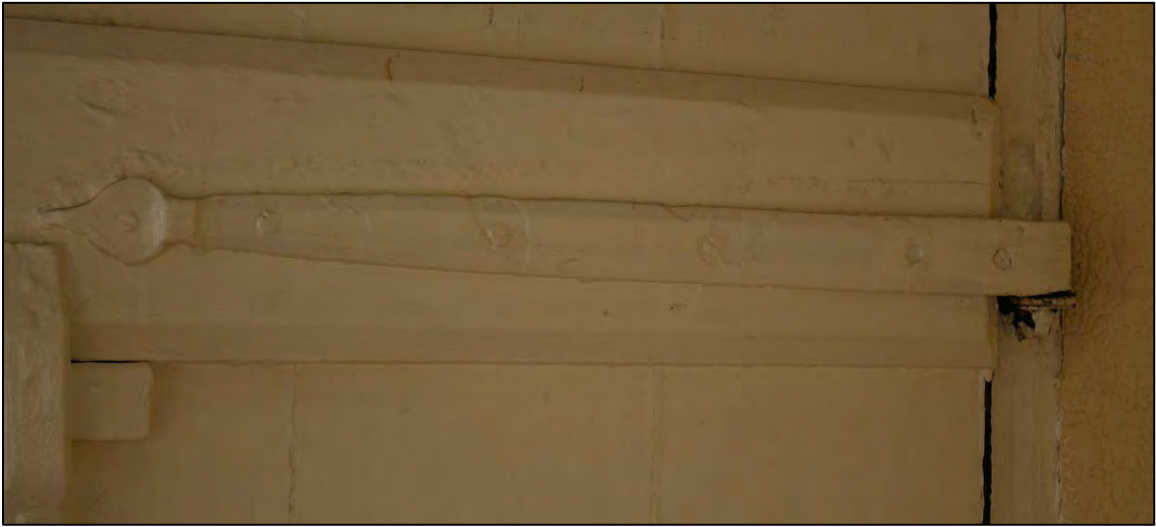
**Plate 10**

Many of the fittings within the building, particularly the doors appeared to have been original to the late-17<sup>th</sup> century. The extensive use of spearhead hinges on plank and batten doors fitted closely with this date (Plate 10, Alcock and Hall 1994, 22). Although the stairwell had no distinctive decoration that could have dated it to a specific period the use of the chamfered plain Newel post was common as far back as the 17<sup>th</sup> century and before and the evidence would suggest it was an original feature. Likewise the majority of floorboards and ceiling joist remain original with 9" floorboards common throughout the building.

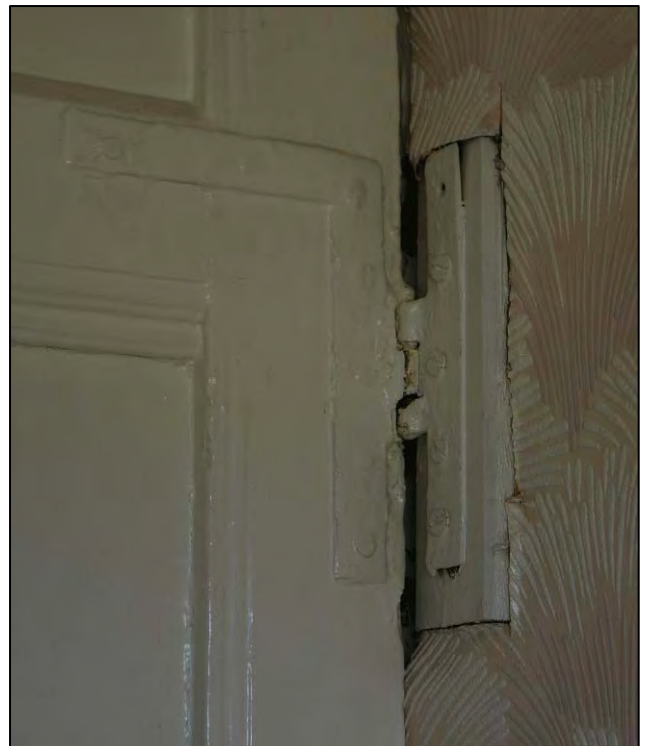
**Plate 12**

The floor boards were original 9" oak boards laid transverse across the room. The ceiling was supported by a single transverse beam with chamfered soffit face. On the eastern wall of the room a single beam ran above the fire place with two peg-holes denoting stud partition. A plank and batten door with spearhead hinge passed to a cupboard that ran to the south of the chimney stack. A panelled door was set within the panelling with early-18<sup>th</sup> century L-hinges (Plate 12).

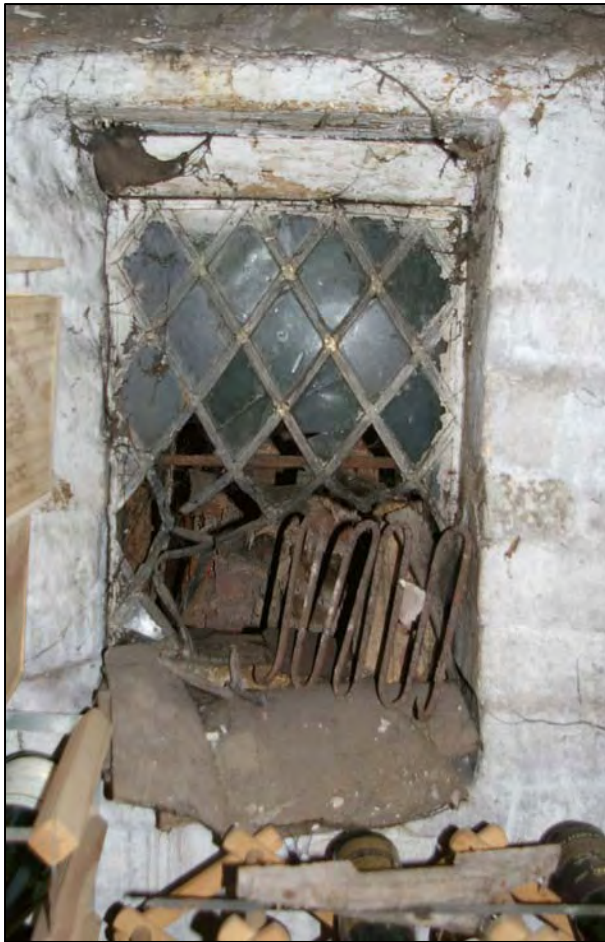
**Plate 13**

The ground floor room of the northern wing is plain with a transverse beam supporting the ceiling with chamfered soffit face with plain joists either side. Access between this and the main range is via a corridor with access to the quarter-turn stairwell. On the western wall was a blocked light with stone jambs in common with that surviving on the exterior eastern façade. A plank door led beneath the stair. The underside of the stairwell was partitioned by lath and plaster. To the east an alcove led to the side of the chimney stack. A single diagonally leaded light with chamfered stone jambs opened onto the western fire hearth (Plate 13). The half-turn

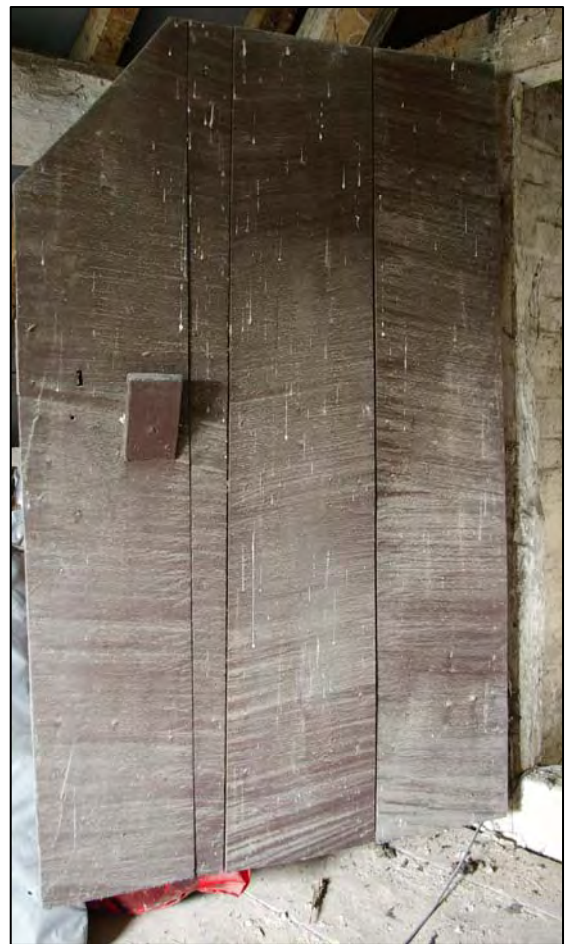
**Plate 14**

Two rooms set either side of the main chimney-stack on the main range and were partitioned by stud-walling within the trusses. Entered by plank and batten doors between the studs with spearhead hinges and distinctive wood handles (Plate 14, this have been mimicked elsewhere in the house, however these appeared to be original). There were 9" oak floorboards throughout. The room in the north wing was separated by a vertical stud wall partition unconnected to the truss. A single plank and batten door with central light was set between the studs. The floor was of 9" oak boards but was raised above the level of the rest of the range.

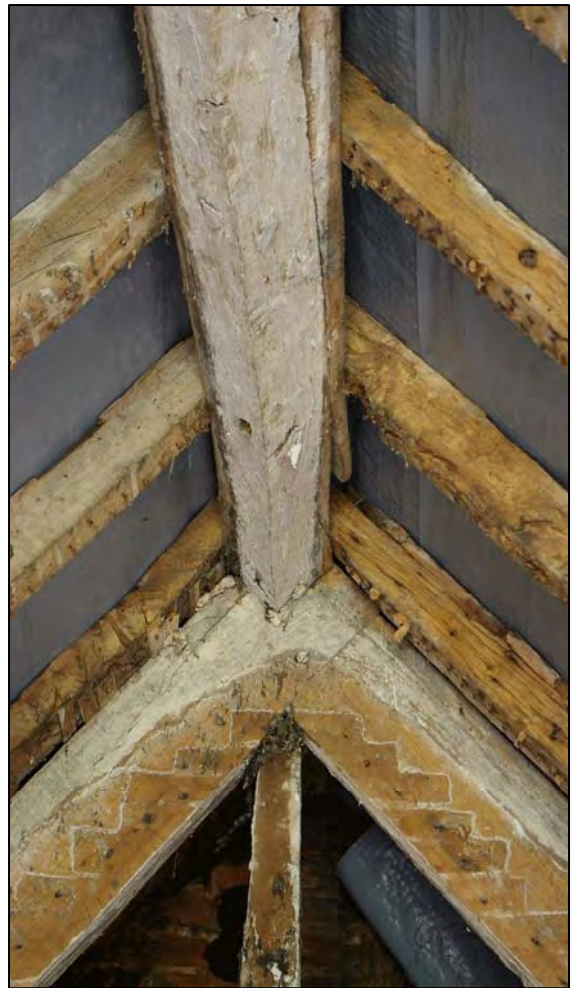
**Plate 16**

The roof was supported by the end gables and two trusses. The trusses were roughly identical and were of king-post construction with a noticeable high set collar (Fig. 12, Plate 16). The internal area was infilled with studs and lathe and plaster construction originally. Twin through-purlins ran either side of the principals with a square cross-section ridge purlin at the apex. Wind-braces were present jointed to the exterior purlins at either end of the range but only on the southern side.

The roof-structure also appeared to be entirely contemporary. All three surviving trusses were of a similar style. The purlins on the main range all ended abruptly adjacent to the chimney stack and there was no evidence of former scarf joints to connect them and suggest the chimney was inserted. Noticeably wind braces were only present on the southern side of the roof structure of the main range (with no evidence for former braces on the northern side of the structure) which suggested there was always the added support of the central northern wing that meant they were not necessitated on the northern side.
