Birmingham Town Hall:
An Archaeological Watching
Brief (Phase 2) 2004

Project Number. 1196

June 2004

by
John Halsted

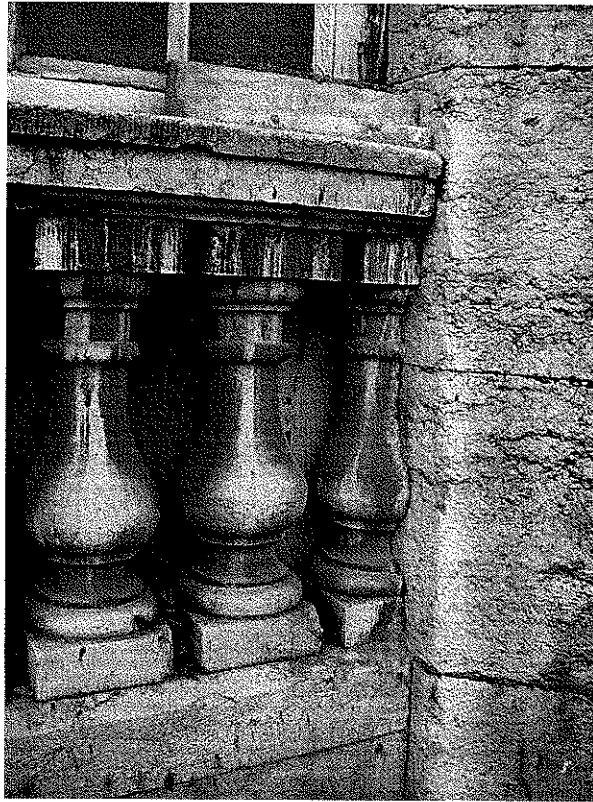
Plate 2 Showing *in situ* balustrade feature at window 2

Renovation work being carried out on the windows in the northern elevation of the Town Hall revealed evidence of a phase of alteration in the architectural design. Six windows are present at the northern elevation together with a central entrance (Plate 1). Two windows have a stone balustrade feature beneath (Plate 1; Plate 2), with the others having plain stone sills. It can be demonstrated that the balustrade features were once present in windows 3 and 4, to either side of the entrance. A scar from a baluster was partially visible on the inside face of the jambs of these windows. This demonstrates that the plain sills are a later addition (Fig. 3, Plate 3). The sills have clearly been inserted after the removal of the balustrade features at windows 3 and 4. The presence of the former balustrade was confirmed when the sill stones of windows 3 and 4 were removed for renovation and a full baluster scar became visible (Plate 4). The effect of removing the balustrades was to lengthen the glazed window panels.

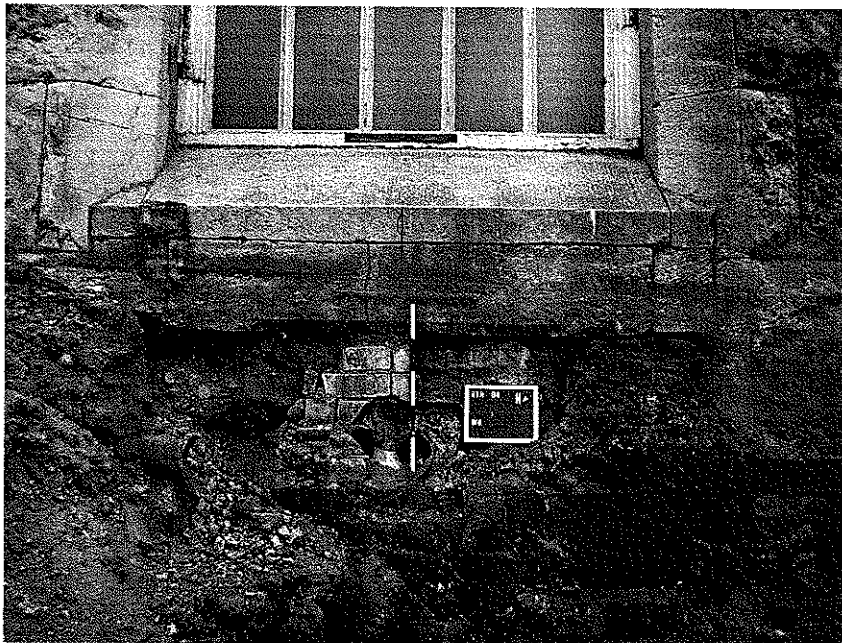
Plate 5 Showing alterations to brickwork beneath window 4

The presence of brickwork recorded beneath the two sill stones of windows 3 and 4 contrasts with the stonework at the same level beneath windows 1 and 2 (Plate 1; Plate 5). This may be further evidence to suggest a phase of alteration. This is supported by the presence of dark purple brickwork (contrasting with the red Selly Oak Brick plinth) beneath windows 3 & 4, which appears to represent alteration to the external face. The sill stones of windows 3 and 4 rest upon this purple brick, which also butts against the internal face of the sill stones. This demonstrates, therefore, that the alteration to the windows is contemporary with the alteration to the brickwork below the existing sills.

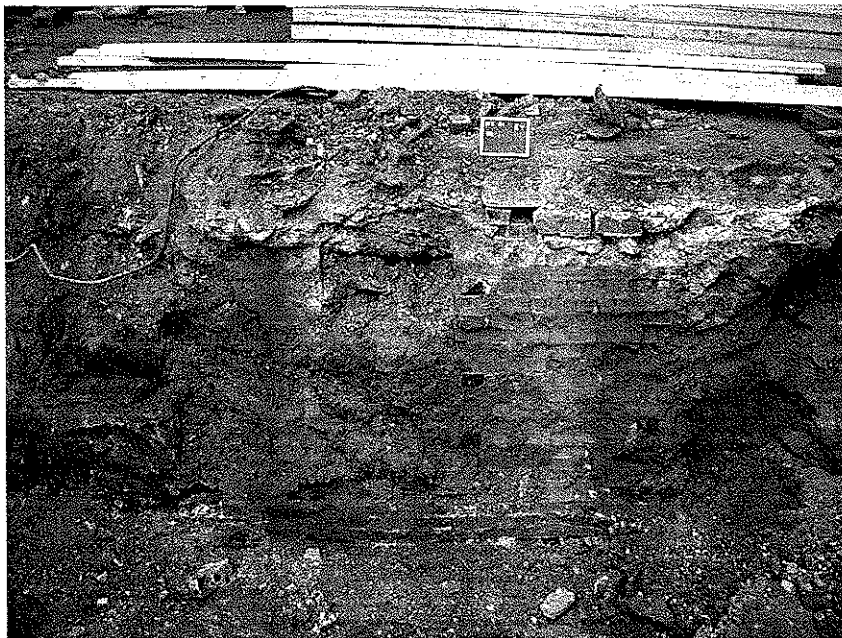
Plate 7 South-west facing section through stratigraphy in area of groundworks to the north of the Town Hall

The south-west facing section was also made up of a natural red clay visible to the base of the trench (recorded up to 0.6m in depth), overlain by a layer of natural orange sand and gravel, 0.65 m in depth (Fig. 5b, Plate 7). A layer of modern rubble hardcore was present above the gravel recorded up to a depth of 0.7m. A brick wall was visible in the section running north-west to south-east and walling perpendicular to this was also visible in the section (Fig. 5b). This brickwork is likely to be associated with modern service features, since a similar brick manhole or capped drain was also visible in section.

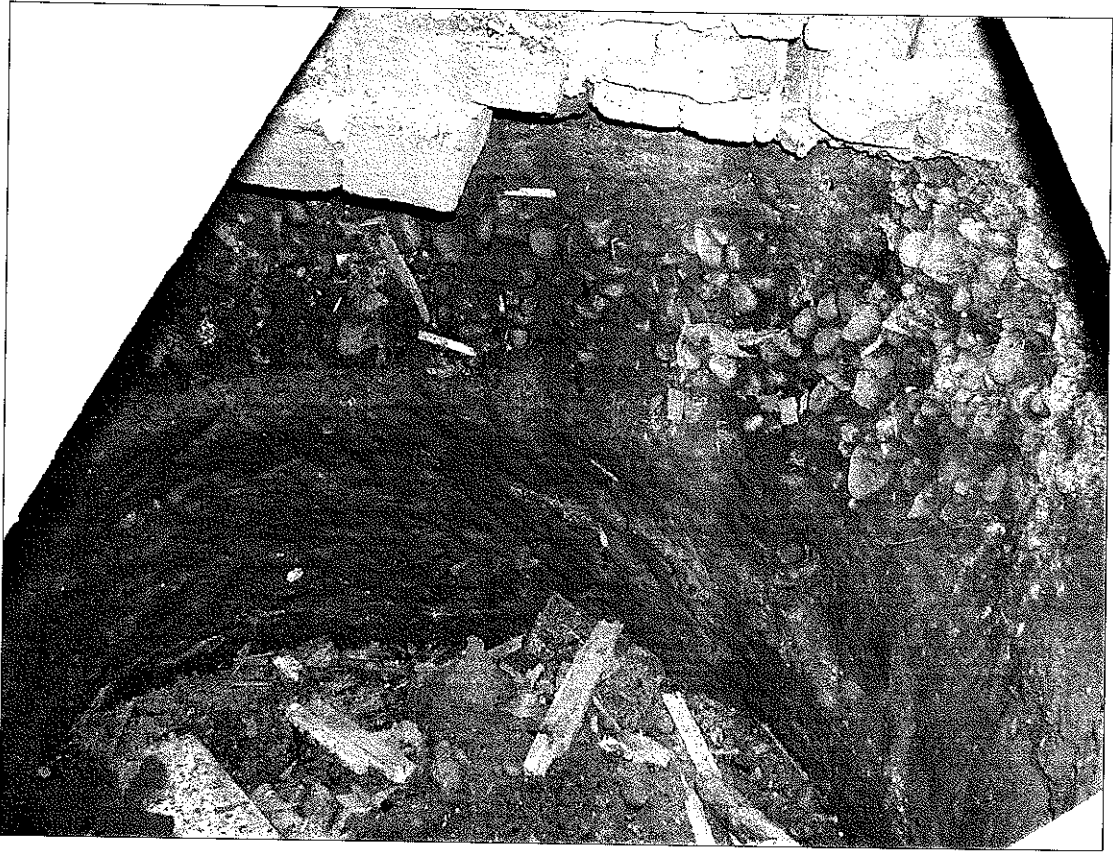
Plate 8 The well recorded in the basement of the Town Hall, with basement wall and floorboards

A well was recorded in the basement of the Town Hall, visible after the removal of floorboards (Fig. 6; Plate 8). The well was partially under the western basement wall of the Town Hall and was c.1.5m in diameter. The well had been infilled in the past, although the upper portion was open to a depth of c.1m. The fill of the well was not investigated further, due to health and safety considerations. The well appeared to be dug through natural red sandstone. The Town Hall appears to be located at the junction between sand and gravel deposits and Lower Keuper Sandstone, explaining why sandstone has not been recorded in the trench to the north of the building (British Geological Survey sheet 168, 1955). No artefacts were recovered from this phase of the watching brief.

The well recorded in the watching brief lies below a wall constructed between 1848 and 1851 during the works undertaken to extend the basement area (*ibid.* 21-22). The well almost certainly pre-dates the construction of the Town Hall and is likely to relate to previous settlement in this area of Birmingham.
