**TUTBURY CRYSTAL
GLASSWORKS, BURTON
STREET, TUTBURY,
STAFFORDSHIRE:**

**AN HISTORIC BUILDING
RECORDING AND
ASSESSMENT. 2005**

Project No. 1358

By Chris Hewitson

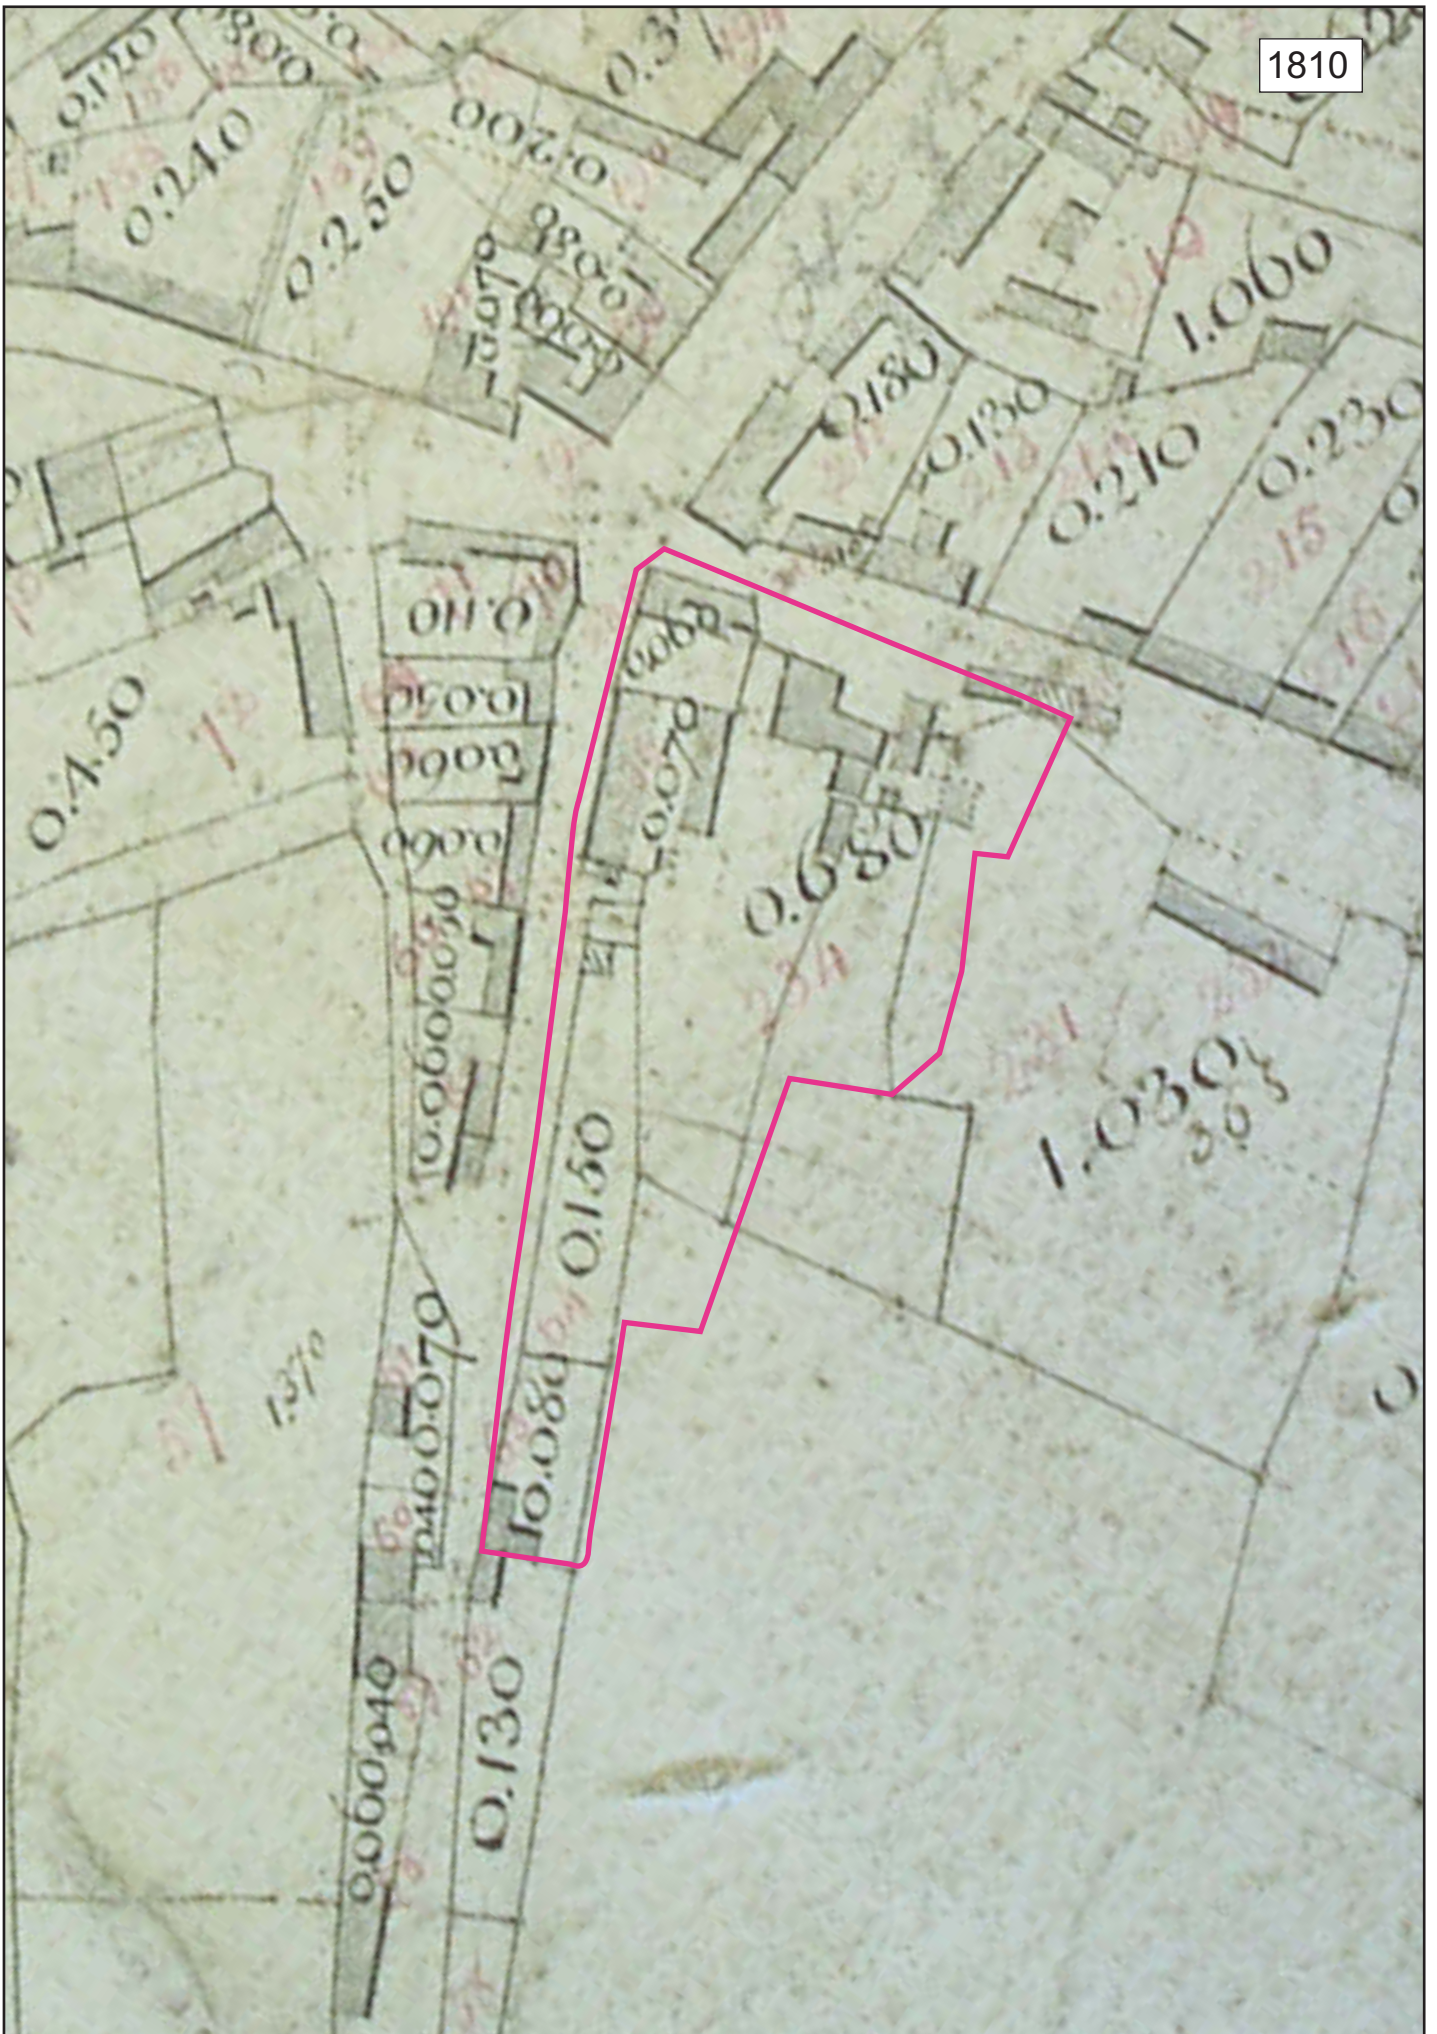
Fig.3

The 1810 Estate Map of Tutbury (Fig. 3) indicates that a number of structures relating to the Glassworks existed on the site. At this time the land was sub-divided into four plots. Two existed along the Ludgate street frontage, a further plot of what appeared to be terraced houses on the corner facing Burton Street, with a further much larger plot to the rear with access from Burton Street. This was defined by an S-shaped complex of buildings.

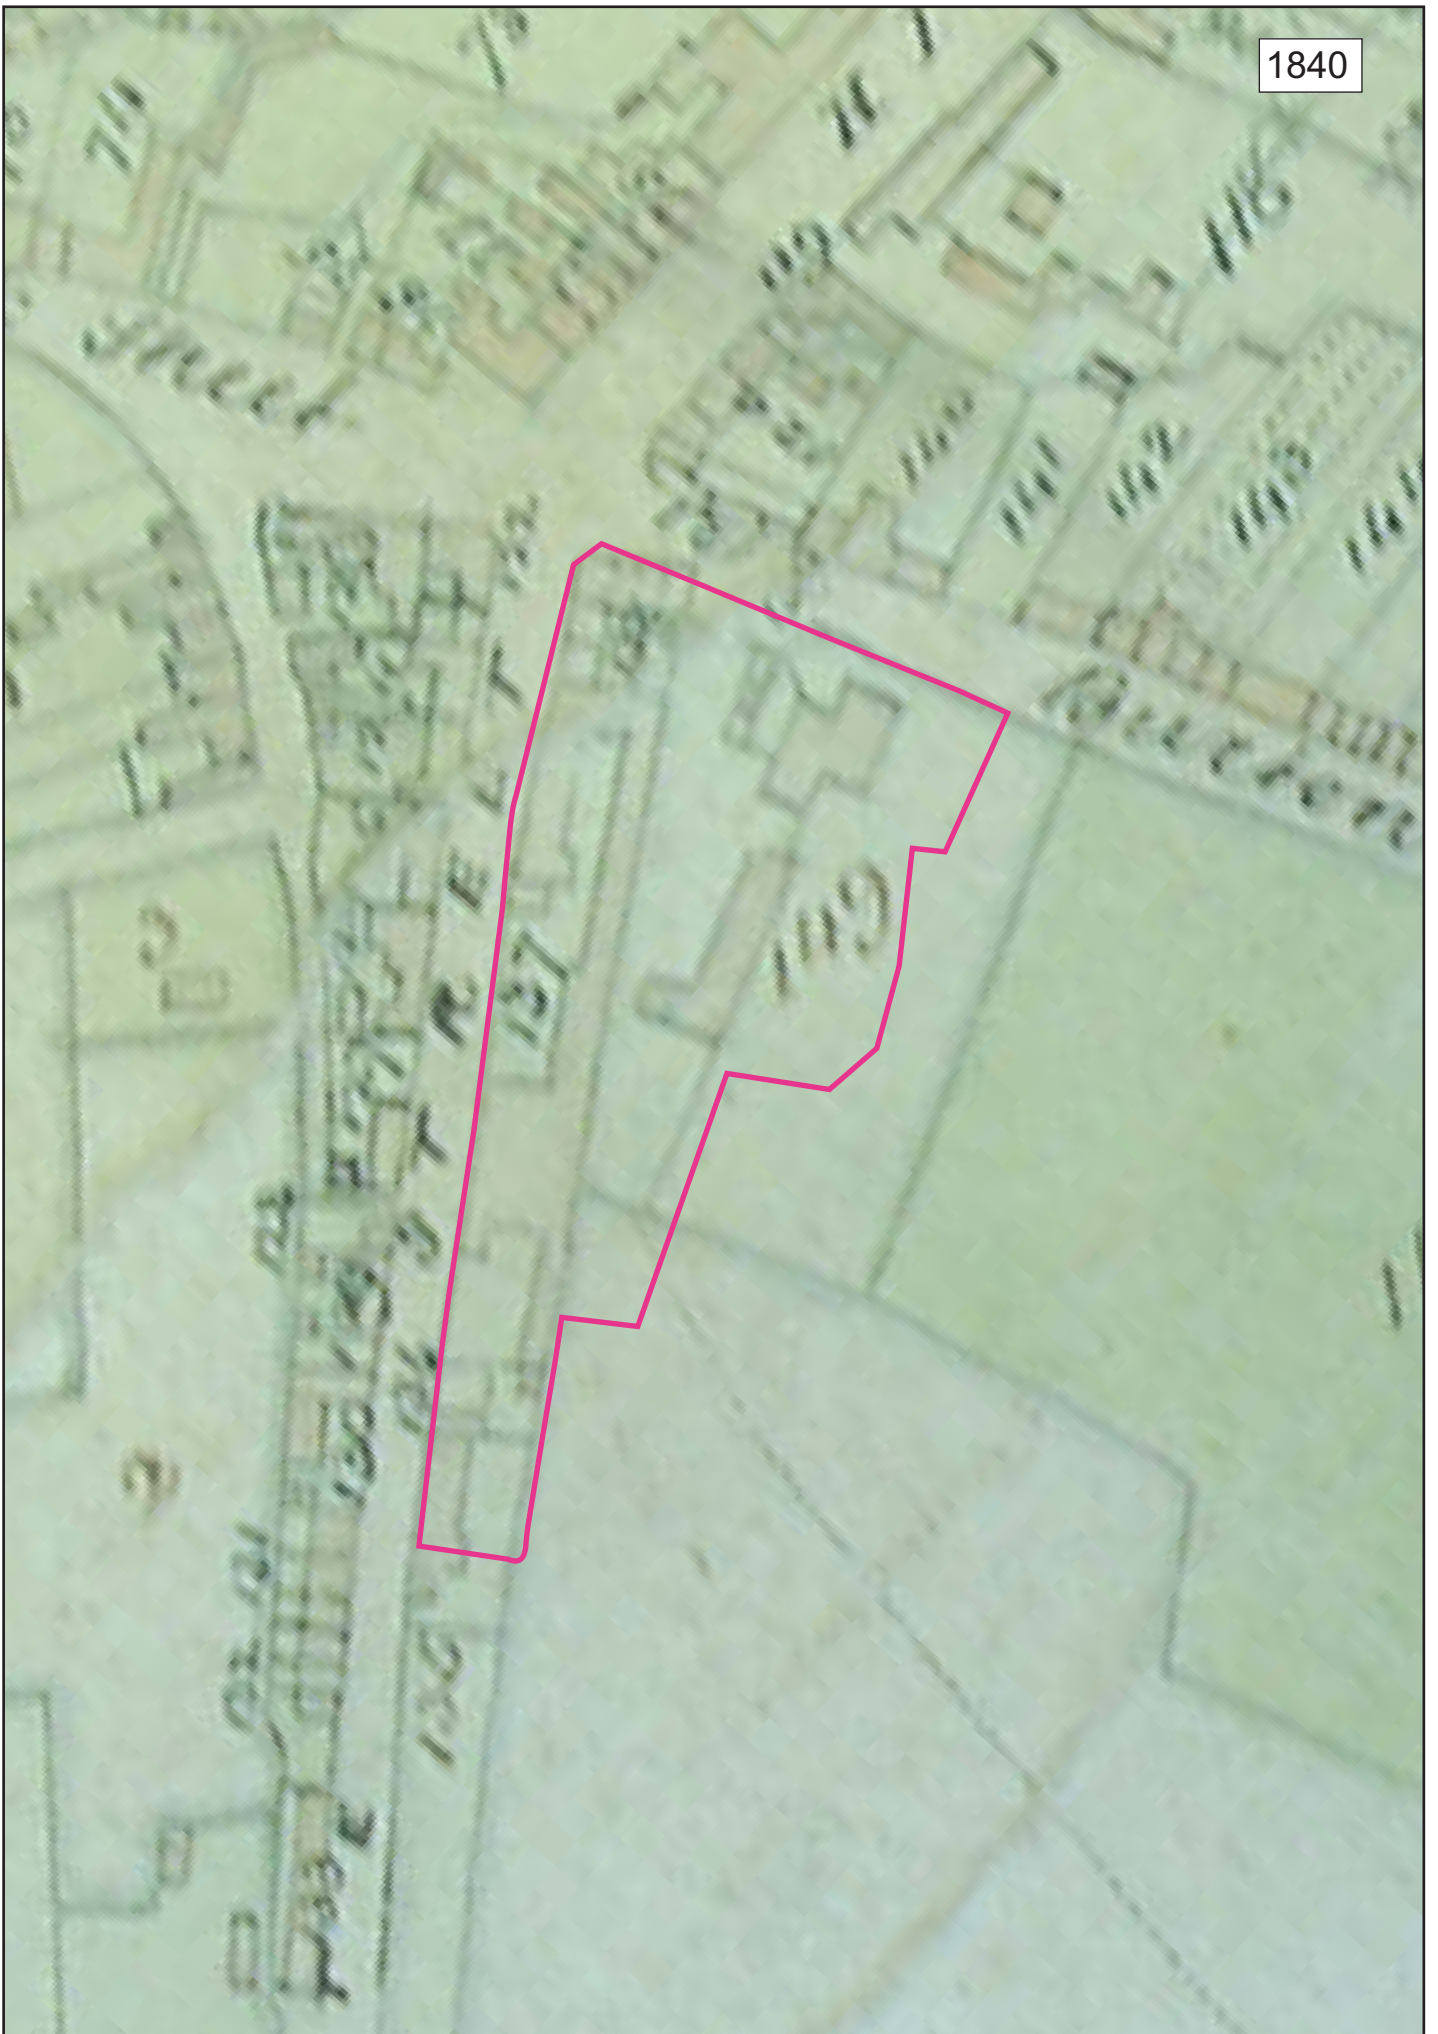
Fig.4

By the 1840 Tithe apportionment (adopted as the base for the 1840 Parish Map, Fig. 4), the two plots facing Ludgate Street had been amalgamated to form a single land

apportionment with the extension of the buildings to include a series of long ranges. The plot of terraced houses facing Burton Street had been extended along Ludgate Street. The large plot to the rear was extended and an additional L-shaped range was constructed.

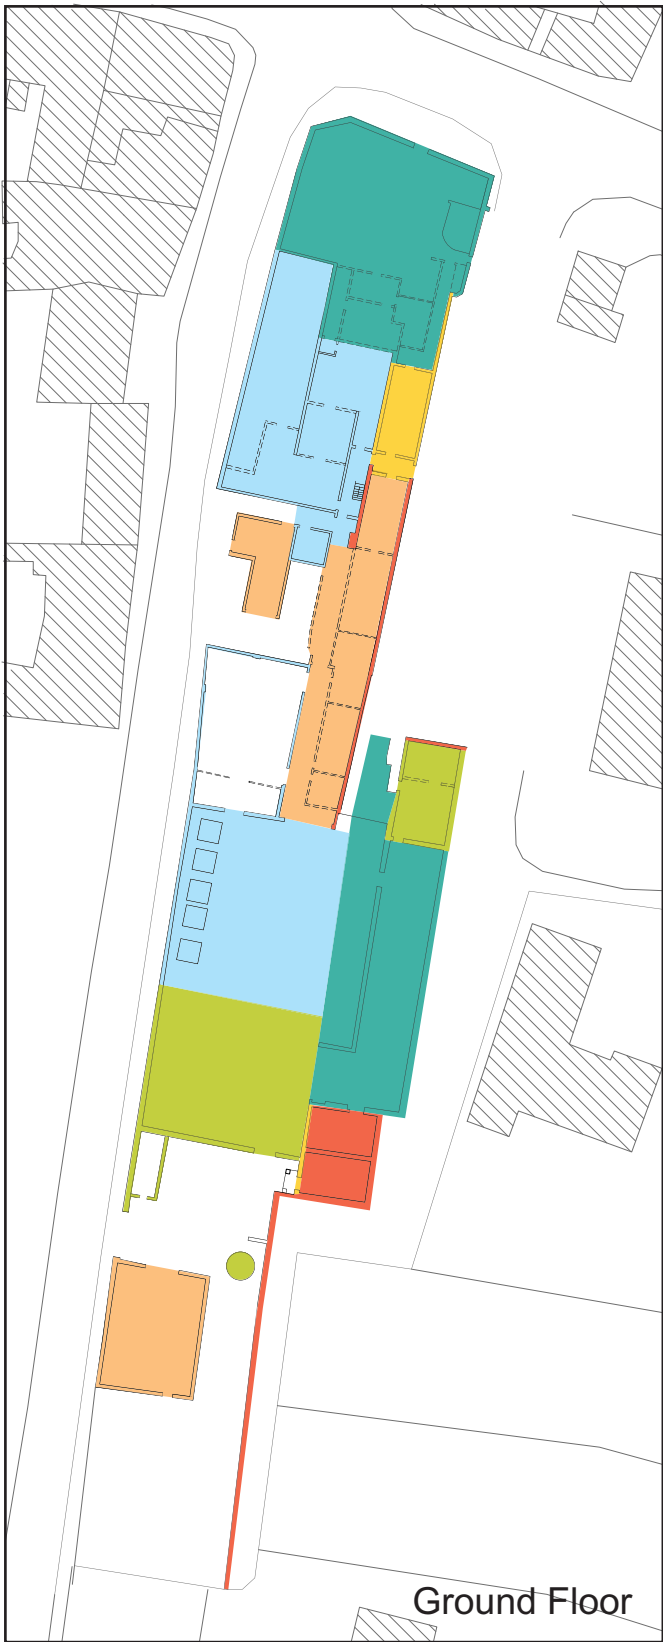
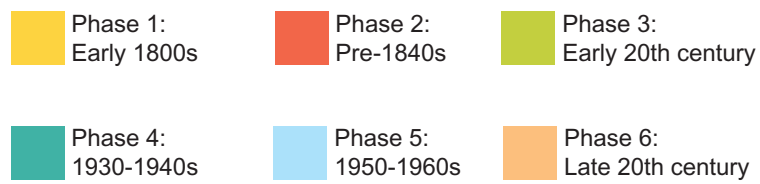
Fig.10

8.1 Phase 1 – Early-19th century

8.2 Phase 2 – Pre 1840s

8.3 Phase 3 – Early-20th century

The most significant alteration during Phase 4 was the addition of structure A. Stylistically this dates to the 1930s and appears to have replaced a series of terraced houses that existed on the corner of Ludgate Street and Burton Street. Presumably these were former factory houses owned by the works (the 1891 census lists glassworkers occupying these house numbers) and were subsequently demolished and replaced as part of the expansion of the works under the management of Webb, Thomas Corbett.

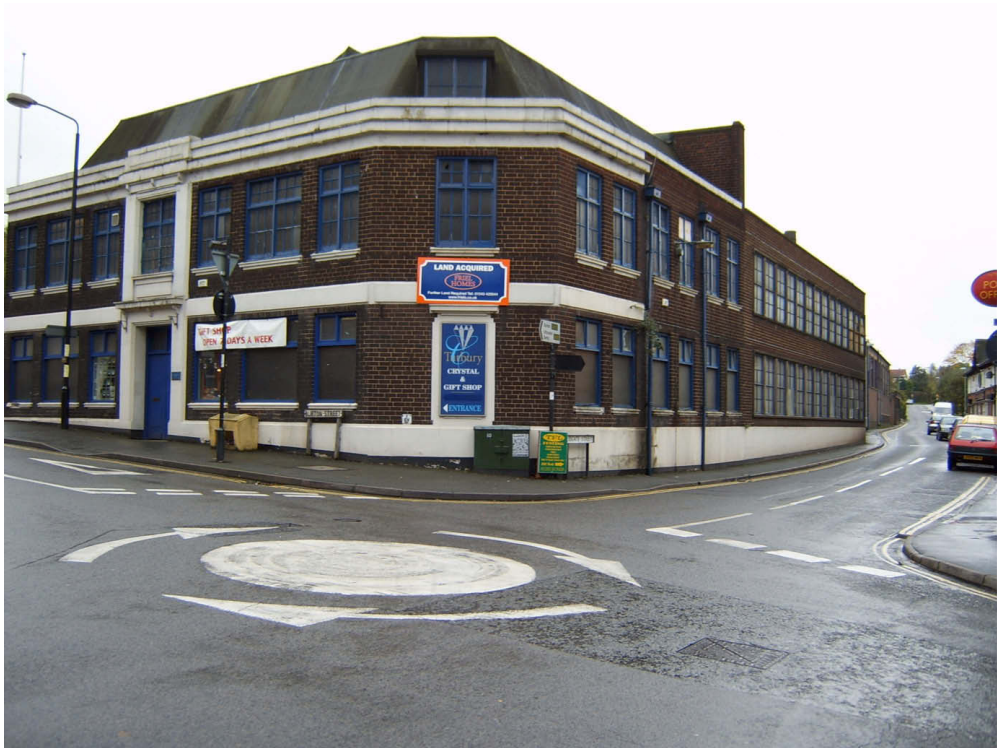
Plate 1

Structure A (Figs. 7 and 8; Plate 1)

Two-storey office/workshop block. 1930-1940s in date. Built in reinforced-concrete and steel-girder box construction, in-filled in machine-cut red-brick in the Flemish Garden Wall bond. L-shaped plan associated with the available land plot.

The principal façade faced north (Burton Street). Central two-storey bay with moulded surround extending to roof level, with central doorway and casement window above. There is a false architrave above the door flanked either side by three symmetrical bays of ground and first floor windows. The western (Ludgate Street) façade continued with six bays of ground and first floor windows. The eastern façade had three utilitarian bays of windows with a side entrance located in the southernmost bay. Plain whitewashed concrete plinth throughout, and a wide moulded concrete string and upper wall coped in concrete on the principal façade which continued within the first two bays on the western façade and the initial bay on the eastern façade. Flat-roof construction with later addition of felt-covered roof.

Open interior plan on ground and first floor. Single original toilet block on ground floor. Subsequent sub-division using plasterboard partition. Later alteration had resulted in the open plan continuing into Structure B and C. Floors are of concrete construction. Roof structure was formed in I-shaped steel girders.

Structure B (Figs. 7 and 8; Plate 1)

Two-storey workshop extension. 1950s in date. Built in reinforced-concrete box-construction, in-filled in machine-cut red-brick in Stretcher bond. Sub-rectangular plan designed to fill available land plot.

The principal façade faced west (Ludgate Street) and was a continuation of, and mimicked structure A. There were 14 bays of plain eight-pane casement windows on ground and first floors with continuous narrow concrete sills and heads. Plain concrete plinth continued from structure A. Flat roof structure.

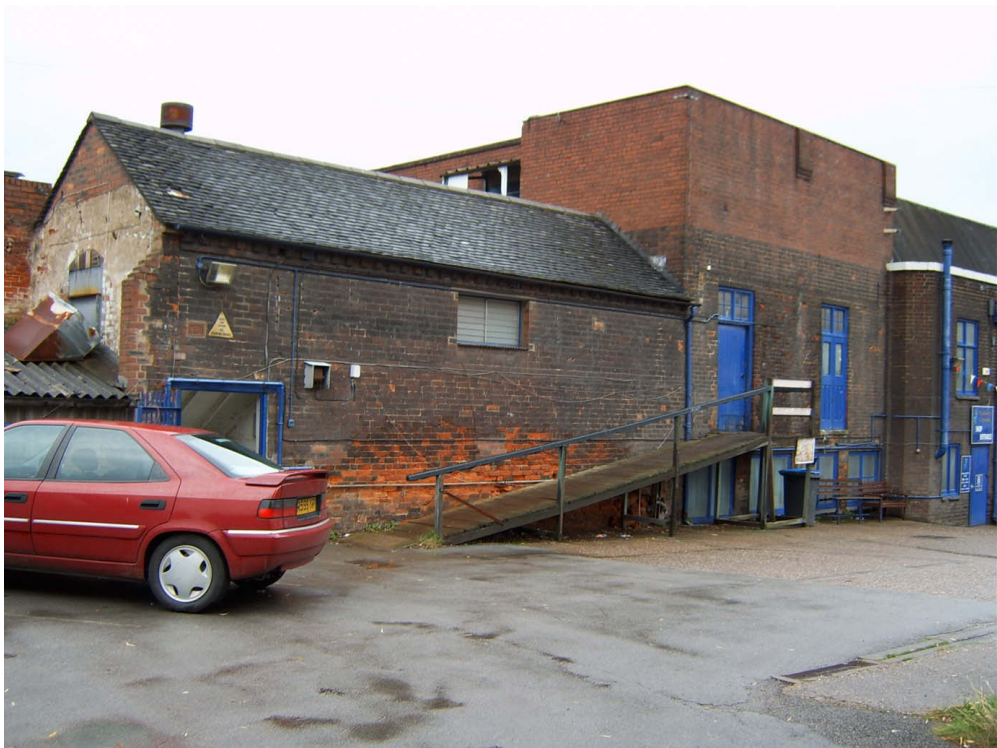
Plate 2

Structure C (Figs. 7 and 8; Plate 2)

Three-storey workshop. Original build dated to the mid-to-late 19th century. Original build in hand-made red-brick predominantly in Stretcher bond which survived for two stories. Later, late-20th century, upper storey continued up in machine-cut red-brick in the Flemish Garden Wall bond. Interior build had been extensively replaced by reinforced-concrete box construction contemporary with the construction of structure A.

Eastern façade consisted of two bays with four basement level windows and two doorway at first floor level above. Single doorway accessed by wooden ramp, other appeared to be extant. Later internal plasterboard sub-division associated with conversion to storerooms and workshops. Originally part of a series of linear workshops. It had been converted as part of the 20th century renovations to open workshops.

Structure D (Figs. 7 and 8; Plate 2)

Two-storey workshop. Early-19th century in date. Built in hand-made red-brick in the Flemish Garden Wall bond. The eastern Façade was plain with a single doorway on the ground floor leading down to basement level ground floor. Single light in the first floor. Eaves had dentilated pattern. Pitched slate roof. The southern façade, formerly enclosed by building to the south, had a semi-circular arched opening now bricked-up.

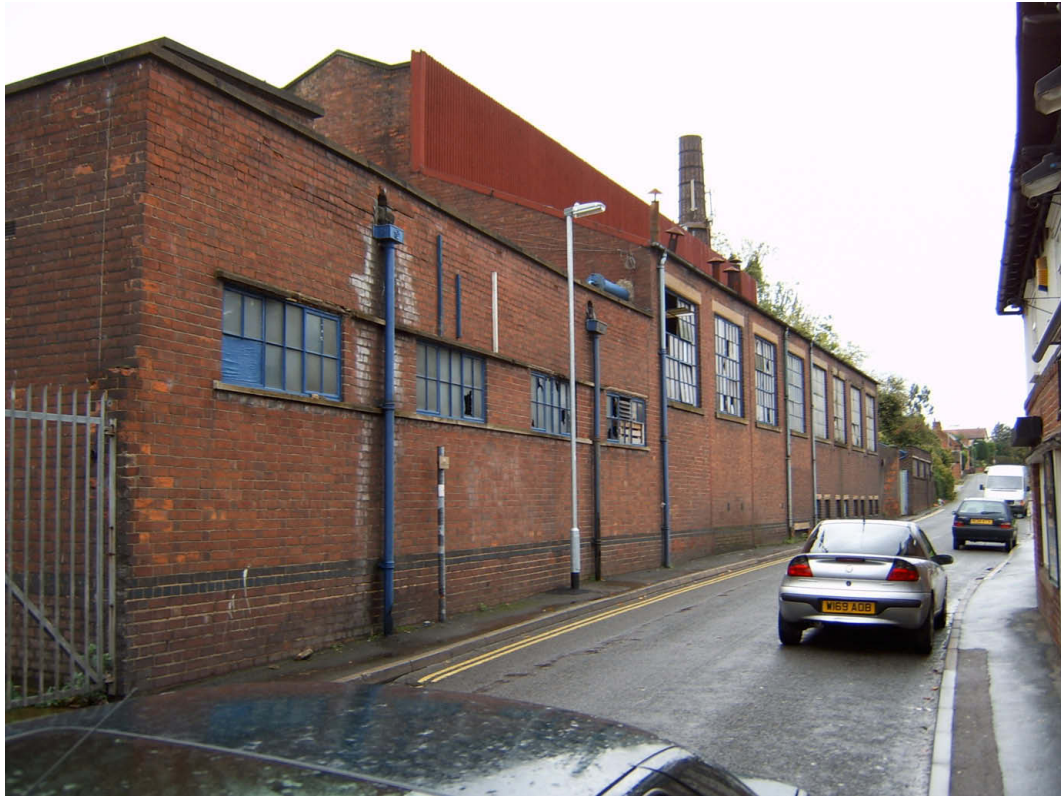
Plate 3

Structure H (Figs. 7 and 8; Plate 3)

Single-storey flat-roofed industrial block. Dated 1952. Built in machine-cut red-brick in the Flemish bond. Sub-rectangular in plan designed to fit land plot.

Principal façade faced west (Ludgate Street). Consists of four bays with tall 12-pane casement windows set high in the wall. Continuous head and sill to windows in reinforced concrete. Two-course string of engineering bricks set low in the wall continued onto northern façade. Northern façade was plain, a single noticeable feature is two plaques dated *H.I. 1836* and *W.E.G. 1952*. Top of walls was simple cement coping.

Structure J (Figs. 7, 8 and 9; Plate 3)

Large 8-bay single-storey industrial block. Two phases of build but of similar design. The earliest dated to the early-20th century, whilst the second phase was constructed in the 1950s. Built with box-girder construction with in-fill in machine-cut red-brick in Flemish bond. Open rectangular plan.

The principal façade faced west (Ludgate Street). Consisted of 8 bays of large 40-pane casement windows. The ultimate four bays also had low, ground-level twin-lights associated with the basement. The southern gable façade was of narrow rigid steel joists (RSJ) and brick composite construction. There were three high rectangular lights.

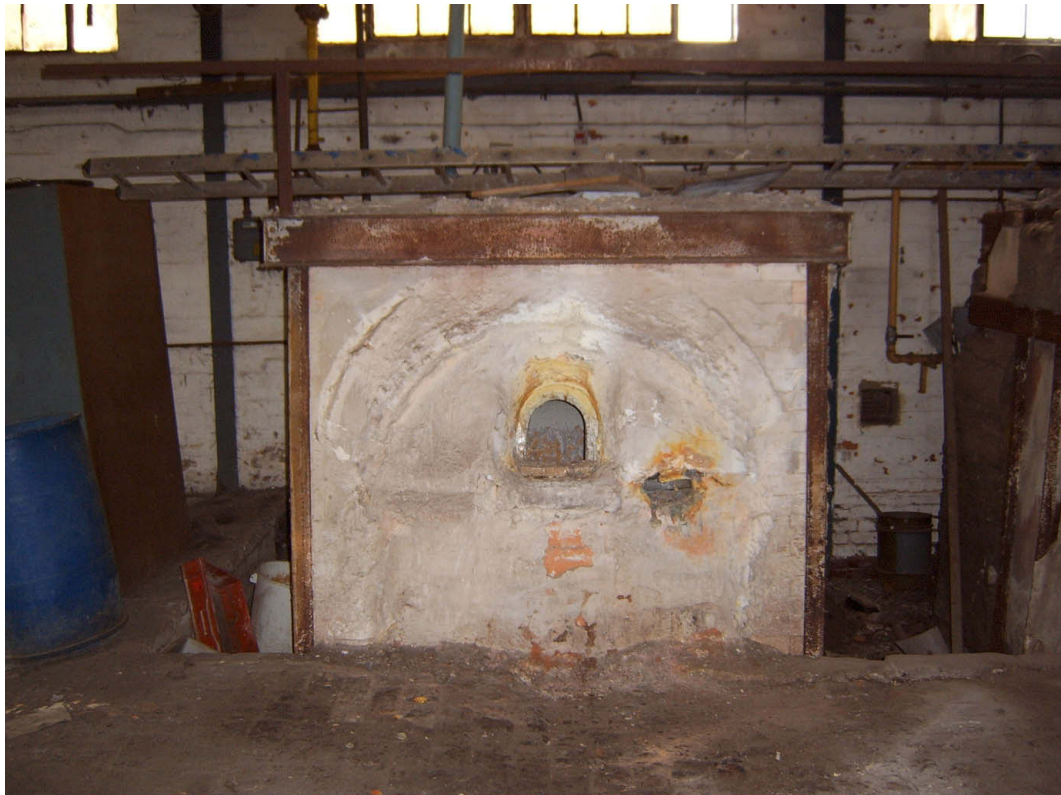
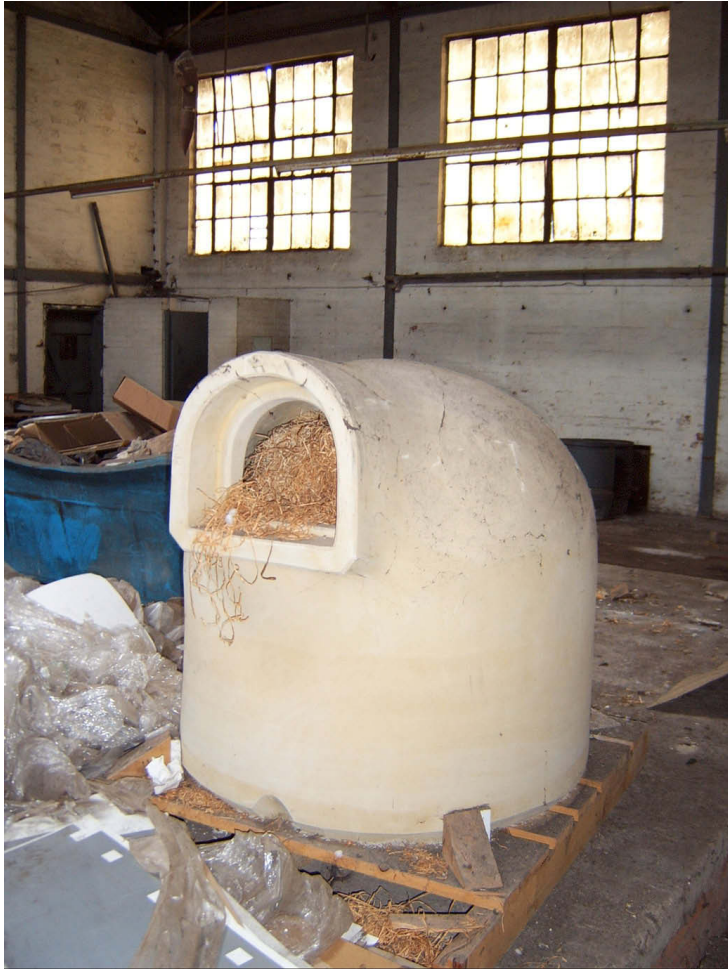
Plate 4

The principal features located within the interior were five gas-powered pots (Plates 4 and 5) located on the western side of the room and set within their own pit. These were covered pots with small glory holes at the front similar to those manufactured at the Stuart Crystal Works, Lye (Dodsworth 1982, 16). They were set within a cube constructed of reinforced brick and steel joists. Located at the southern end of the structure centrally was a large square concrete base which covered the remains of the oil-fired furnace located in the basement. Immediately surrounding the furnace were wear marks within the brickwork consistent with continual usage as part of the glass-blowing process. This suggested that there were several pots located equidistant around the furnace.

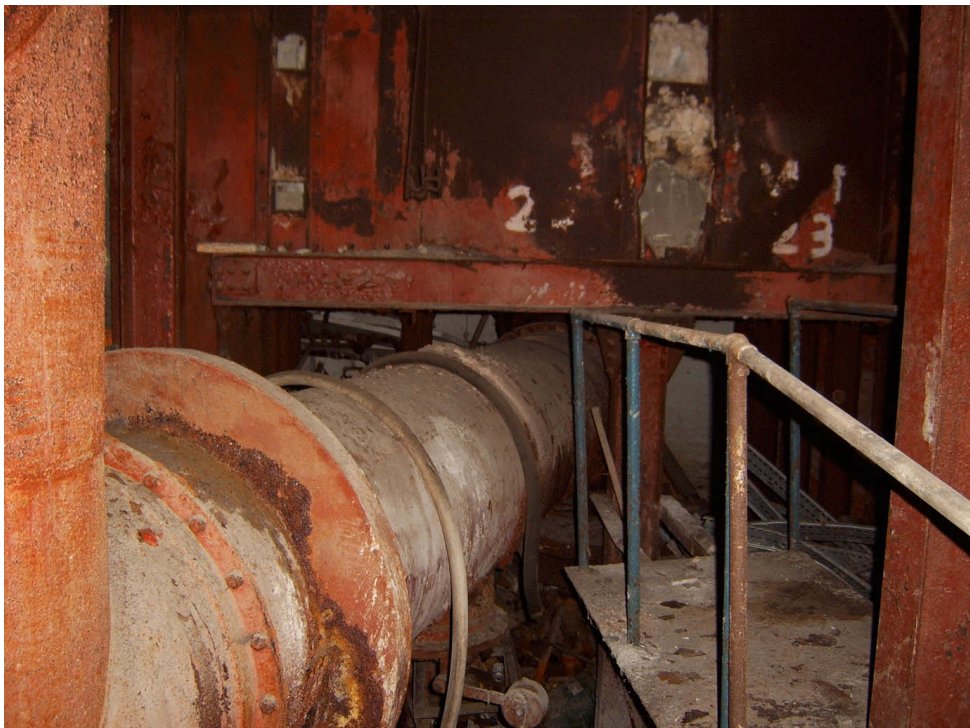
Plate 6

The basement was an open pit extending from the yard under the structure. It housed the remains of the oil-fired glass furnace (Plate 6). Access was via a ramp located on the western side of the pit. The remains of the furnace consisted of a large circular metal drum (c.2.5m wide and a minimum of 1.0m deep) raised from the floor and set centrally between two stacks of bricks. These were recuperators (Plate 7) which recuperated the heat from the furnace and recycled it. They acted in pairs one passing waste fumes from the furnace into the mesh of bricks to heat them whilst the other heated the air prior to it passing into the furnace. The waste fumes were removed to the stack via a series of steel tubes. Air flow was assisted by a fan and the fumes passed through a brick-built structure, the equivalent of a water-scrubber which cleansed the air prior to it passing to the chimney stack. An underground tunnel took the waste fumes to the stack and contained oil residues supporting the supposition that the furnace was oil fuelled as opposed to gas or coal fuelled. A further passage passed to the north-west and the street it contained a large fan its function unclear.

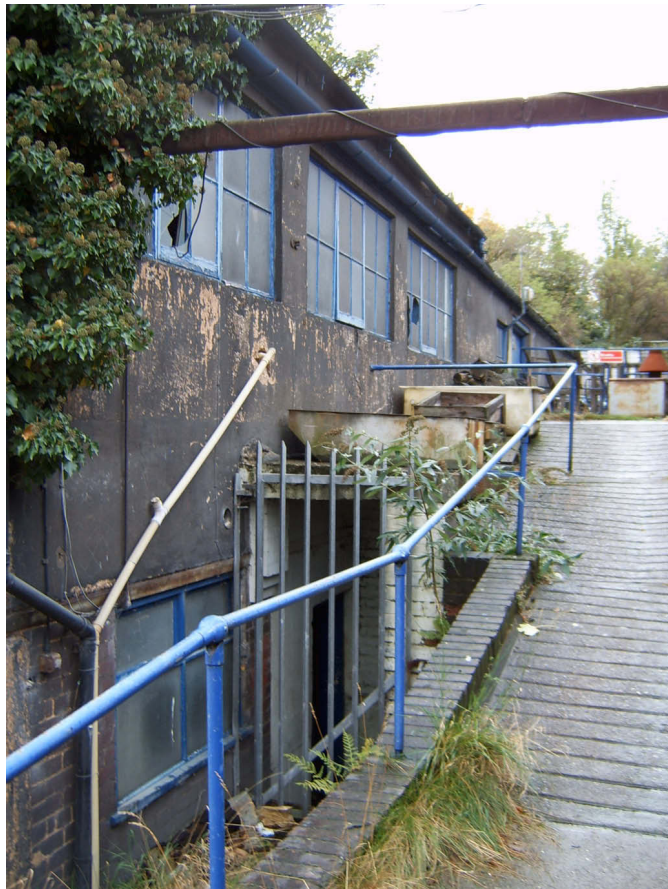
Plate 8

Structure L (Figs. 7 and 8; Plates 8 and 9)

Principal façade faced west and onto the ramp at first floor level. Consisted of five bays at the northern end with a wide doorway access and four lights. The remainder of the façade was plain. The northern gable was largely ivy-clad. However, remains of hand-made red-brick in Flemish Garden Wall bond, of a previous east-west range abutted the structure.

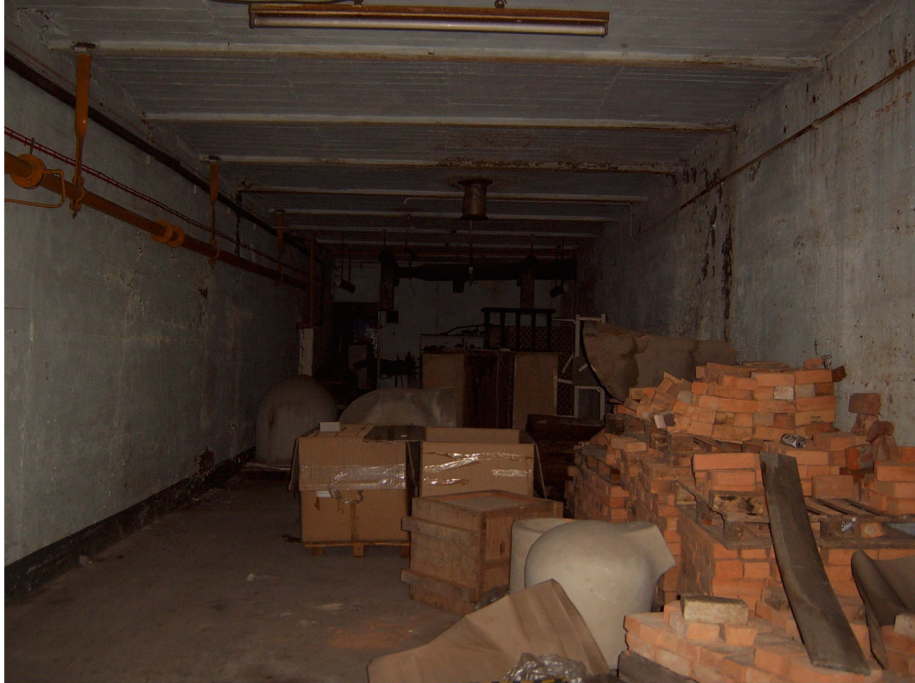
Plate 9

The ground floor was filled with debris (Plate 9). However, it is likely that this was the original location of the annealing tunnel or lehr. Electrical controls in the corner supported this supposition. The first floor was signed as the fitting room and it is likely to have been a combination of storage and small-scale secondary glass-working since the date of its construction.

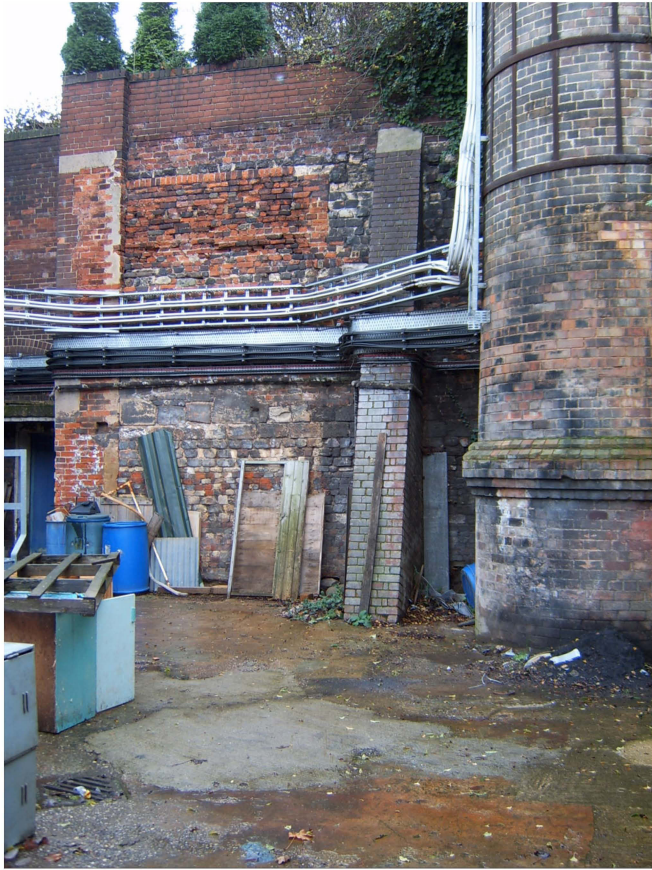
Plate 11

Structure R (Fig. 7; Plate 11)

North-south retaining boundary wall. The earliest construction was early-19th century but with later 19th century alteration and addition. This was in a conglomerate of hand-made red-brick, re-used fire-brick and sandstone. Subsequent construction in hand-made red-brick with irregular bond. The east-west original southern wall of structure N, constructed in hand-made red-brick in the stretcher bond, abutted this wall. The wall had been subsequently raised up to its full height of c.6.0m and was reinforced by a buttress in machine-cut red-brick in English Garden Wall bond.

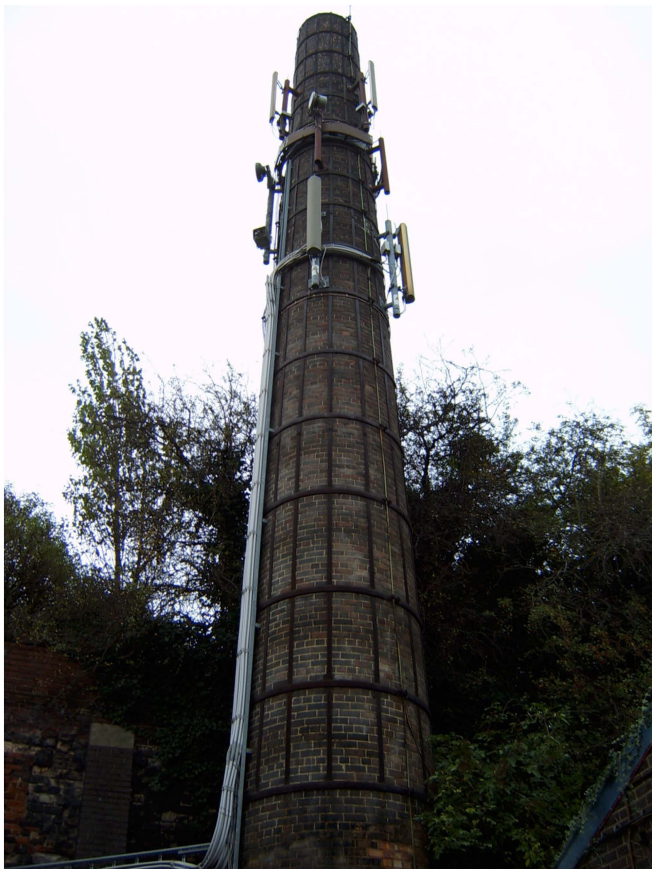
Plate 12

Structure Q (Figs. 7 and 9; Plate 12)

Circular chimney-stack. Late-19th to early-20th century in date. Constructed in machine-cut red-brick in the English Garden Wall bond. Simple stepped decoration at the base. Reinforced by iron rings from c.3.0m to the top of the stack. Stack is c.2.5m in diameter and 15-20m high. An underground tunnel located in the basement beneath structure J ran directly to the flue. The chimney was designed as stack for flue for oil-powered furnace.
