**SITE 5, WARWICK  
STREET, BIRMINGHAM**

**AN ARCHAEOLOGICAL  
EVALUATION 2007**

Project No.1627

By Bob Burrows

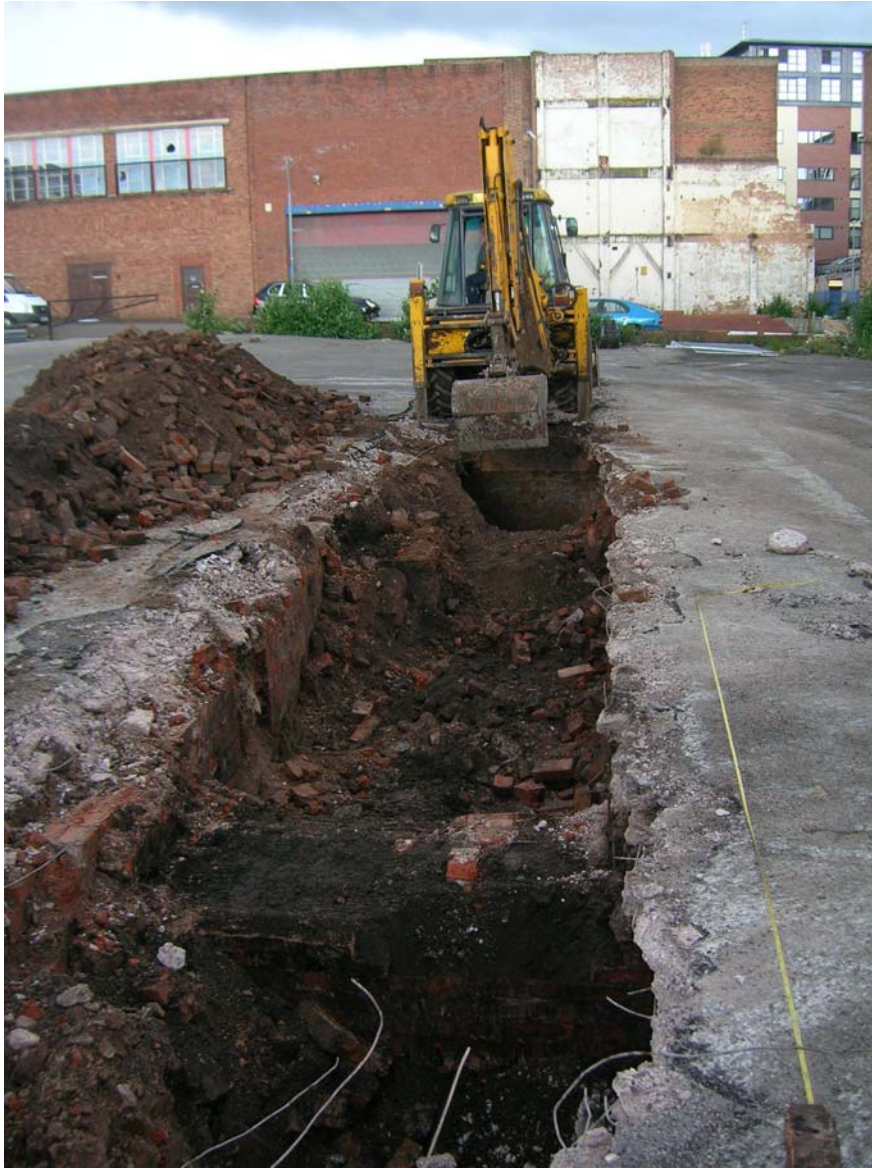
Plate 1

- 1 Trench 1, machining
- 2 Trench 1, 1011 and 1012
- 3 Trench 1, 1003, 1012, 1011 and 1008
- 4 Trench 2, 1012
- 5 Trench 2, 2004

All topsoil and modern overburden was removed using a JCB excavator with a toothless ditching bucket working under direct archaeological supervision, down to the top of the uppermost archaeological horizon or the subsoil (Plate 1). Because of the depth of the overburden it was not possible for reasons of health and safety to enter the trenches for the purpose of hand-cleaning.
