**Historic Building Record and  
Interpretation.  
WSM33743**

**Project No. 1300**  
March 2005

**Historic Building Record and Interpretation of Bell Hall Farm, Hartle Lane,  
Belbroughton, Worcestershire WSM33743**

**By Leonie Driver**

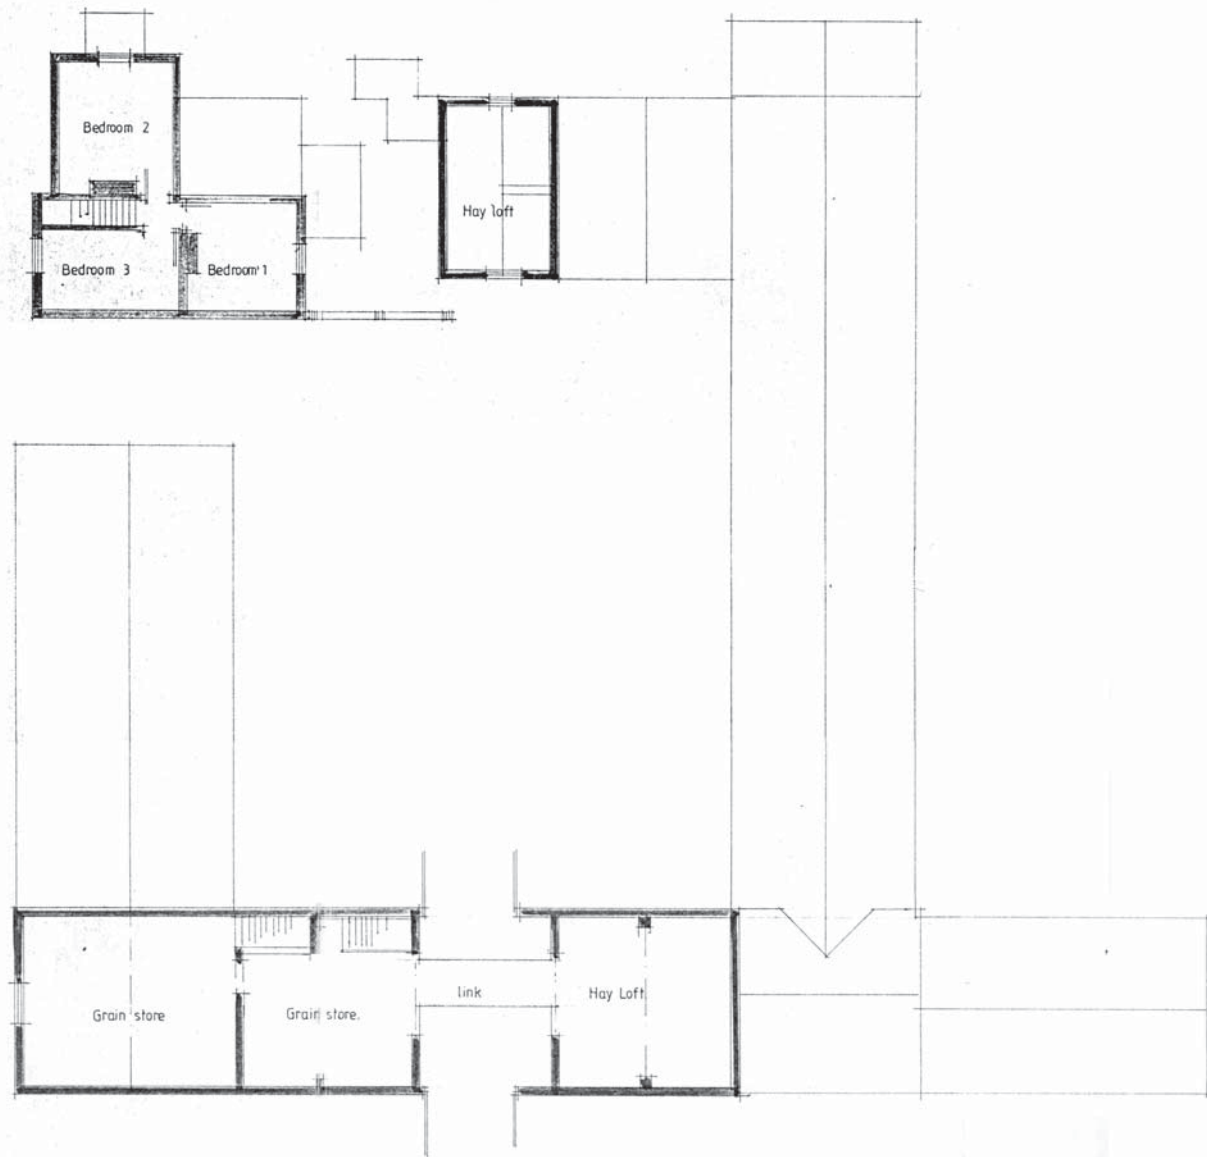
Fig.9

*First Floor Plan*

## **6.0 Description of the buildings (Figs. 8 to 10)**

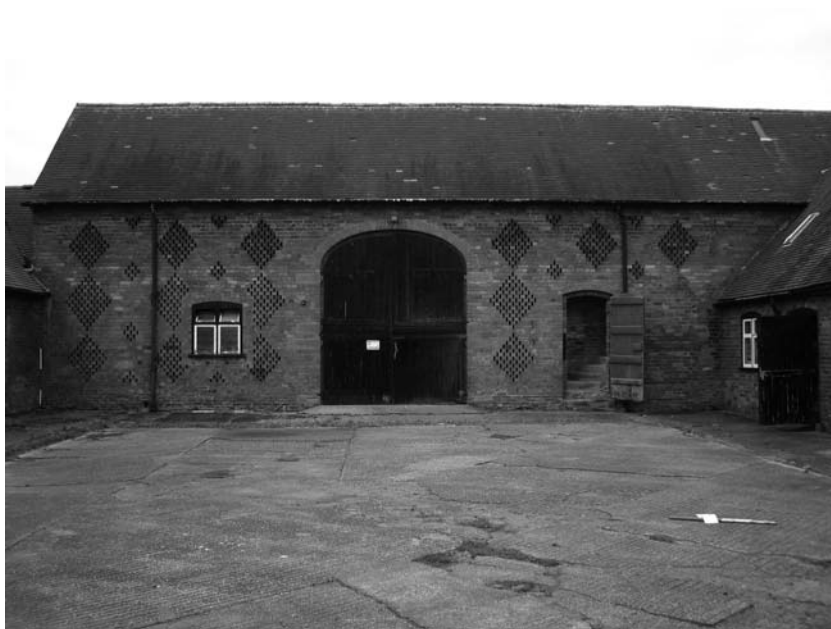
Plate 1

The east facing elevation, towards the courtyard, has central, full height, barn doors under a 3-centred arch. Each of the barn doors is subdivided again, into two tiers of wooden doors on each side. The doors are supported by four pairs of decorative sandstone ashlar hinge blocks (Plate 2). The central barn doors are flanked by lozenge-shaped arrangements of air vents in two sizes. The segmental-arched

doorway to the centre of north bay giving access to a stone staircase leading to the granary at the far north end of the west range. The segmental-arched window to the south bay, which contains a wooden cross-window frame.

The barn would have originally been used for the storage and processing of crops such as corn. The features of the barn were essential to the efficient processing and proper storage of the products of the farm. All barns required a tall unobstructed area within which the threshing floor would be located. Threshing was carried out during the winter months, so it was essential that barn had large openings, which would bring light to the threshing floor (Brunskill 1999: 40) It was typical that these doors to open outwards (so not to obstruct the threshing process), it was also common for the barn to have two sets of doors either side of the threshing floor, this allowed carts to enter the building with their loads of corn (*ibid*). On either side of the threshing floor at Bell Hall Farm are bays, these would have been used for the storage of the sheaves of corn. The barn was later re-used to pen animals at ground floor level, and a bridge inserted to provide access across to both bays at first floor level.

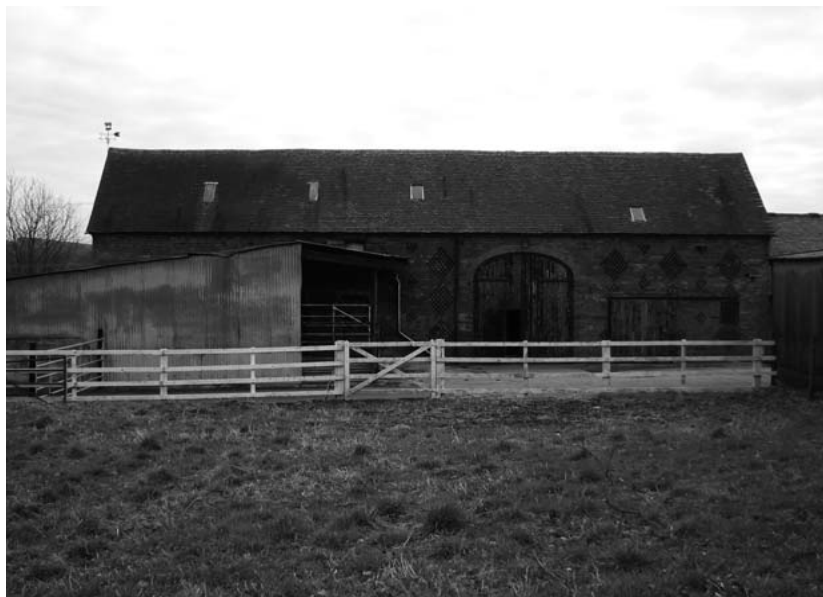
Plate 3

The west facing elevation of the barn (Plate 3) is also characterised by air vents of the type seen on the east elevation, and central full height wooden barn doors under a 3-centred arch. Four pairs of sandstone hinge blocks are present, however the bottom ones are mostly covered by the concrete yard surface, and the middle pair are not in use, due to the original doors having been replaced. The south bay of the barn has an inserted 20<sup>th</sup>-century sliding door and adjacent to this, an inserted 20<sup>th</sup>-century window. To the north bay there is an inserted 20<sup>th</sup>-century window under a segmental arch.

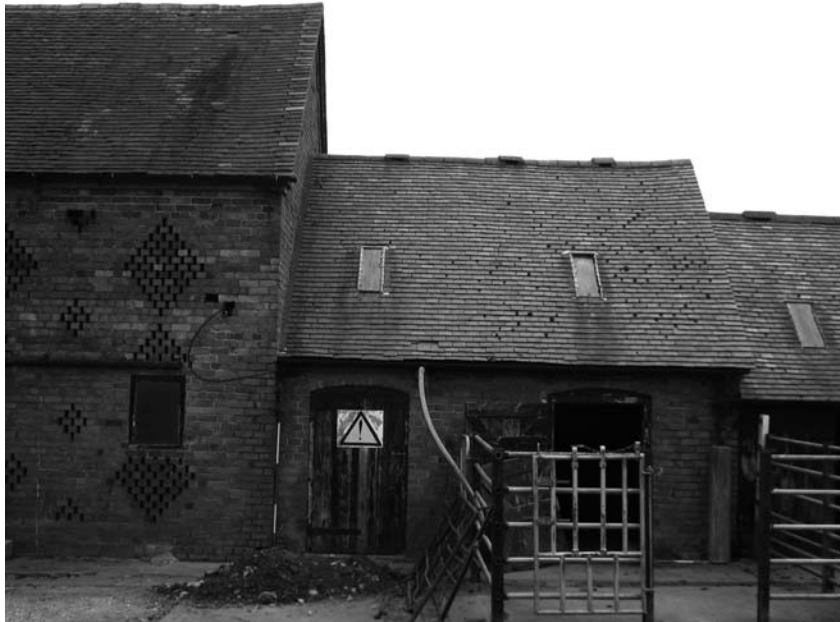
Plate 9

To the south of the barn is a row of single-storey, west facing structures. These are made up of a feed room and loose box (of the same structure, and a continuation of the south range) to the north (Plate 9), each with a segmental-arched doorway. The loose box has a concrete and brick floor and an inserted feeding trough with an inserted window/trap above in its northeast corner. There is a blocked segmental-arched doorway in the south wall of the loose box formerly giving access to the cowhouse to the south .

Another element of the farmyard complex is the loose box on the south side of the west range. Loose boxes were common and found on practically every farm. A loose box consists of a room or compartment with a door and a window, the animal was able to move about freely (Peters 1981: 71). Loose boxes could be used for single cows when sick or calving; they could serve as a hospital ward for a sick or foaling mare; they could accommodate small groups of bullocks or heifers in bad weather (Brunskill 1999: 75). The Worcestershire cowhouse alongside the loose box is a type found across Worcestershire, and on occasion in other counties (Peters 1981: 69). Nearly all examples of Worcestershire cowhouses are single-storey, and are of a design which dates from c.1800 (*ibid*). The north and south ranges provided further space to house animals, it is possible that the north range may have originally been used for stabling horses, and the south range was used for cattle.

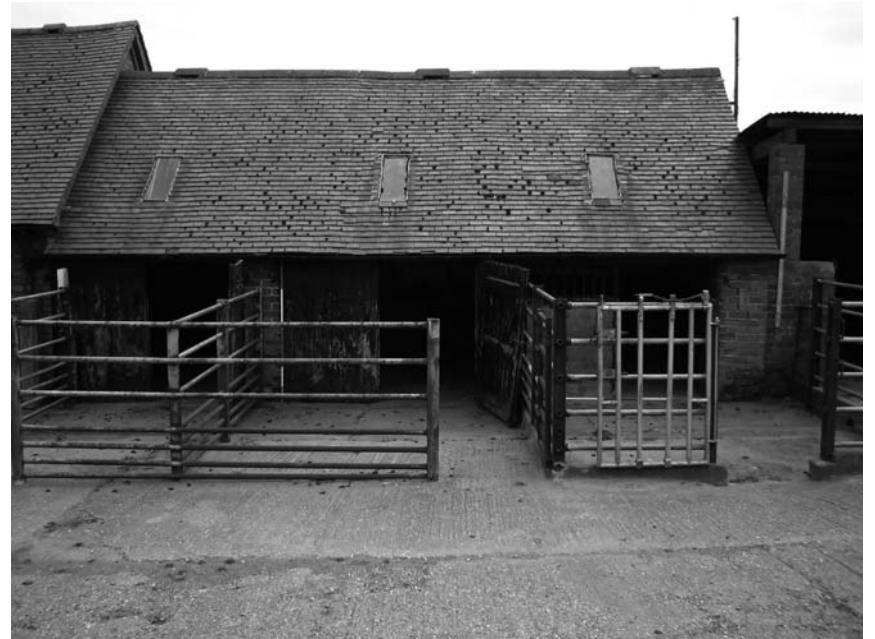
Plate 10

A Worcestershire cowhouse is situated to the south of the loose box (Plate 10), it comprises three-bays between square piers with bullnose brick corners. The cowhouse was formerly open fronted, and is an addition to the farmyard complex dating to the later-19<sup>th</sup> century. It has been subject to alteration during the 20<sup>th</sup> century, when it was fitted with gates, and the internal space subdivided by an inserted concrete block wall between the centre and south bay. The short principal roof trusses of the cow house are bolted rather than jointed. The southern gable end of this cowhouse has a circular pitching eye.

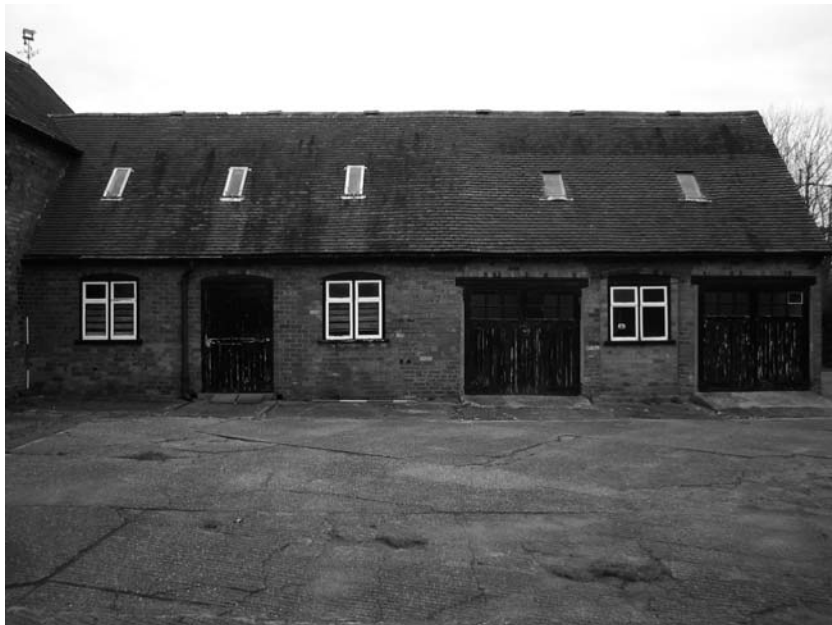
Plate 11

The south facing elevation (Plate 11) is of roughly six bays. There are segmental-arched windows to the west and centre, both with cross-pattern wooden frames, and a window with contemporary frame at the east end within a blocked doorway with segmental head. The doorway at the west end of the range also has a segmental-head.

There are two inserted garage doors in this elevation, one in the centre and one at the east end. The north facing elevation (Plate 12) has two blocked segmental-arch windows on the east and centre of the range. There is an inserted doorway at the west end.

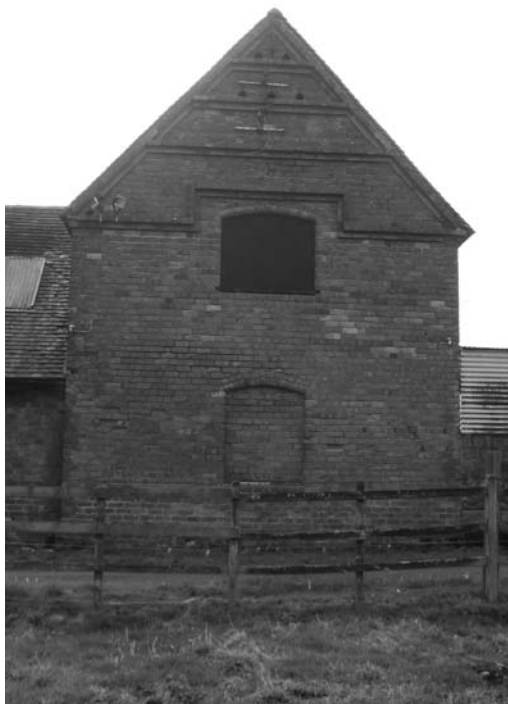
Plate 13

The north gable end of the west range adjoins the west end of the north range (Plate 13). The gable has a blocked segmental-arched window at ground and first floor levels. There are several tiers of brick banding decorating the gable, the lowest is stepped over the first floor window, forming a dripstone band. Butting against the west side of this gable end is a low wall of reused sandstone blocks with herringbone tooling, the blocks were probably first used during the 18<sup>th</sup> or early 19<sup>th</sup>-century.

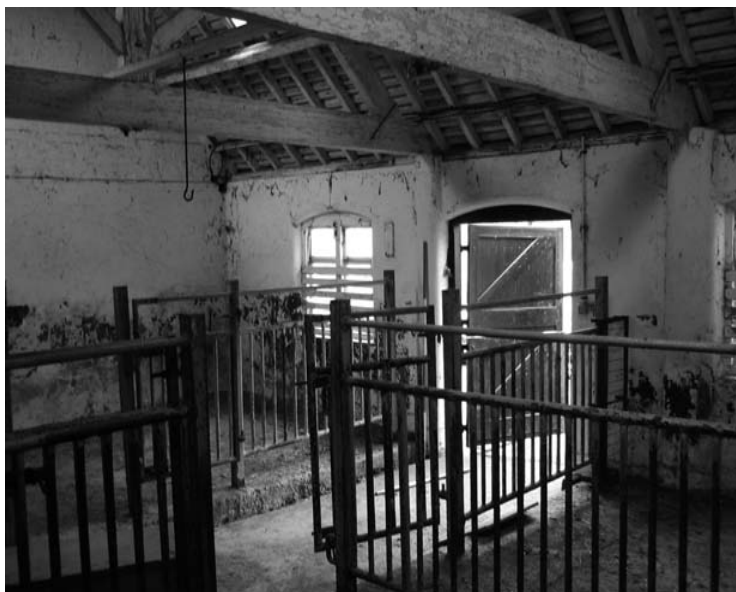
Plate 14

The east end of north range has a concrete floor and brick and plaster walls. There is a blocked doorway with segmental-arch in the west wall which would have given access to the other room of the range. There is a blocked window in the north wall of the room and a further blocked door in the south wall (Plate 14), both of these blocked features are set within a raised brick frame. The room has a suspended, hard board ceiling, with king-post roof truss above. The interior of the west end of the range is very similar to that of the east end but it has undergone fewer changes, retaining its original windows and doorways (Plate 15). The area does not have a suspended ceiling, the king-post trusses of the roof can be seen. The room has an arrangement of 20<sup>th</sup>-century metal stalls.

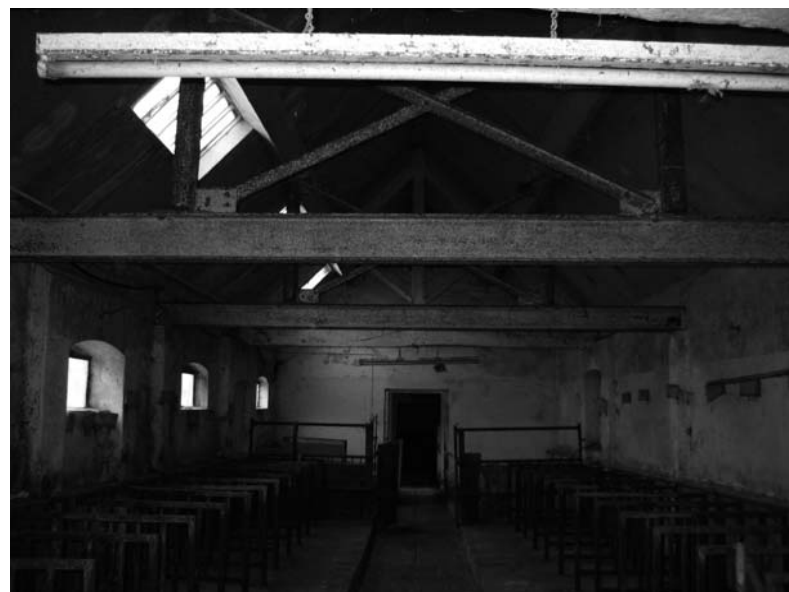
Plate 16

The west end of the south range is made up of a long narrow room fitted with metal stalls dating from the mid to late 20<sup>th</sup>-century (Plate 16). The floor is of concrete and the walls are plastered. Two windows at the west end of the room in the north wall and a blocked window towards the east end of the room are set within raised brick surrounds (as seen previously in the north range). The roof was constructed of two king-post trusses above the raised brick surrounds, with two intermediate steel queen-post trusses.

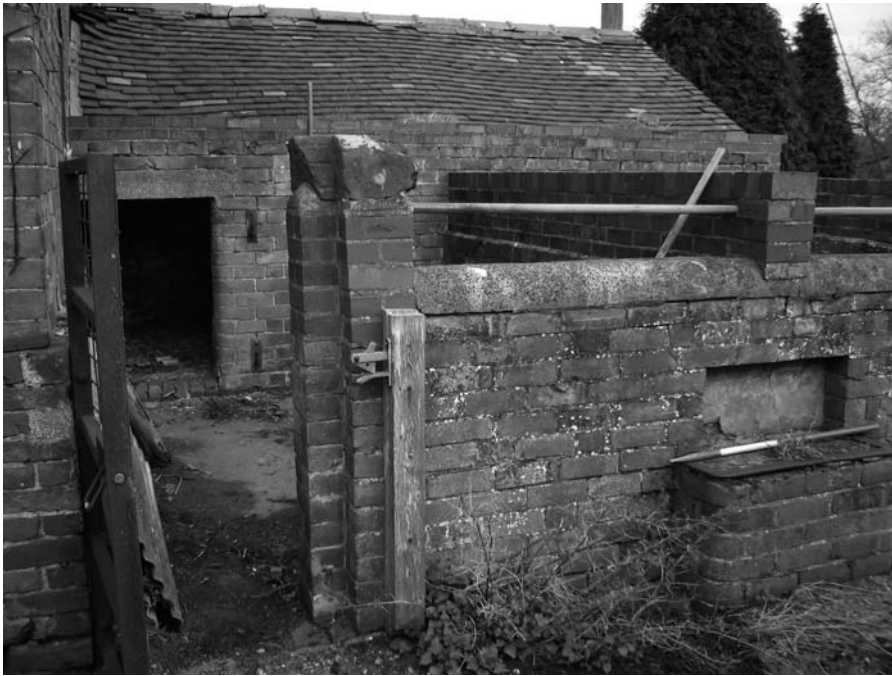
Plate 17

Adjoining the east end of the north range are a pair of late 19<sup>th</sup>-century pigsties (Plate 17). These have undergone some alteration during the 20<sup>th</sup>-century, including the blocking of the feeding system. They are brick built with a plain tile roof. The pigsties appear on the 1889 OS map.

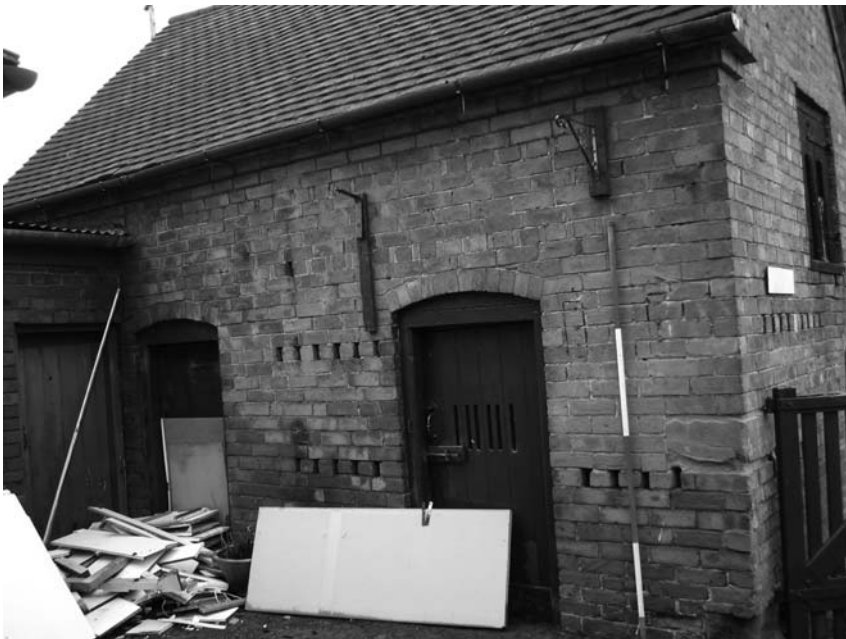
Plate 18

The east range is aligned N-S and faces west onto the courtyard. It is made up of two main parts. These are a single-storey 'parlour' building at the south end, butting against the south range, and a two-storey building to the north (Plate 18). There is also a group of very small brick buildings to the north and east of the north end of the range. The purpose of the two main buildings is not clear. Access to interior of the 'parlour', as it is marked on the existing ground plan, was not possible. The two-storey structure alongside may have been used as pens for small livestock, with a hen loft above.

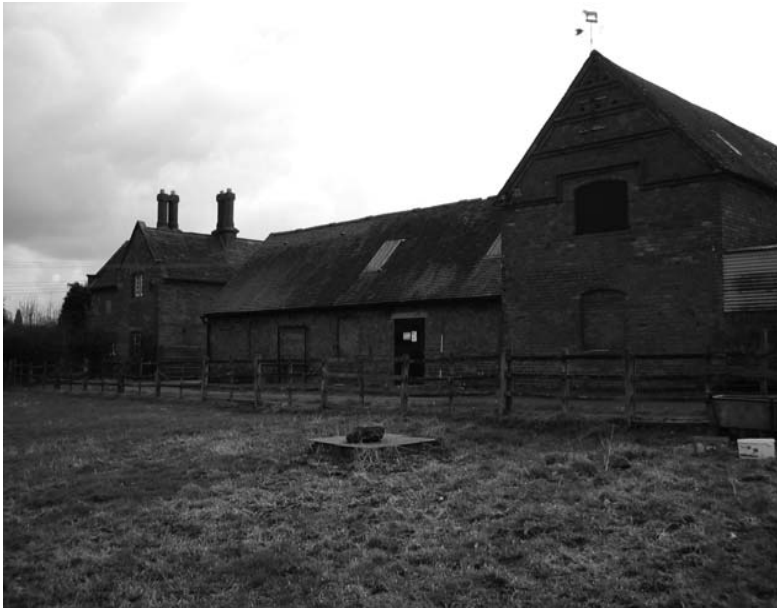
Plate 21

The two-storey farmhouse is located in the northeast corner of the farmyard complex (Plate 21). It is L-shaped with entrance range, and is aligned E-W facing east, away from the courtyard. It is in a nominal Tudor Gothic style, constructed of red brick, laid in Flemish Stretcher bond with sandstone ashlar dressings. The house has a plain tile roof with octagonal chimney.

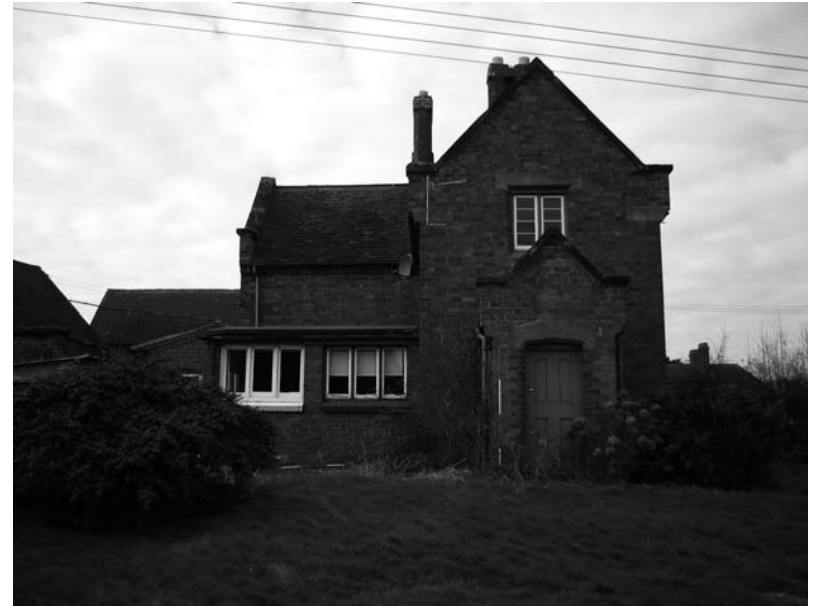
Plate 22

The east facing elevation (Plate 22) is characterised by a porch with four-centred arch doorway and stone coped gable corbelled out at the sides. A two-light casement window beneath a chamfered stone lintel is situated above the porch. The west wing of the house is set back on the south side of this elevation, there is a 20<sup>th</sup>-century kitchen extension in front of the west wing.

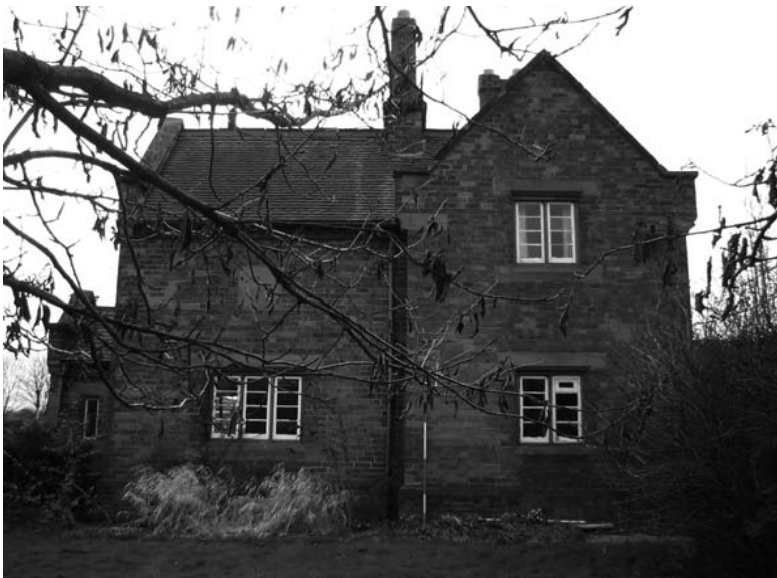
Plate 23

The gable end of the west wing is a prominent feature in the north elevation (Plate 23), and is situated on its west side. The rest of the elevation is taken up by the east wing. The west wing has a two-light casement window at ground floor level and an identical window directly above. The east wing has a single three-light casement window at ground floor level. All the windows in this elevation have stone sills and lintels. At first-floor level above the ground floor window of the east wing, is a plain stone block, perhaps intended for an inscription.

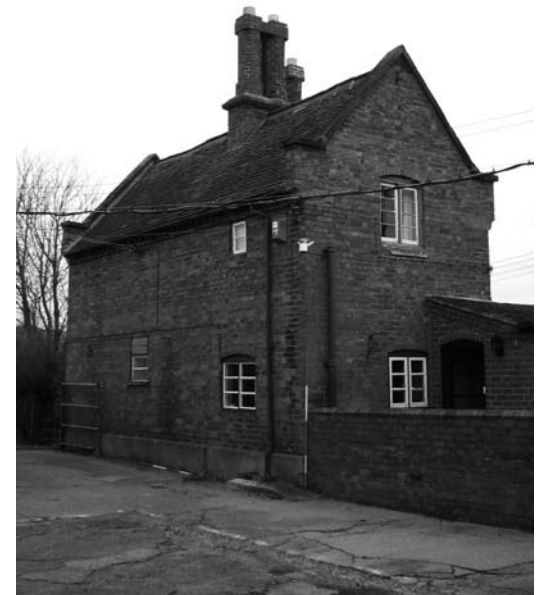
Plate 24

The west facing elevation has three small windows (Plate 24). The window at ground floor level on the south side of the elevation has a segmental-arched casement. The south elevation of the farm house has a single storey late 20<sup>th</sup>-century entrance porch, along side the later porch is a segmental-arched casement window, a similar window of larger proportions is situated directly above at first-floor level.
