Land at Moreton Business Park,
Moreton-on-Lugg, Herefordshire:

an archaeological watching brief
2006

Project No.1450

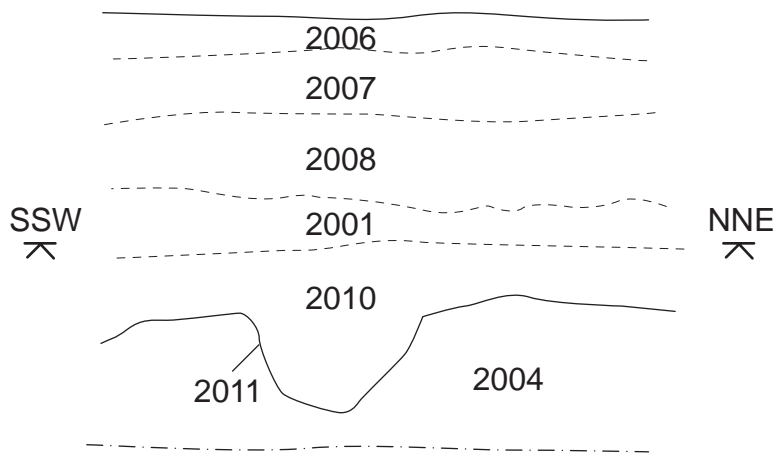
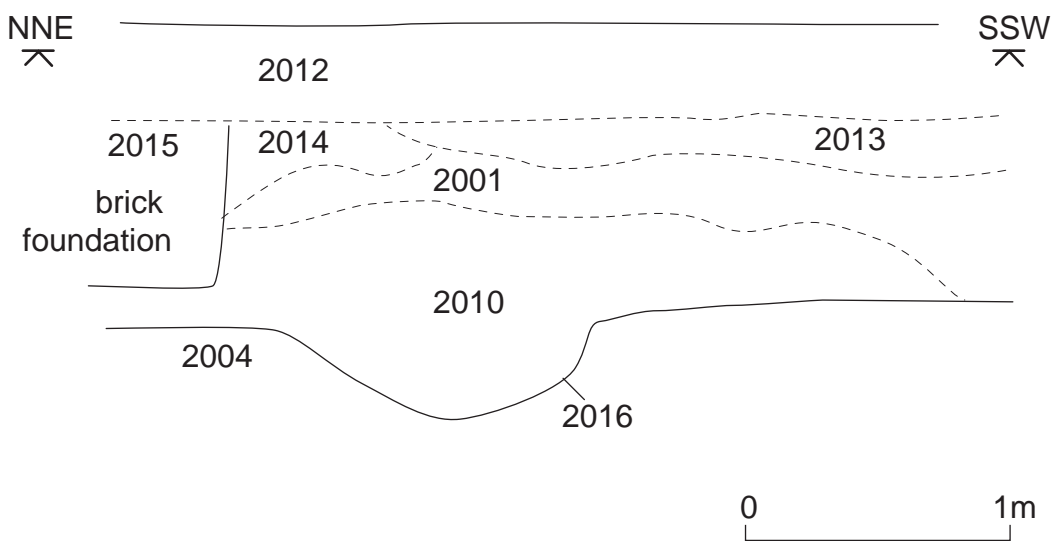
Fig.5

About 14m further south in Trench 20, was a northwest- southeast orientated ditch (2003; Fig. 4, Section 3 and Plate 3), 0.80m wide and 0.40m deep, with steep-sides and a flat base. It was filled by a reddish brown sandy clay (2002). Approximately 36m south of ditch 2003, was a pit or ditch terminal (2011; Fig. 5, Section 4 and Plate 4), 0.65 wide and 0.39m deep, with a 'U'- shaped profile extending west beyond the section of Trench 20. It was filled by the overlying alluvial clay silt (2010) that also sealed natural subsoil 2004 to a depth of 0.22m here. About 3m further south another pit or ditch terminal (2016; Fig. 5, Section 5) was recorded extending east beyond Trench 20. This was 1.20m wide and 0.40m deep with a shallow 'U'- shaped profile and was filled by the overlying alluvial layer 2010.

On the east side of the Trench 20 (Fig. 5, Section 5), the upper alluvium 2001 was sealed by a black, ashy, modern deposits (2013 and 2014) and was cut by a foundation trench (2015) for a cement-bonded brick wall. The modern deposit 2013/4 that appeared to consist of ash or very similar material was often encountered at the same stratigraphic level over the majority of the site. Here it was overlain by a sequence of three deposits (2012), the main constituent of which was stone chippings. These deposits were all recorded as one context and date to the time of the military base or later. Their combined thickness was 0.30m and the surface of the uppermost layer of chippings formed the ground surface at the time of the excavations.

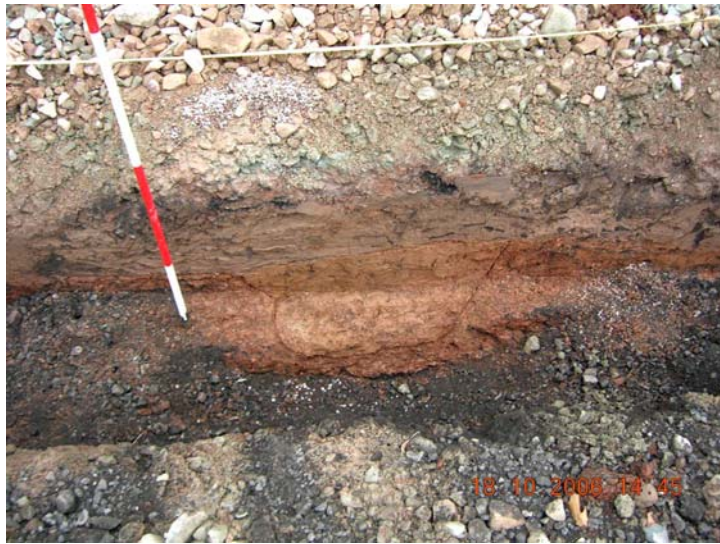
Plate 1

In Trench 19 was a northeast- southwest orientated ditch (1904; Fig. 4, Section 2 and Plate 1), 1.06 wide and 0.42m deep, with steep- sides and a slightly rounded base. It was filled with a mid pinkish-brown sandy clay (1905) containing a few small pebbles. Approximately 2.5m south of ditch 1904, was a similarly aligned ditch (1906; Fig. 4, Section 2 and Plate 2); 1.62m wide and 0.40m deep, with a gentle 'V'- shaped profile. It was filled by a grey-brown clay-silt alluvium (1902) which formed a layer that also overlay the natural subsoil 1903.
