**St. Thomas á Becket  
House, Ettington,  
Warwickshire**

**Archaeological Evaluation  
and Watching Brief.**

**Final Report**

Project No. 1783

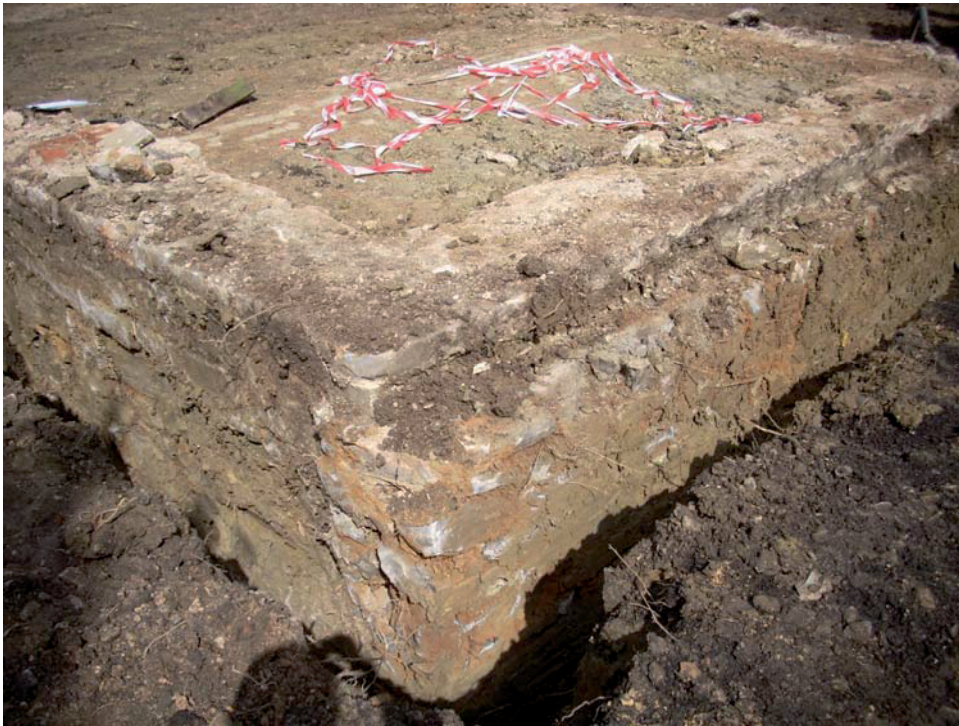
Plate 2: The south west corner of the mausoleum

The exterior walls were constructed from the same blue sandstone as the rest of the church, but the interior structure (including the arched roof, supports and ledges) were constructed of unfrosted red brick (Plates 2 and 3).

Exterior dimensions were measured as length 6.6m, width 5.5m, depth below ground 1.8m. The internal dimensions were measured as length 5.0m, width at base 3.8m, height at centre 2.15m. The interior of the crypt was formed by an arched roof running along the length of the structure. A central brick column on each side of the structure supported the roof and the coffin ledges. There were eight ledges in total in addition to four spaces on the floor for coffins to be placed. No remains were present. The ledges were 2.2m long, 1.25m wide, and were 0.11m thick at the centre (one brick depth). The top of the lower ledge was 0.55m from the present floor level, whilst the top of the upper ledge was 1.23m from the floor. The stairwell leading down into the crypt was in a state of disrepair. The wall retaining earth on each side of the stairway was not bonded into the main structure. It was built from similar stone, but the workmanship appeared different, the blocks were smaller, and was capped by three courses of red 19<sup>th</sup> century unfrosted brick. It is likely that this was a later addition, or possibly part of later repair work on the crypt.

The Shirley Crypt that lay under a transept on the southeast side of the church is still present, although is susceptible to flooding. Foundation trenches around the remaining church footprint showed that the original stonework remains intact, except for some modern disturbance (late 20<sup>th</sup> century) around the southwest of the church adjoining the tower. This stonework will remain *in situ* and will be encased by the new foundations.

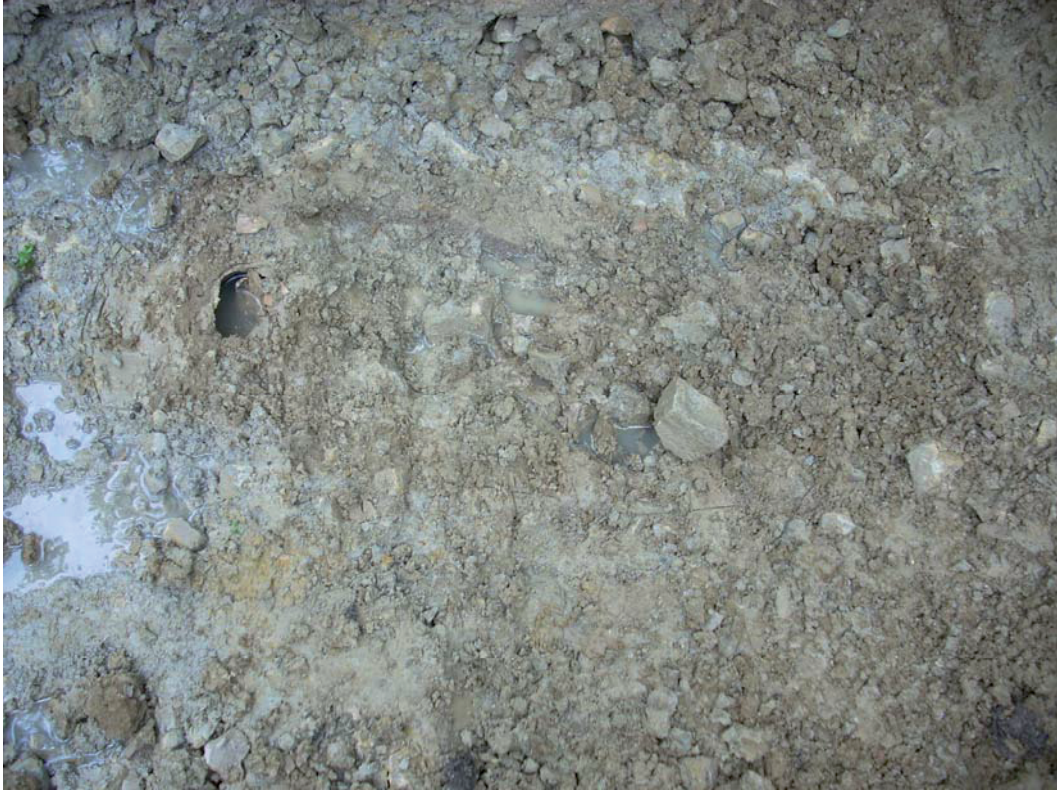
Plate 4: Possible human skull remains

The pit for the septic tank was also located within the area of the pathway, at the eastern end of Trench F. An initial 2 x 2m square pit was excavated to a depth of 1.4m. At a depth of approximately 1.3m below the ground surface a skull was found. The size and shape were consistent with that of a small human skull (Plate 4). The skull appeared to lie at the end of a shallow grave shaped cut (**1013**). Once the skull was uncovered, no further excavation was undertaken and it was therefore impossible to tell if this was part of an articulated skeleton or just charnel remains. The standing gravestones in the cemetery indicate a direction of burial aligned towards the northeast (as with the nave of the church), however the position of the skull within the cut would suggest that the skeleton was aligned generally towards the southwest, suggesting a different burial phase to the main graveyard.

The location of the septic tank was moved to the south in order to avoid disturbing this potential burial. No further remains were encountered. The trench was sealed by a layer of subsoil (**1008**).

Given the presence of the church and burial ground, the site had the potential for archaeological remains, especially inhumations, to be disturbed during the excavations. Careful planning to avoid all known graves led to very little human remains being discovered during the watching brief. The skull located at the bottom of the septic tank pit may have been part of an articulated skeleton, however it was not excavated and was left *in situ*. Due to the orientation of the grave cut (**1013**) it is possible that this grave predates the church. However it is also possible that the skull represents charnel thrown into the grave once the main burial had taken place, which was a fairly common occurrence during the medieval period.

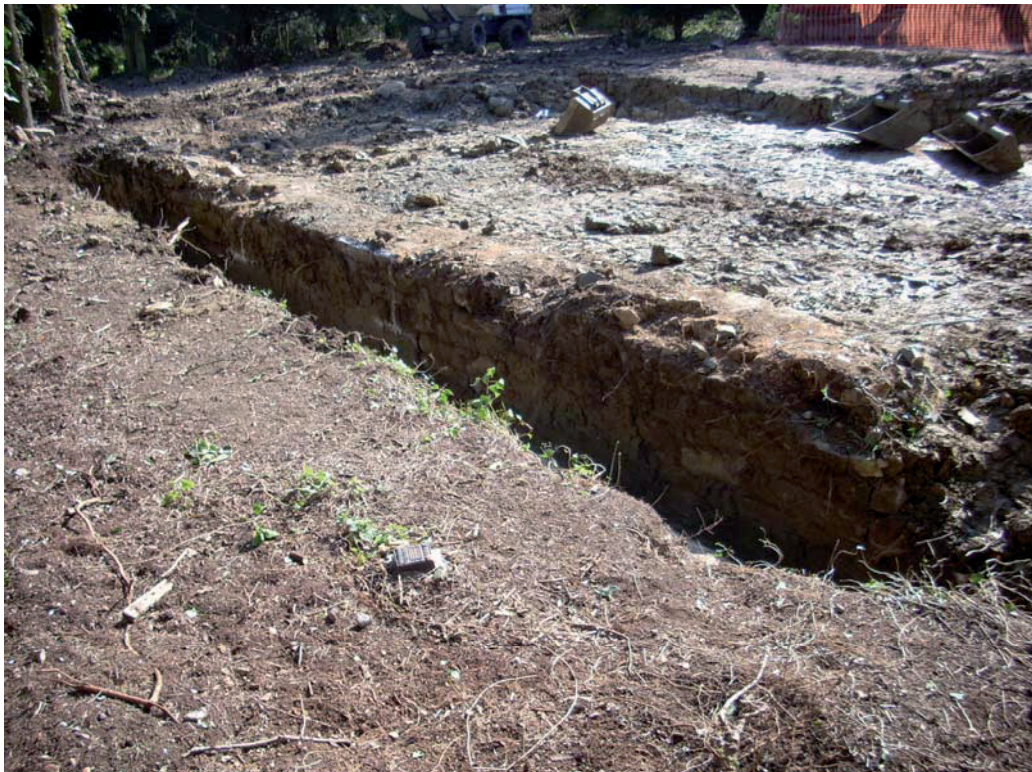
Plate 5: Foundation trench along northwest side of church footprint

This trench was continued from the end of Trench C along the northwest side of the church (Fig. 3) all the way to the existing tower structure at the west corner of the church (Plate 5). It was stepped from 2.7m to 2.5m, then to 2.0m, and finally to 1.5m as it reached the tower. No features were seen in this stretch of trench. One piece of late 18<sup>th</sup> / early 19<sup>th</sup> century glazed pottery was recovered from (**1001**) The final 5m of trench was along an area previously disturbed in modern times. A quantity of concrete had been placed into the ground disturbing it, but the trench was able to be dug. The depth of the wall and the natural was consistent with that of the south wall, on the opposite side of the structure, remaining at a depth of 0.9m throughout the trench. The natural, subsoil and topsoil levels remained consistent.
