Report No. 455

THE CHURCHYARD OF ST. PHILIP'S CATHEDRAL, BIRMINGHAM

An Archaeological Desk-Based Assessment

by
Birmingham University Field Archaeology Unit

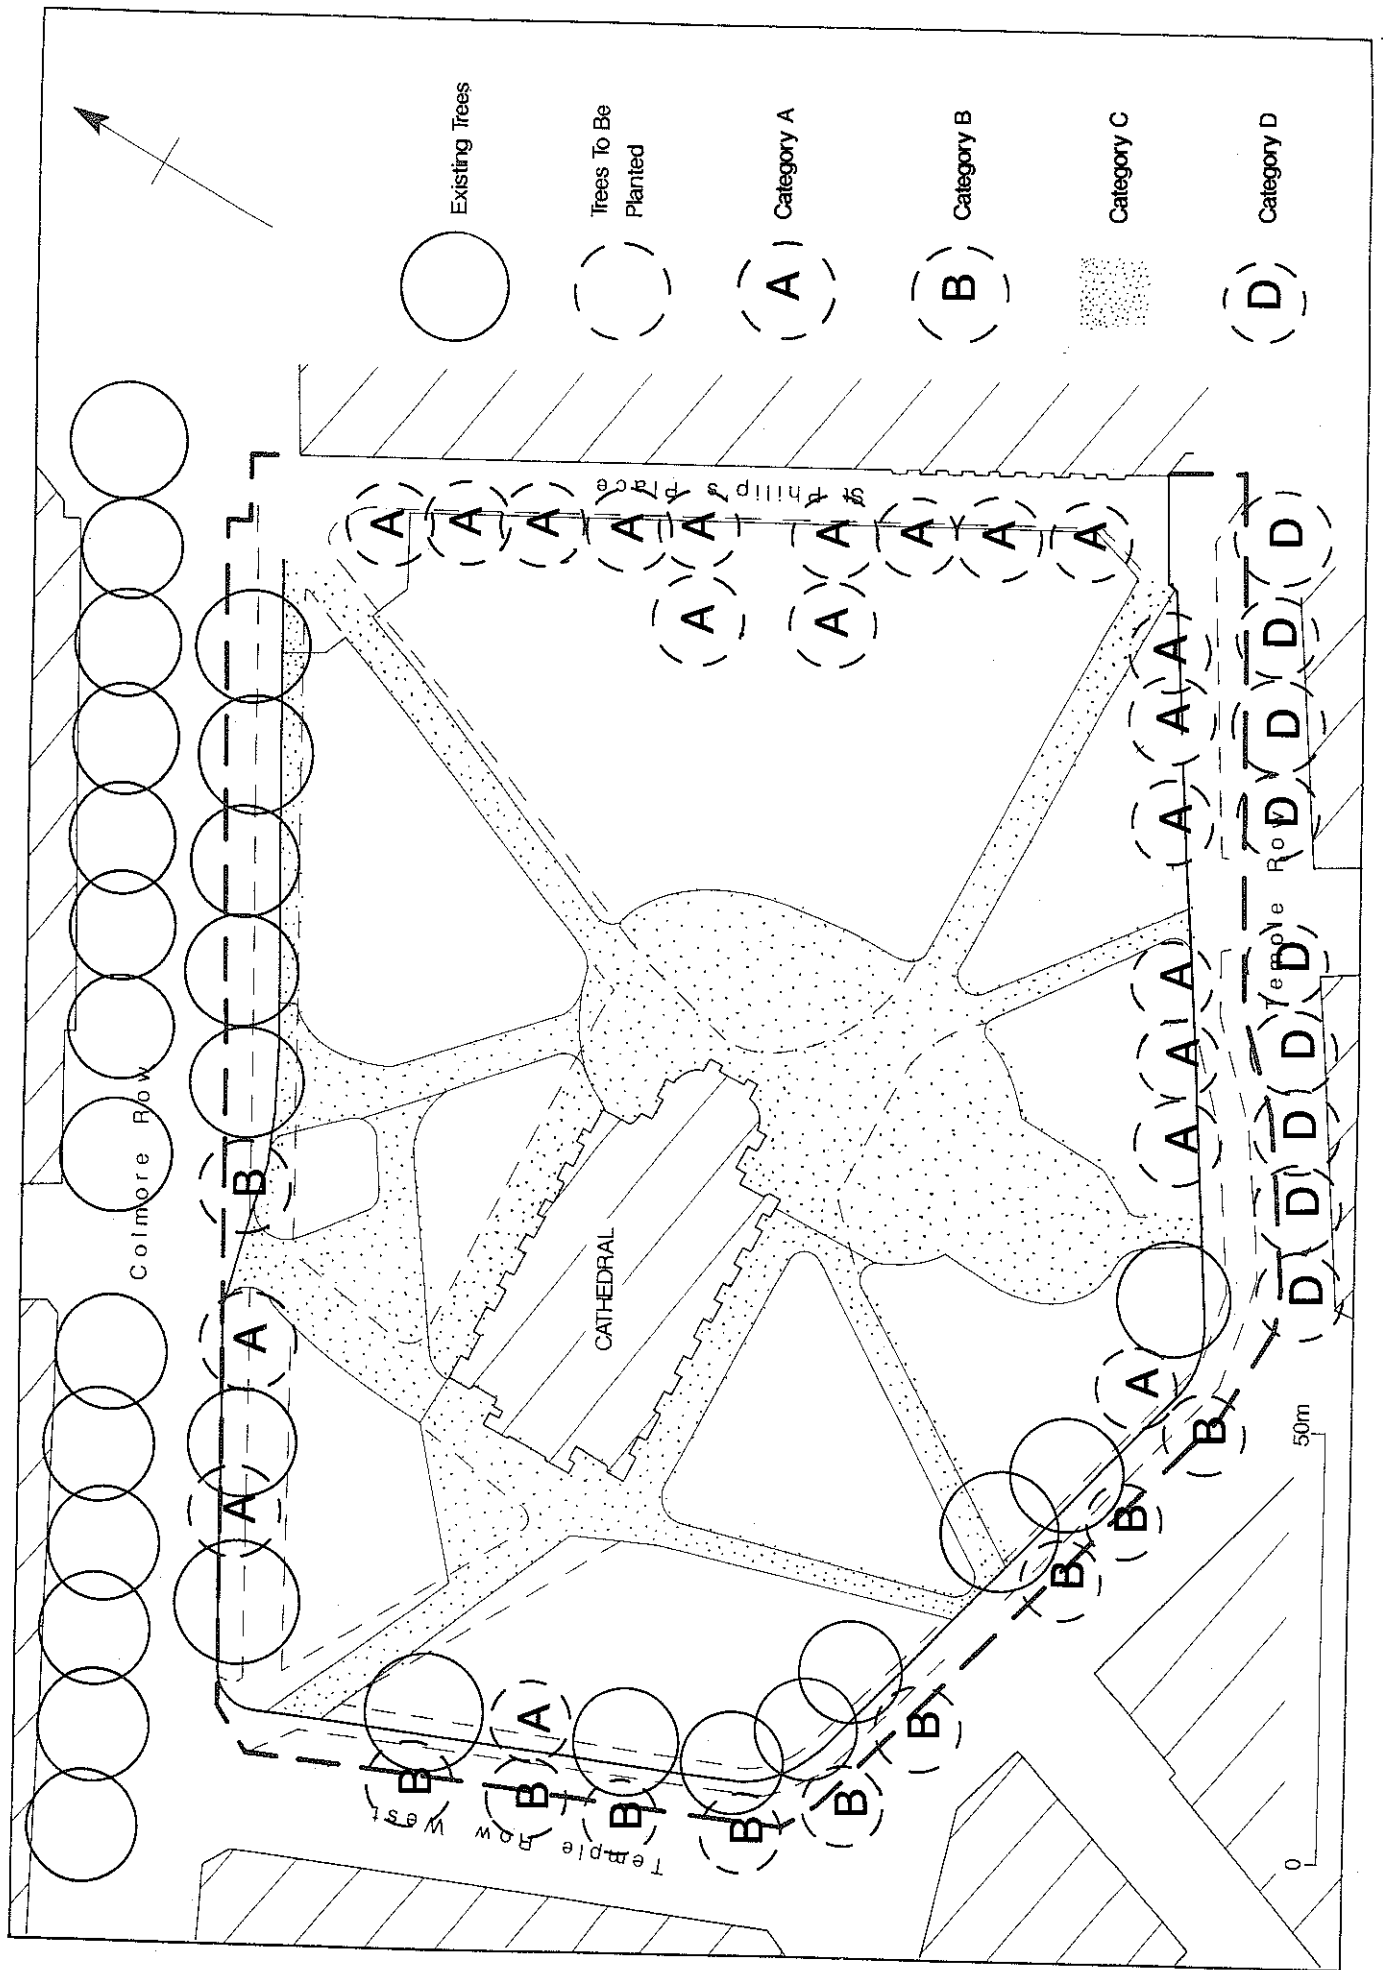
| Fig.4 | Archaeological implications. |

groundworks, or due to the location of groundworks and their proximity to areas of archaeological potential. For the purposes of this report this potential effect has been divided into four categories (Fig.4):

Category A) Proposals which are potentially very destructive to archaeological remains which may have been little disturbed by any development within the churchyards history. Generally 'any development' refers to the contraction of the churchyard boundary in the 19th century.

Category B) Proposals which have the potential to be very destructive to archaeological remains which have probably already suffered some degree of disturbance due to developments in the churchyards history.

Category C) Proposals which are potentially less destructive due to the nature of the proposed development or due to their being sited in an area where below ground deposits are likely to be of less significance.

Category D) Proposals which are unlikely to have an effect on archaeological remains associated with the churchyard.

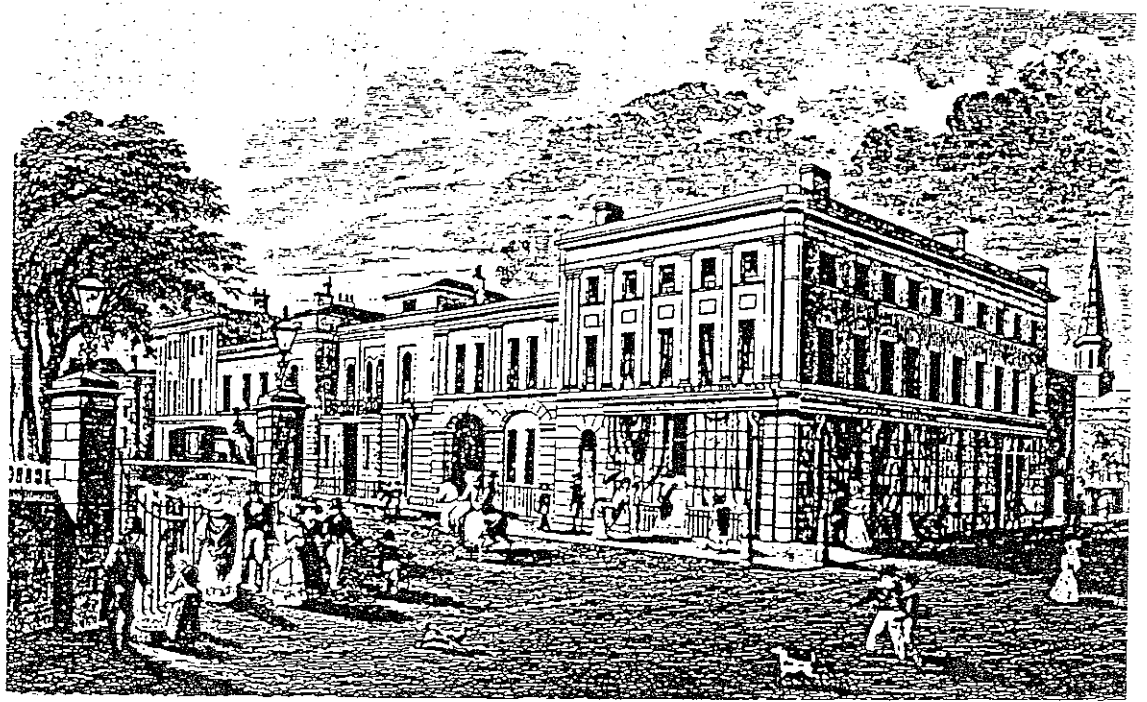
| Fig.8 | Illustration (<i>c.</i> 1830) showing earlier boundary wall. |

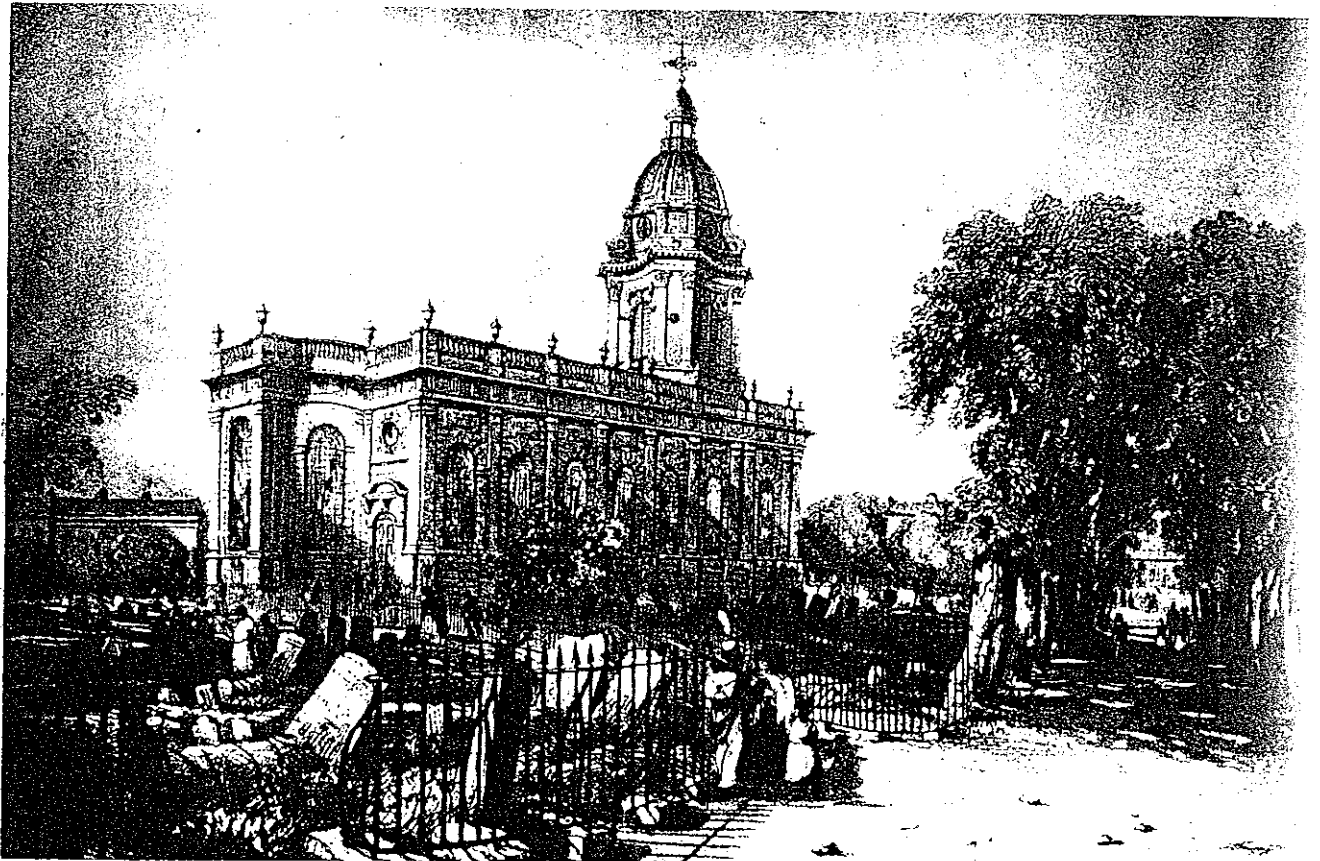
| Fig.9 | Illustration (<i>c.</i> 1840) depicting change to boundary. |
