Birmingham University Field Archaeology Unit  
**Project No. 618.2**  
February 2001

**Salvage recording on the site of the former  
gasworks, Gas Street, Birmingham,  
West Midlands**

by  
Stephen Litherland

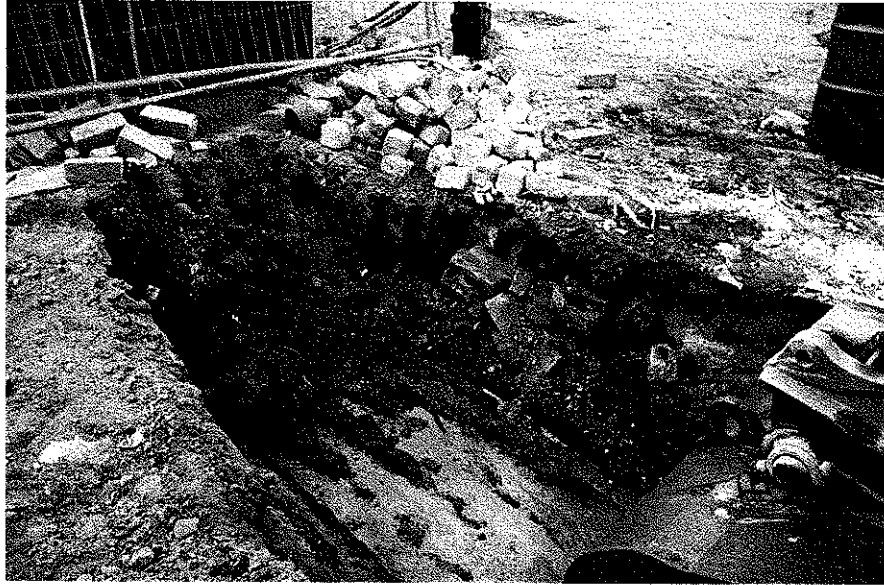
Plate 13

Retort House. When the gasworks was in operation it comprised an open yard to the south of the 'Coke Shade' overlooked by a terrace of buildings fronting Gas Street, but by 1870 it lay within the footprint of the Anchor Tube Works (fig. 7). In contrast Area IV was dominated by three gas holders, although the terrace of buildings fronting Gas Street continued southwards into this area. Archaeological observation consisted of two main elements. This comprised selective monitoring of the piling operation (plate 11) over both areas, the removal of substantial foundations for the former garage that occupied Area III (plate 12), and clearance of obstructions to the piling operation using a 360 excavator with a toothed bucket (Plate 13).

Lower down the site of the gasworks, but at a roughly similar height to the floor of Building a, the remains of a clamped brick built tank containing a coal tar residue (Building c; fig. 6 & plate 13) were located during piling. This had to be cleared from the site and the feature was recorded prior to its removal. The tank was adjacent to the central gas holder and may have been part of the purifying system. Recording was limited for health and safety reasons due to the highly toxic nature of the coal tar. Further recording
