**An archaeological watching
brief during groundworks at
St. Philip's Place,
Temple Row, Birmingham,
West Midlands**

Birmingham University Field Archaeology Unit
Project No. 845
December 2001

by
Richard H. Cherrington
with illustrations by Nigel Dodds

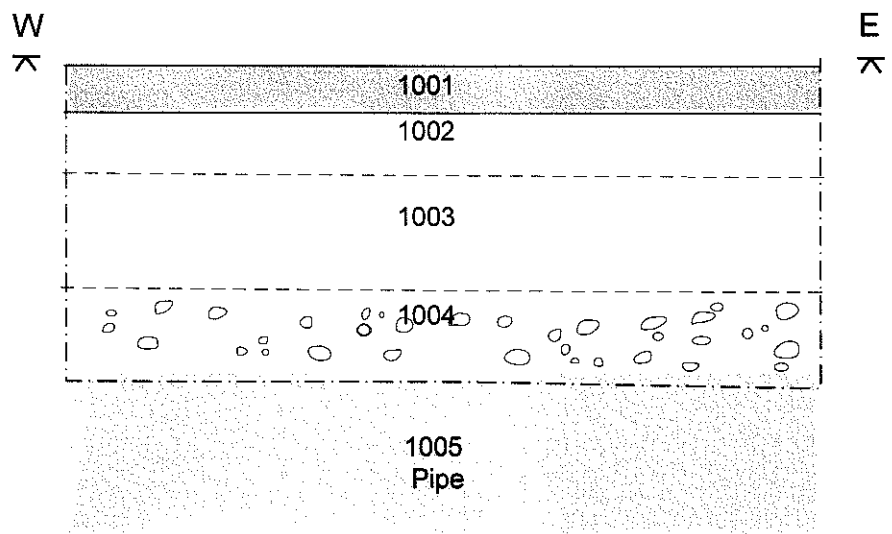
Trench 1

This trench was 25.2m long and 0.4m in width and depth. The trench excavation followed the course of existing services, maximum depth being reached when these existing services became visible. The trench was dug into re-instated ground, which appeared to consist of 0.34m of mixed layers containing orange sharp sand, grey roadstone, and sand and gravel ballast; these were all sealed by a 0.06m thick layer of concrete paving slabs (Fig. 3; Plate 4). No evidence of archaeological deposits or human remains was recorded.

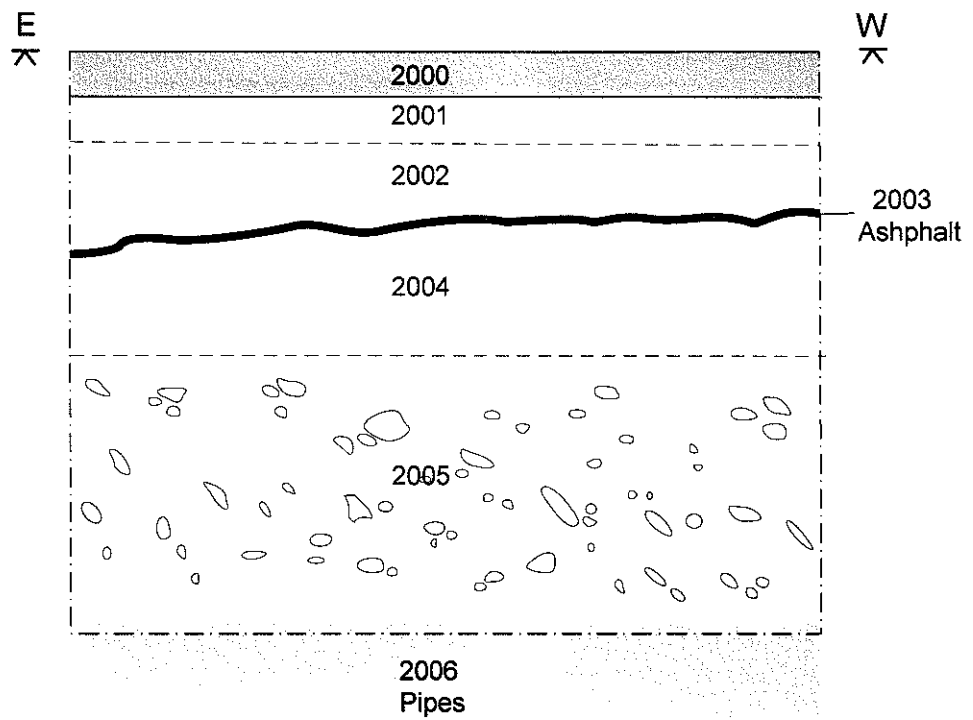
Trench 2

This trench was 7.8m long, 0.4m wide and 0.75m deep. As in the case of Trench 1, the excavation followed the course of existing services, with maximum depth being reached when existing services became visible. The trench was dug into re-instated ground, which appeared to consist of 0.69m of mixed layers containing red building sand, pinkish grey roadstone, lenses of asphalt, and silted sand and gravel; these were all sealed by a 0.06m thick layer of concrete paving slabs (Fig. 3). No evidence of archaeological deposits or human remains was recorded.

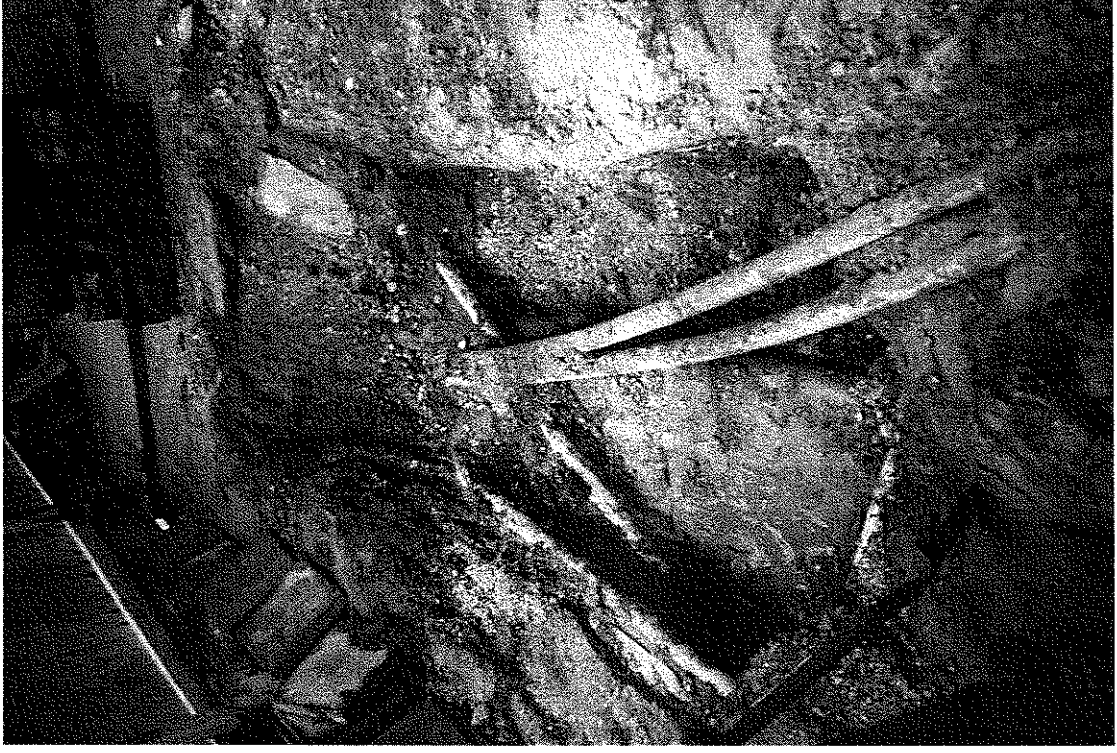
Plate 2

This trench constituted a pit measuring approximately 6.1m by 2.4m and was dug to a depth of 1.3m, where existing services became visible. The pit was dug into re-instated ground which appeared to consist of 1.24m of mixed layers containing red building sand and gravel, concrete, clean red building sand, mixed brown earth and pebbles, and orange brown sand and pebbles; these were all sealed by a 0.06m thick layer of concrete paving slabs. No evidence of archaeological deposits or human remains was recorded.

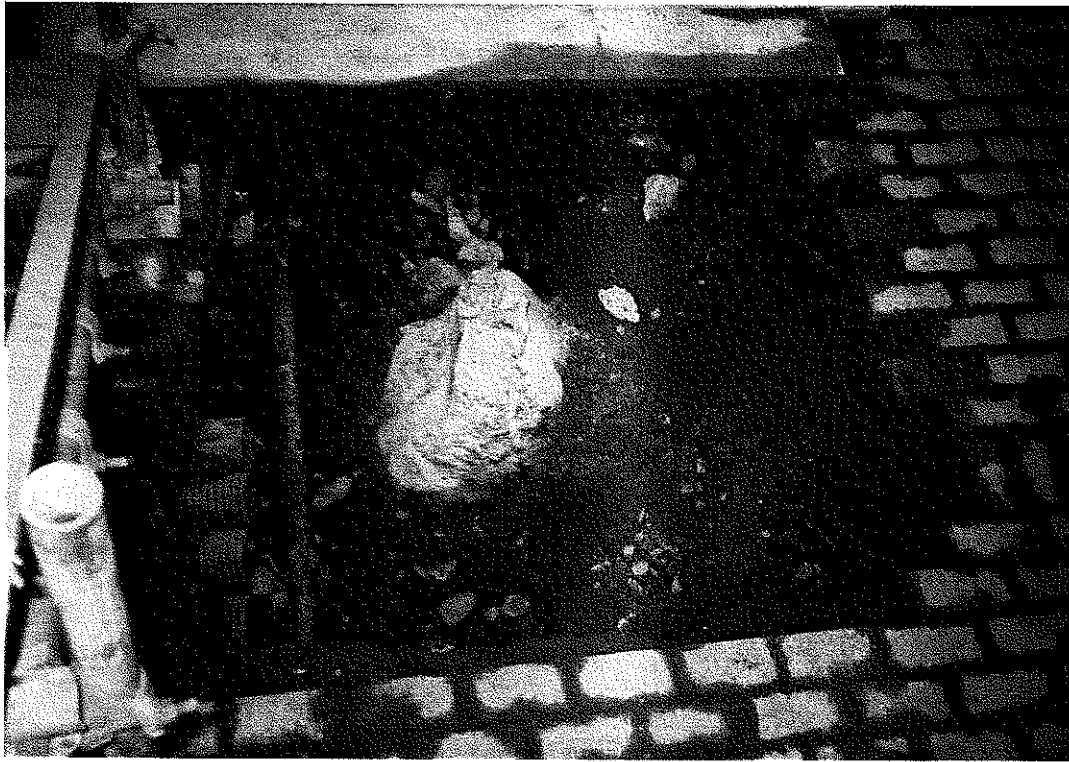
Plate 3

This trench constituted a pit measuring approximately 1.5m by 3.0m and was dug to a depth of 0.8m, where existing services became visible. The pit was dug into re-instated ground which appeared to consist of 0.74m of mixed layers containing concrete and mixed brown earth with pebbles, sealed by a 0.06m thick layer of concrete paving slabs. No evidence of archaeological deposits or human remains was recorded.
