**Rounds Timber Yard, Castle
Street, Tipton:**

An Archaeological Evaluation

Project No. 1299
December 2005

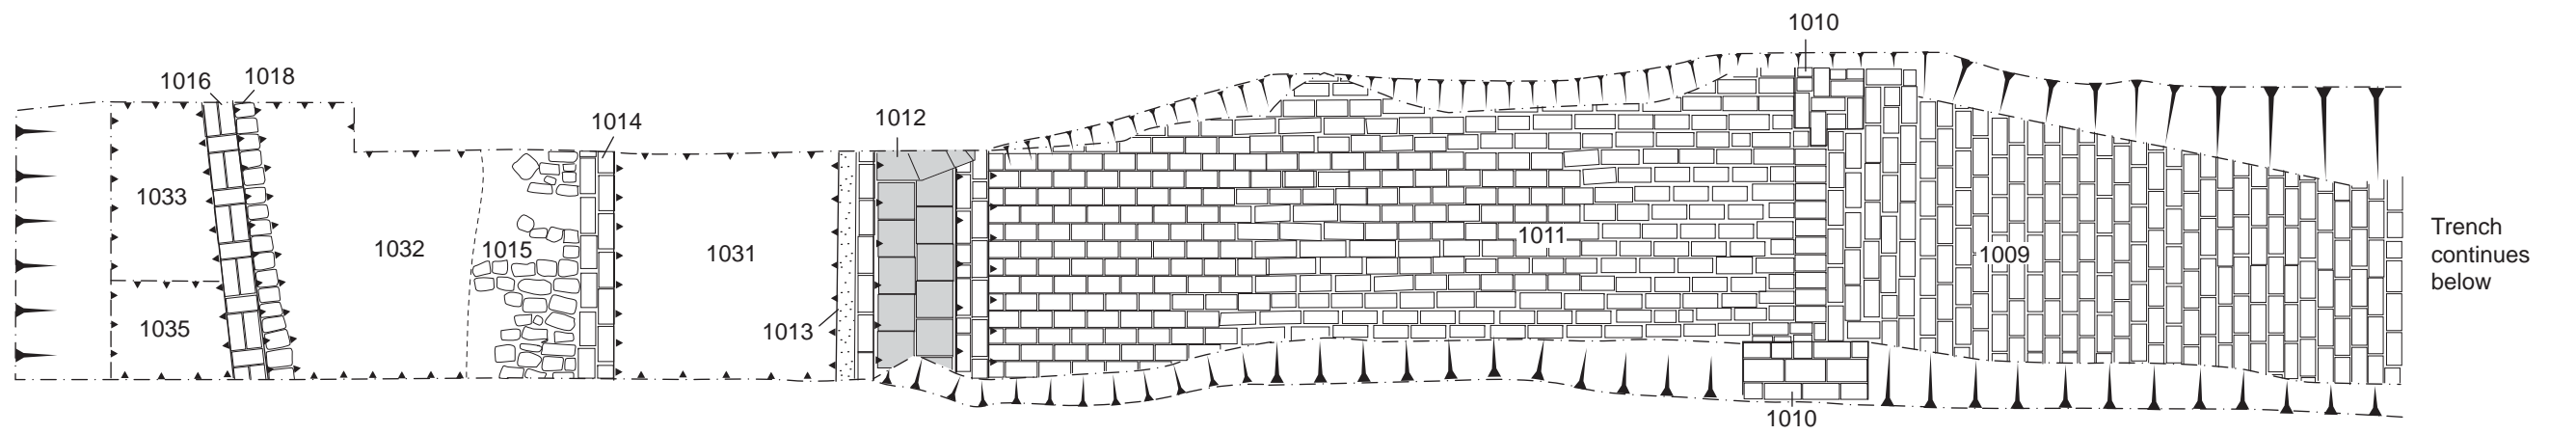
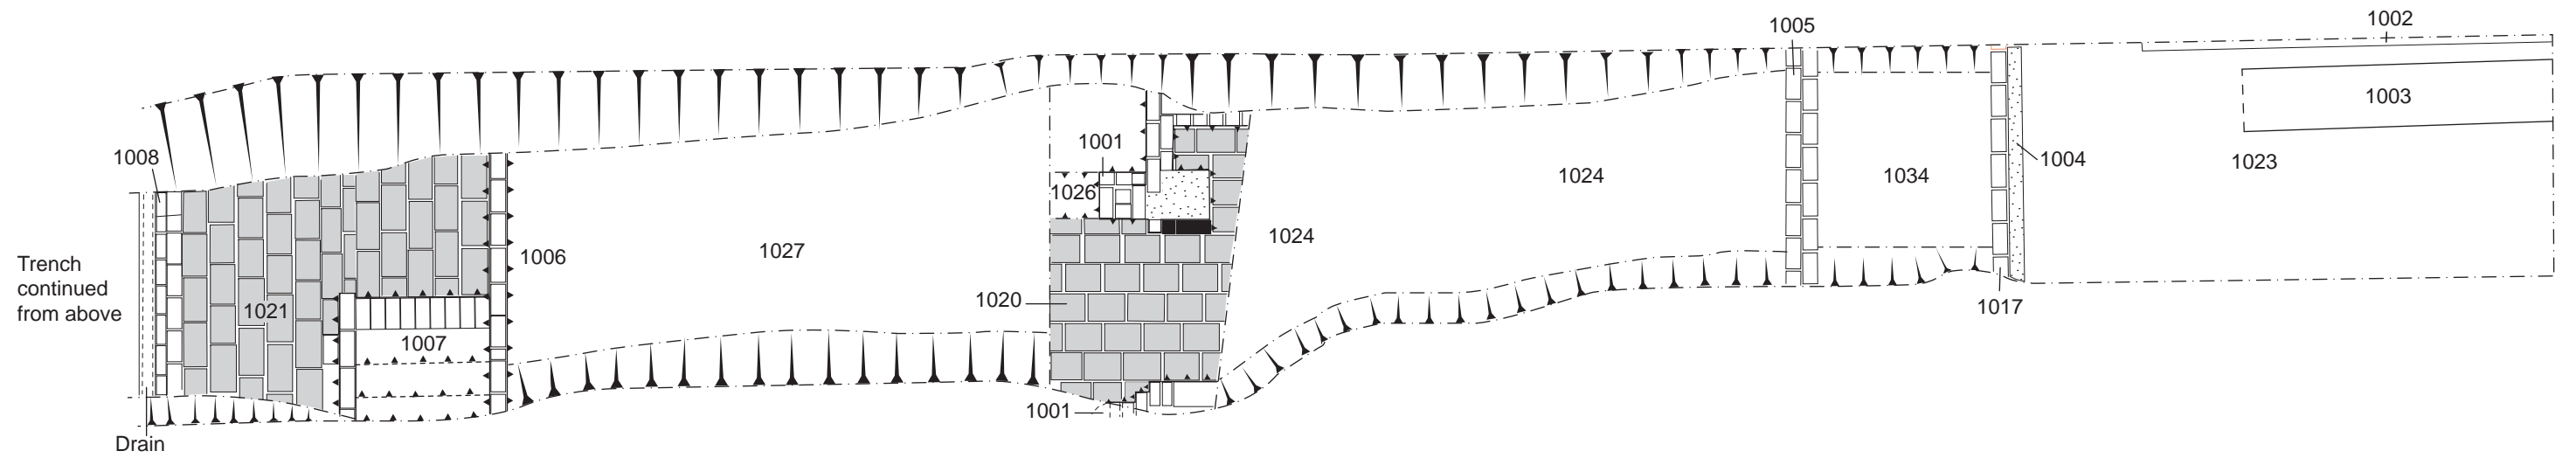
Fig.5

Structural evidence for the early cellar, were two walls (1002 and 1004, Figs. 4 and 5, Plate 2). Wall 1002 was only visible in the south-facing section of the trench. Wall 1004 was a half brick thick and at right angles to 1002. A gap between these two walls probably relates to an entrance to the cellar in its northwest corner. The underside of the ceiling (1003) had been rendered and whitewashed or painted. The cellar had been constructed using hand made clamped-bricks that were thinner than 3" suggestive of a relatively early date.

Immediately outside the terrace (to the west) a deposit of grey clay-silt containing coke, charcoal and brick fragments was identified (1032), with the remains of a cobbled surface set into it (1015, Fig. 5). The garden wall associated with the house with the circular drive depicted on the First Edition Ordnance Survey Map (Fig. 3) was also revealed at this end of the trench (1016/1018). It appeared to have been constructed in two phases, although this may equally have represented repairs. A garden soil had built up against it on the house side of the wall (1033 and 1035). Pottery dating to the late 19th centuries was recovered from both the cobbled surface and the garden soil (Ratkai, pers. comm.). Overlying the whole of the trench was a levelling deposit of crushed brick and mortar (1022) with a surface of Type 1 hardcore (1000).

The cellars were infilled with loose brick rubble (1024, 1025, 1027, 1028, 1029 and 1030 Figs 4 and 5). Deposit 1027 contained large fragments of sandstone that showed some evidence of being worked.

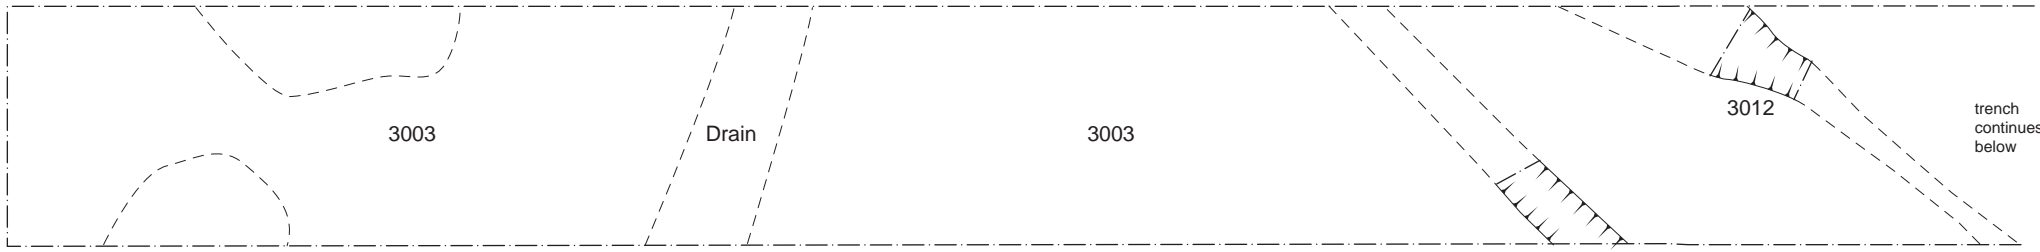
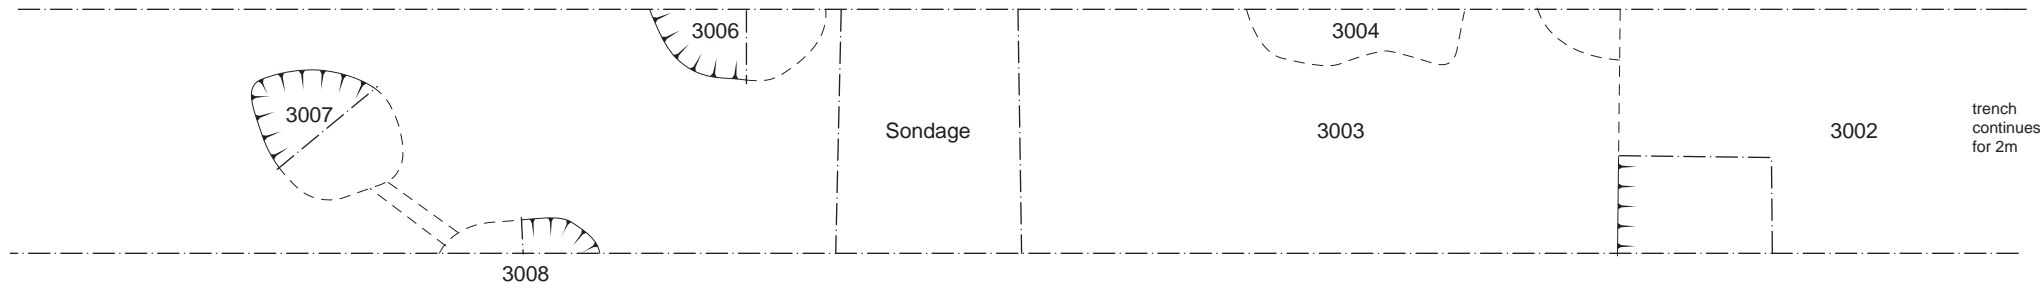
Fig.6

Several features were observed cutting the natural subsoil in Trench 3 (Fig. 6) however, they were ephemeral, and it was unclear as to whether they related to the construction of the canal, the construction of the wharf or were later disturbances (Plates 8 and 9). Overlying these features, was a 0.3m deep layer of dark grey clay silt (3002), containing brick and tile fragments, mortar flecks and 19th century pottery. Sealing this deposit was a modern layer of hardcore.

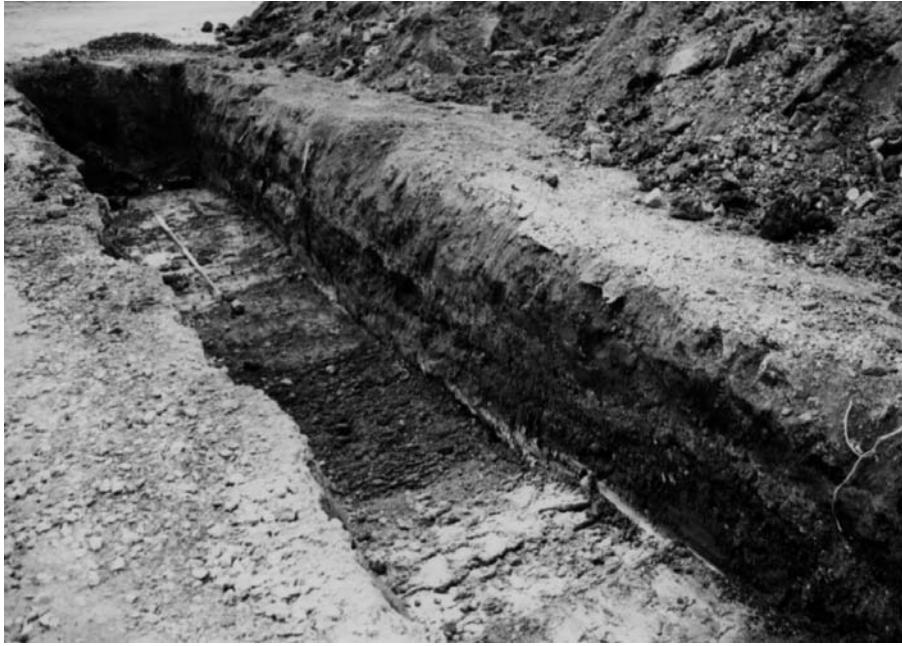
Plate 1

Trench 2 was initially excavated to a depth of 1.2m, then a machine excavated sondage was dug in the centre of the trench. The archaeological deposits were characterised by a 2.3m deep sequence of layers, comprising layers of black silt with coke and ash, crushed brick, redeposited yellow clay subsoil and pink sandy gravel (Plate 1). A similar sequence of deposits was identified in Trench 3.

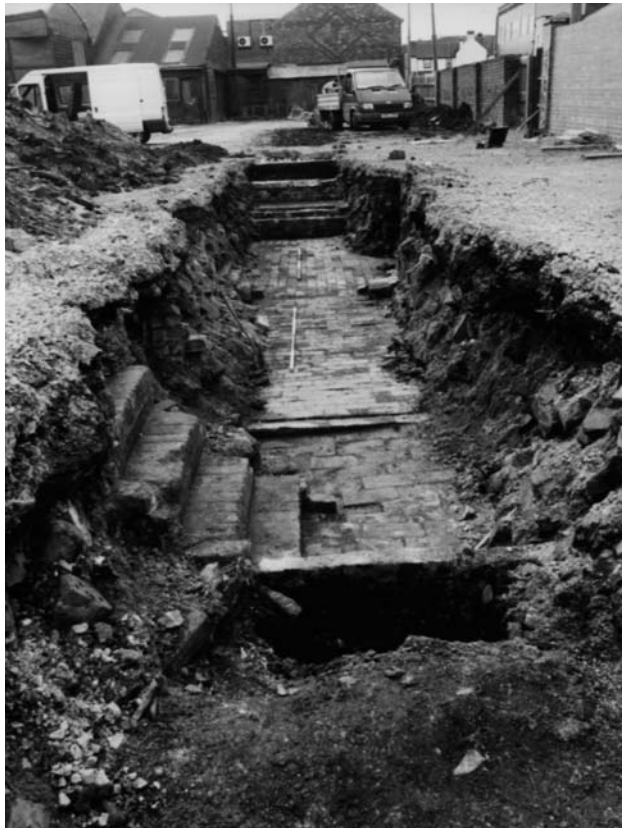
Plate 3

To the west of this cellar, walls and floors associated with cellars belonging to a double terrace were observed. The floor levels of these later cellars were not as deeply sunken as the earlier building. In fact, they were probably semi-sunken, and were therefore similar to those in the remaining standing building on the site. They appeared to be of one phase of construction, and were divided by a half brick thick wall (1006, Fig. 5). However, the floor level in the westernmost terrace was slightly higher than the other (Plate 3), and brick dimensions and mortar varied between walls.

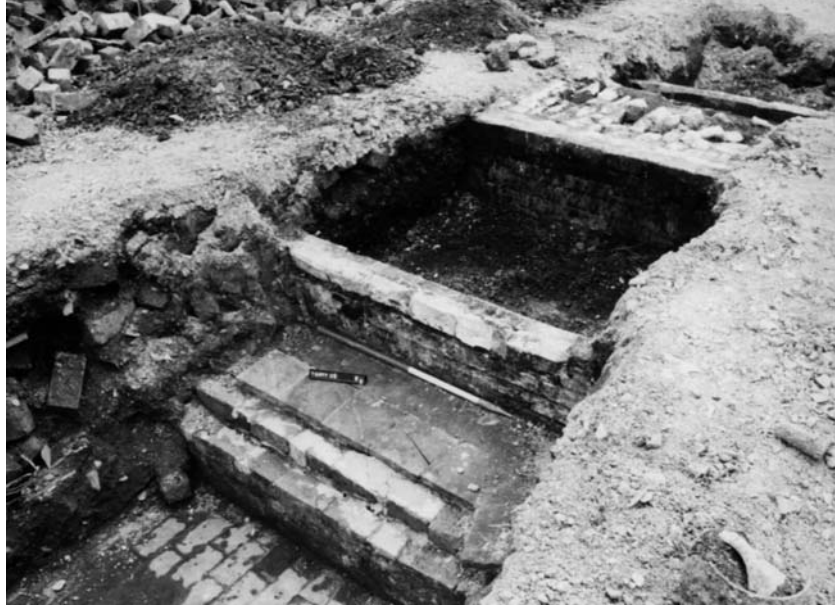
Plate 4

Both cellars were originally accessed by staircases on the outer walls, the remains of which are represented by walls 1005 and 1017, and 1013 and 1014 and the remains of a red quarry tile step (1012, Plate 4). This may also explain why the eastern gable wall was only a half-brick thick at this level. The stairwells had been infilled with a deposit of coke, ash and clinker (1031 and 1034). A second staircase into the western cellar (1007, Plate 5) gave access from the rear of the house, and it is not inconceivable that this was actually from the outside of the property.

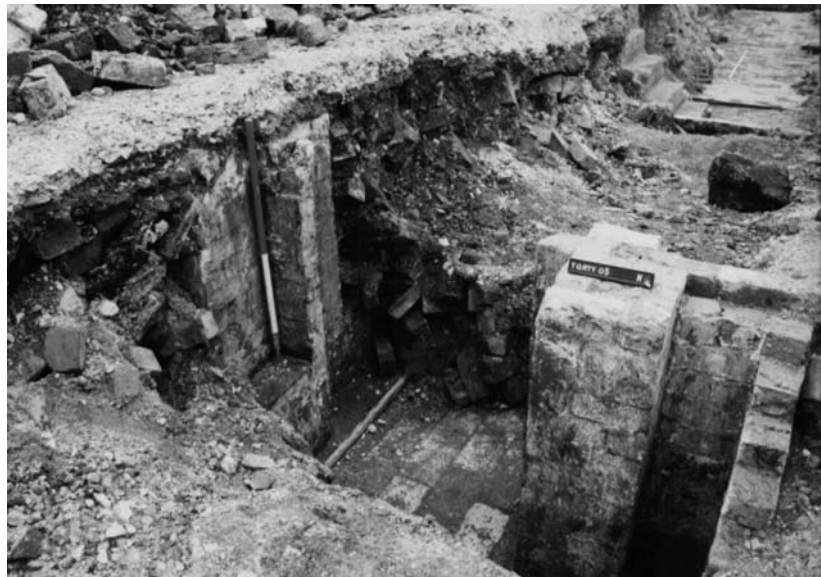
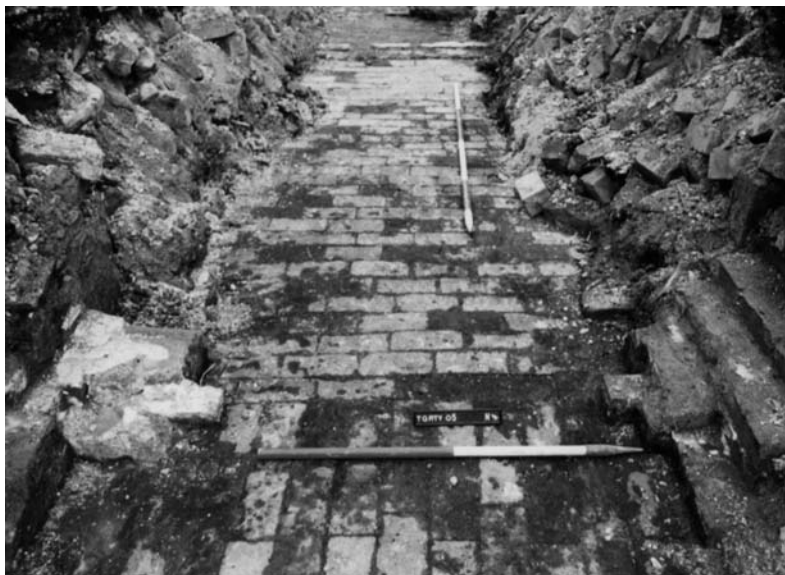
The cellars were divided by a half-brick thick wall (1006), and both had been further sub-divided into smaller rooms by walls 1001, 1008 and 1010. There was also evidence of linking doorways through 1001 and 1010 (Plates 6 and 7). The floor of the easternmost cellar was constructed from brick pavers throughout (1020). The western cellar had several different floor types denoting different rooms; brick pavers (1021) at the bottom of the central staircase, and engineering bricks in the other rooms (1009 and 1011). Floor surface 1009 had a shallow drain running parallel to wall 1008, which was constructed from grey flue tiles.
