**Former site of Rounds  
Timber Yard, High Street,  
Tipton, an archaeological  
Watching Brief 2006-  
2007**

Project No. 1488

Accord Housing Association Ltd

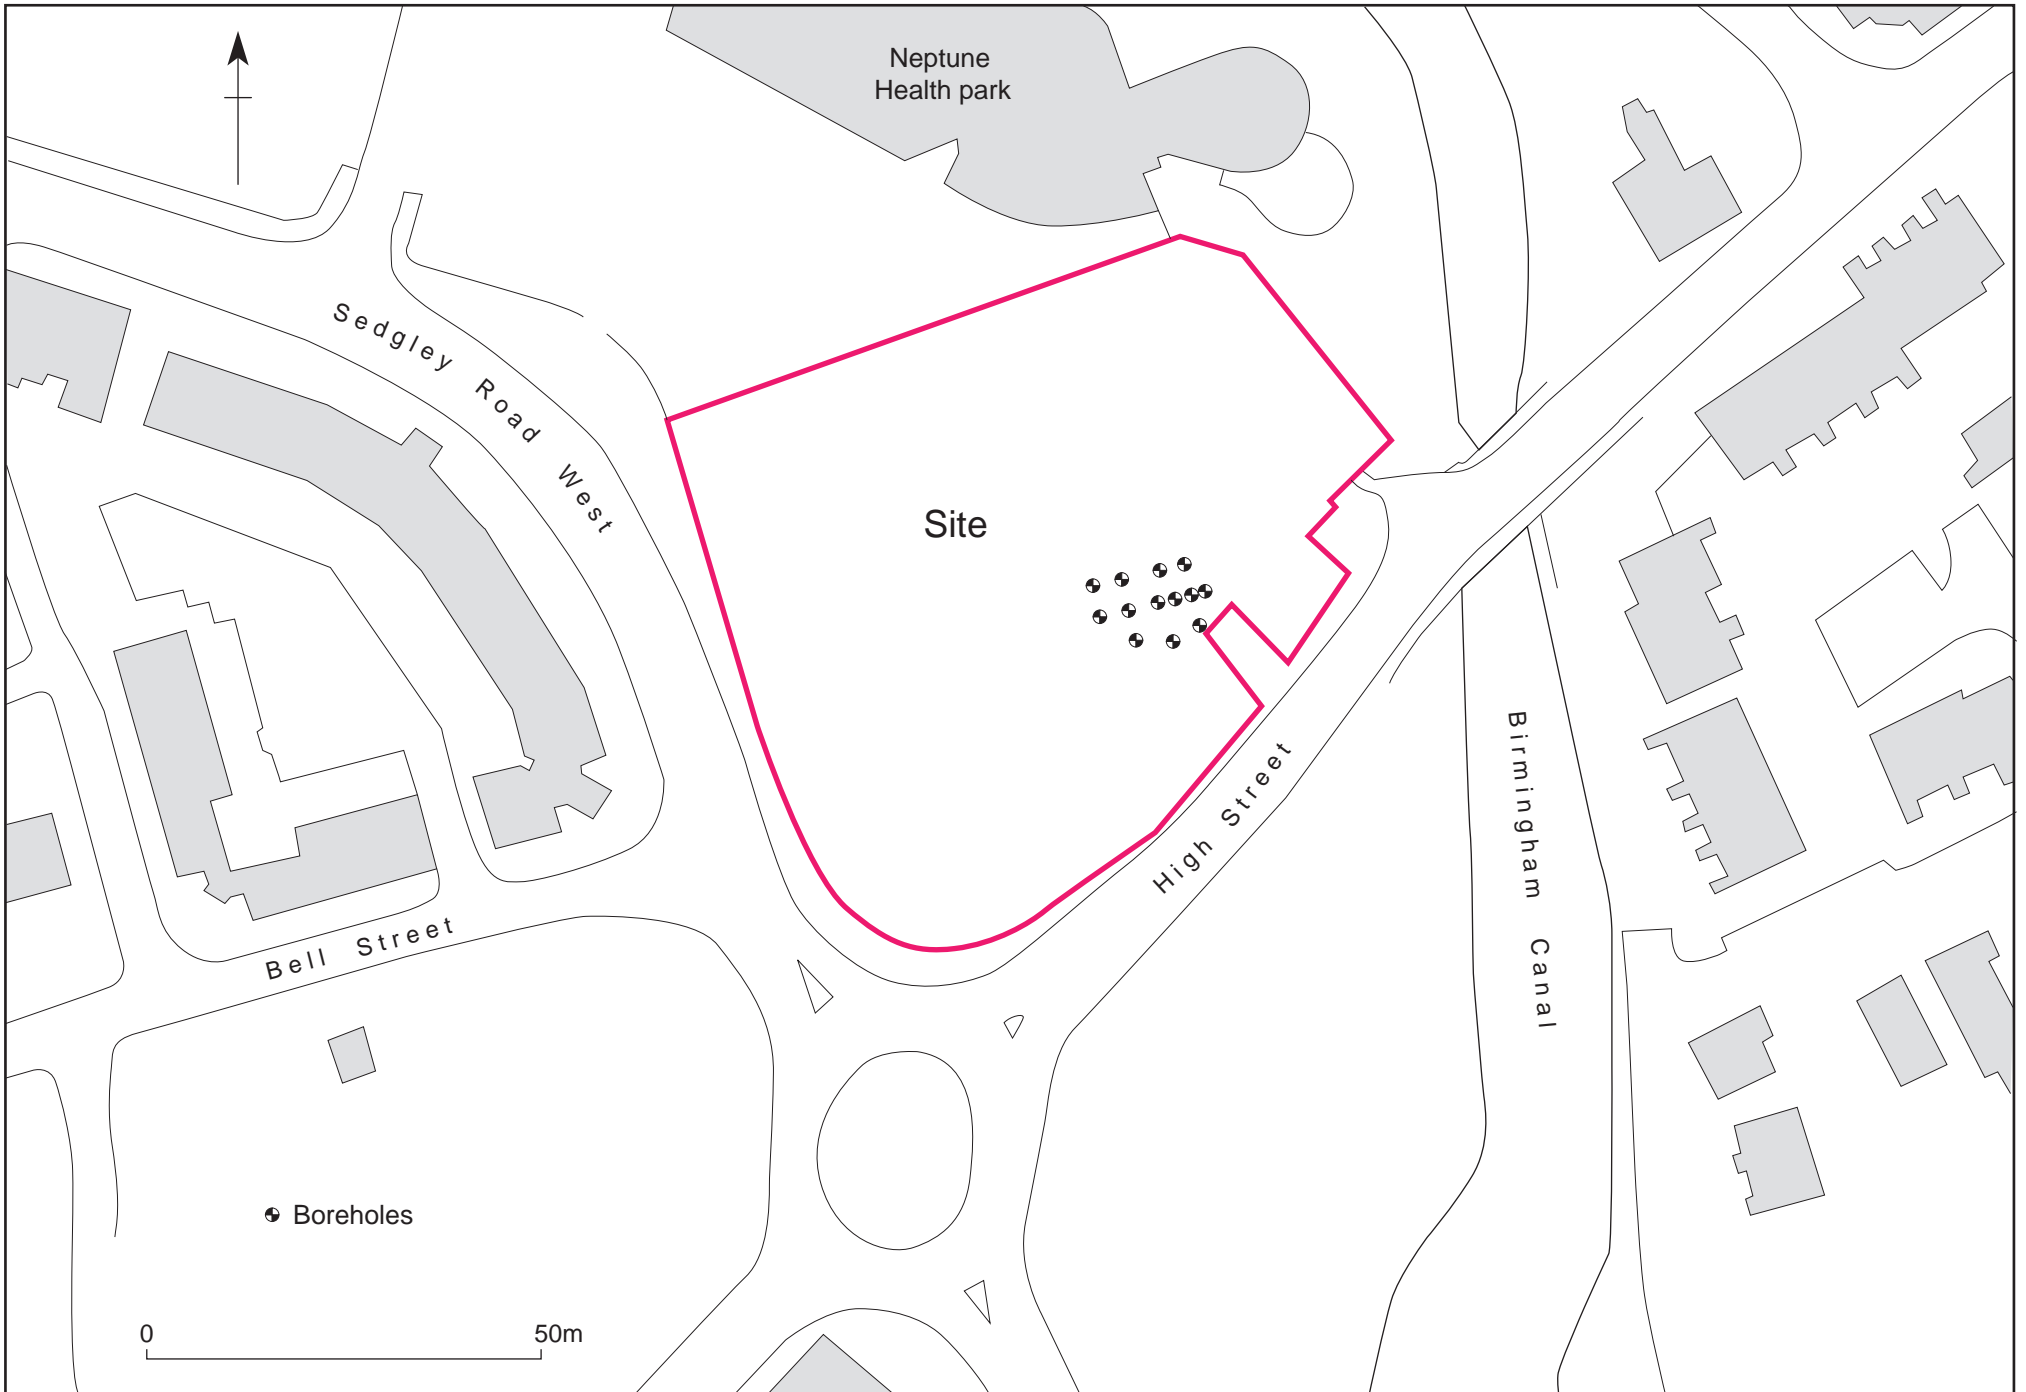
Fig.1

The development area, hereafter referred to as 'the site', is centred on NGR *395265, 292273* (Fig. 1). It is located on land lying at the junction of Sedgley Road West and High Street and bounded to the northwest by Neptune Health Park, (Fig. 2), with the Birmingham Canal lying to the north and east. The site is at a height of 146m above OD, the underlying geology is Carboniferous coal measures (BGS map sheet 167).

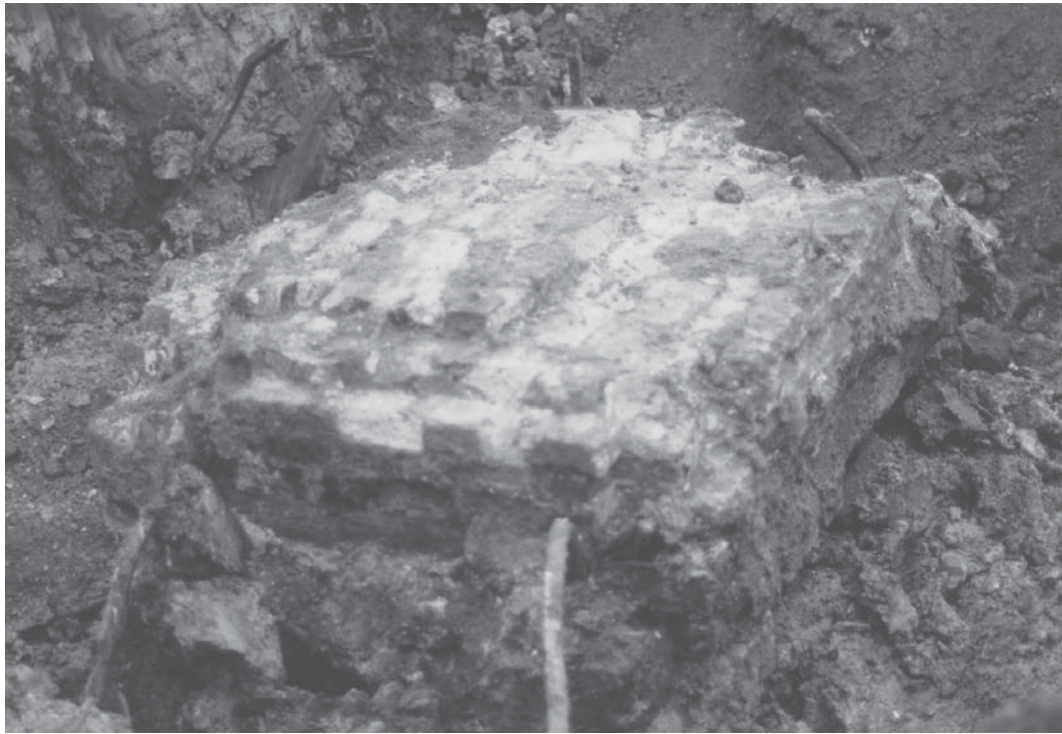
Plate 1

*Plate 1 Brick structure 1052*

In the southwest area of the site, a pair of parallel brick foundations (1052) were recorded. These were 1m apart, 1.50m long by 0.45m thick by 0.80m deep and cut into the natural subsoil 1000. The foundations were underpinned by horizontal wooden sleepers aligned with the masonry. Upright iron rods, 45mm square in cross-section, were secured in holes through the thickness of each sleeper and ran up through the masonry, near each end. These rods extended above the surface of the masonry and the projecting ends were bent at random

angles (Plate 1). It seems possible that this arrangement represented the foundation for heavy machinery. The sleepers may have been intended to counteract the effect of vibration whilst a possible use of the iron rods would be to secure the machinery on the foundations.

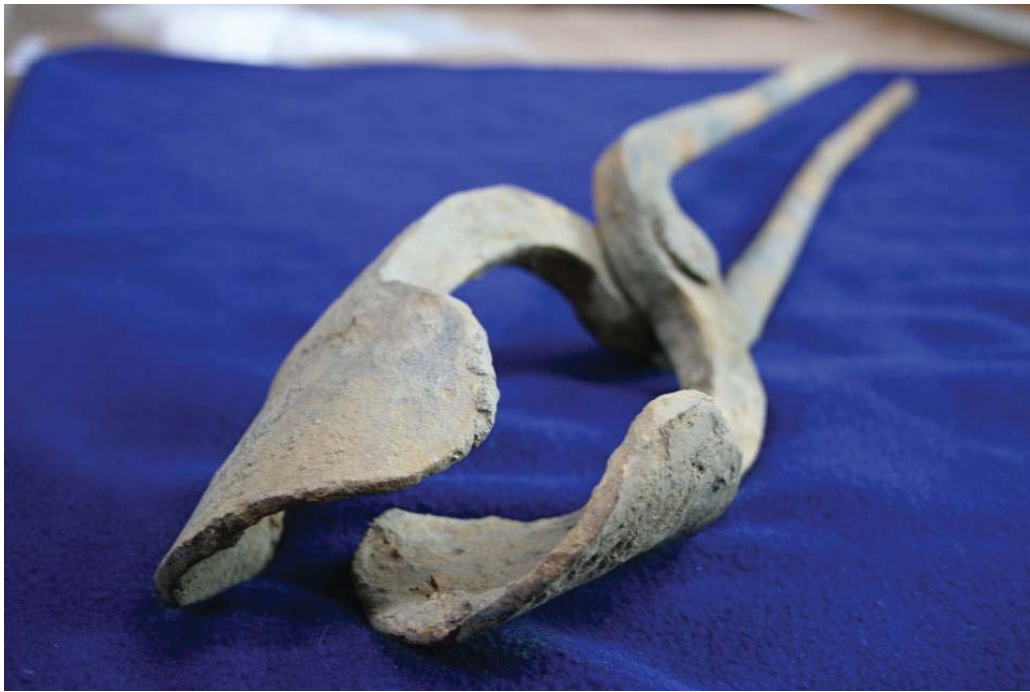
Plate 2

*Plate 2 Forging tongs from layer 2003*

A pair of near-complete forging tongs was also recovered from the site (layer 1023; Plate 2). These tongs, 780mm in length, were very well-preserved, although they had seized around the bolt that joins the two arms of the tongs.

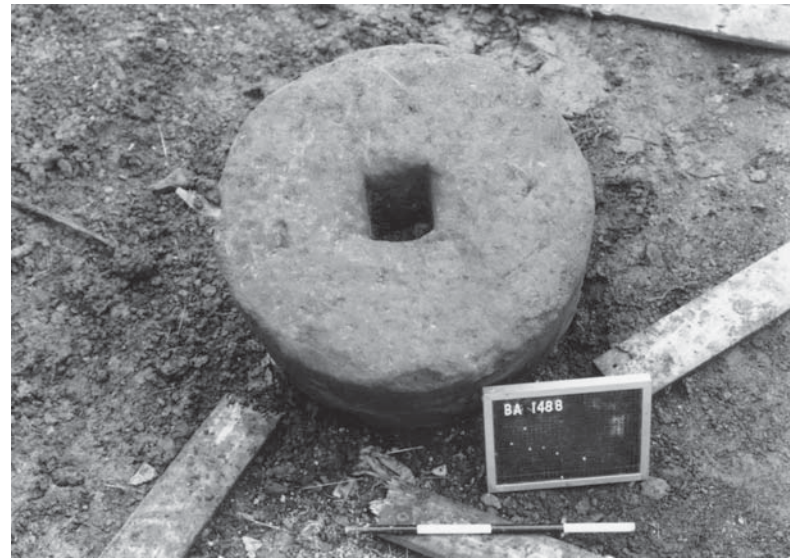
Plate 4

*Plate 4 Cylindrical grind stone No. 1, from above*

Two stone 'cylinders' were recorded on the site, both in secondary contexts. These substantial objects, made of solid stone could only be moved by mechanical excavator and were not, therefore, retained. The stones were wrought from a very hard, reddish stone, possibly Old Red Sandstone. The first smaller cylinder (Plates 3 and 4) measured 0.52m diameter by 0.33m thick and was perforated by a 0.09m, square section hole through its centre. One of the flat faces was hammer or chisel dressed to an even surface. The opposite face was slightly less even and had a single diametric furrow with rather irregular edges, averaging about 50mm wide and 5mm deep. The central perforation was blocked at this face by a domed mass of rusted iron. The circumference of the cylinder was smoothly dressed or else had been smoothed by usage.

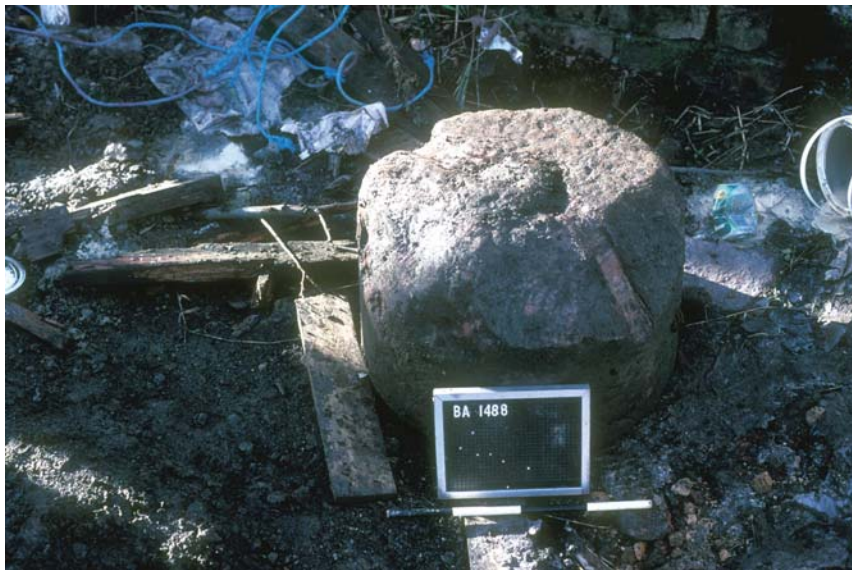
Plate 5

*Plate 5 Cylindrical grind stone No. 2 from the side*

The second, larger, stone cylinder (Plate 5) was similar but 0.59m in diameter and 0.30m thick. Part of it was obscured by a fused mass of clay, coal, and iron that adhered to the sides and one of the flats. These objects may have been grindstones. The central, square sectioned perforations capped with iron on one side suggest attachment to a drive shaft perhaps.

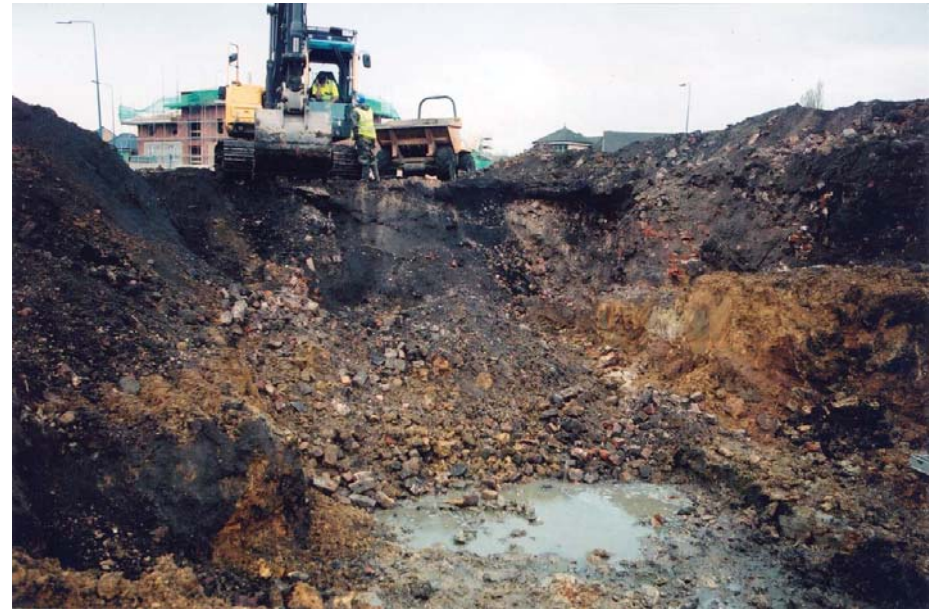
Plate 6

*Plate 6 Showing general industrial overburden 1025, during machining*

Over the majority of the excavated area an accumulation of industrial refuse (1025) 0.30m-1.90m thick was recorded sealing the industrial features (Plate 6). This consisted mainly of sandy silt with coal dust, ash and demolition rubble of brick and lime mortar. In most of the recording a single context number was used to describe all of these deposits though it was clear that they had accumulated over a period of time during the later 19th century and the first half of the 20<sup>th</sup> century, and were not the result of a single depositional event. Much of the detritus included in the overburden 1025 appeared to have been the result of iron working activity, including fused masses of sand, burnt clay, coal dust and iron, along with artefacts seemingly related to iron working (Macey-Bracken below).

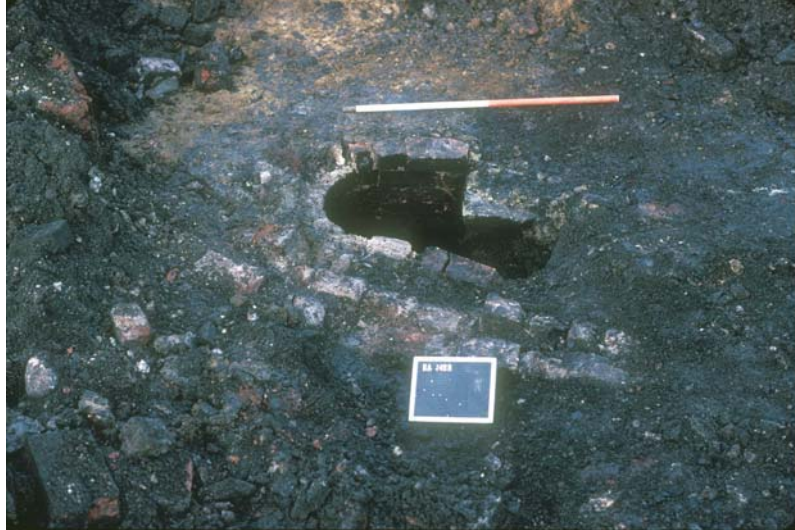
Plate 7

*Plate 7 Showing D-shaped brick shaft looking northwest*

A water- filled, brick lined shaft 1008 was located c. 17m east of the group of industrial features associated with large structural wooden sleepers (1041 and 1052). The shaft was set in a circular construction trench filled with re-deposited light grey clay. The structure was D-shaped in plan (Plate 7) and measured internally 0.51m by 0.49m. The curved side was of a single thickness of stretcher-laid bricks bonded with lime mortar. The straight side was defined by a log of 0.15m diameter, set horizontally across the ends of the brickwork and a partly overlain by a stone slab.

The level of water in the shaft was 0.63m below the present surface of the masonry. Probing below the surface of the water with a rod indicated a depth of at least 2m; the rod hit solid material at that level. The straight side beneath the split log was also probed and appeared to be of material that was harder than wood. As found, the top surfaces of all of the bricks bore traces of lime mortar. This indicates that further courses existed originally, above the level at which the feature was recorded. A short stretch of a brick wall (1068) aligned northeast-southwest was recorded adjacent to the feature (Plate 7).

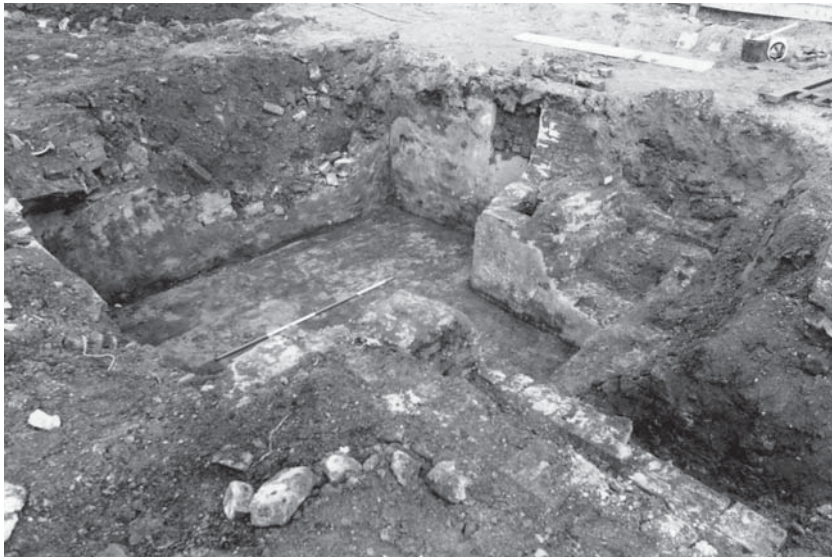
Plate 8

*Plate 8 Showing Cellar 1024 looking north*

The best preserved structure on the site was a cellar 1024, lying approximately 5m from the middle of the northeast boundary (Figs. 9 and 10; Plate 8). The masonry was of red brick bonded with coal-flecked lime mortar. The building consisted of a brick floored room (1003) measuring internally 4.35m by 3.55m, with a much smaller, seemingly contemporary vault (1004) projecting from the southwest corner. The latter structure was backfilled with redeposited clay (1006) and a single sherd of pot was recovered from this (see below).

There was sufficient survival of masonry above the springing, on either side of cellar 1024 to indicate that it took the form of a barrel vault. There was a wide opening, presumably the entrance, in the middle of the southwest wall of the larger chamber. Near the middle of the opposite wall was a small (0.52m wide) opening with its sill at 1.03m above the original brick floor. The cellar was modified by the addition of an internal abutting structure (1005) in the southeast corner. This structure was made up of red brick bonded with lime mortar and must have been added not long after the completion of the original structure. Further modification consisted of the blocking of the opening in the southwest wall and of the opening into the smaller room. Thereafter the internal wall faces (including the blocking masonry), and the brick floor were plastered over with a coat of cement. At a still later stage the narrow opening in the northeast wall was blocked with dry-laid brickwork. The structures were backfilled with rubble.
