HALESOWEN ABBEY,  
HALESOWEN, DUDLEY.  
ARCHAEOLOGICAL  
EVALUATION,

2007

**Project No. 1695**

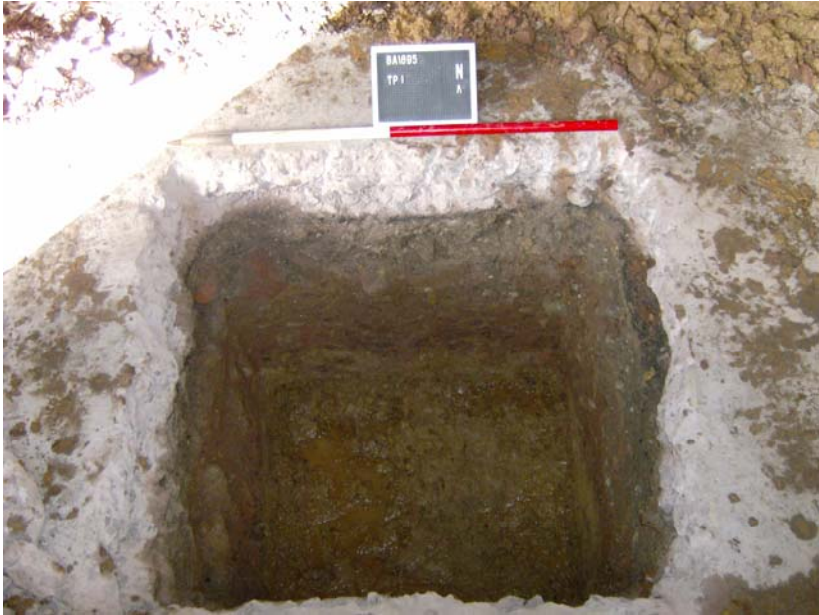
Plate 1

Test pit 1 (Figs. 2, 3 and 4, and Plate 1) measured 1m<sup>2</sup>, and was excavated within the north range of the eastern barn complex, to a depth of 0.84m below the modern ground surface (128.05m AOD). At this depth natural clay **1007** was encountered, sealed by 0.22m of brown sandy-clay (**1006**), that was in turn overlain by 0.40m of clay (**1003**). The western side of **1003** contained large amounts of sandstone rubble. **1003** was sealed by 0.12m of brown silt **1002** that in turn was overlain by 0.03m of **1001**, consisting of black coal, clinker and slag. This probably acted as a bedding layer for the concrete which at present constitutes the barn floor (**1000**).

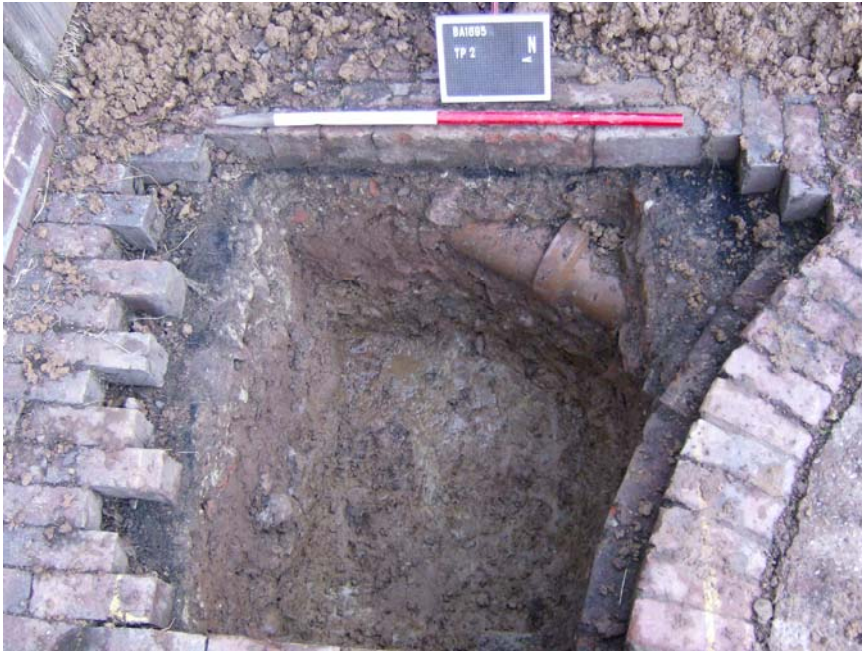
Plate 2

Test pit 2 (Figs. 2, 3 and 4, and Plate 2) was in the northwest corner of the courtyard of the eastern barn complex and was located at the proposed site of a manhole. This test pit was 1m<sup>2</sup> in plan and was excavated to a maximum depth of 0.76m below the modern ground level (128.07m AOD).

Natural subsoil **2005**, which consisted of grey sandy-clay with pebbles throughout, was identified at the base of the test pit. Above this was a layer of soft beige silt-rich clay with pebbles (**2004**). This was sealed by **2003**, a layer of brown sandy-clay 0.25m deep. Above this was a layer 0.16m deep (**2002**), consisting of brown sandy-silt rich in rubble, especially roof tile and mortar, or plaster. In turn **2002** was overlain by 0.05m of industrial waste and charcoal (**2001**) which seemed to form a bedding layer for the brick built floor surface (**2000**) (the current yard surface). In the southeast corner of the test pit was a ceramic drain 0.18m in diameter. The cut for this was not visible in the section so it is difficult to fit this into the stratigraphy of the trench.

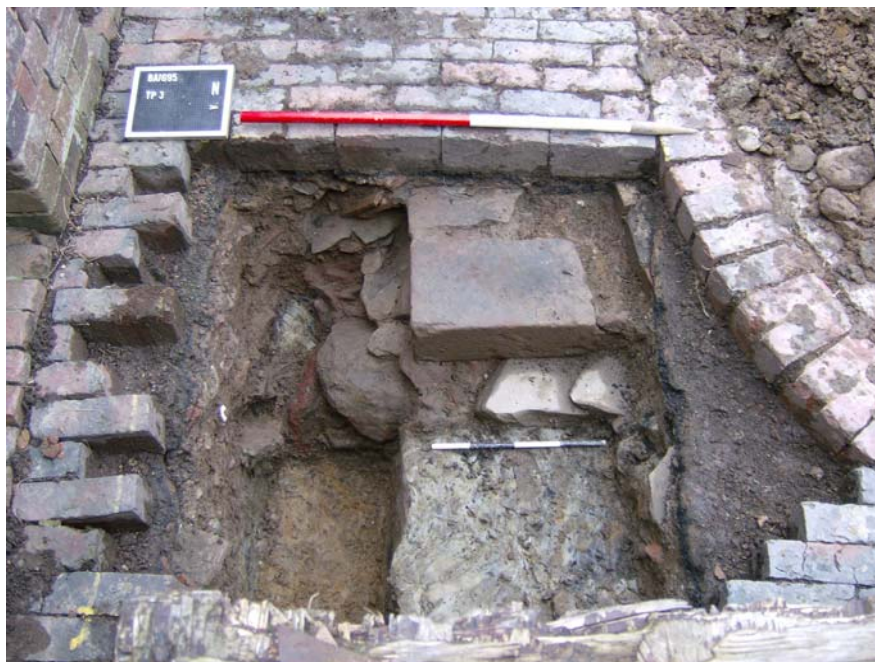
Plate 3

Test pit 3 was located in the southeast corner of the courtyard of the eastern barn complex (Figs. 2, 3, 4, and Plate 3). This was the proposed location of manhole 2. This test pit was 1m<sup>2</sup>

in plan and was excavated to a maximum depth of 0.72m below the modern ground surface (128.09m AOD), at which depth the natural subsoil (**3008**) was encountered. This appeared to be dipping downwards towards the southwest of the test pit. Above this was a deposit of soft grey clay (**3007**) 0.18m thick. Sealing this in turn was a layer of compact blue-grey clay 0.2m thick (**3004**). This deposit contained quite large quantities of charcoal.

3004 was cut by a foundation trench (**3006**) which was about 0.4m deep, and was filled by a mixture of sandstone rubble and broken tile set in sandy-silt (**3005**) with the remains of a single course of masonry set on this. Although within the narrow confines of this test pit the dimensions of this wall could not be ascertained, it is most probable that this is the south-eastern corner of a structure. Overlying this was a layer of sandy-silt rich in demolition rubble (**3003**), from which medieval pottery and tile were retrieved dating to the 16th century.

**3003** was capped by a narrow band of black coal and slag which was 0.04m deep (**3002**). This was in turn overlain by a narrow band of beige silt and clay 0.01m deep (**3001**). These contexts probably constitute the bedding material for the brick floor surface (**3000**).

Some of the archaeological deposits can be related to the monastery buildings as they are understood as illustrated in Fig. 3. The corner of a foundation wall encountered within Test Pit 3 (**3006**, Fig. 4, Plate 3) aligns with the conjectured location of the south-eastern corner of the chapter house. In all likelihood this deposit is an *in situ* monastic remain. The uppermost level of this deposit survived 0.16m below the modern ground surface, directly below the make-up layer of the floor surface. This suggests the potential for the preservation of archaeological deposits associated with the standing buildings close to the surface in this area of the site. It also seems likely that the structural remains identified in Test Pit 4 represent the south wall of the north cloister alley (**4008**) with perhaps one of its external buttresses (**4009**). It may be that the sandstone blocks identified in the base of Test Pit 7 (**7004**) may represent the east wall of the west cloister alley.

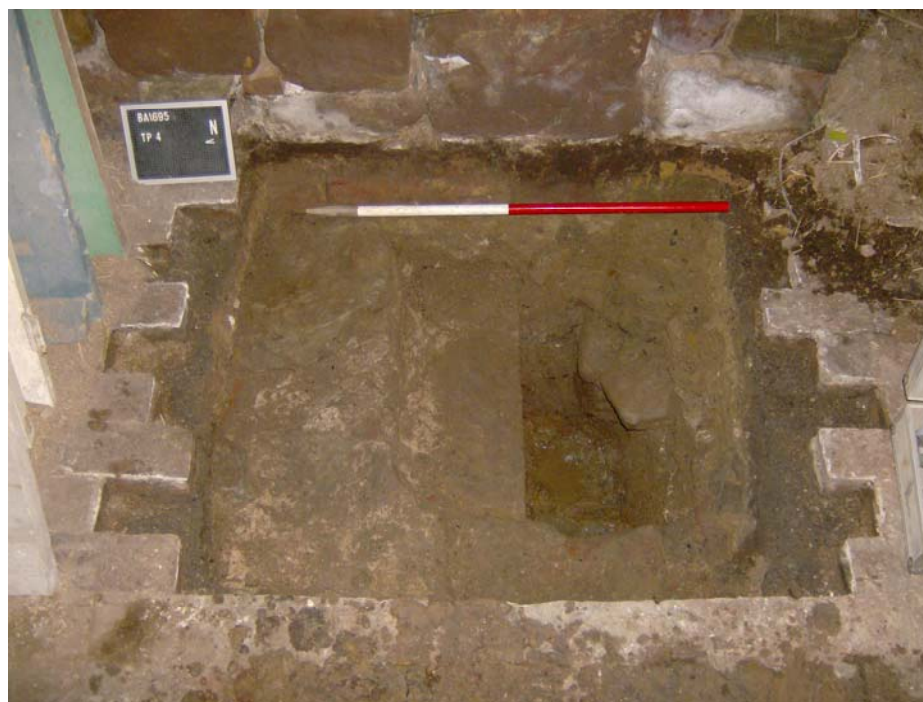
Plate 4

Test Pit 4 (Figs. 2, 3, 5, and Plate 4), was located within the north range of the western barn complex. The test pit was 1m<sup>2</sup> in plan and was excavated to maximum depth of 1m below the modern ground surface (127.07m AOD).

Natural subsoil (**4007**), comprising of compact grey clay, was identified at the base of the trench. Over this was a layer of orange sandy-gravel 0.1m deep (**4006**). This was sealed by 0.24m of brown sandy-silt **4005**.

It is probable that the foundations of walls **4008** and **4009** are cut through **4005**. However as these walls were left *in situ* it was impossible to determine the relationship between **4005** and the structure. **4008** was aligned north-south and although the full extent could not be ascertained within the confines of the test pit, it was at least 0.5m long, 0.33m wide and 0.5m high. It was constructed from large pink sandstone ashlar blocks of which two courses survived. No mortar was visible. Butting this wall to the east, on an east-west alignment, was wall **4009**. Constructed in a similar manner to **4008**, this was at least 0.66m long, 0.2m wide and 0.48m high. Again the nature of the footing and the stratigraphic relationship were not evident, however, two courses of pink sandstone ashlar blocks were present. To the north of this wall it is probable that the rubble core (**4010**) had been mortared in place, although the full nature of the wall could not be ascertained.

It is probable that layer **4004** post-dates the walls. This was a narrow deposit of crushed mortar or plaster in a silt matrix 0.04m deep. Sealing this and the walls was layer **4003**, which consisted of sandstone and tile demolition material set in beige sandy-silt that contained late 17th to early 18th century pottery. This had a maximum depth of 0.4m. This deposit had been cut by the foundation trench (**4001**) for the internal dividing wall within the existing barn. This wall seemed to be constructed by a primary fill of lime mortar and silt (**4011**) onto which large sandstone blocks (**4000**) had been placed. The area of the test pit was sealed by a layer (**4012**) consisting of black coal and slag which seemed to form a bedding for a brick floor (**4002**) which at present constitutes the internal floor of the barn.

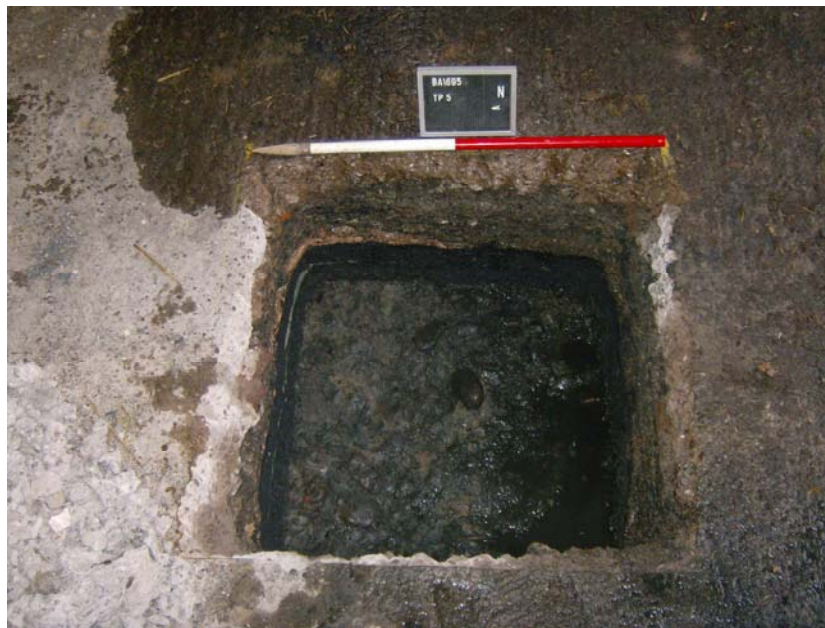
Plate 5

Test Pit 5 (Figs. 2, 3, 5, and Plate 5), was located within the northeast corner of the courtyard of the western barn complex; in the proposed location of manhole 3. The top of the natural

subsoil (**5005**), which consisted of brown sandy-clay and was encountered 1m below the modern ground surface (126.66m AOD). Sealing this was 0.38m of beige sandy-silt (**5004**) with pieces of sandstone throughout that, in turn, was overlain by cobble floor surface (**5003**) constructed of rounded pebbles compacted into a clay matrix, which has in places been stabilised with broken roof tile. This deposit had a maximum depth of 0.1m. Sealing this was a layer of black crushed coal (**5002**) with a maximum depth of 0.2m, very compact and probably representing a surface construction.

Sealing this was layer **5001** a dark grey deposit of coal, silt and charcoal, with crushed brick or tile and mortar dating to the late 18<sup>th</sup> - early 19<sup>th</sup> centuries. Sealing this was a layer of concrete 0.14m deep that made the present yard surface (**5000**).

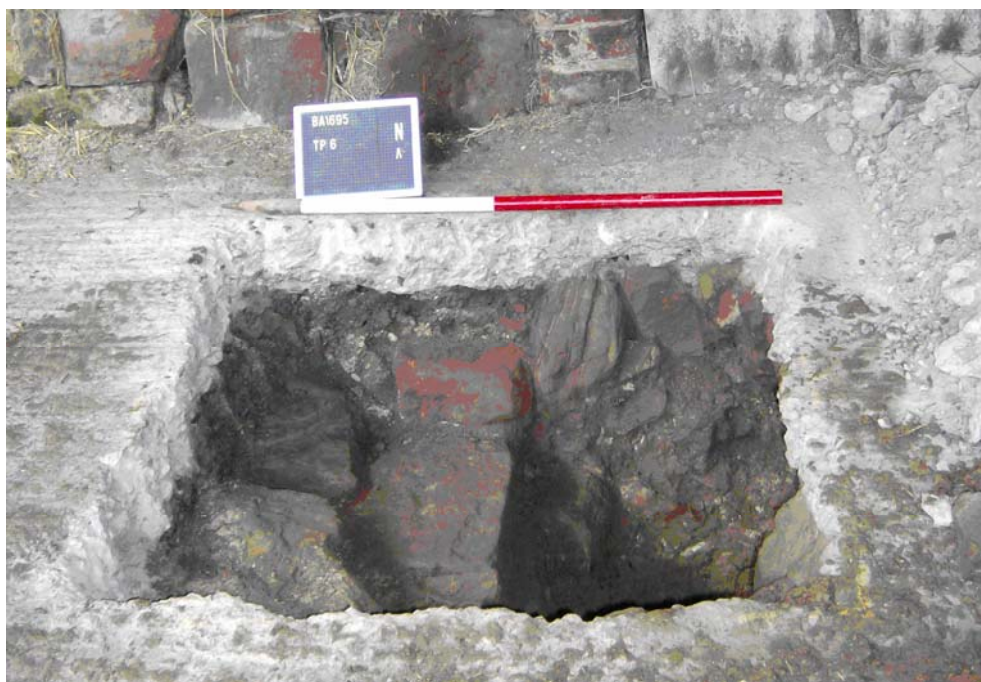
Plate 6

Test Pit 6 (Figs. 2, 3, 6, and Plate 6) was located in the northwest corner of the courtyard of the western barn complex. The test pit was 1m<sup>2</sup> in plan and was excavated to a depth of 0.9m below the modern ground surface (127.06m AOD). The earliest deposit encountered at the base of the pit was the natural sub-soil **6009**, consisting of grey sandy-clay with gravel throughout. Sealing this was **6008**, a layer of beige sandy-clay 0.22m deep. This was overlain by a layer of brown silt rich clay with bits plaster or mortar throughout (**6007**). This had a maximum depth of 0.46m.

**6007** was cut by a foundation trench (**6005**). This was 0.46m deep and at least 0.6m wide. The foundation was constructed from large sandstone blocks with some sign of mortaring (**6002**), set into the foundation trench by silt and clay (**6004**). This foundation was overlaid by a 0.2m layer (**6003**) of demolition rubble set in silt containing 17th to 18th century pottery that, in turn was overlain by layer (**6001**) consisting of a charcoal rich silt and clay. This had a maximum depth of 0.12m and was only present in the northwest corner of the trench. Finally, the area of the trench was sealed by the concrete floor surface of the yard. (**6000**).

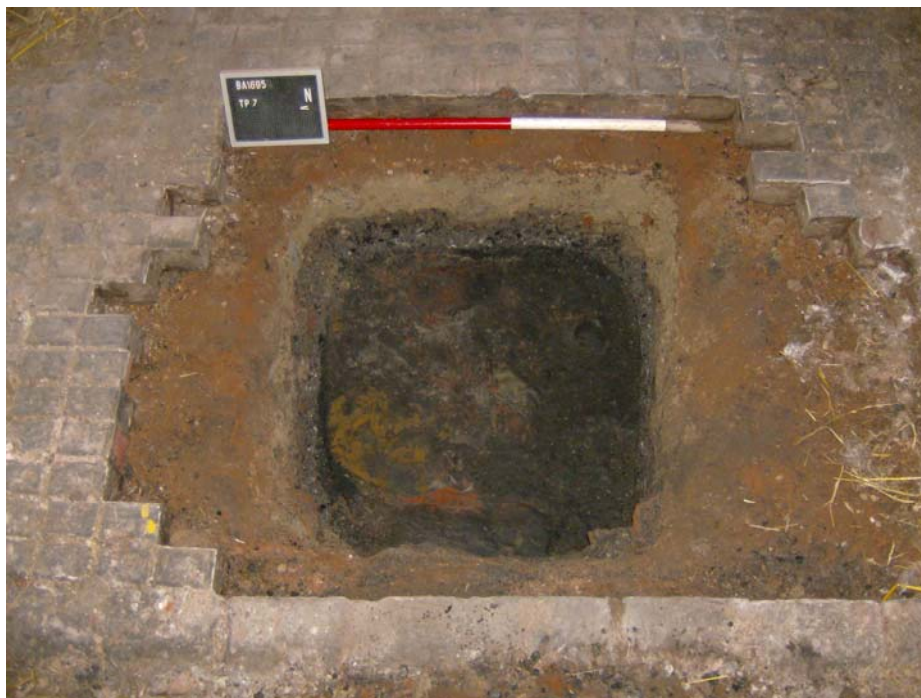
Plate 7

Test Pit 7 (Figs. 2, 3, 6, and Plate 7) was located within the western range of the western barn complex, was 1m<sup>2</sup> in plan, and was excavated to a maximum depth of 0.58m below the modern ground surface (127.34m AOD).

The earliest deposit encountered consisted of large sandstone blocks (**7004**) that had been heavily heat affected. Above this on the southern half of the trench was a deposit of slag (**7006**) 0.04m deep. This was extremely hard, suggesting the possibility that this could be an *in situ* deposit. Above this was a layer (**7003**) of loose charcoal and ash-rich industrial waste that had a depth of 0.2m. Sealing this was a layer of sandstone rubble compacted with sand and silt (**7002**) which had a maximum depth of 0.15m. Some roof tile was retrieved from this feature. Above this was a layer of orange silt and sand (**7001**) that was 0.1m deep. This layer seemed to be the bedding layer for the brick built floor surface (**7000**) that (at the time of excavation) made the barn floor surface. No datable finds were recovered from this test pit.

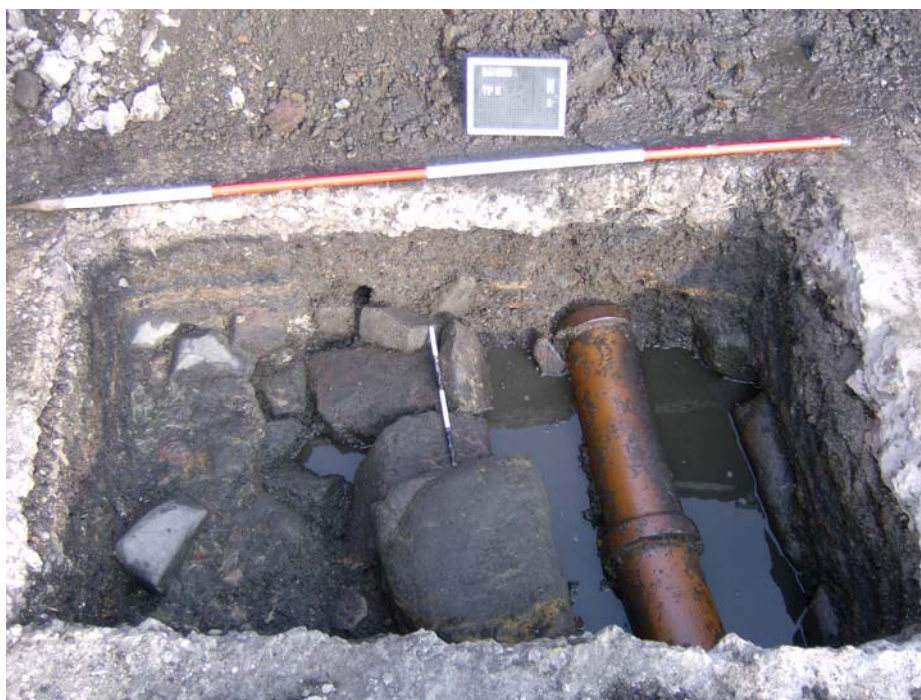
Plate 8

Test Pit 8 (Figs. 2, 3, 6, and Plate 8) was located in the southwest corner of the western barn complex. Although originally 1m<sup>2</sup> in plan, this trench was extended to the east to further understand the deposits encountered. Altogether this trench was 1m wide and 1.8m long, and excavated to a depth of 0.65m below the modern surface (127.16m AOD). Due to the very wet conditions of the excavation, and the immovable nature of the deposits, the archaeology was

not fully defined. The trench was aligned northeast-southwest, respecting the alignment of the western wing of the western barn complex, which is the only part of the farm complex not to be aligned with abbey.

Probably the earliest deposit encountered was a large stone wall at the western side of the test pit. This wall (**8008**) seemed to be aligned northwest-southeast, parallel to the later barn structures. It consisted of large sandstone facing blocks (**8012**) although later activity seemed to have nudged these out of alignment. The wall seemed to have a rubble core held together with lime mortar, present at the south-western extent of the trench. Similarly at the north-eastern extent of the trench the edge of a further structure, made of large, possibly dressed, sandstone blocks was evident (**8013**).

Sealing these structures were a series of layers, the earliest of which was **8007**, a deposit of grey silt, rich in industrial waste. This was 0.02-0.06m deep and filled some of the cracks between the stonework. Sealing this was a 0.04m deep layer (**8006**) of beige silt, again rich in industrial waste. Above this was **8005**, a layer of black industrial waste with coal and slag, 0.4m deep. In turn this was overlain by 0.05m of layer (**8004**) consisting of brown silt, again rich in industrial waste. This was sealed by 0.1m of grey silt **8014** that contained mixed coal and slag throughout.

These layers had been cut by a pipe trench (**8003**). This seemed to be 'v' shaped in plan, with probably an original pipe trench located over the facing blocks (**8012**) of wall **8008**, and then being moved to the northeast of this feature, presumably to avoid having to excavate the wall. A ceramic pipe was located in the north-eastern cut. This had been broken, and as a consequence was flooding the trench. The pipe trench had been backfilled by a mix of silt and industrial material (**8002**). Sealing this was a layer of rubble hardcore (**8001**) 0.1m deep, which acted as a levelling layer for the concrete floor surface of the farmyard (**8000**).

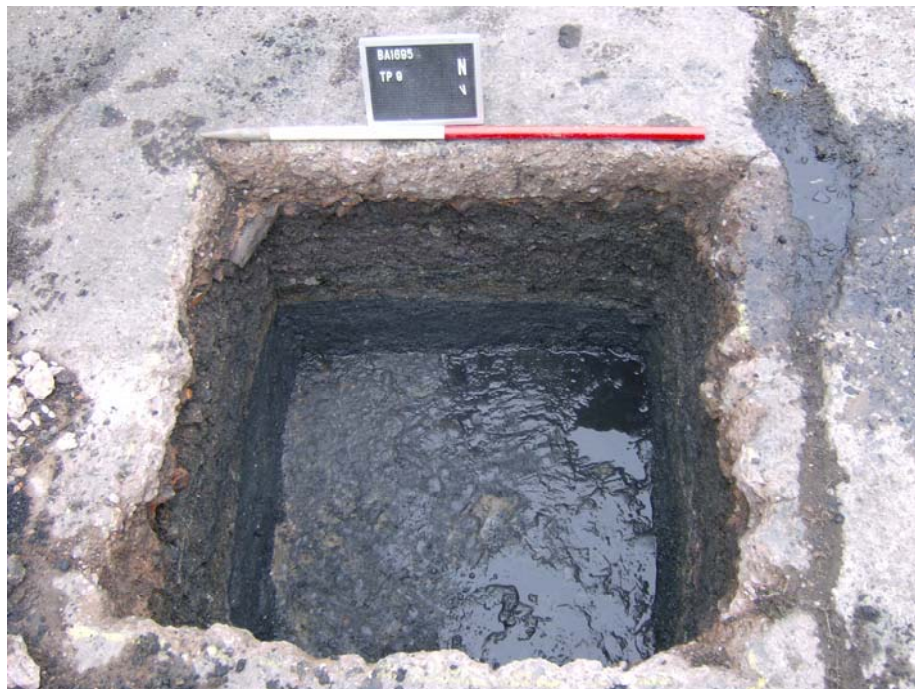
Plate 9

Test Pit 9 (Figs. 2, 3, 7 and Plate 9) was located towards the southeast corner of the yard of the western barn complex, in the proposed location of manhole 4. This pit was 1m<sup>2</sup> in plan and excavated to a maximum depth of 0.8m below the modern ground surface (126.94m AOD).

The earliest deposit encountered was the natural subsoil **9007**, which consisted of grey gravel-rich silt and clay. Overlying this was a 0.2m deep layer (**9006**) which consisted of beige silt and clay with pebbles throughout. Above this was a pebble surface (**9005**) constructed of small rounded pebbles compacted into a silt and clay matrix. In turn this was sealed by a layer of black crushed coal (**9004**) 0.18m deep that seemed to make up an old surface. This was capped by a layer of sandy-silt with burnt coal and crushed brick rubble. Overlying this was a 0.1m deep layer (**9002**) of purple sand and silt with slag and stones throughout. Sealing this was a layer (**9001**) of dark grey silt with charcoal, brick and tile rubble throughout that was 0.12m deep. Sealing this was the concrete floor surface of the farmyard (**9000**).

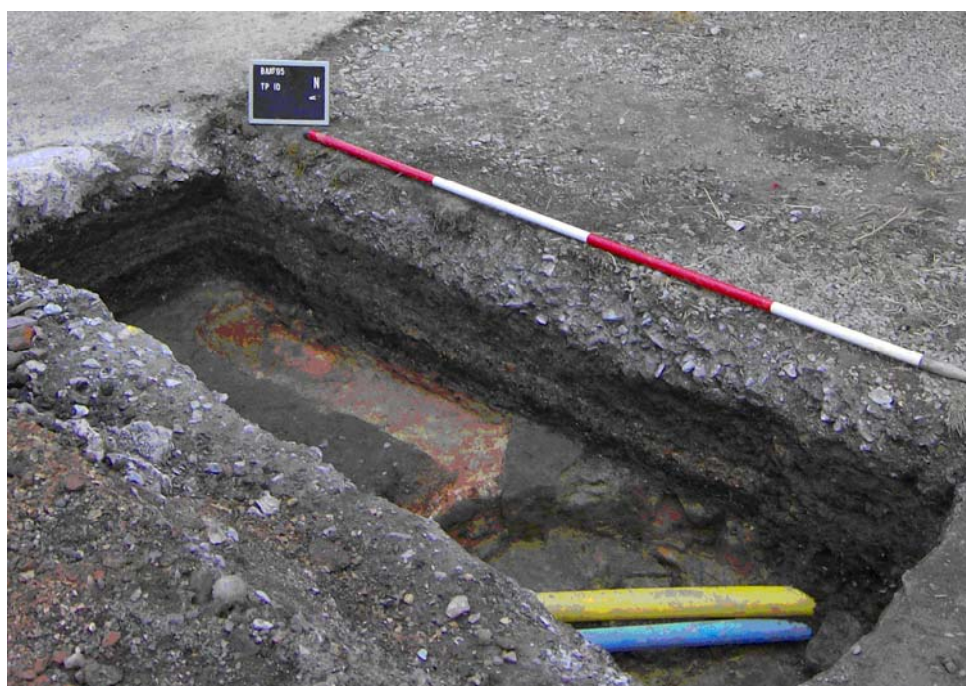
Plate 10

Test Pit 10 (Figs. 2, 3, 7 and Plate 10) was located over the proposed course of the drain on the line of the frater range south wall. The majority of the southern, and the entire western wall of the frater range still stand, and it was considered important to define the extent of preservation at this point. The test pit was 1m wide and 2.2m long and aligned northeast-southwest. This was excavated to a maximum depth of 0.8m below the modern ground surface (126.69m AOD).

Probably the earliest deposit encountered was not excavated and only observed in the edge of the modern service cut. This layer, **1110**, was probably a layer of buried soil, and consisted of beige sandy-silt with pieces of sandstone throughout. This was at least 0.2m deep. Above this, and also only visible in the edge of the cut for the service trench, was a narrow layer (**1112**) of grey silt 0.05m deep. It is possible that the foundation wall (**1108**) pre-dated both of these layers; although within the confines of the test pit the relationship was not clear. The remains of the frater south wall were clearly visible, and consisted of the remnants of large ashlar blocks of sandstone on the south face of the wall, and of a sandstone rubble block core. The gaps between the stones were full of sand, presumably weathered sandstone. The southern extent of the wall was not encountered within the trench. Butted to the northern side of this wall was a mortar floor surface (**1111**) 0.04m deep. This seemed to have been heat affected. There was little evidence of a robbed out tile floor in the topography of the layer, however a narrow band of silt parallel to the wall was visible in plan.

Above this surface seemed to be a layer of stone demolition rubble (**1107**), 0.05m deep, and which had some pieces of broken glazed floor tile within it. The top of this layer seemed to have been incorporated into pebble surface **1105**, which was overlying this to the northwest of the trench. This was 0.04m deep, and consisted of rounded pebbles within a silt matrix. Above this was a layer of black crushed compacted coal (**1104**), which seemed to form a surface that sealed both the earlier floor surfaces and the remains of the wall. Overlying this was a layer (**1106**) that consisted of alternating lenses of black coal and ash, and crushed brick or tile, 0.15m deep. Over this was a layer of grey silt, with gravel and coal contained throughout.

Cut through all previous deposits was a modern service trench (**1102**). This was 0.4m wide and 0.5m deep, and aligned north-south. This contained live services (gas and water) which could not be excavated, and was backfilled with silt and large quantities of sandstone rubble (**1101**). It is apparent that to the west of the cut there had also been quite a bit of modern disturbance. Whether this was due to an earlier, larger service trench, or to the topography of the surrounding land, was impossible to determine within the confines of this pit. The area of Test Pit 10 was sealed by a layer of stone hardcore (**1100**) which was 0.14m deep, and by the concrete farmyard surface, present in the northern corner of the test pit.

The wall encountered in Test Pit 10 (**1108**) is almost certainly the frater range south wall; as the majority of this wall is still standing, and the line of its continuation through the trench was quite clear (Fig. 10). It is also clear that a floor surface, presumably associated with the frater range south wall, was preserved within the structure (**1111**). It is possible that this is the remains of mortar bedding for a tiled floor; a small amount of evidence supported this hypothesis, although no *in situ* tiles remained and the mortar appeared to be burnt in places. It is tempting to associate this burning with a violent period of dissolution, however, it is just as likely to represent a hearth deposit.

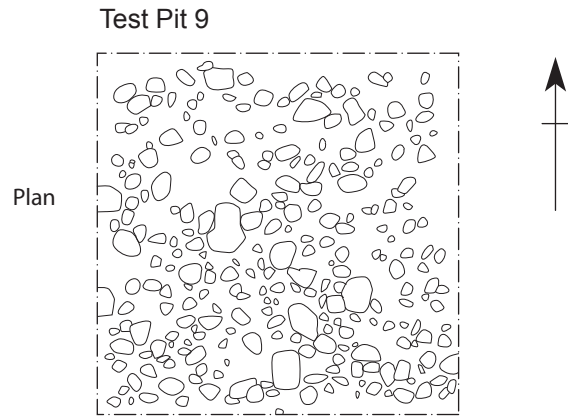
Fig.7

**Figure 7-** *Test pits 9 and 10, plans and sections*
