**Patton House Cottages, Bourton,
Shropshire:
An Archaeological Watching Brief.
2005**

by
Emma Hancox

An archaeological watching brief was carried out at Patton House Cottages, Bourton, Shropshire (NGR SO 5861 9472) in December and January 2004/5. Birmingham Archaeology was commissioned to undertake the work in order to meet a condition of the planning permission, requested by Shropshire County Council. The development concerned the construction of a garage and an extension to the existing 18th century house.

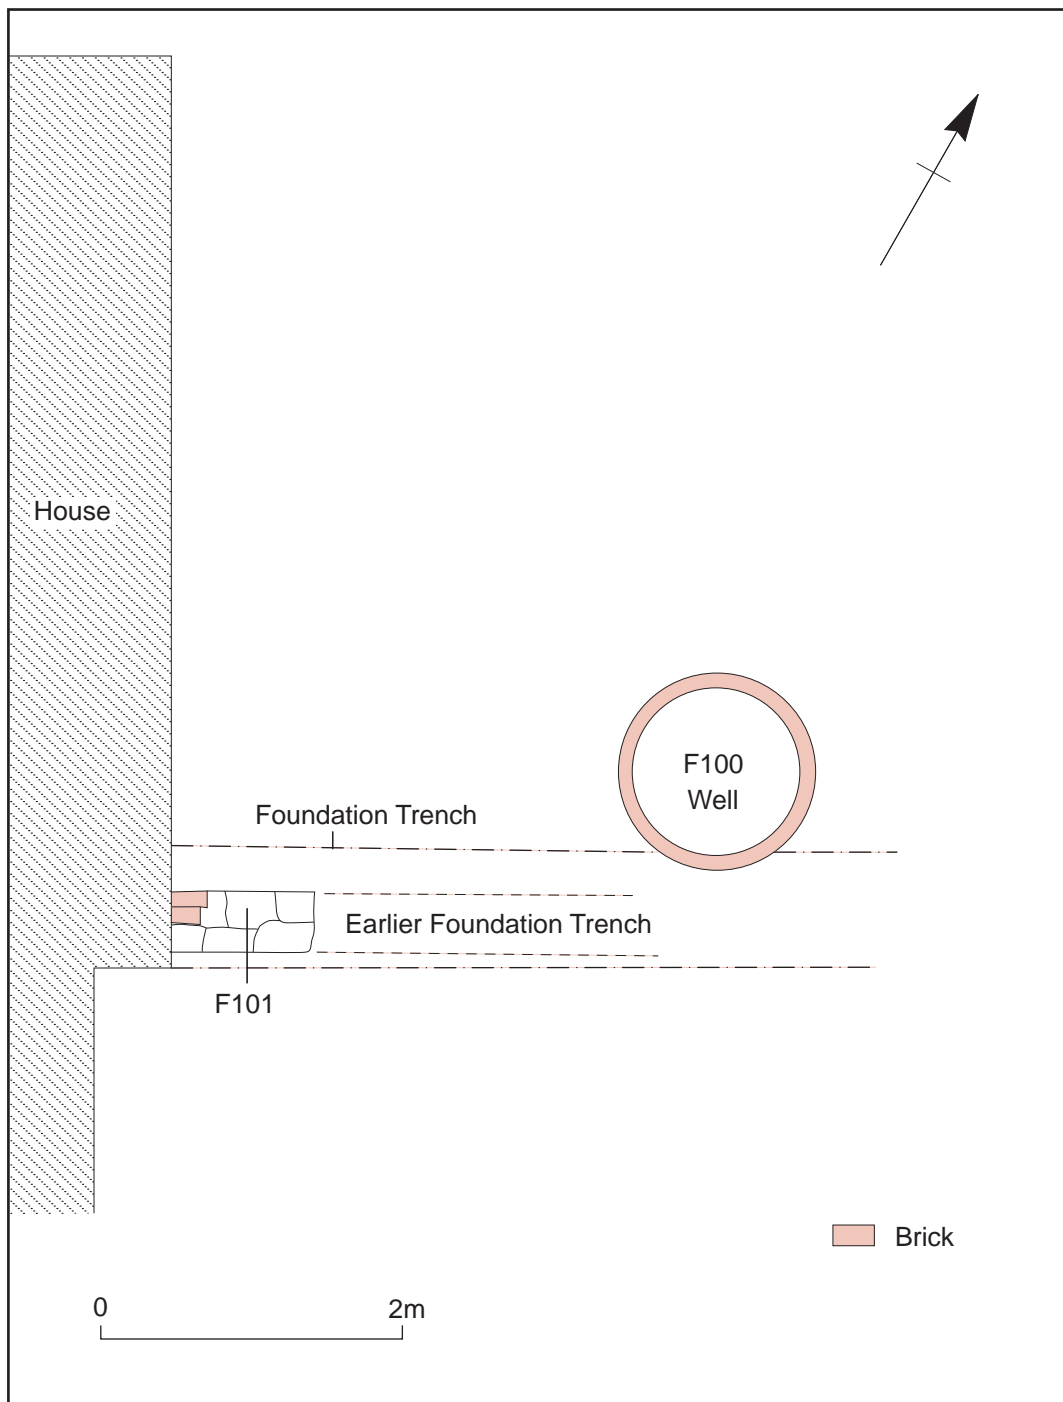
Fig.3

Excavation was initially stopped soon after it began following the discovery of a well, F100. The well (Fig. 3, Plate 3), was located roughly 2.0m away from the back wall of the house, on the edge of the foundation trench. It was 0.9m in diameter, built of stone and was still full of water. It was capped with a large stone slab c.3.0m square.

A wall foundation F101, was recorded which butted up against the back wall of the house (Fig. 3). It jutted out roughly 1.0m from the house within the new foundation trench and was similarly aligned. It cut the natural subsoil and comprised the remains of a brick wall on a limestone foundation. Very little survived and no dating evidence was recovered.

A mid-brown clay layer was observed in the top 0.4m of the foundation trenches. This contained 19th century pottery and overlay both F100 and F101.

The exposed wall stub was a later addition to the house and probably represented an former extension to the property, now demolished. There was no stratigraphic relationship between the well and the wall since the foundation trench runs just to the south of the well. The well had been capped at some stage, perhaps when the wall of the earlier extension was constructed.

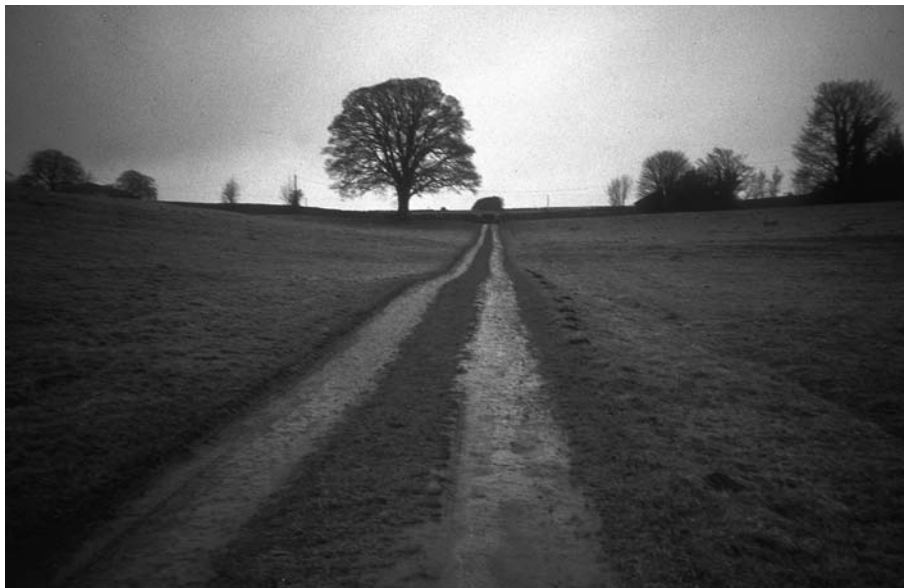
Plate 1

Patton House Cottages are located on the east side of the B4378 between Brockton and Bourton, just outside Much Wenlock, Shropshire. The site is situated on high ground, on a southeast facing slope just below the visible earthworks of the deserted medieval village of Patton (Plate 1). The natural geology of the area is limestone bedrock with overlying clays.

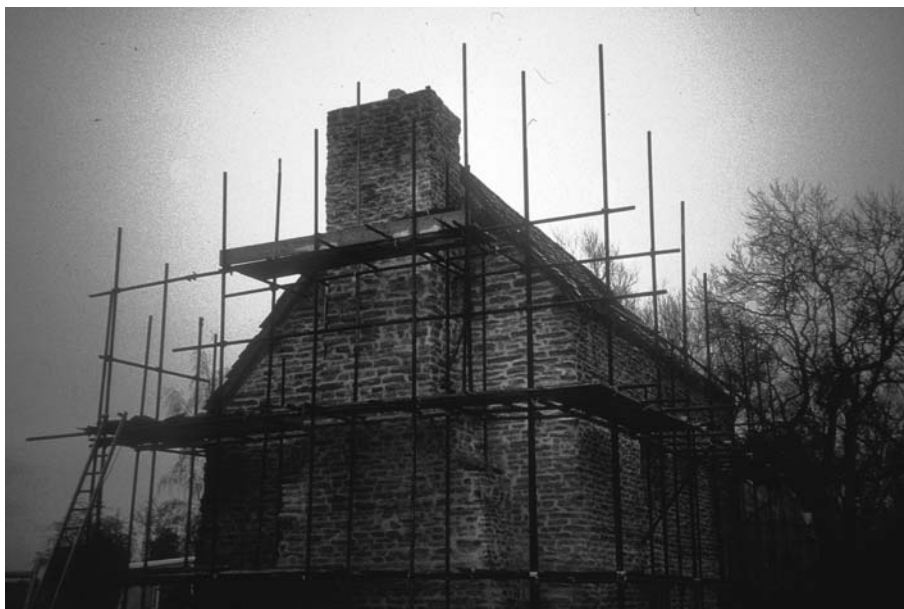
Plate 2

Patton House Cottages, upon which the extension was due to be built appeared, from its construction to be of roughly 18th century date (Malcolm Hislop pers. comm. Plate 2). It is currently in a state of disrepair and is not a listed building.
