Fairmile Fencing, Gower Street, St Georges, Telford, Shropshire:

An Archaeological Building Record, 2004 Project No. 1204

By Chris Hewitson

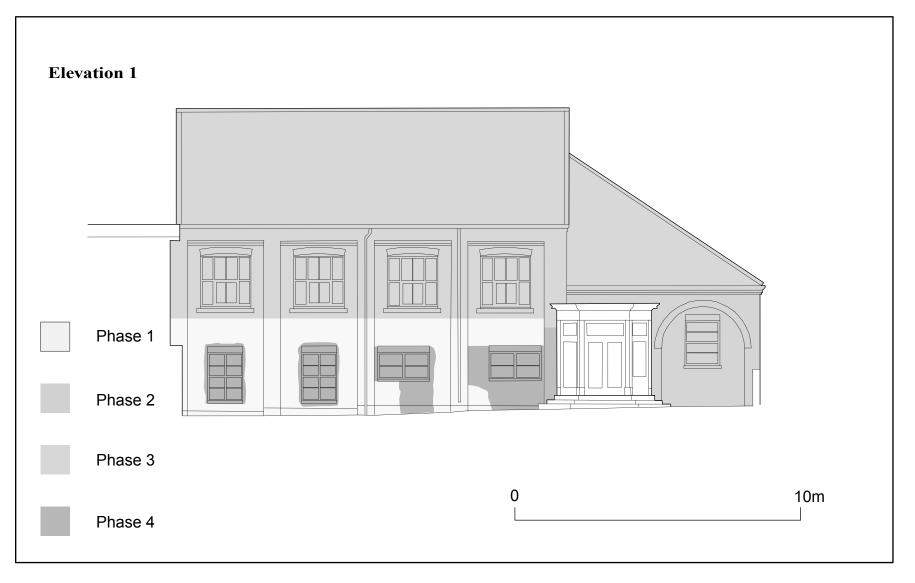
The two-storey range (Elevation 1, Figure 3, Plate 2) located to the rear (west) consisted of four bays of pier and panel construction. This was a two phase construction, the ground floor was constructed of dark-red clam ped brick in English Garden W all bond.

The first floor was of m achine-cut bricks in English G arden W all bond. Each bay contained a segmental-arched window at first floor level with replacement double-glazed frames. At ground floor four later rectangular casement windows had been added.

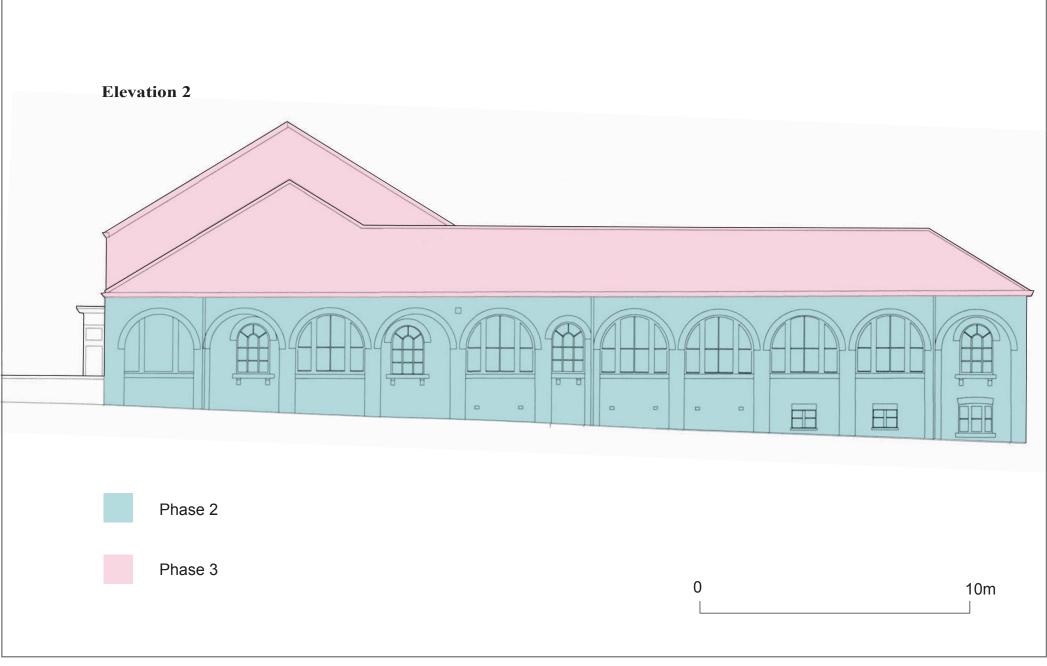
The single-storey front façade (Elev ation 2, Fi gure 4, Plate 1) was built in m achine-cut red-brick laid in Flemish bond. It consisted of eleven bays, five wide bays either side of a narrow central bay. These were semi-circular arched with brick heads each containing either wide sem i-circular arched sash windows or narrower sem i-circular arched casement windows. At the northern end of the front façade three ground-level windows provided light for the basem ent. The entr ance was located on the southern façade (Elevation 1, Figure 3) by m eans of a late 20 <sup>th</sup> century addition bay porch. Adjacent to this was a semi-circular arched bay. The northern façade contained three rectangular sash windows with flat heads and ce ment sills (Elevation 3, Figure 5, Plate 3). A central subterranean doorway with steps leading down to it was flanked by four segmental arched ground-level windows. The slate roof was pitched and hipped at either end.

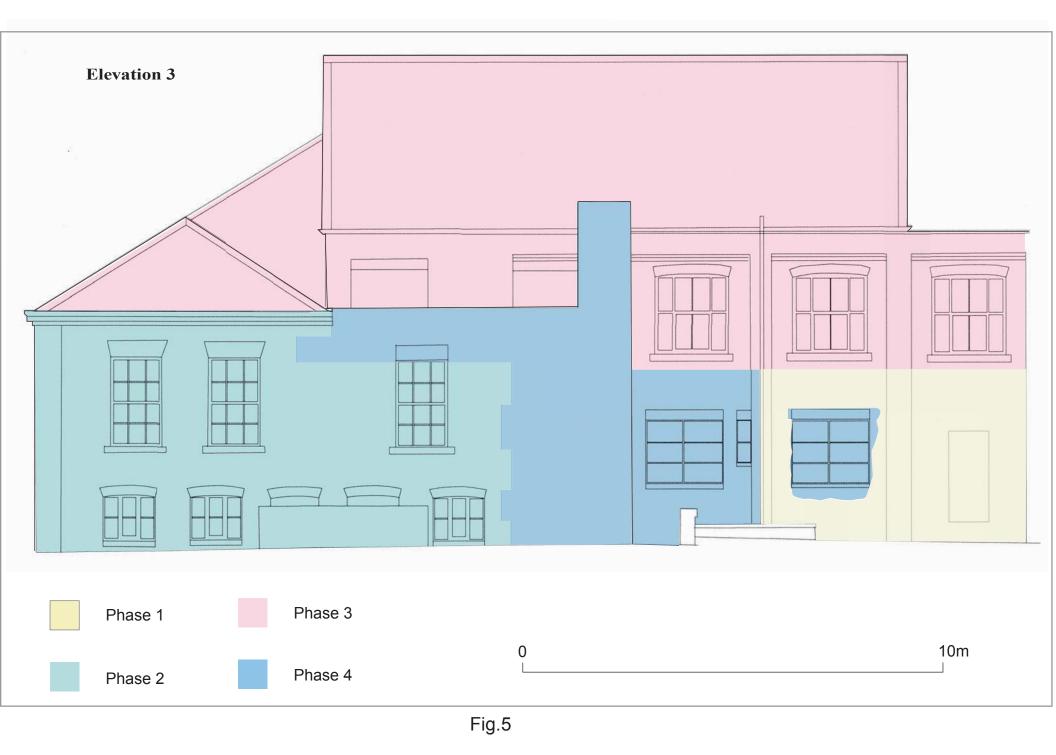
The pattern appeared to be mimicked on the northern façade (Elevation 3, Figure 5, Plate 4) but only two bays w ere visible the rest having been obscu red by the extension of the main range to the rear.

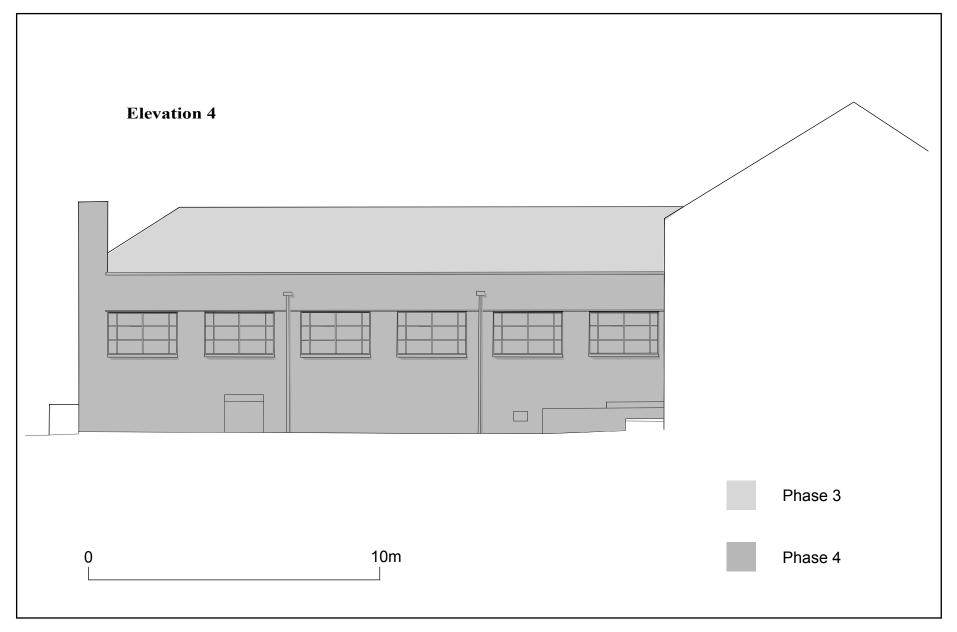
The northern half of the m ain range (Elevati on 4, Figure 6) was extended at the rear by the construction of a flat-roofed m id-to-late  $20^{th}$  century on e-and-a-half storey structure. Its west-facing façade was plain with six ev enly spaced rectangular casem ent windows placed high at ground floor level. Steps led dow n to a basement entrance to the structure at the southern end.

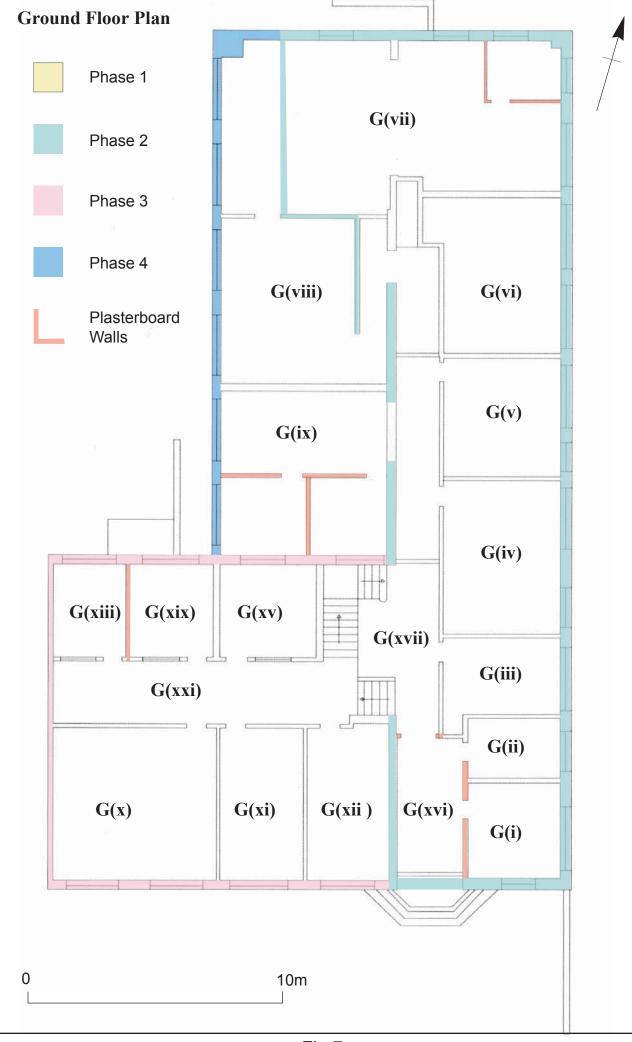
Fig.7

The interior of the structure consisted of a main north-south range with a central corridor and office room s located either sid e. A ba sement floor existed at the northern end likewise with a central corridor and room s e ither side. Access was f rom the central corridor by a straight stairw ell and the exterior through the doorway located in the northern façade. A second basem ent was accessed from the rear and the ground floor of the rear range. It consisted of a wide corridor with a safe-room to the north.

The rear ran ge consisted of two-stories with mezzanine floors each with a central eastwest corridor and rooms either side. It was connected to the main range by means of an open stairwell.
