Lanercost Gardens, Throckley, Newcastle upon Tyne

Archaeological Watching Brief Report

for Northern Gas Networks

v.2.0
21/09/2022

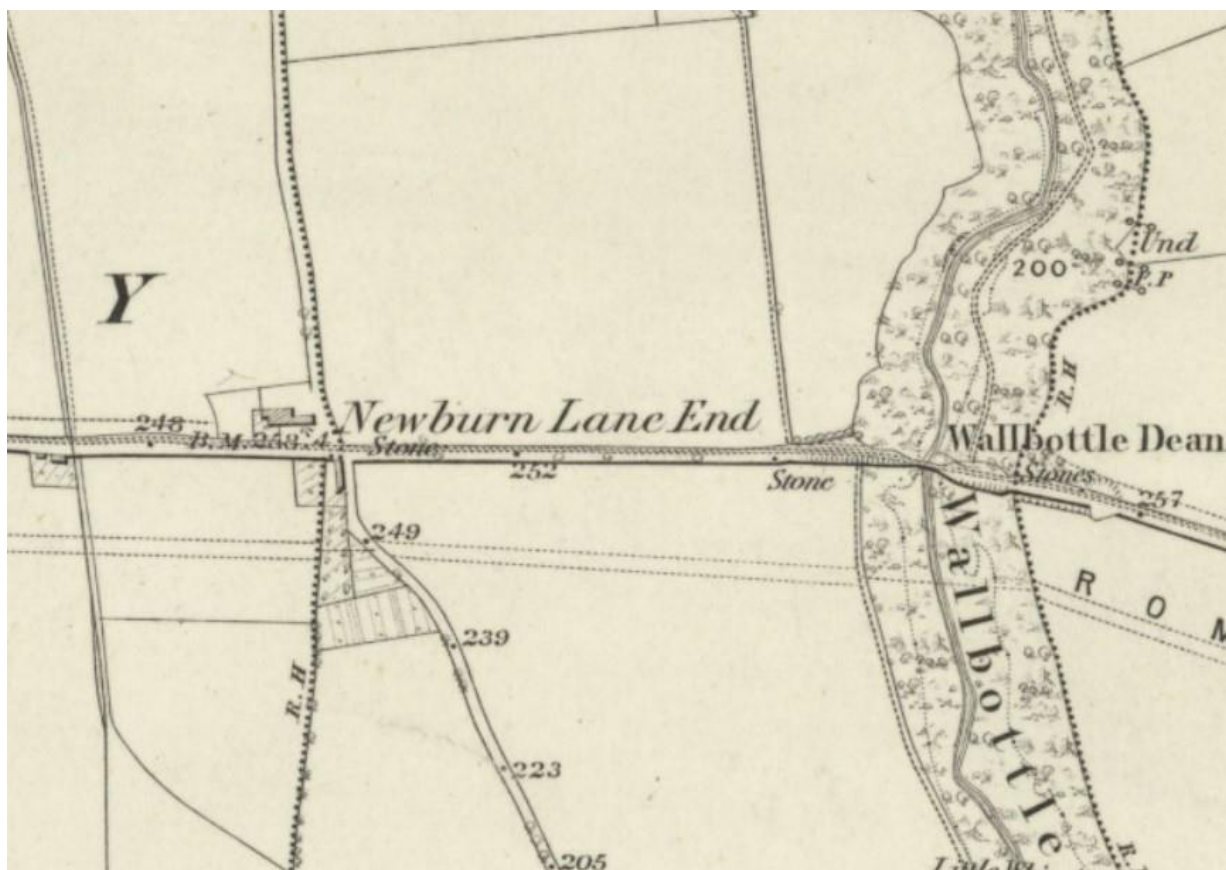
Figure 2: Extract from the 1865 1st edition Ordnance Survey 1:10560 showing the undeveloped area north of Newburn Lane End (Contains OS data Crown copyright and database rights, 2022)

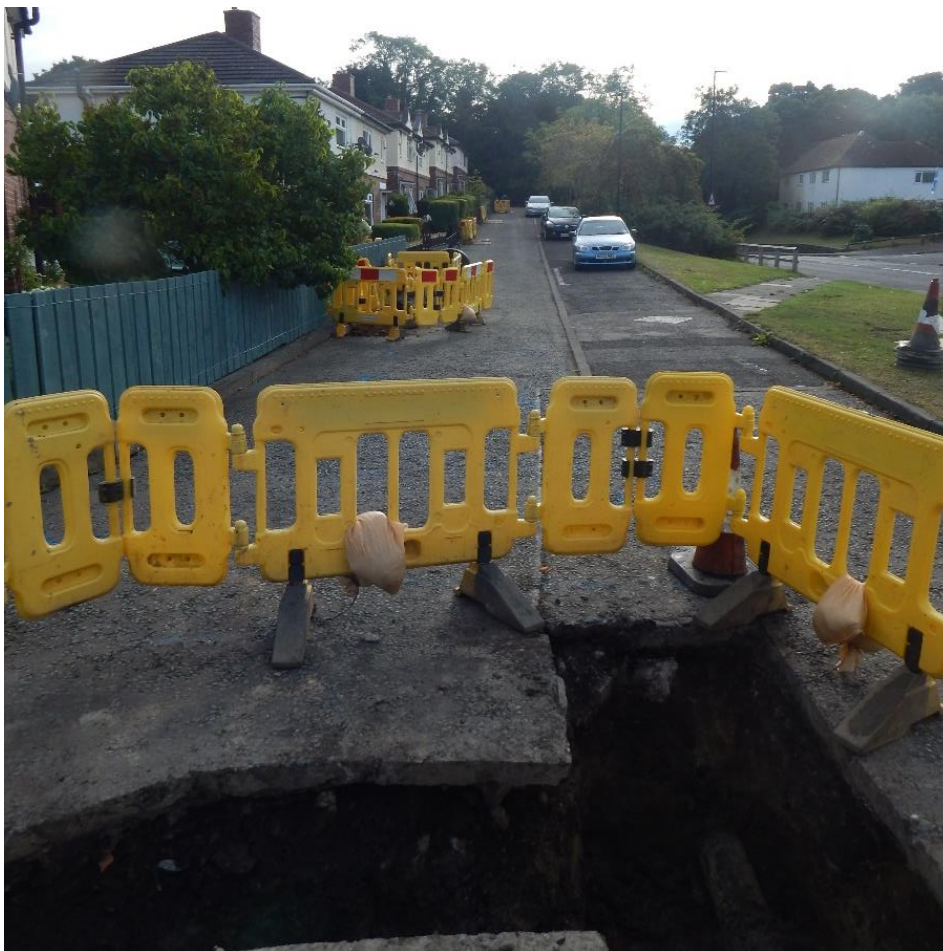
Figure 6: View across Lanercost Gardens, facing east

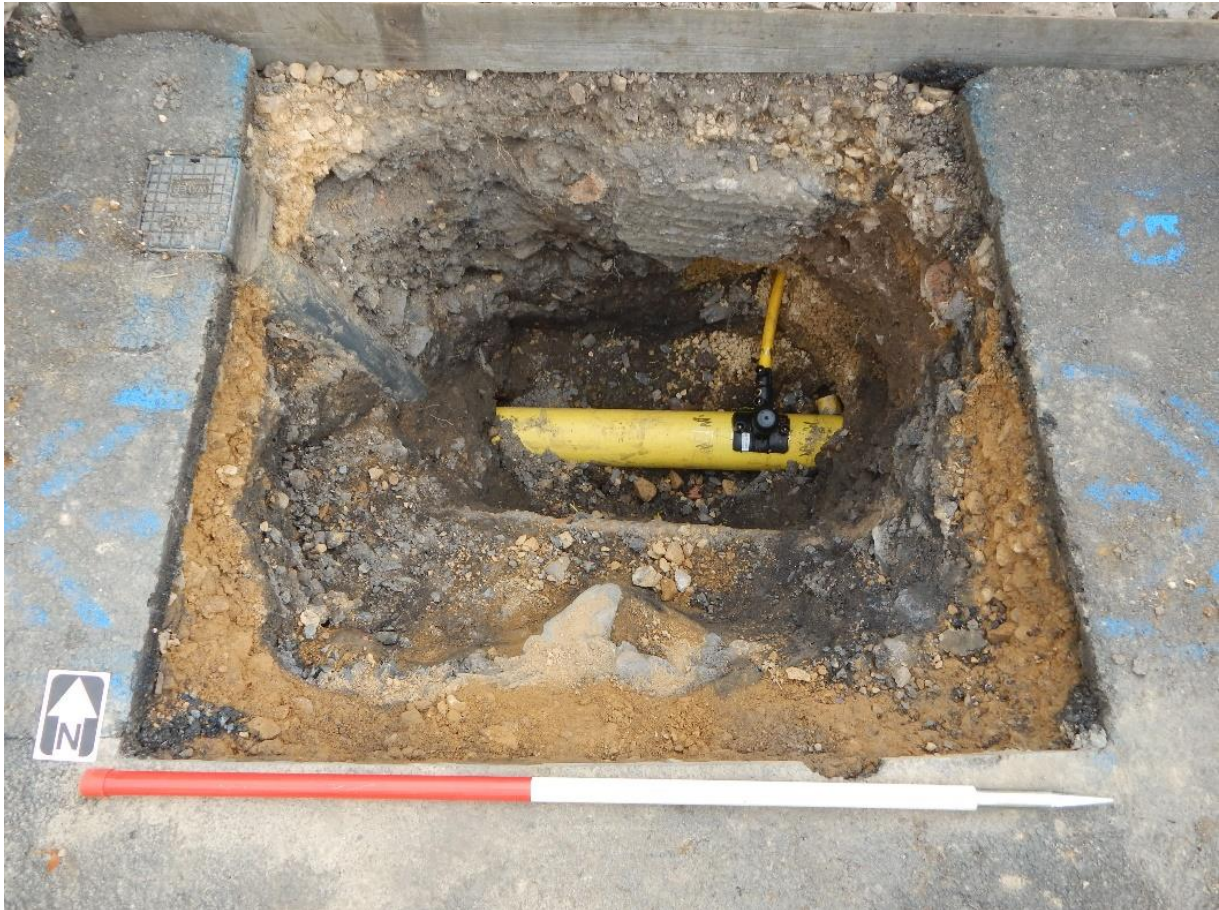
Figure 7: View of Trench 7 at 36 Lanercost Gardens, facing north

7	NZ15957 66851	No. 36 Lanercost Gardens	1.16m x 1.00m x 0.92m Depth	0.20m pavement make-up above 0.10m grey stone chippings above redeposited natural clay, heavily stained with coal dust. Sand & Fine gravel in NE corner.	Sterile
8	NZ15973 66849	No. 34 Lanercost Gardens	1.20m x 0.82m x 0.88m Depth	0.20m pavement make up above redeposited natural clay, heavily stained with coal dust. Occasional stone inclusions. 0.50m depth fine sand layer in North facing section related to a previous intervention/trench for the electric cable.	Sterile
9	NZ15975 66849	No. 32 Lanercost Gardens	0.90m x 0.80m x 0.83m Depth	0.20m pavement make-up above 0.10m grey stone chippings above redeposited natural brown clay, stained with coal dust. Occasional inclusions brick & stone chippings.	Sterile
10	NZ15989 66849	No. 30 Lanercost Gardens	1.00m x 0.86m x 0.86m Depth	0.15m pavement make-up above 0.15m grey stone chippings above redeposited natural brown clay, heavily stained with coal dust/ash. Frequent inclusions, stone chippings.	Sterile

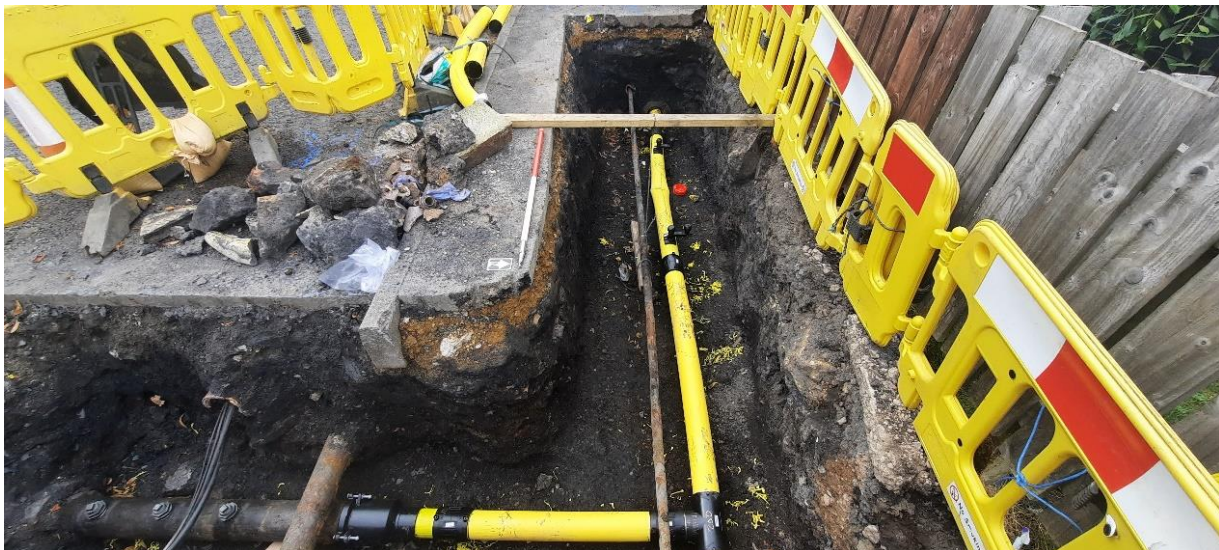
Figure 8: View of Trench 14 and Trench 14a, facing west

Trench	Location (GPS)	Connection - House Number	Trench Size (m)	Description	Interpretation
14a	NZ16018 66848	No. 22 & No. 24 Lanercost Gardens	1.98m x 1.42m x 1.00m Depth	Extension to TR.14, North to South at east end of TR.14 onto the road. 0.20m layer of road make-up, (Grey stone chippings) above 0.80m thick backfill layer from original gas mains trench/intervention. Backfill consistent with that in TR.14.	sterile
15	NZ16023 66849	No. 22 Lanercost Gardens	1.60m x 0.75m x 0.85m Depth	0.20m pavement make-up above redeposited natural brown clay, stained with coal dust. Occasional inclusions brick & stone chippings.	Sterile
16	NZ16025 66849	No. 22 Lanercost Gardens	1.58m x 0.93m x 0.92m Depth	0.20m pavement make-up, 0.10m stone chippings above redeposited natural brown clay heavily stained with coal dust. Occasional inclusions, brick & stone chippings	Sterile
16a	NZ16030 66849	No. 20 Lanercost Gardens	2.10m x 0.98m x 0.75m Depth	0.20m layer of pavement make-up, (Grey stone chippings) above a 0.55m layer of primarily coal dust detritus/waste frequent stone chippings and occasional brick inclusions	Sterile

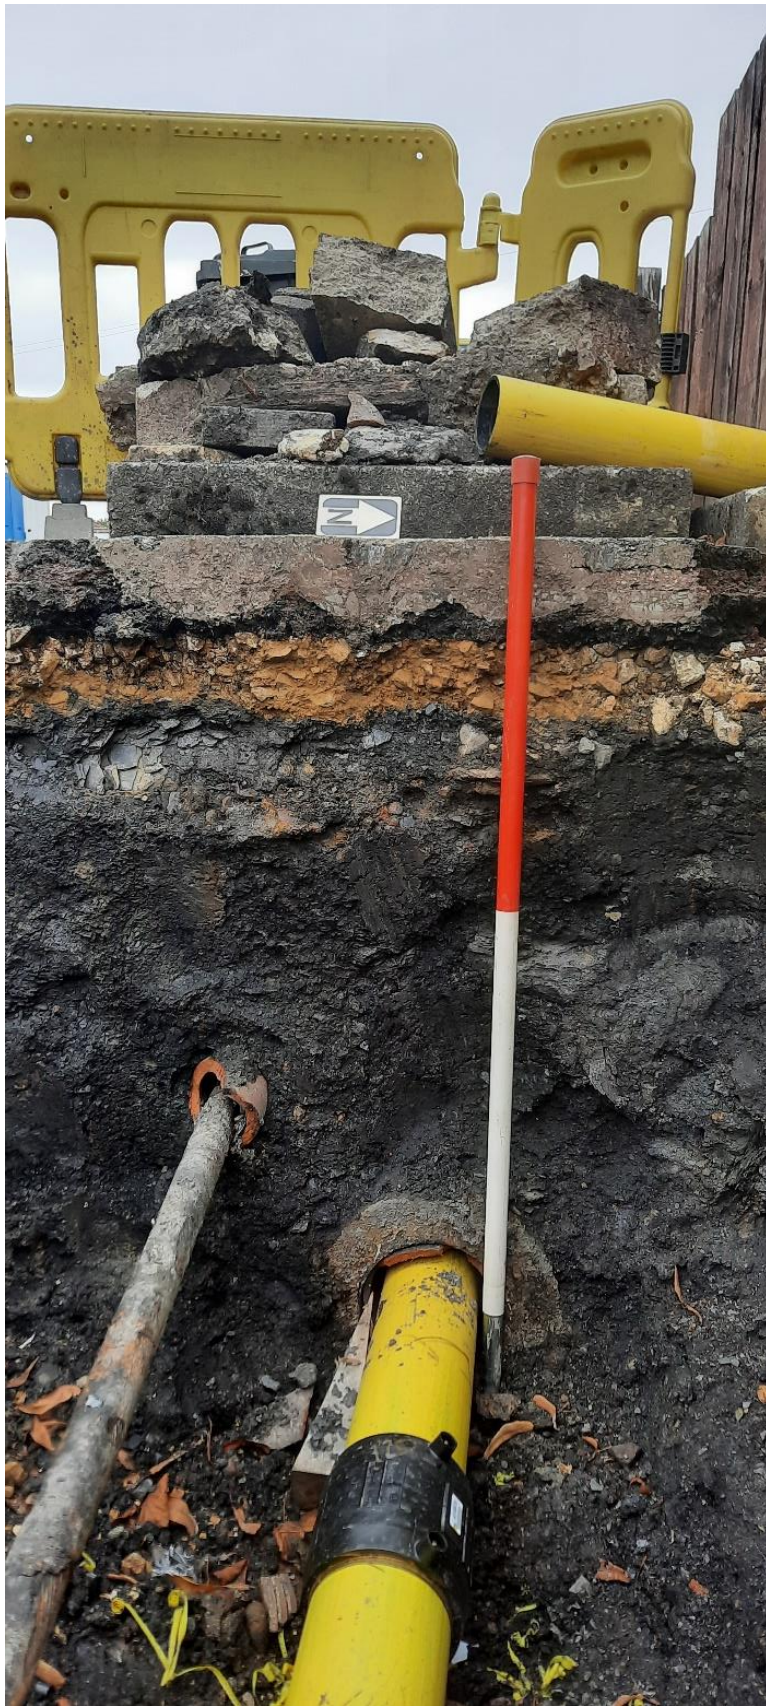
The stratigraphy was regular across all the trenches comprising modern made ground, comprising either a tarmac surface or concrete pavement slabs overlying levelling layers of gravel and sand. Below this was a mixed sandy clay with occasional coal dust and poorly sorted stones. In all cases this was interpreted as re-deposited geological sediment resulting from the excavation and subsequent backfilling of the original gas pipeline works. In all cases the stratigraphy was interpreted as re-deposited geological sediment resulting from the excavation and subsequent backfilling of the original gas pipeline works.

Figure 9: Detail of the east facing section of Trench 14
