Rochester Cathedral

Report on the excavation of three drainage test pits in the garth

Graham Keevill, Cathedral Archaeologist

Rochester Cathedral cloister – Report on the excavation of three drainage test pits in the Garth

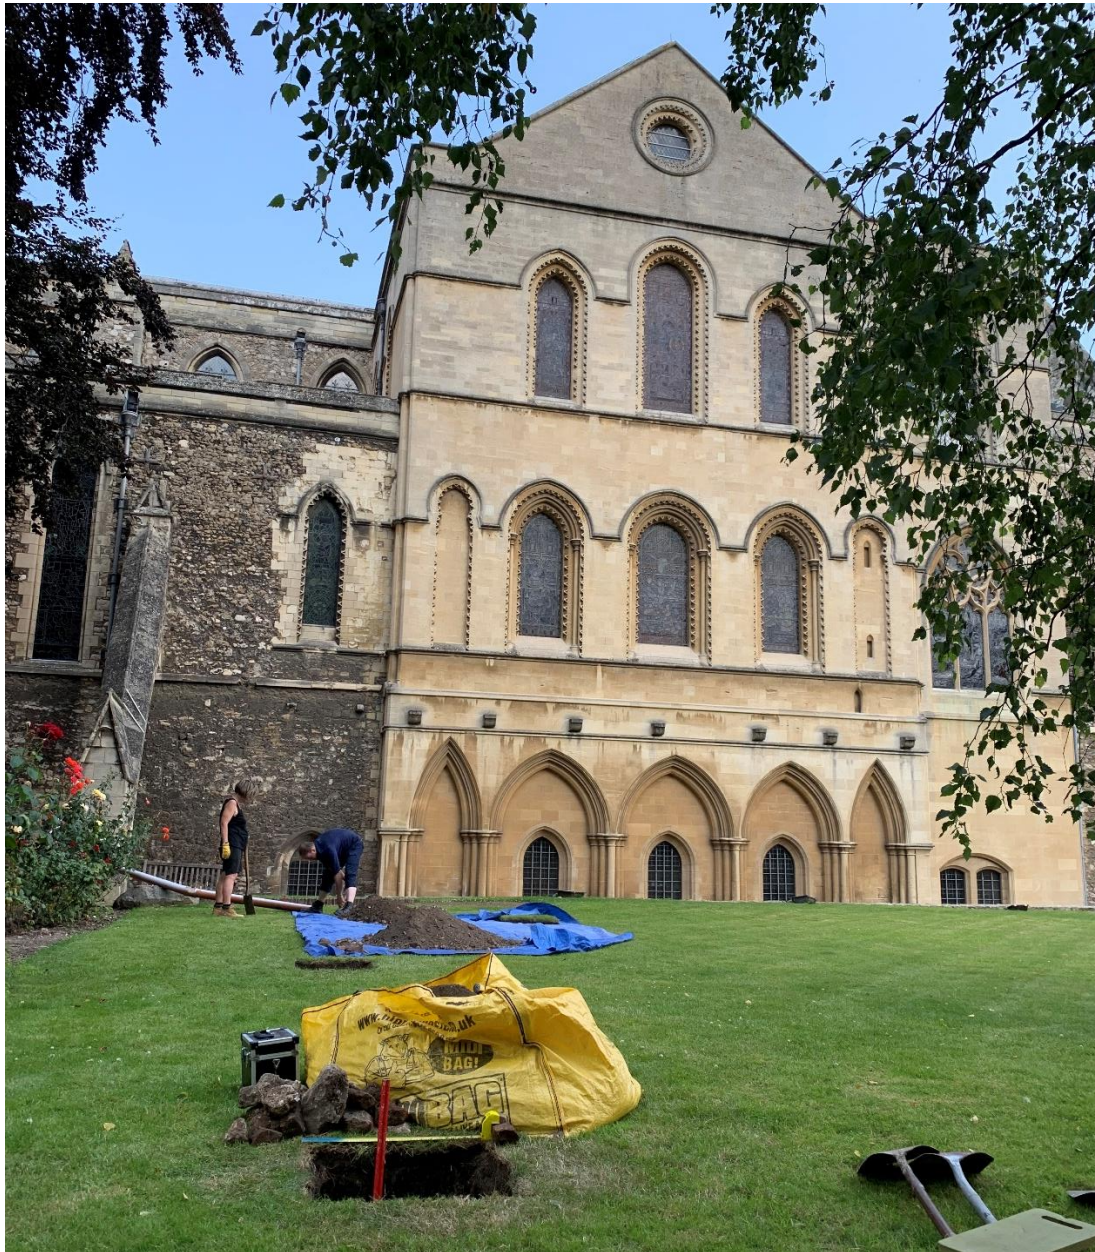
Figure 1: The cloister garth test pit excavations in progress, July 2021

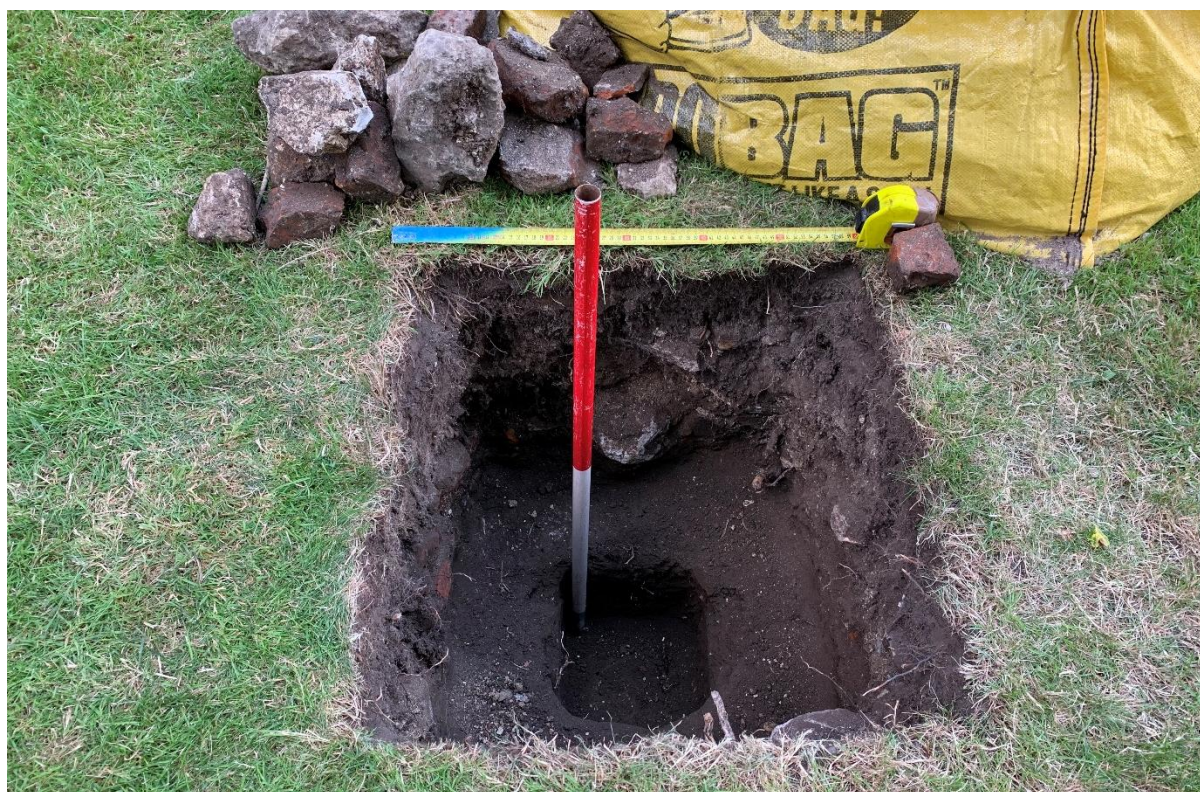
Figure 4: Pit 1 after excavation looking north, with rubble from layer 2 much in evidence.

In PP1 the topsoil sealed a hard, compact 0.45m-thick layer of mid-brown silty clay (**2**) containing large amounts of coarse demolition rubble (stone, tile and brick). This filled all but the bottom 50mm of the initial 0.6m-deep excavation, but did not continue into the sondage at the bottom. Finds from this layer were largely of late medieval or early post-medieval date, but also included some modern material. The significance of this and rubble deposits found in the other two pits is discussed below. In PP1, the rubble layer sealed a mid-brown gritty silty clay (**3**) occupying the remaining 0.35m of the excavations (ie the base of the pit and all of the sondage). The bottom of this layer was not found, so its full thickness is not known. Finds were of post-medieval date except for a flint flake probably of earlier prehistoric date; the layer also contained much charcoal and oyster shell (a small sample of the shell was kept).

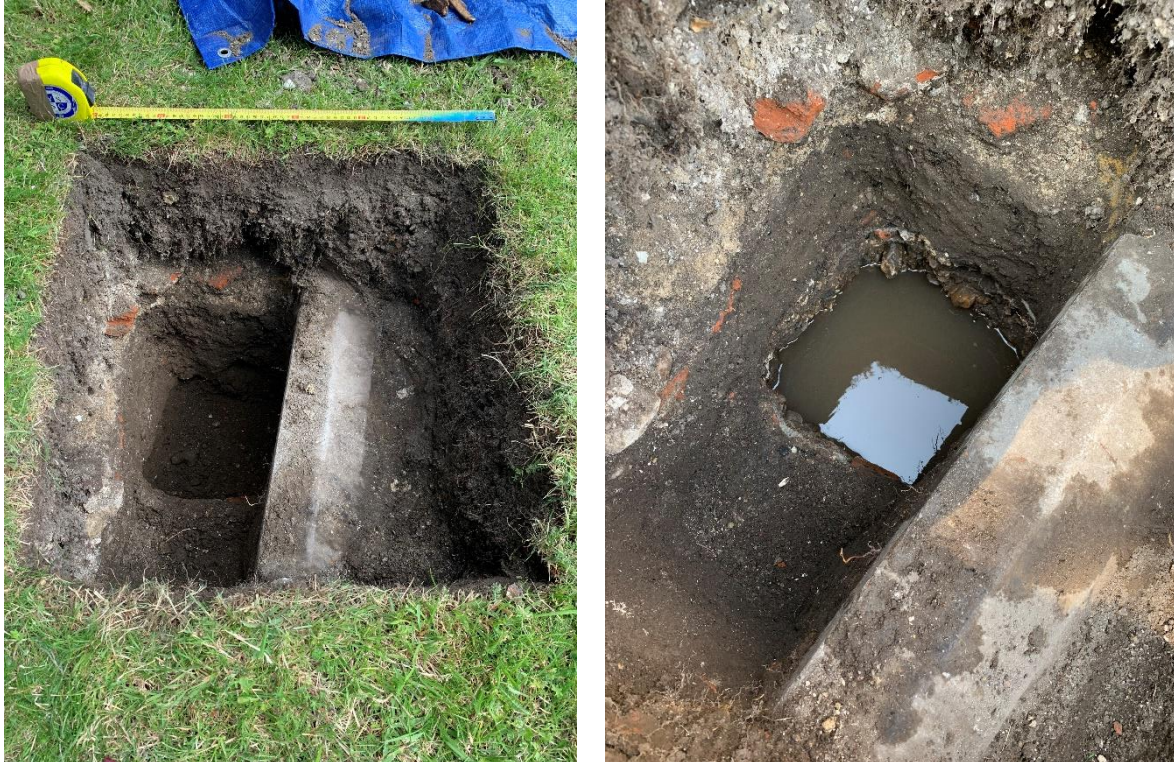
A similar sequence was observed in PP2, although discovery of electrical cable cover **6** in the east half of the pit constrained further excavation to the west half (the sondage was therefore dug in the north-west corner of the pit). No trench for the cable could be recognized, but it had been cut through a very similar rubble layer (**5**) to the one found in PP1. The soil matrix was exactly the same, as was the general character of the rubble. In this case no medieval or early post-medieval tile or stone was found, but one small piece of 18th/19th-century pottery was present along with a few very small clay pipe stem fragments. Layer **5** was only 0.28m-0.3m thick, but as in pit 1 it overlay a gritty mid-brown silty clay (**7**), 0.25m thick at the base of the pit and continuing into the sondage. Here the gritty soil sealed a second rubbly layer (**8**) with a very distinctive 'crust' (almost a surface) at the top of grey mortar containing small pieces and flecks of charcoal and chalk. 'Salt and pepper' mortar of this type is common in the Medway during the 18th century/very early 19th century. The rest of the layer comprised dark brown silty clay with abundant flint pebbles and occasional small pieces of brick. These were not diagnostic but were consistent with an 18th-century date.

Figure 5: Pit 2 looking north on completion (left), with a detail of the sondage looking north-west during the first pour of water. Note the distinctive mortar lens just above the sondage, and the flint pebbles below this. The coarse rubble layer (**5**) is also clearly visible in both photographs.

Pit 2 contained arguably the most interesting sequence of layers, although the finds from the pit were inconsequential. Layer 8 would appear to be 18th or possibly very early 19th-century in date because of the 'salt and pepper' mortar layer or crust at its top - a characteristic material which is as datable as pottery or other finds of the same era. This might have been a poured layer or just an area of trampled material, but in either case it suggests a very definite horizon at which some activity was taking place. The most obvious context for this would be the demolition of the west cloister (cellarer's) range during the first decade of the 19th century, although it could be a little earlier and related to a smaller-scale demolition of other buildings around the cloister.

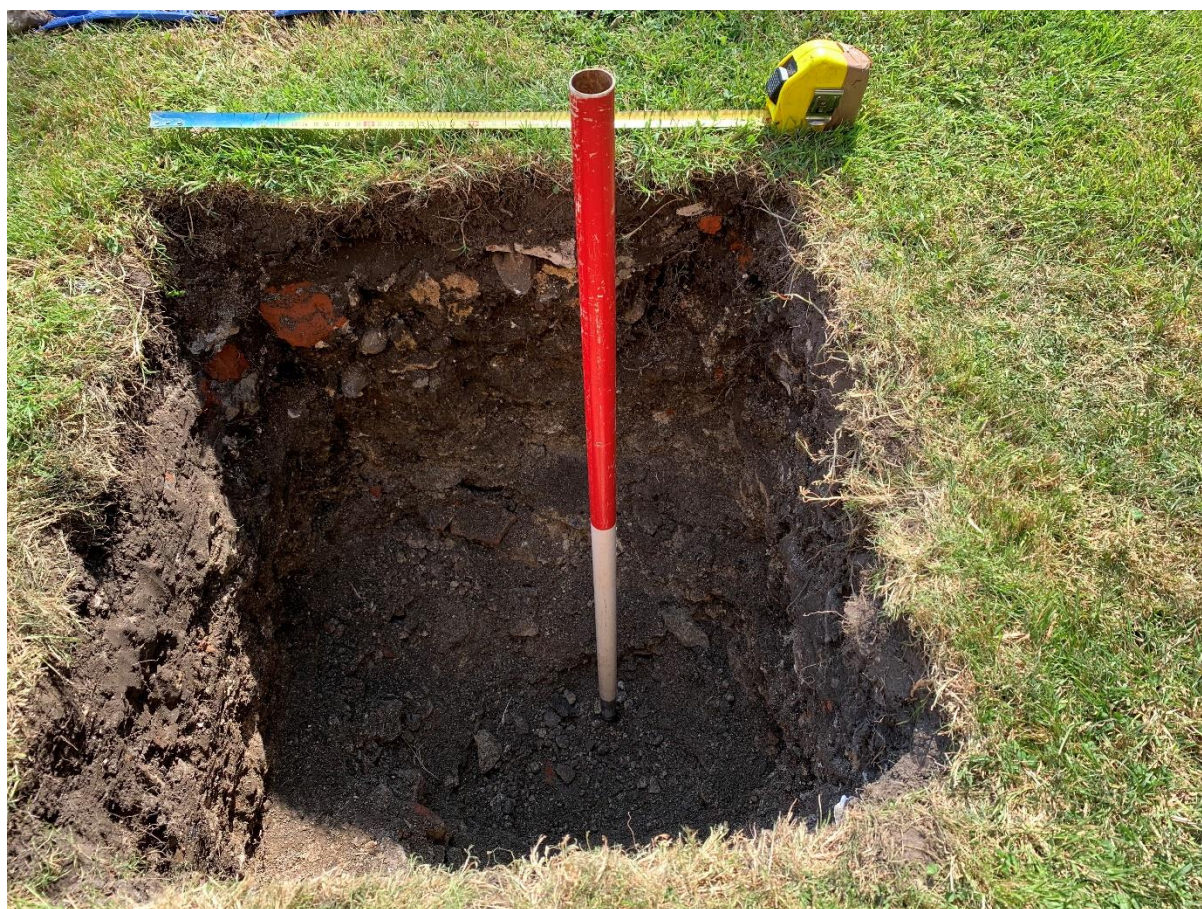
The stratigraphy in PP3 initially looked similar to what had already been excavated in the other two pits, but it quickly became apparent that the sequence here was actually very different. Only one rubble layer (10) was found, and this occupied the entire depth of the pit (ie 0.85m except for the 80mm topsoil): it continued beyond the base of the excavation. The rubble here was very loose and poorly compacted, to the extent that it was not possible to excavate a clear sondage in the bottom of the pit – the sides were too loose, and rapidly collapsed. The fill was also very porous, and the percolation testing had to be abandoned because the lower part of the pit could not retain water long enough for it to fill up. It drained away as fast as more water could be poured in. The general character of the brickwork in the rubble suggested a somewhat later date than the material in layers 2 and 5, but the only finds were a single piece of late medieval or early post-medieval floor tile and a piece of 18th-century Staffordshire salt-glazed pottery.

Figure 6: Pit 3 looking south, with rubble layer 10 occupying all but the top 80mm of the excavation.

The looseness of the rubble in pit 3 is perhaps something of a conundrum. It contrasted sharply with the rubble layers in pits 1 and 2. The latter can certainly be regarded as one and the same deposit, but was layer 10 different? As Figure 3 shows, pit 3 is only 5m south-east of Sir George Gilbert Scott's late 19th-century flying buttress, erected to provide support for the outward-leaning wall of the South Quire Aisle (the buttress can also be seen in Figure 1 but is not on Figure 8). Excavations in this area for the HTFE project in 2015 showed that an extensive area around the buttress had been disturbed when it had been built (including substantial foundation works). This would have damaged the late medieval tile pavement in the west cloister walk as well. The tile from pit 3, and the rubble generally, could therefore derive from Scott's operations rather than demolition of either the west cloister range or the Prebendal House.

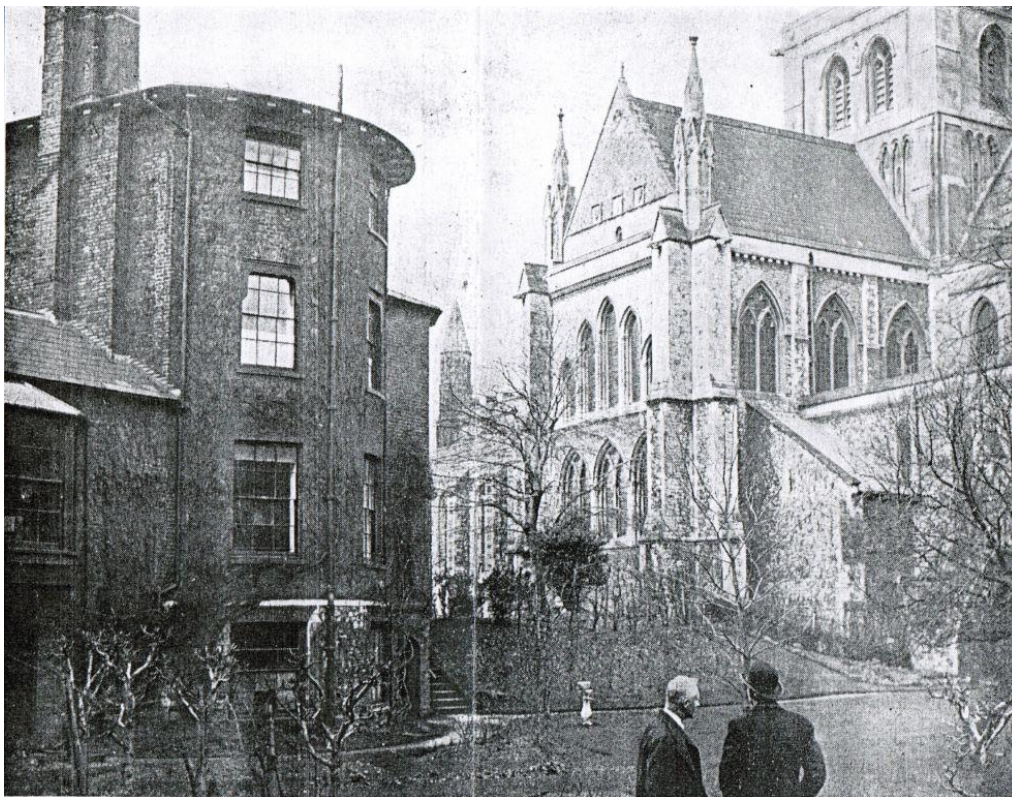
Figure 7: Photograph of the Prebendal house and west side of the cloister in 1937, showing the very different landscaping created in c 1805 (see also Figure 8).

Layers 7 in pit 2 and 3 in pit 1 were very similar, and are regarded as the same. They probably represent landscaping of the cloister and garth after demolition of the west cloister range, when the new Prebendal House had new gardens laid out around it. These are shown on the 1867 1:500 Ordnance Survey town map of Rochester, and can also be seen in late 19th/early 20th-century photographs (Figures 7 and 8). If these layers do represent an early 19th-century garden soil, it follows that the overlying rubble layers (2 and 5) must be of later date. The demolition of the Prebendal House in 1937 again provides an obvious context for this. The presence of earlier finds is not problematic: the house had been built over and through earlier buildings and features (including the tiled pavement in the west cloister walk), and it is very likely that earlier material became mixed with more modern artefacts during its demolition.

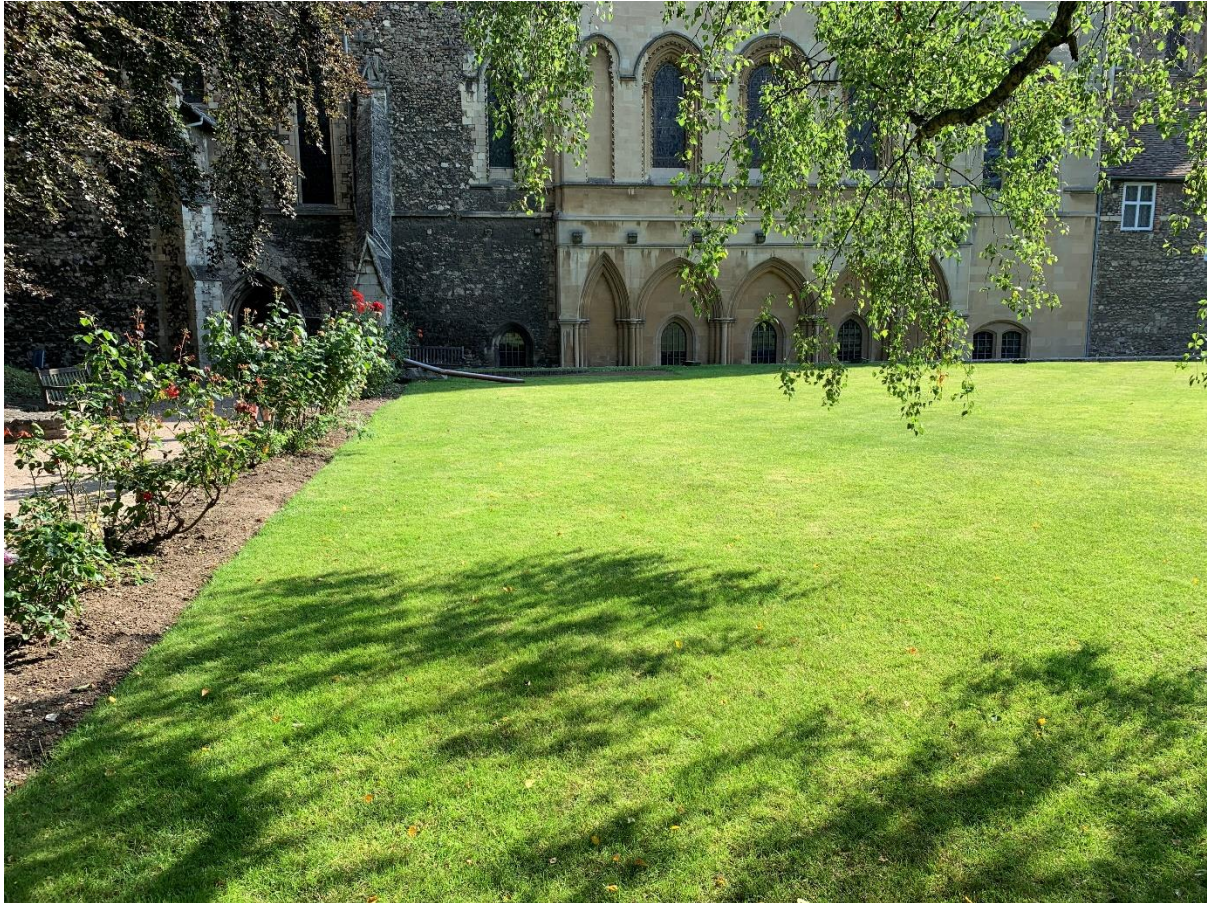
Figure A1: The garth on 19 July 2021, immediately before the start of the excavations.

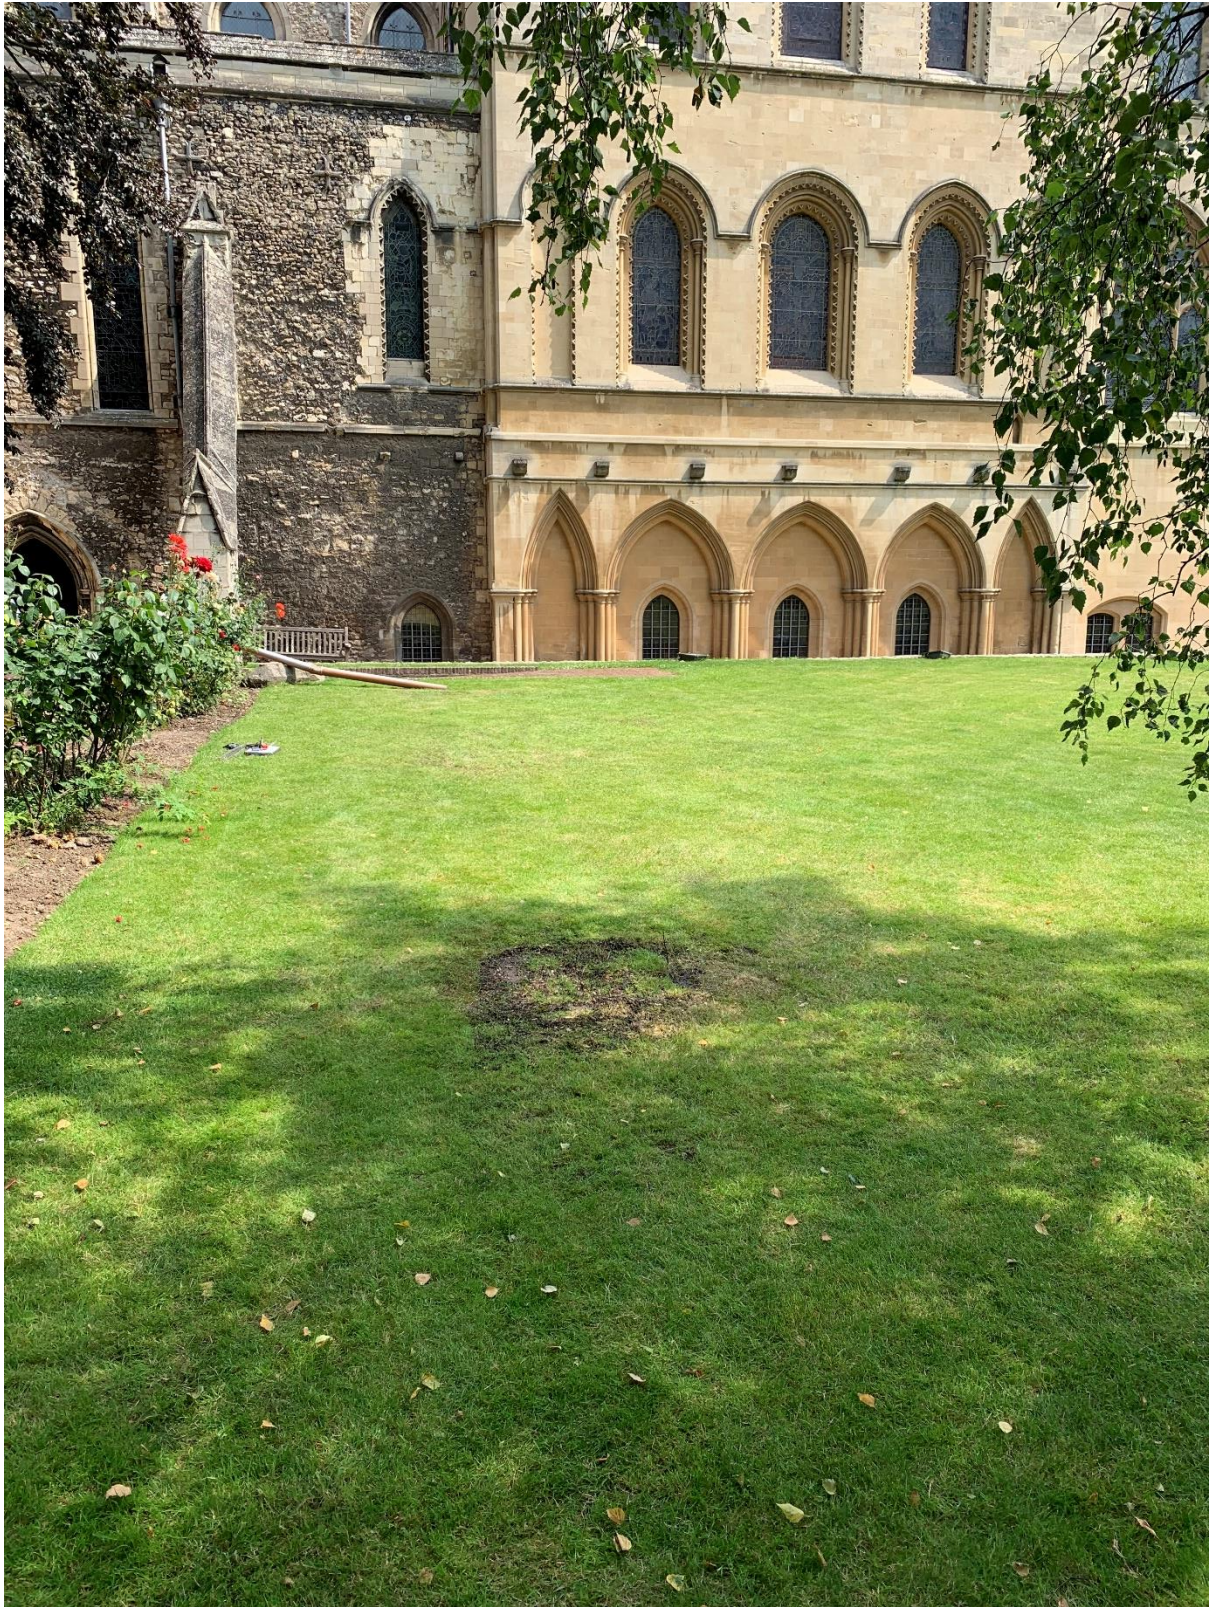
Figure A2: The same view on the afternoon of 20 July 2021 after the three pits had been backfilled and the turf replaced.
