## Excavation and Recording in the Norman Garden at Taunton Castle

# Excavation and Recording in the Norman Garden at Taunton Castle

Somerset HER number: 42892

Site Code: TCK20

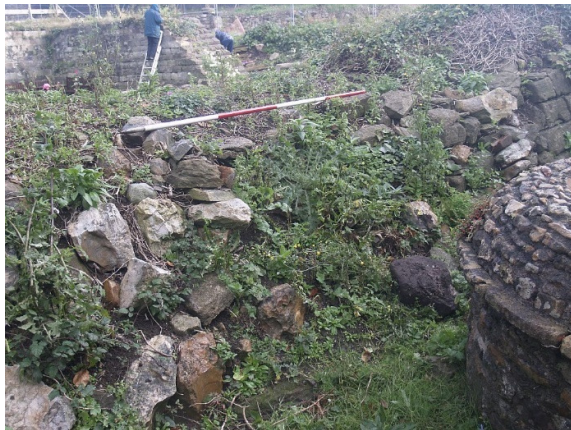
**Figure 2:** Trench B showing wall cores and half-sectioned rockery walls and soil. Looking east.

The rockery area was excavated on 10 and 12 November 2020 by James Brigers. The core of the wall was found to comprise red gravelly clay with occasional small pieces of stone. Two distinct but similar wall cores were recorded which confirms Rodwell’s interpretation that the wall was rebuilt from this point (B11).

At the east end of the excavated area, on the south side, a large cut was evident that appeared to have been made to provide a setting for a line of stones in the rockery and further modern disturbances were excavated to the west of this. A small trench was extended to the well which recorded an offset foundation-course comprising vertically-sided stones. Where seen these were mortared with cement and must have been disturbed by landscaping or later gardening activities as was the single surviving course of the battered wall stones above. Some difficulty was found in relating these to the drawings produced by Rodwell (1984) and it appears that the courses on either side of the rockery are misaligned by one course on the drawing, possibly because his datum does not appear to be level.

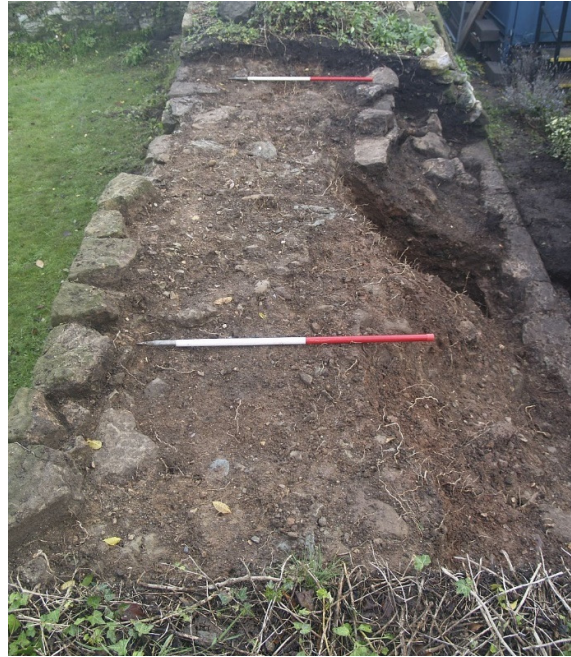
**Figure 3:** The rockery area from the south-west with the 1930s well head to the right.

This “end” may have discouraged Gray from digging further west, leaving this area to be cleared by the landscapers. They must have uncovered the continuation of the south face of the wall and converted the gap to a rockery rather than rebuilding. This indicates that the stonework from the missing area of face had been robbed in antiquity otherwise collapsed stones would have been found and probably reused. It is possible that this robbing took place during the original sinking of the adjacent well from a higher ground level and the stone robbed where it was accessible. It is not known when the well was dug but it had probably gone out of use by the time of the 1888 Ordnance Survey plan of Taunton as it is not shown.

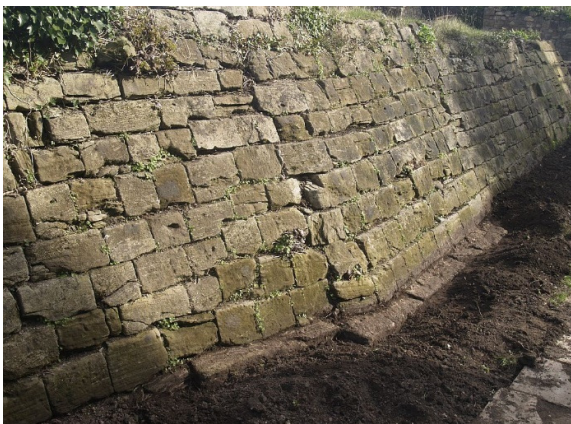
**Figure 4:** Wall B from the west showing the foundation course exposed by gardening at B2.

After the end of the excavation, gardening work to the east uncovered a foundation course beneath the topsoil. Only the tops of the stones were observed but four well-dressed blocks were visible parallel to the wall from B2 to B5 and extending slightly beyond B2 as the rebuilt wall line diverged northwards. It seems likely that this foundation continued eastwards before the realignment when it was lifted for reuse. At the east end, the blocks were more irregular in shape, possibly from in situ damage, at B3 which appears to be the west side of an infilled gateway.
