## **Structures known as the “Great Stables”, Tattershall Castle, Lincolnshire: Level 3 Historic Building Survey**

Tattershall Castle, Sleaford Road, Tattershall, Lincolnshire, LN4 4LR

**Dr James Wright FSA**  
**Triskele Heritage, Sneinton, Nottinghamshire**

October 2022

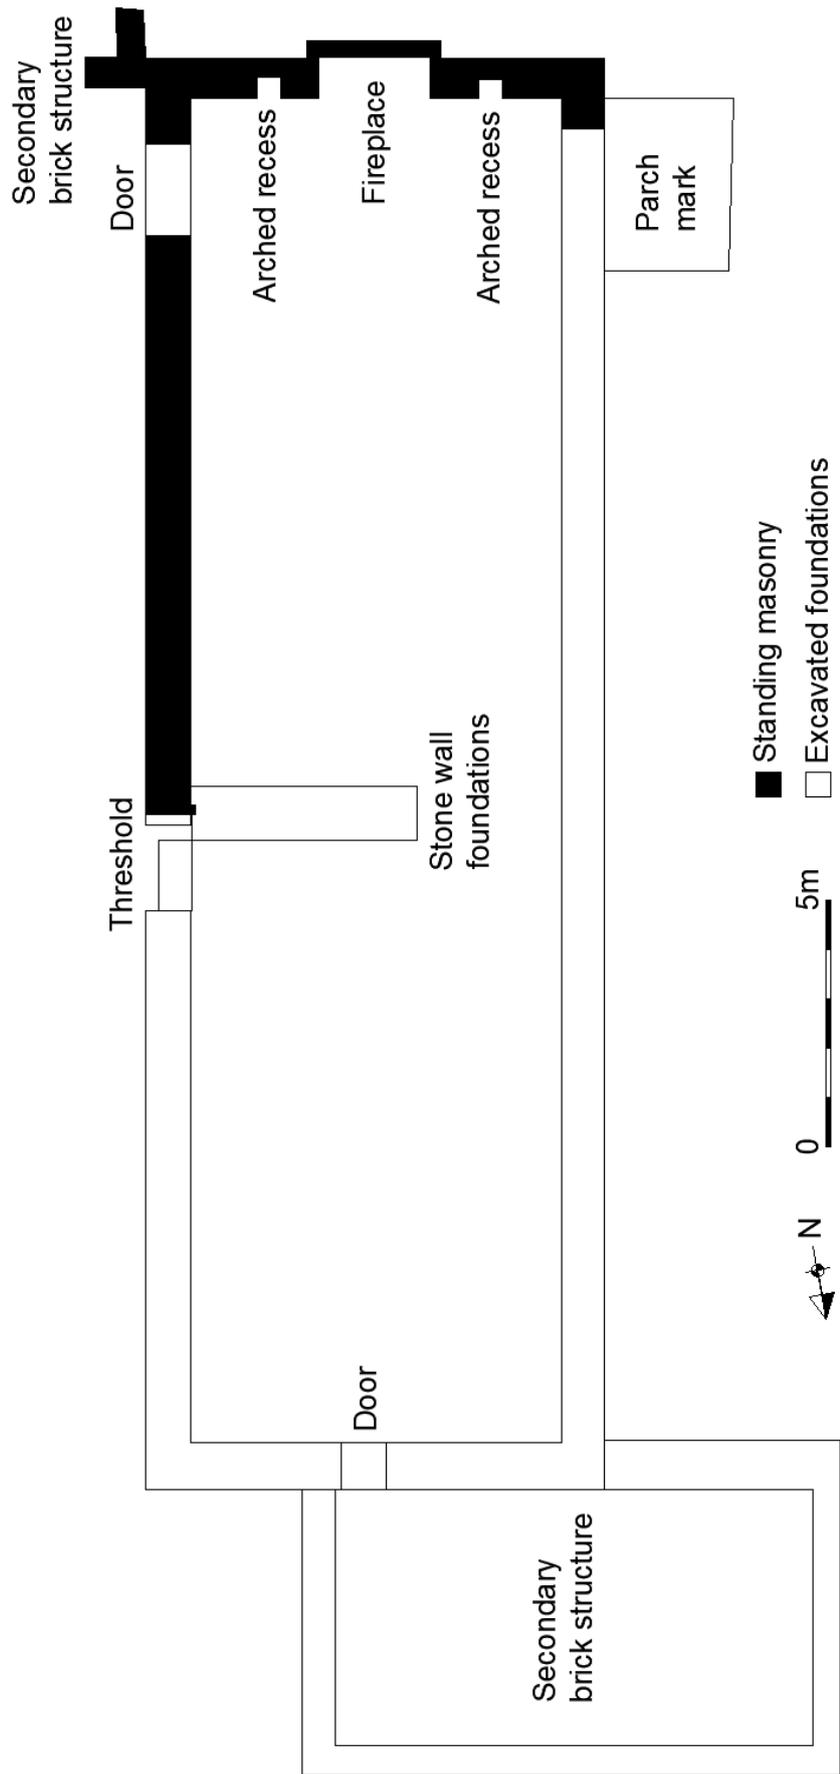
Figure 4 Plan of the building known as the stables

The group of roofless brick and stone buildings, considered in the present document, stand in the north-west corner of the Outer Ward and are orientated north-south (Figure 2, Figure 3, Figure 4 & Figure 5). They comprise the fragmentary standing remains of the south elevation and part of the east elevation of the south range (Figure 5). The north end of the east elevation and all the west elevation of the south range, plus the north range are defined only by their excavated foundations (Figure 4).

The south range measures 27.28 by 7.47 metres internally. It is divided by a transverse stone foundation into two spaces measuring 13.95 x 7.47 metres internally (south) and 12.23 x 7.47 metres internally (north). The wall thickness of the south range varies between 0.84 and 0.88 metres. The dimensions of the south range brickwork vary between 105-125mm (breadth) x 50-60mm (thickness) x 210-225mm (length), with four courses measuring 251-255mm. The north range abuts that of the south range, is orientated east-west and measures approximately 10.02 x 6.8m externally. Its walls are c 0.7 metres in thickness. It was not possible to gauge the brickwork dimensions of the northern build as only the upper face of the excavated remains was visible.

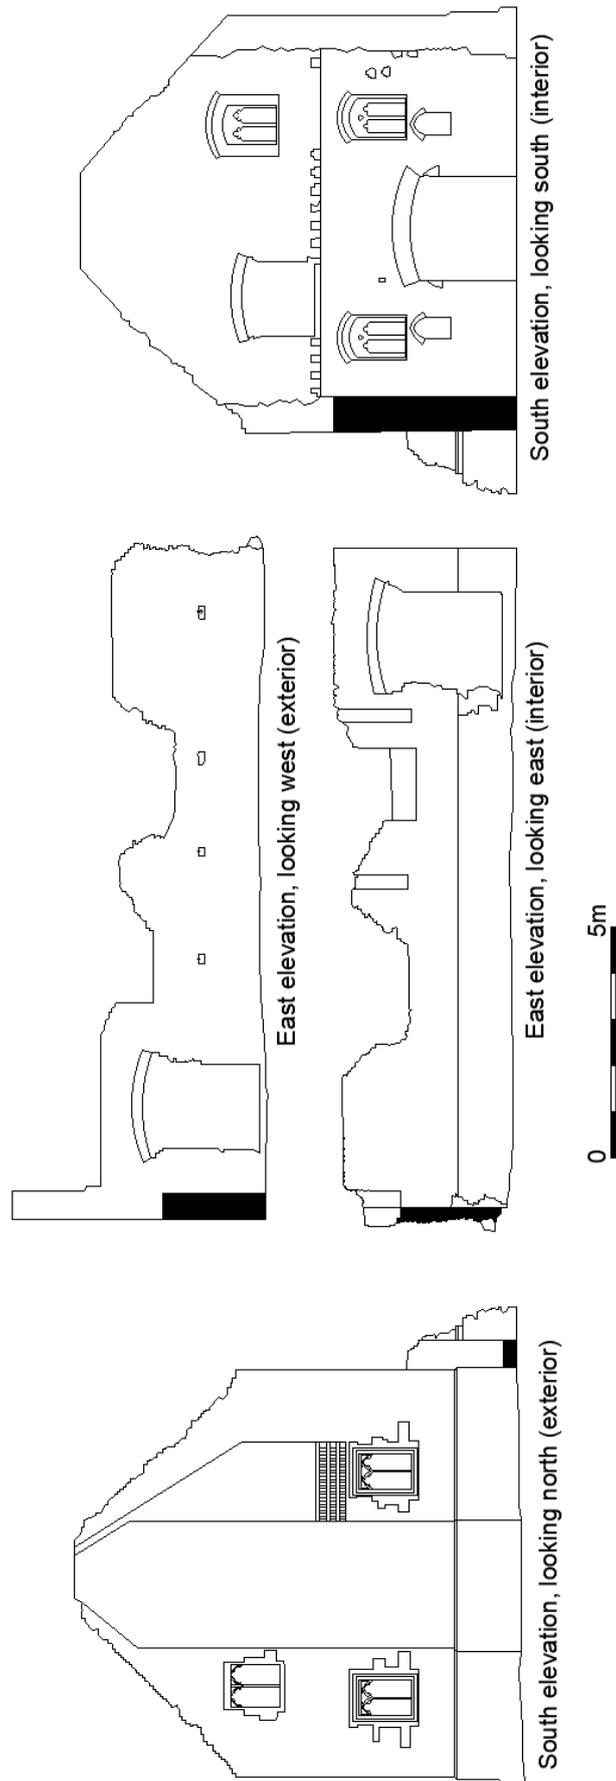
Figure 5 Elevations of the upstanding elements of the building known as the stables

The upstanding masonry at the south end of the south range represents a relatively intact gable end (Figure 5, Figure 24 & Figure 25). At ground floor level it features a centrally located fireplace flanked by two recesses with pointed drop-arch heads. There is a low plinth, 0.2m above ground level, to the east of the fireplace but not to the west. Above are two stone, square-headed windows with Y-tracery and two-light trefoil heads. Internally, the segmental rear-arch and embrasure are of moulded brick. Externally the stone reveal has a moulding comprised of a chamfer, scotia and shallow cavetto underneath a four-centred arch with a flat head (Figure 26). The window mullions were all replaced by Weir (Curzon & Tipping 1929, 203). Overall, the design is akin to a simplified version of the mid-fifteenth century windows of the Middle Ward lodgings at Tattershall – the windows of the Outer Ward building lack relieving arches, label moulds and pierced spandrels (Figure 27).

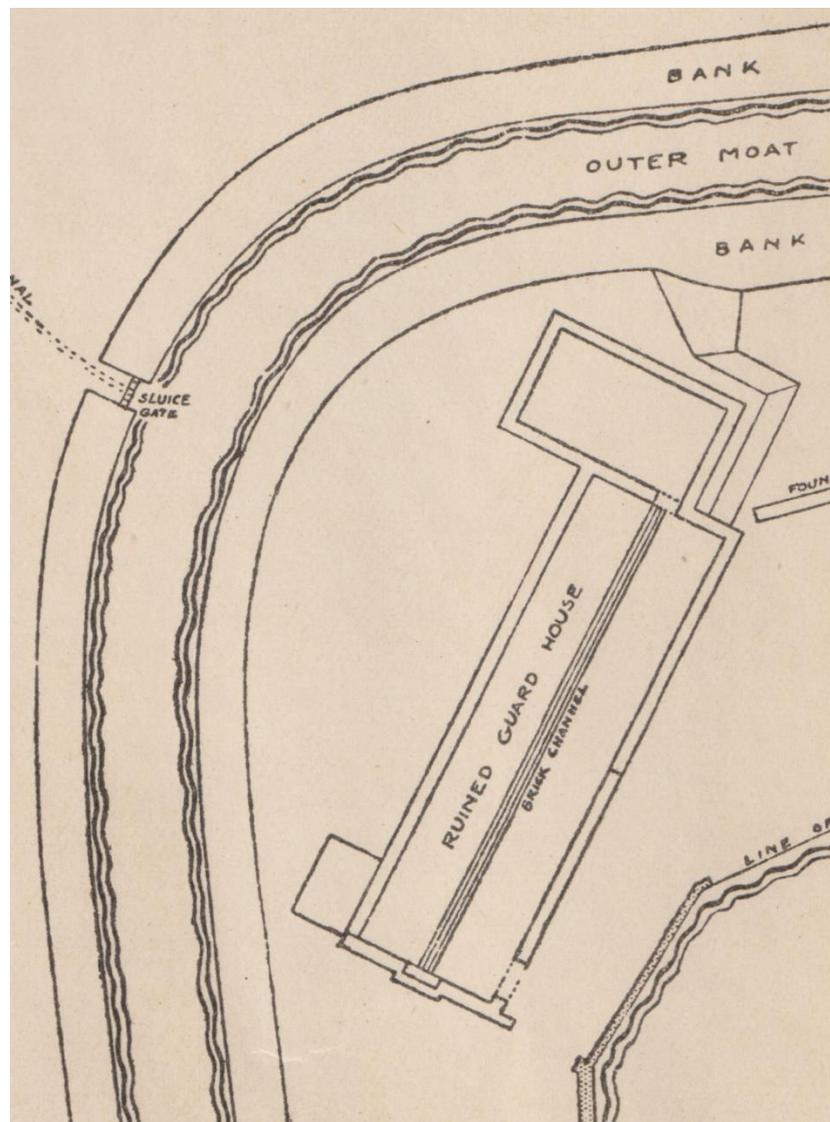
Figure 19 Detail of Weir's 1914 plan showing the excavated remains of the building. Note the central brick channel (Picture Source: Curzon & Tipping 1929)

*In excavating the ground within the walls a brick channel has been exposed running the full length of the building down its centre. It is possible that its purpose was connected with the warming of the rooms by distributing the heat from the fireplace, at which point the channel appears to start" (Curzon & Tipping 1929, 203-04).*

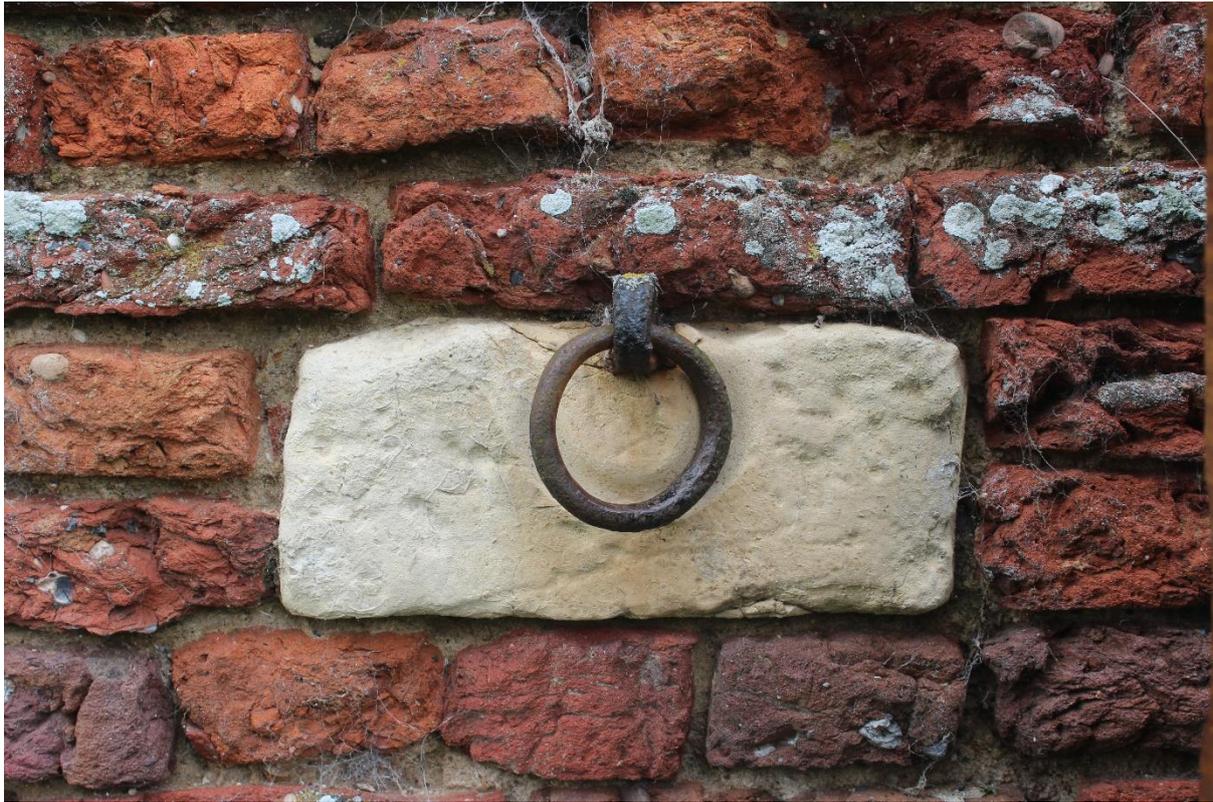
Figure 20 The northernmost of four stones originally associated with iron rings in the east elevation of the building, looking west

may have been a building connected to equine provision at the castle but insisted that the iron rings (Figure 20) in the east wall “gave a clue to its purpose” as “*the Great Stable*” (Curzon & Tipping 1929, 146).

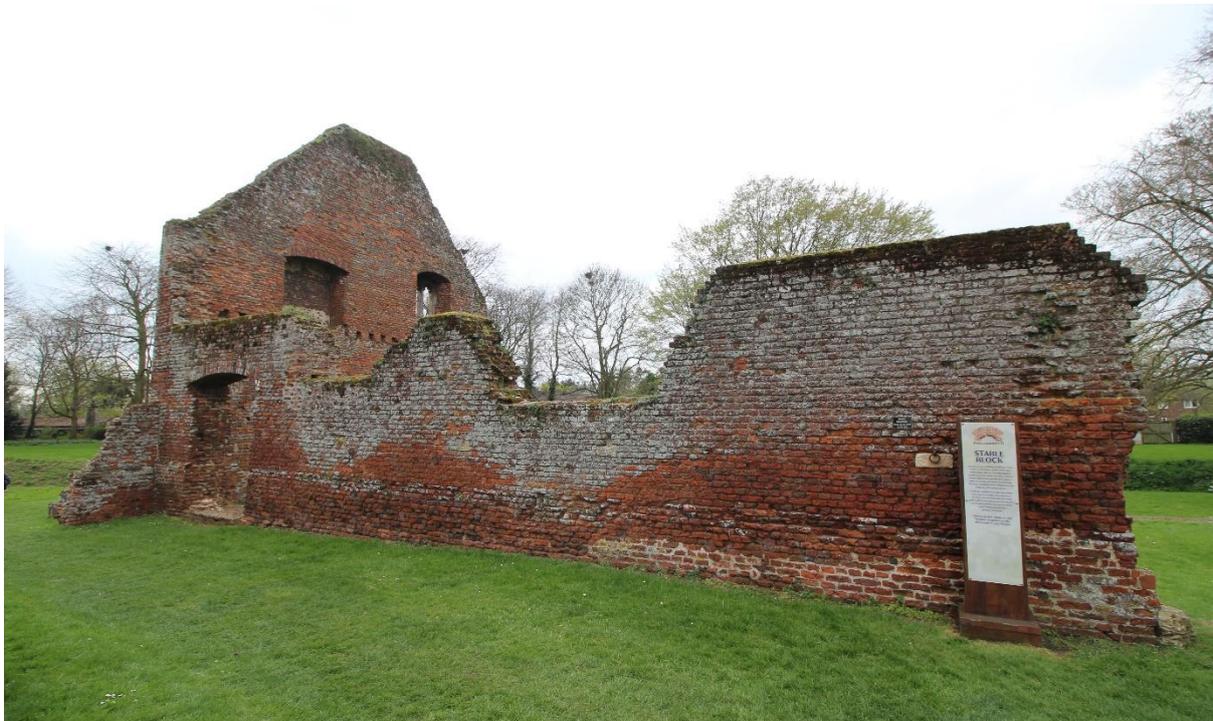
Figure 23 The east elevation of the building, looking south-west. Note the interpretation panel identifying the building as the "Stable Block". Image taken in February 2017.

The eastern elevation is in a variable state of preservation (Figure 23 & Figure 31). Although much of the masonry survives for approximately 14.53 metres at the southern end almost to eaves height, only the foundations remain in situ for the remaining 12.75 metres at the north end. The south end of the east elevation has a high plinth 1.02-1.05 metres above present ground level. This contrasts with the remaining stub wall of the western elevation which has two plinths 0.25 above ground level with another 0.78m above that (Figure 5). The doorway at the south end was almost entirely rebuilt during the 1912-14 conservation works, although there are traces of earlier brick jambs in situ (as noted by Weir: Curzon & Tipping 1929, 203). This historic opening is confirmed on the 1788-89 Nattes drawing (Figure 9) and 1857 photograph (Figure 12).

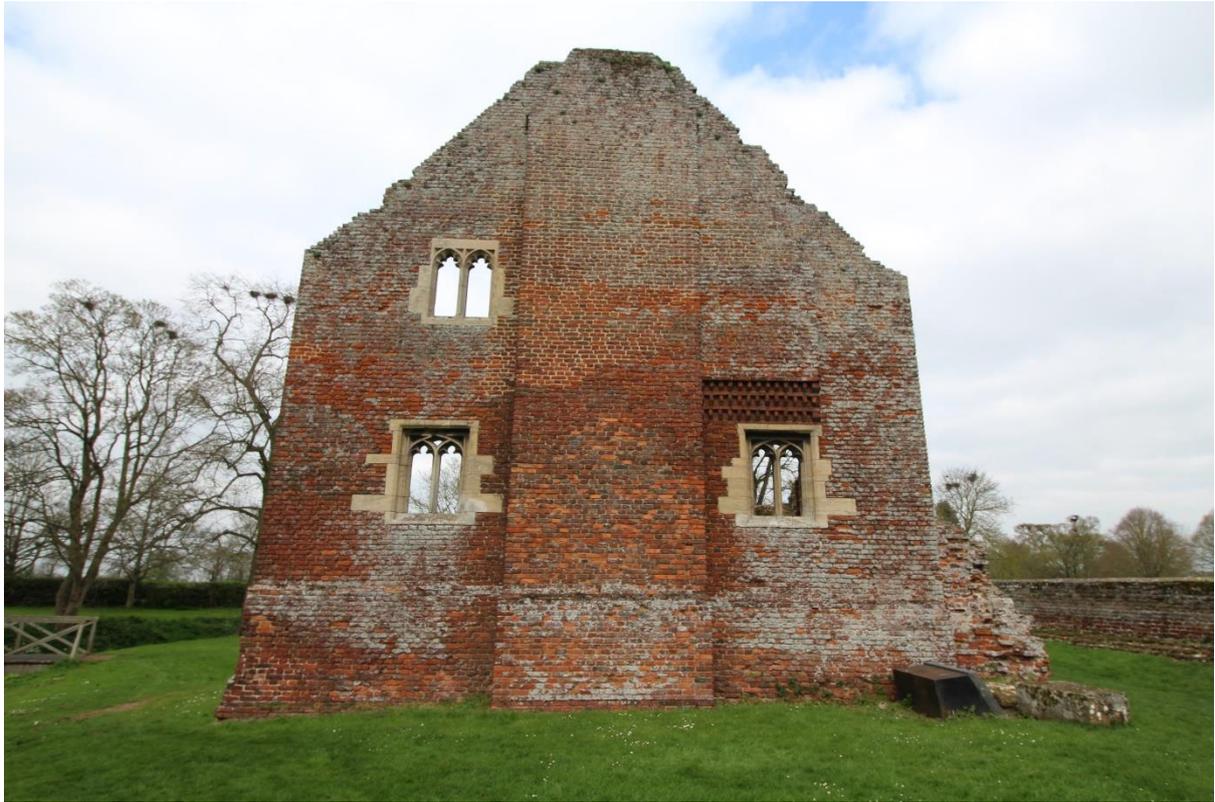
*Figure 24 South elevation of the south range, looking north*

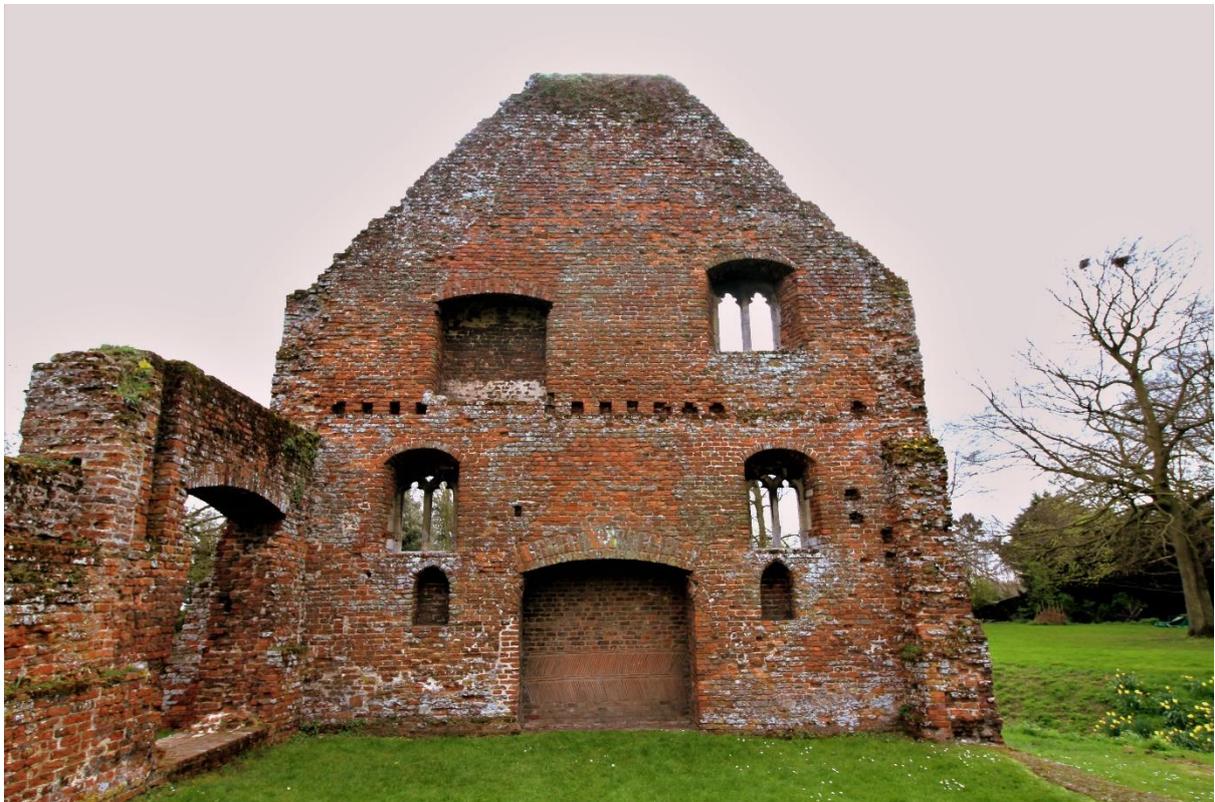
*Figure 25 South elevation of the south range, looking south*

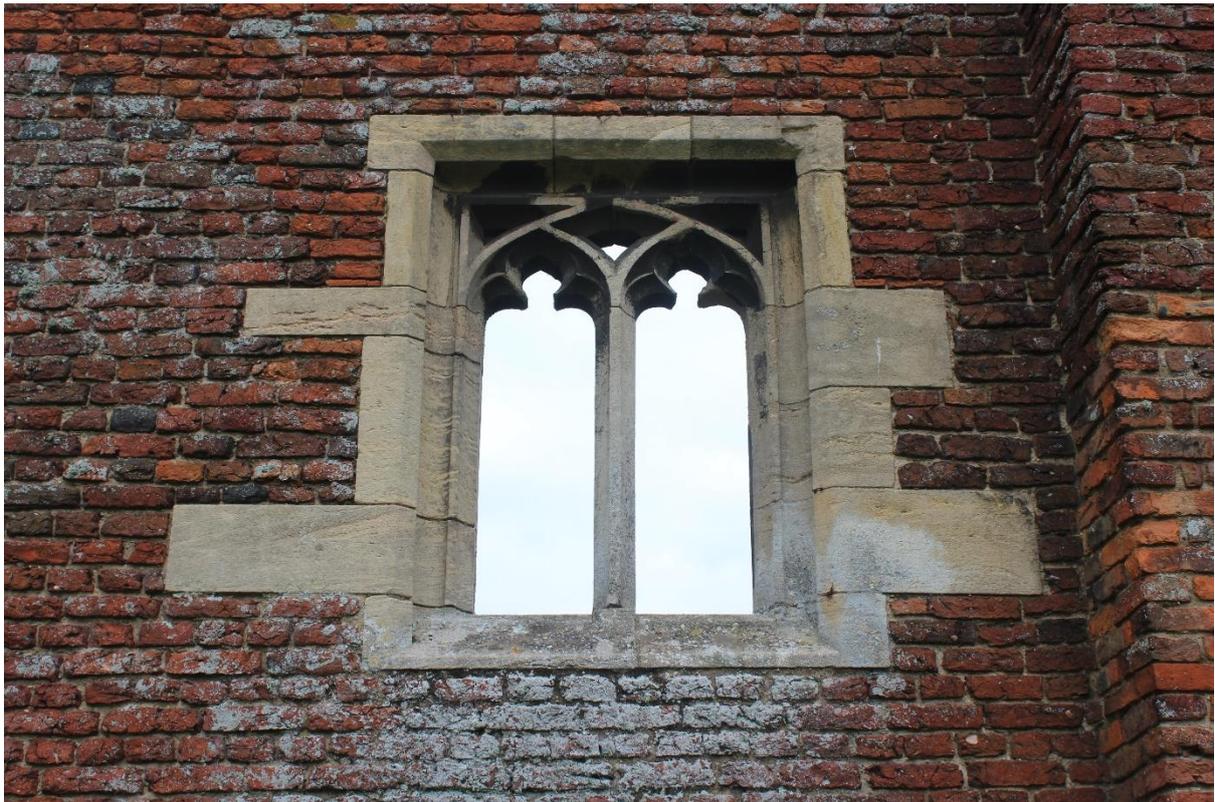
*Figure 26 Ground floor window in the south elevation of the south range, looking north*

The timberwork of the first-floor framing was originally supported on a ledge associated with 11 joist holes. The first floor has an off-centre fireplace that fed smoke into a three-tier, brick-corbelled projecting chimney stack. The first-floor window to the west of the fireplace is of different design to those at ground floor (compare Figure 26 to Figure 28). The embrasure

In common with the Middle Ward lodging (Figure 27) and great tower (Figure 3), the fenestration of the south elevation (Figure 26 & Figure 28) features a mix of contemporary Perpendicular Gothic tracery elements (such as the central mullion rising from cill to head) with anachronistic motifs drawn from the period of earlier fourteenth century Decorated Gothic (such as the Y-tracery). Hart (2010, 128) has noted that, during the early phase of Perpendicular, a natural conservatism led to the survival of older styles but that a later reaction took place in the fifteenth century against the strict austerity of the style which “*prompted reintroduction of some of the old, curved forms.*” Harvey (1978, 150-1) pointed out that the Decorated form persisted in buildings of the Lancastrian Court Style and those within its orbit. Cromwell was very much a member of that community and either he or his master builders (or of course both) may have had a particular penchant for such a deliberately anachronistic Decorated Gothic design (Wright 2021, 144-46). The decision to do so may have been part of a wider scheme of atavism which saw the use of antiquated tracery, mouldings, armorials and even the form of the great tower at Cromwell’s houses at Tattershall and Wingfield Manor. The function of this anachronism may have been intended to promote Cromwell’s ancient lineage at a time when he was vying to promote his political rise to power at Lord Treasurer of England (Wright 2021, 125-26).

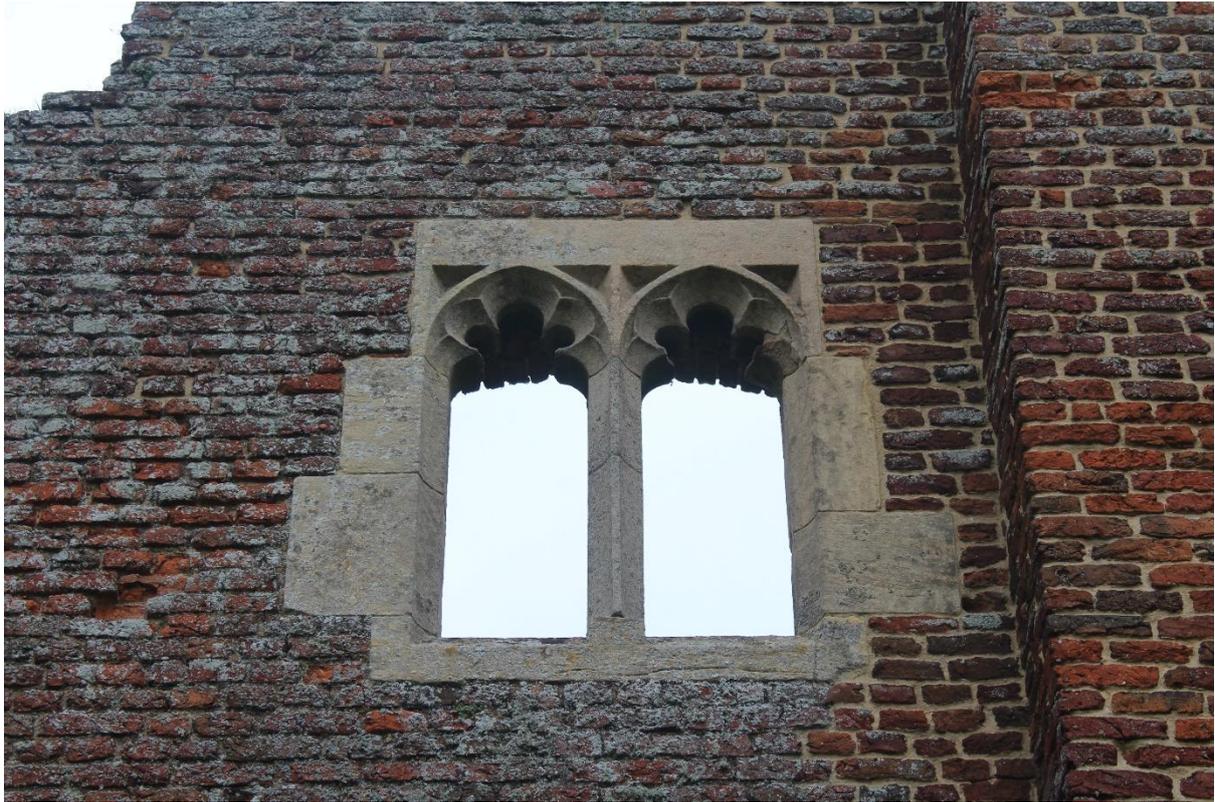
*Figure 28 Ground floor window in the south elevation of the south range, looking north*

arrangement is the same – moulded brick segmental rear-arch and jambs – however the external reveal has two-light tracery with a perpendicular central mullion flanked by cinquefoil cusps beneath a four-centred arch with a flat head.

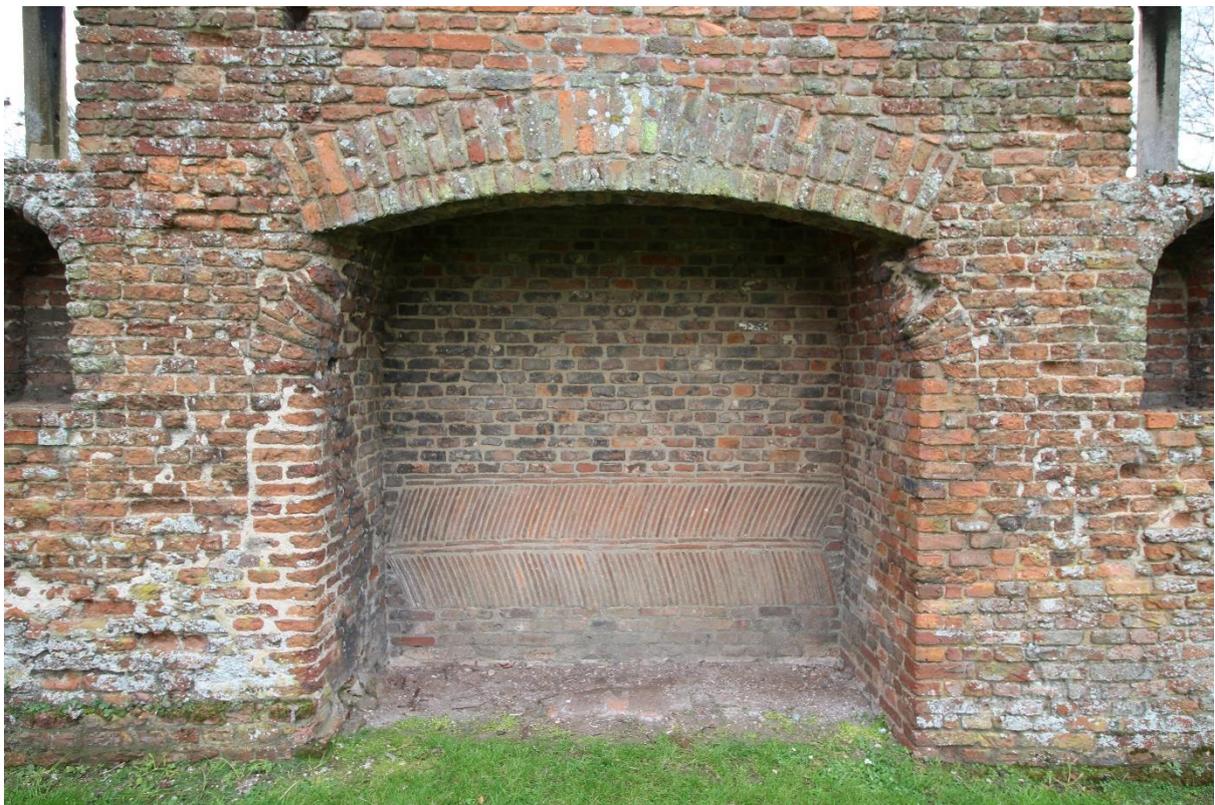
*Figure 29 Detail of the rebuilt ground floor fireplace in the south elevation, looking south. Note the springers for the original arched head in the jambs below the current lintel.*

The two segmental arched fireplaces were restored under Weir in 1912-14 (Curzon & Tipping 1929, 203). The ground floor example had been almost destroyed when a hole was punched through the middle of the south elevation chimney stack at a point between 1727 and 1788-89 (Figure 8). Only six courses of the springers survive on each jamb, but the remaining impression is of a very flat arch like those in the Middle Ward lodgings (Figure 29). The entire fireback was rebuilt with brick and two courses of end-on herringbone tile. The first-floor fireplace has also been restored with only one brick of the eastern springer surviving in situ. A single course of bricks supported a hearthstone of which just a fragment remains beneath the eastern jamb.

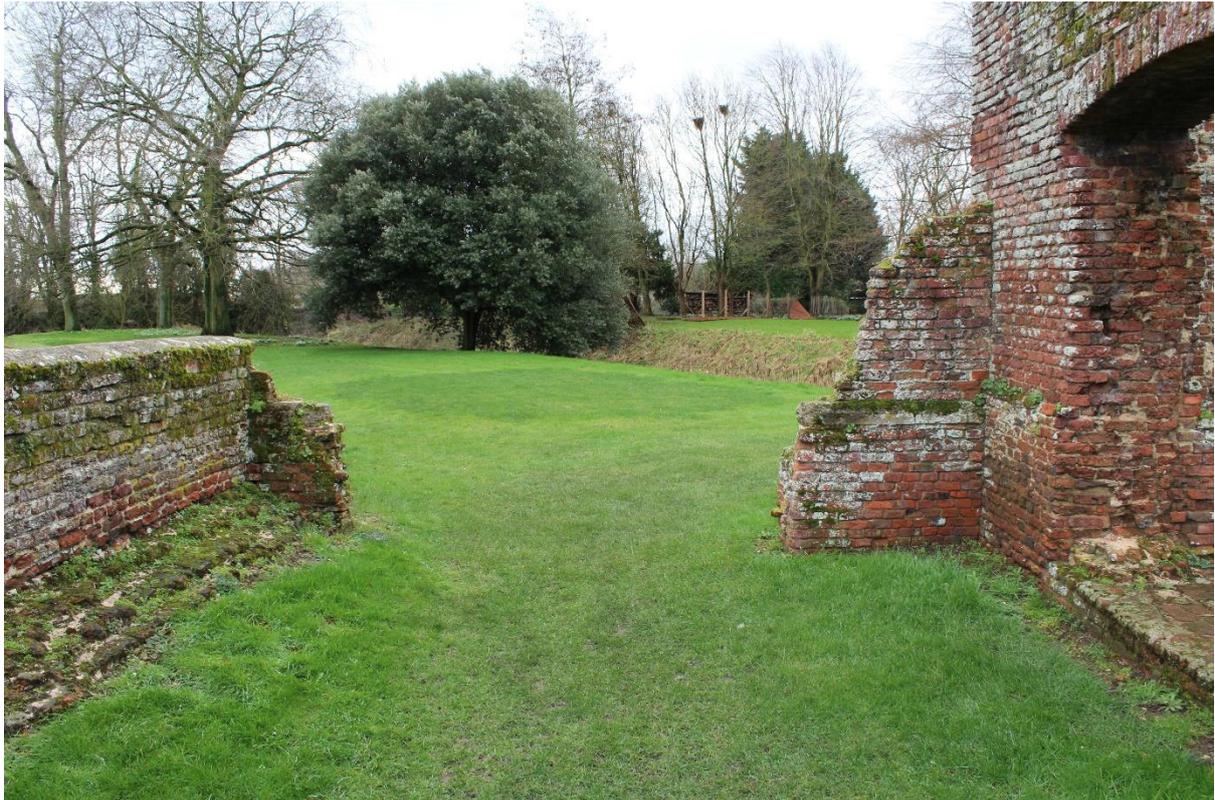
*Figure 30 Possible gateway between the building (right) and Inner Moat wall (left), looking south*

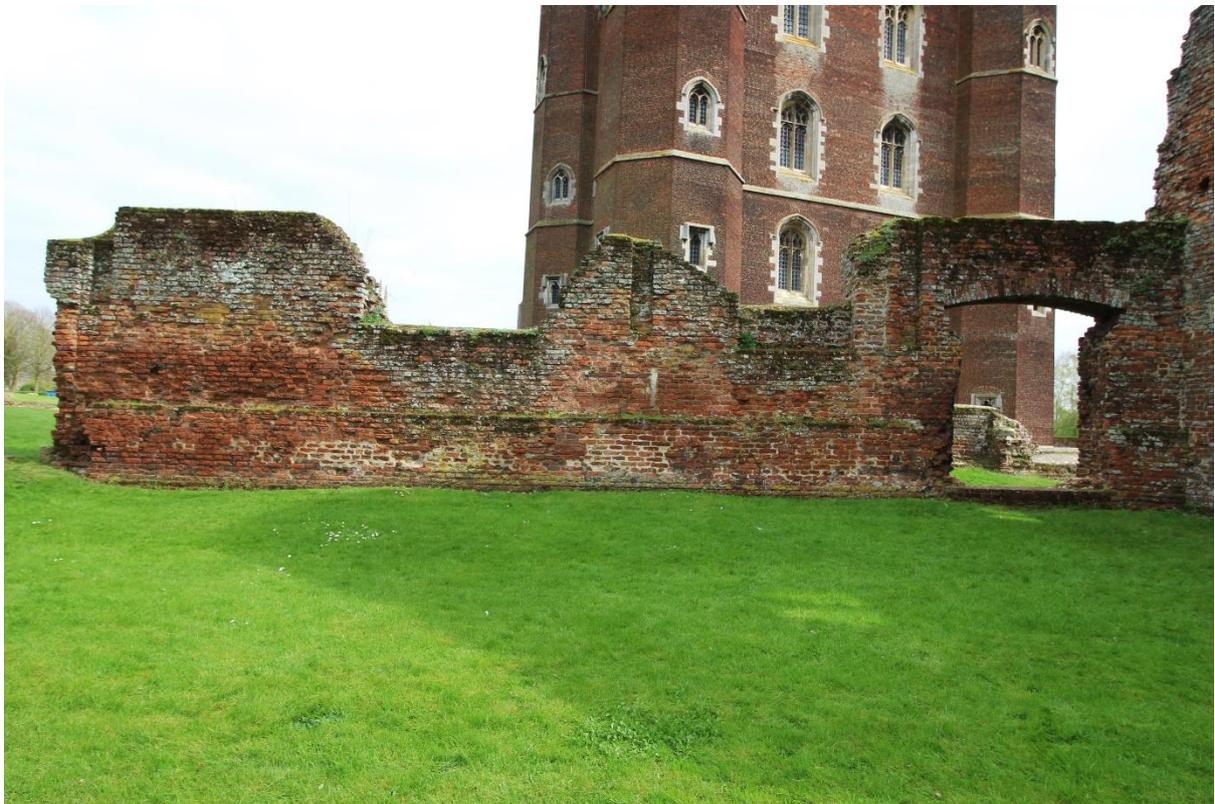
*Figure 31 East elevation of the south range, looking east*

At the north end of the eastern elevation are clear traces of a bonded brick return in the masonry suggesting that a transverse wall divided the south range internally (Figure 4, Figure 5, Figure 31 & Figure 33). This seems to correspond to an in situ 1.1 metre wide stone foundation which can be traced for 4.57 metres in length (Figure 4, Figure 5 & Figure 34). Weir noted the presence of this stone wall and confirmed that it was built directly on top of an earlier foundation, which is presumed to have been constructed in brick (Curzon & Tipping 1929, 203). The transverse wall was probably originally constructed in brick and divided the fifteenth century south range into two near-equal spaces. Millicent's 1727 illustration (Figure 7) can be compared to that of Nattes in 1788-89 (Figure 9) and it seems that a high gable was probably introduced during the mid-eighteenth century. It is presumed that the transverse wall was rebuilt at this time with a stone groundwall. The 1857 photograph illustrates that the high gable end was built of stone at ground level and brick from just below the head of a centrally placed door (Figure 12).

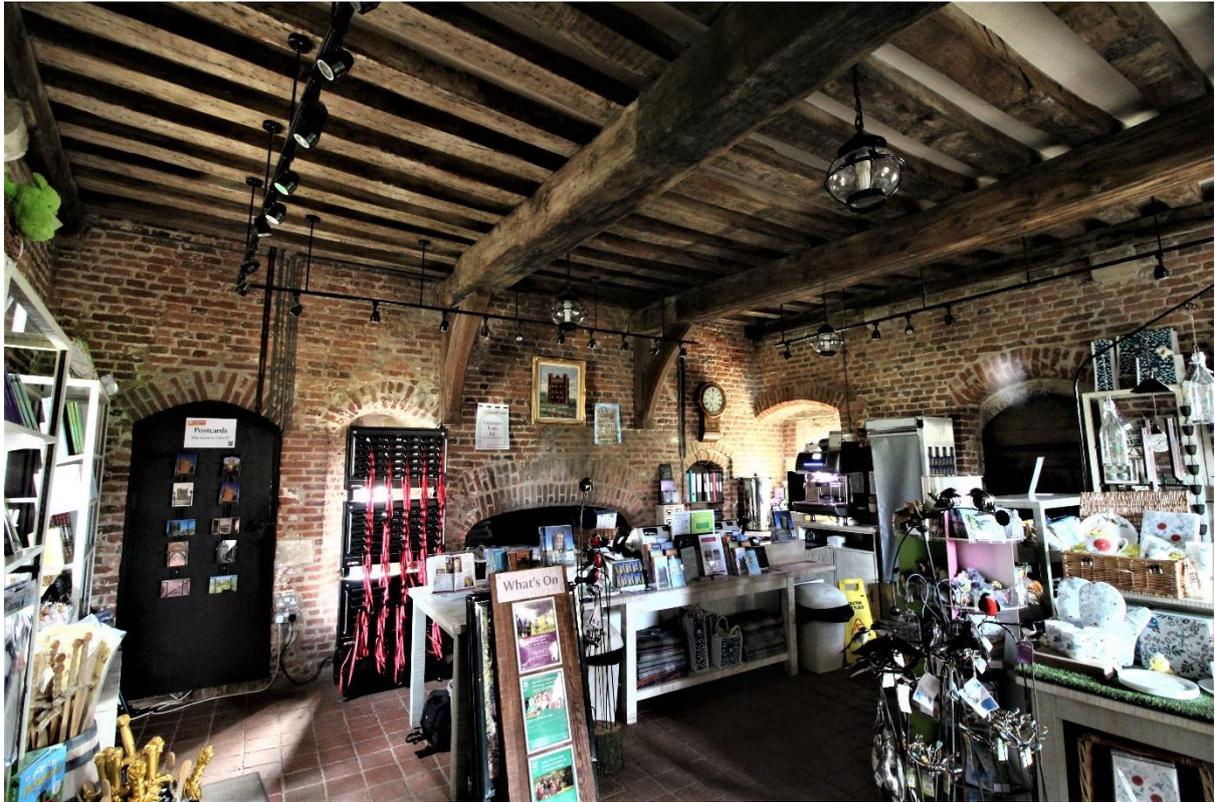
*Figure 32 Ground floor of the Middle Ward lodging, looking south-east. Note the posts and knee braces supporting the bridging beams*

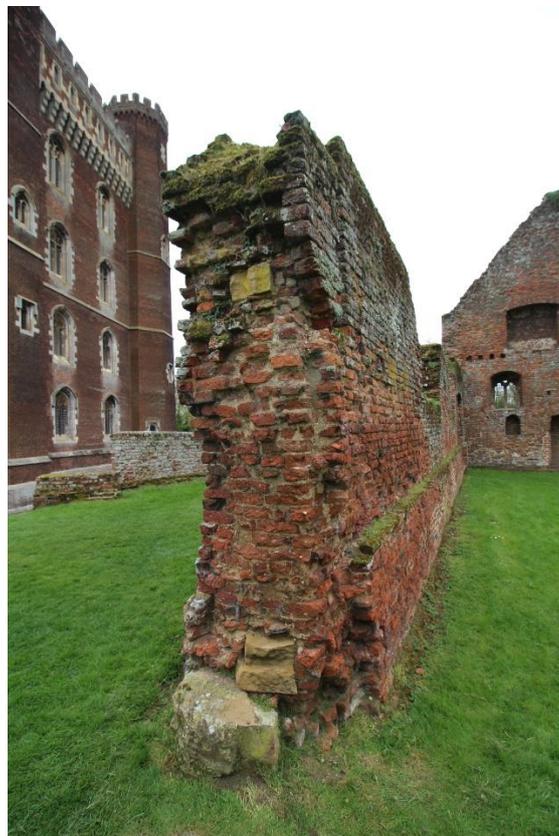
*Figure 33 North end of the surviving east elevation wall, looking south-east. Note the stub of the projecting transverse wall and the base of the stone door jamb*

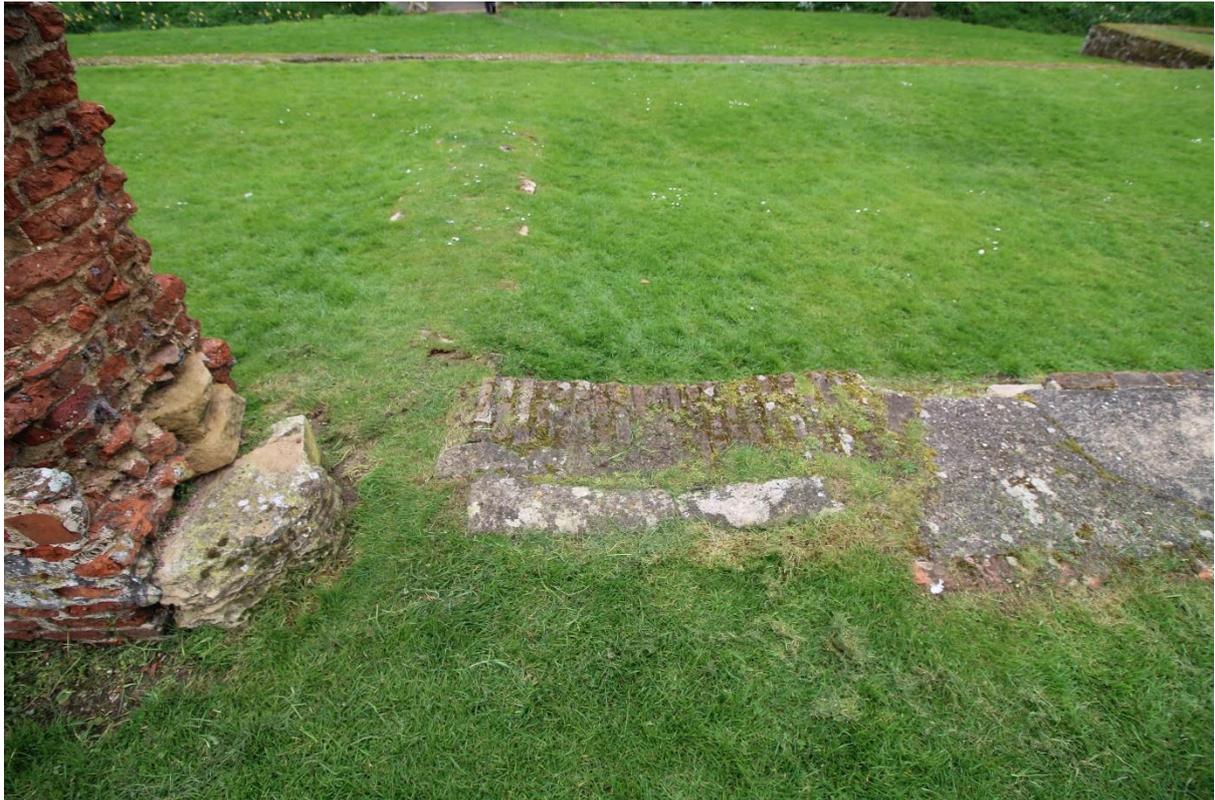
*Figure 34 Threshold to the north of the surviving east elevation wall, looking west. Note the partially buried stone foundation of the transverse wall*

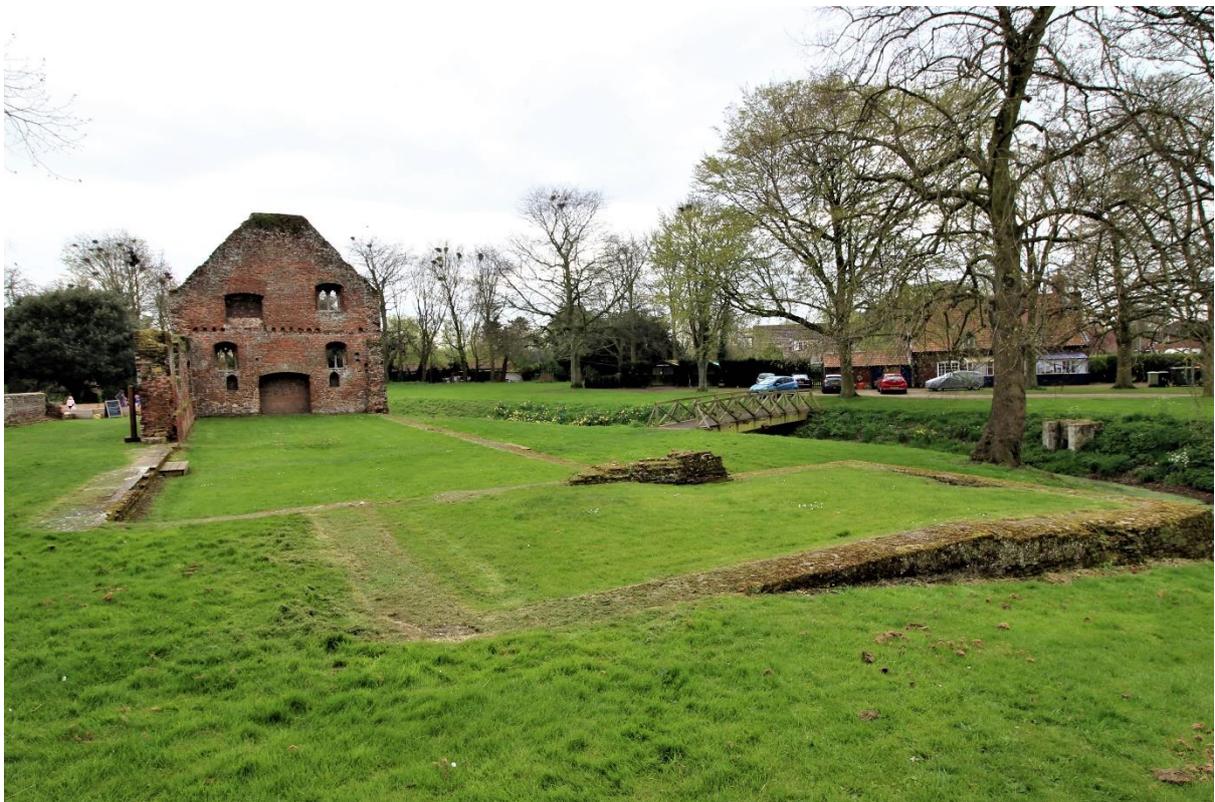
*Figure 35 The site, looking south. Note the foundations of the north range (foreground) and south range (midground)*

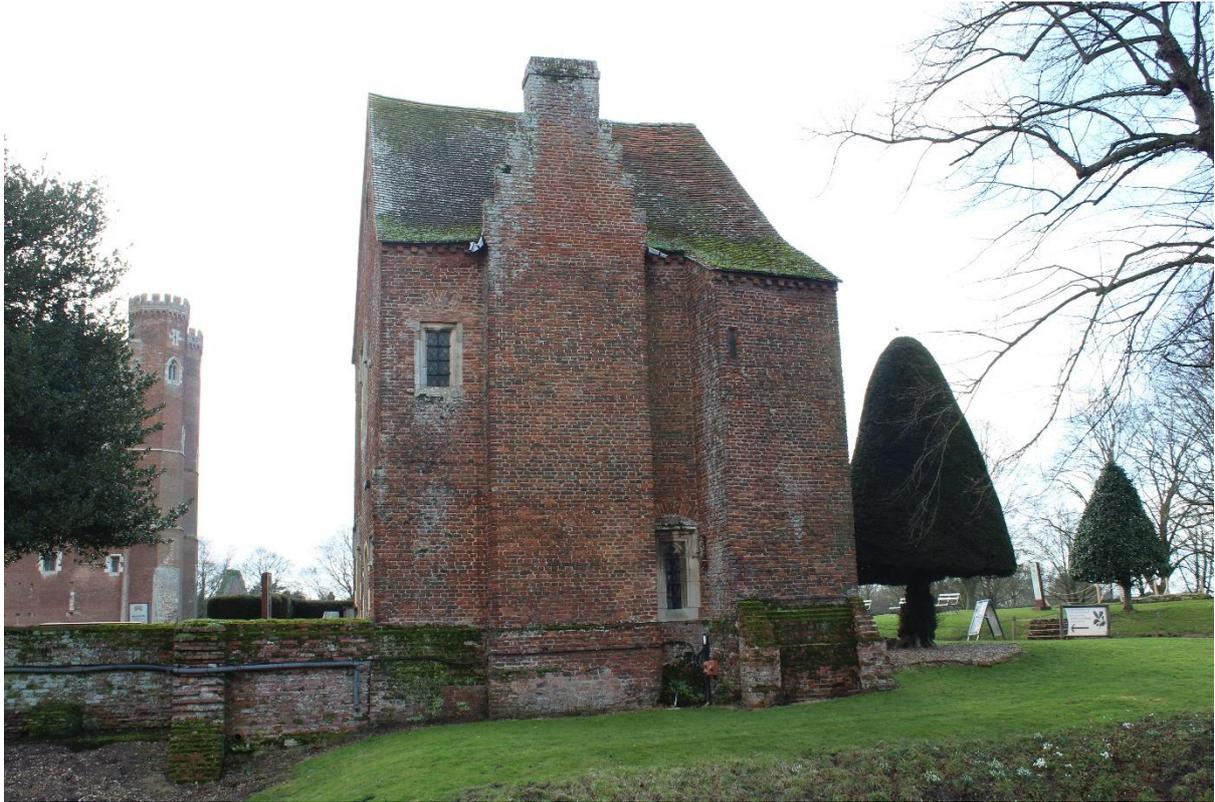
*Figure 36 East elevation of the Middle Ward lodging, looking west. Note the projecting latrine block to the right*

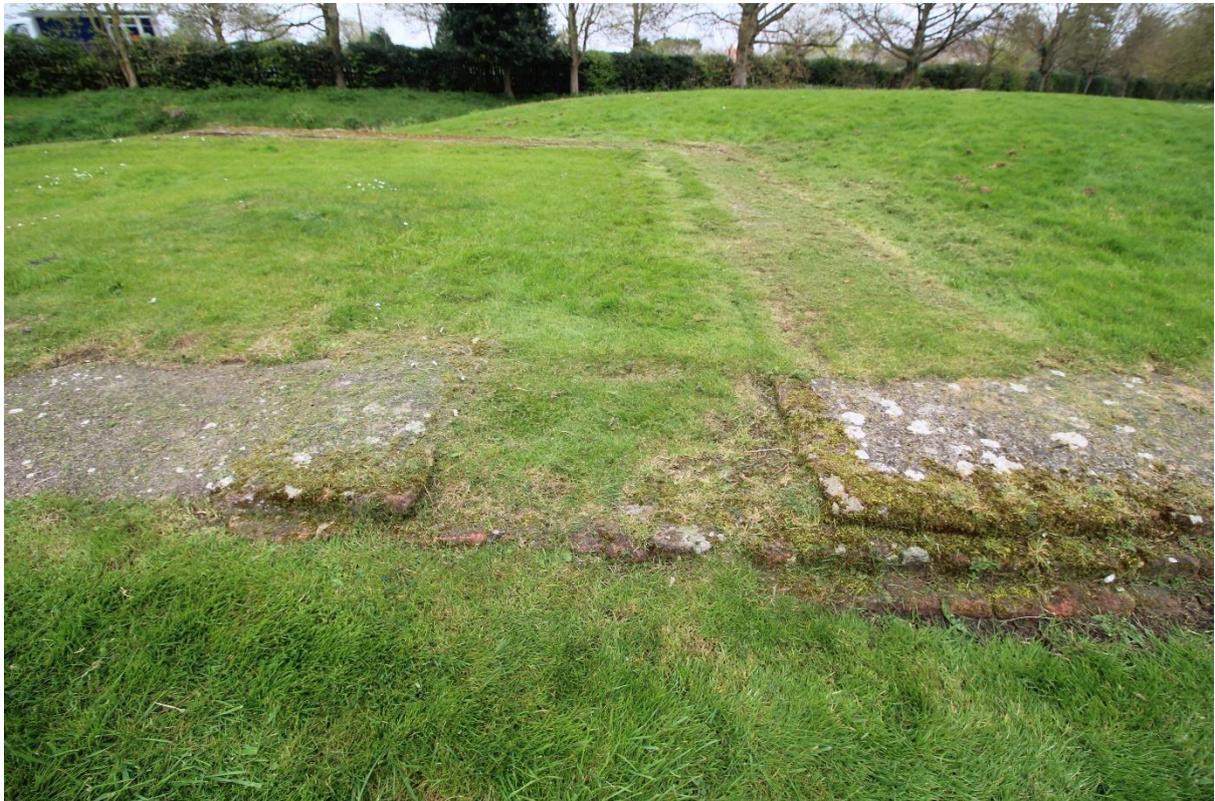
*Figure 37 Threshold between the south and north ranges, looking north*

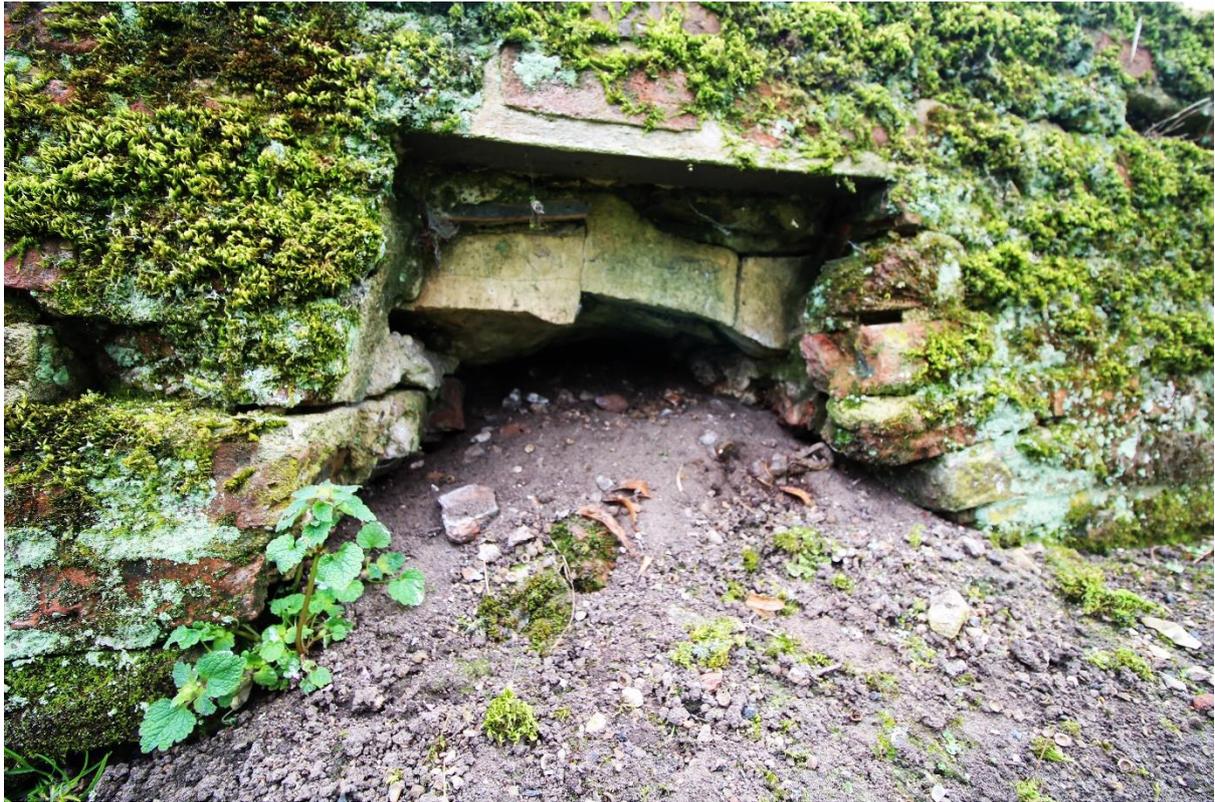
*Figure 38 Blocked drain in the foundations of the west elevation of the north range, looking east*
