HS2 WPO29 – Historic Environment Works – Washwood Heath Depot – Enabling Works North Contract

Final Report for Historic Building Recording Survey

Document no.: 1EW04-LMJ-EV-REP-NS03_NLo8-029001

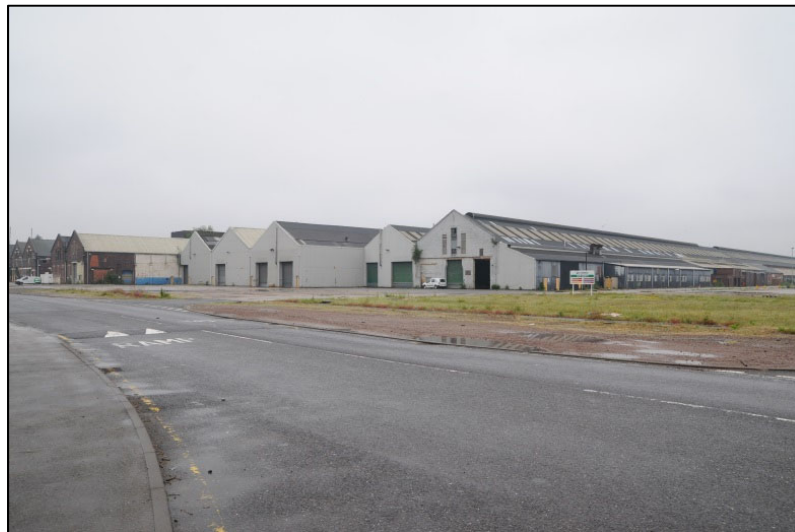
Plate 1 View from the current entrance to the north-east with Block G in the foreground

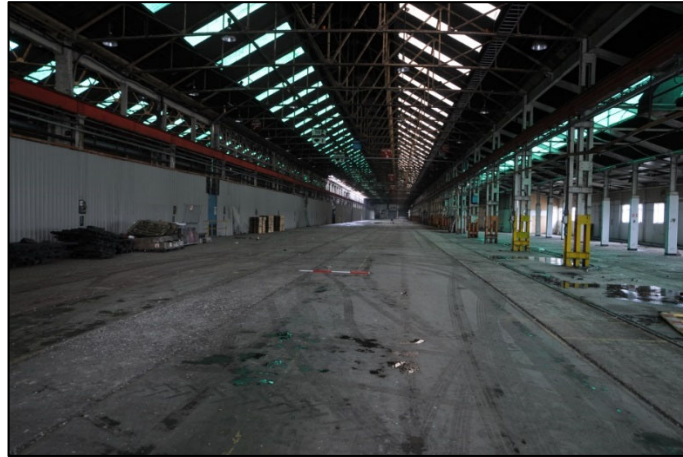
- 6.2.8 As previously noted, G₂ is constructed as a later lean-to structure (Plate 2) which is open for much of its length, with G₁ to the north and G₃ to the south. At the western end of G₂ there is a modern single-storey office space (G₅), which has a corridor running along its length and a modern part-glazed partition to offices beyond, this part of the building was constructed in the later part of the 20th century and the offices are entirely modern.

Plate 2: Internal view of Block G showing G3 with G2 and G1 to the right of the photograph

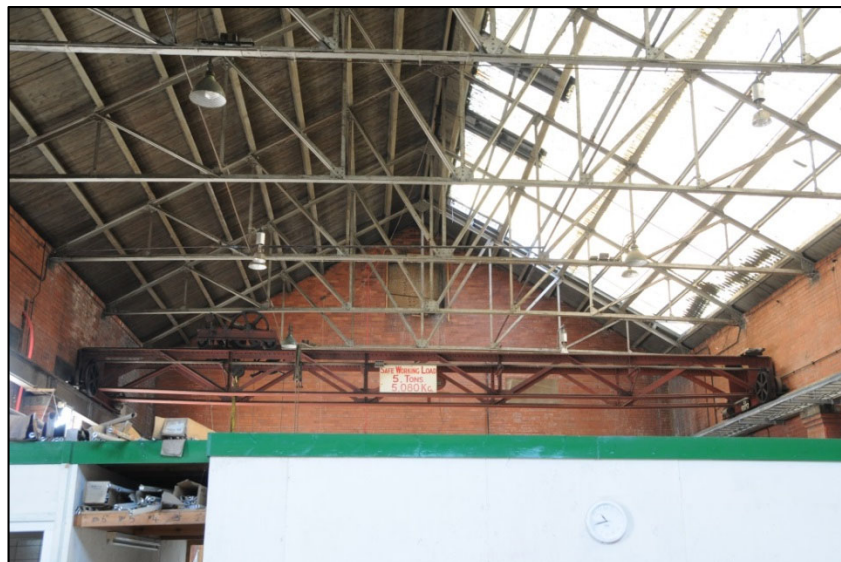
- 6.2.24 Internally, C6c has two levels at ground floor level there is a steel plate platform and walkway supported on brick piers and steel stanchions (Washwood062: Appendix C). To access the basement level below (C6d), there are two cast-iron stairwells surrounded by railings. The walls of the ground floor room have glazed white brick up to the level of a chequerboard pattern tiled dado (Washwood053: Appendix C). Stone capped brick pilasters in the north and south walls of C6c support an I-sectioned steel rail and overhead crane with a five ton lifting capacity, manufactured by Higginbottom and Mannock Ltd of Manchester (Plate 4). The crane above the former engine house is likely to be an original feature as the company Higginbottom and Mannock was founded in Manchester in 1878 and went into liquidation by 1925 (Grace’s Guide (e), 2018) The roof structure over the space is supported on lightweight steel trusses with wooden purlins supporting a match boarded and felted covering

Plate 4: Travelling crane over the former Engine House C6c

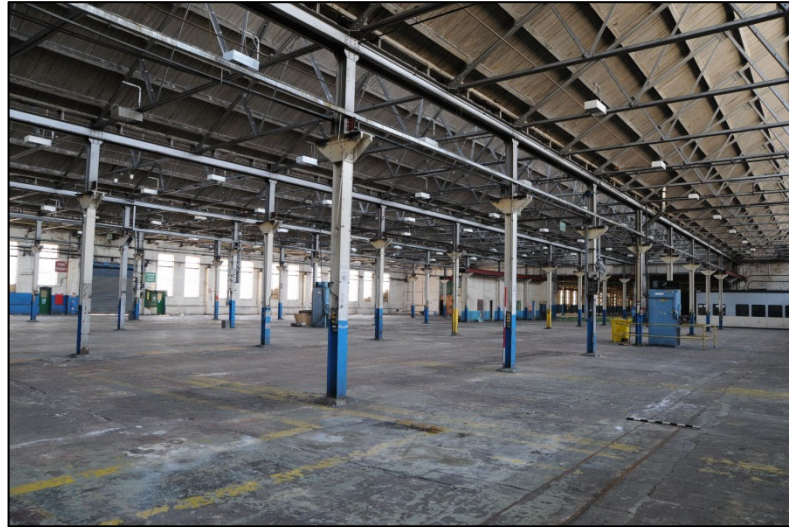
Plate 5: showing the steel stanchions and the saw-tooth roof structure of Block D

- 6.2.27 Block D comprises nine open sheds aligned along an east to west axis. The rows of steel stanchions that support saw-tooth roof structure (Plate 5) each have a shouldered bracket towards the top of each stanchion. Scorch marks on these brackets indicate that horizontally-mounted beams seen in the other sheds have been removed. The space is lit from above by south-facing continuous skylights in the southern pitch of the saw-tooth roof. The plan of the site from 1929 shows that this area was used as a machine shop and by 1948 it is marked as 'old machine shop' (Appendix B: Plates 6 And 9), Little evidence was found within the building to indicate this function.

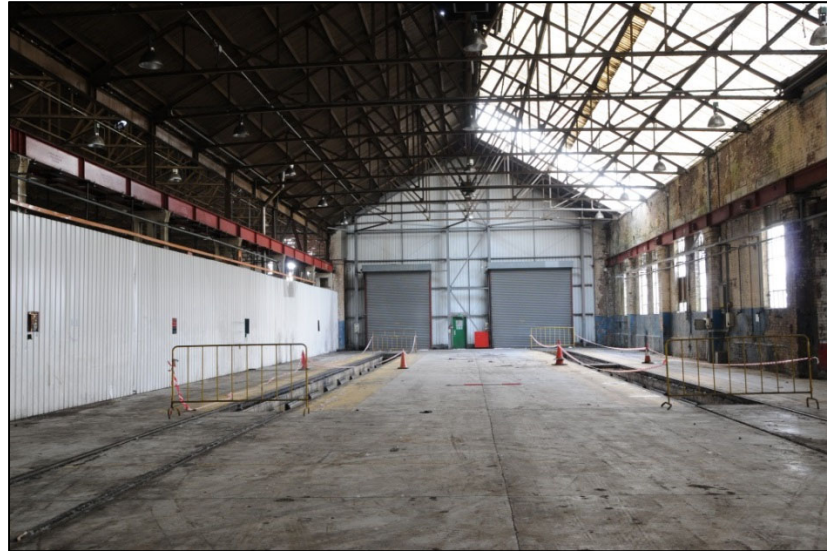
Plate 6: Inspection pit at the western end of F1

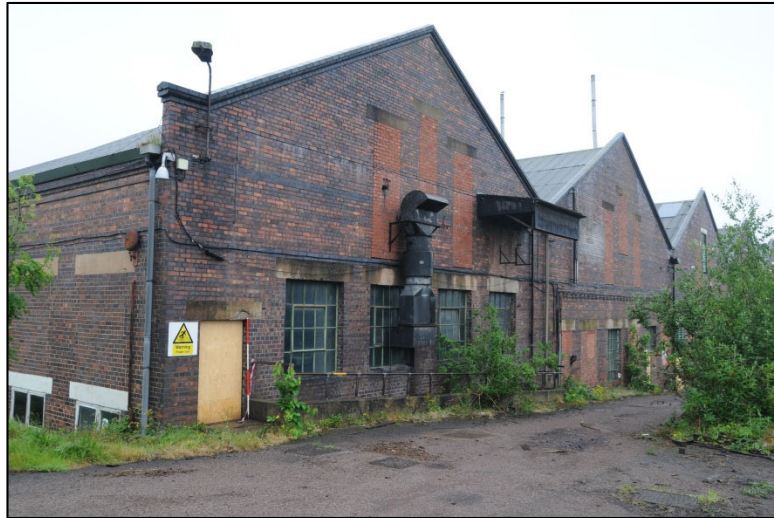
Plate 7: Window openings at the western end of A6

- 6.2.41 Externally, some early ground floor window openings with metal frames survive at the east end of A6 and A5 (Washwood231: Appendix C); above these, the high-level windows in the apex of the gable have been blocked (Plate 7). The south elevation of A6 was overgrown at the time of survey, however, it was possible to note the presence of blocked window openings along this elevation and the presence of external capped regularly-spaced brick pilasters (Washwood233: Appendix C). The external ground level on this side of the building has been raised to give vehicle access to the road on the south side of the site, and a stair has been cut into the raised

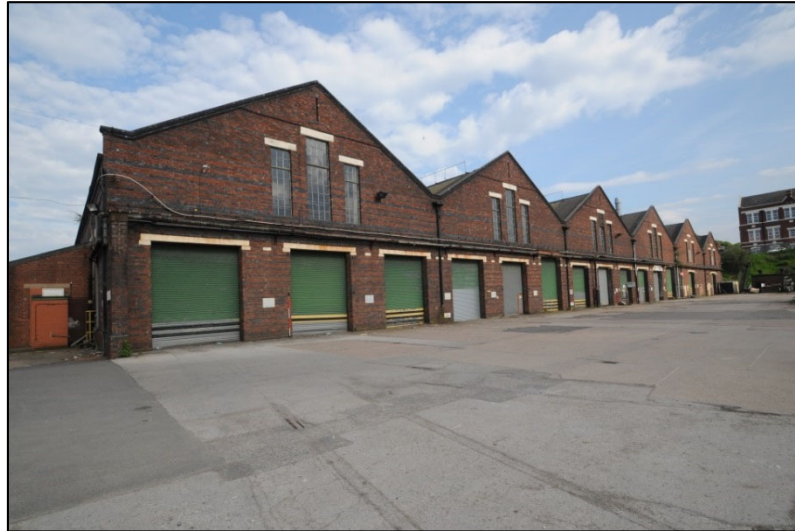
- 6.2.45 Externally, the north-facing elevation of Block B has pairs of regularly-spaced window openings with a stone lintel which also appear to be part of the original early 20th century buildings. Partially blocking these window openings, are single-storey brick lean-to buildings (Washwood159: Appendix C) which appear on the plan dated from 1962 (Appendix B plate 10). The east gable end of Block B mirrors the west gable with its entrances and window openings (Washwood162: Appendix C); however, the entrenched rail tracks present on the west side of the building have been removed on the east side.

Plate 8: Western gable end of Block B

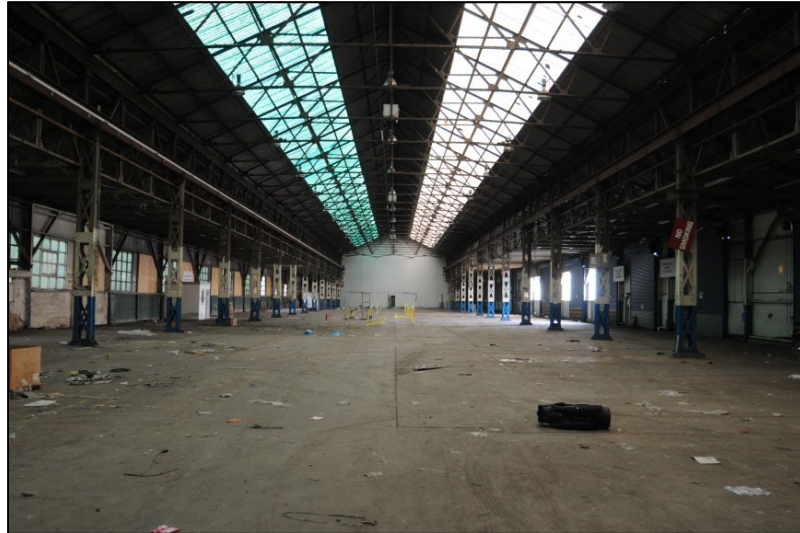
- 6.2.50 Internally H1 is lit from above by a skylight in each pitch of the roof which runs the full length of the shed (Plate 9). The aisles formed by the lean-to structures on the north and south of H1 are lit by window openings where there is no roller shutter door present. The cast concrete floor has no embedded railway lines, and the rows of vertical, paired I-sectioned steel stanchions supporting the roof have the horizontal mounted steel beam noted in the other sheds. Although the shed has an external covering that is entirely modern the internal steel frame survives, and still present within H1 is an overhead crane which runs along the horizontally mounted steel beam (Washwood130: Appendix C). Apart from the overhead crane noted in the former engine house C6c, this is the only surviving example in any of the remaining sheds that once would have been a common feature, evidenced by the presence of the horizontally-mounted steel beams noted throughout the site.

Plate 9: Interior of Shed H1

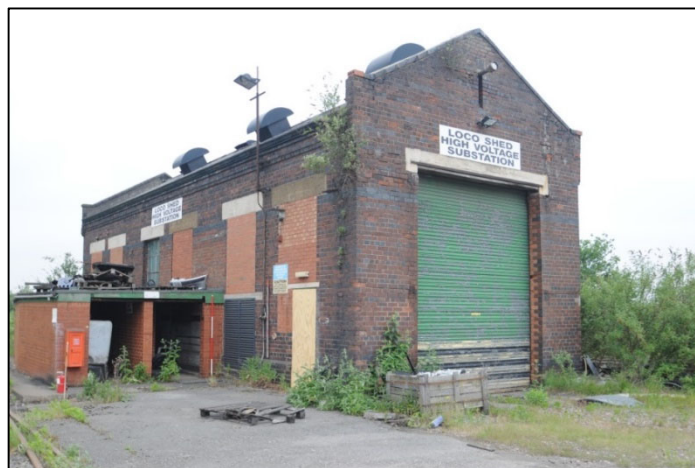
- 6.2.55 Another structure noted during the walkover survey of the site was a small loco shed situated at the south-west end of the site (Plate 10), with a door in both gables and large blocked windows to the sides. This building appears on the mapping from the early part of the 20th century (Appendix B: Plate 4) and was probably used to store a shunting engine that moved goods around the site. The brick walls are constructed using common bonded bricks with three courses of stretchers to one course of headers.

Plate 10: Loco shed at the north-west end of the site

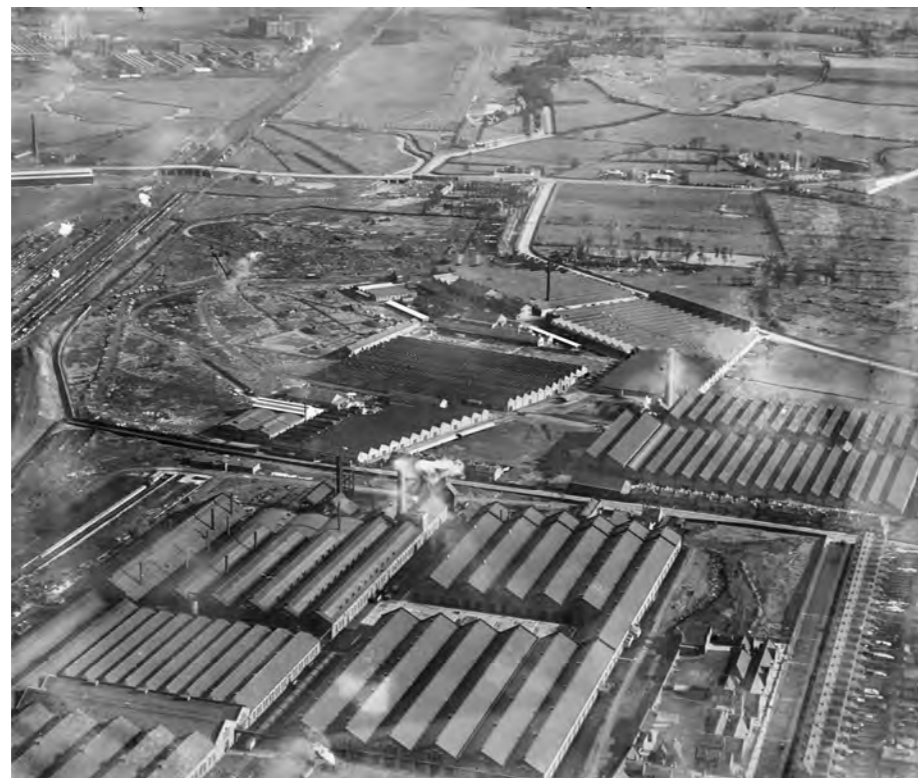
Plate 7: Aerial Photograph of the Wolseley Motor Works and the Midland Railway Carriage Works, Ward End 1930 © Historic England

- 6.1.16 The plan from 1929 shows a gantry and bridge joining the machine shop to the north, and the 'wood wagon building and repair shed' to the south. This gantry and bridge can be seen on the aerial photograph taken in 1930 (Plate 7: Appendix B). Three other aerial photographs taken at the same time as the one illustrated are shown on the 'Britain from Above' website but with the Wolseley Motor Works being the main target.

- 6.3.2 The industrial character of the Washwood Heath area during the mid part of the 20th century is best summed up by an aerial photograph taken in 1930 when the works was at peak production (Appendix B: Plate 7). The photograph shows the Carriage Works with the former Wolseley Motor Works in the background and fields beyond. Undoubtedly, the noise and smell generated from these major manufacturing hubs would have formed a significant element in contributing the industrial character of the area. Since the closure of the former Carriage Works in 2004 and the closure and demolition of the former Wolseley Motor Factory (LDV Truck and Van) in 2009, the environmental impacts of these heavy manufacturing hubs have all but gone. Only light traffic now enters the works, through the main entrance gate on the north side (Plate 12) and heavy industrial character has thus been altered.

- 6.3.3 The aerial photograph from the 1930 (Appendix B: Plate 7), shows that the majority of the buildings on site were of a single storey construction and only the factory chimney (now demolished) would have been visible from a distance. This suggests that works would not have been visually dominant from the surrounding townscape in the past, but that their presence would have been marked by the chimney and likely by noise and traffic as noted in the paragraph above. Today the works are still low rise, and increasingly isolated from public view; hidden behind fences, housing, mature trees and hedge rows. In the later part of the 20th century a dual carriageway (A47) was constructed to the north of the site and new light industrial units introduced in to the part of the space once occupied by the former Washwood

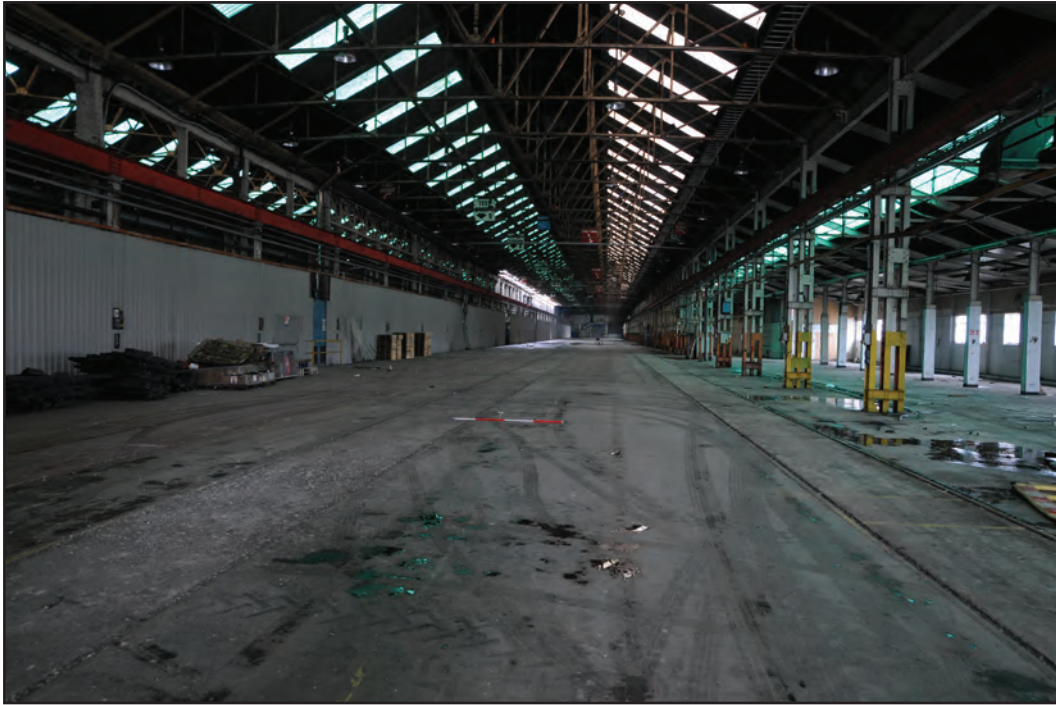
Photograph No. Washwood001
Description: General view of shed interior
Site Location: G3
Direction From: E

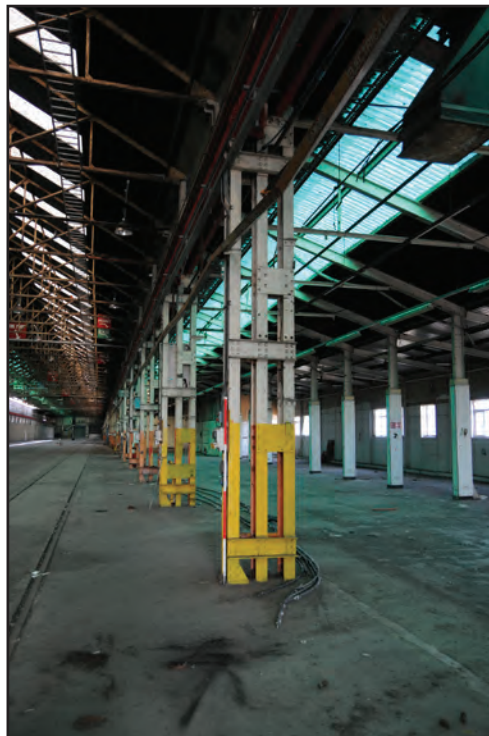
Photograph No. Washwood002
Description: Detail of stanchion on north side of G3/south side of G2
Site Location: G2/G3
Direction From: ESE

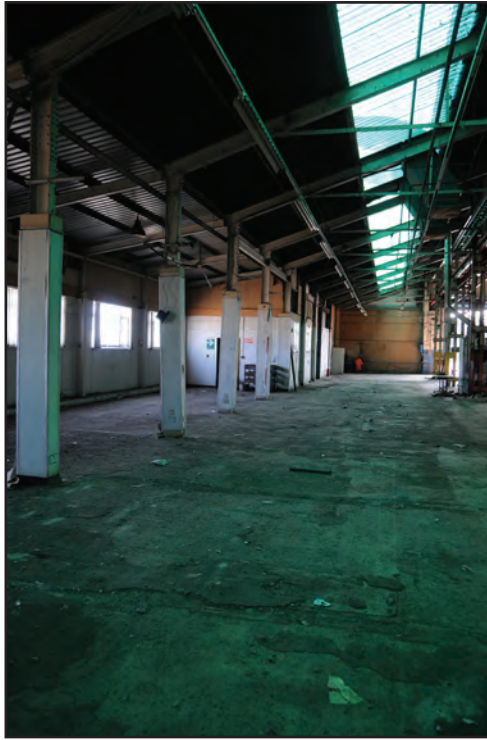
Photograph No. Washwood003
Description: General view of shed interiors
Site Location: G1/G2
Direction From: W

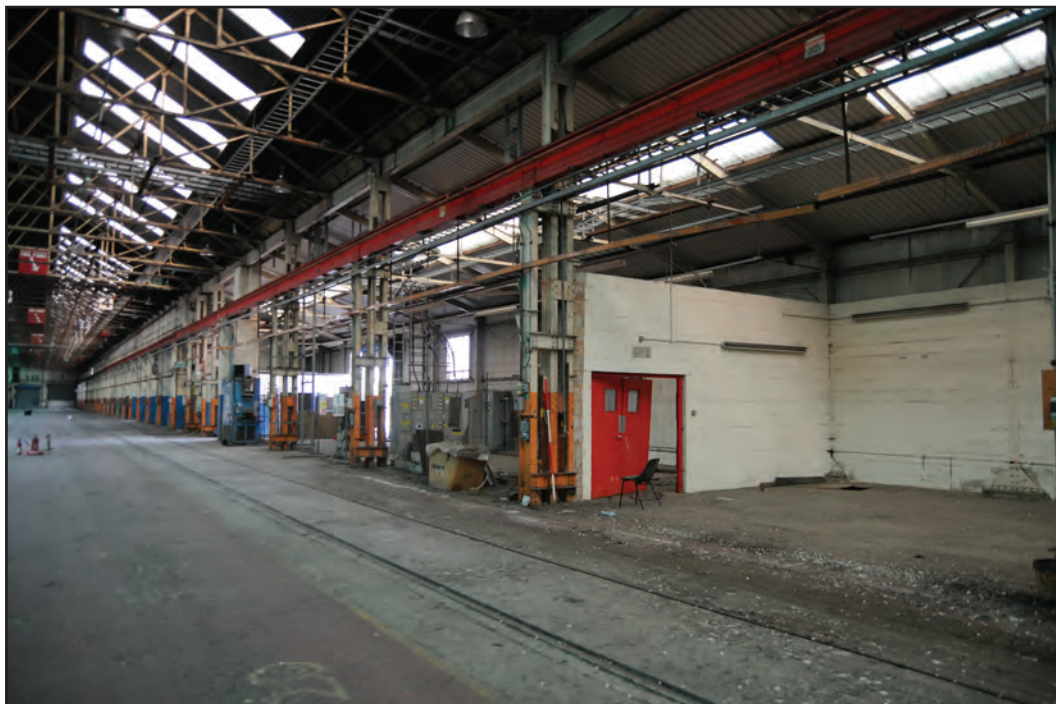
Photograph No. Washwood004
Description: Shed interiors with detail of breeze block internal division in G2
Site Location: G2/G3
Direction From: SE

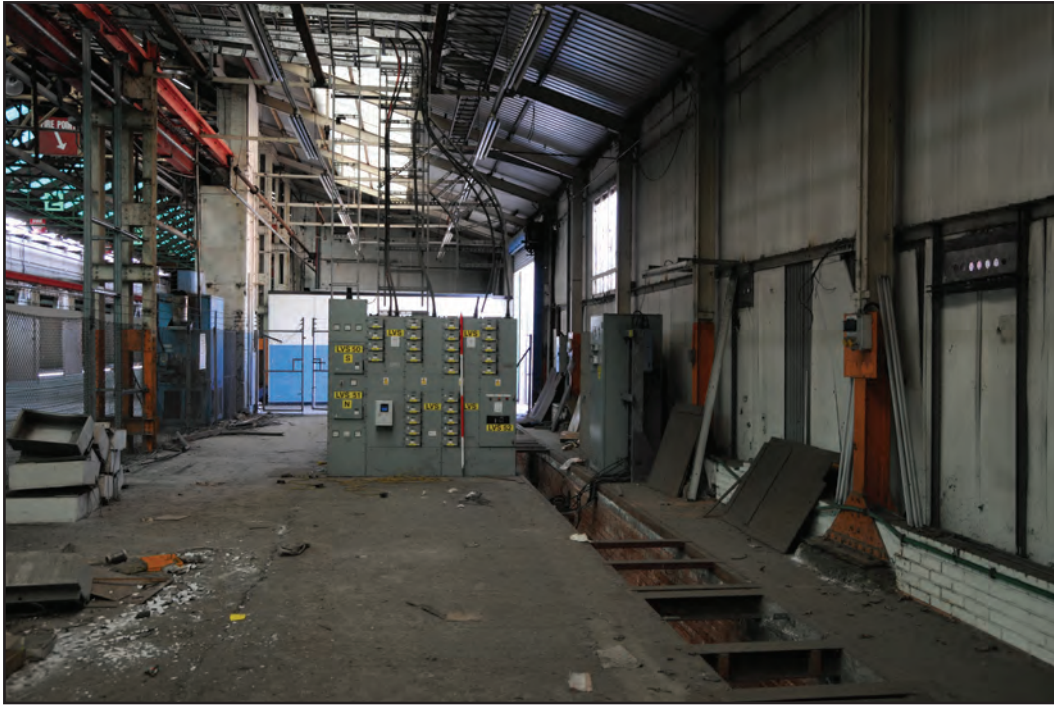
Photograph No. Washwood005
Description: Shed interior with inspection trench and electrical boxes
Site Location: G2
Direction From: E

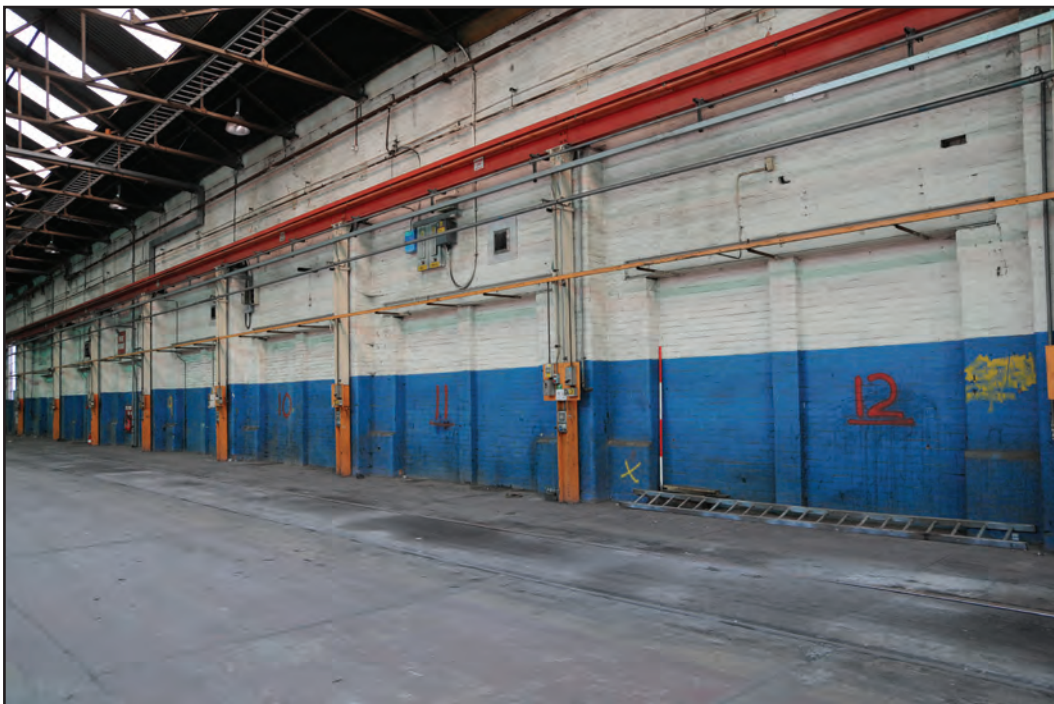
Photograph No. Washwoodo10
Description: Brick wall on north side of G3 with blocked openings, stanchions and steel rail
Site Location: G3
Direction From: SE

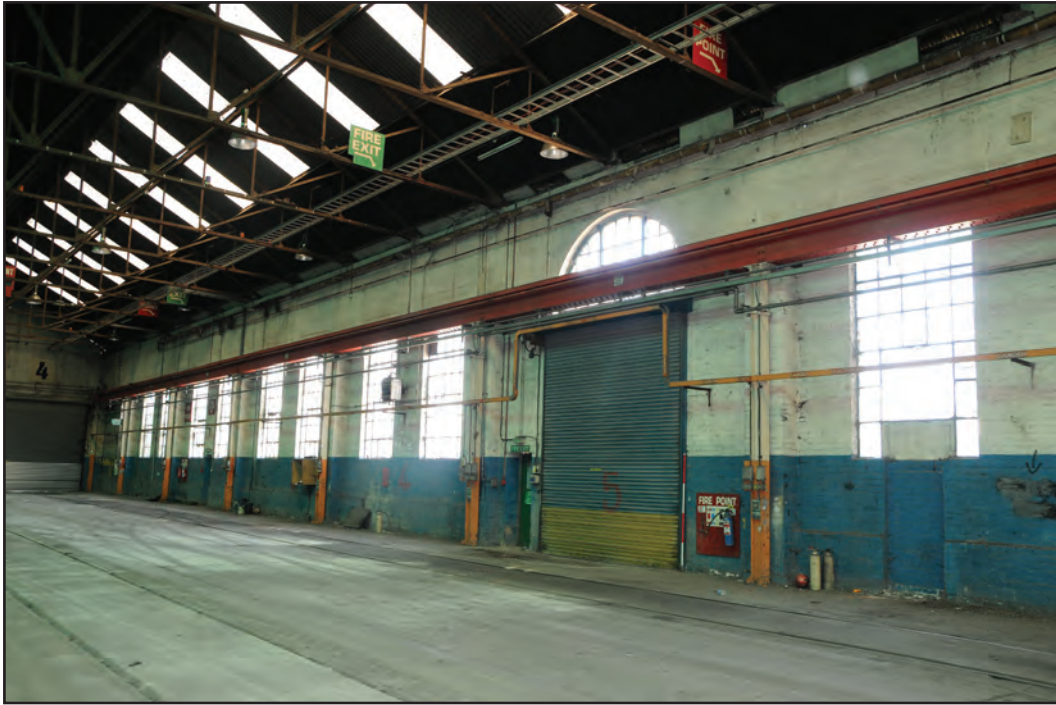
Photograph No. Washwood011

Description: Brick wall on north side of G3 (W end) with windows, roller door and steel rail

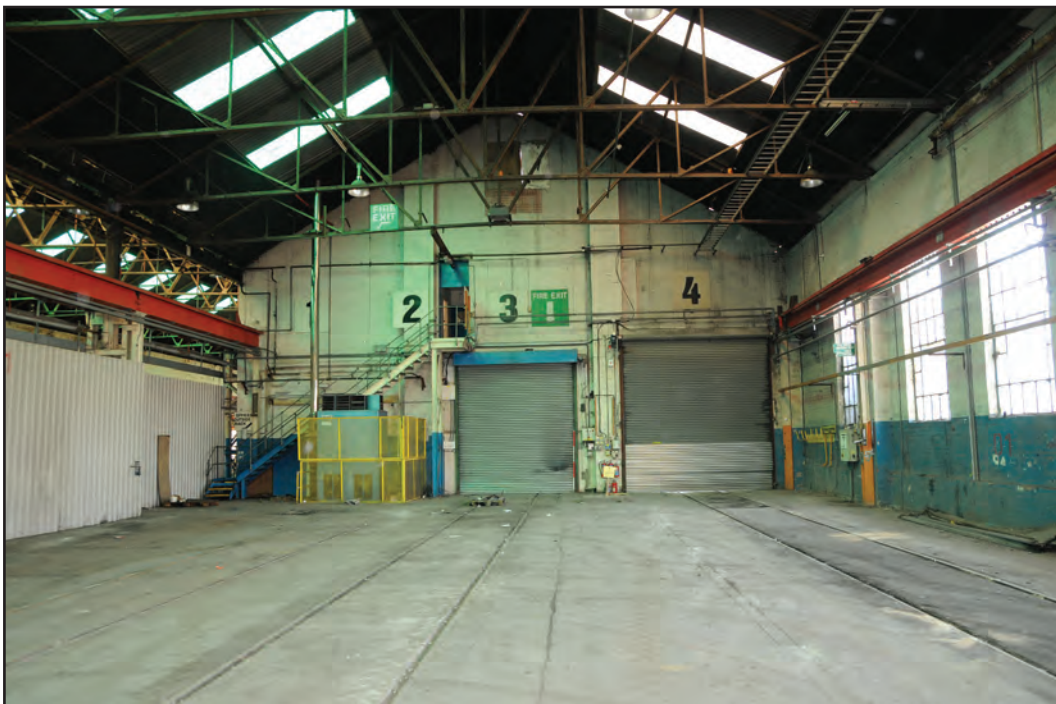
Photograph No. Washwood012

Description: west gable end of G3 with doors and stairs for entry into G6

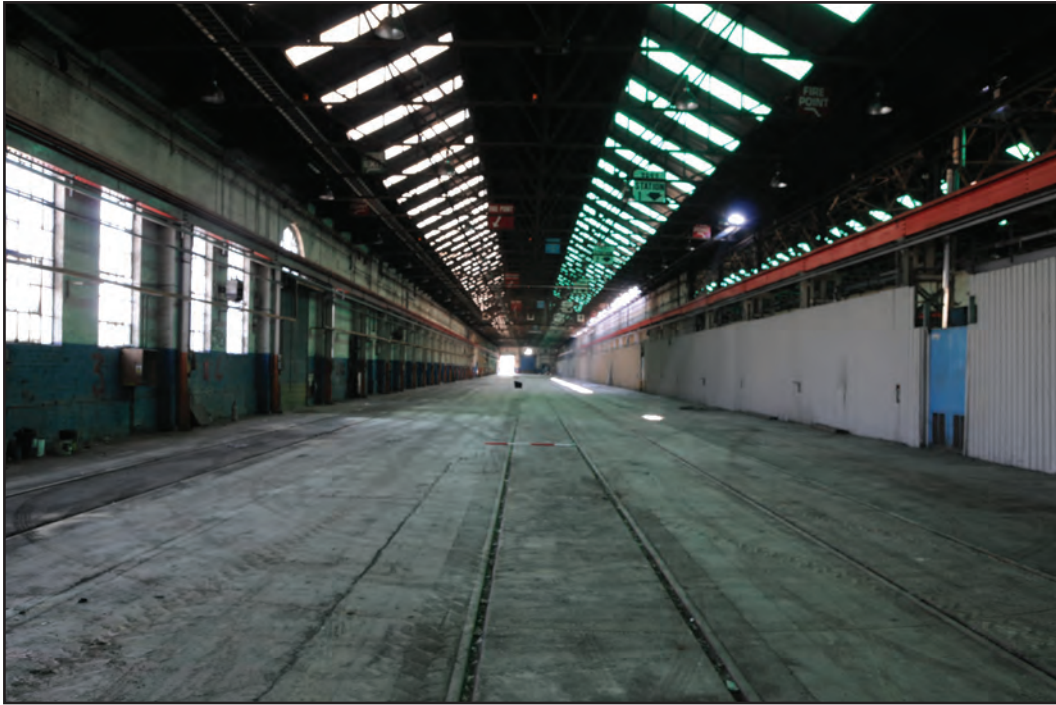
Photograph No. Washwood013
Description: Shed interior with rail tracks
Site Location: G3
Direction From: W

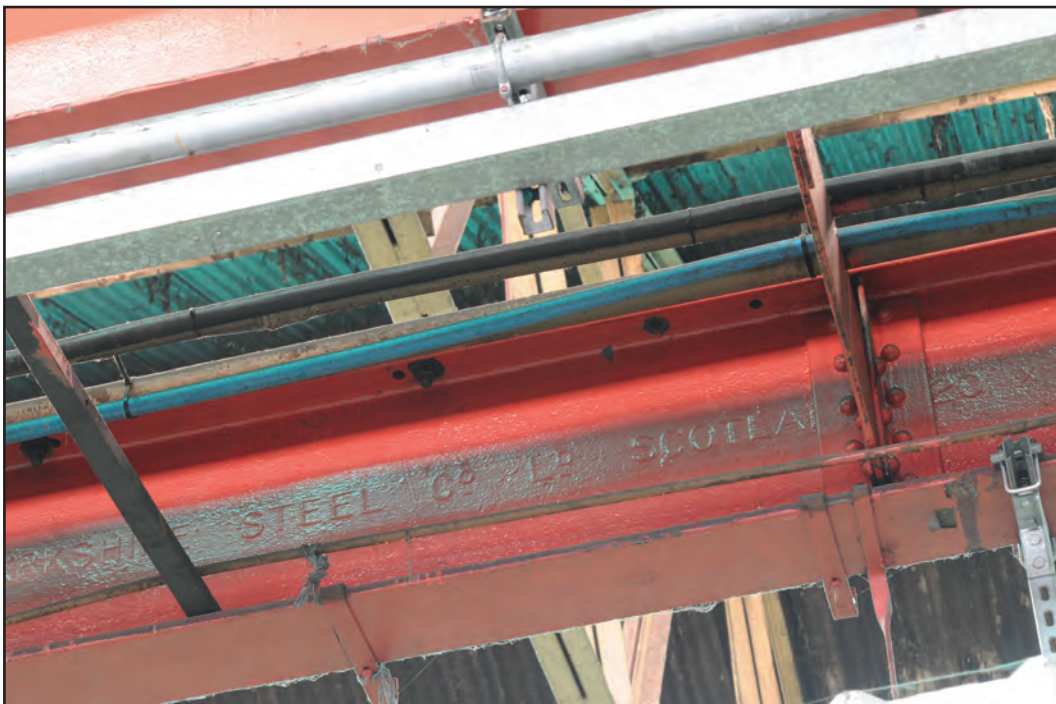
was registered in 1897 and was nationalised in 1951 under the Iron and Steel Act becoming part of the Iron and Steel Corporation of Great Britain, it is likely therefore that the foundry mark present indicates that the steel work dates somewhere between 1897 and 1951.

Photograph No. Washwood014
Description: LANARKSHIRE STEEL CO LD SCOTLAND 20 X 7 1/2 Foundry mark on steel rail
Site Location: G4
Direction From: N

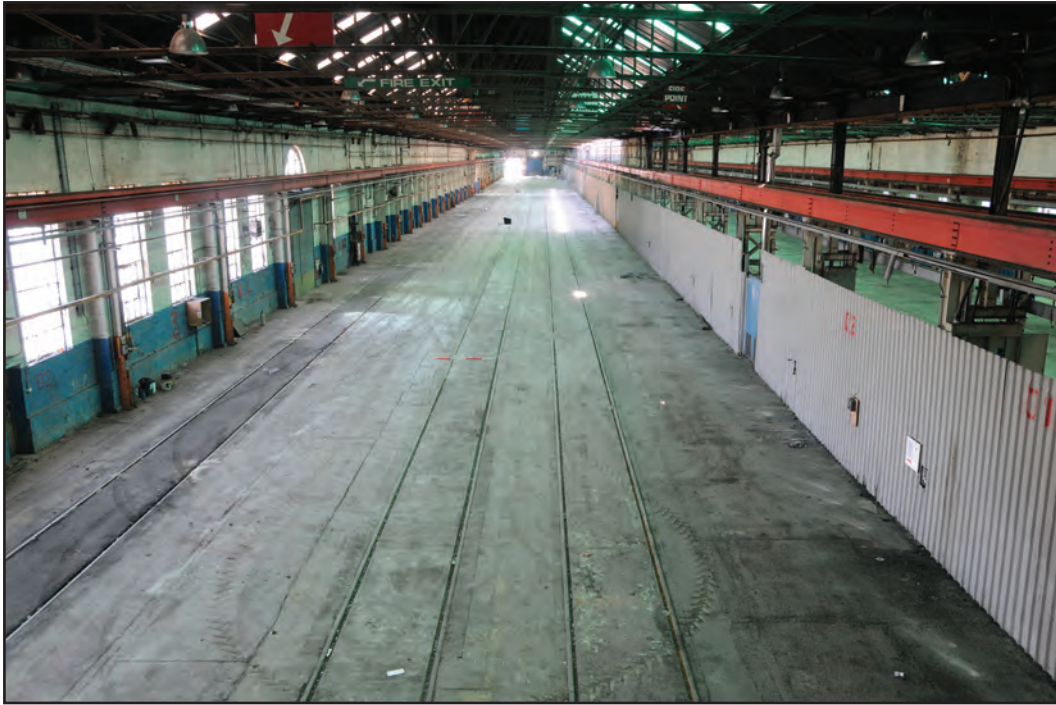
Photograph No. Washwood017
Description: Shed interior with rail tracks from top of staircase
Site Location: G3
Direction From: Above W

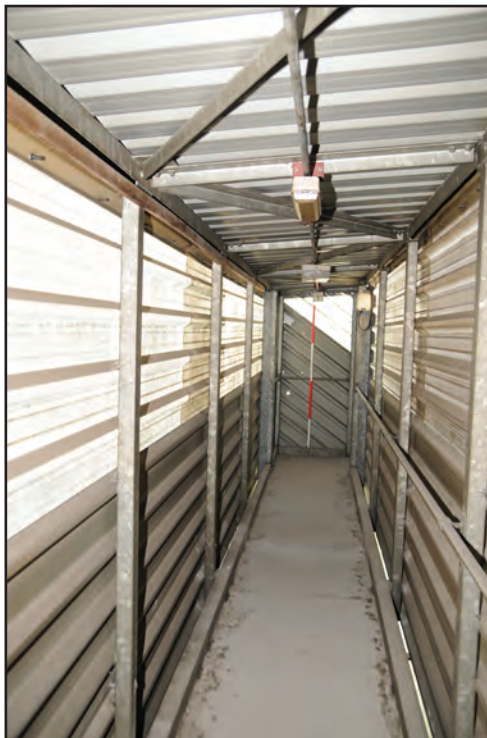
Photograph No. Washwood018
Description: Bridge on 1st floor to gain access from external staircase on north
Site Location: G7
Direction From: S

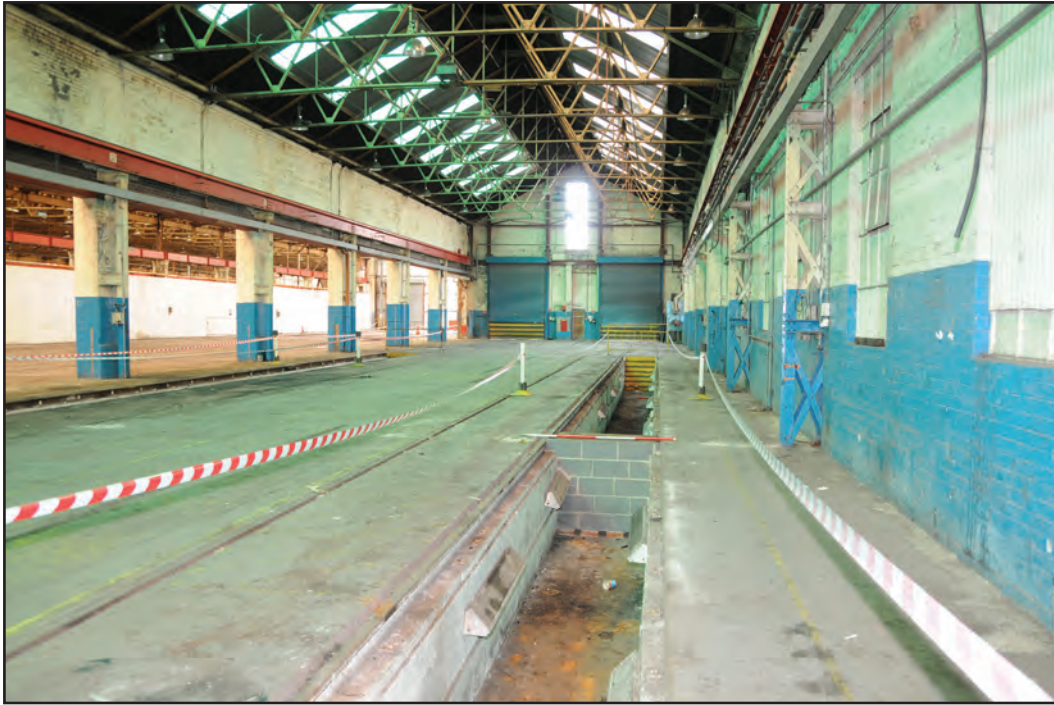
Photograph No. Washwood021

Description: west gable end with roller door entries, inspection trenches and south side brick pilasters

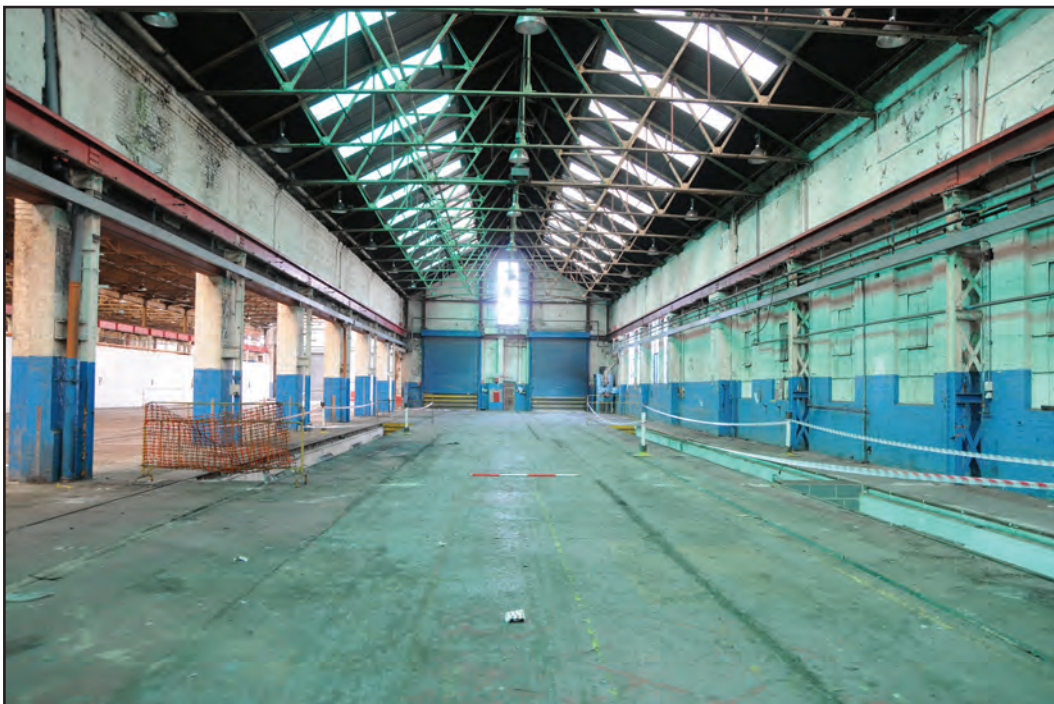
Photograph No. Washwood022

Description: west gable end and shed interior with roof trusses

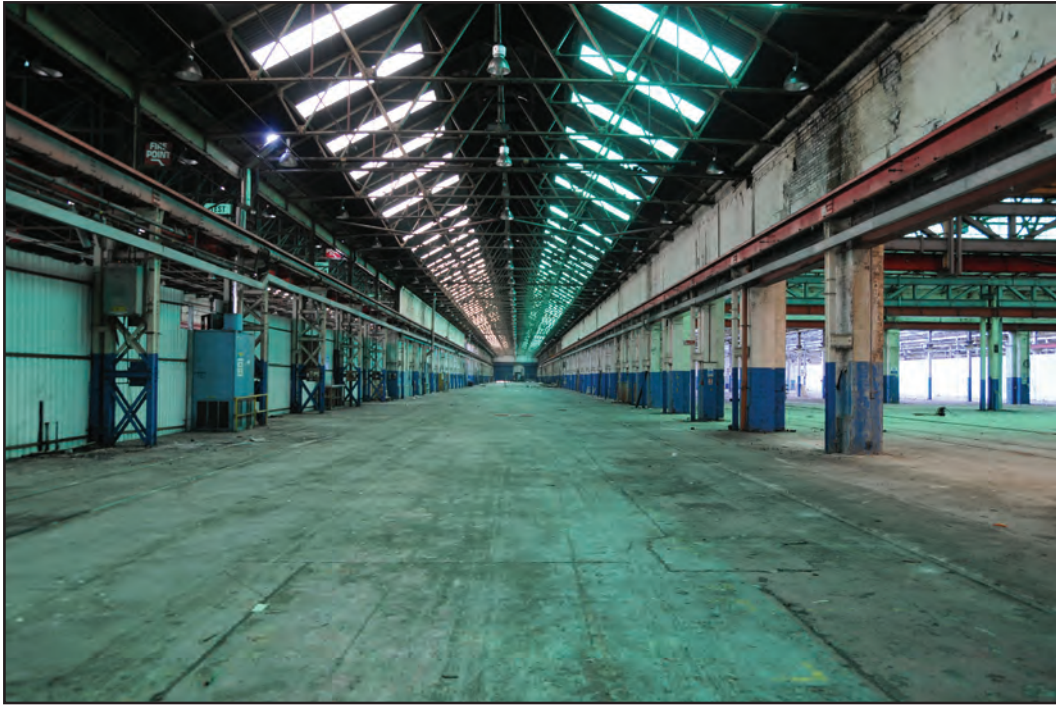
Photograph No. Washwood023

Description: Central area of shed interior with stanchions on north and pilasters on south side

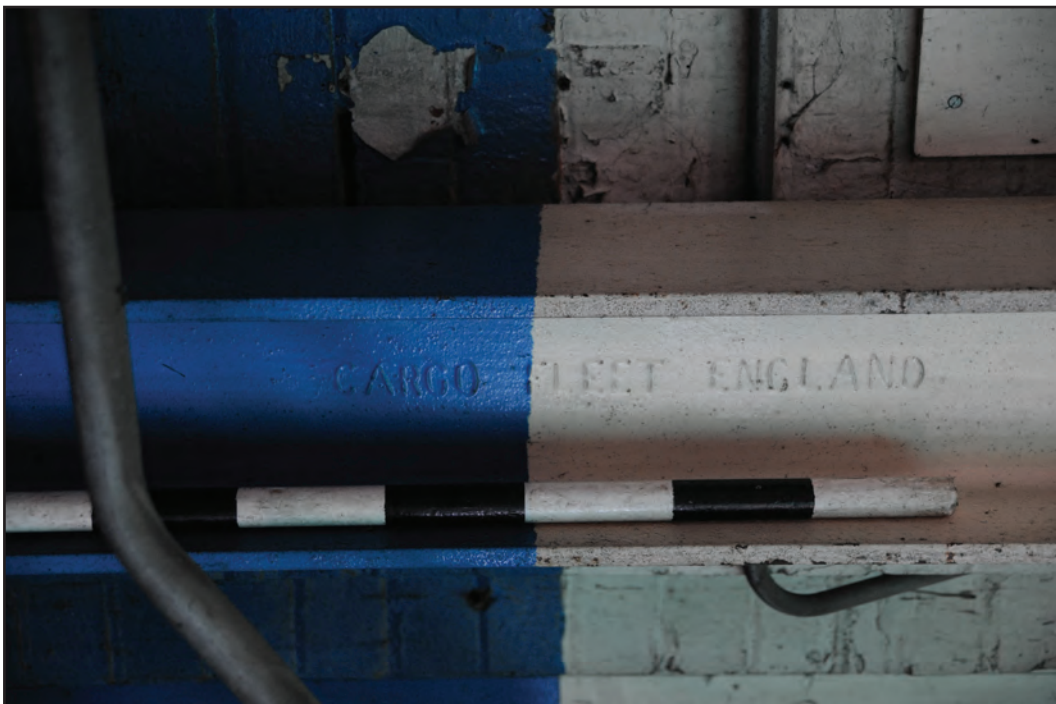
Photograph No. Washwood024

Description: CARGO FLEET ENGLAND foundry stamp on west gable end interior

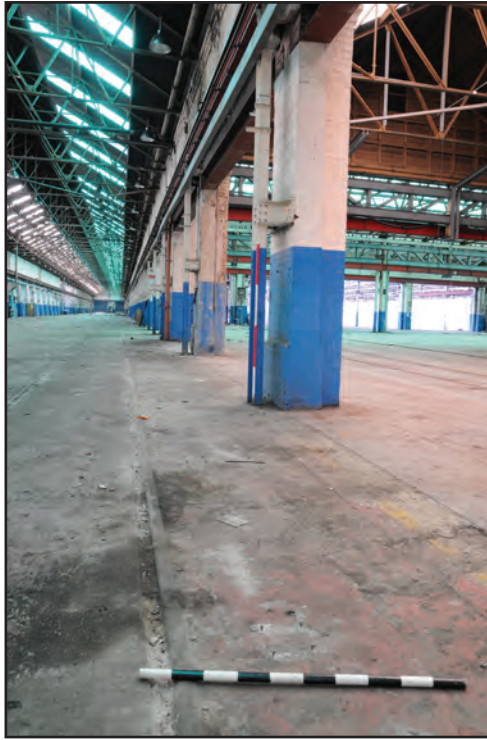
Photograph No. Washwood025

Description: Brick pilaster on south side of G₄/north side of F₁ with set screws in foreground

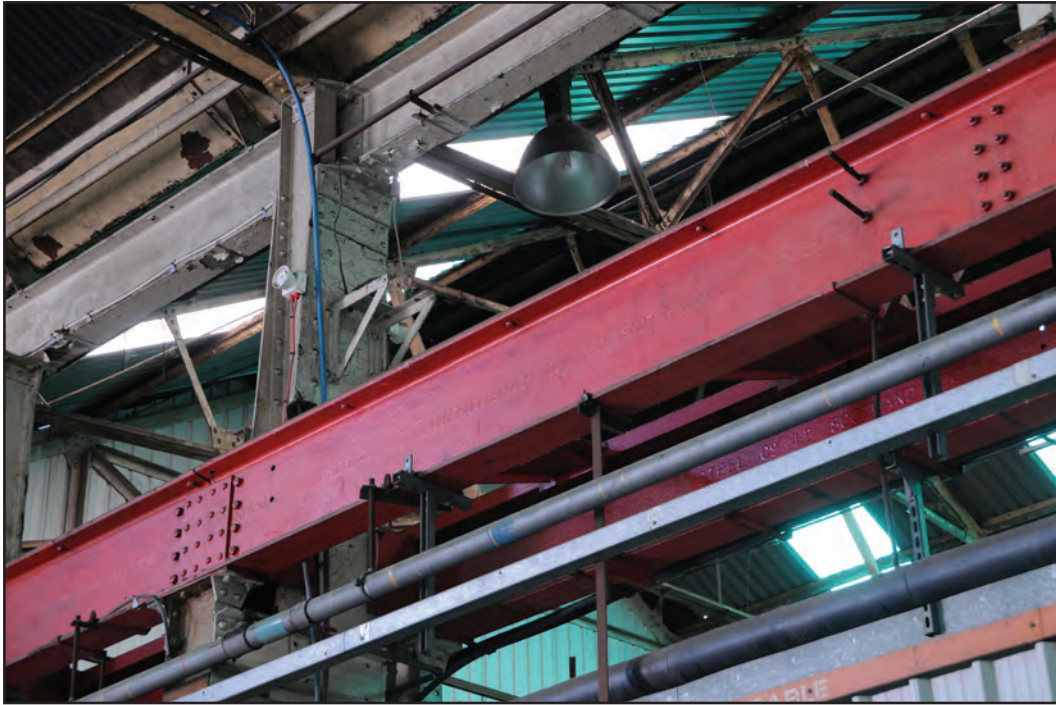
- 6.2.16 In 1912, The Appleby-Frodingham Steel Co was formed by Frodingham Iron Co taking over the Appleby Iron Co. A British Industries Fair Advert noted that the company was part of The United Steel Companies (Grace's Guide (d) 2018).

Photograph No. Washwood030
Description: APPLEBY-FRODINGHAM ENGLAND 22 X 7 foundry mark on north side rail at west end of shed
Site Location: G3
Direction From: S

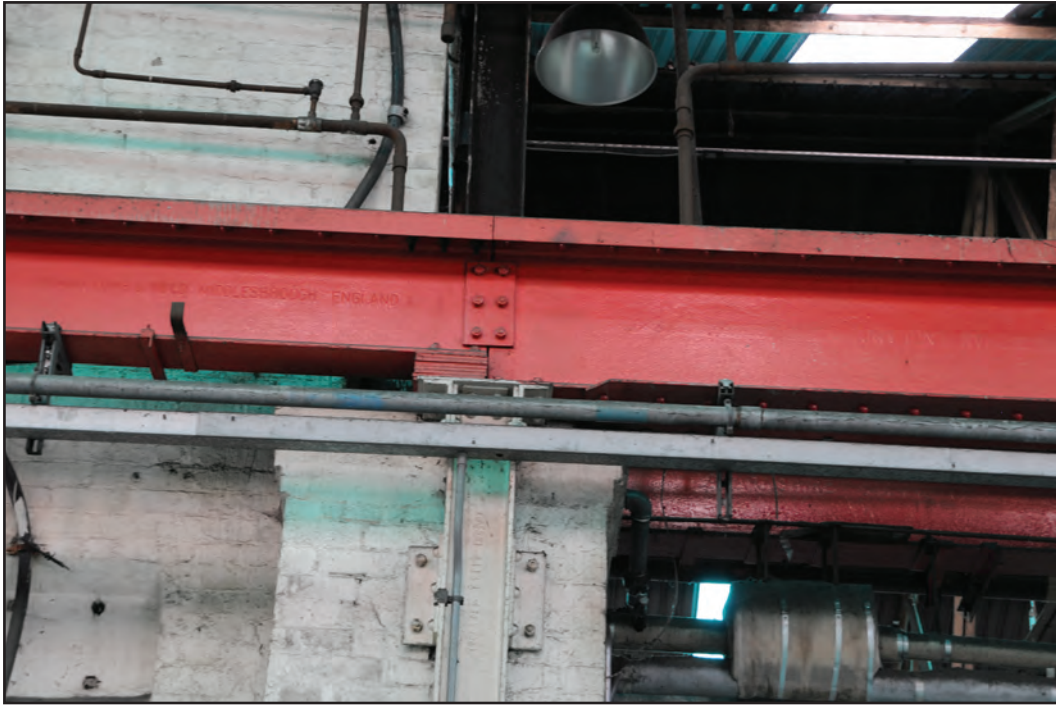
Photograph No. Washwood031

Description: Change in steel rail in centre of shed north side (aligned with west end of G2)

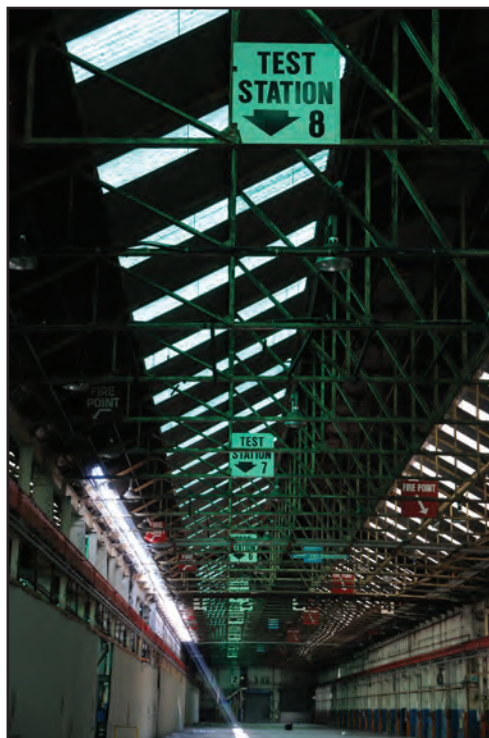
Photograph No. Washwood032

Description: Signage on roof trusses

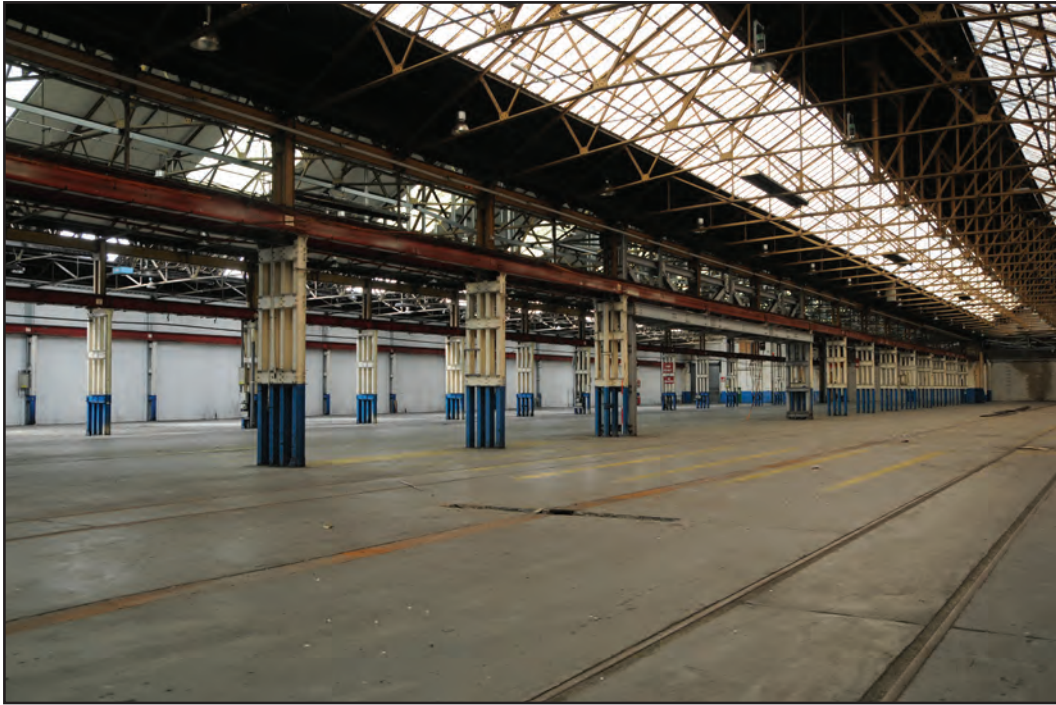
Photograph No. Washwood033

Description: View across shed interiors with train rail in foreground and stations demarcating shed divisions. Taken from within C1

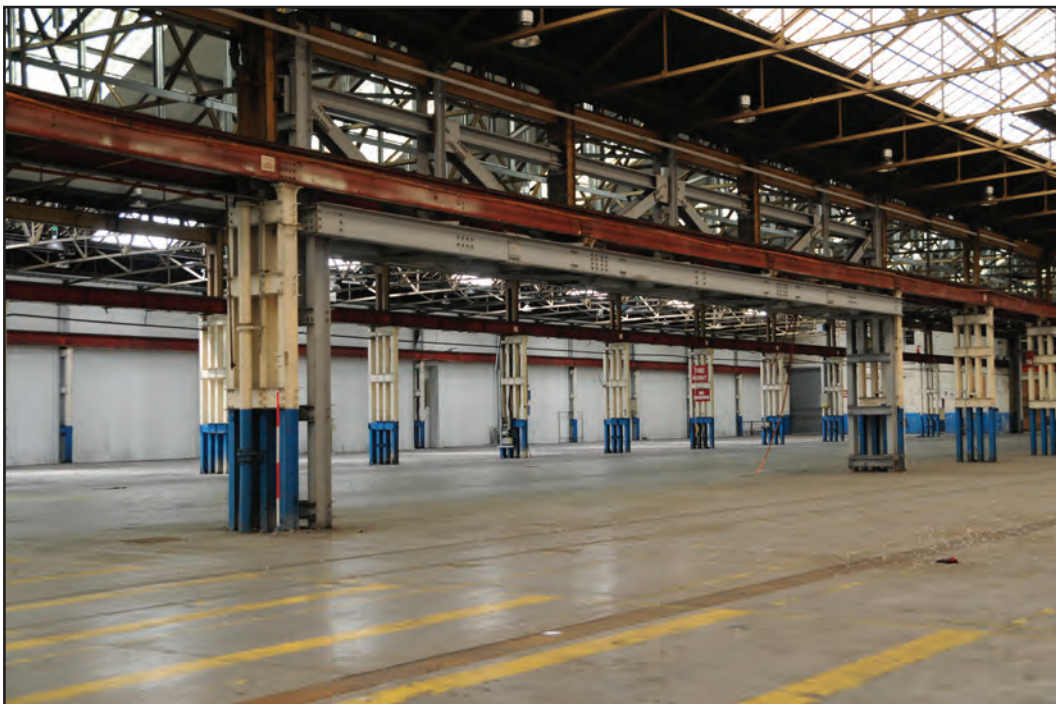
Photograph No. Washwood034

Description: Missing stanchion to allow for "sideways movement" between sheds C1 and C2

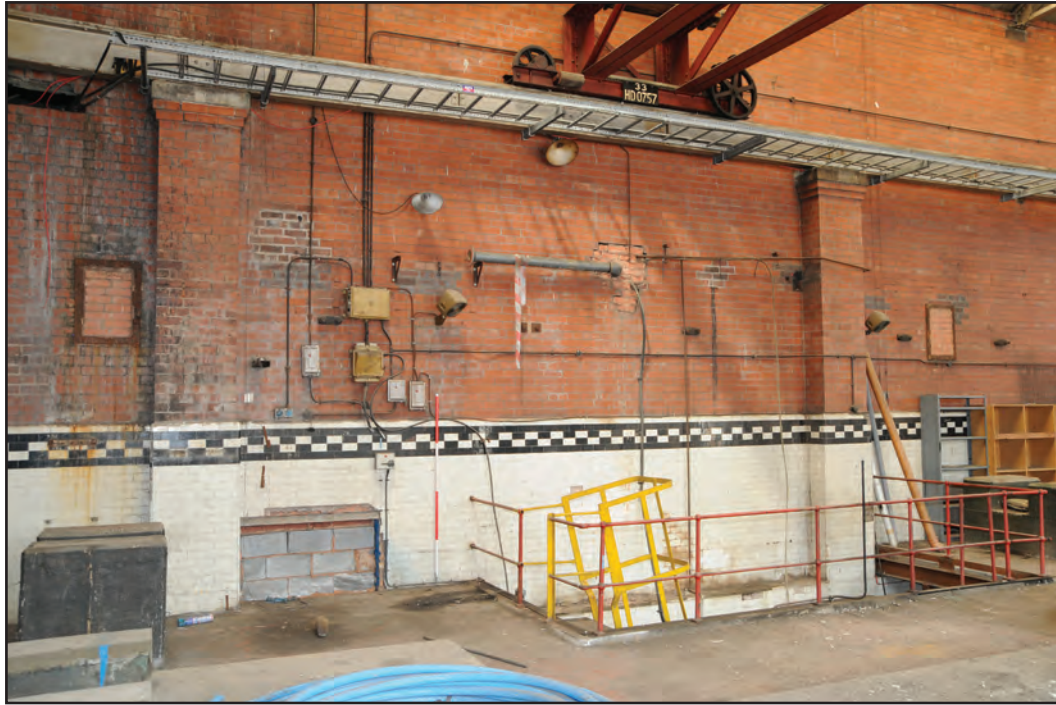
Photograph No. Washwood052

Description: Interior north elevation of first floor office space

Site Location: C6b
